Appendix A

Photos

848 Fifth Street Contractor Photos

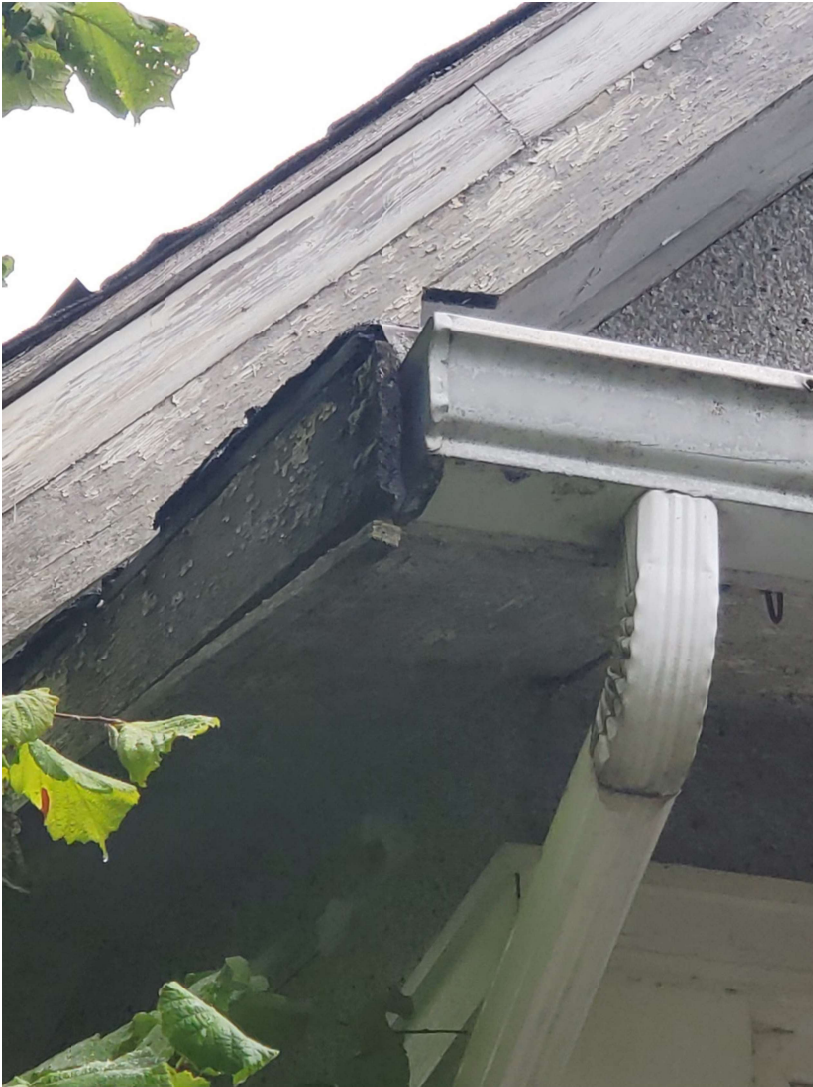
849 Roof eaves rotten and high potential of mold and structural damage

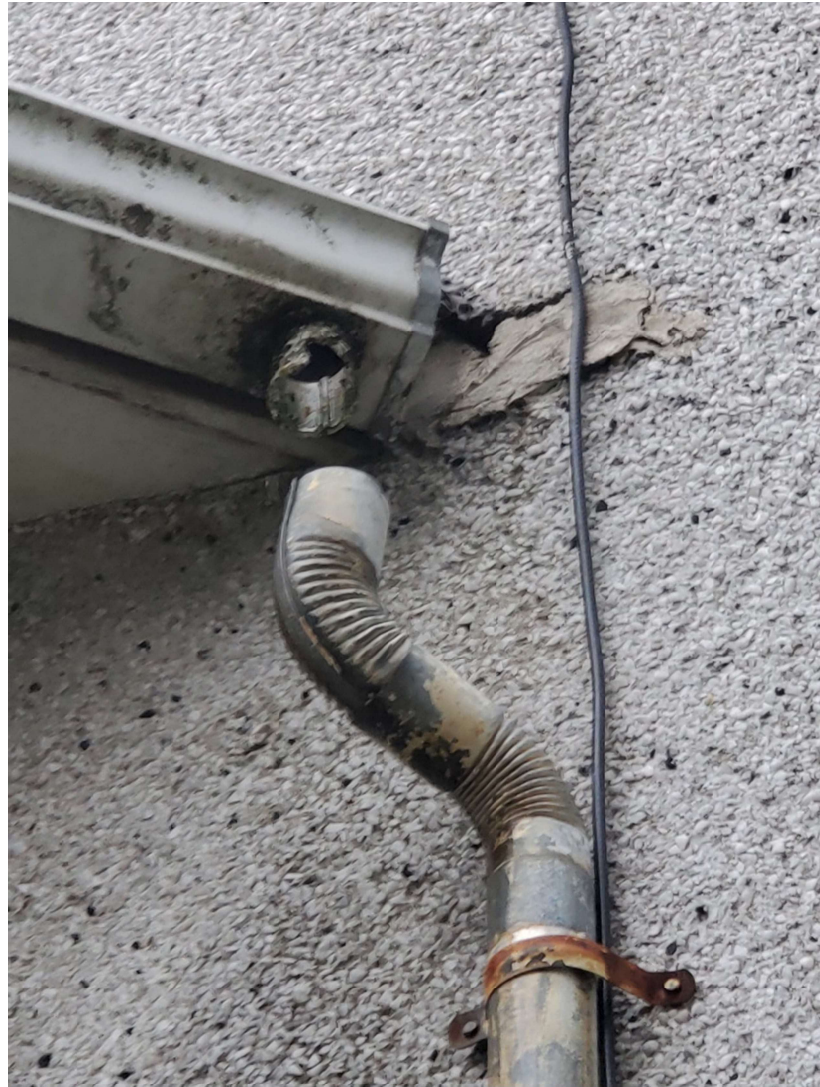
616 Long term gutter and stucco failure, high chance of internal rot and mold

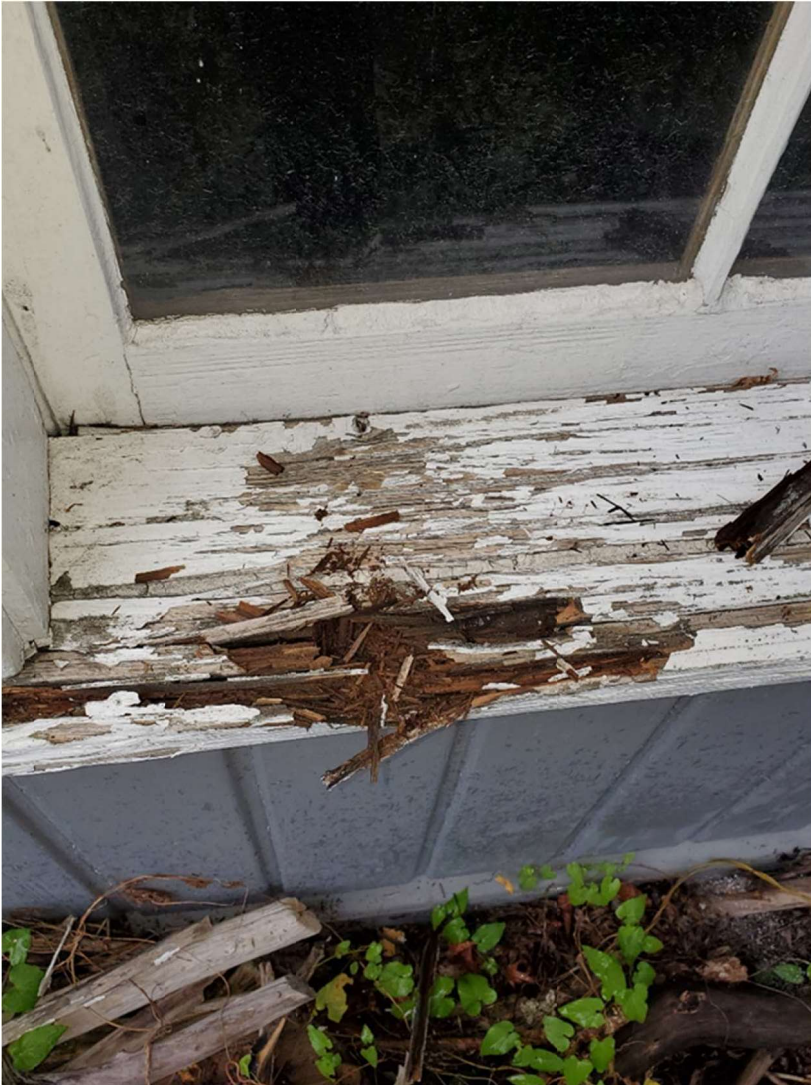
416 most wood windows beyond repair, fully decayed

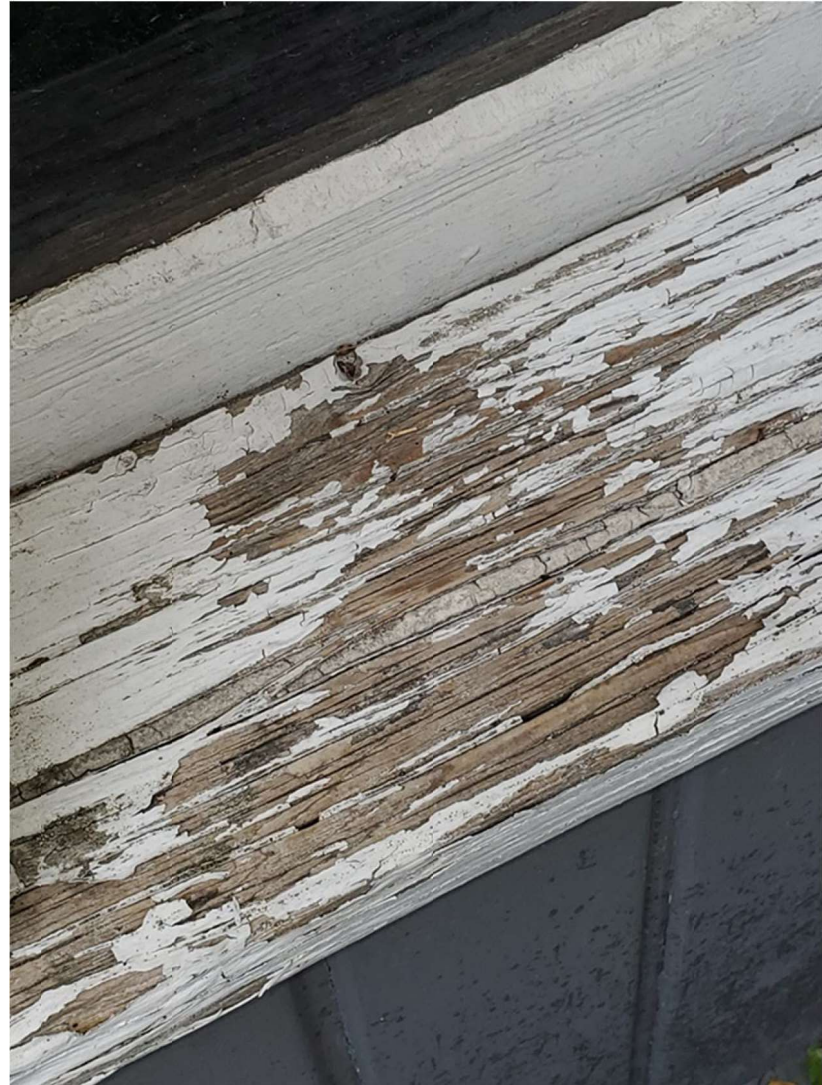
503 most wood windows beyond repair, fully decayed

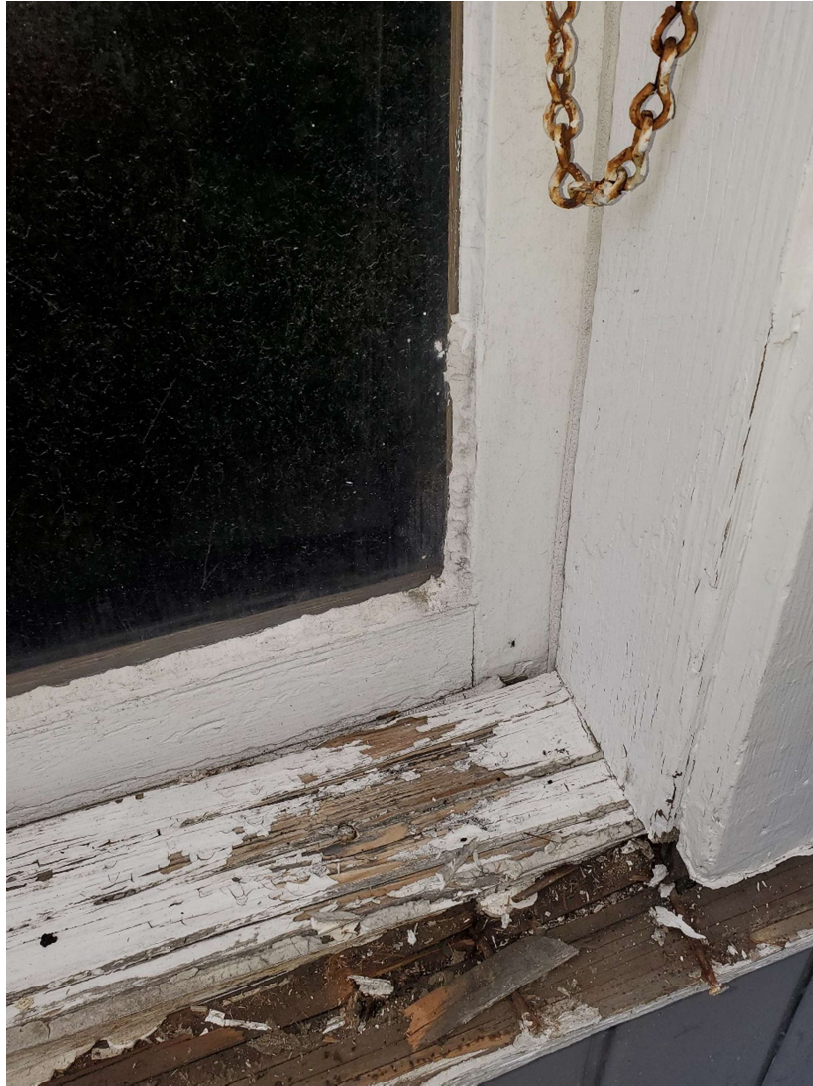
439 most wood windows beyond repair, fully decayed

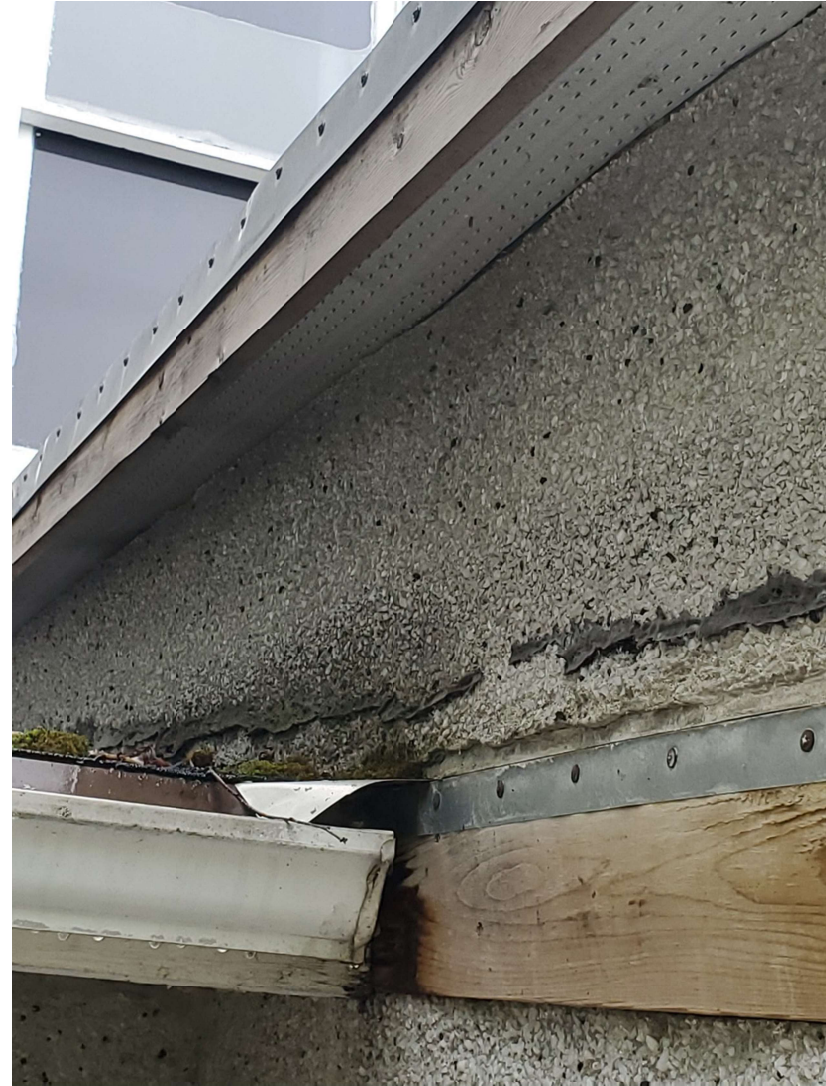
926 poorly maintained roof edges, high chance of internal water damage

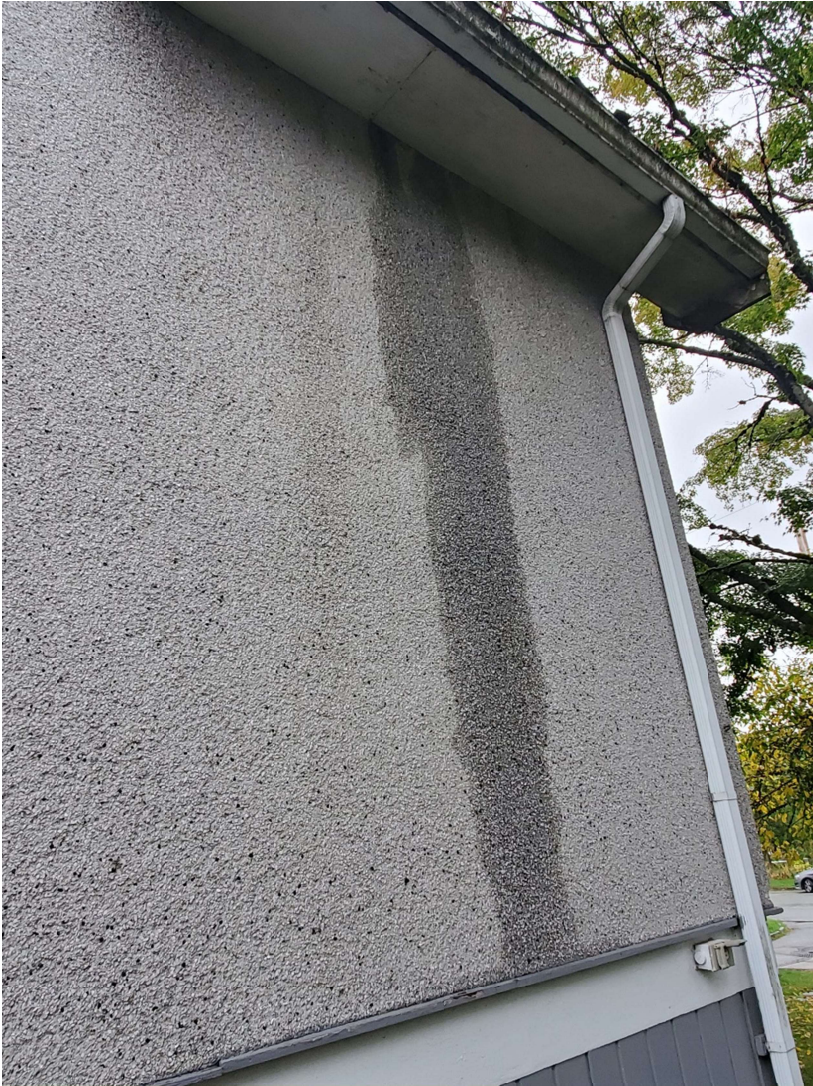
621 roof failure, high chance of structural damage

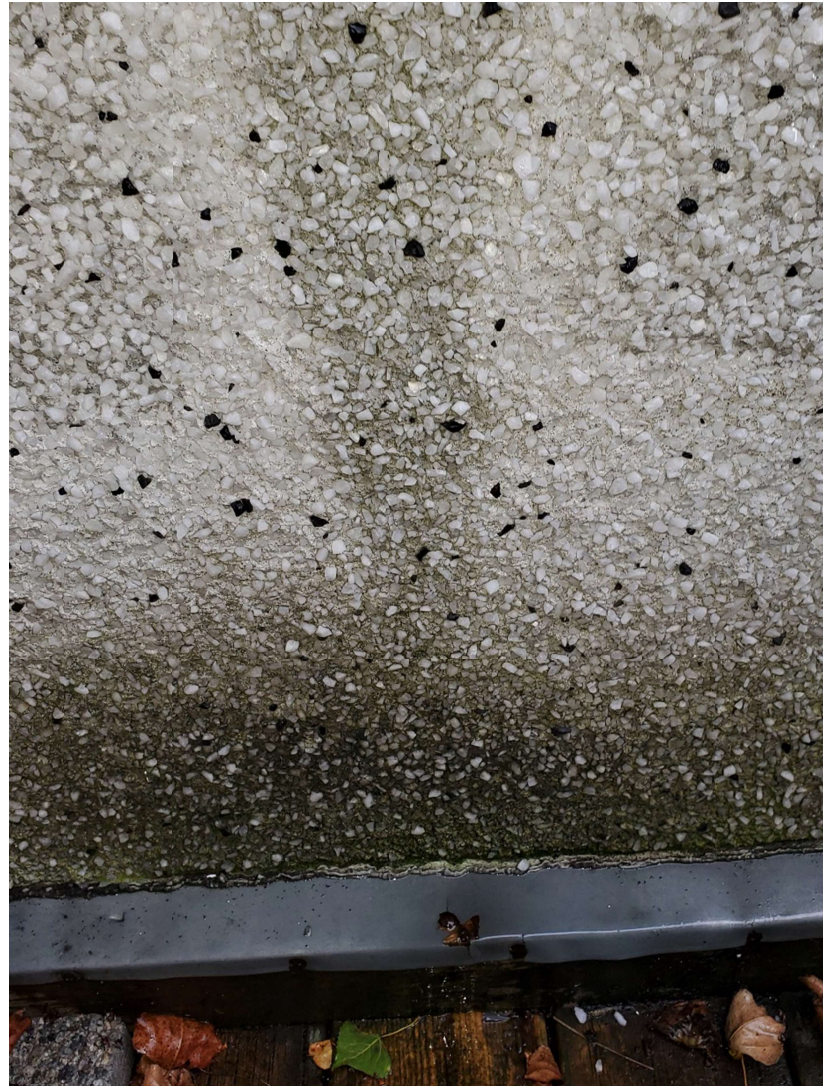
356 long term stucco failure, high chance of structural damage

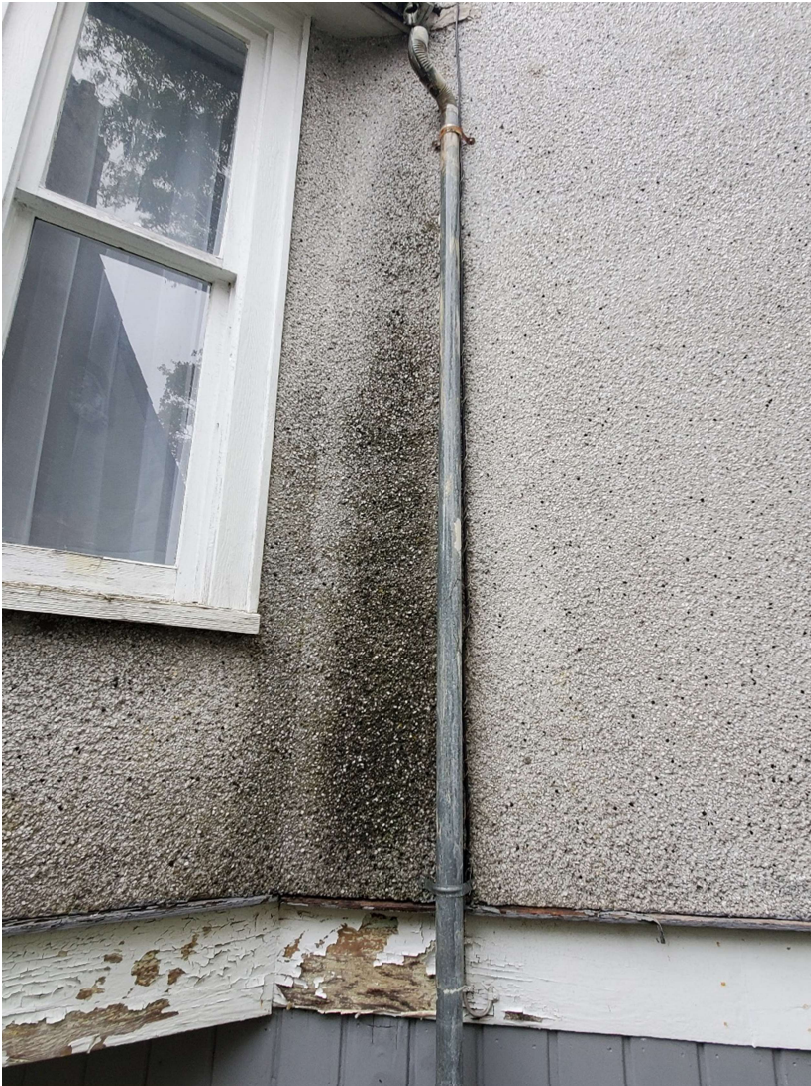
608 long term gutter failure, high chance of structural damage

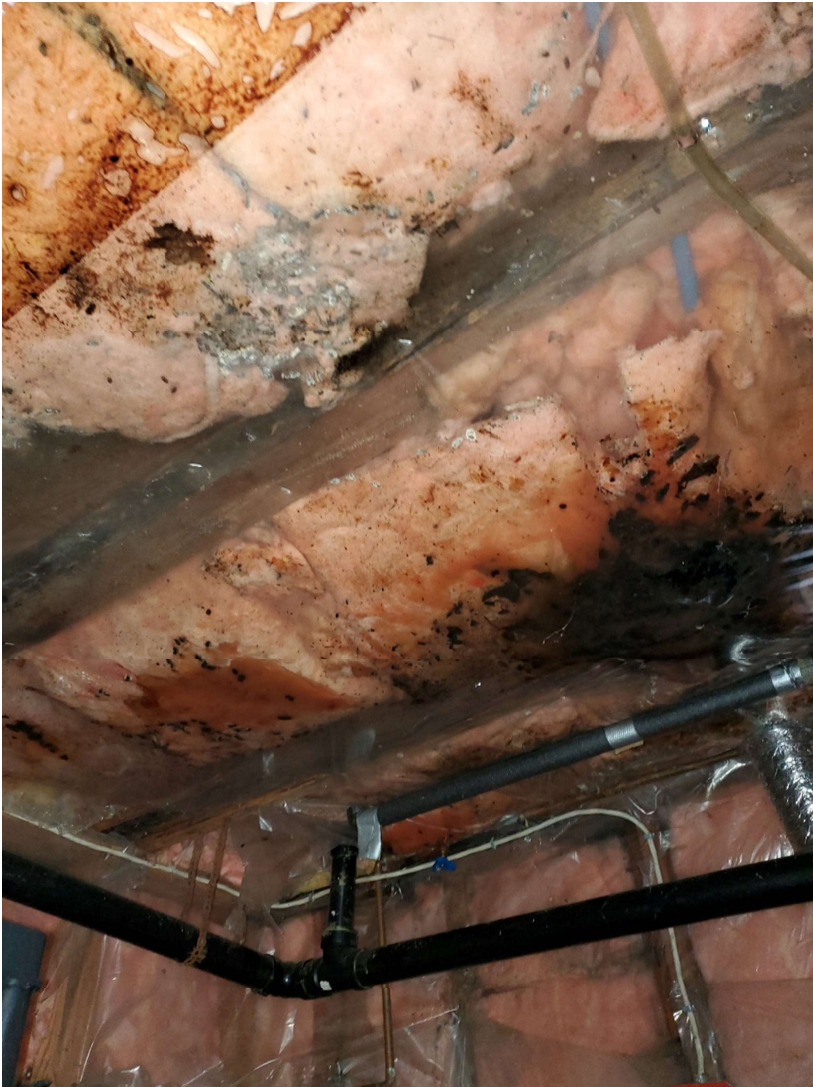
037 active water damage evident in basement along with mold

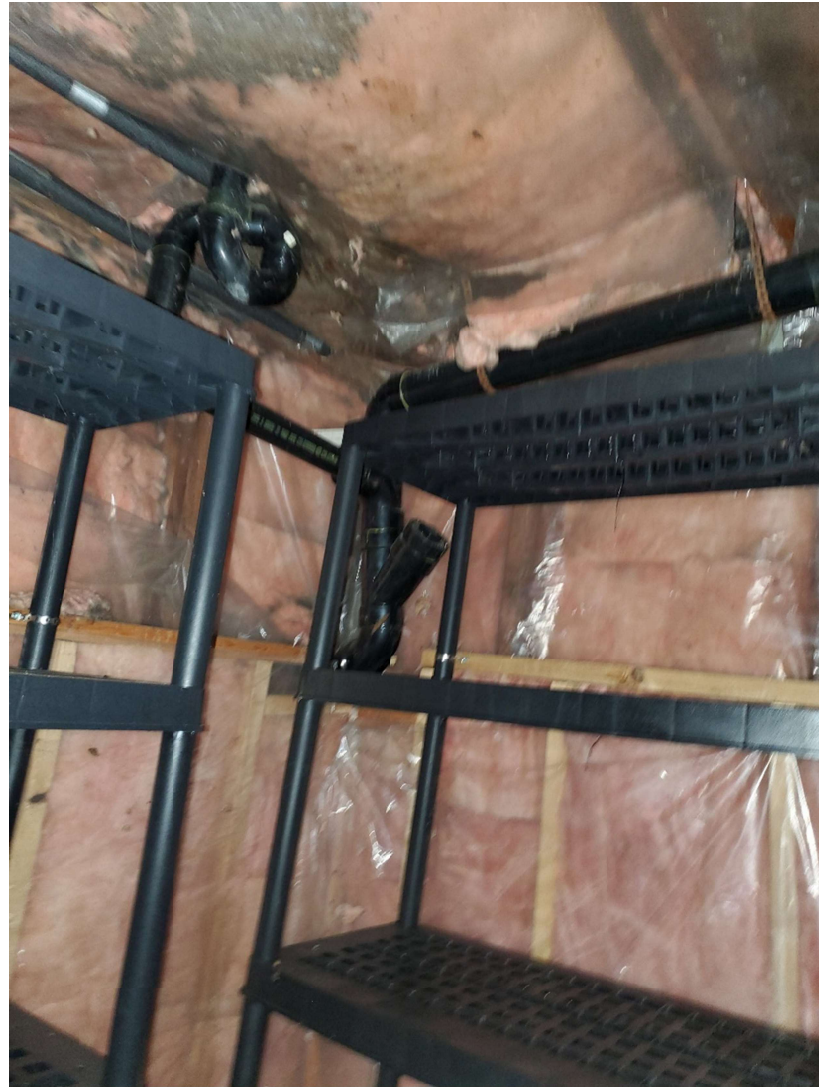
049 water damage

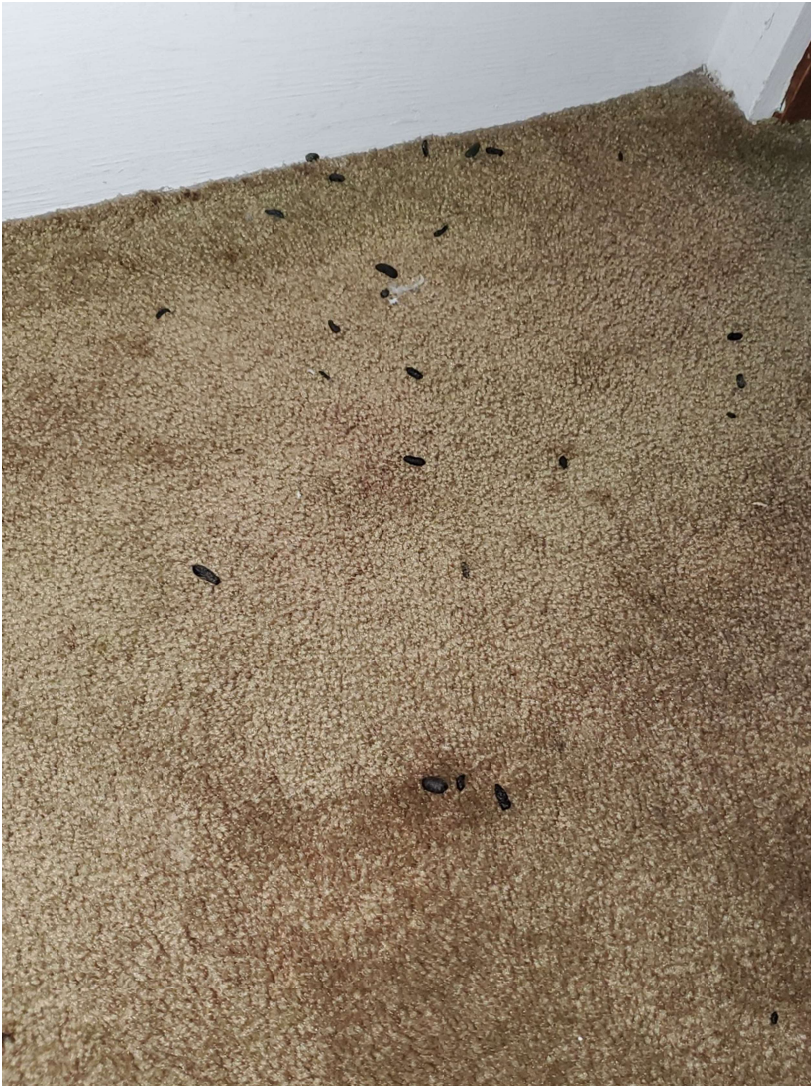
209 Rodent infestation (rats)
