# Heritage Conservation Plan

102 Seventh Avenue, New Westminster BC :: Maddock House ~ 1941

Prepared by Elana Zysblat, CAHP :: Ance Building Services :: Revised for September 2021

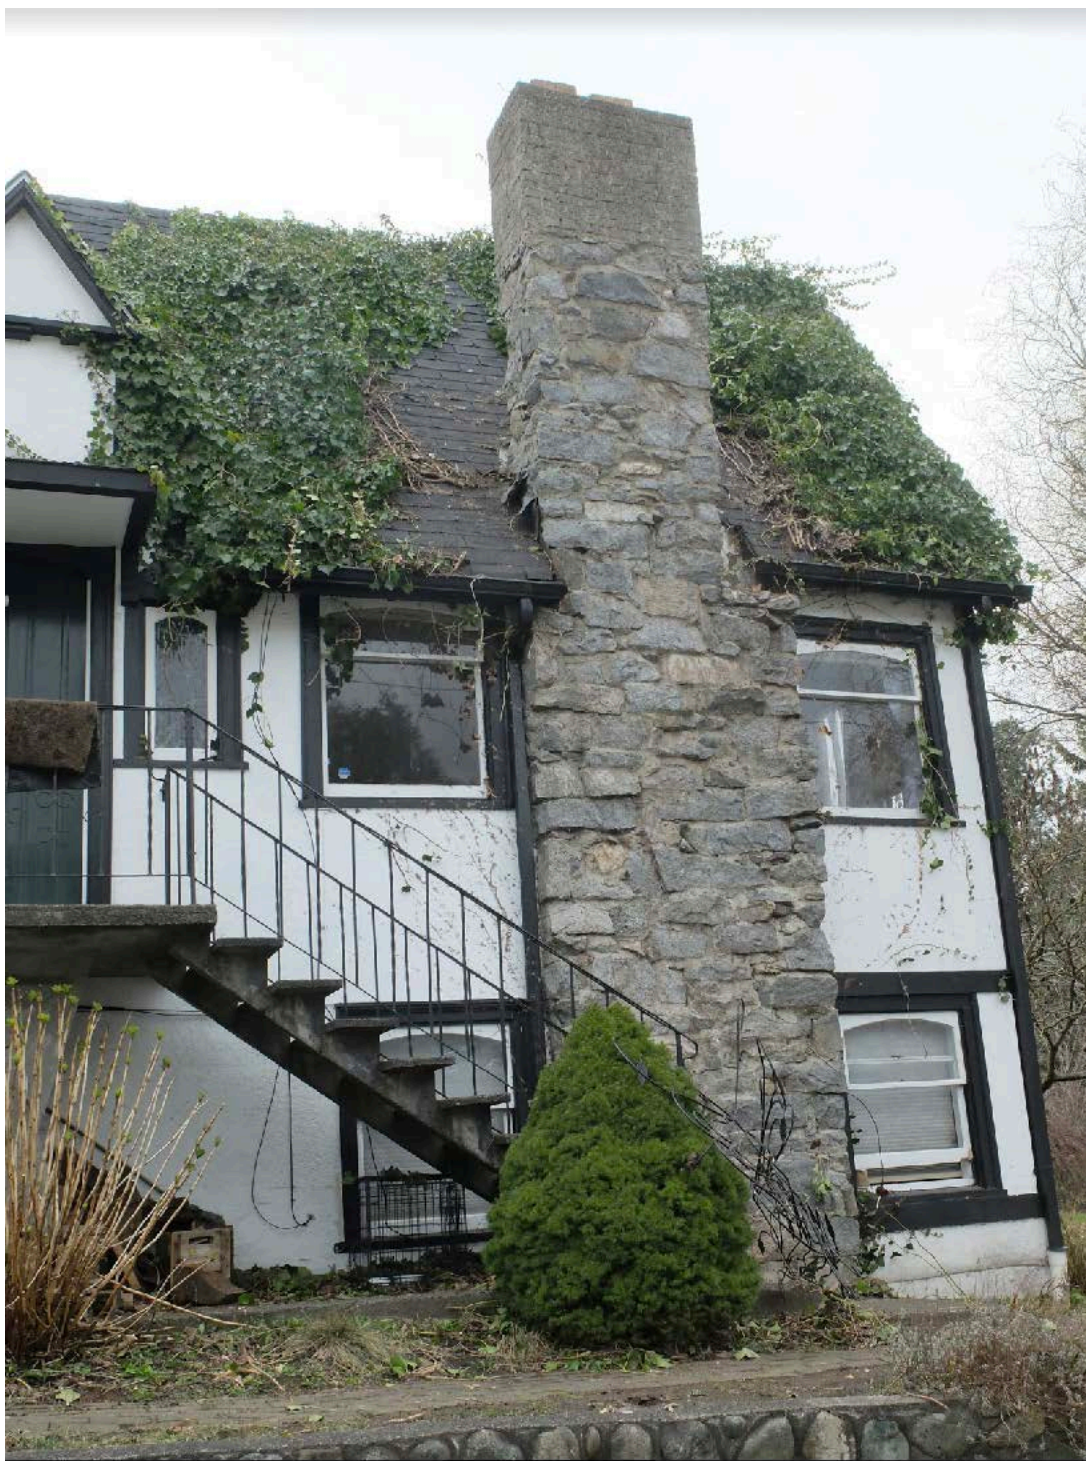
1st Street granite & concrete brick top chimney exposed after vine removal in early 2021.

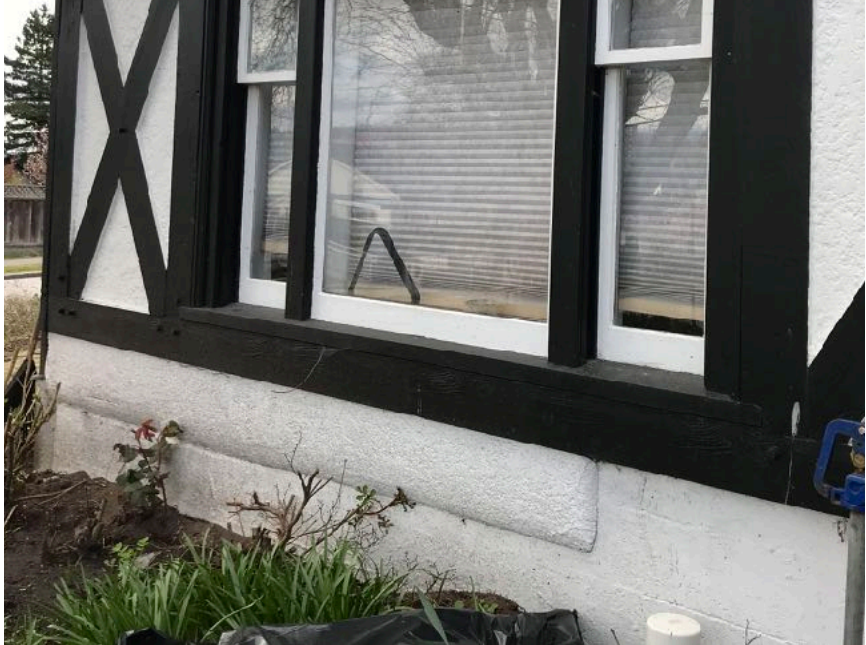
The visible portions of the board-formed concrete foundation on the exterior appear in **good** condition, but a full structural assessment of the foundation was not conducted.

Right: A photo of the northeast corner of the white-painted board-formed concrete foundation

Structural engineer to thoroughly inspect existing concrete foundation. Preserve in situ with no proposed changes.

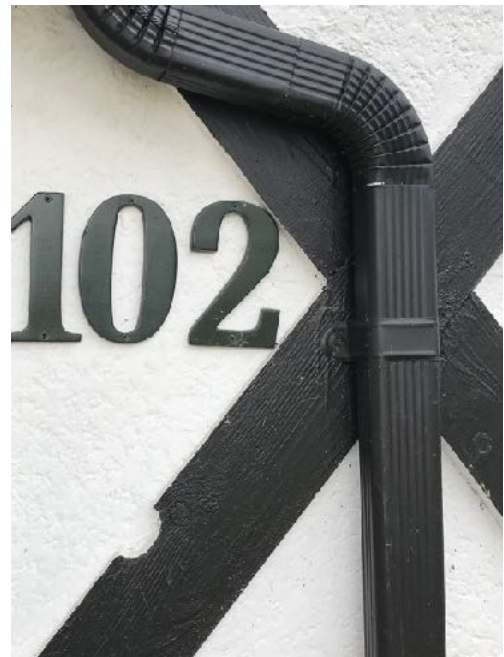
The fascia and trim boards as well as the decorative half-timbering boards are all in **good** condition. No individual board was identified as damaged or deteriorated.

Right: A close-up photo of the intentional rustic character of the half-timbering boards

Preserve all exterior wood elements in situ, unless certain boards are determined by a finishing carpenter to be damaged beyond repair and confirmed by heritage consultant. Boards that cannot be preserved are to be restored (replaced in-kind with the same dimension, profile and unique rustic finish).

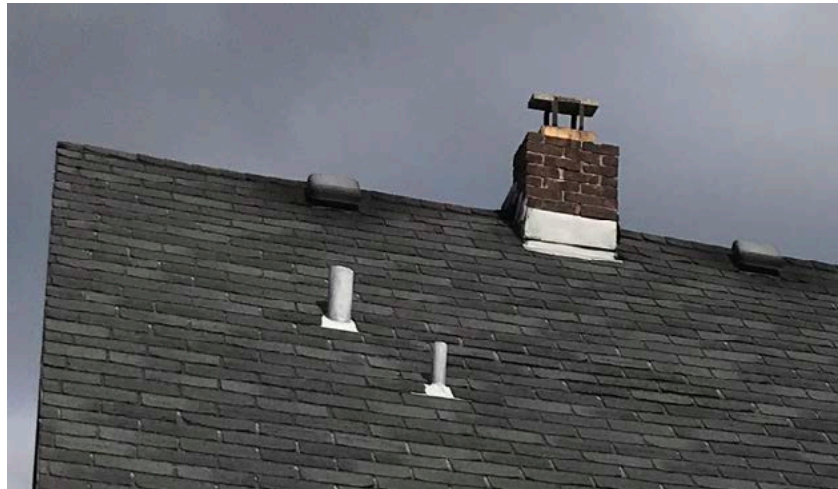
The internal brick chimney at side gable peak is in **fair** condition with gaping mortar joints and possibly inappropriate mortar. The excessive flashing is distracting. This chimney needs to be closely assessed by a conservation mason.

Work with a conservation mason to assess both chimneys and conduct careful repointing for internal red brick chimney and carry out repointing, repairs and installation of missing granite stones (rustic, organic cuts as per current character of chimney) at granite end-wall chimney. For end-wall chimney also restore missing granite stones (see missing area in photo) using the ashlar pattern and multi-sized rough cut stones, and address inconsistent repairs and brick sizes at concrete brick stack.

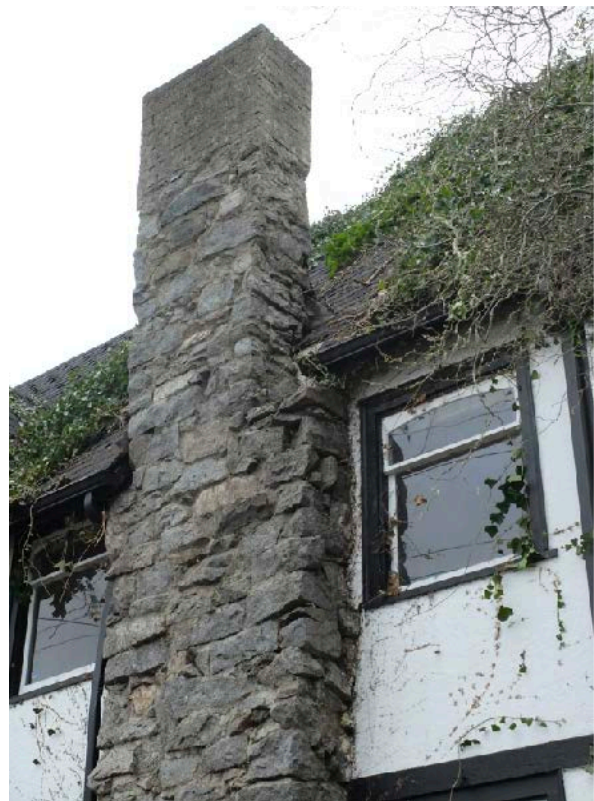
The granite & concrete brick top end-wall chimney on the 1st Street elevation is also in **fair** condition. There is evidence of inappropriate or inconsistent repairs in the concrete brick portion of the stack and evidence of missing mortar, loose granite stones and even missing granite stores on the north edge where it meets the roof. This chimney needs to be closely assessed by a conservation mason.

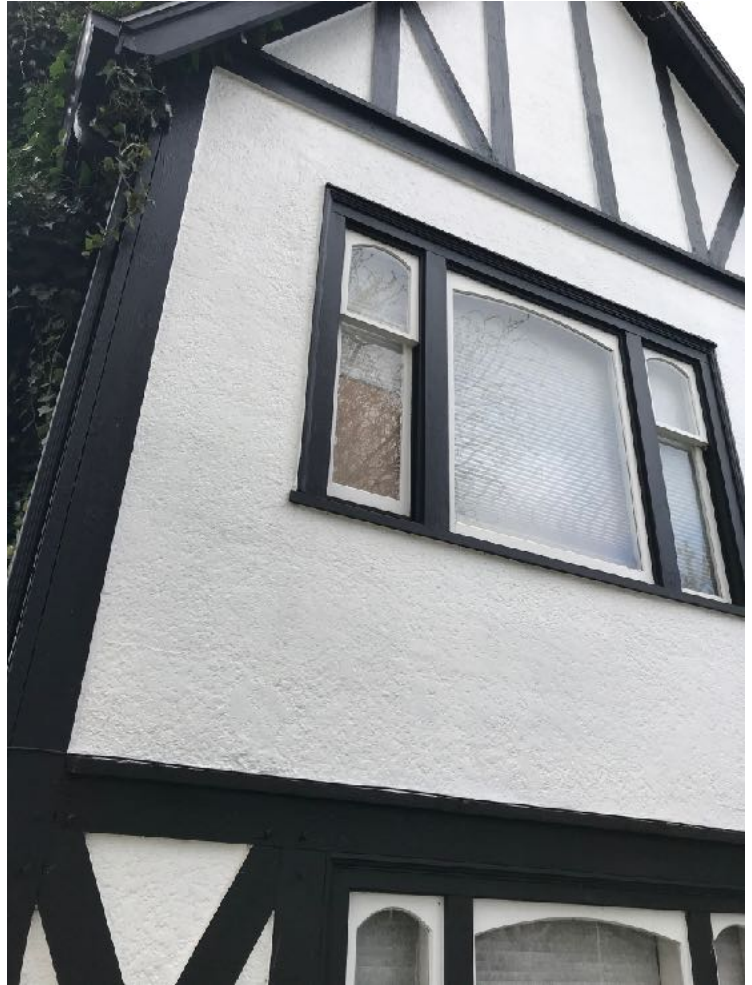
All of the windows and doors are wood and appear to be original to the 1941 construction and design. They appear to be in **good** condition but their individual operability was not assessed yet.

Right: A photo showing the segment-top wood windows.

Preserve all the windows and the front and side (1st St.) doors in situ. Assess their operability and perform any repair and maintenance needed to improve these, using an experienced finishing carpenter with proven experience in working with historic windows and doors.

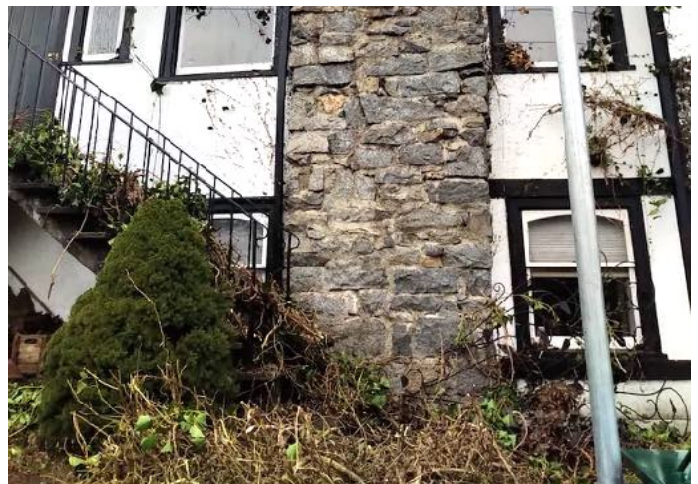
Likely a 1960s replacement of an earlier stair case, this concrete stair at the 1st Street entrance is distinguishable and subordinate as an addition and is in **good** condition. The only flaw is its unnecessary twinned flights, the northern of which blocks an original basement window and encroaches too closely on the character defining granite chimney.

Right: The northern flight of the side concrete stair blocking a window and in very close proximity to the granite chimney.

1. **Restoration:** Removal of the northern flight of a twinned stair on the East elevation, introduced in the 1960s, which cuts across a ground level window opening and partially obstructs the visibility of the character defining end-wall chimney. The southern flight, which is a stair direction deemed to be original to the design of the house, will be retained.
2. **Rehabilitation:** Adjustment of a few window and door openings on the two lowest visibility elevations (west and south) to accommodate layout changes on the interior.

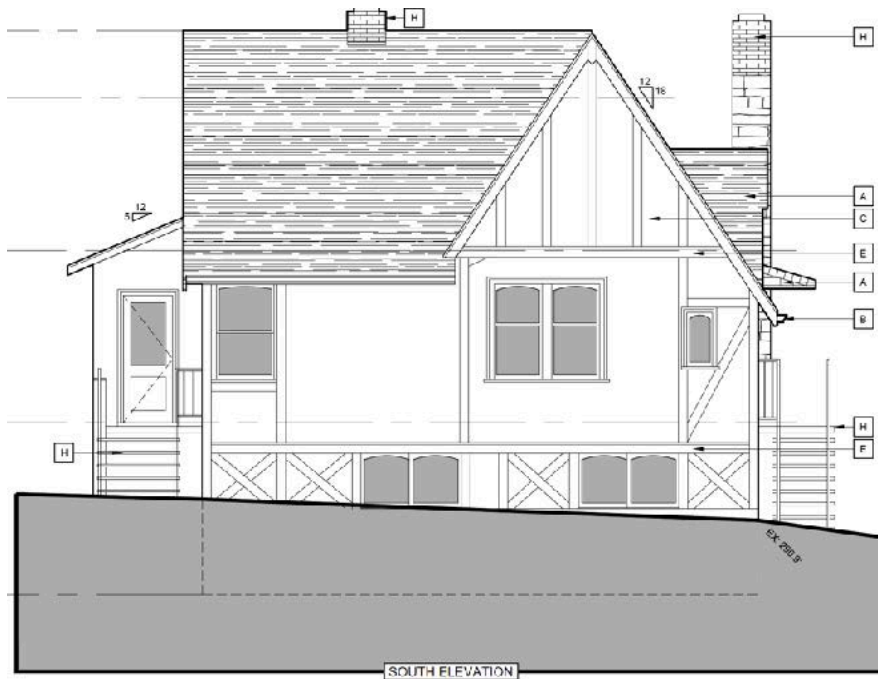
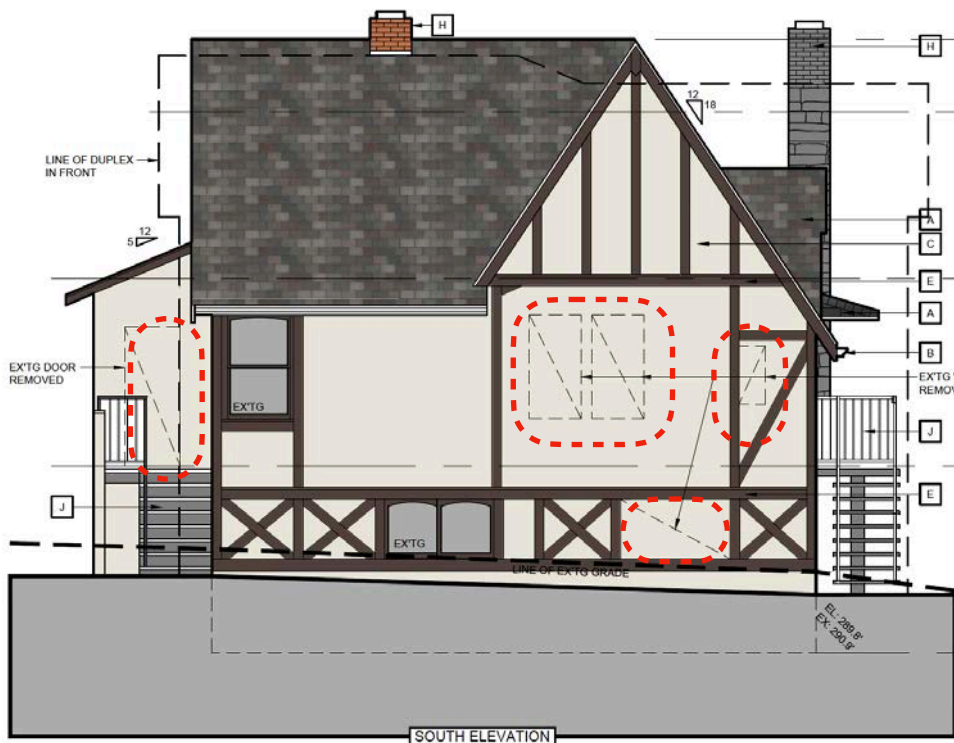
Window and door opening changes to this very low visibility elevation to accommodate adjusted interior layouts (see outlined in red on proposed elevation).

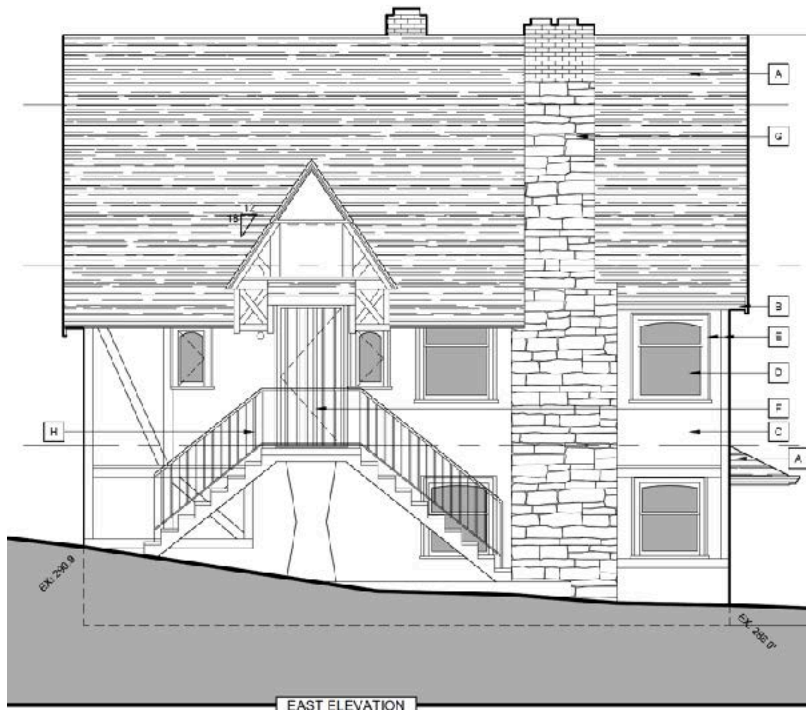
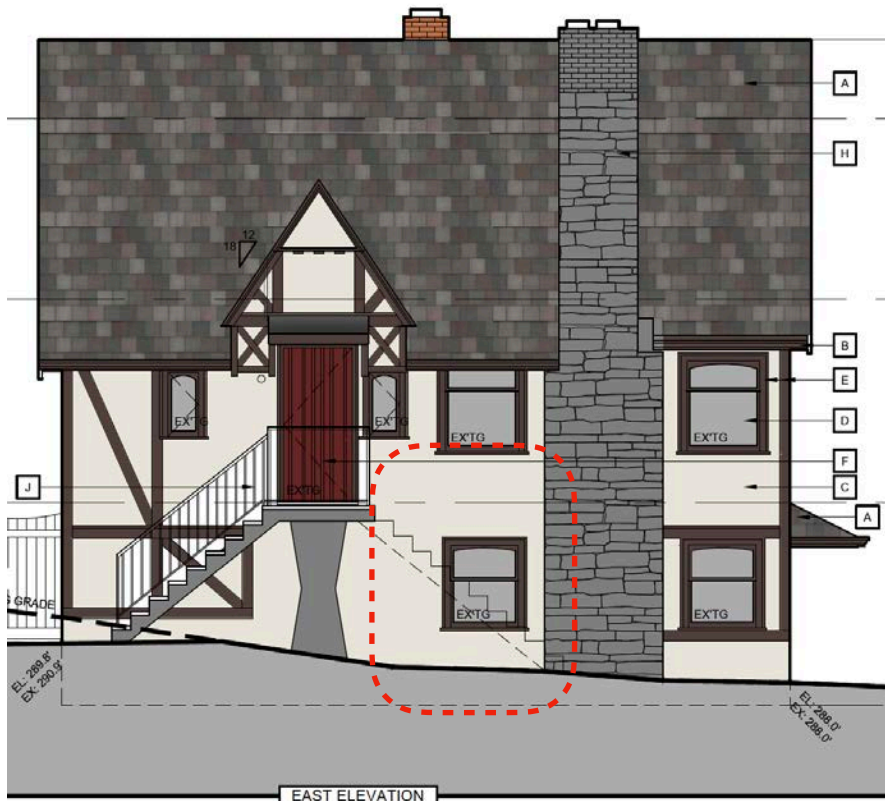
Removal of northern flight of exterior stair

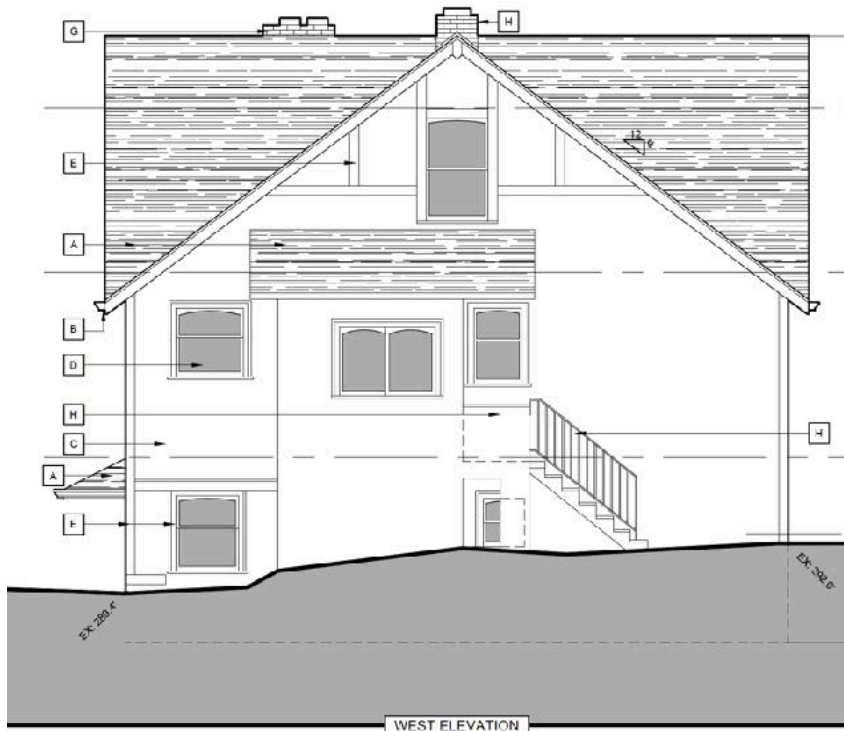
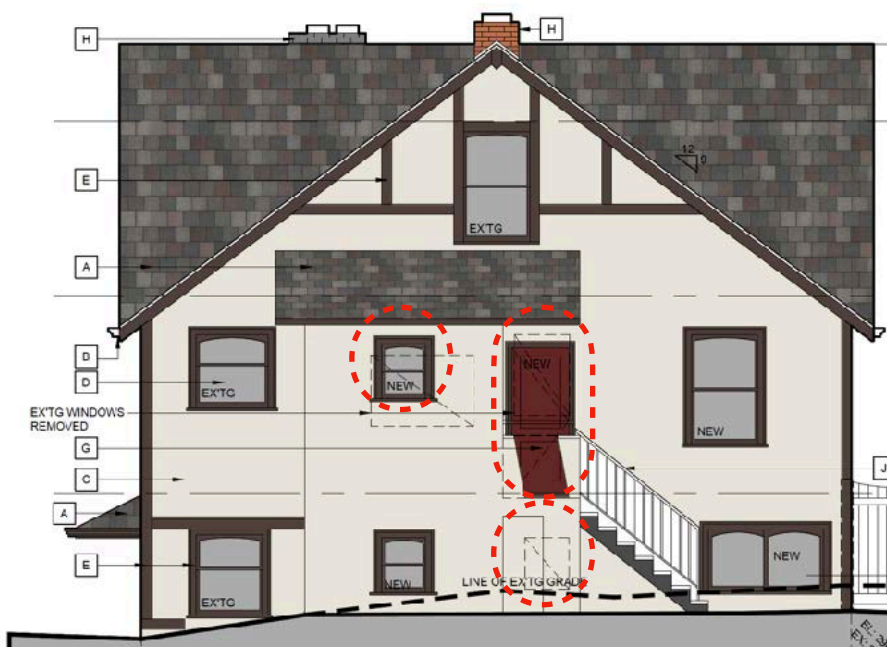
Window and door opening changes to this very low visibility elevation to accommodate adjusted interior layouts (see outlined in red on proposed elevation). Change of one window size (replica in-kind of existing window, but smaller), removal of a window, and change of one window opening into a door, through the relocation of the existing door from the porch structure to the elevation wall, now facing west.
