*Special Limited Study Heritage Value Assessment;
Heritage Conservation Plan and
Statement of Significance*

Property Heritage Value Assessment

323 Regina Street

Edgar House, 323 Regina Street, New Westminster, BC

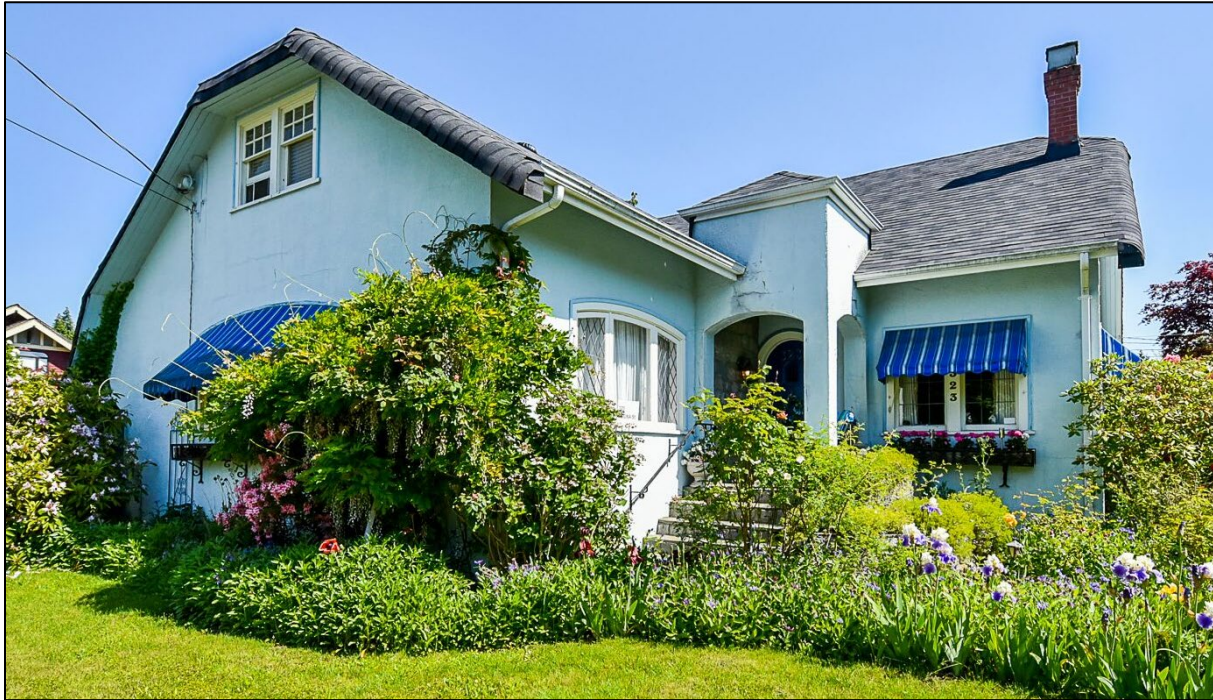
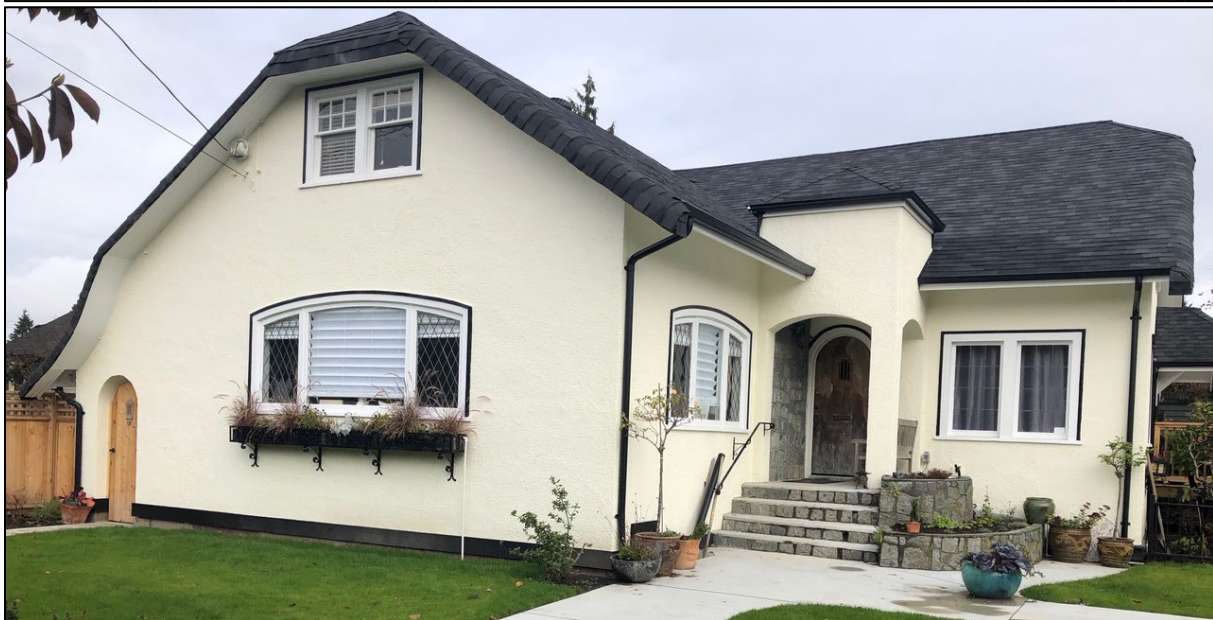
A number of changes and some restoration work has already taken place to this historic place. For a comparison view of the work already completed, please refer to Figs. 17a and 17b below, from 2019 and 2020 respectively.

Figs. 17a and 17b: Comparative views of Edgar House at 323 Regina Street, 2019 (top) and 2020 (bottom), illustrating the various work done on site, listed in full on the following page. (Sources: Vallee (top) and Holisko)

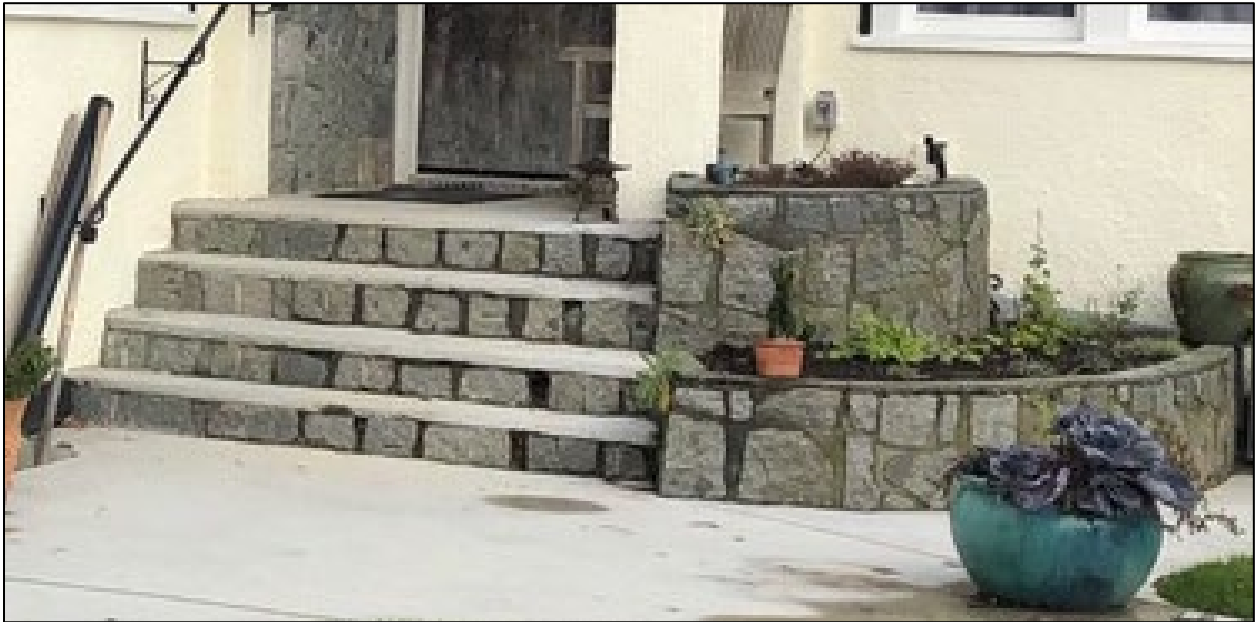
Overall, the condition of the walls and building envelope of Edgar House, from roof to foundation, appears to be good and having aged well. In particular, there are no major cracks visible in either the stuccoed walls or foundation. One small area of concern is the stone front steps that appear they could benefit from some minor cleaning and maintenance (Fig. 18) such as to remove moss/algae growth.

Fig. 18: Front stone steps and planter of Edgar House at 323 Regina Street, 2020, illustrating the minor maintenance concerns, such as moss growth and other plants growing between the stone slabs. (Source: Holisko)

- Any additional landscaping being put in should have a minimum 2-ft clearance between the vegetation and the building face. This is preferable to ensure there is sufficient space from the structure and to remove any threat to the foundation or the building’s finishes over time.

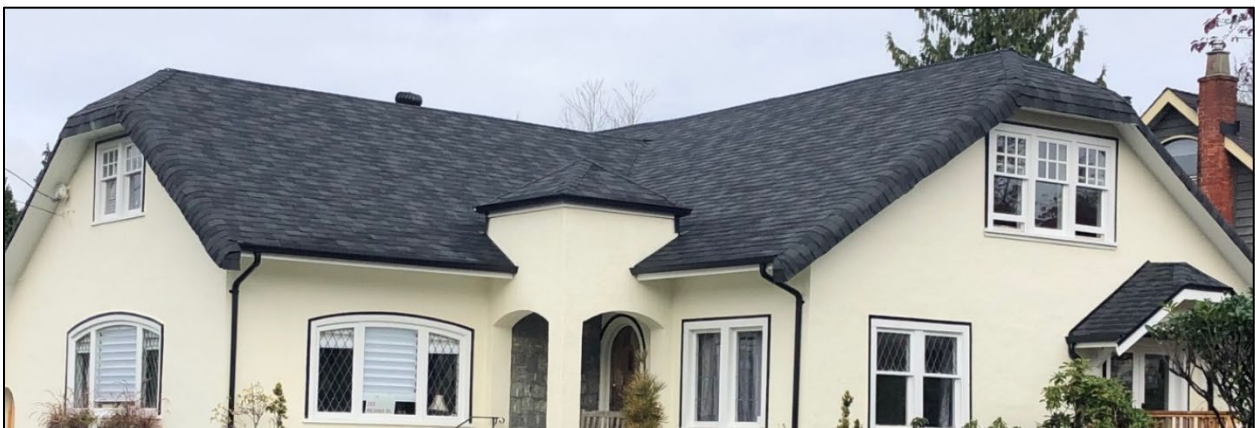
The roof is in very good condition, overall (Figs. 19 and 20). It is difficult to determine the condition of the waterworks system from photographs, however, it is understood that these were recently replaced (with rounded aluminium ones to resemble the older more traditional style) and should therefore be in good working order. They should be checked regularly to ensure their continued efficient functioning.

Fig. 19: Front view of Edgar House at 323 Regina Street, 2020, illustrating the good condition of its roof. (Source: Holisko)

- The roofing and waterworks should be **preserved**, and regularly monitored and maintained to ensure their ongoing good condition.

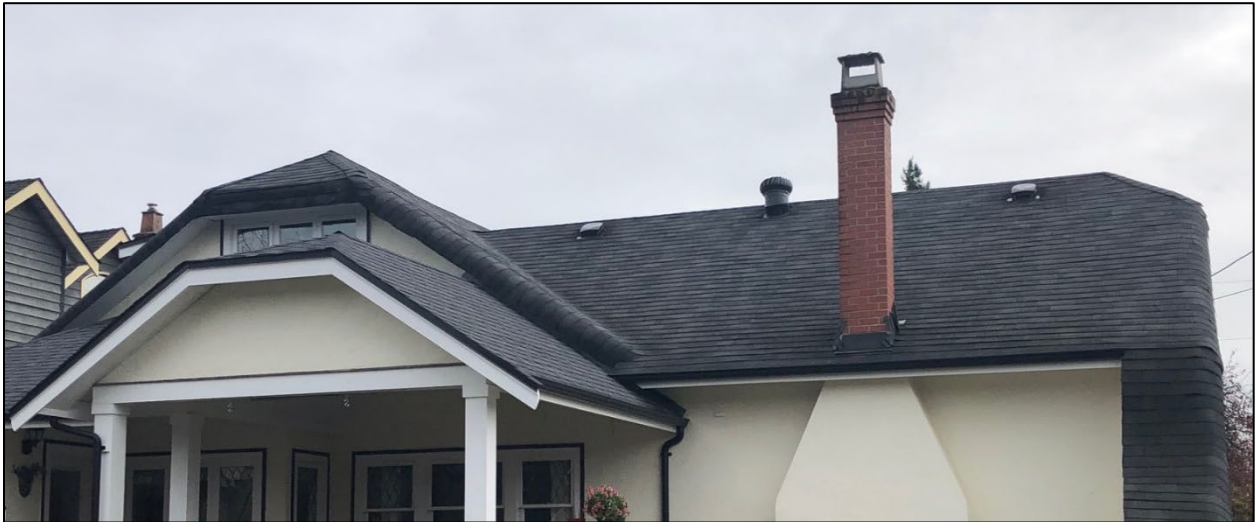
Fig. 20: Back view of Edgar House at 323 Regina Street, 2020, illustrating the good condition of its roof. (Source: Holisko)

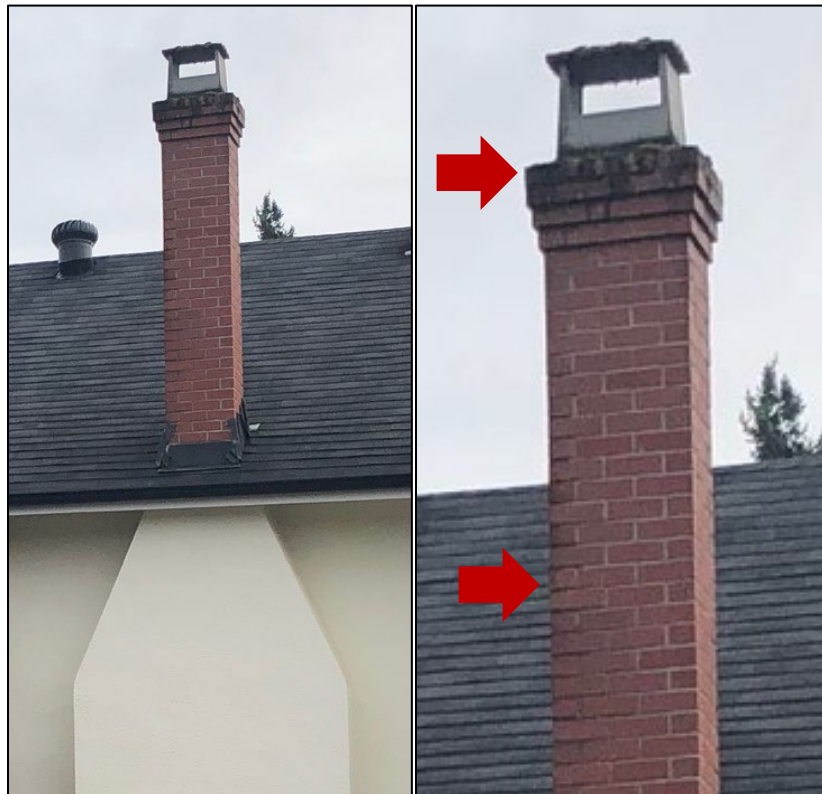
There is a chimney on the house, along its northwestern side (see Fig. 20 above), and it seems to be in largely good condition, with an intact chimney cap (Fig. 21a). It is worth noting that there are some signs of deterioration and loss of mortar, particularly in the areas that appear dark between the bricks (along the left side of Fig. 21b). The top of the chimney also appears that it could benefit from some cleaning and maintenance.

Figs. 21a and 21b: Fig. 21a (left) shows a detail shot of the Edgar House chimney, highlighting its largely good condition. Fig. 21b (right) shows a closer view of the chimney stack, showing some signs of deteriorating mortar and areas in need of cleaning (pinpointed by red arrows). (Sources: Holisko)

- The chimney should be **preserved**, and **rehabilitated**, as needed. This should include regular monitoring and repointing by certified professionals, to avoid it needing to be rebuilt entirely down the road.
- Although certainly not recommended, if, overtime, it does degrade to the point of needing rebuilding, it should be dismantled to the roofline, the bricks should be cleaned and then re-used to rebuild the chimney with its original bricks, as much as possible.

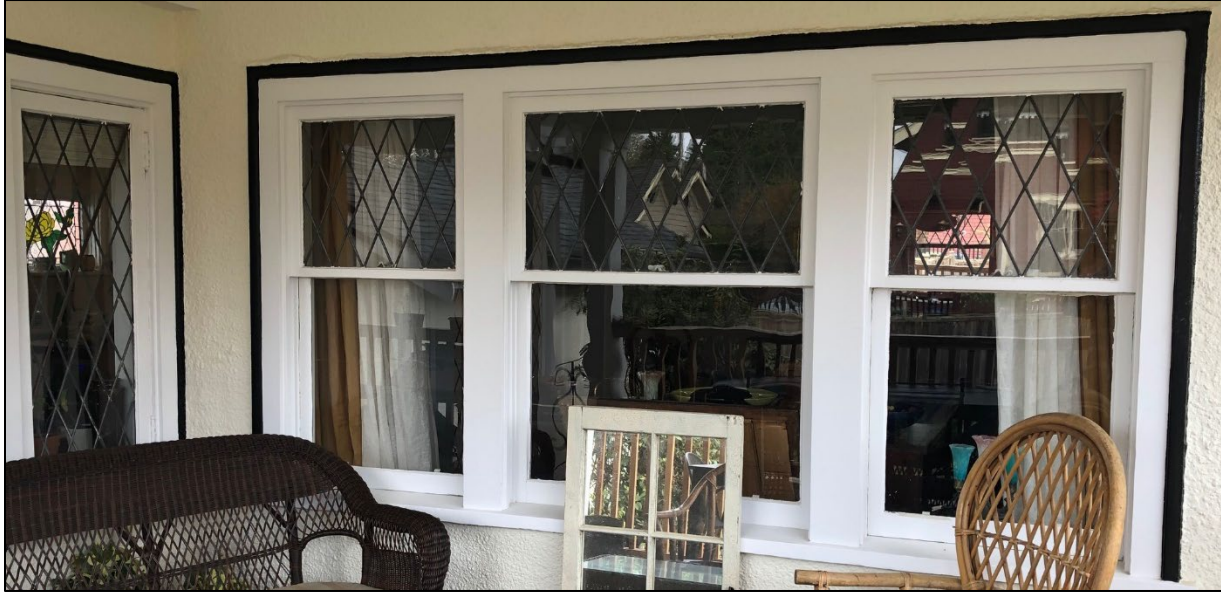
Some of the windows of the house have been replaced (or repurposed on site), although many are still original and, considering the age of the building, these intact windows and doors are in good to very good condition (as visible in Figs. 13 and 14 above and Fig. 22 below).

Fig. 22: The back deck of Edgar House at 323 Regina Street, 2020, illustrating the good condition of its original windows, with diamond patterned panes. (Source: Holisko)

- The arched front door should be carefully **rehabilitated** (sanded down and re-stained) and **preserved**.
- All remaining original wood windows should be **preserved**.

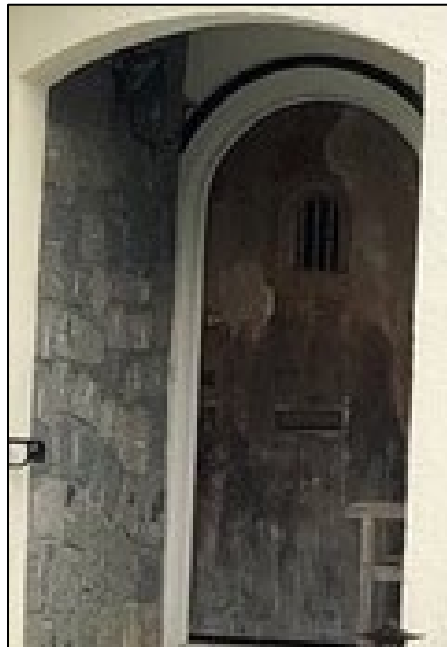
Otherwise, the only other condition concern with regards to the windows and doors is with the front door, with its faded and splotchy staining (Fig. 23). It is hoped that this is simply a cosmetic concern that can be rectified by sanding and re-staining, although it should be inspected for any signs of rotting prior to any work being done on it.

Fig. 23: Detail view of the front door of Edgar House at 323 Regina Street, 2020, illustrating its faded and splotchy staining. (Source: Holisko)
