# New Westminster Community Heritage Commission

349 AND 351 CUMBERLAND ST

## **ENGINEERING PROPERTY / BUILDING CONDITION ASSESSMENT**

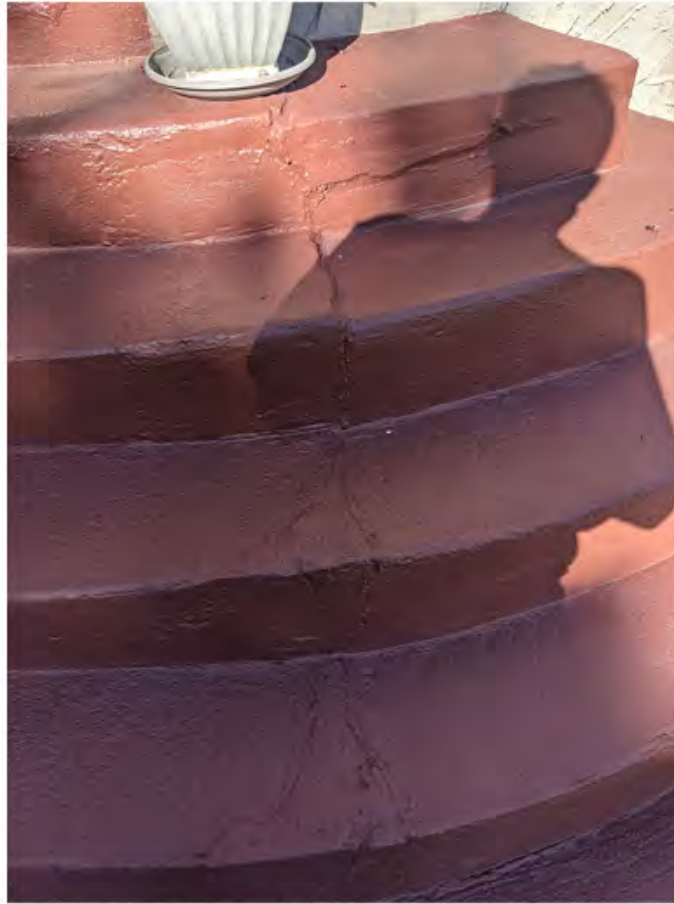
CMG observed evidence all around the Subject Building that would suggest that there is extensive differential settlement in the Subject Building. The water flowing around the foundation walls over the years likely softened the soil in various locations that caused the strip footings to settle, and likely crack. This has adversely affected the foundation so that vertical cracks are all over the walls on the inside and outside of the Subject Building. The south-east corner showed the most

unit 349 - south entryway stairway cracks have increased in depth over the past 15 years.jpg

Underpinning the foundation would be the only permanent way to fix this issue at approximate cost of \$90 000 (2021) CAD.

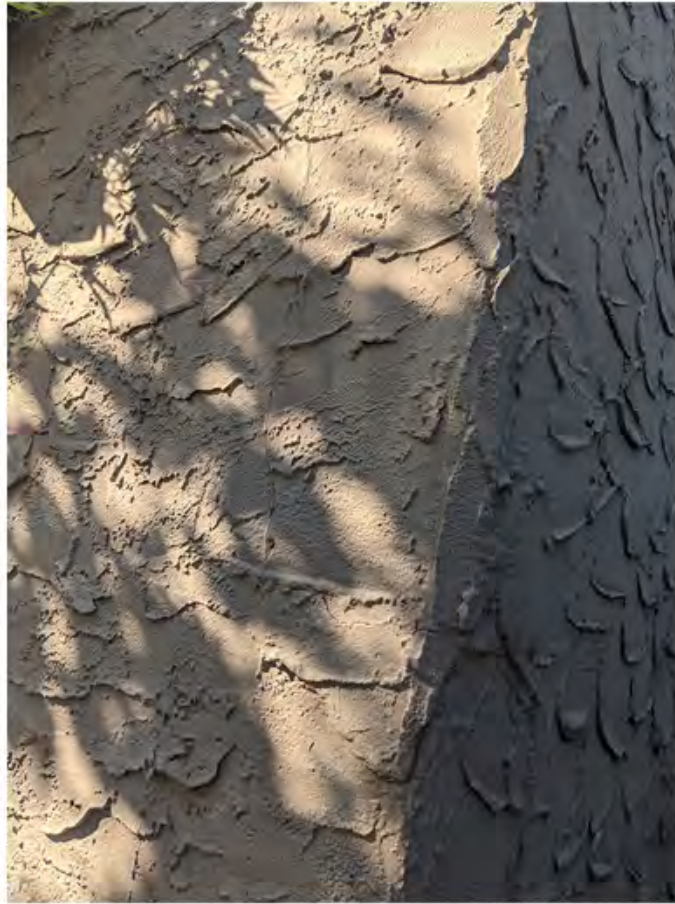
crack in stucco on south wall east side.jpg

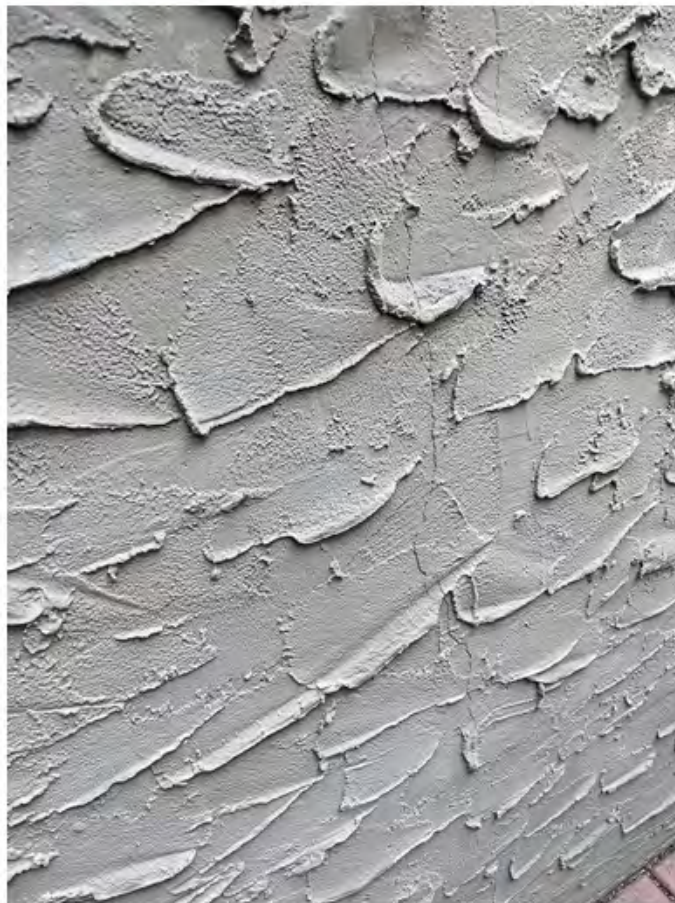
crack in stucco on west wall central area.jpg

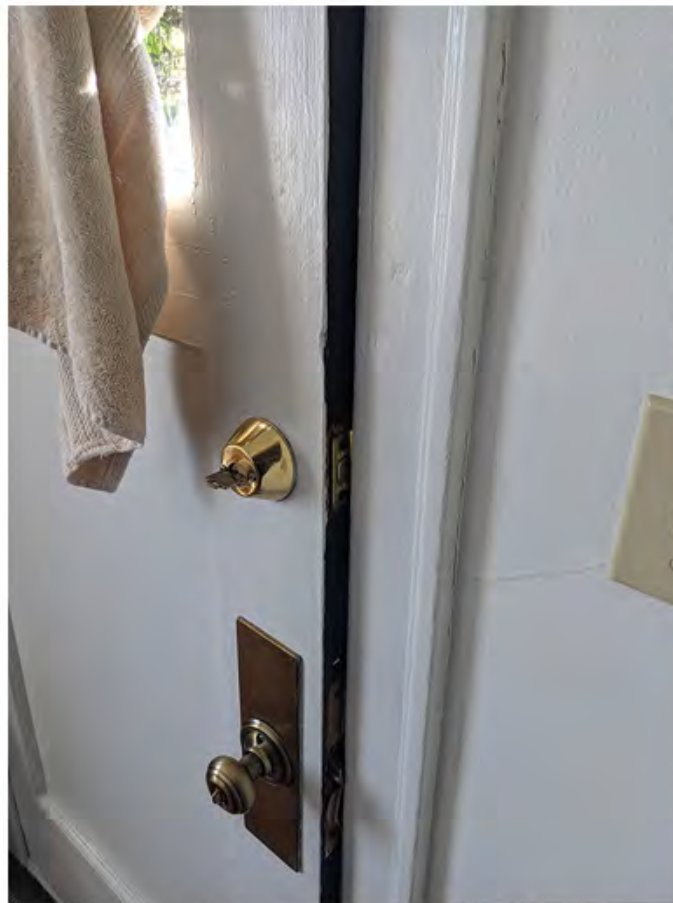
unit 349 - south doorway binding on open and closure.jpg

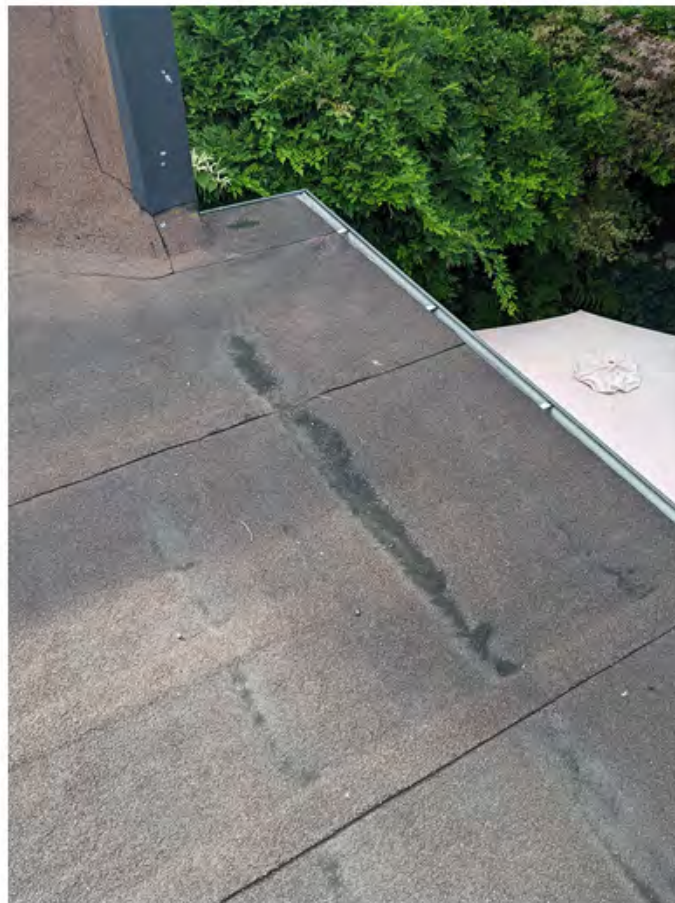
CMG observed a lack of granular material on the rolled asphalt surface. The surface also had raised folds in it that was evidence of further degradation. Based on this evidence, the roof surface was in critical condition and should be replaced in the next year at a rate of \$200 / m<sup>2</sup> that will also add an insulation package to reduce the slope of the roof so that the eavestroughs can do their job and reduce storm water next to the north foundation wall. The rate will also include replacement of any rotten roof sheeting and any rotting structural wood in the roof support system. Based on an approximate rooftop surface of 170m<sup>2</sup>, the cost to resurface the roof will be \$200/m<sup>2</sup> \* 170m<sup>2</sup> = \$34 000 (2021) CAD.

degraded rolled asphalt due to ice damming.jpg
