*Statement of Significance and
Condition Assessment for
63 Merivale Street*

Condition Assessment

April 2021

63 Merivale Street ~ New Westminster BC

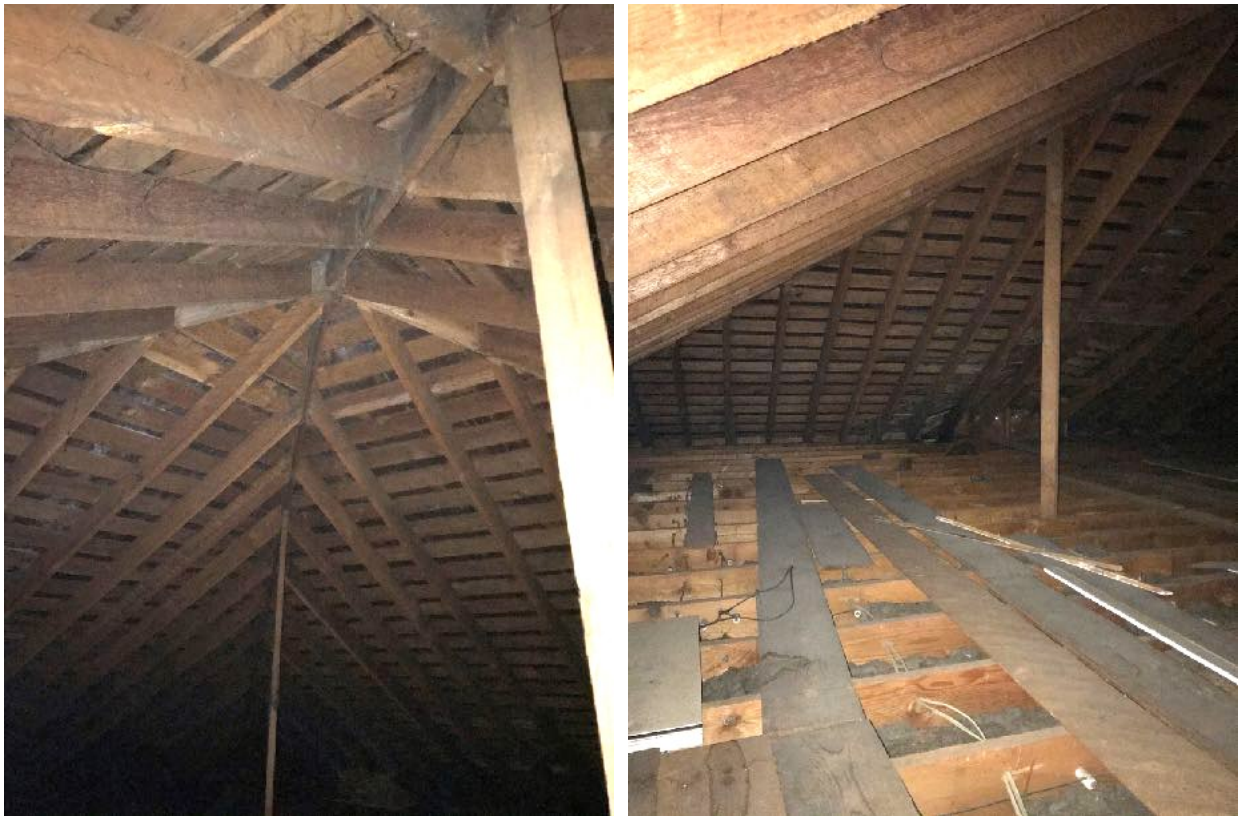
The building lines are true to the eye. There is no visual evidence of structural distortion. The old-growth wood frame roof structure and second storey ceiling timbers visible in the attic are all in good, dry condition and represent traditional, enduring construction practices and skill.

Above: photographs of the attic space showing the well constructed, dry roof structure and second floor ceiling beams.

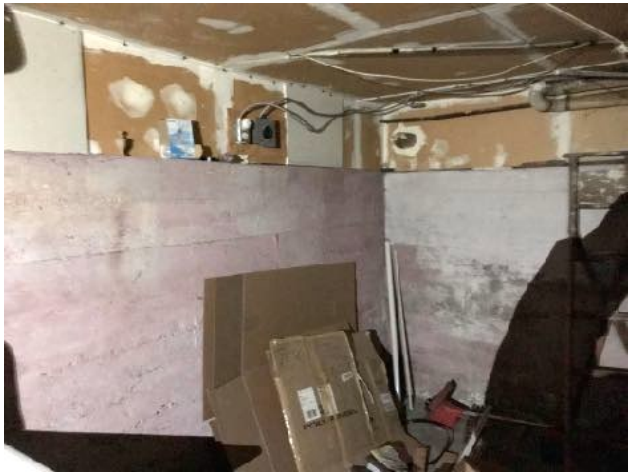
The board-formed concrete foundation visible in the basement level is in good condition. No evidence of cracks, moisture damage or other deterioration was observed. The portion of the foundation visible on the exterior (south elevation) does have a few cracks but remains structurally sound.

Above: interior (left) and exterior (right) photographs of the board-formed concrete foundation.

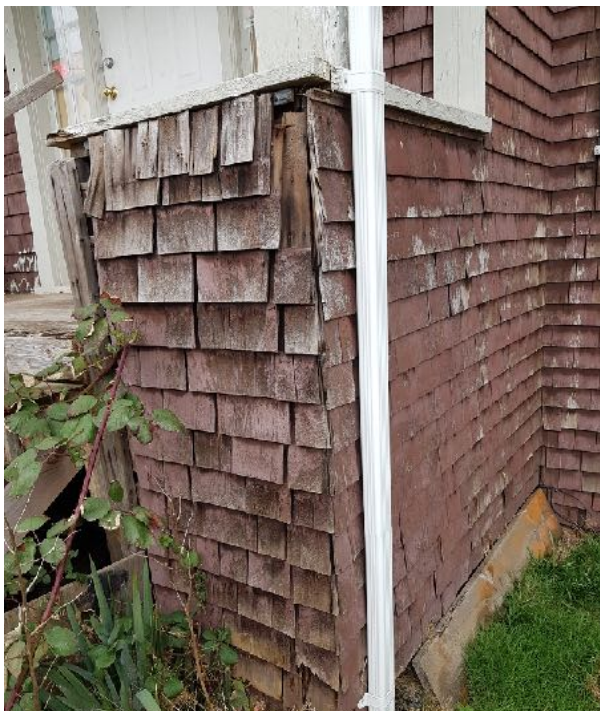
The entire exterior is clad in square butt cedar shingles. Their condition varies from elevation to elevation with the front (west) exhibiting the worst condition (poor). The same deteriorated condition of shingles is observable on an extension on the east (rear) corner. The shingles on the south elevation are in fair condition (except at the rear extension where they are poor) and those on the north elevation are in good condition. The shingles at the building corners, front porch, rear extension and where the shingles meet the foundation all appear to be warped/damaged beyond repair.

Above: front porch shingles (left) in the worst condition and north elevation (right) shingles in good condition.

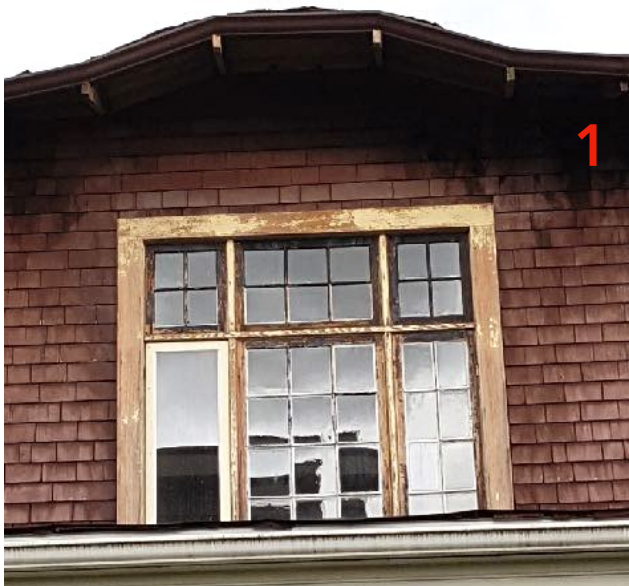
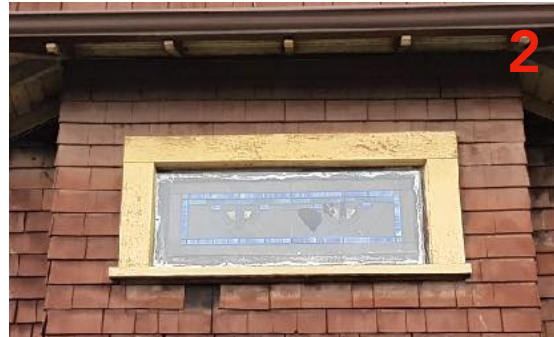
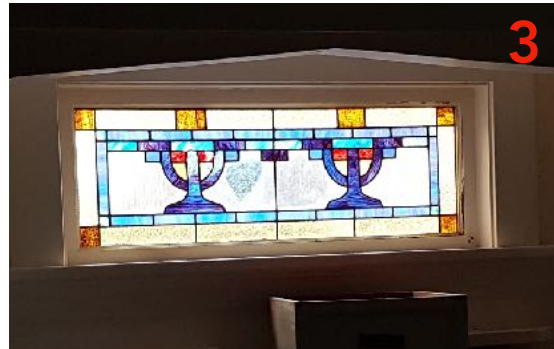
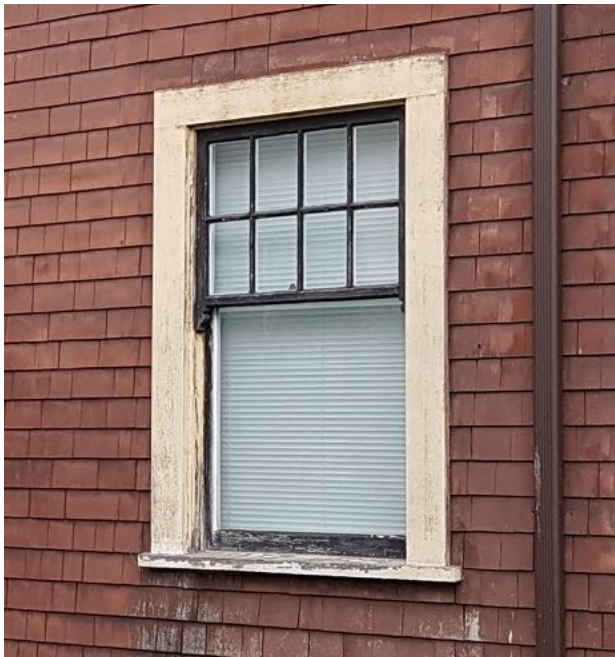
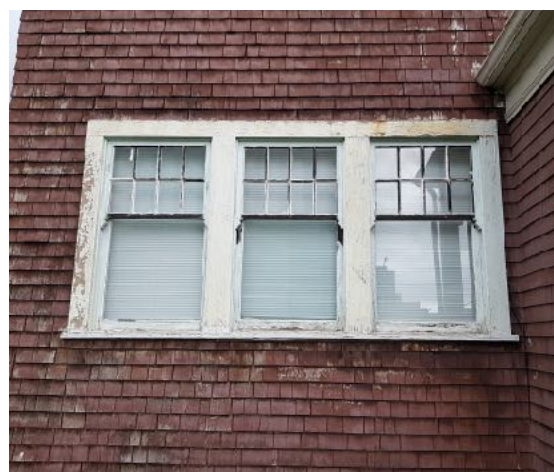
All the window openings are original as are the wood sashes in them. Some may have been replaced in the 1920s but the majority appear to date from 1916 making them 105 years old at this time. The assembly above the front entrance (#1) is the only evident case where a previously divided-light sash (one of six that make up this assembly) has been replaced with a single-light wood sash. Given their age, their functioning condition is remarkable. All sash conditions vary between poor and fair and all require repair and maintenance - especially with regards to putty replacement and repainting. One original art-glass window in excellent condition survives in the southern elevation projecting bay (#2 and #3). The operability of each of the windows was not assessed.

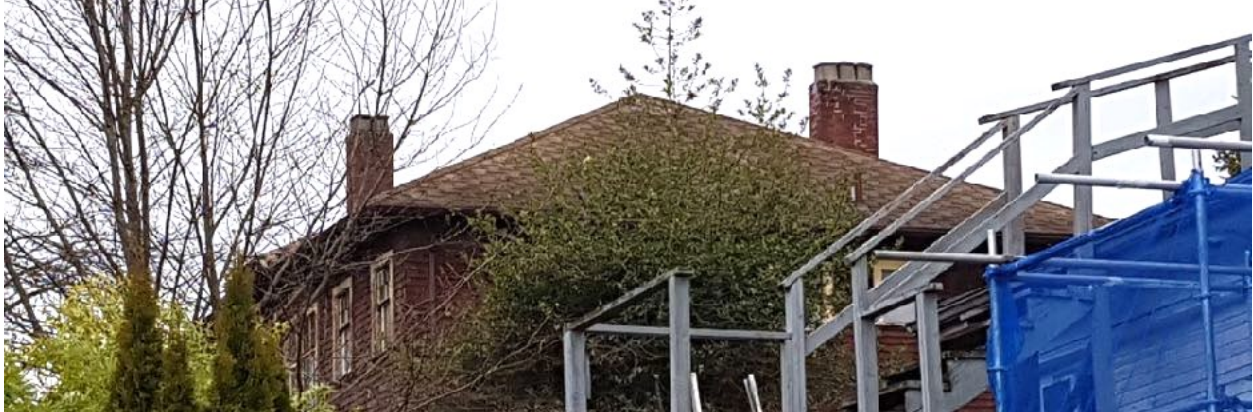
The building has two internal brick chimneys, which project prominently from the roofline, and are in fair condition. Both chimneys are exhibiting mortar failure and require repointing.

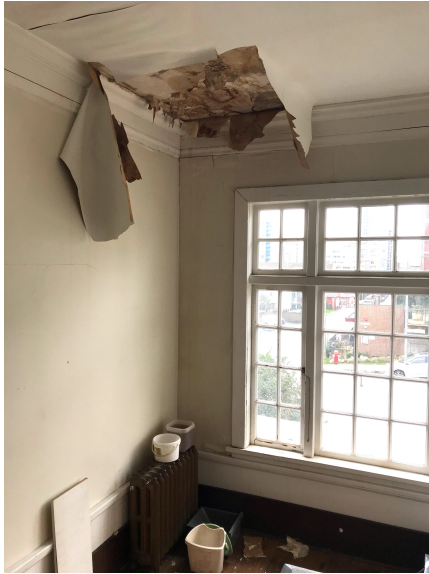
The interior is in good condition. floors and ceilings on the interior are solid, level and dry. There is no evidence of damage due to lack of maintenance or mechanical failures, except for what appears to be water damage in the ceiling in a corner of the main stairway leading to the second floor (see photo on next page). As the building is vacant, and disconnected from electricity, the lack of mechanical heat in the winter and and natural ventilation in the summer can bring on significant and quick damage and deterioration. Furthermore, it is evident that since the building was vacated, break-in/s have occurred for the purpose of stealing the copper wires which has left damage to certain wall and ceilings (see photo, right). The vacant state of the building puts it at risk of further vandalism, damage and deterioration.

This photo shows water damage in the ceiling in a corner of the main stairway leading to the second floor
