Heritage Conservation Plan

Holy Eucharist Cathedral - 501 Fourth Avenue - New Westminster, BC

Elana Zysblat, CAHP - heritage consultant - Ance Building Services

November 2023

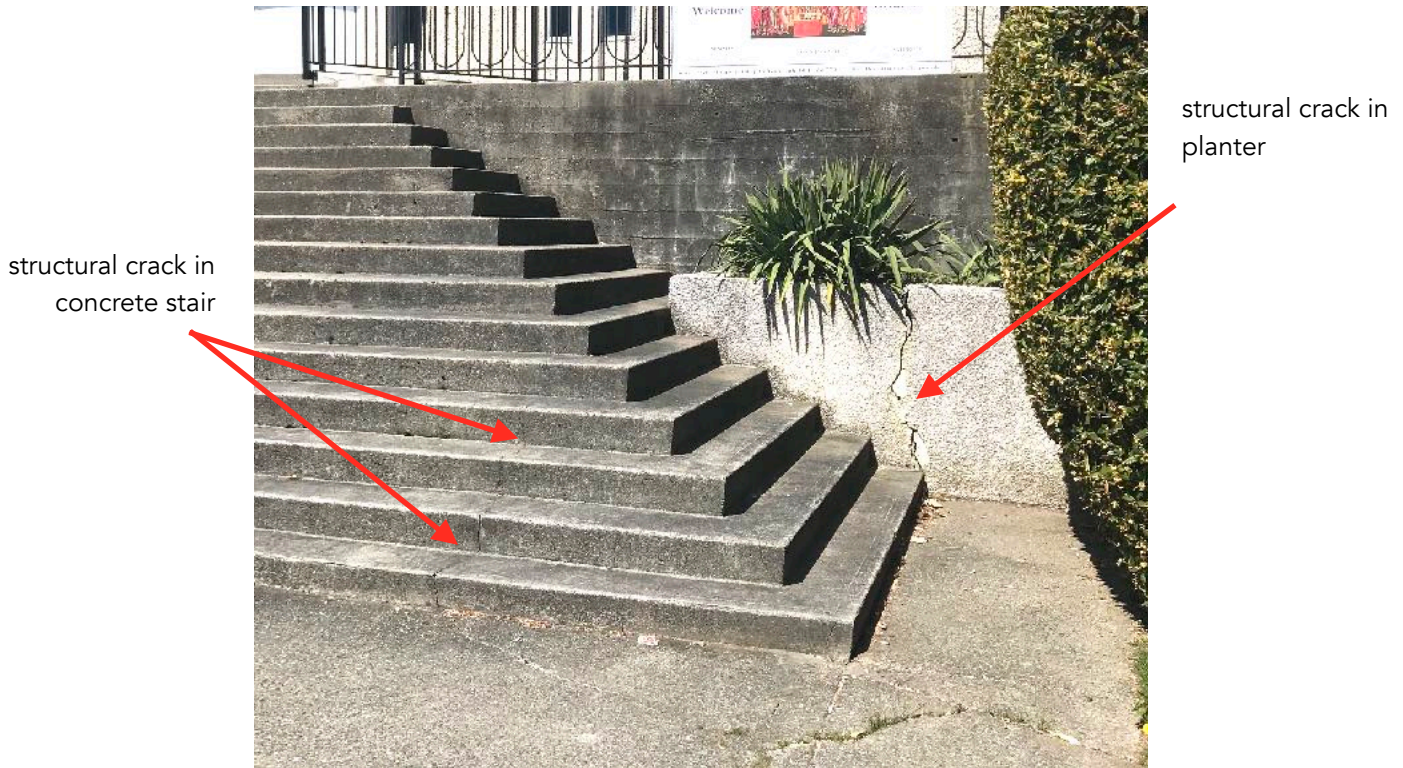
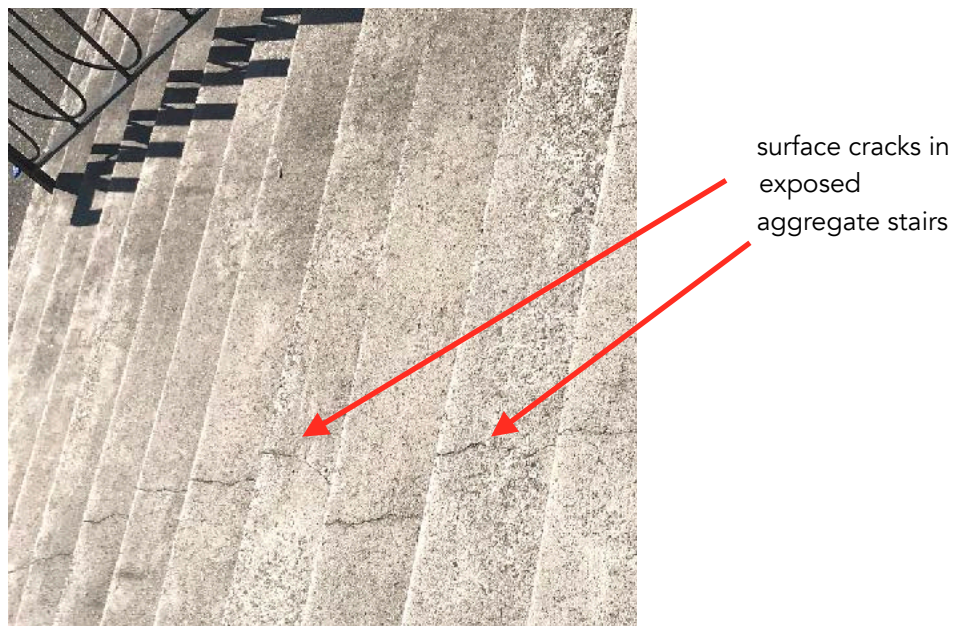
Front stairs and entrance podium

The original poured concrete stairs and hollow podium, with exposed aggregate stairs, are in fair to good condition, but exhibiting wear as well as some cracks - both structural cracks and surface cracks.

Reconstruct the podium and grand stair in their current dimensions and 1960s finishes while adapting the interior of the large hollow podium to a finished, useable space (in this case an Accessible entrance and lobby to the church hall). The only proposed change to the stair and podium design would be the elimination of the final three stairs (circled in the existing photo, right) to the church doors, which would eliminate another Accessibility obstacle, making the walkway connecting the new mixed-use building to the now completely level church podium an Accessible route to both buildings. This rebuilding opportunity also eliminates the need to repair the many structural and surface cracks on the existing concrete structure.

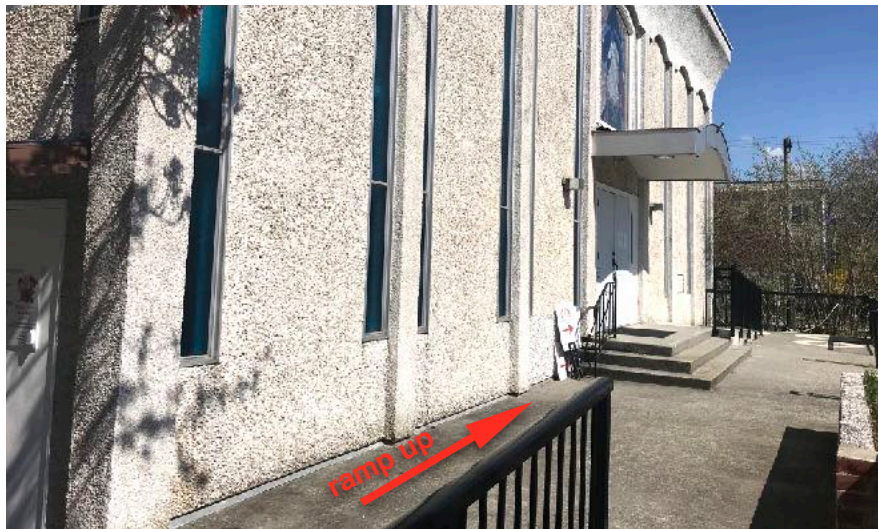
Although the grand entrance and stairs are valued as a prominent feature of the historic place, not all patrons are capable of ascending 18 steps up to the entrance doors (15 stairs plus another 3 from the podium). A poured concrete accessibility ramp which leads from the parking lot to the top of the podium, was installed in 2017 to mitigate this issue, but it falls short of providing fully non-ambulant access to either the church or hall. After ascending the ramp to the church entrance podium, an additional three exterior stairs still need to be climbed, and, although the hall entrance doors are Accessible from the parking lot, once inside, patrons must descend an additional dozen to the hall (basement) level itself. Given the building's large, diverse parish of all ages and abilities, and its robust community rental program, the lack of adequate Accessibility of the current stairs and ramp results in the historic place not being accessible to non-ambulant patrons.

Photo showing the last section of the 'accessibility ramp' arriving at the entrance podium but more stairs at the church entrance doors are left to tackle.

Rebuild the entrance podium and stairs to finally resolve the ongoing challenge of the existing lack of Accessibility to both church and hall, increasing and improving both the religious and secular uses of the historic place. In this new configuration, which will not be perceived as different from the street, the basement level hall will now be Accessible at street level from an entrance below the podium (1) and the church will be Accessible via elevators in the new mixed-use building next door (2) that lead onto the reconstructed entrance podium.

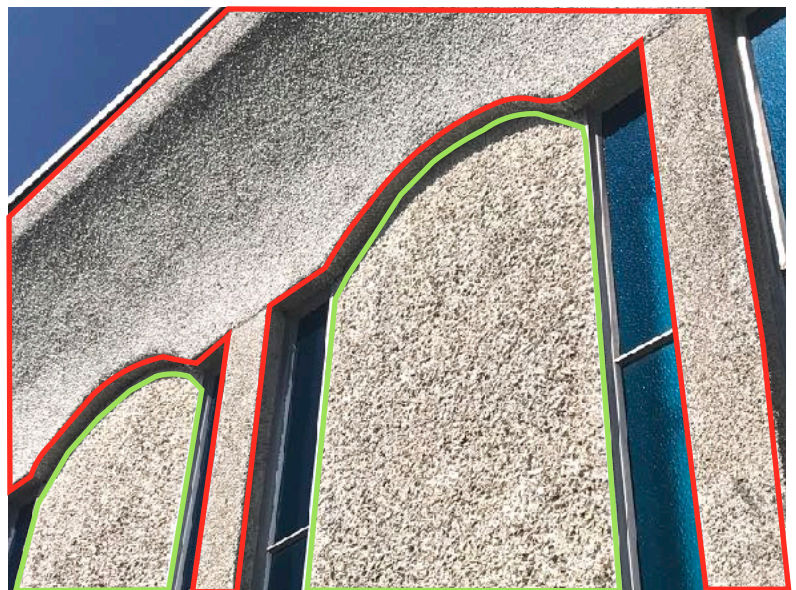
1. A finer, granulated stucco finish on cornice and pilasters (outlined in red)
2. A rougher dash quartz stone stucco finish on main walls (outlined in green)

The stucco is generally in good condition but several areas of minor damage (staining, cracks or failure) have been identified, mostly at the cornice corners.

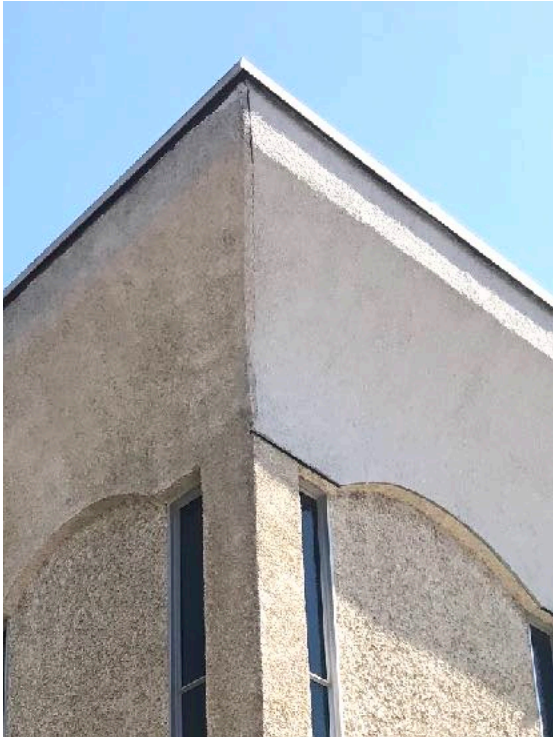
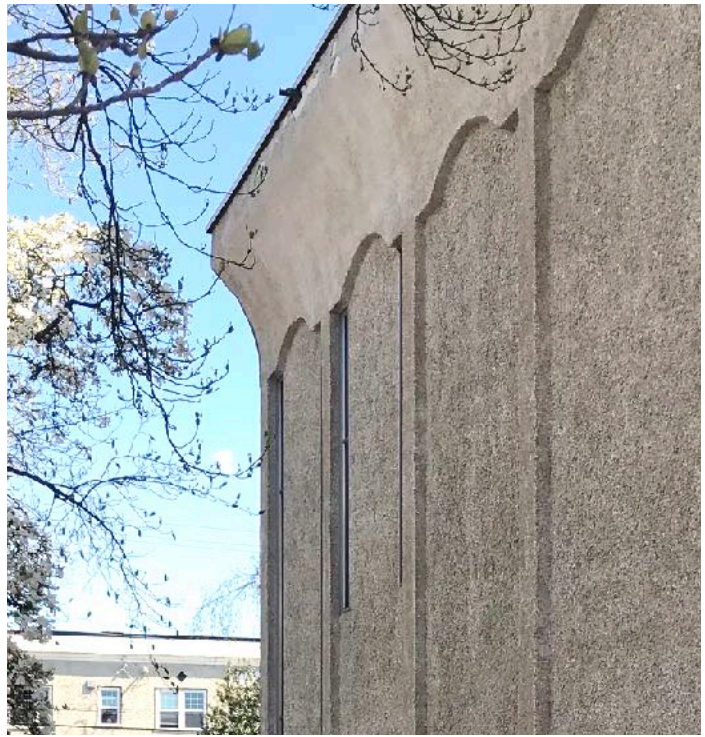
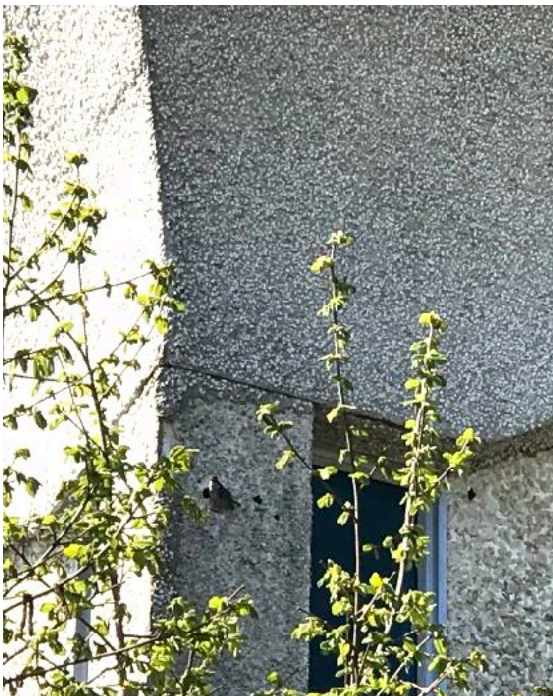
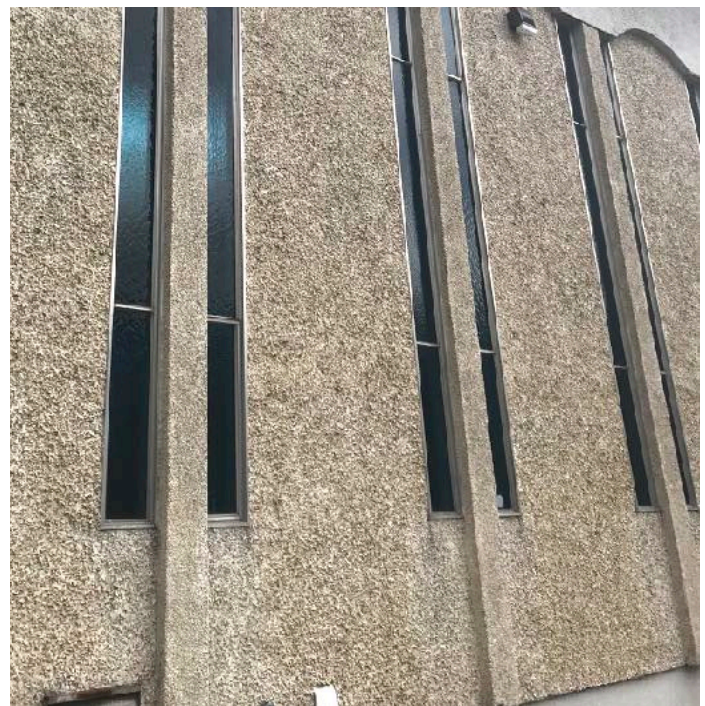
Stucco damage

Above left: Cornice at corner of parking lot and lane showing a crack in the stucco.

Above right: Cornice at corner of lane and yard showing missing/failing stucco just below an new roof drain installed 13 years ago. **Below left:** Cornice at corner of front and yard showing stucco damage caused by woodpeckers **below Right:** Evidence of moisture staining on stucco below windows at parking lot.

Address the sources of damage to the exterior stucco finish (woodpeckers and faulty roof drainage) and spot repair the stucco by matching the specific original texture. Trade hiring and repair supervision to be guided by a heritage professional.

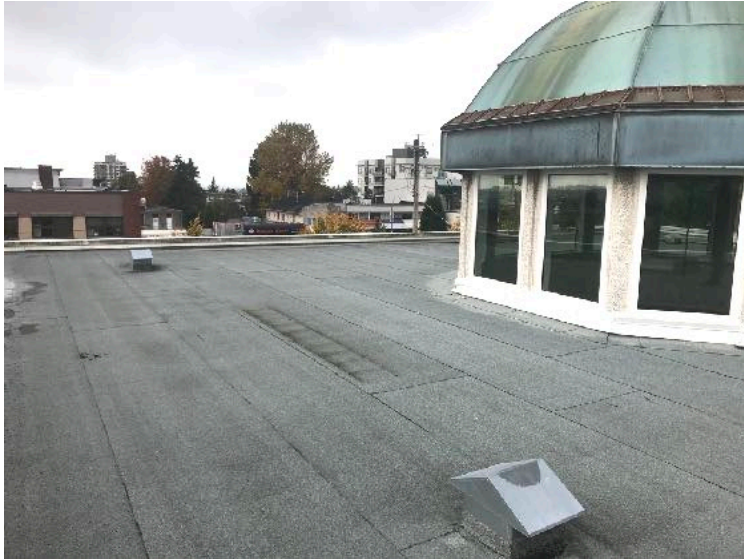
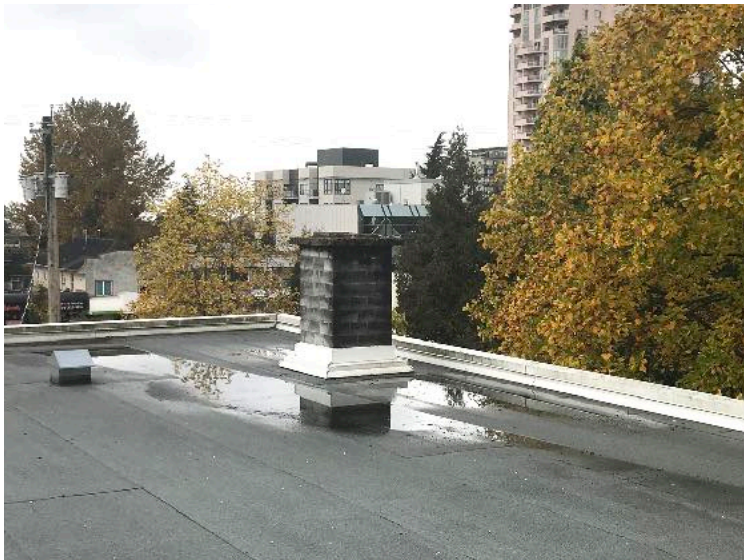
Roof and rainworks

The cathedral has a flat, torch-on roof which appears to be in good condition and reasonably vented. The drainage however, isn't functioning optimally as after a rainfall there are areas where water pools. Especially near the edges, as seen in the photos below. The downspouts on the cupola appear to be inconsistent and in need of some adjustments or replacement. There is evidence of water staining on the stucco at the cupola eaves.

Assess flat roof drainage, venting, edge coping and cupola downspouts and make adjustments to repair and optimize the shedding of water off the cupola and off the roof in a manner that doesn't allow water pooling on the roof nor dripping down the side elevations.

Improve access to roof hatch so that congregation members can regularly and safely access the roof for periodic inspection (twice a year, before and after winter). Keeping a regular eye on the functionality and condition of the flat roof is crucial. See Maintenance Plan.

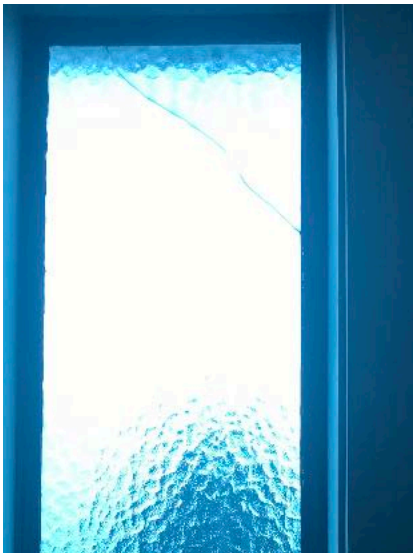
F11-3 (top light)

Cracked window panes:

The original design of facing upper and lower opening windows in the church was intended to enable passive (natural) ventilation in the church and needs to be used regularly and fully (both upper and lower lights) in the summer months. Replace broken window panes in-kind with

textured blue glass and restore the original opening and closing mechanisms of all opening windows to open fully, lock securely and be sealed properly when closed. All opening transom windows (upper windows) will need to be fitted with removable bird screens (ideally with transparent nylon netting to reduce aesthetic impact) to ensure that birds cannot fly into the church when the windows are open. Trade hiring and repair supervision to be guided by a heritage professional.

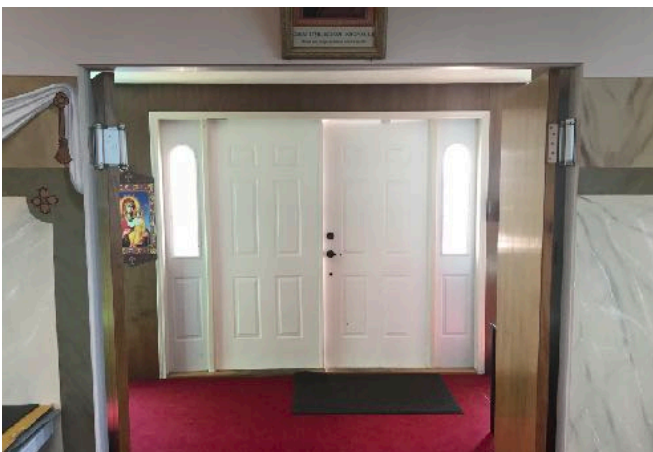
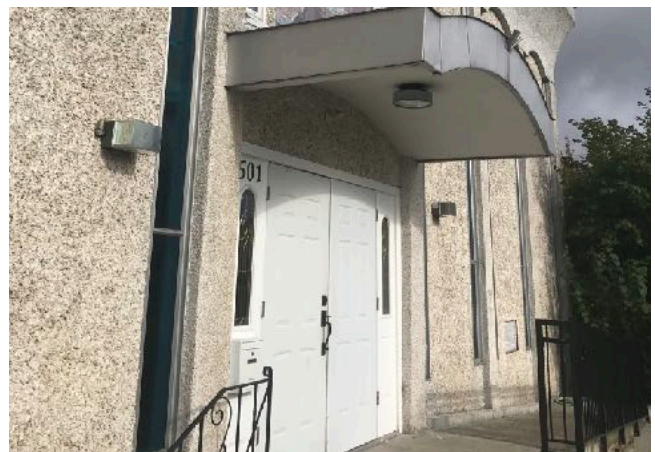
Doors

The current front door assembly (below) is of insulated steel, however it is not properly sealed in its frame. There is noticeable air leak around the entire assembly in winter time. The design, colour and material of this door are not in keeping with the original 1960s door which was solid, carved wood with a lacquered finish and full height blue glass sidelights on either side (see above archival photo). The incompatible appearance of the current door, which was installed in recent decades, diminishes the authentic design of the facade elevation.

Restore a solid carved, unpainted wood door assembly with glazed sidelights to the front entrance, as per the original 1968 design, and based on the earliest colour photographs of the church upon completion. The sidelights can be of textured blue glass or match the blue-toned stained glass sidelights above the door depicting traditional Ukrainian octagonal stars. Final design, intervention plans and construction supervision to be guided by a heritage professional.
