## Attachment E

*Building Inspection Report Feb 4, 2025*

*707 Queens Avenue*

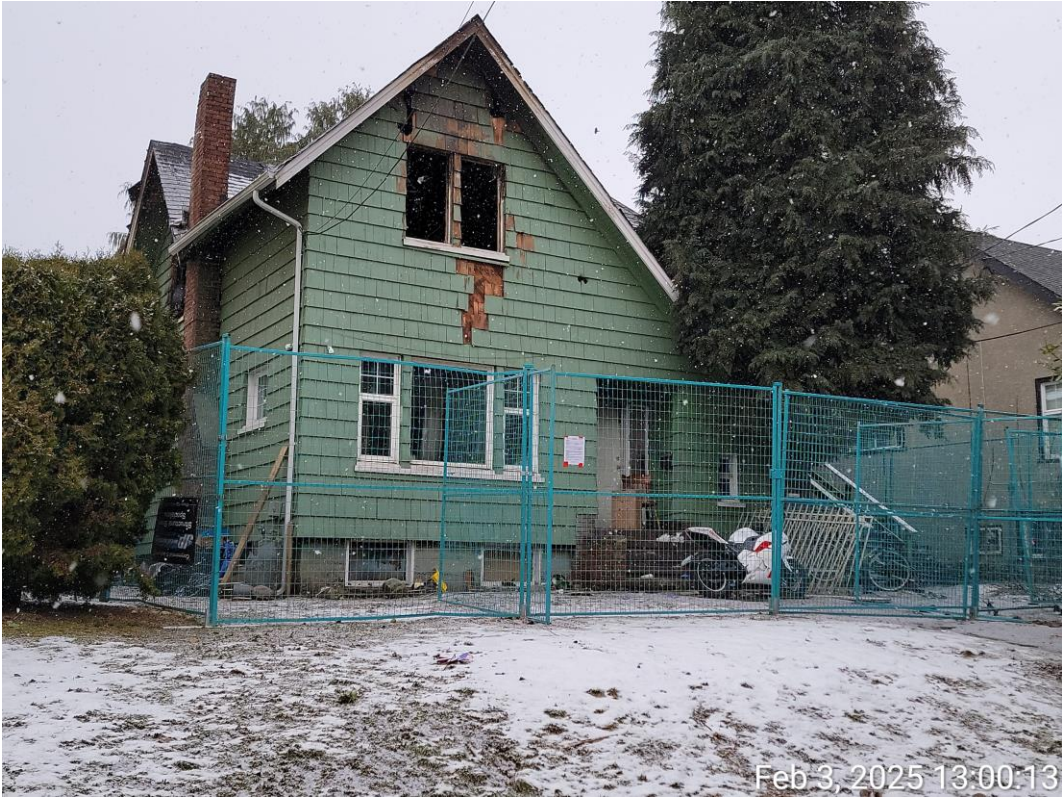
**Picture 1:** Front elevation of house. Windows on upper level blown out.

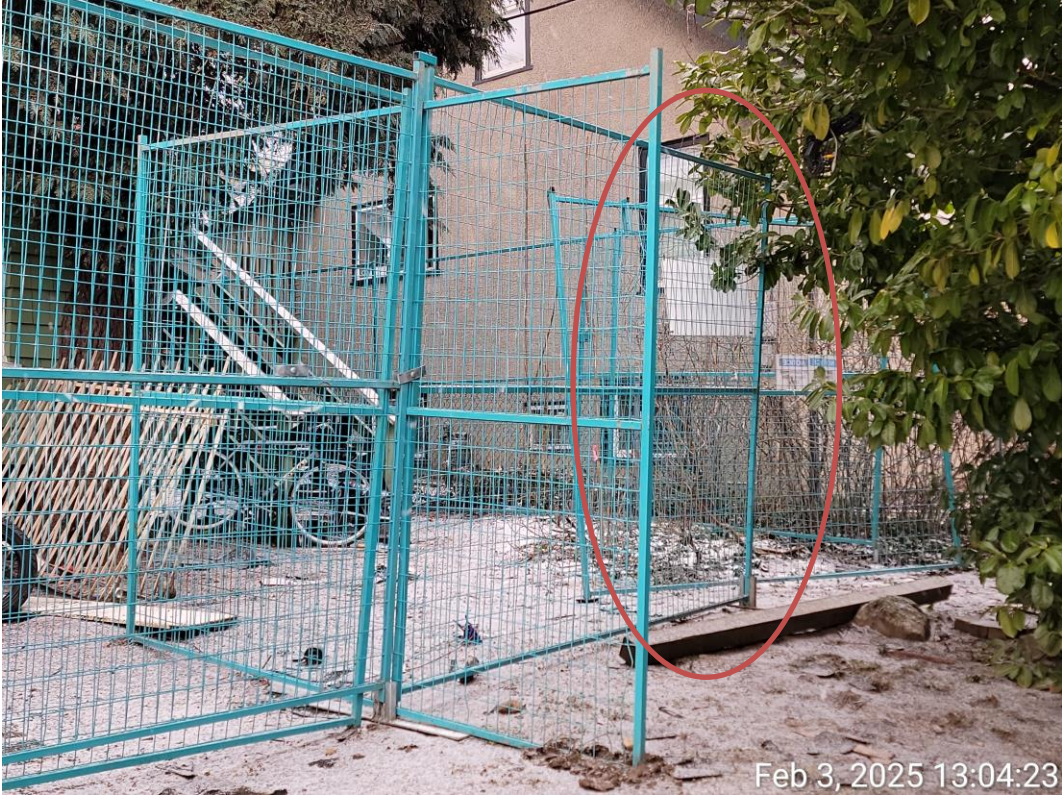
**Picture 2:** Gap in front fence.

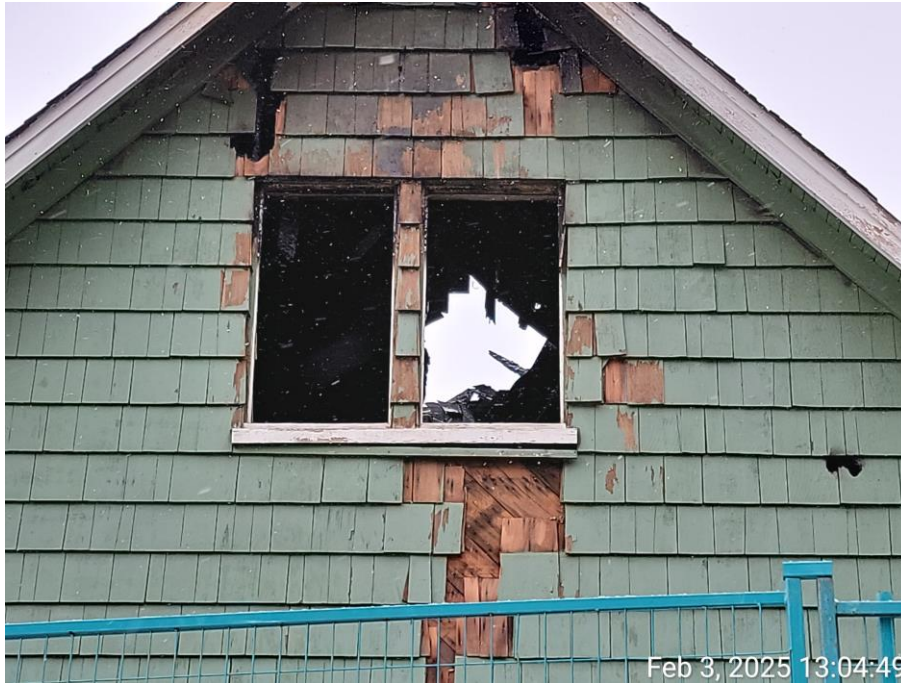
**Picture 3:** Collapsed roof. Current conditions do not comply with structural requirements of subsection 9.4 or Part 3 of the Building Code. Roof is not expected to support the minimum specified loads as required in subsection 9.4.2., for both snow and dead & live loads.

- **STRUCTURAL DAMAGE**; Significant structural damage, putting structure not into compliance with structural requirements under the BCBC 2024. This includes Part 3 and / or section 9.4 (Structural Requirements). Current building state not in compliance with section 9.23 (Wood-Frame Construction). In order to rectify, the following would be required:

- Review and approval from a registered structural engineer.
  - Minimum expected repairs; Full removal and replacement of roof structure, majority of the floors joist assemblies removed and replaced, majority of the stud walls removed and replaced.

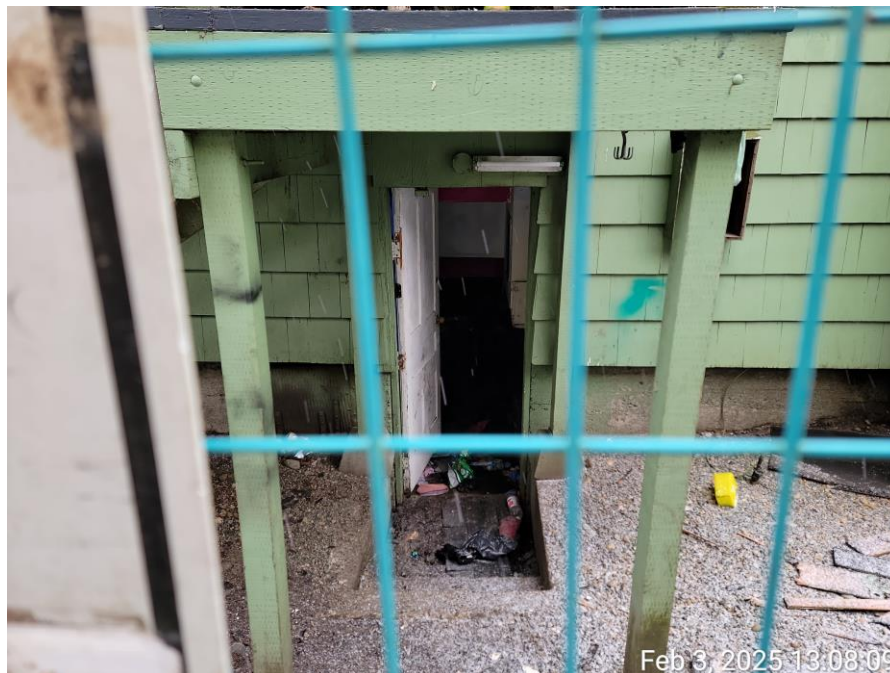
**Picture 4:** East side door, kicked in after previous inspection by JG. Doors currently not secured against unauthorized entry as required in subsection 9.7.5

- A Building Permit to demolish the garage and house is required.
- Site must remain secure from unauthorized entry.

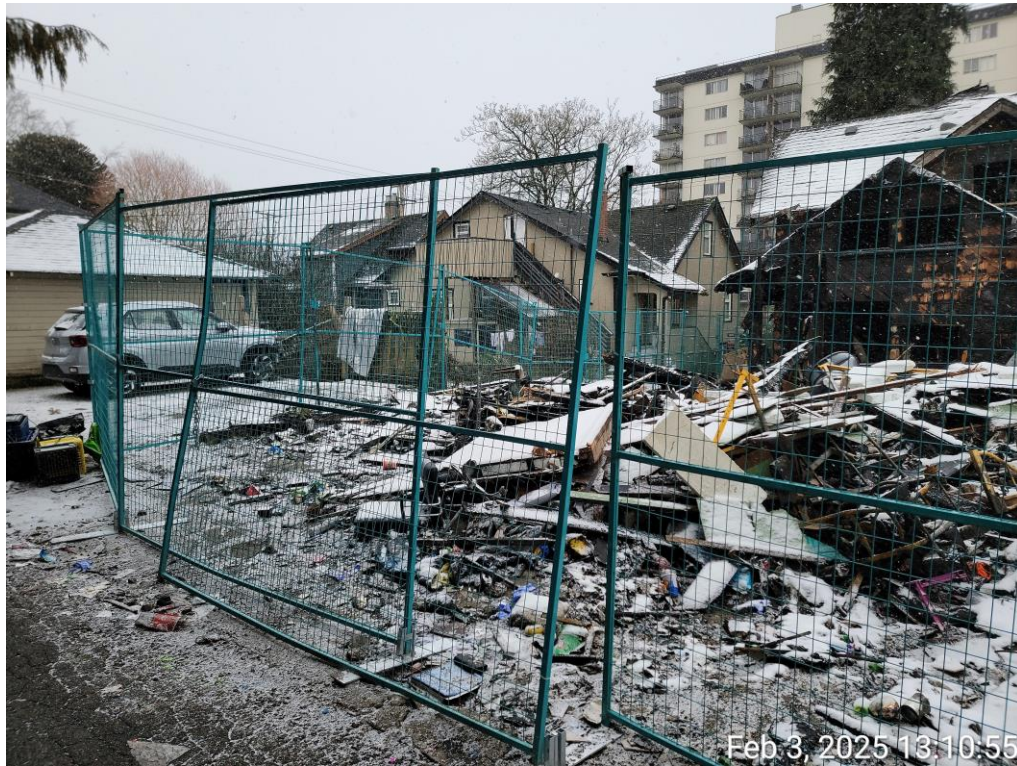
**Picture 5:** Rear yard, garage destroyed. Note gap in fence.

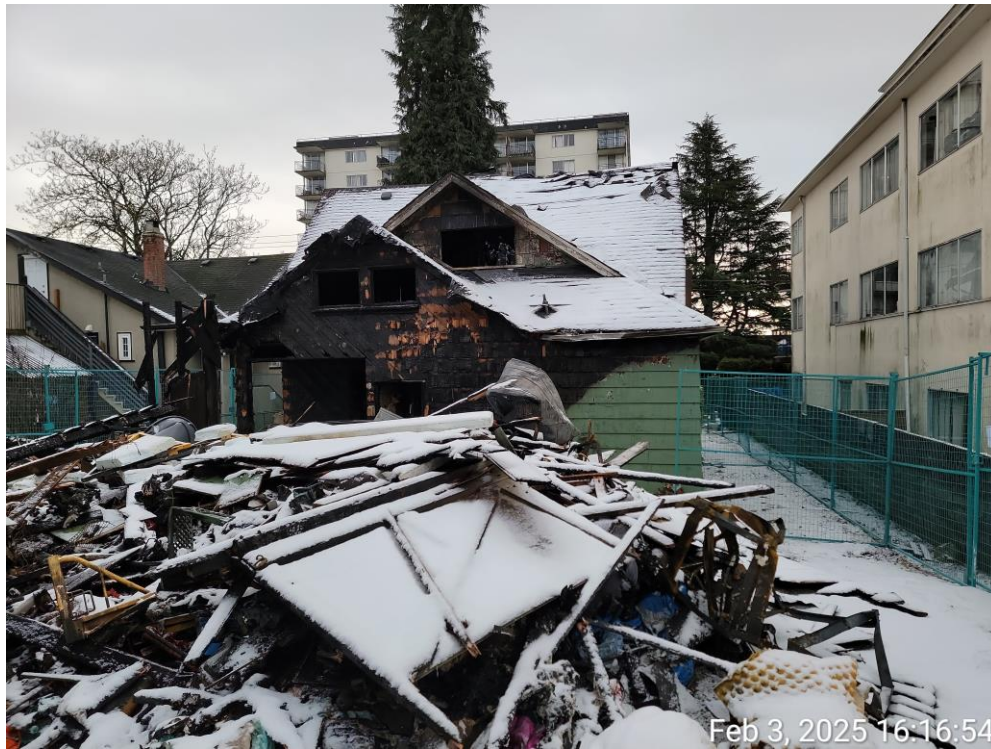
**Picture 6:** Rear of house, garage rubble in foreground. Note roof line sagging.

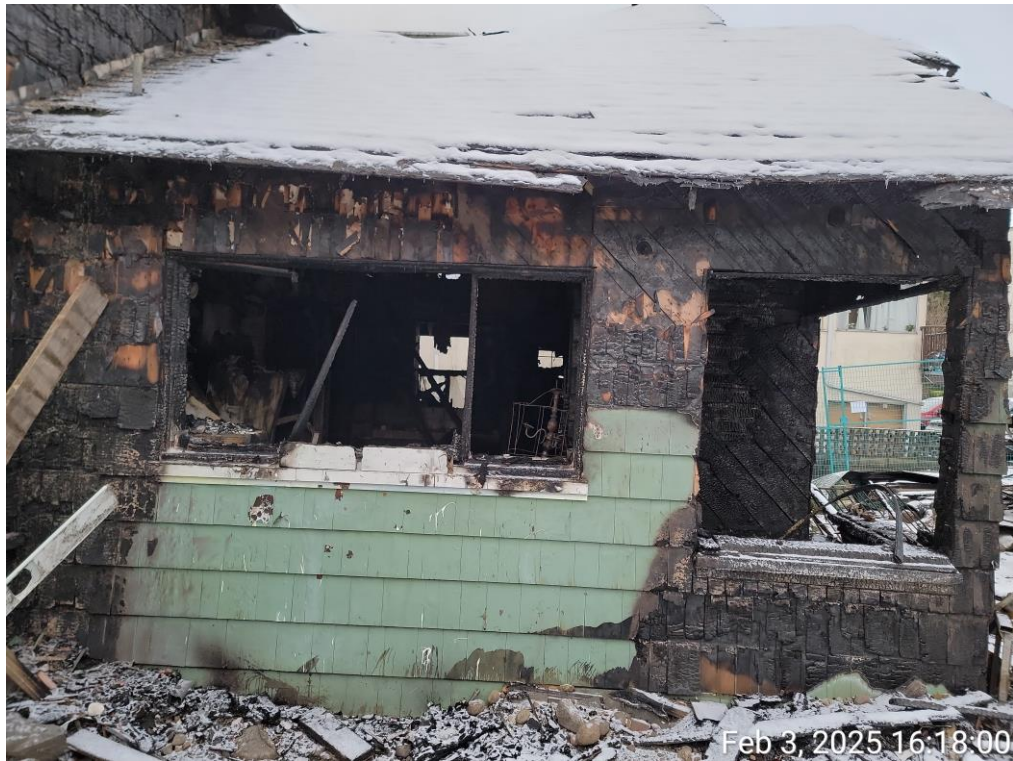
**Picture 7:** East side, rear portion of house. Significant damage to structure

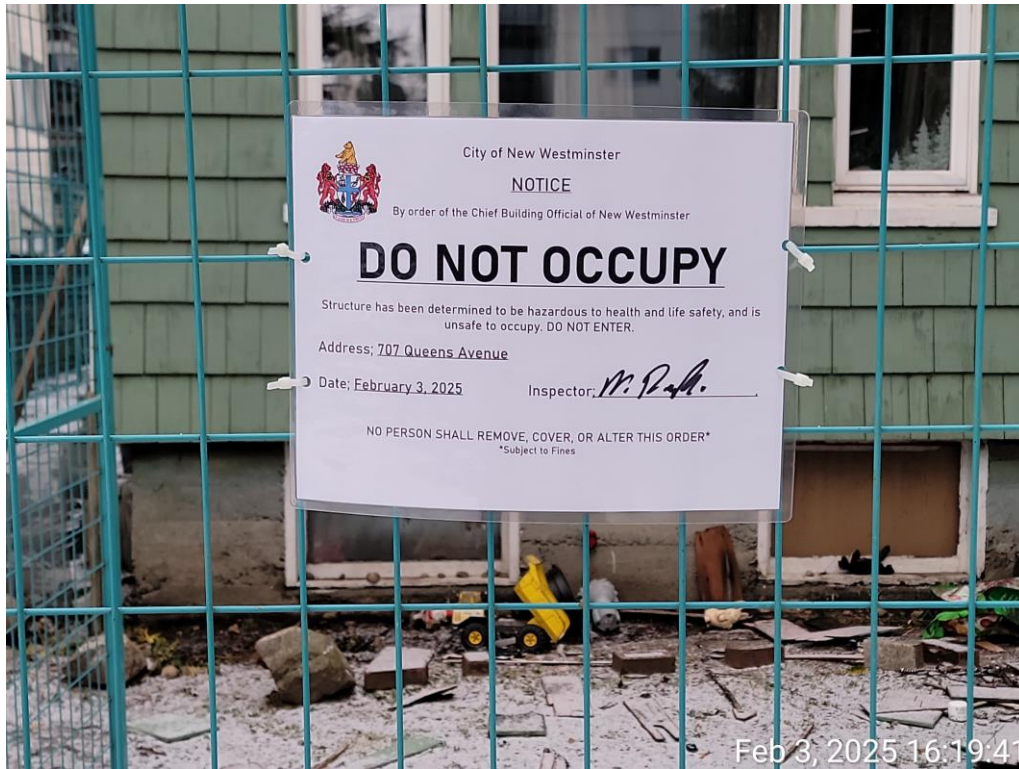
**Picture 8:** Do Not Occupy Order posted on front fence. Additional orders posted on rear and side yards.
