## Attachment # 1 Current State, Risks, and Concerns of the MVH Street Lights (Photos)

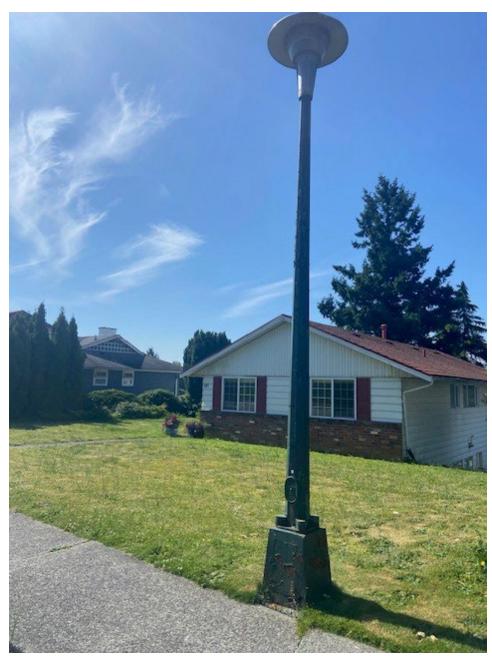
Typical MVH Site 1 lamp standard

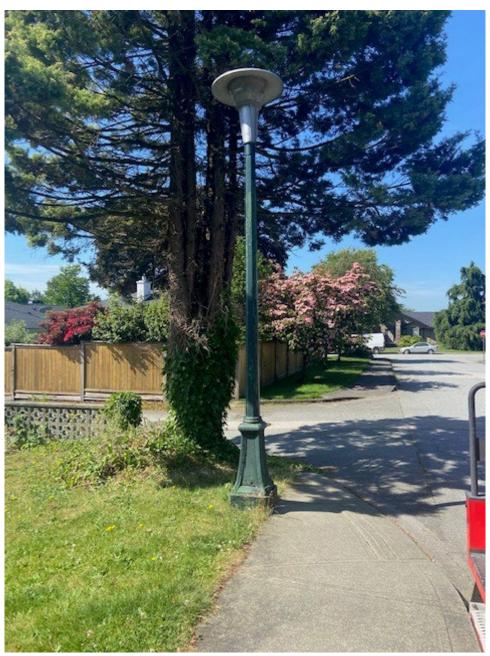
Typical MVH Site 2 lamp standard

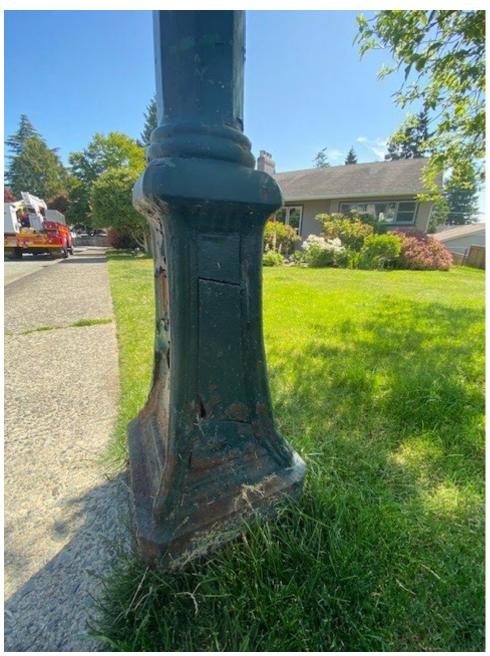
Typical Base MVH

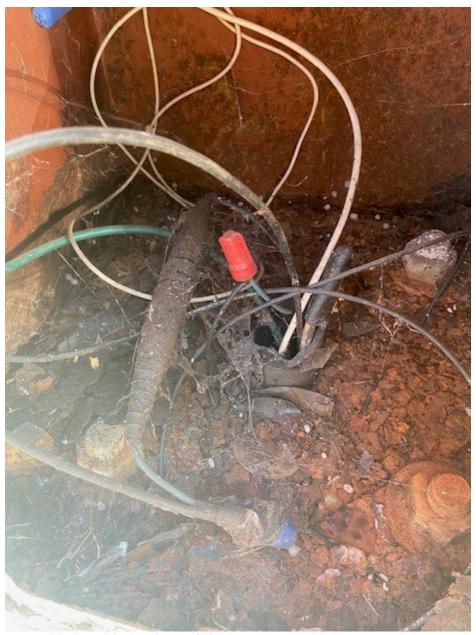
Inside hand hole view of the base top and heavy metal decay

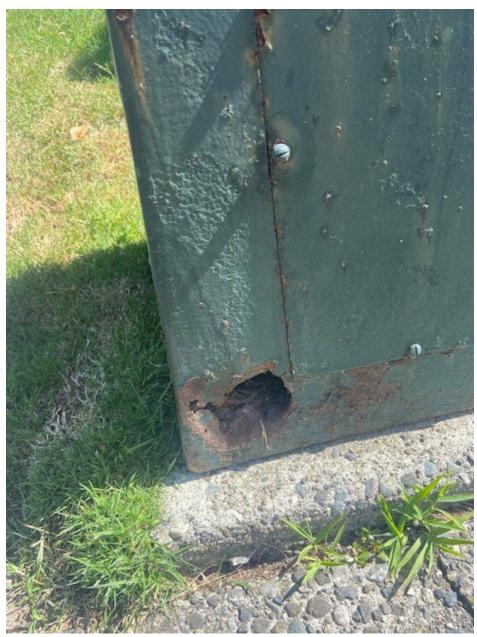
Typical base style

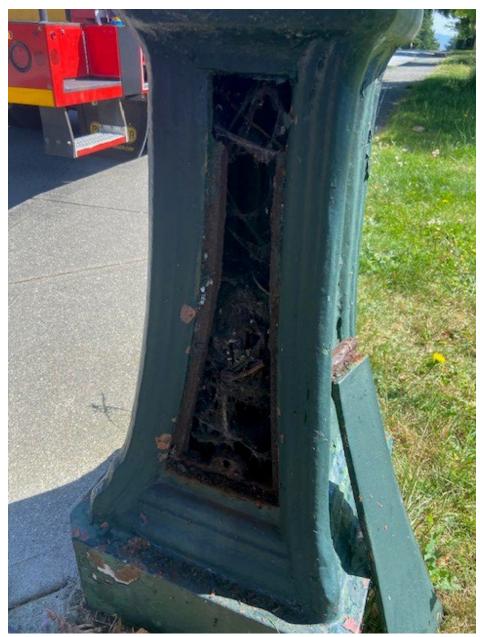
Typical base access hatch with inside metal corrosion
