## Attachment E

*Owner's Engineering Report Dated  
12 June 2025*

### MEMORANDUM # 9

**Project Address:** 53, 4<sup>th</sup> Street, New Westminster, BC

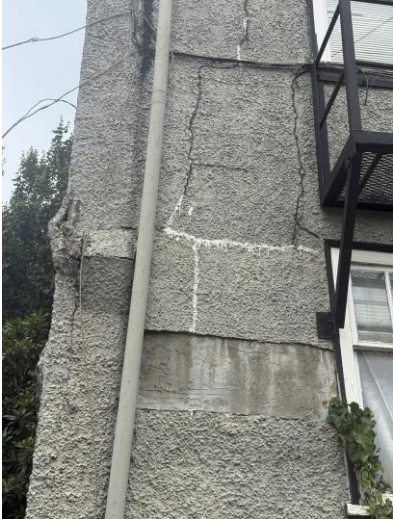
3	<p>June 2025</p> <p>There are some stucco peeling observed in the South-West corner of the building. The amount of cracks on the siding were increased comparing to the same photo taken on 2020 ( below image)</p>

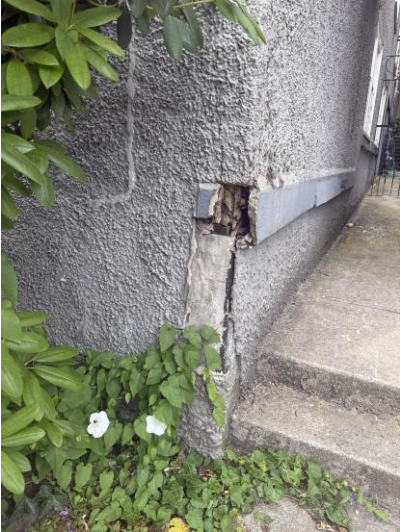
**On the exterior walls review, we found some minor increase in the South wall stucco and finishing. In the south-east side of the building, there is stucco peeling off the wall, which shows progress compared to the photos taken on 2020. On the south-west side of the building, we observed the same minor increment.**

5	<p>June 2025</p> <p>There are some stucco peeling observed in the South-Eest corner of the building. The amount of cracks on the siding were increased comparing to the same photo taken on 2020 ( below image)</p>

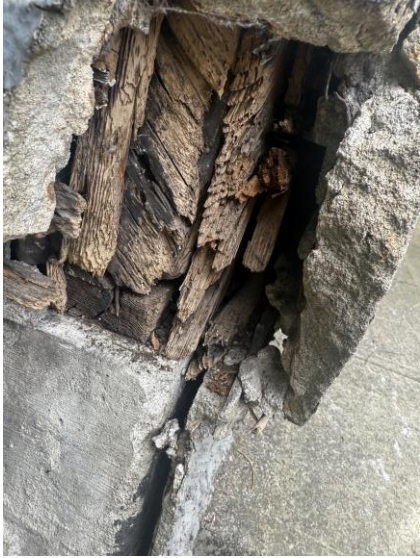
By peeling off the stucco, there are some rotted wood on the south-east side of the building framing, which should be fixed and replaced as well. We observed the same thing in the last review at September 2024, but nothing happened from the owner / landlord side regarding the fixing of rotted wood or peeling matters on the stucco.

7	<p>On the South -East corner there are rotted wood visible. These rotted wood is the framing of the lower floor and must replaced immediately as it is rotted now.</p> <p>The amount of rotting will be defined while the GWB layer is removed on interior side and framing to be opened.</p>

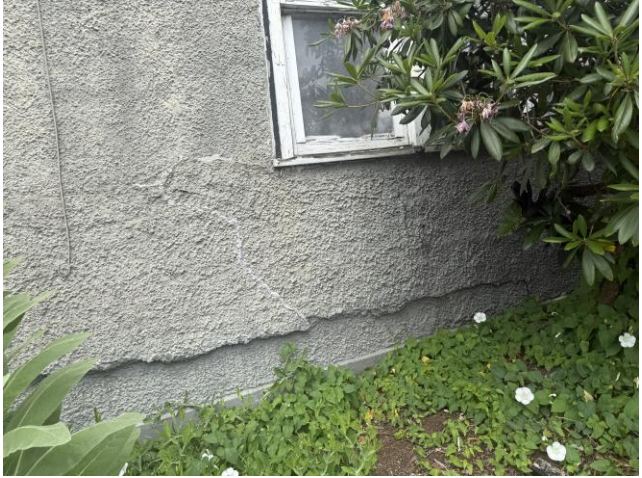
8	<p>On the South side of the building the cracks on the siding stucco are visible and increasing regarding the last year reviews.</p>

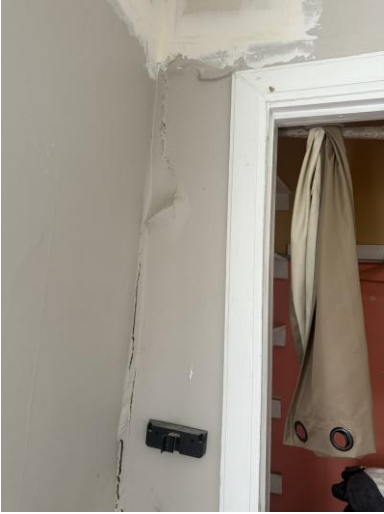
9	<p>In Unit #1; a crack observed in June 2025.</p> <p>There are some cracks on interior walls on the GWB / Gypsum plaster which is not increased significantly comparing the last year review as per below image.</p> <p>In 2024, the contractor opened the GWB and the framing reviewed regarding the angles between joists, walls, posts/ beams.</p>

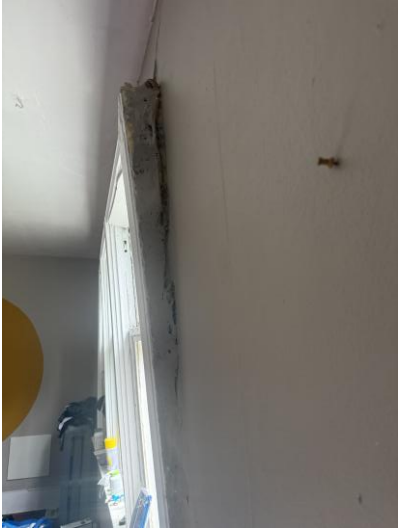
11	<p>Window – Interior – Unit #1 : June 2025</p> <p>There are some cracks on interior walls on the GWB / Gypsum plaster which is not increased significantly comparing the last year review as per below image.</p> <p>In 2024, the contractor opened the GWB and the framing reviewed regarding the angles between joists, walls, posts/ beams</p>

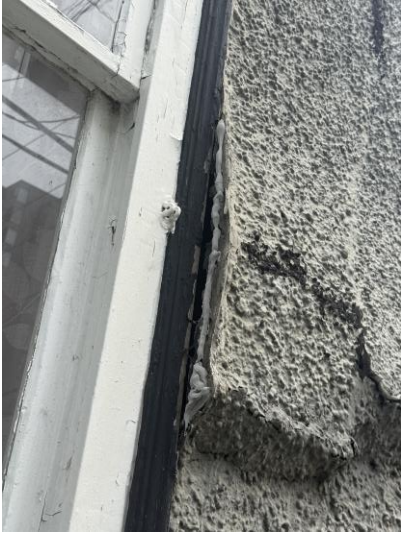
13	<p>This spot on the Soth-West corner of the building also have a building envelop issue.</p> <p>As shown and is obvious in the image water ingress can be happened and provide some issues regarding the moisture and its consequences. In the images 17, 18, 19 &amp; 20 there are some moisture issues that reflects on the GWB at the same spot interiors.</p>

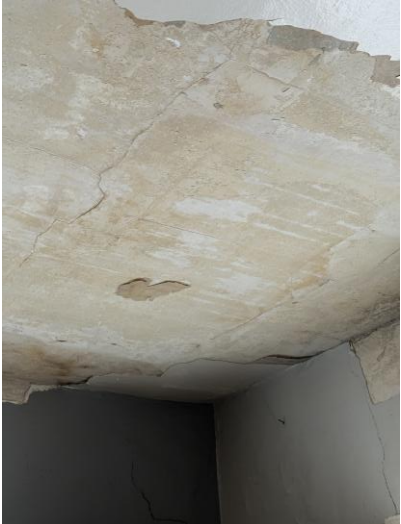
14	Moisture trace on the ceiling

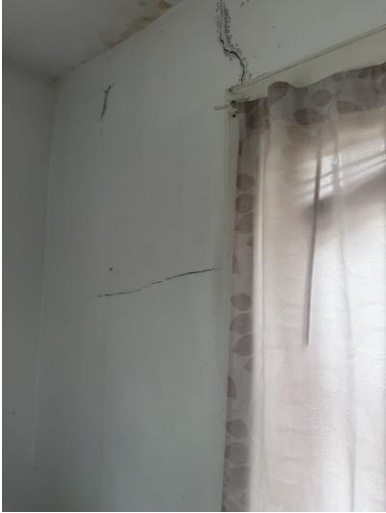
15	Some cracks on the window opening in unit #2

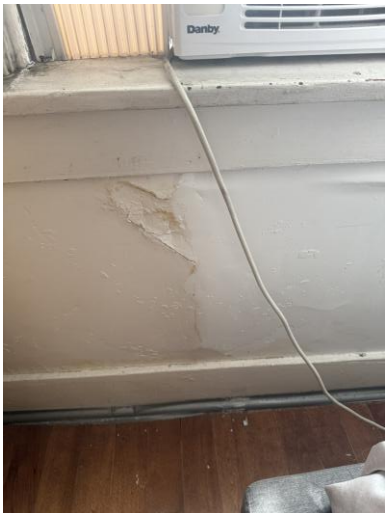
16	Cracks and moisture issues on the lower side of the window opening in the unit #2

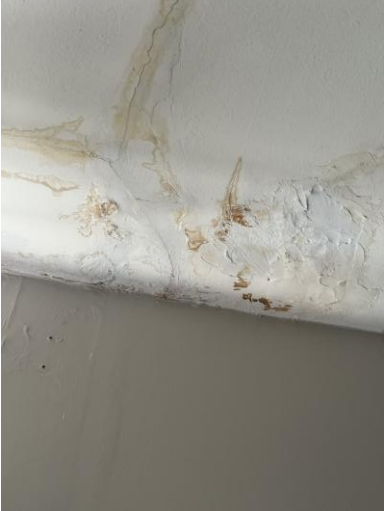
17	Moisture in the ceiling in unit #4

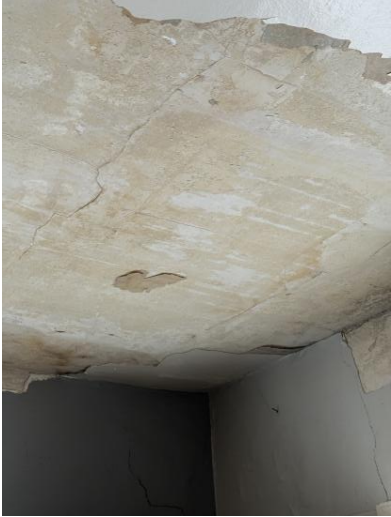
19	Moisture in the ceiling in unit #4

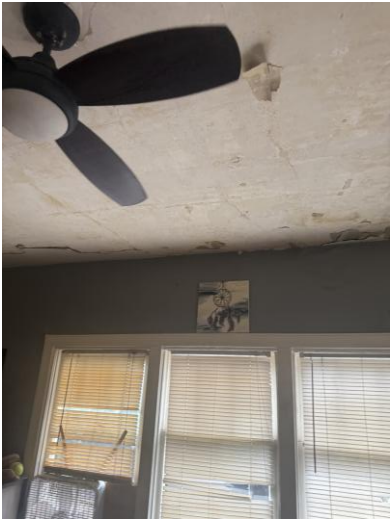
20	Moisture in the ceiling in unit #4
