FIELD REVIEW REPORT

Date of Report: June 20, 2025

Project Name: 53 Fourth Street ("Carnarvon Court"), New Westminster

RAHC Project Number: 25124

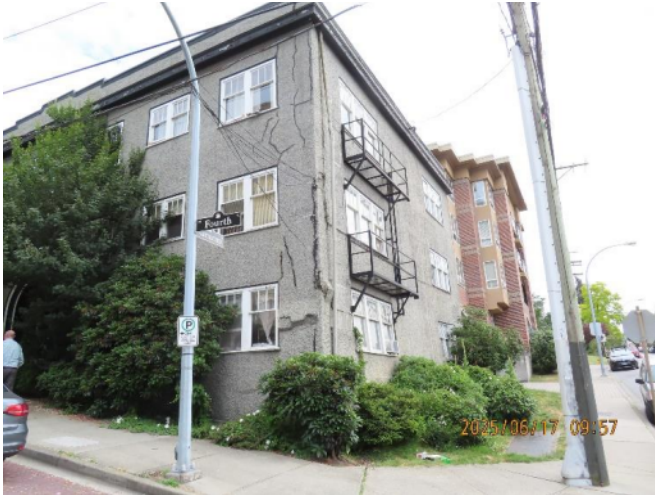
1. Southwest corner from southwest vantage.

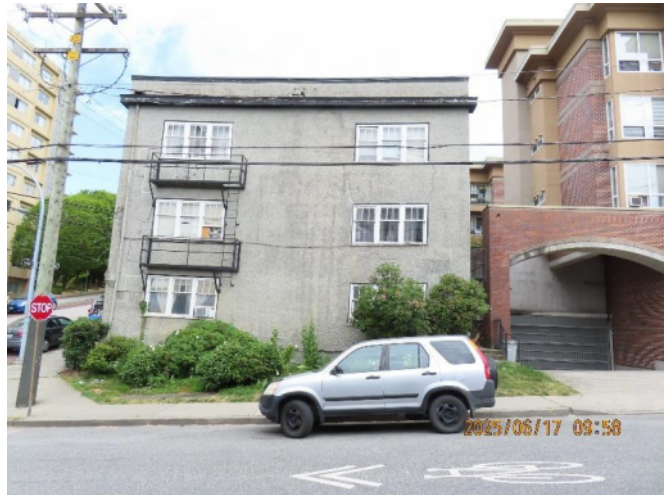
6. Significant lateral deformations along the full width of the south exterior wall are evident from both the exterior and interior sides. The wall from the top of the foundations to the second floor is obviously out of plumb, with the upper part of the wall leaning inward (i.e. toward the north).

2. South wall from south vantage.

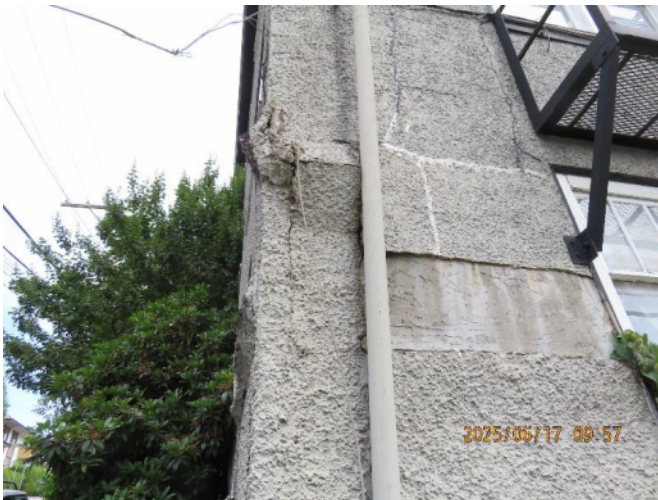
8. Research via Google Maps Street View indicates that the deformation and damage of the exterior stucco finishes progressed (in the captured images) from slight and difficult to detect in 2009 to pronounced and obvious in the latest images from June 2024.

3. Damaged and deformed stucco at southwest corner.

- g. Reinstate the building envelope on the new framing, and repair any other obvious damage to the envelope in consultation with a building envelope engineer.
12. If additional and/or more specific structural engineering advice is required, RAHC would be pleased to assist as we are able.

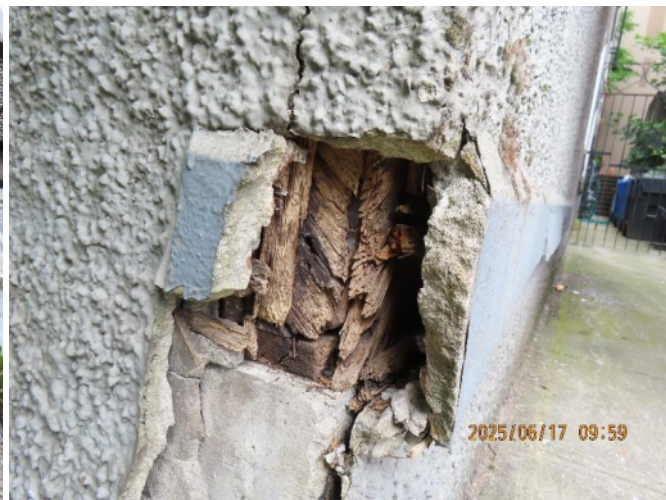
- a. Softening and decomposition of the wood framing of the wall and edges of the floors due to decay from water ingress through the building envelope system.

4. Exposed and decayed framing at southeast corner.

- e. Repair or replace any decayed floor framing (joists, rim joists, and/or sheathing).
 - f. Install a new stud wall to the underside of the second floor, sheathed with plywood, and anchored to the foundations.

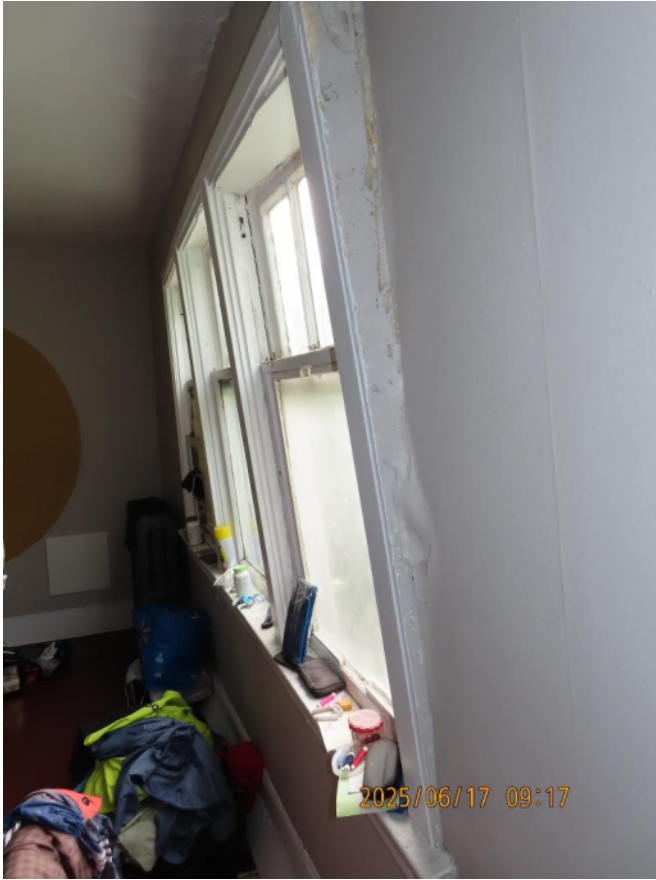
7. Significant vertical deformations of the central area of the main floor near the south exterior wall were observed in Units # 1 and 2. We were not able to access the second-level units directly above, but vertical deformations in the floor of the corridor near the doors to these units suggest that similar but probably somewhat less severe vertical deformations are present in the second floor near the south exterior wall.

5. Obvious deformation around window in Unit # 1.
