Attachment G

*Owner's Engineer Reports
(MAF and ASYAM) From March 2019
to September 2024*

Project No.: G20080-00

Re: Existing Apartment Building
53- 4th Street
New Westminster, B.C.

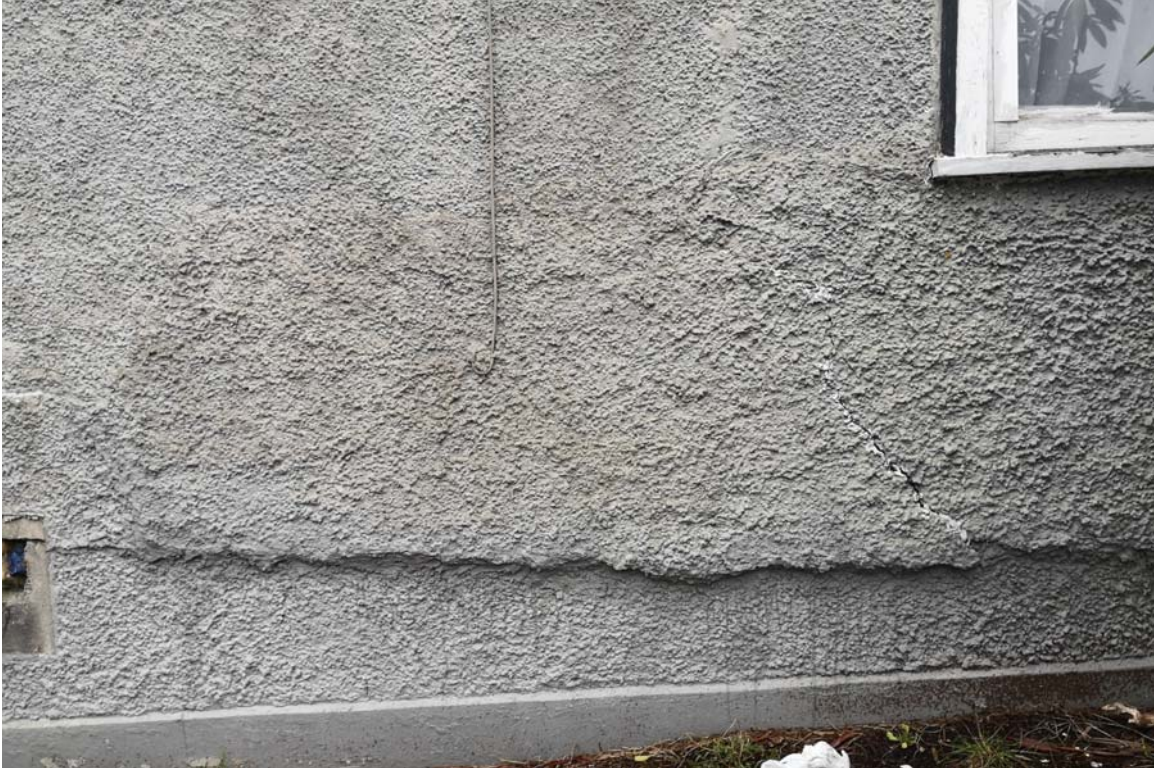
Picture #1: BOTTOM OF SOUTH WALL (BUBBLING OF BOTTOM SECTION)

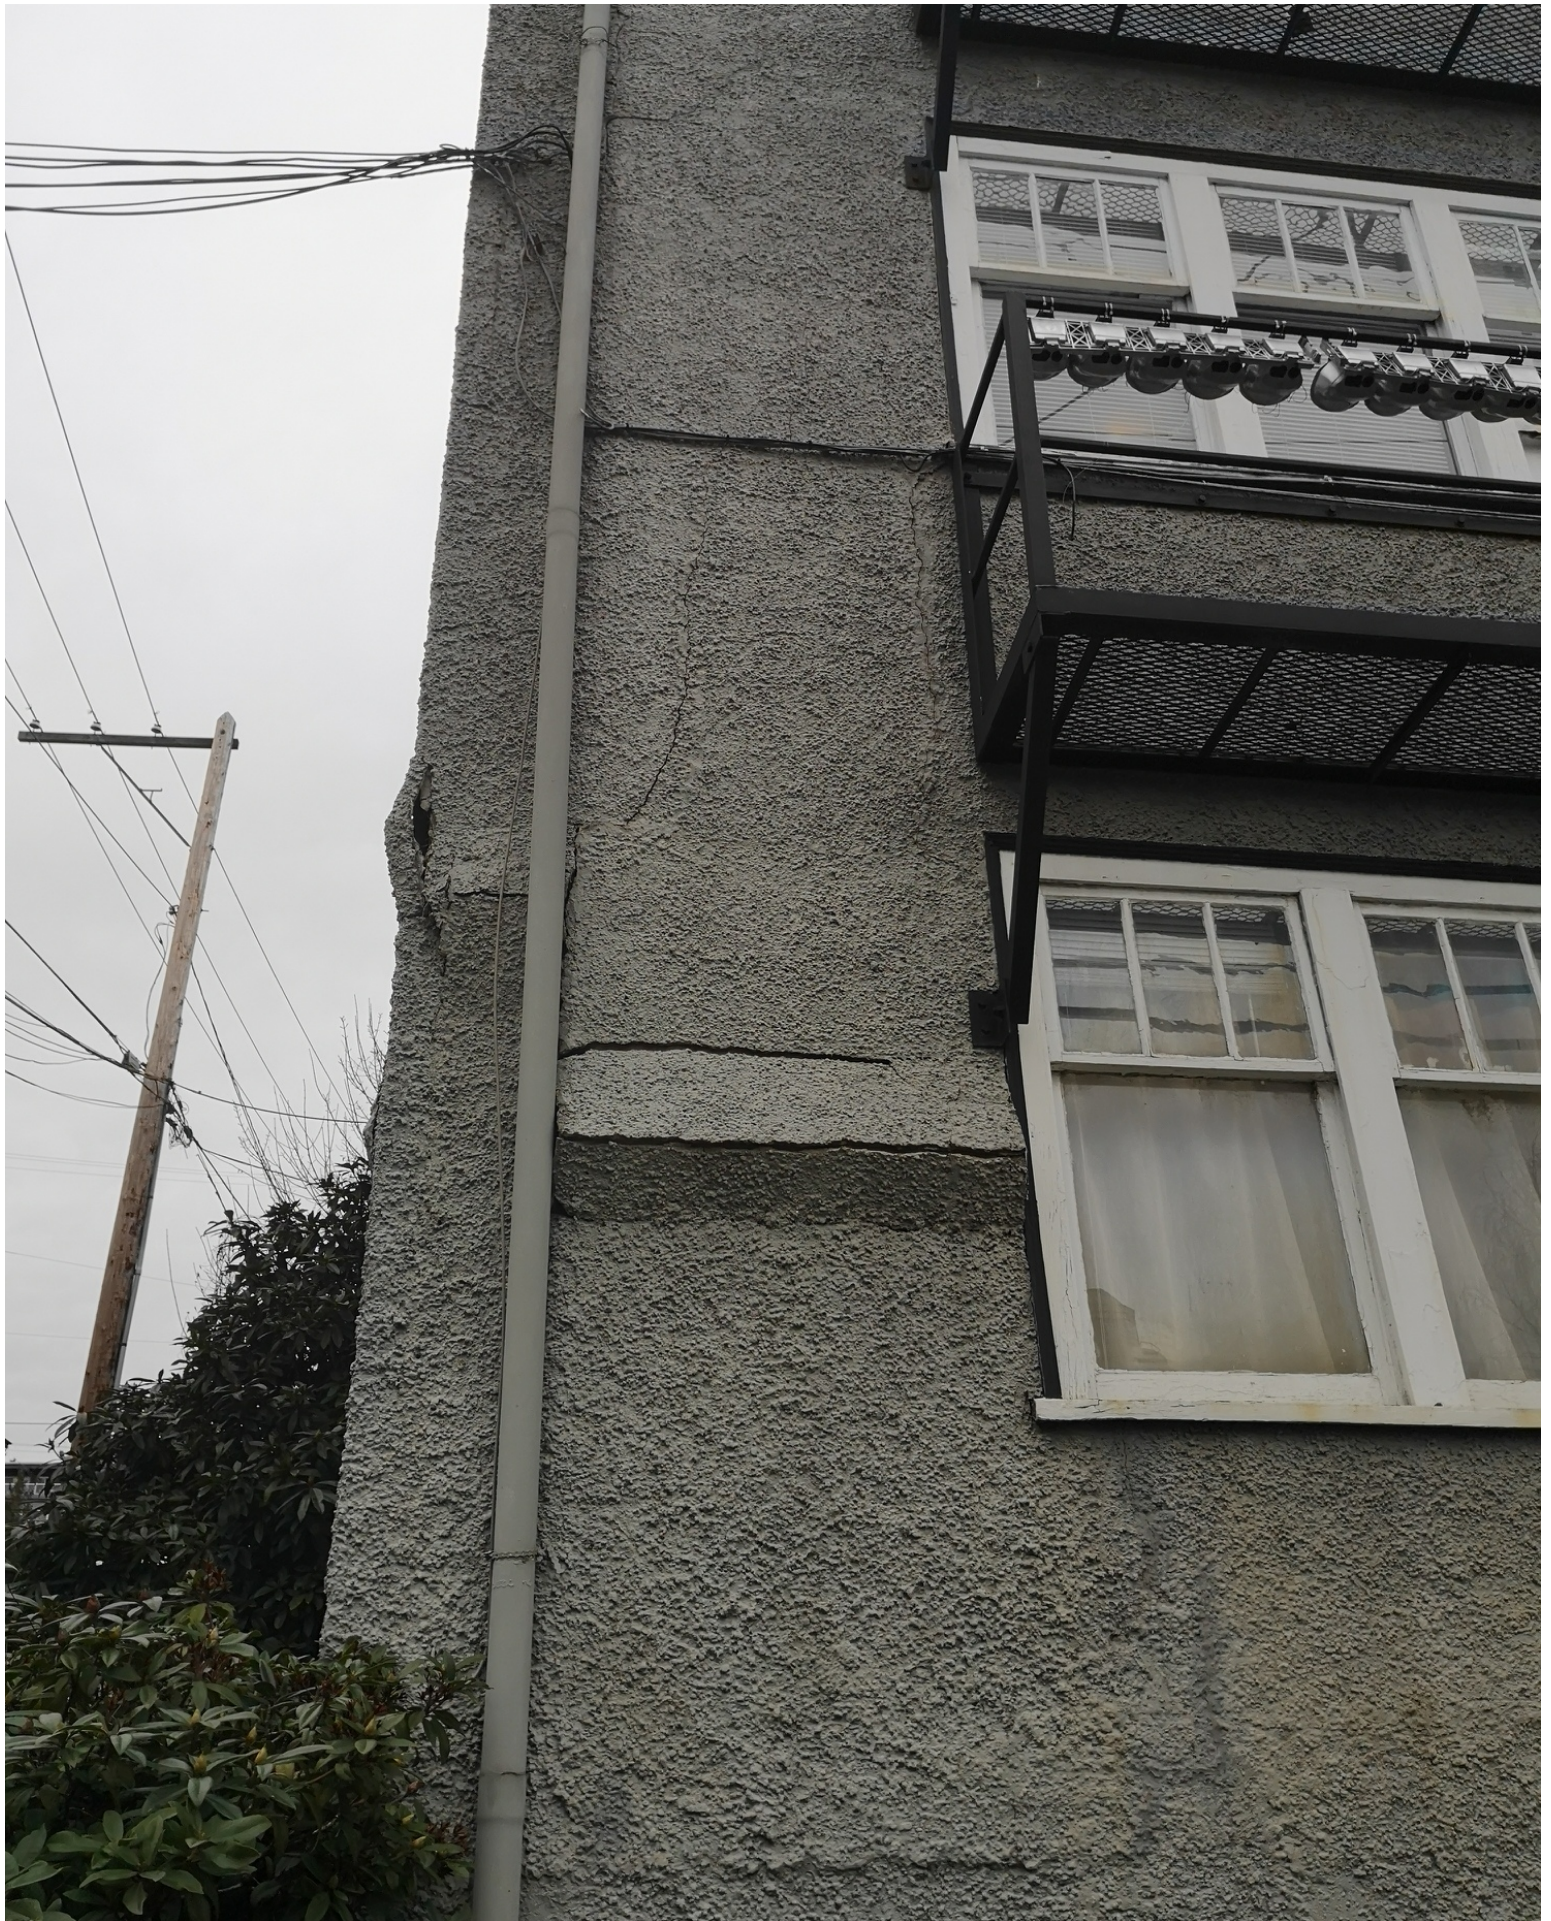
PICTURE #2: EAST SECTION OF SOUTH WALL (WALL BUBBLED AT THE MID-SECTION)

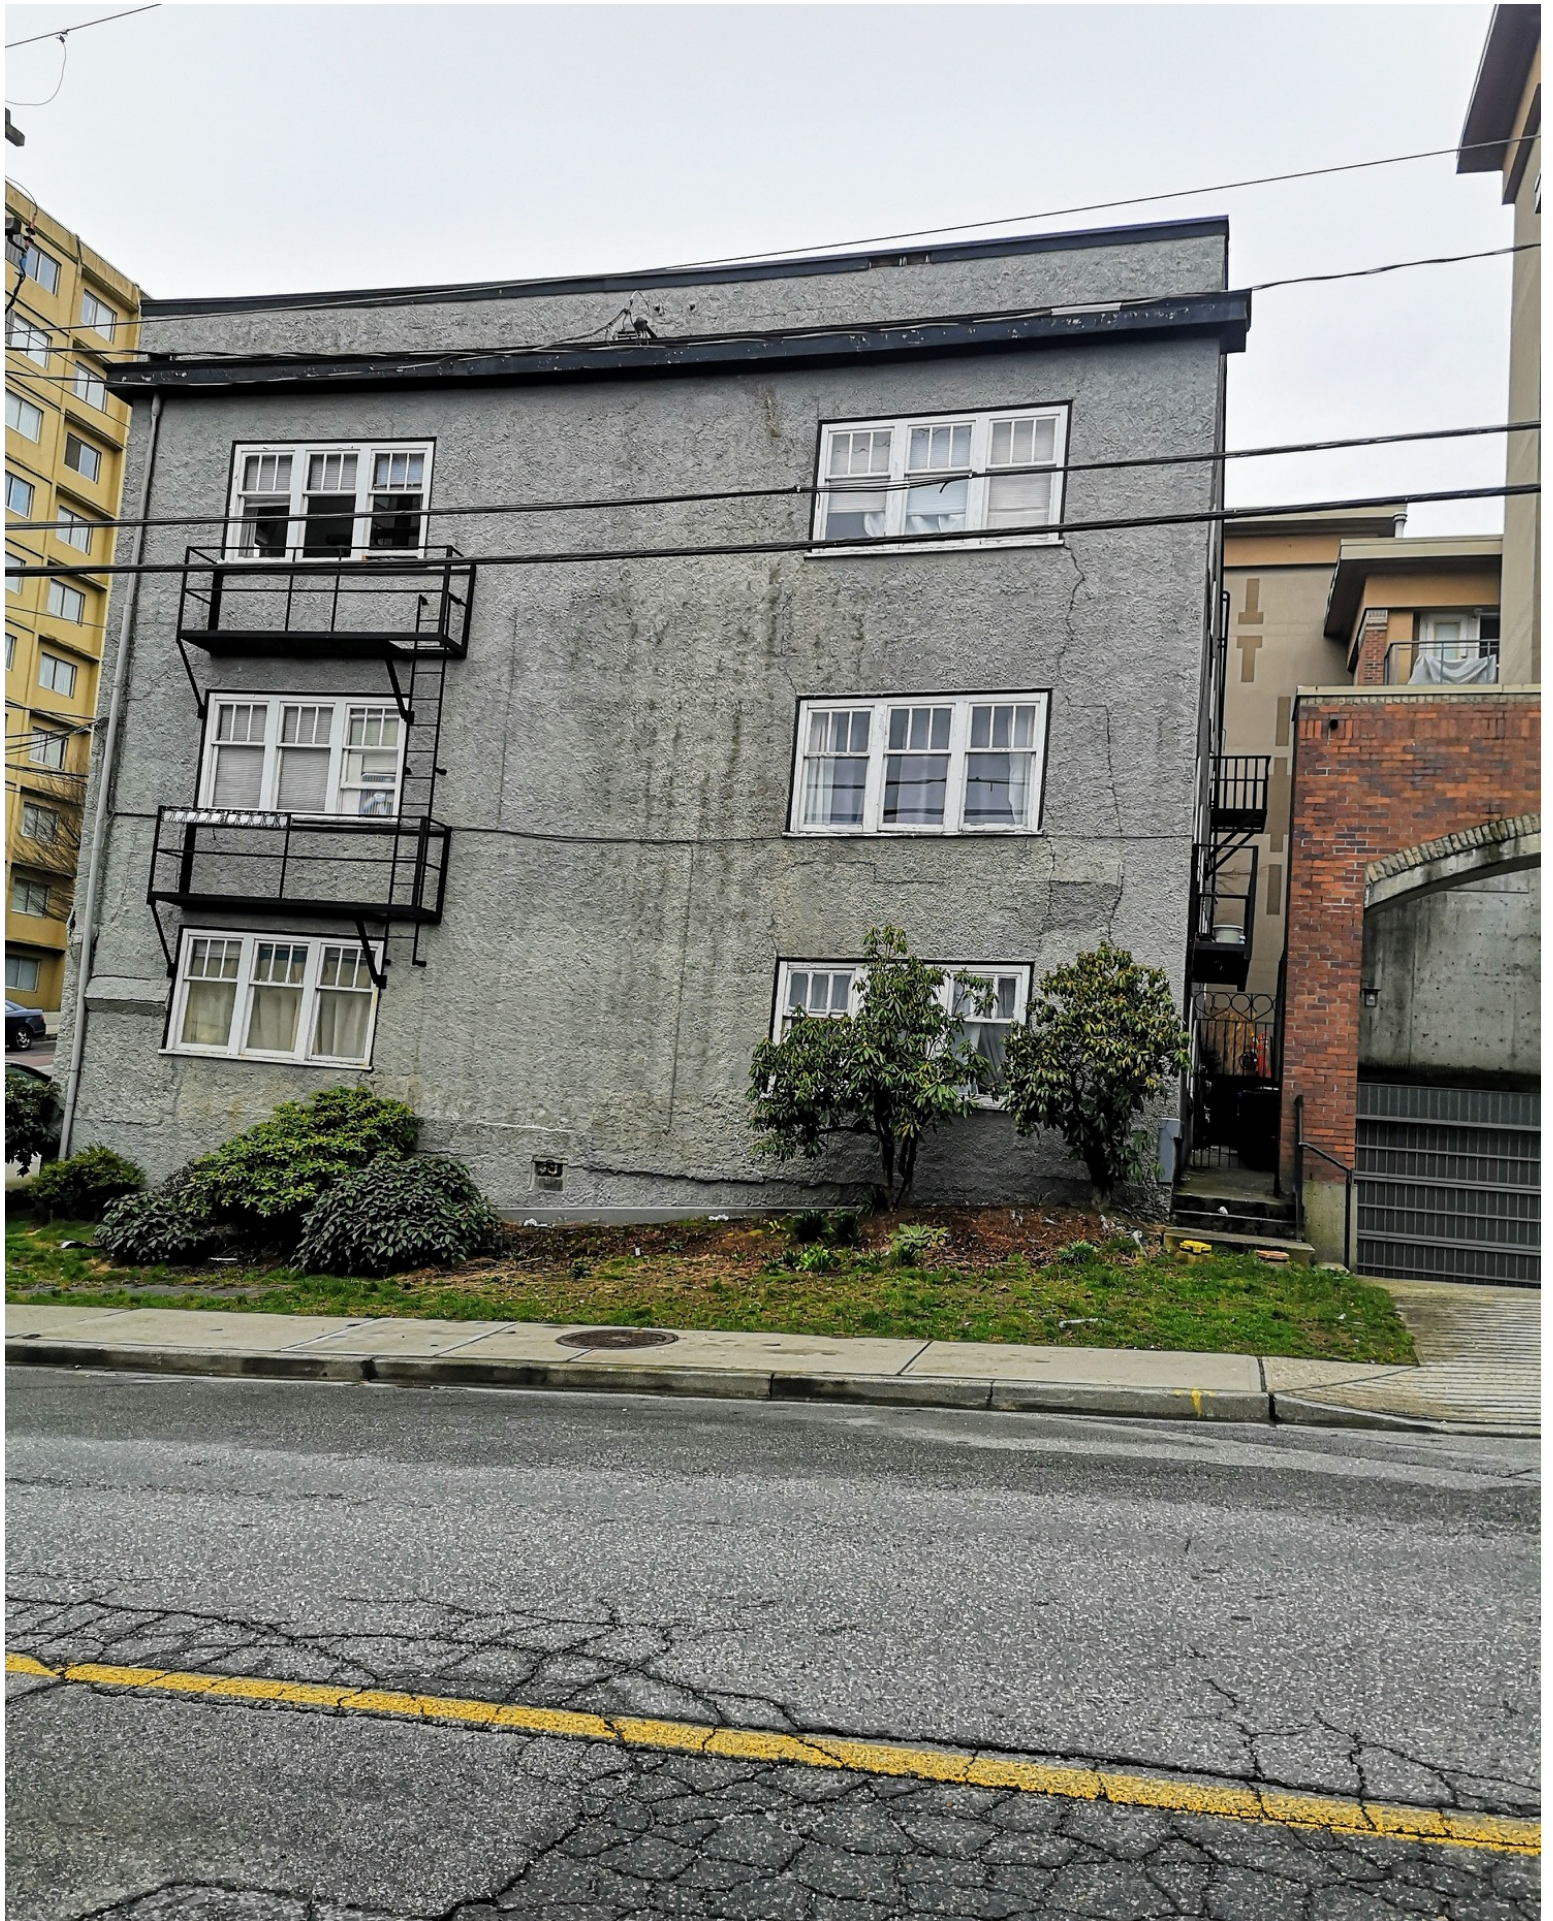
2. There are alligator cracks along the south fronting street. Forming of alligator cracks is an indication the near surface soils are soft.
3. Based on our site reconnaissance and discussion with Mr. Niakouei, we concluded that building had subsided on the south side. However, the settlement has been stabilized. The settlement is likely due to consolidation of the near surficial soils. Except for minor adjustment for doors and repairing of the damaged on the east and south exterior walls, there is no immediately safety issue for the building.

PICTURE #3: SOUTH WALL (NOTED ALLIGATOR CRACK ON ROAD)

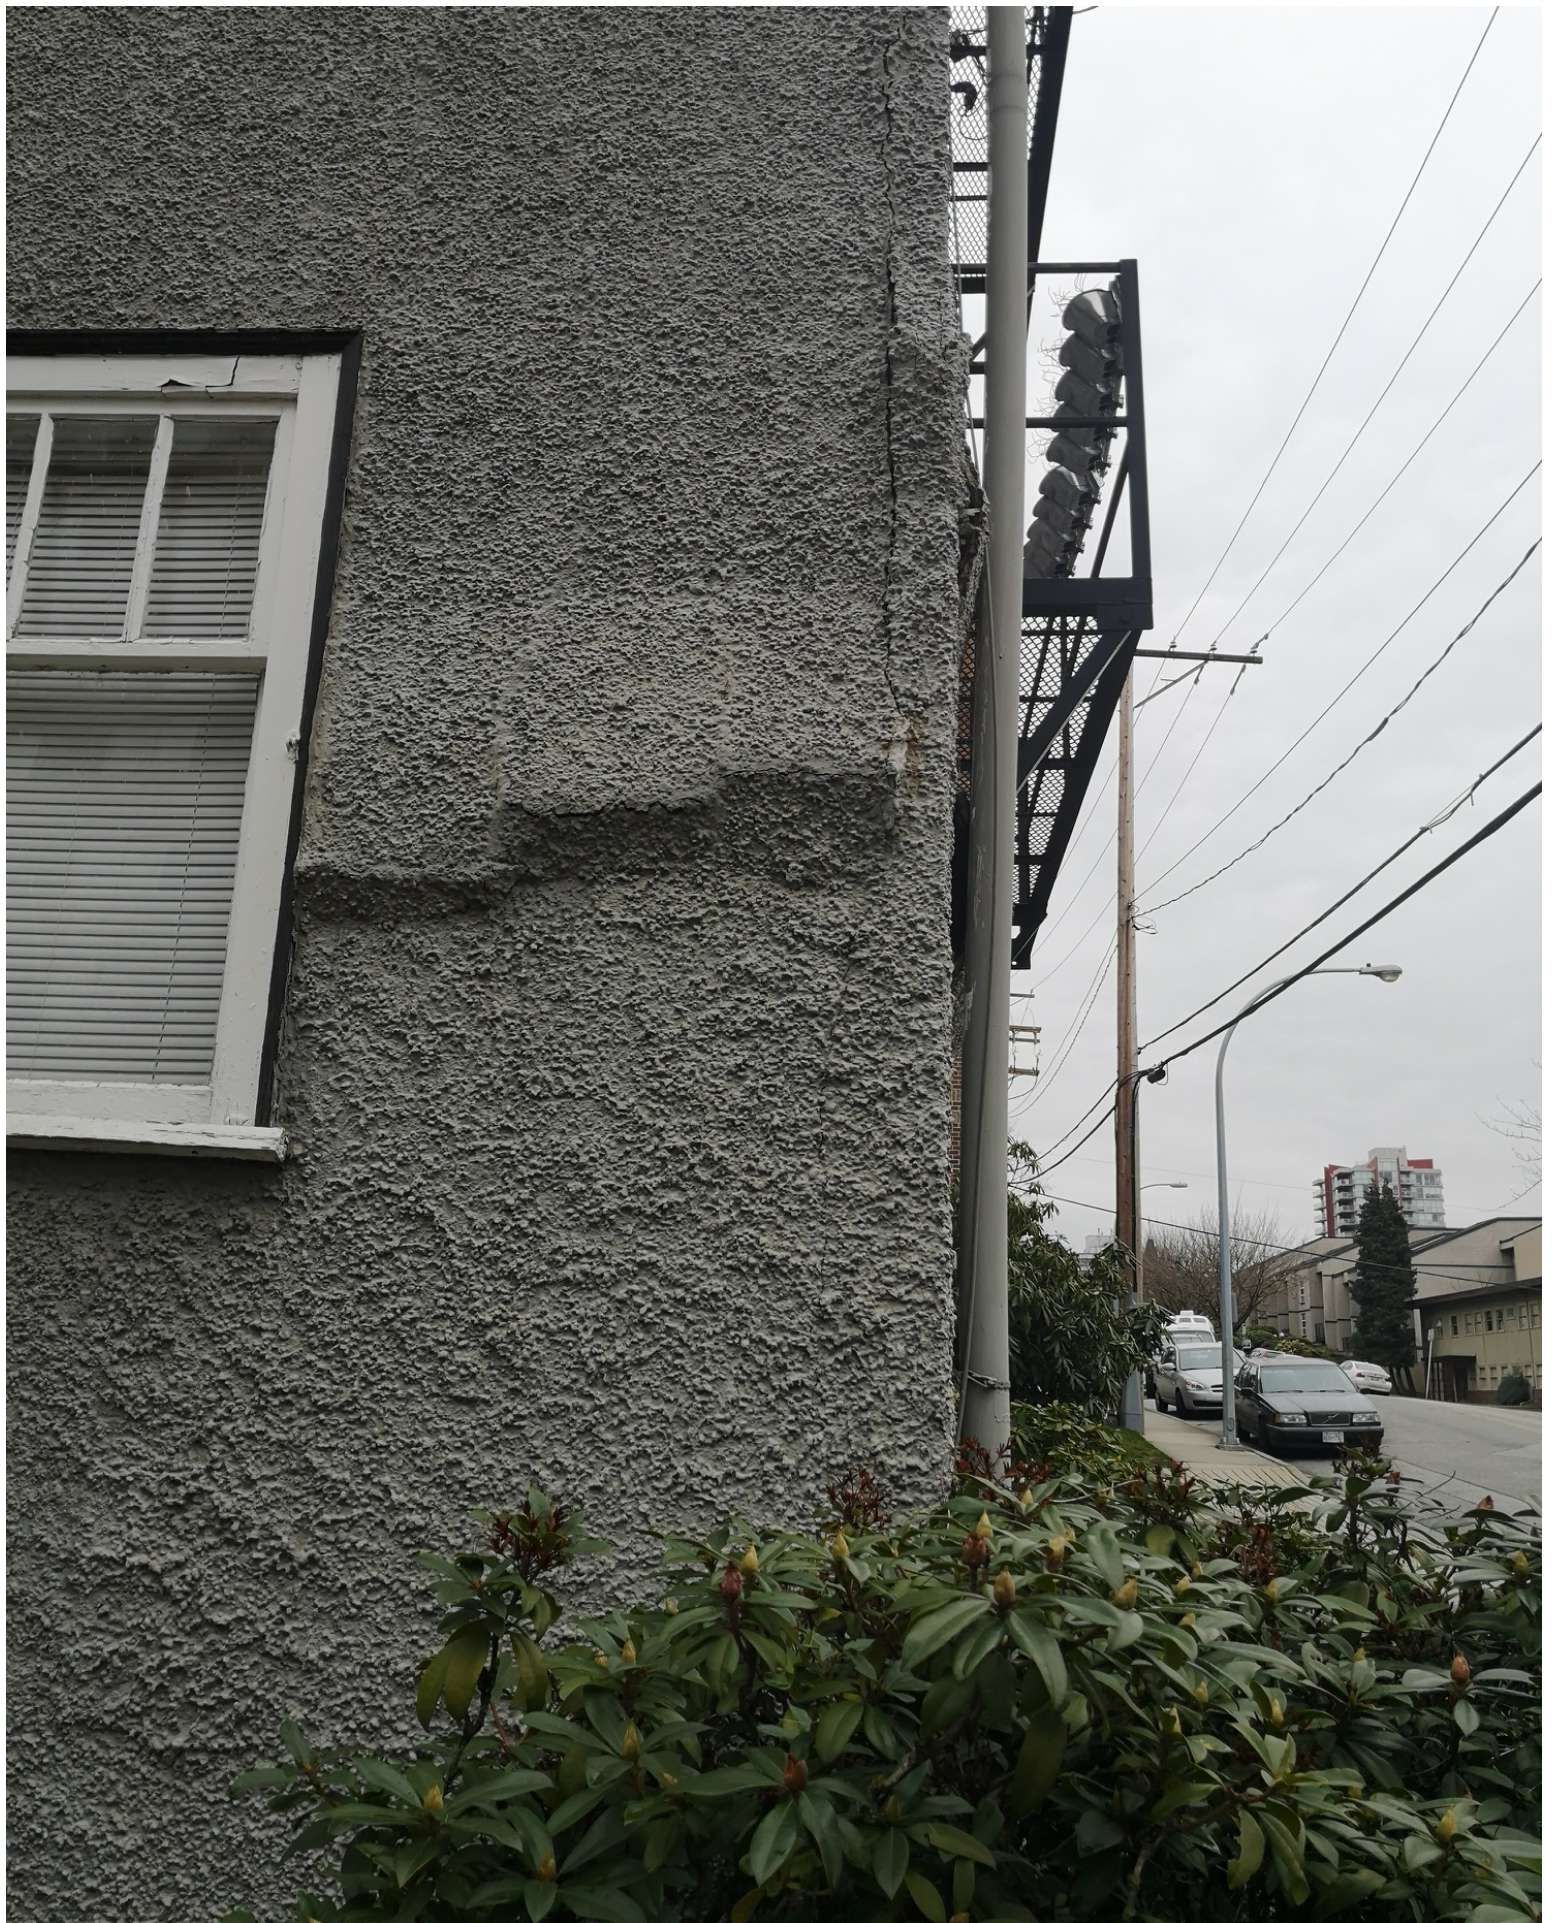
PICTURE #4: SOUTH SECTION OF EAST WALL (BUBBLE ON WALL NEXT TO MAIN FLOOR WINDOW)

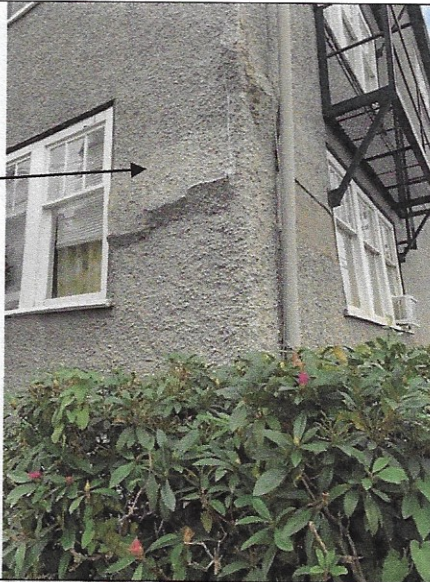
3	A bubble in South-West corner of the building which siding is bubbled and stucco has already separated / peeled off the building.

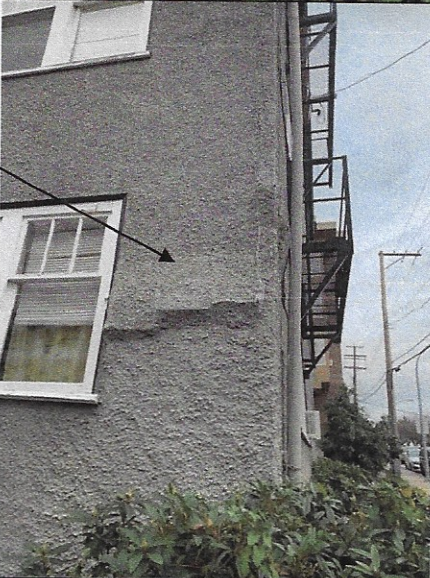
4	Same bubble on stucco of different angle.

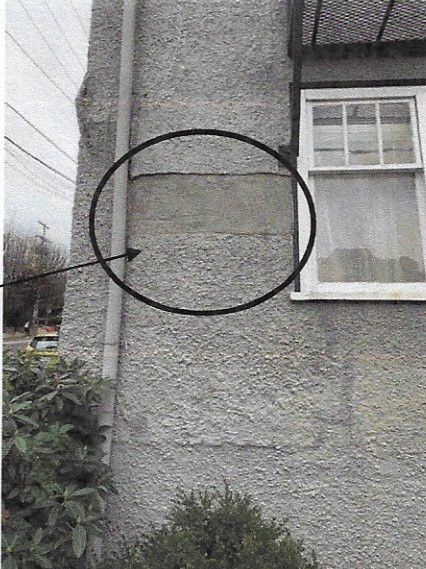
In South west corner of the building, one small part of stucco has fallen. This part was peeled of the building in last visit which now, fell completely. This may occur because of penetration water, rain, snow ... in that spot and caused some oxidation on stucco material during few months which caused removal. Or may be caused of additional Settlement in that part of building which needs to have further investigation.

5	<p>A photo of South-West corner of the building which stucco was bubbled in previous site visit and observed the stucco has been peeled off and fell down. Obviously, a thin layer of mortar has been done on this part. This part was bubbled in previous site review (the same as figure 3 & 4) and now it fell down.</p> <p>This needs more further investigation and can be noticeable.</p>

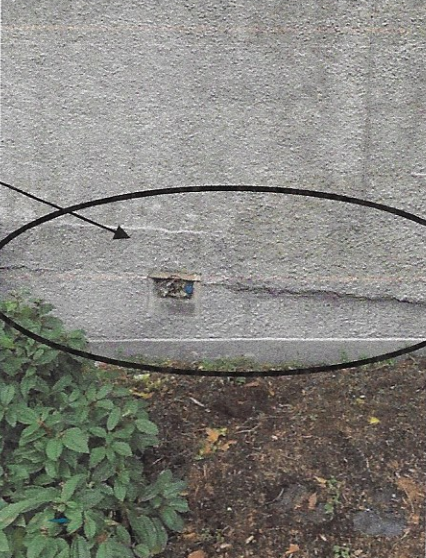
6	<p>Some cracks which caulked before and it seems need to be re-caulking.</p>

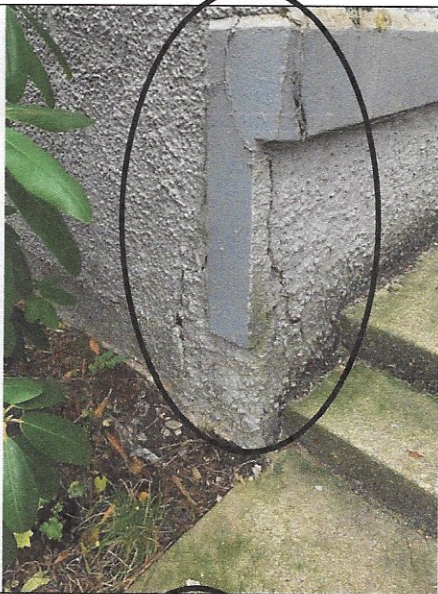
In South-east corner of building there was a crack which filled by caulking and now it seems to become wider. Some cracks on stucco which filled by caulking seems need more caulking to protect of water penetration in to framing material.

7	<p>On the South-East corner of the building there is one crack which need more caulking and need to be fixed. Water, rain can penetrate thru this crack and may cause some rot in framing. Or water may already penetrate and caused some rot. It needs more investigation on framing.</p>

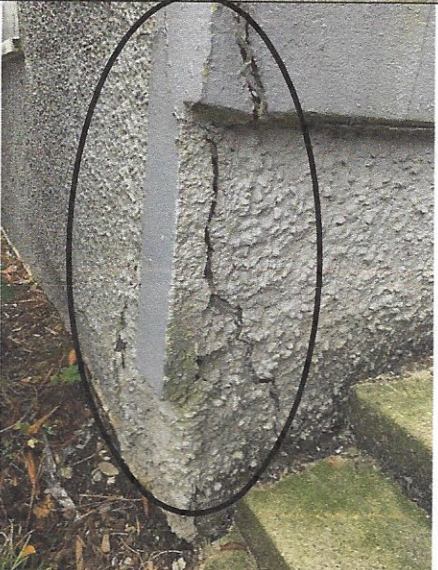
8	<p>Same spot with closer view.</p>

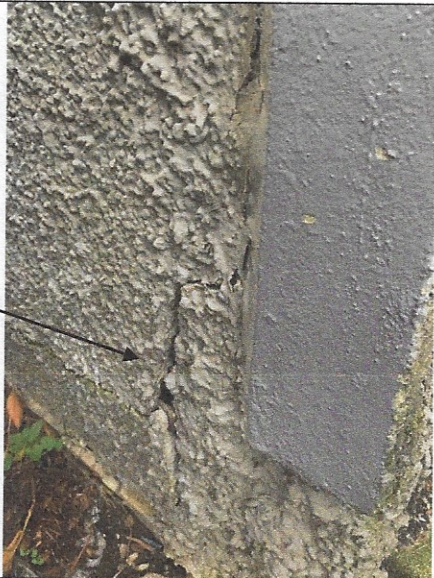
9	Same spot of figures 7 & 8 with different angle which needs more caulking and more investigation on existing framing regarding rot.

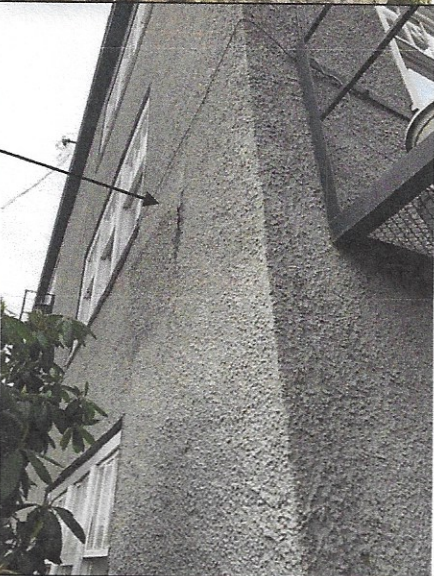
10	This crack also need to be r-caulked

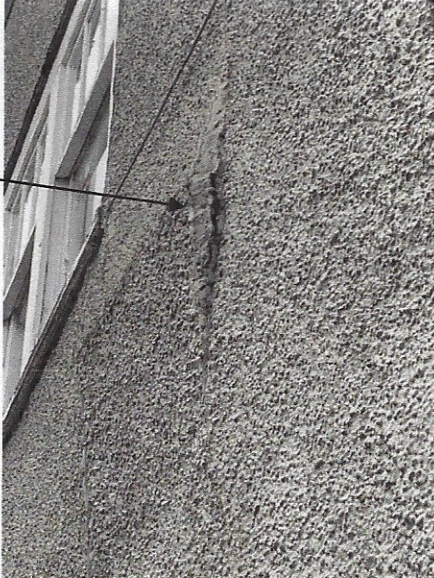
11	Crack is caulked before and needs more caulk to protect on water penetration.

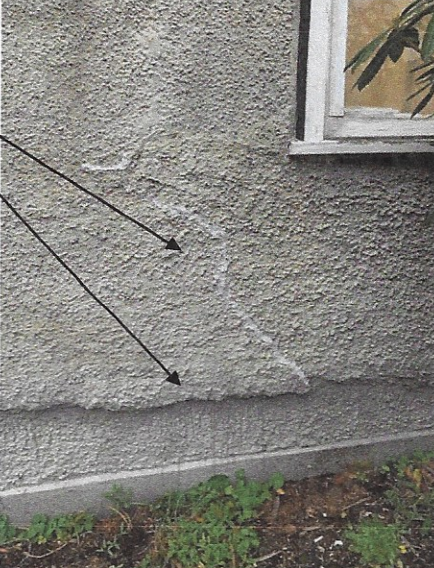
12	Cracks which filled by caulking and needs more caulk.

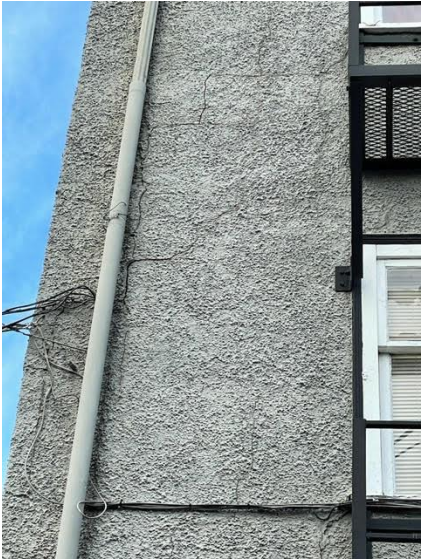
3	Cracks on stucco have been filled by caulking about two years ago.

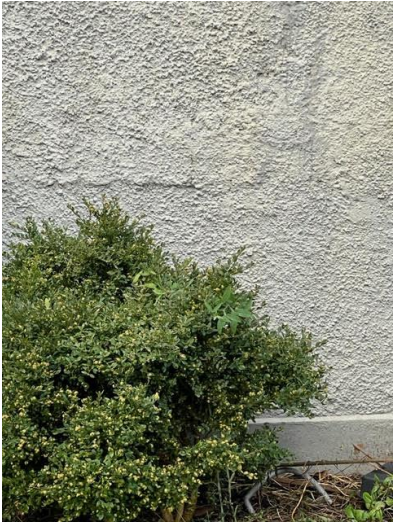
5	Cracks on stucco have been filled by caulking about two years ago.

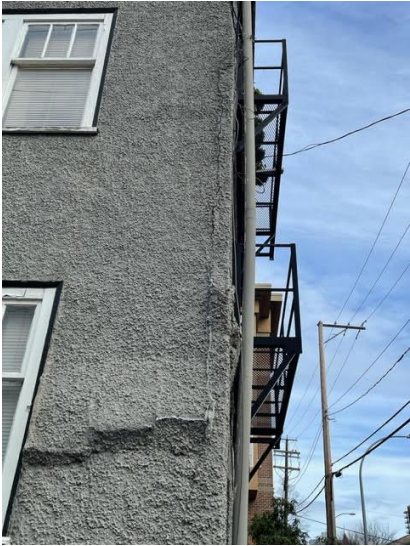
7	Cracks are filled by caulking about two years ago.

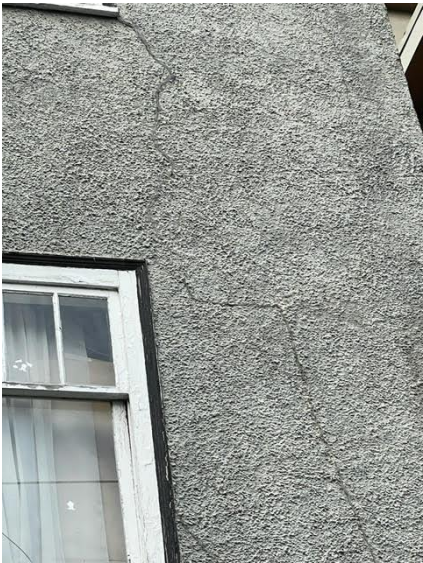
8	Cracks are filled by caulking about two years ago.

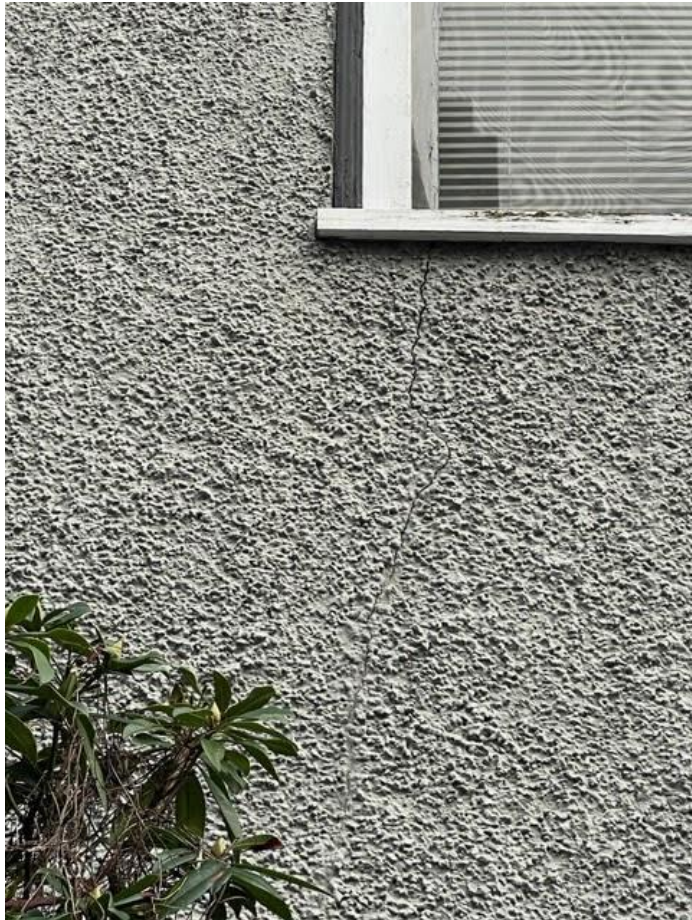
9 This crack is not filled by caulking, it seems new crack. All other existing cracks have already been filled by caulking which shown in other photos, while this one is not filled.

It seems this one is recently appeared which is on the stucco siding and is not on the frame sheathing necessarily.

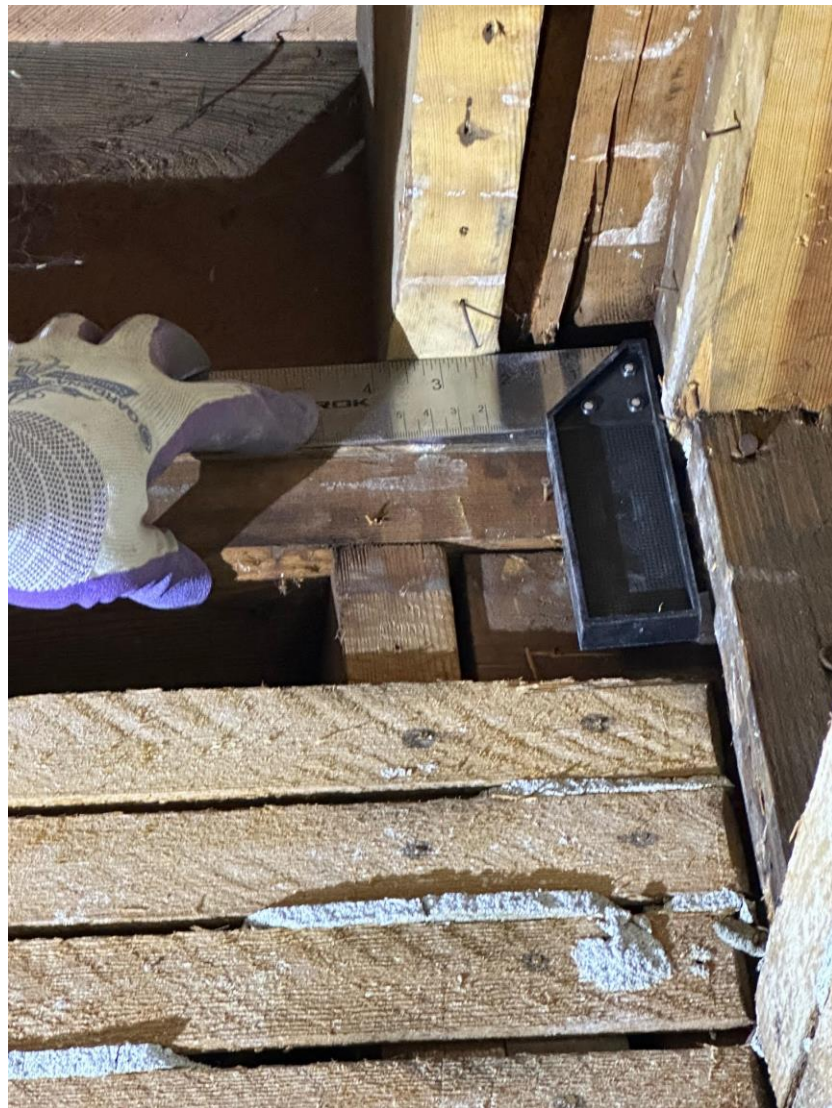
2 The angle between the top plates and joists / stud walls were reviewed.

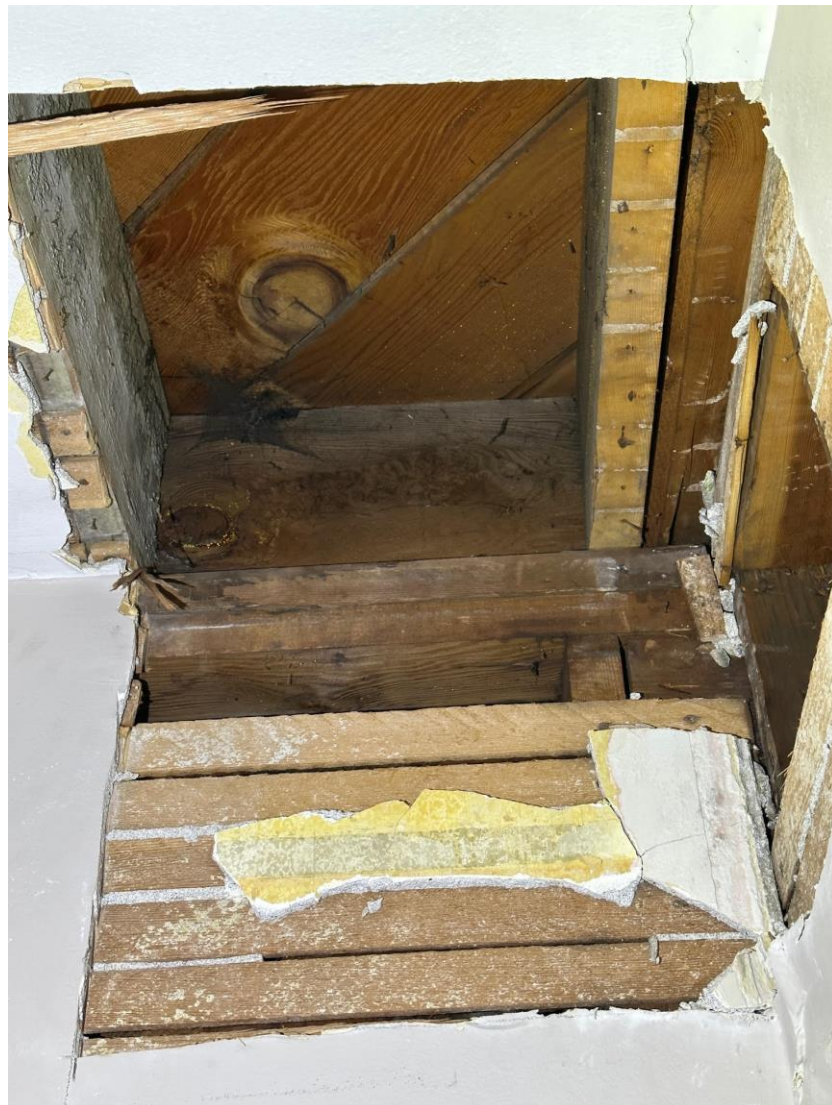
3 Ceiling and wall were
opened up by
contractor

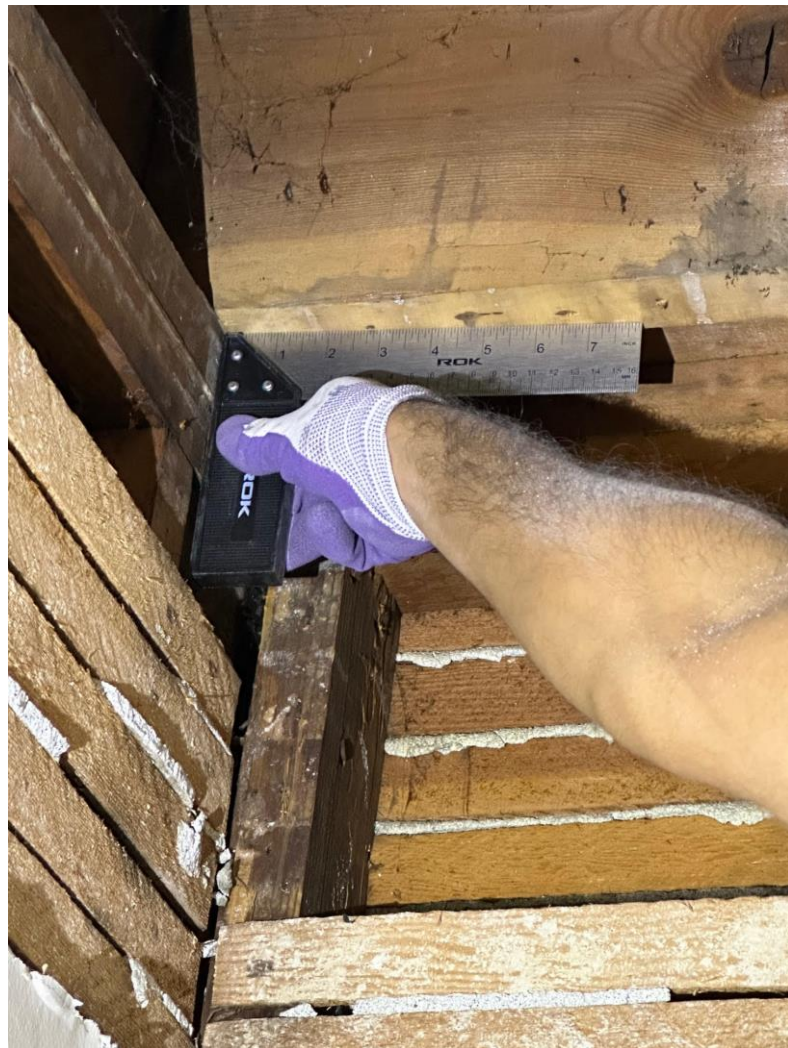
4 Existing angle
between ceiling joists
and wall studs were
reviewed

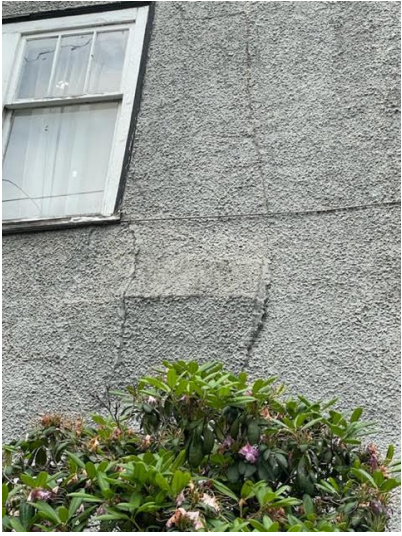
5	Cracks on stucco have been filled by caulking about two years ago.

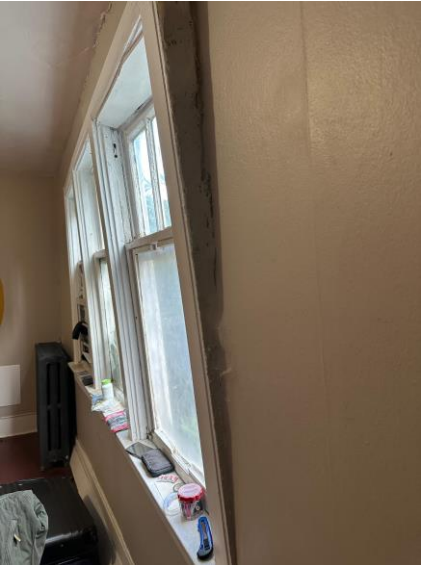
8	Deformed window

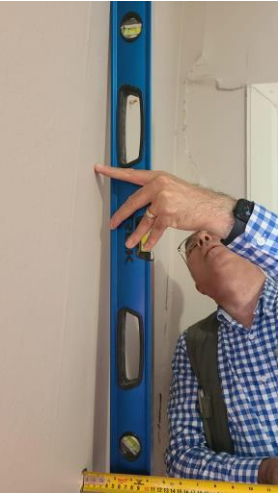
9	Un-plumbness of the wall

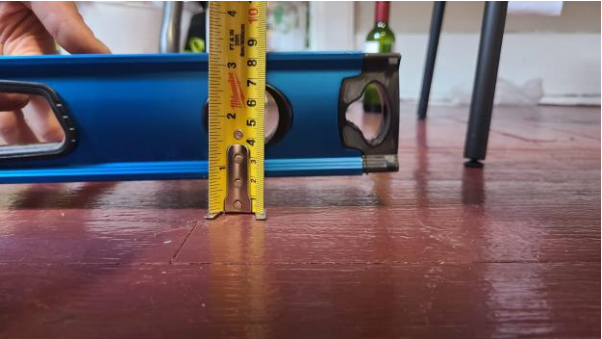
10	Un-levelness of the floor in one room Adjacent to deformed window

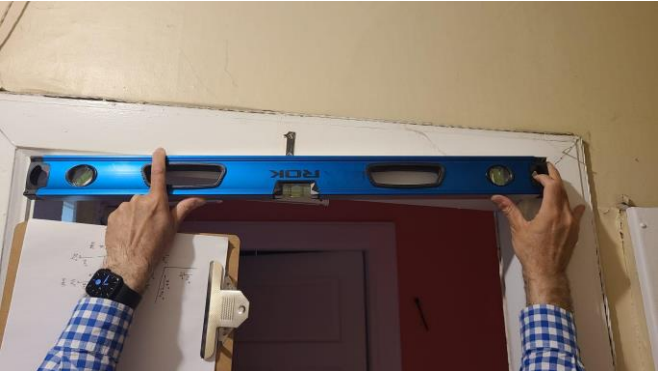
11	Deformed door frame.

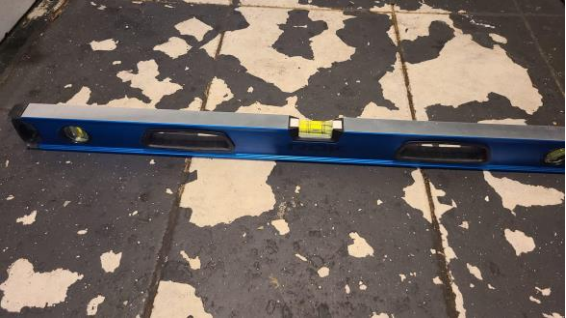
12	Un-levelness of the floor in other room same unit

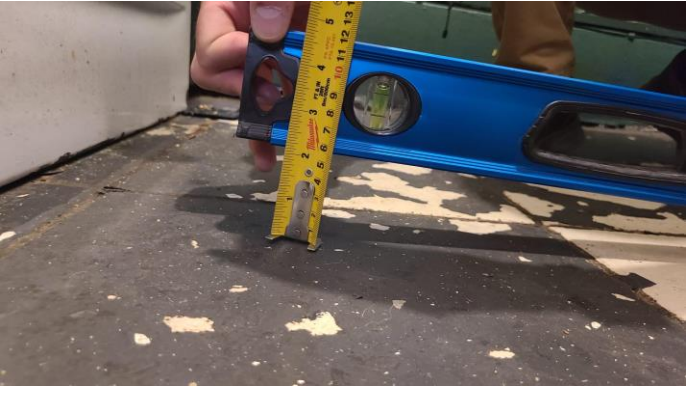
13	Un-levelness of the floor in other room same unit

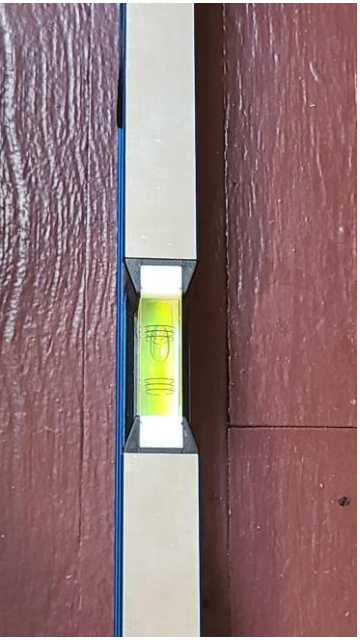
14	Un-levelness of the floor in other room same unit

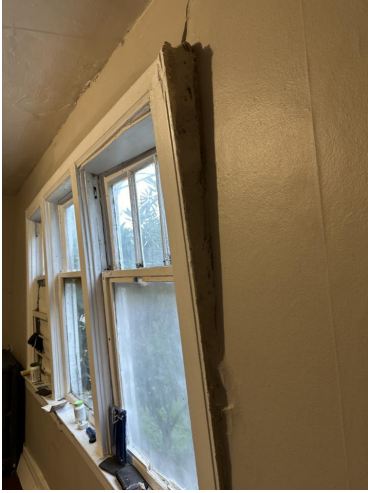
1	<p>Unit #1: Interior</p> <p>The window and wall are almost at the same situation regarding the un-plumbness as previous inspection</p>

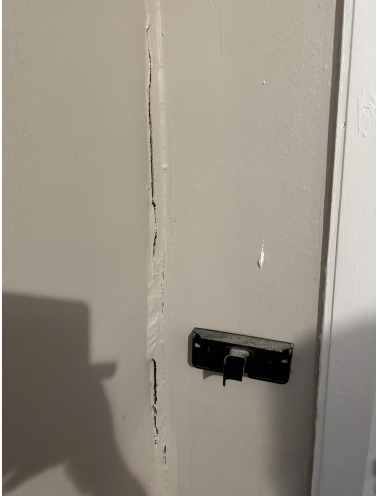
3	<p>There are some cracks on drywall/ plaster/ wall finishing in the corner</p> <p>Unit #1 on the south wall.</p> <p>By reviewing the taken photos on 2023 , the same crack was there and no improvement from interior side.</p> <p>See the next photos</p>

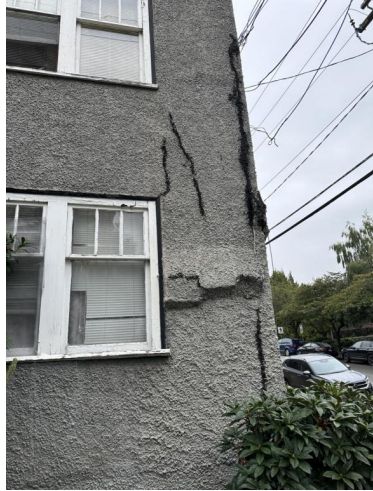
5	<p>This view of the southwest side of the building on the exterior wall. Stucco is peeled off.</p> <p>Compare with the phot of the same spot was taken in 2020 in below</p>

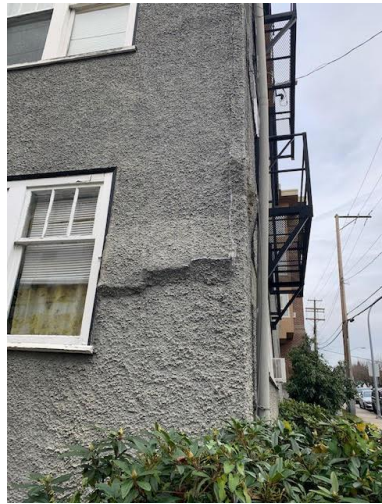
6	<p>This photo was taken on 2020</p> <p>There is a minor improvement in the stucco peeling with the framing.</p>

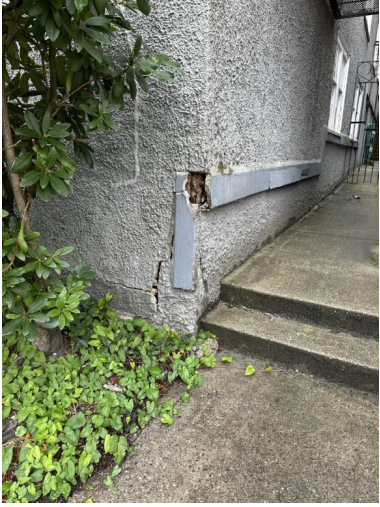
By peeling off the stucco, there are some rotted wood on the south-east side of the building framing, which should be fixed and replaced as well.

7	<p>This view of the southeast side of the building on the exterior wall. Stucco is peeled off.</p> <p>Compare with the photos # 9 & 10 of the same spot that were taken in 2020 in below</p>

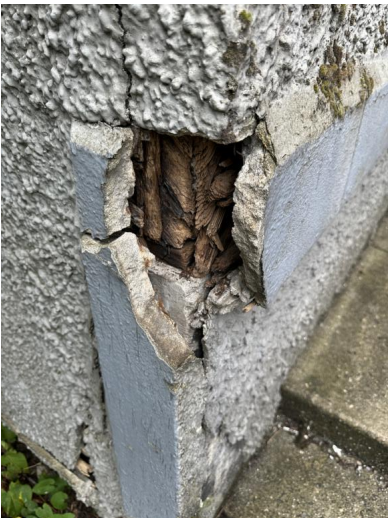
8	<p>This view of the southeast side of the building on the exterior wall. Stucco was peeled off.</p> <p>Compare with the photos # 9 & 10 of the same spot that were taken in 2020 in below.</p> <p>The wood framing at this corner is rotted and need to be repaired / replaced.</p>

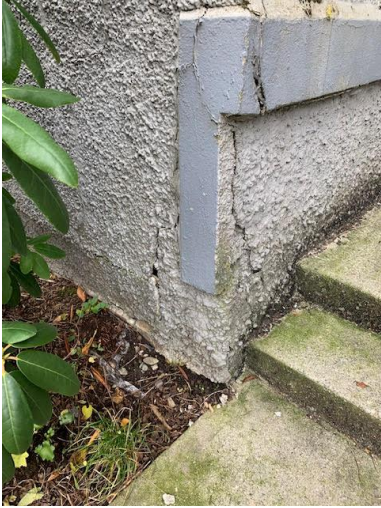
9	<p>This photo was taken on 2020</p> <p>There is a minor improvement in the stucco peeling on this corner.</p> <p>The inside wood / framing is rotted now.</p>

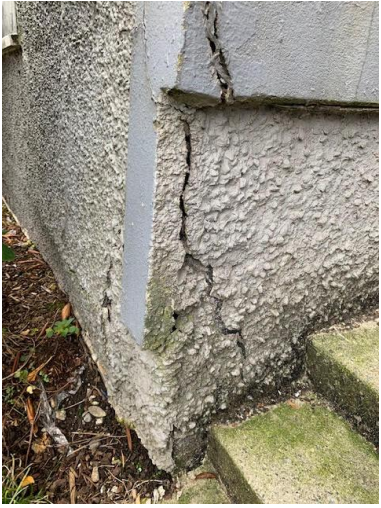
10	<p>This photo was taken on 2020</p> <p>There is a minor improvement in the stucco peeling on this corner.</p> <p>The inside wood / framing is rotted now.</p>
