Attachment H

*Integrated Services Letters from July 2018
to December 2021*

NEW WESTMINSTER

Re: Property known as: 53 Fourth Street, New Westminster, BC
Legal Description: BLOCK 16, NEW WEST DISTRICT, PLAN LMP28797 PARCEL
A AIRSPACE, GROUP 1.

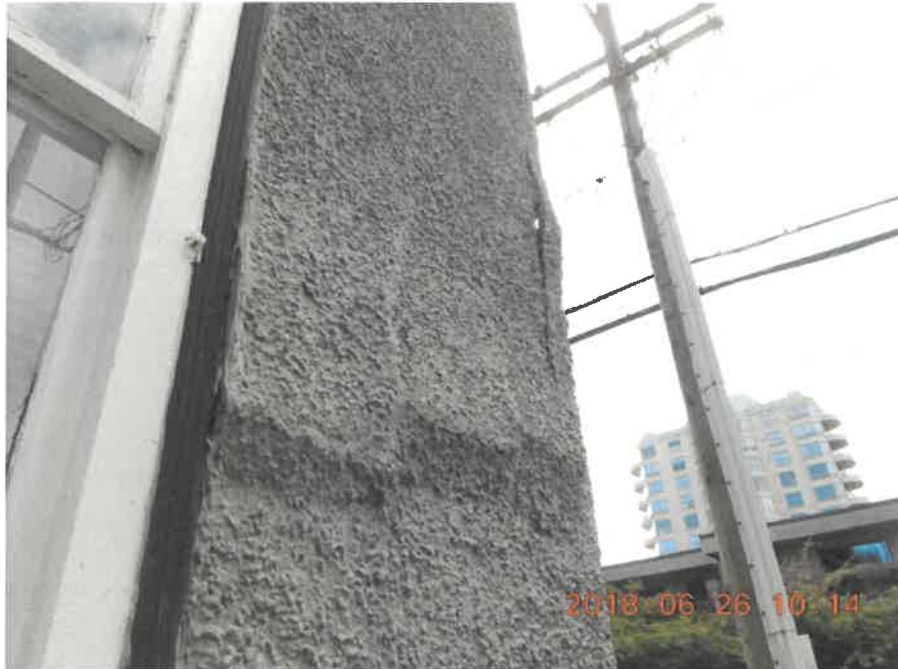
Photo 2: Exterior of the building on the southwest corner. Exterior shows signs of possible water damage.

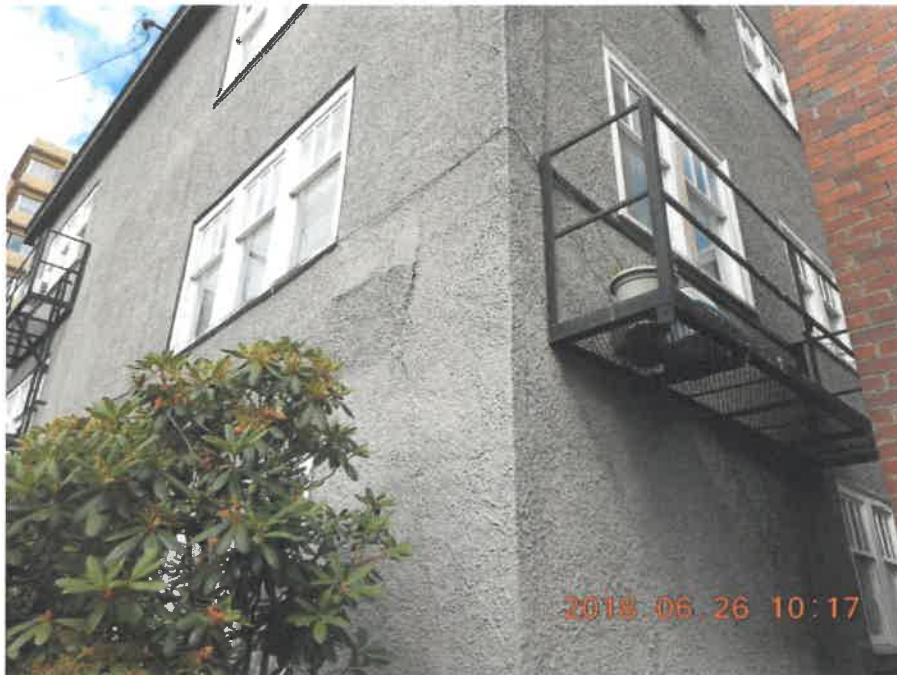
Photo 5: Exterior of the building. Exterior shows signs of possible water damage.

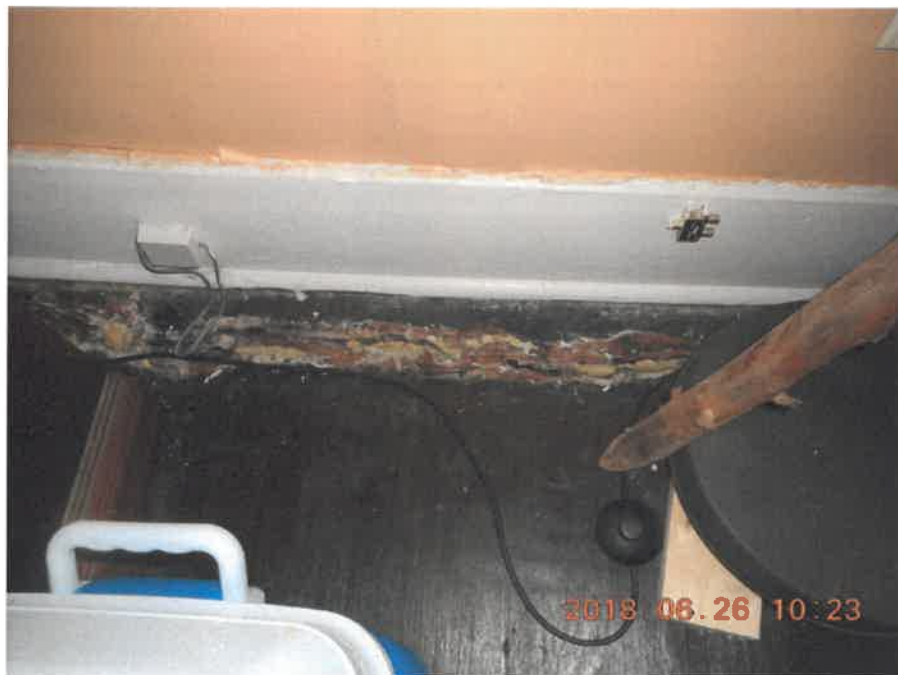
Photo 10: Floor near the exterior Southwest wall – appears to be water damage.

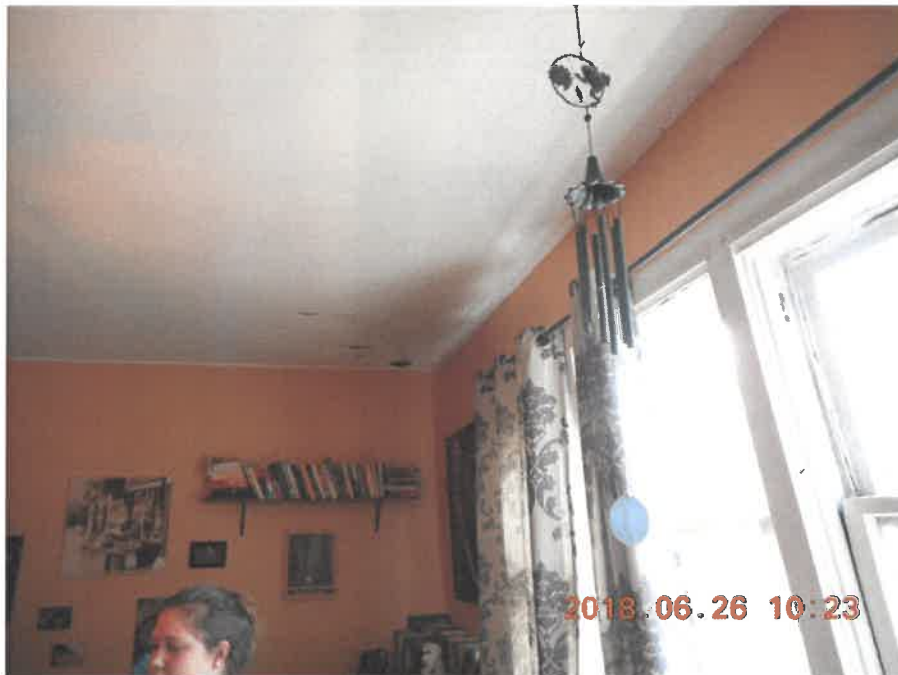
Photo 13: More damaged ceilings.

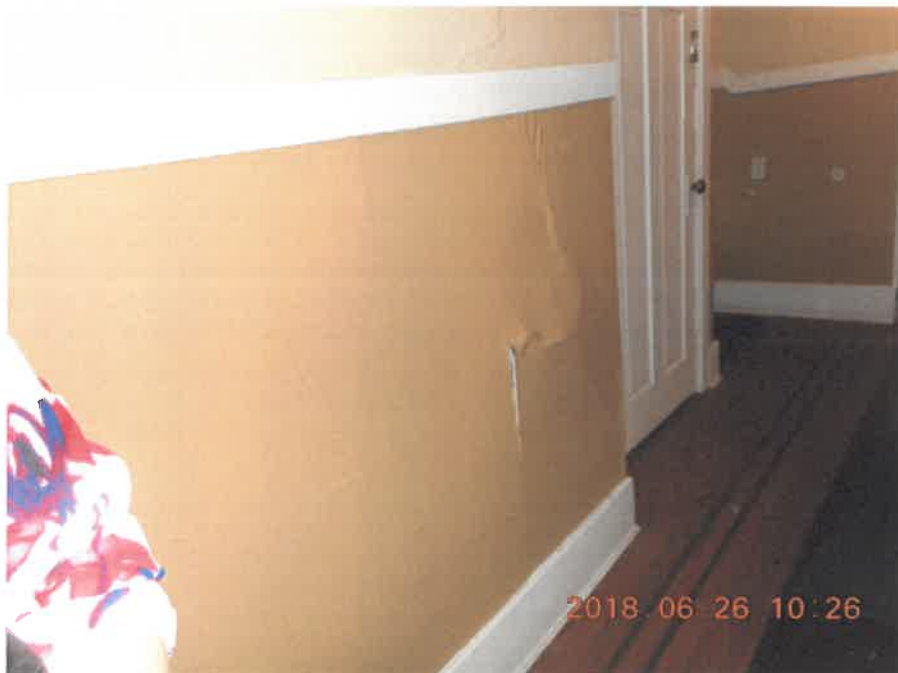
Photo 18: Interior hallway showing damage or cracked walls.

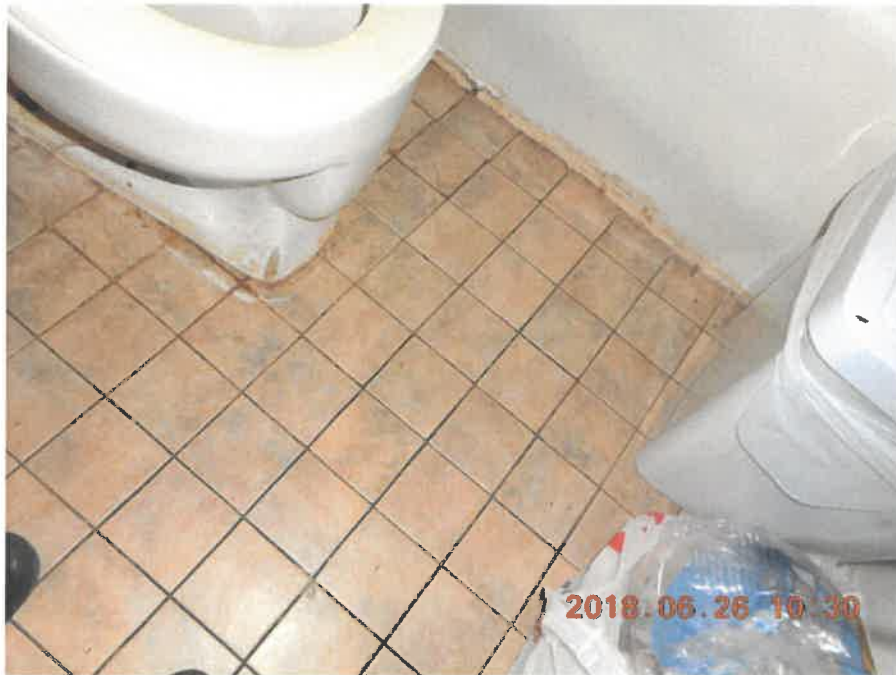
Photo 21: the toilet is loose – likely due to the tiling coming away from the subfloor.

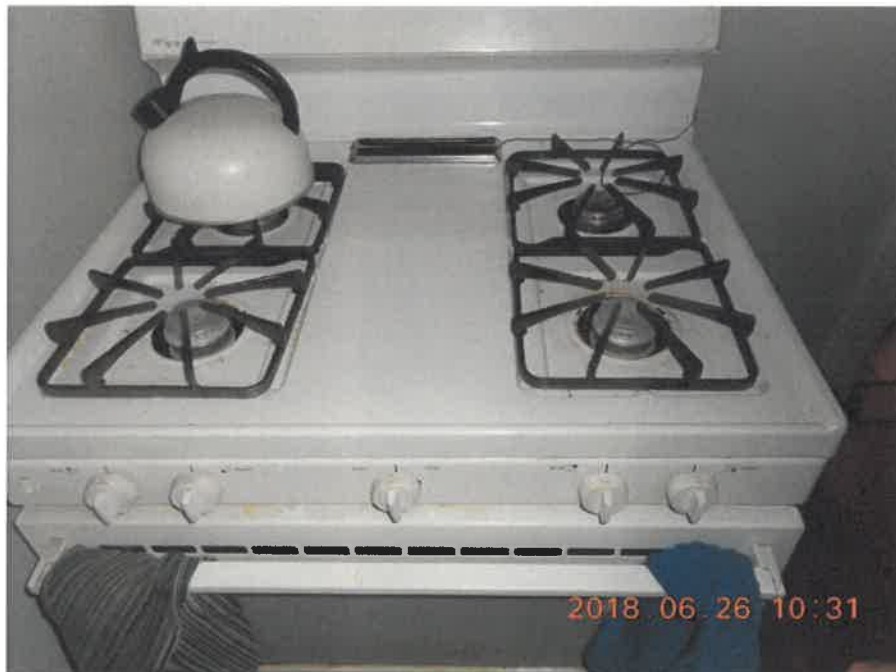
Photo 22: When tested, stove did produce gas but did not light a burner.

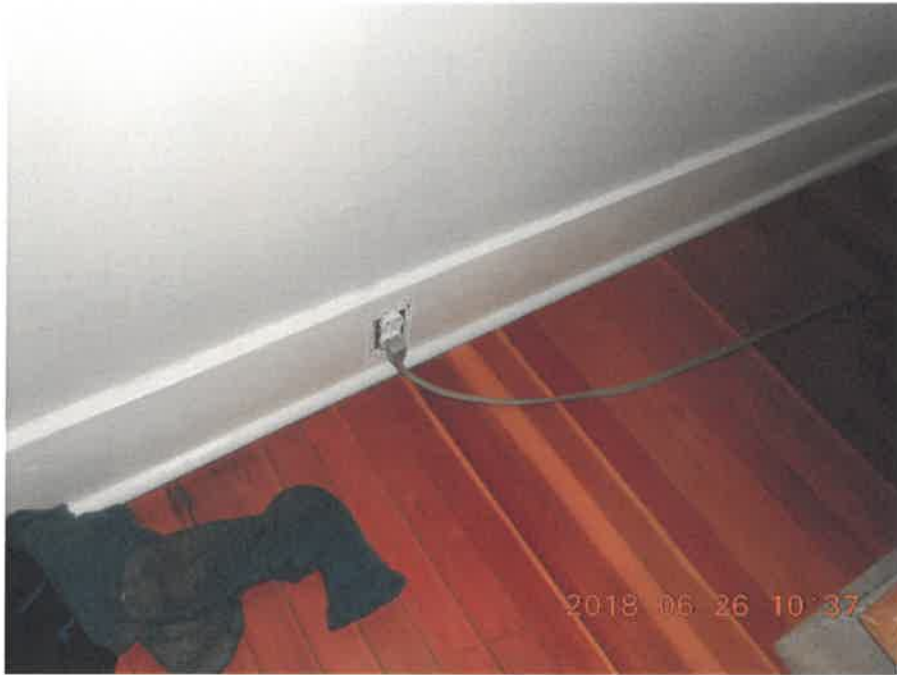
Photo 25: Electrical outlet has no cover plate.

- Living room floor is sloped and requires assessment and repair.
- Light switches and electrical outlets require cover plates (see photo #25).
- Hallway wall is cracked and requires assessment and repair (see photo #26).
- Living room ceiling has a hole and requires repair (see photo #27).

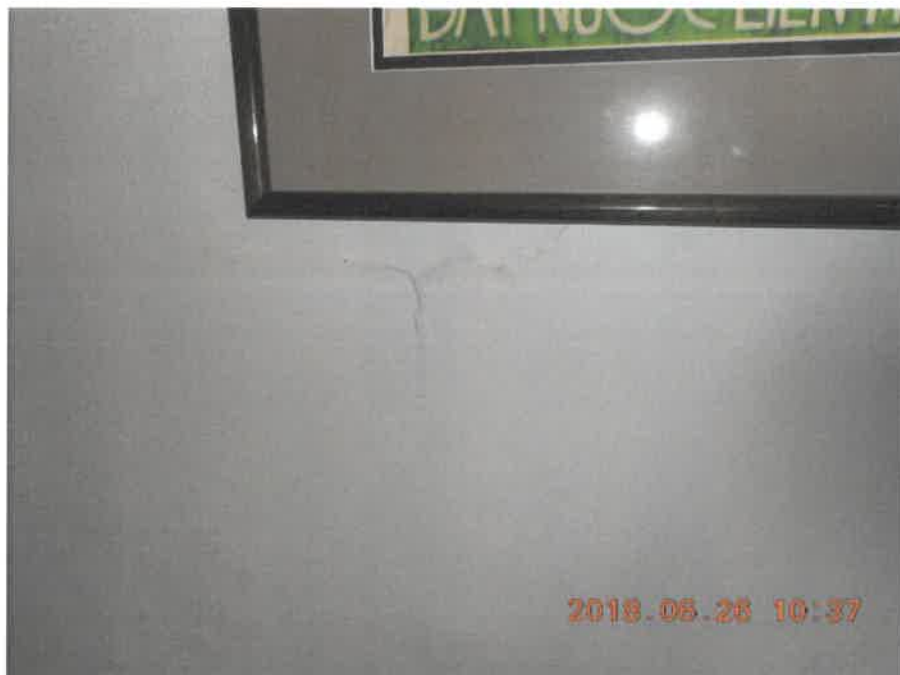
Photo 26: Cracks in the wall.

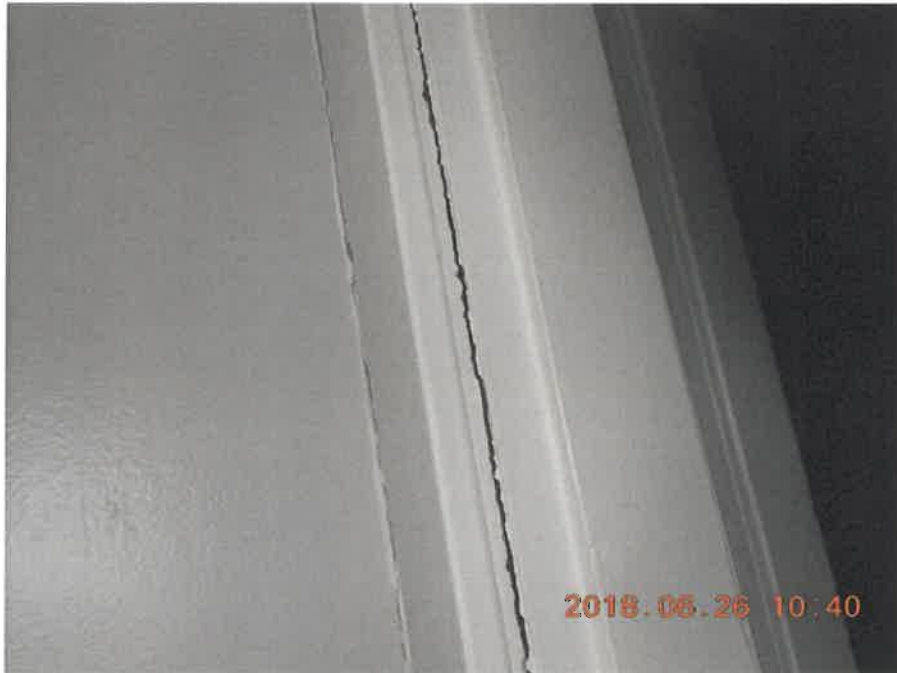
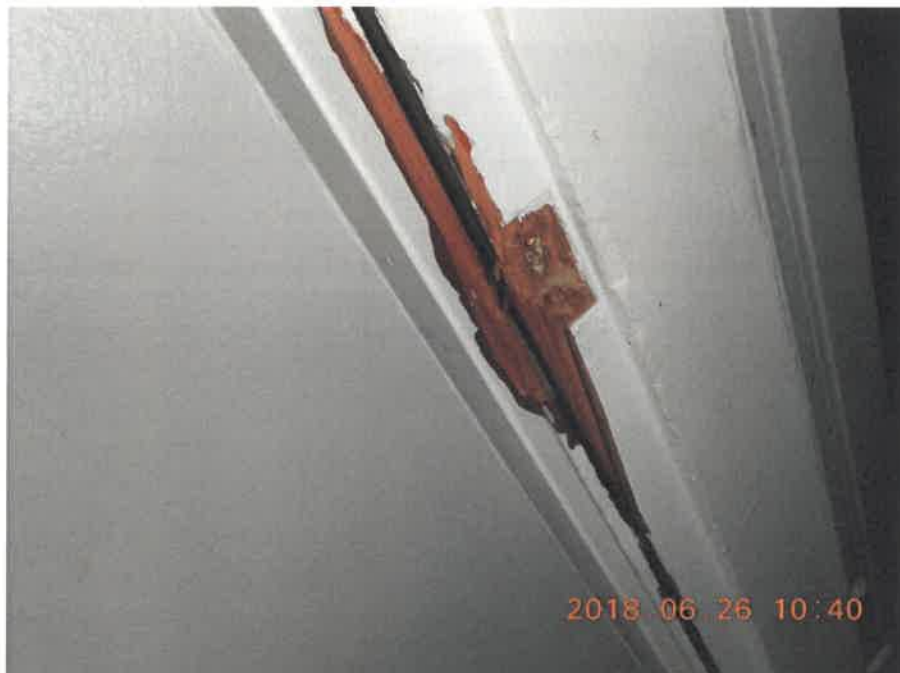
Photo 29: Entry door frame is damaged and coming away from the wall.

Photo 30: Entry door frame is damaged and coming away from the wall.

- Bedroom door trim is cracked and broken (see photo #s 29, 30).
- Caulking around the bathtub and toilet require repair rendering them impervious to moisture to prevent water damage (see photo #31).
- Bathroom sink taps are broken and require repair (left side does not work and right side is leaking – see photo #32).
- Bathroom ceiling has an enormous hole and some small holes and the plaster is crumbling away. Assess and repair (see photo #s 33, 34).

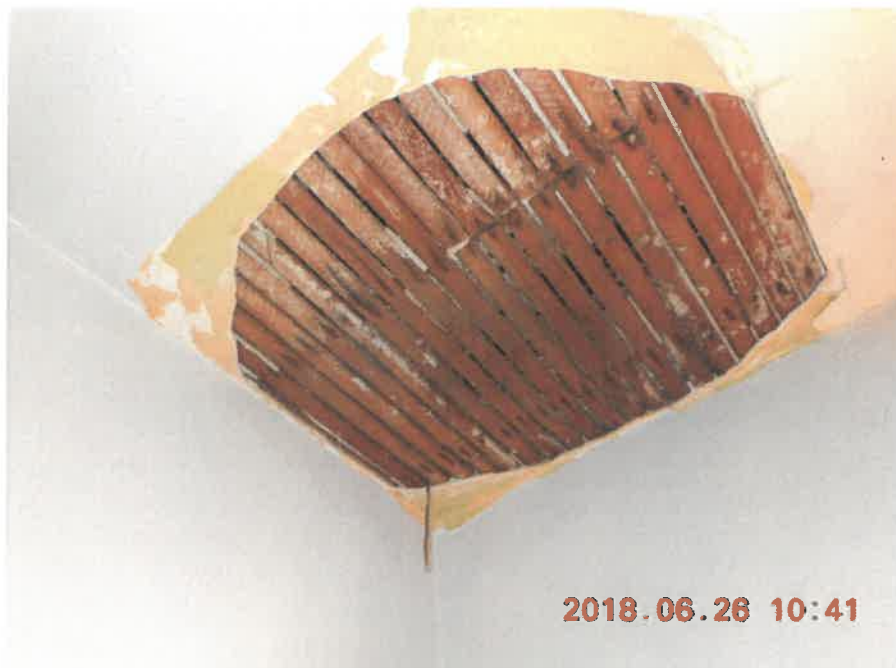
Photo 33: Ceiling in the bathroom with extensive ceiling damage. It appears The plaster has fallen away and the floor of the suite above can be seen.

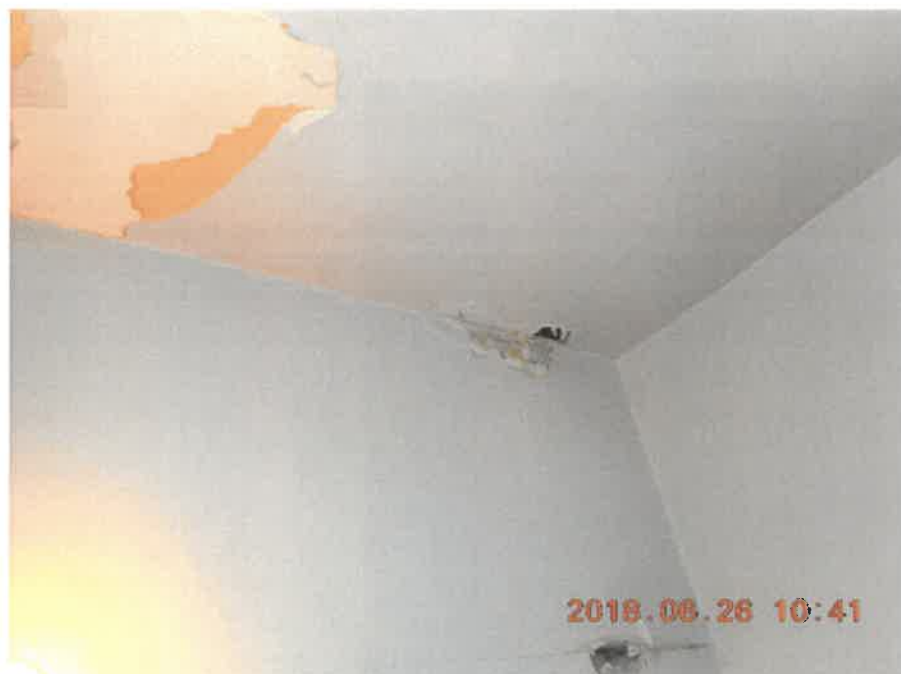
Photo 34: More ceiling and wall damage in the bathroom.

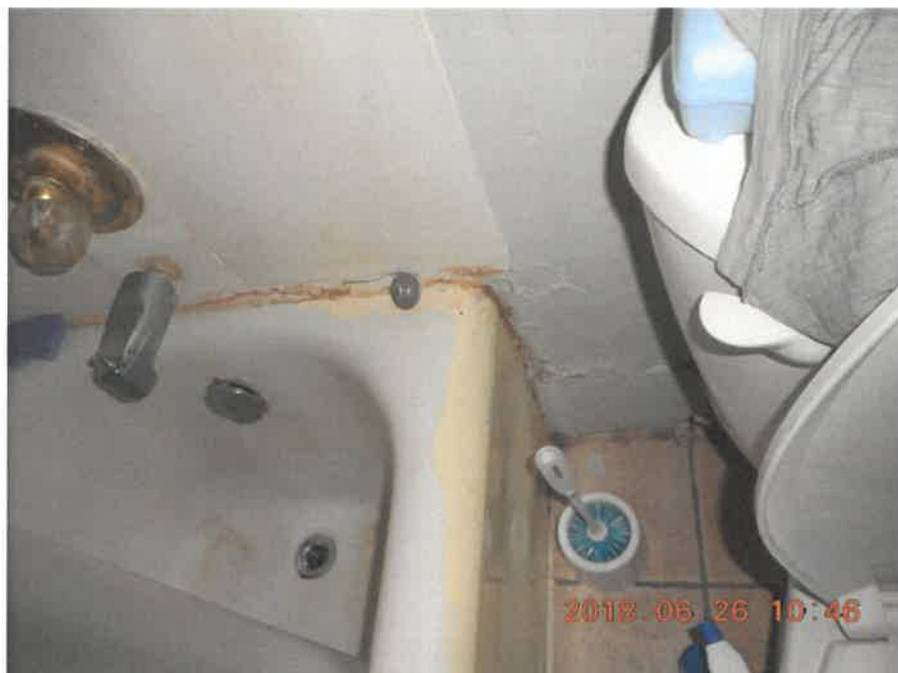
Photo 37: Caulking around the tub, toilet and floor is rotted.

- Caulking around the bathtub and toilet require repair rendering them impervious to moisture to prevent water damage (see photo #37).
- Wall in the living room is cracked and requires assessment and repair (see photo #38).
- Mice were reported in this unit.
- Window frames are rotting and separating from the wall and require repair (see photo 39).
- Countertop has separated from the wall leaving a large gap requiring repairs (see photo #40).

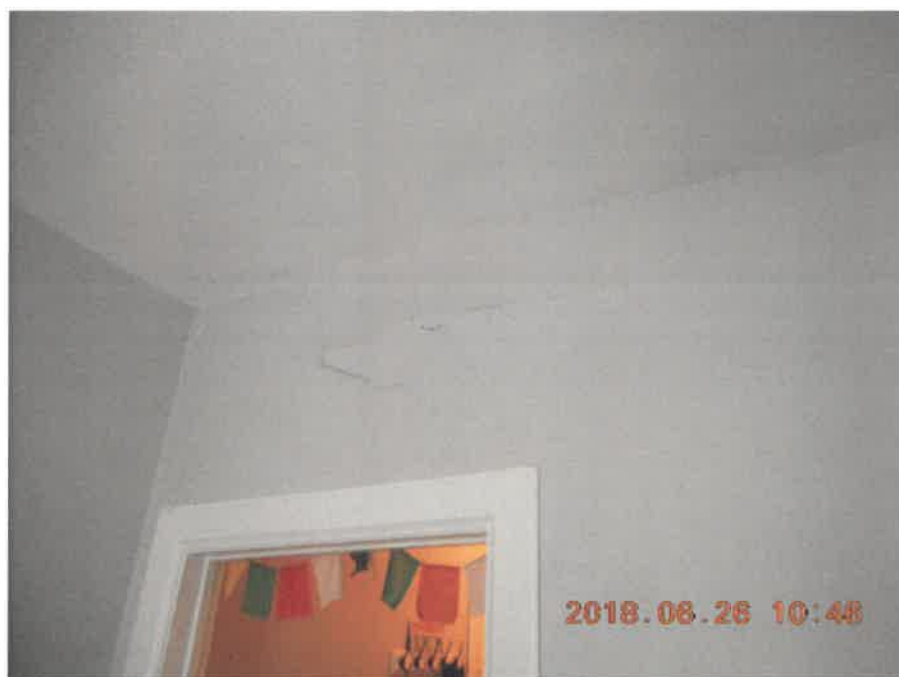
Photo 38: Wall damage.

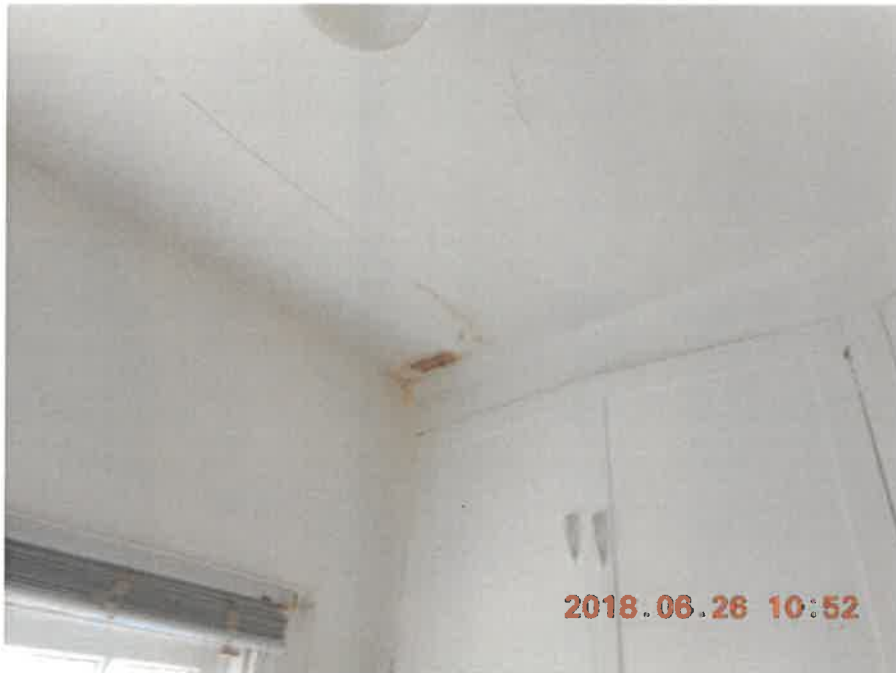
Photo 45: Ceiling is showing signs of cracking and damage.

- Kitchen ceiling is leaking water and requires investigation and repair (see photo #45).
- Kitchen and bathroom tiles are cracked and require repair or replacement (see photo #46).
- Window sills are leaking and require investigation and repair.
- Living room walls and ceilings have large cracks and require assessment and repair (see photo #48).

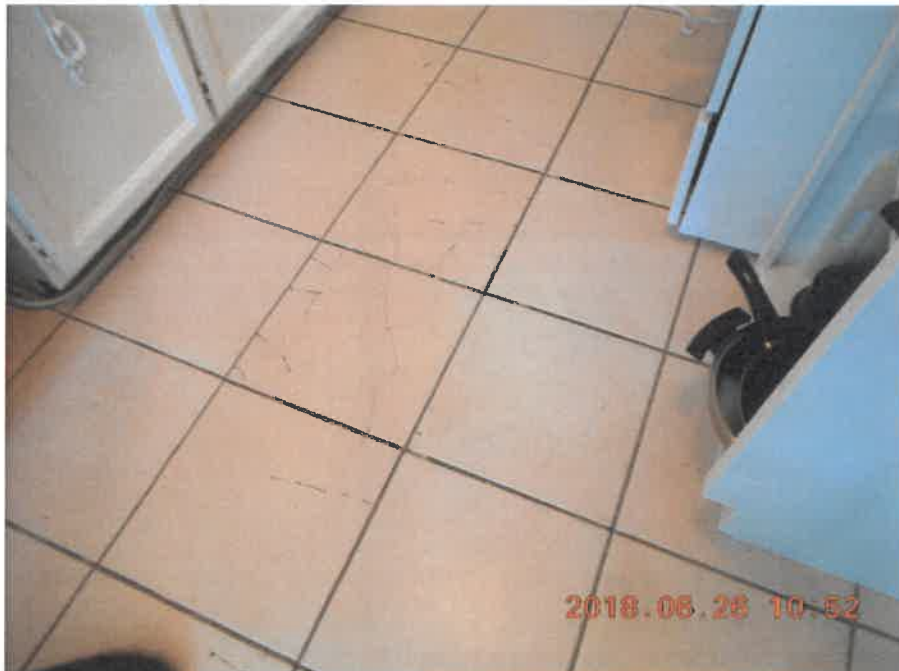
Photo 46: Floor is cracked throughout the kitchen.

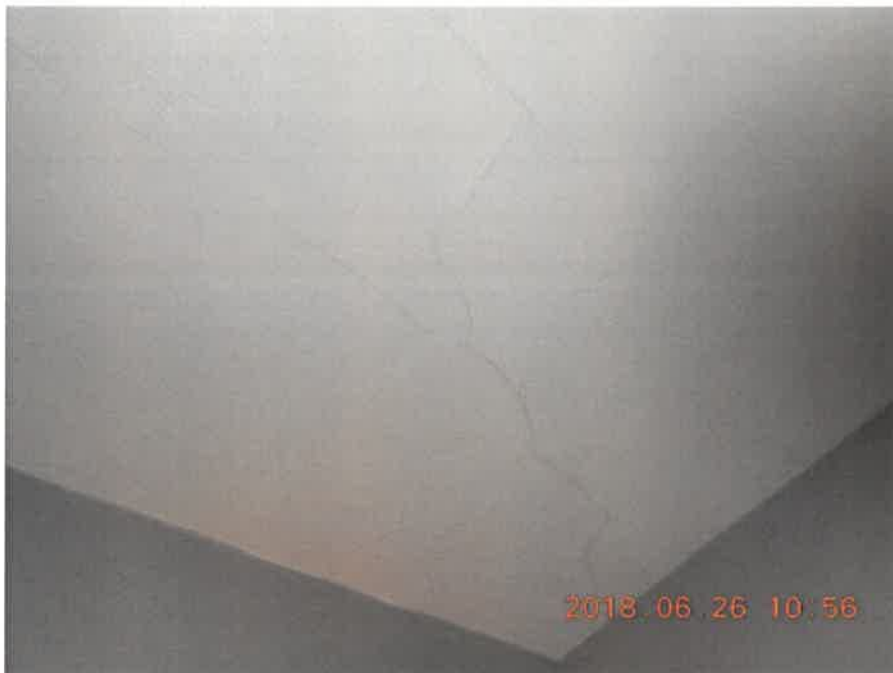
Photo 50: Ceiling is cracked.

- Entry door does not shut properly and requires investigation and repair.
- Ceiling in bathroom has large cracks and requires investigation and repair (see photo #50).

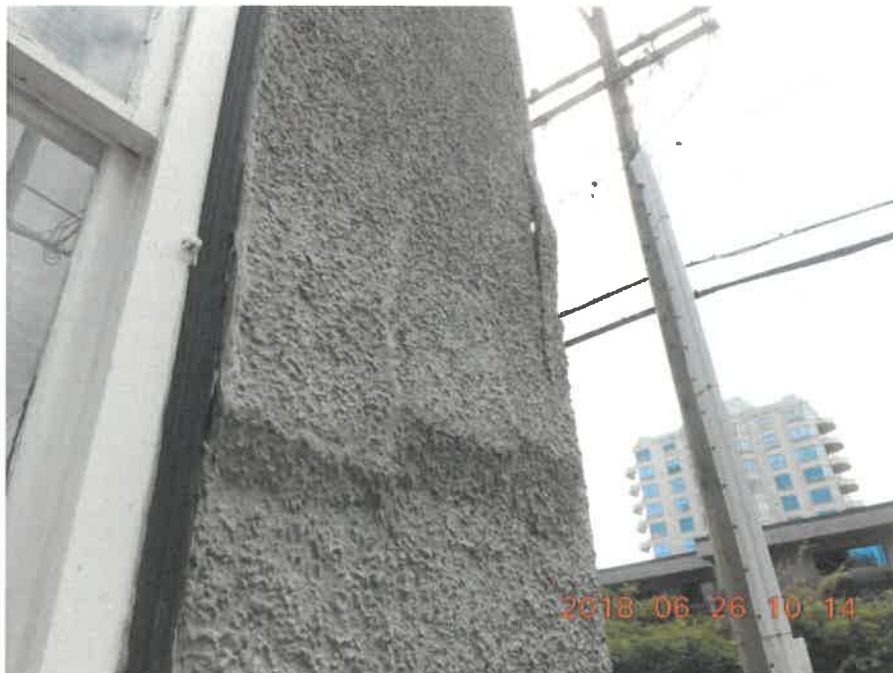
Photo 2: Exterior of the building on the southwest corner. Exterior shows signs of possible water damage.

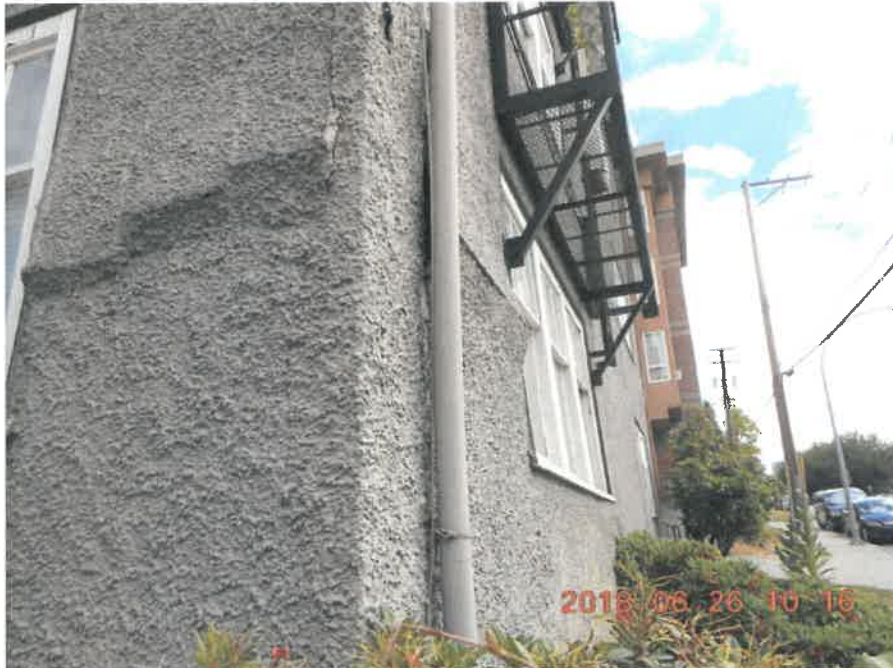
Photo 3: Exterior of the building on the southwest corner. Exterior shows signs of possible water damage.

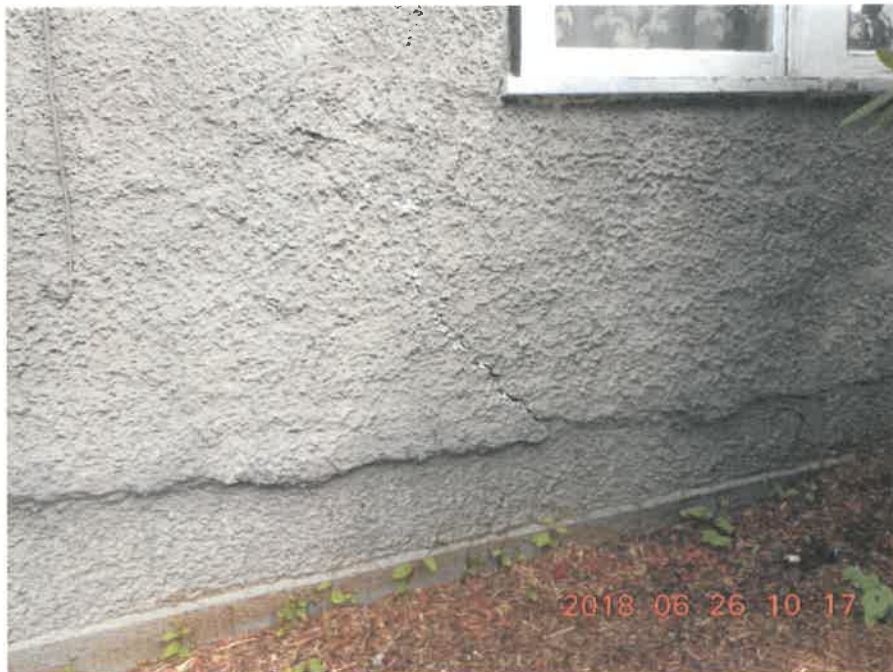
Photo 4: Exterior of the building. Exterior shows signs of possible water damage.

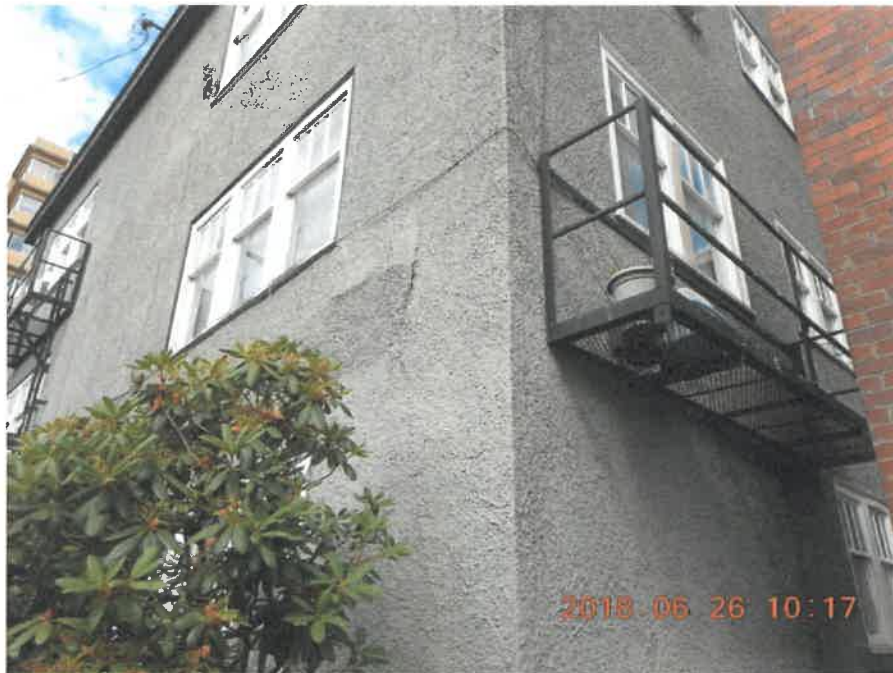
Photo 5: Exterior of the building. Exterior shows signs of possible water damage.

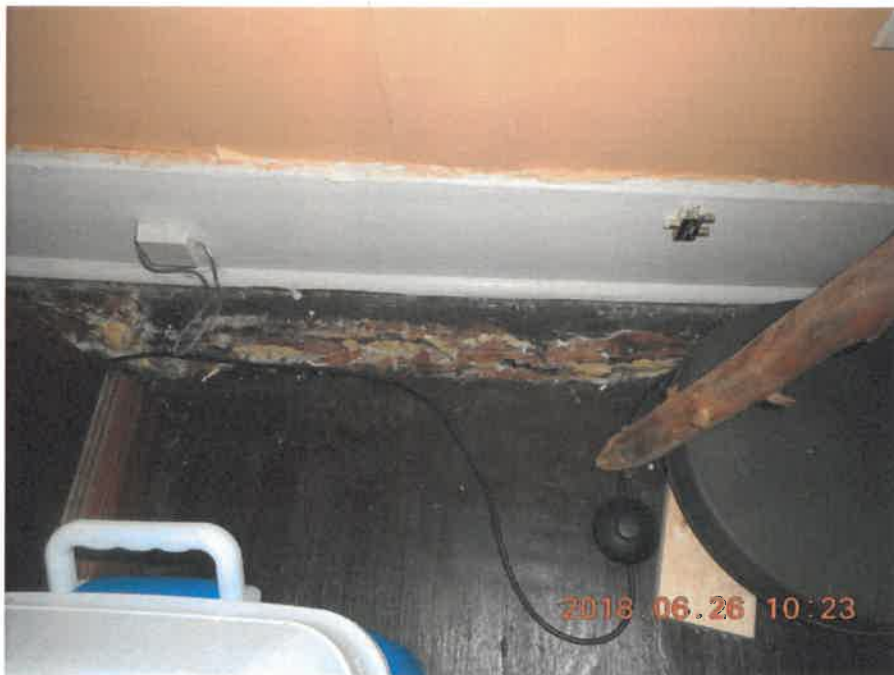
Photo 10: Floor near the exterior Southwest wall – appears to be water damage.

- Southwest living room walls, ceiling and windows are cracked and the window is leaking. The floor below this wall is clearly sloped and requires assessment and repair (see attached photo #s 6-16).
- Ceiling in the bathroom requires repair (see attached photo #s 7-16).

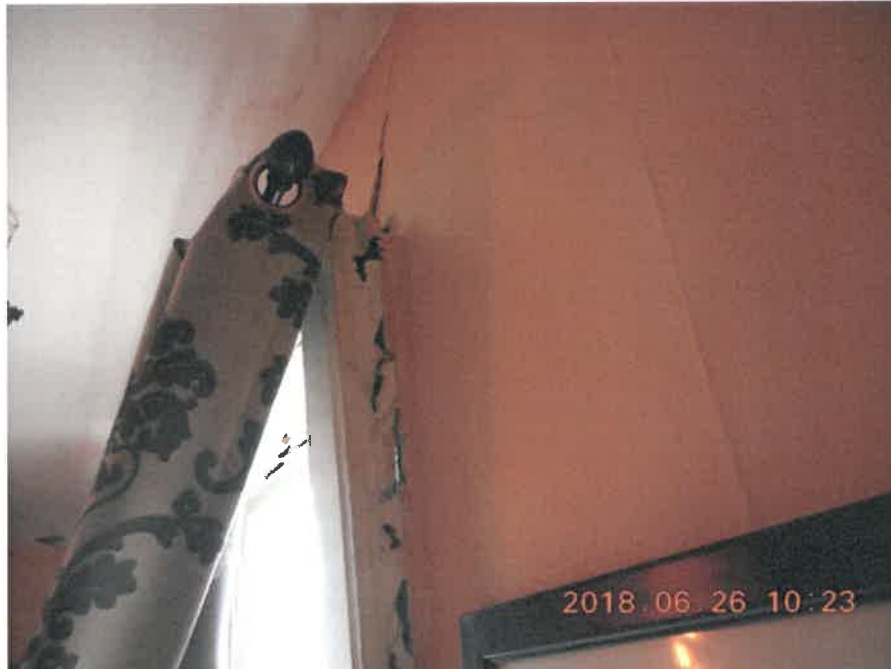
Photo 11: Southwest wall: wall is cracking and window frame is separating from the wall. This appears to be water damage from previous leak.

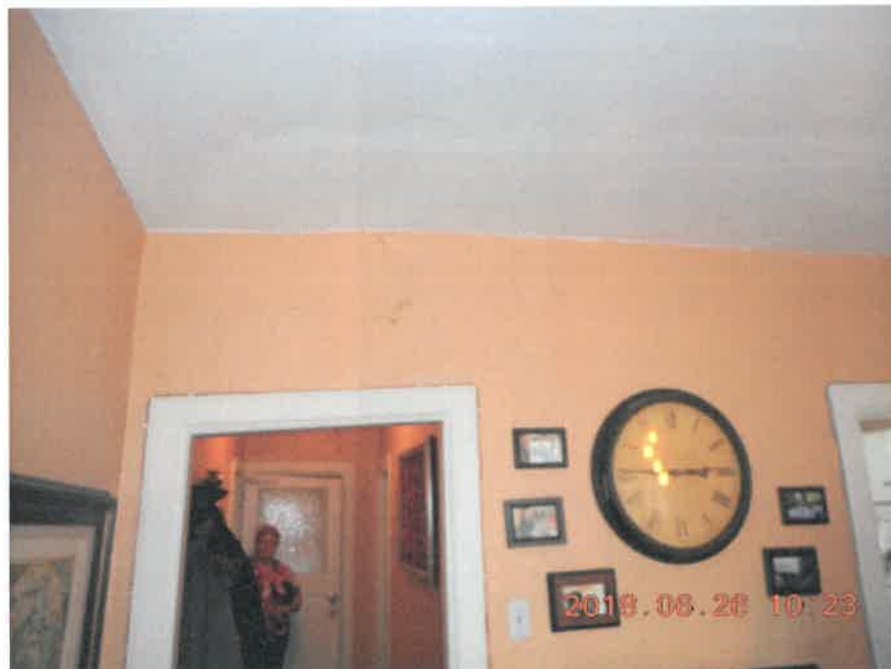
Photo 12: More evidence of cracked ceilings and walls.

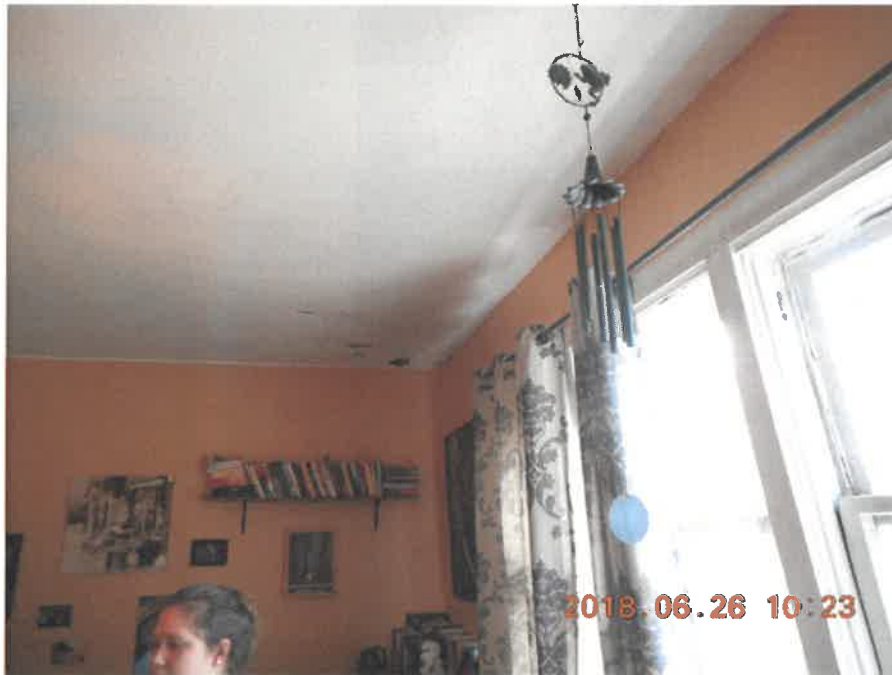
Photo 13: More damaged ceilings.

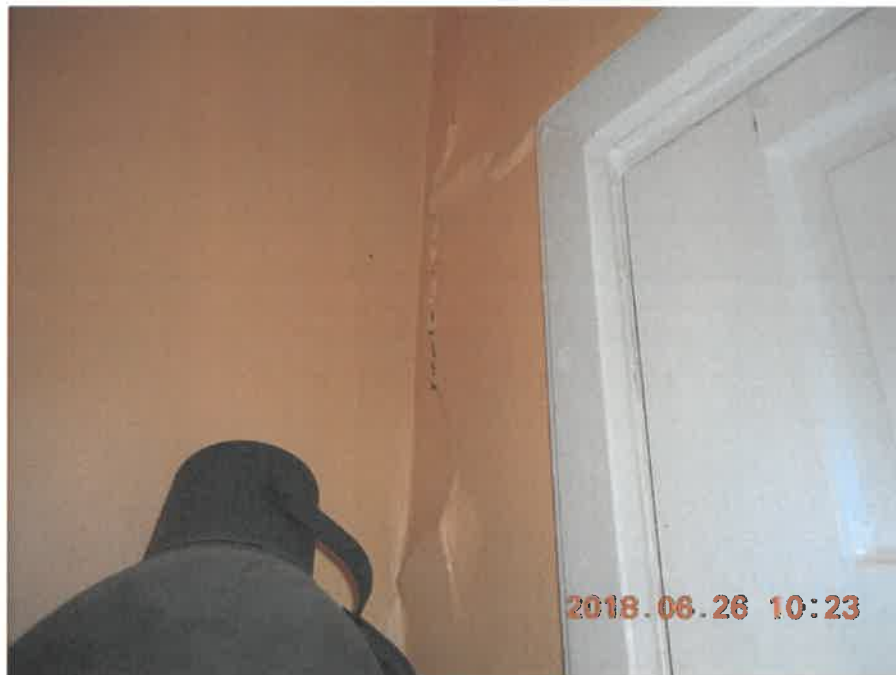
Photo 14: A close up view of the wall near the bedroom door.

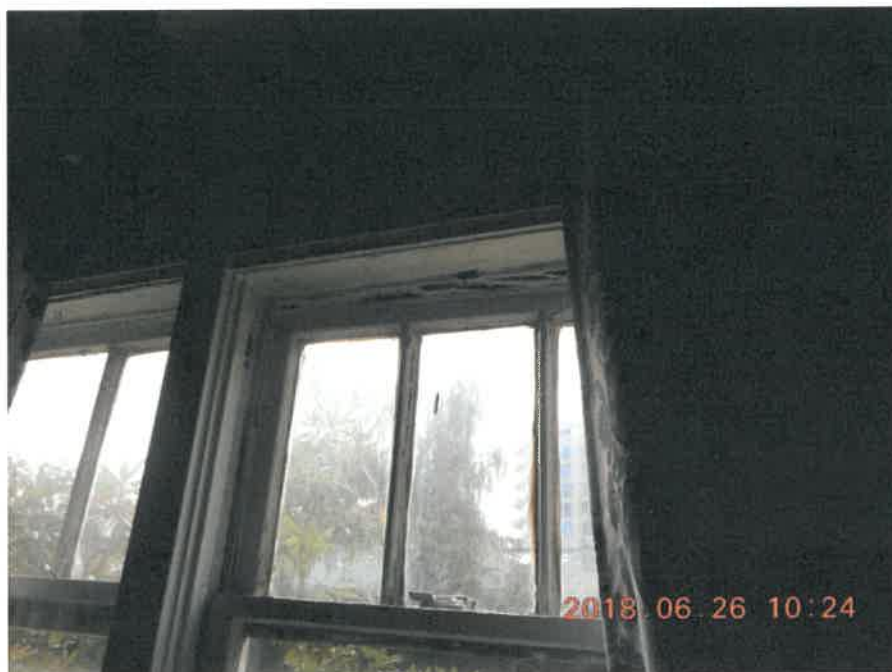
Photo 15: Window frame is water damaged.

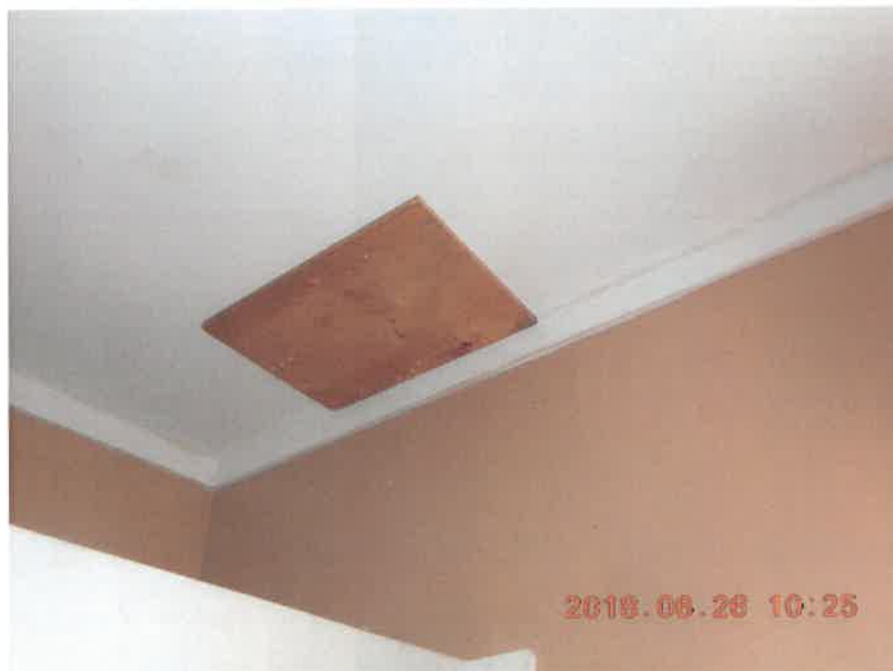
Photo 16: Leak has been repaired but ceiling has not.

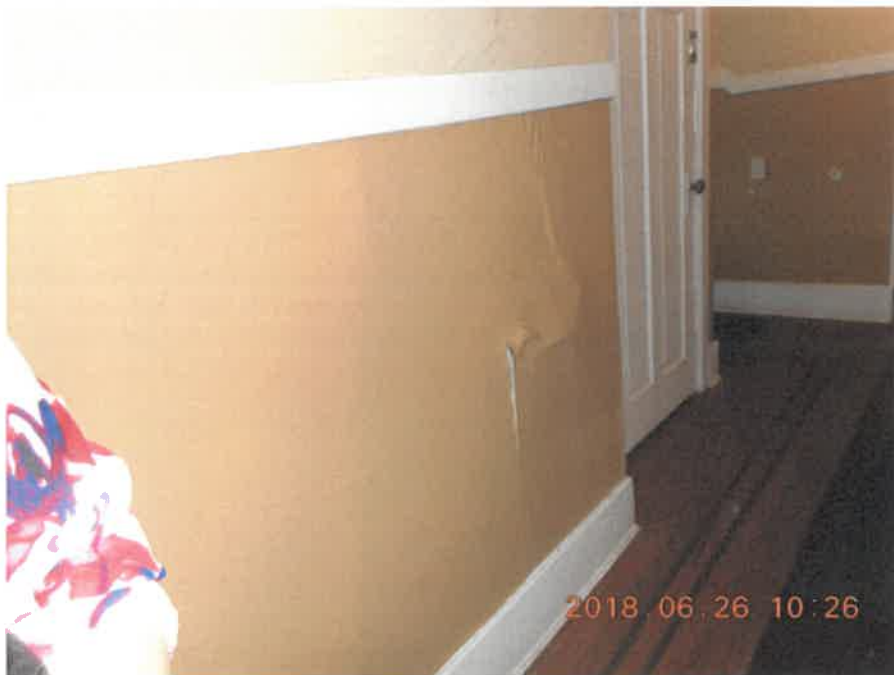
Photo 18: Interior hallway showing damage or cracked walls.

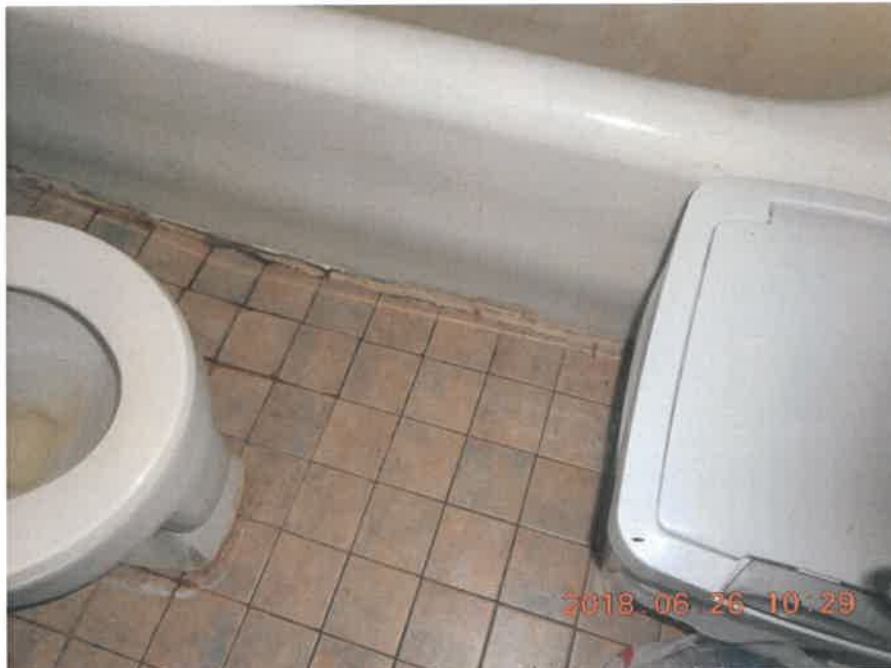
Photo 19: The washroom tile floor is caving in near the bathtub. Touching the tile made it evident that there is nothing below securing the tile and subfloor may be rotted away.

- Unit entry door sticks and does not close properly without force.
- Bathroom floor is extremely sloped. The tiling between the bathtub and the toilet has sunk, the tiles have are loose and the floor beneath seems to be soft and spongy indicating rot – investigate and repair (see photos #19).
- Caulking around the bathtub and toilet require repair rendering them impervious to moisture to prevent water damage (see photo #s 20, 21).
- Kitchen floor is extremely sloped and requires assessment and repair.
- Stove burners would not light during inspection indicating the stove is not functioning properly. Investigate and repair.

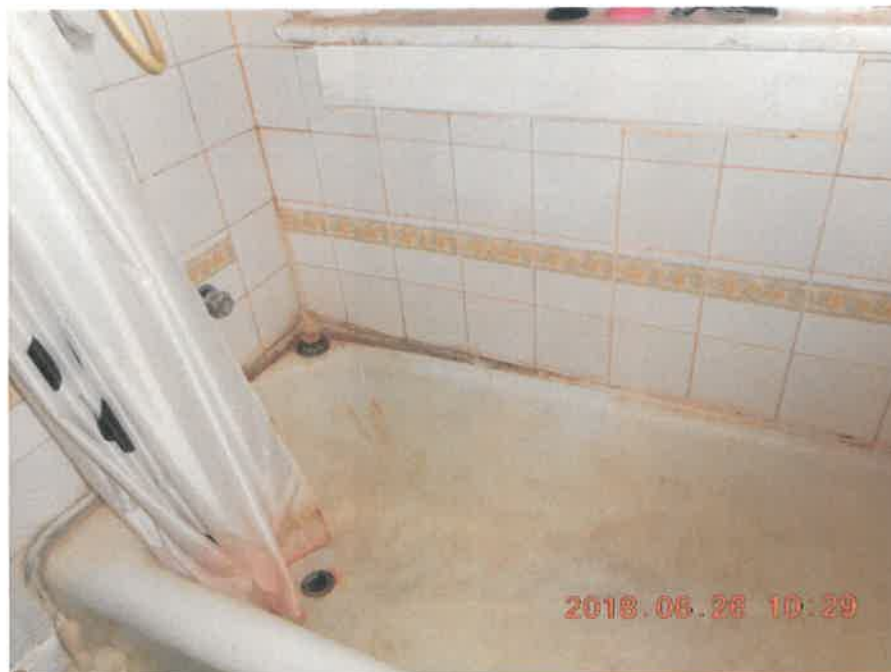
Photo 20: The bathtub requires caulking to render it impervious to moisture and water damage.

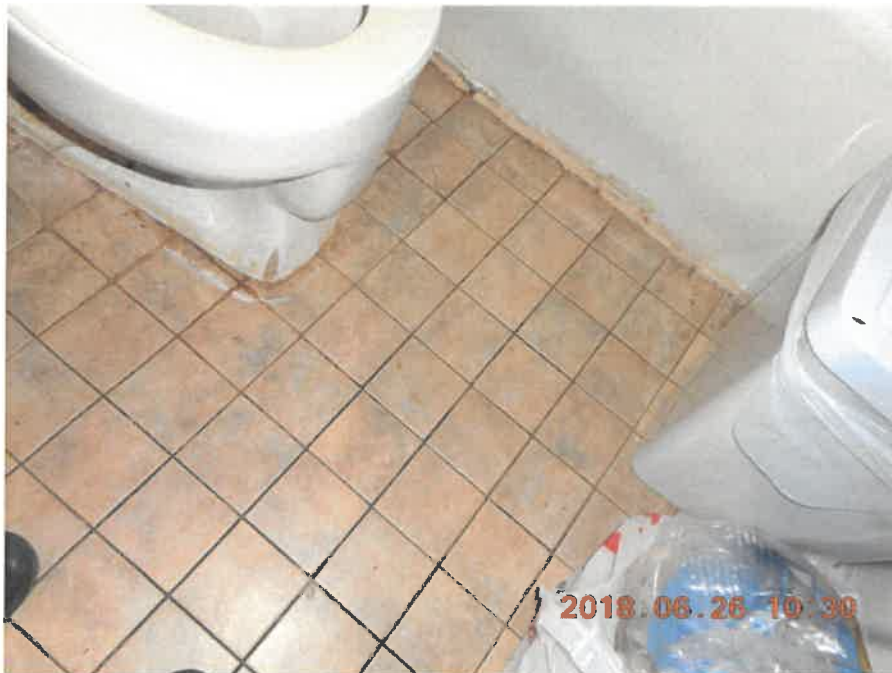
Photo 21: the toilet is loose – likely due to the tiling coming away from the subfloor.

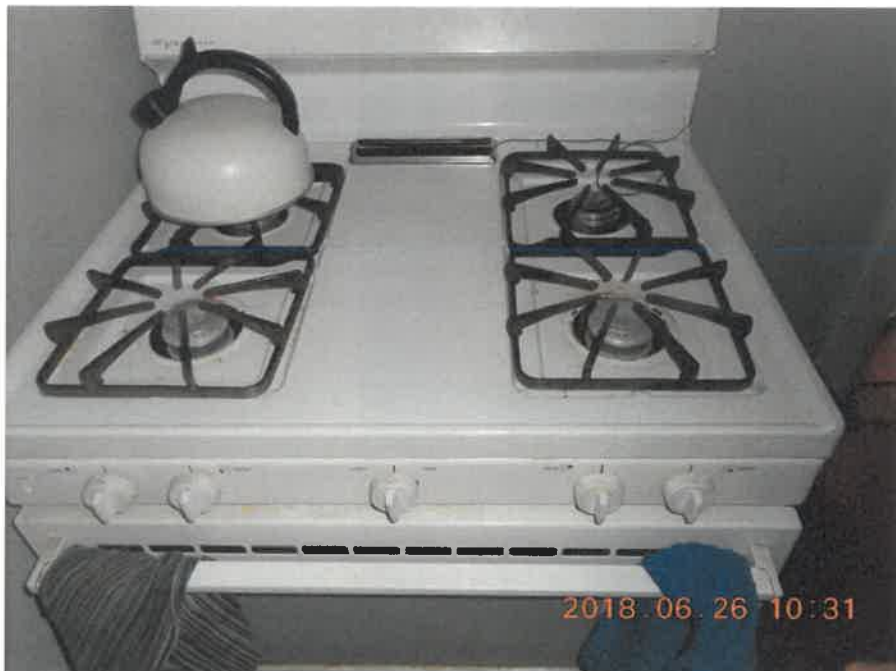
Photo 22: When tested, stove did produce gas but did not light a burner.

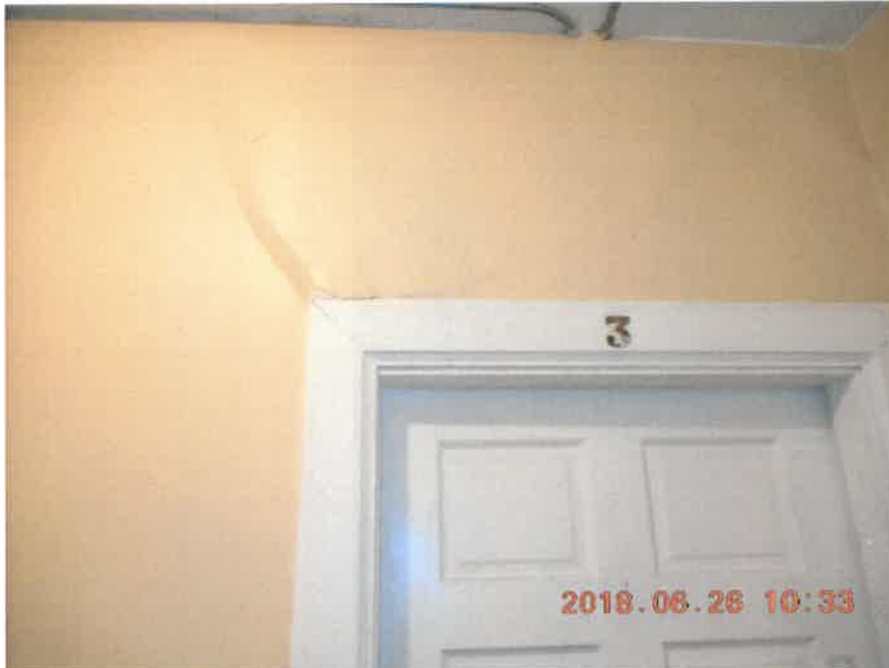
Photo 23: Damaged walls.

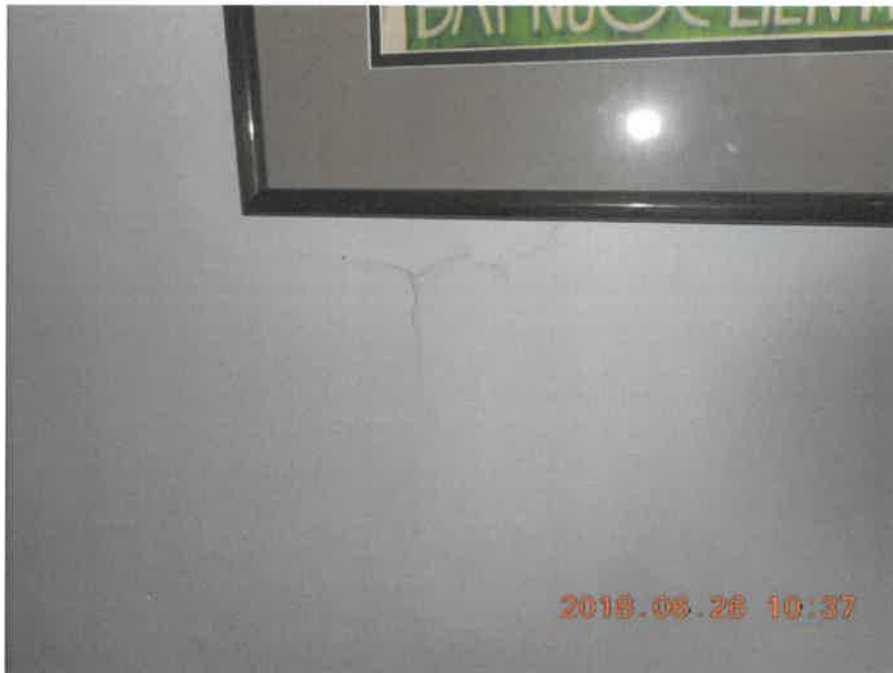
Photo 26: Cracks in the wall.
