Attachment H

*Integrated Services Letters from July 2018
to December 2021*

NEW WESTMINSTER

Re: Property known as: 53 Fourth Street, New Westminster, BC
Legal Description: BLOCK 16, NEW WEST DISTRICT, PLAN LMP28797 PARCEL
A AIRSPACE, GROUP 1.

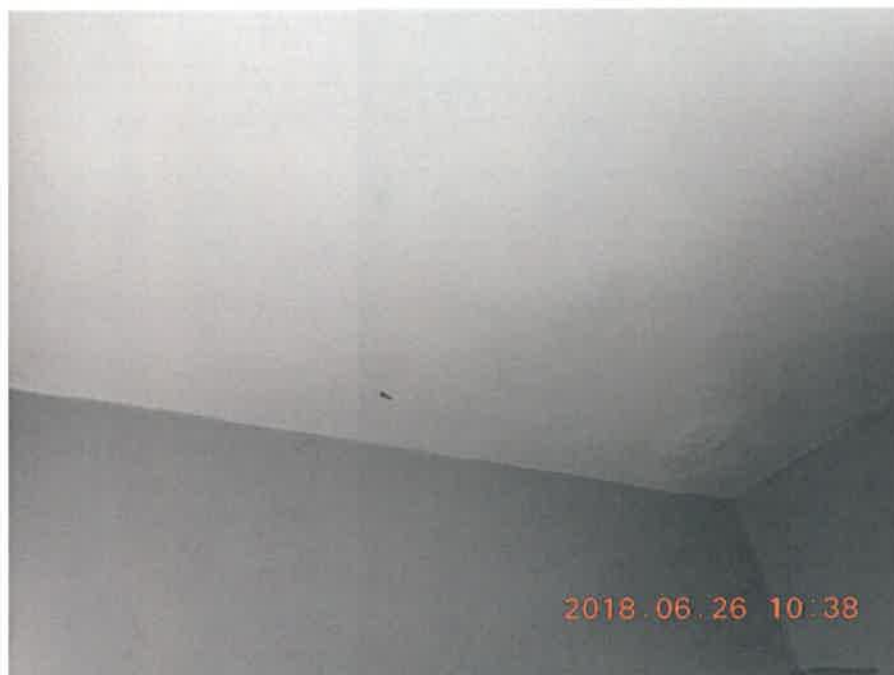
Photo 27: Ceiling appears to have suffered water damage.

- Living room floor is sloped and requires assessment and repair.
- Light switches and electrical outlets require cover plates (see photo #25).
- Hallway wall is cracked and requires assessment and repair (see photo #26).
- Living room ceiling has a hole and requires repair (see photo #27).

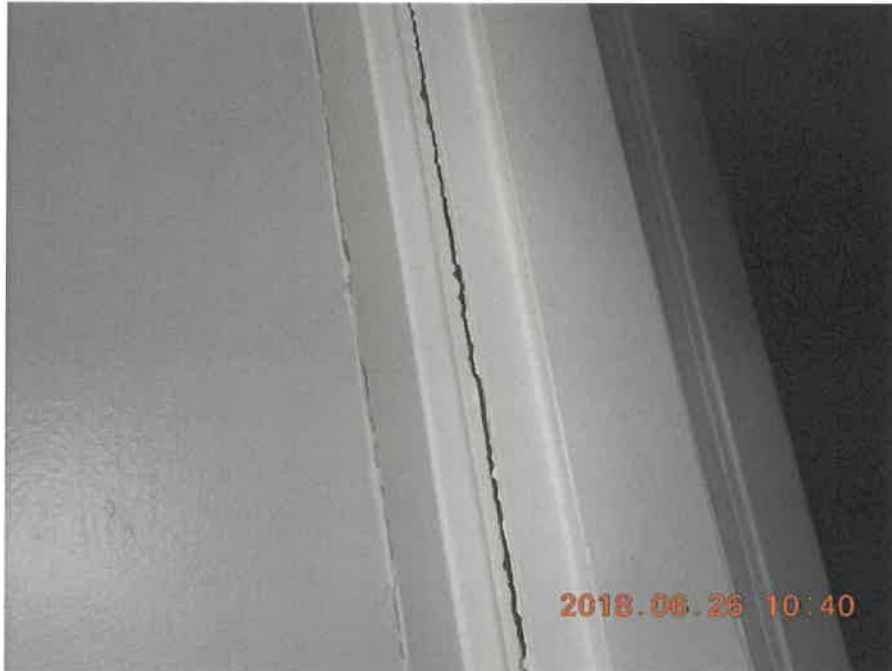
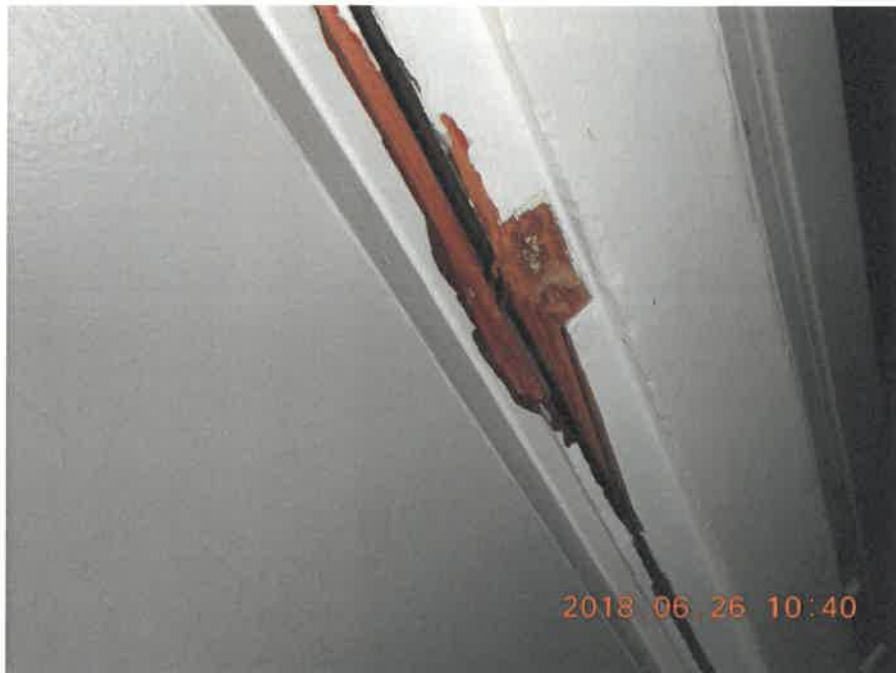
Photo 29: Entry door frame is damaged and coming away from the wall.

Photo 30: Entry door frame is damaged and coming away from the wall.

- Bedroom door trim is cracked and broken (see photo #s 29, 30).
- Caulking around the bathtub and toilet require repair rendering them impervious to moisture to prevent water damage (see photo #31).
- Bathroom sink taps are broken and require repair (left side does not work and right side is leaking – see photo #32).
- Bathroom ceiling has an enormous hole and some small holes and the plaster is crumbling away. Assess and repair (see photo #s 33, 34).

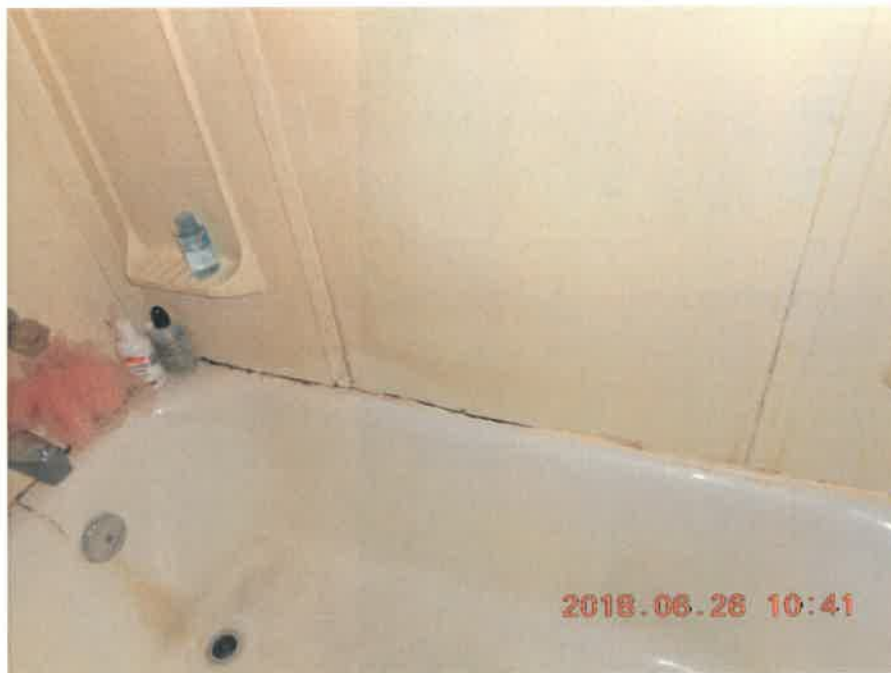
Photo 31: Bathtub requires repair of the caulking around the edge of the tub and at the floor level.

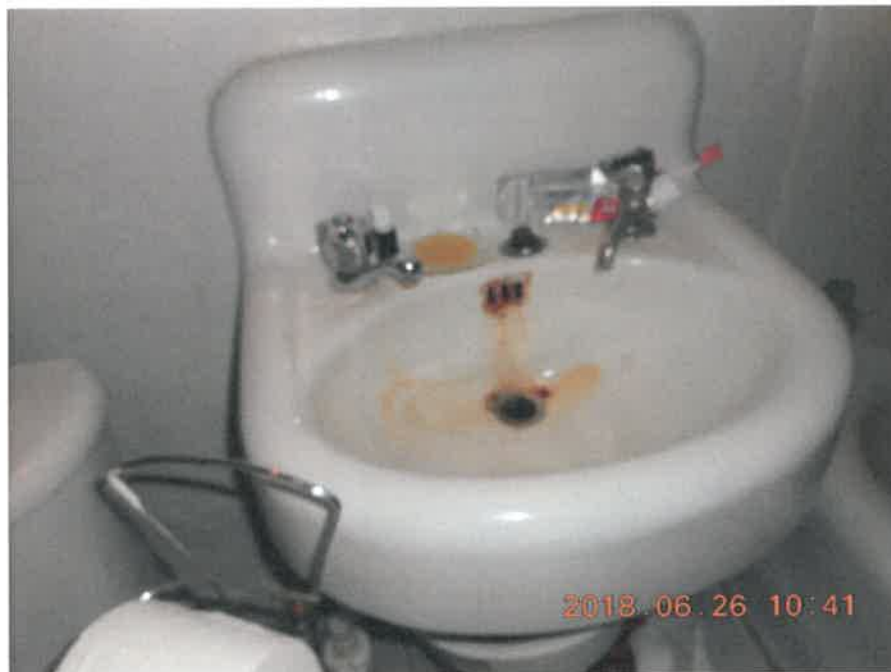
Photo 32: Faucets were not working properly. One on the left does not work and the one on the right is leaking.

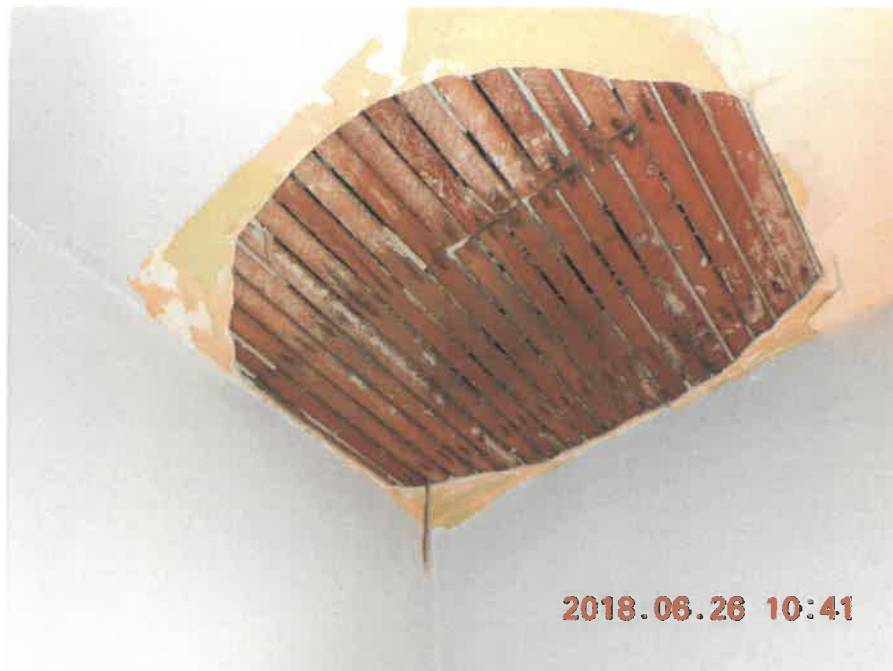
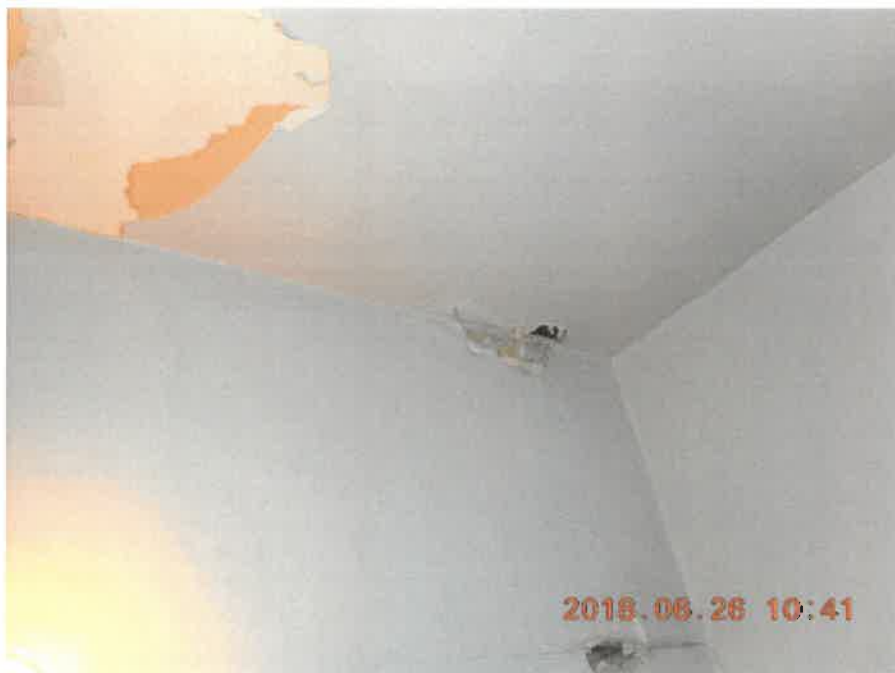
Photo 33: Ceiling in the bathroom with extensive ceiling damage. It appears The plaster has fallen away and the floor of the suite above can be seen.

Photo 34: More ceiling and wall damage in the bathroom.

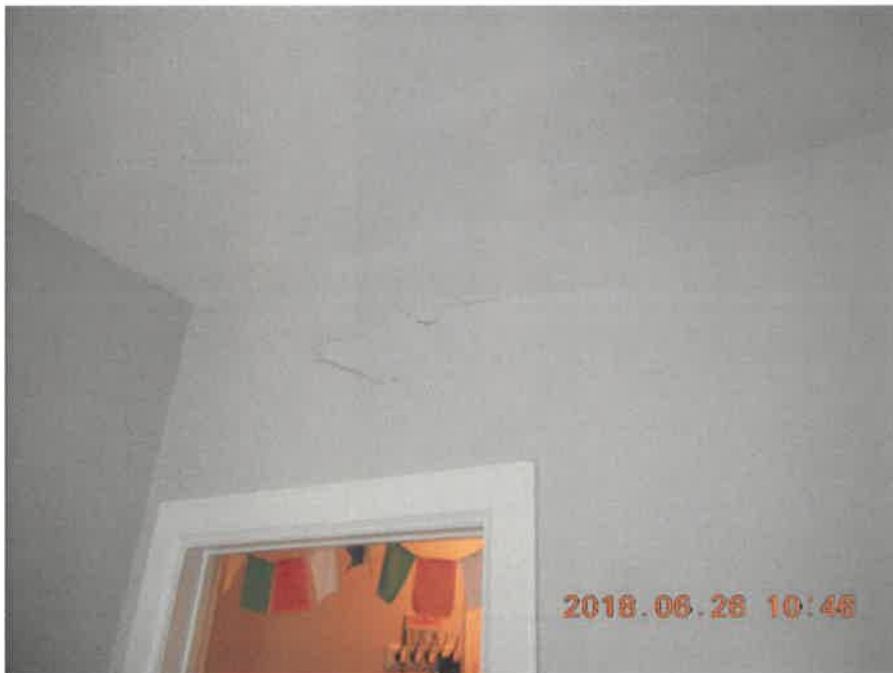
Photo 38: Wall damage.

- Caulking around the bathtub and toilet require repair rendering them impervious to moisture to prevent water damage (see photo #37).
- Wall in the living room is cracked and requires assessment and repair (see photo #38).

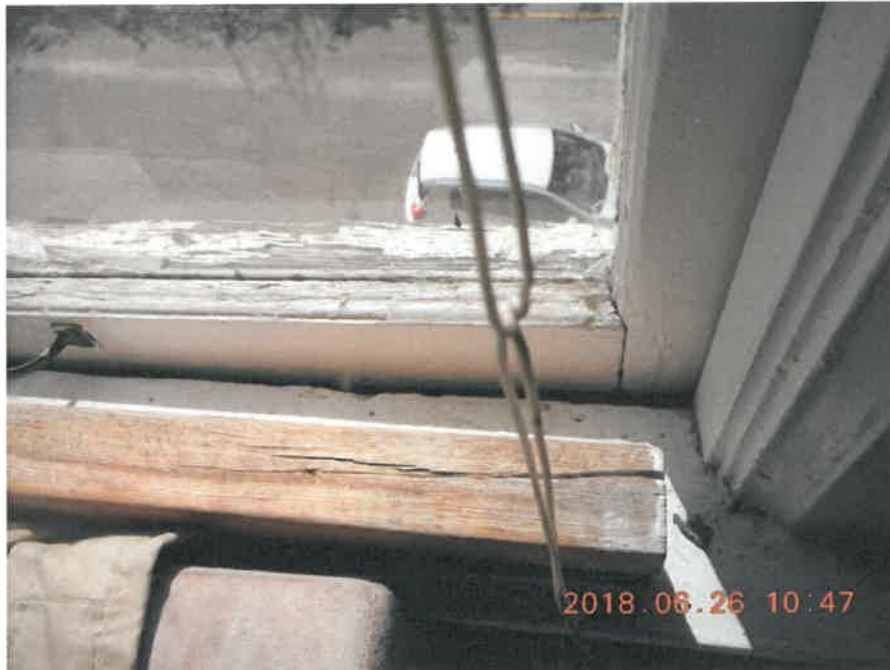
Photo 39: Windowsills are worn and damaged.

- Mice were reported in this unit.
- Window frames are rotting and separating from the wall and require repair (see photo 39).
- Countertop has separated from the wall leaving a large gap requiring repairs (see photo #40).

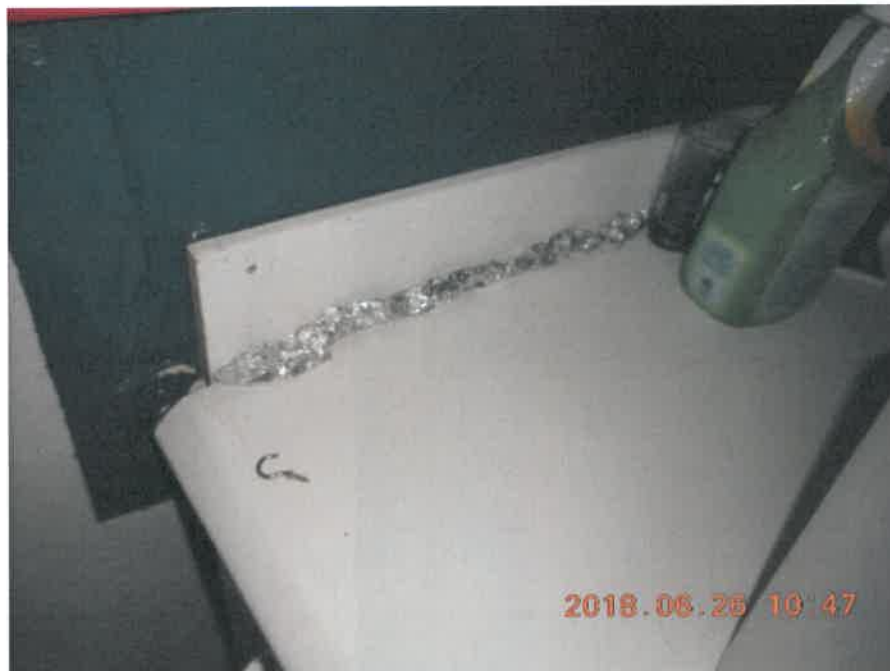
Photo 40: Countertop is separating from the wall leaving a large gap where mice may be entering the suite.

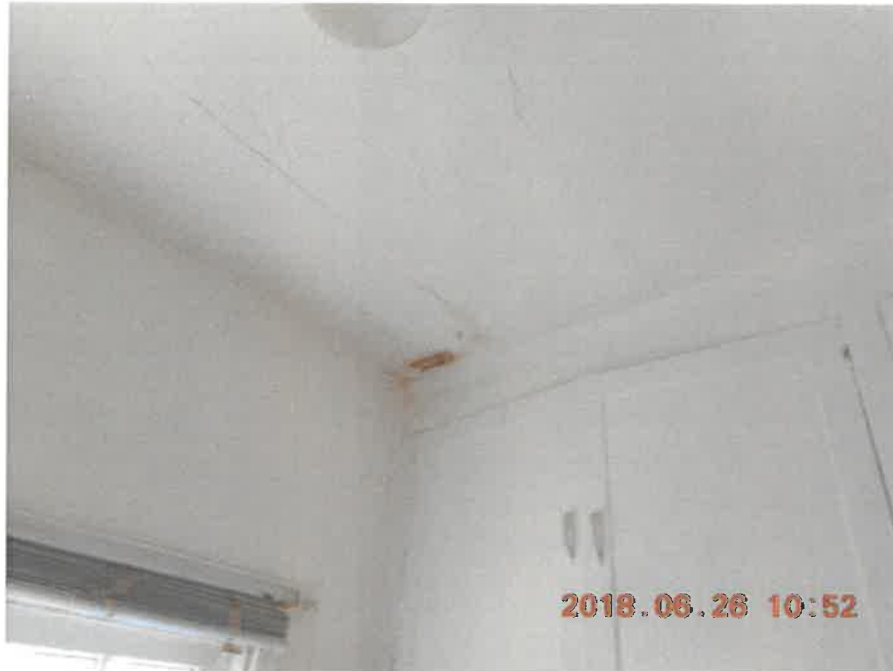
Photo 45: Ceiling is showing signs of cracking and damage.

- Kitchen ceiling is leaking water and requires investigation and repair (see photo #45).
- Kitchen and bathroom tiles are cracked and require repair or replacement (see photo #46).
- Window sills are leaking and require investigation and repair.
- Living room walls and ceilings have large cracks and require assessment and repair (see photo #48).

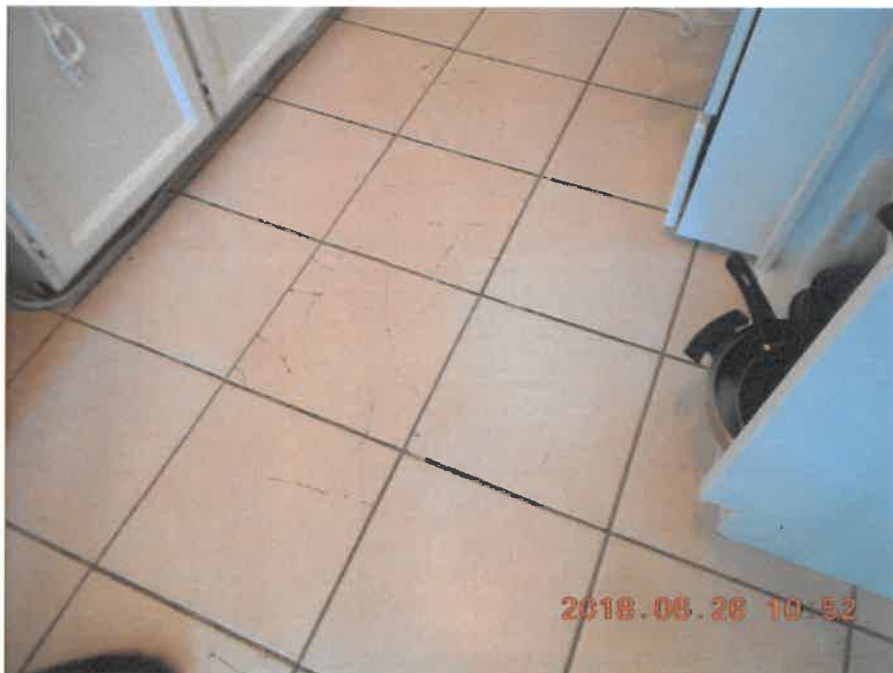
Photo 46: Floor is cracked throughout the kitchen.

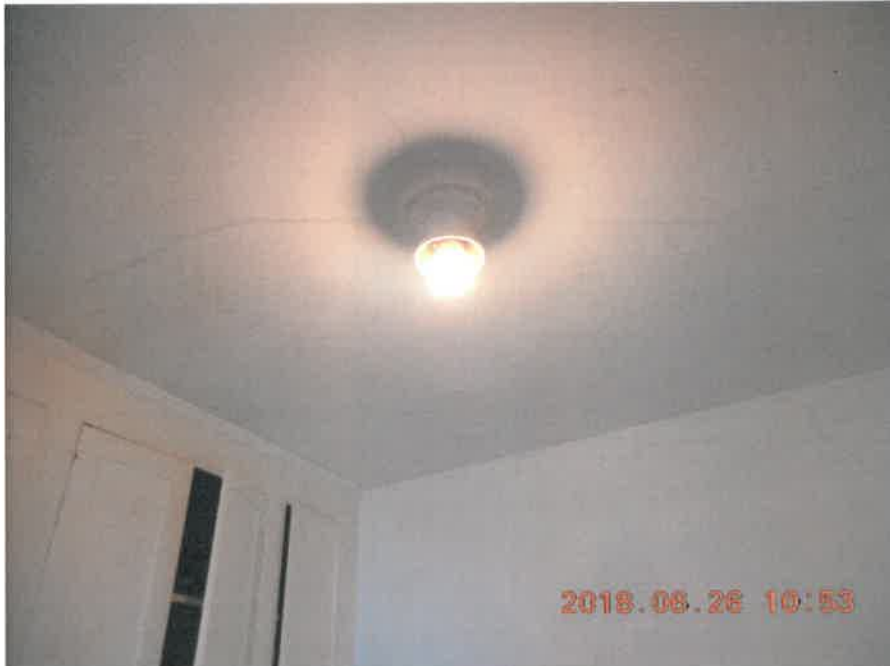
Photo 47: Ceiling is damaged and cracked.

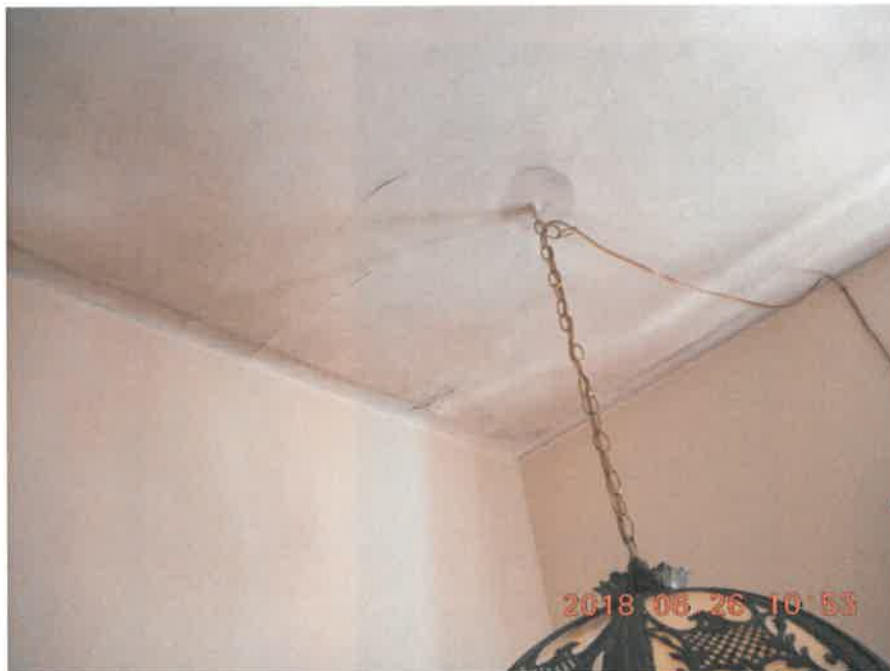
Photo 48: Ceiling cracks and damage from what appears to be water damage.

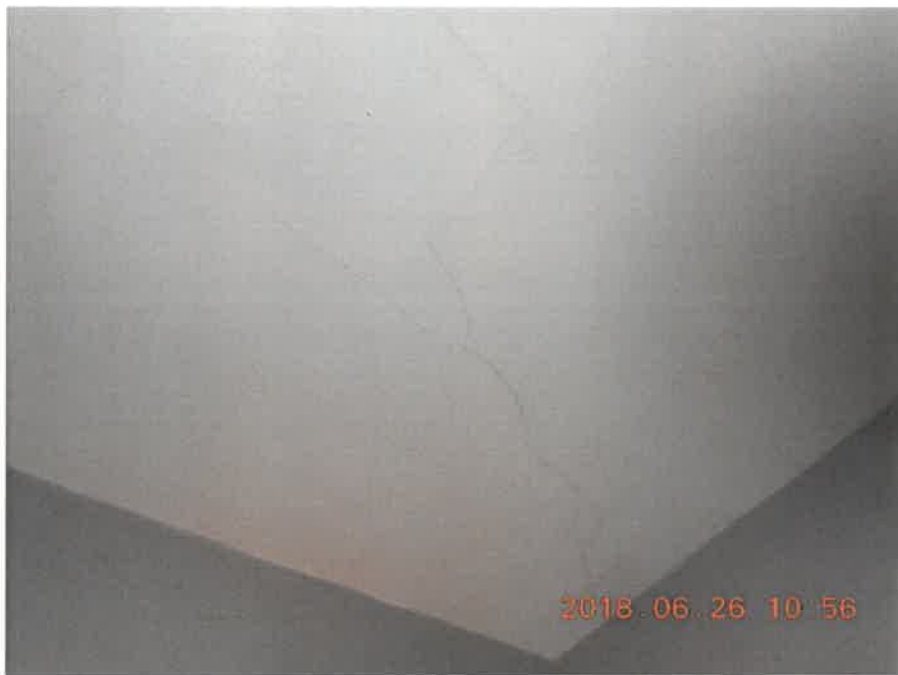
Photo 50: Ceiling is cracked.

- Entry door does not shut properly and requires investigation and repair.
- Ceiling in bathroom has large cracks and requires investigation and repair (see photo #50).

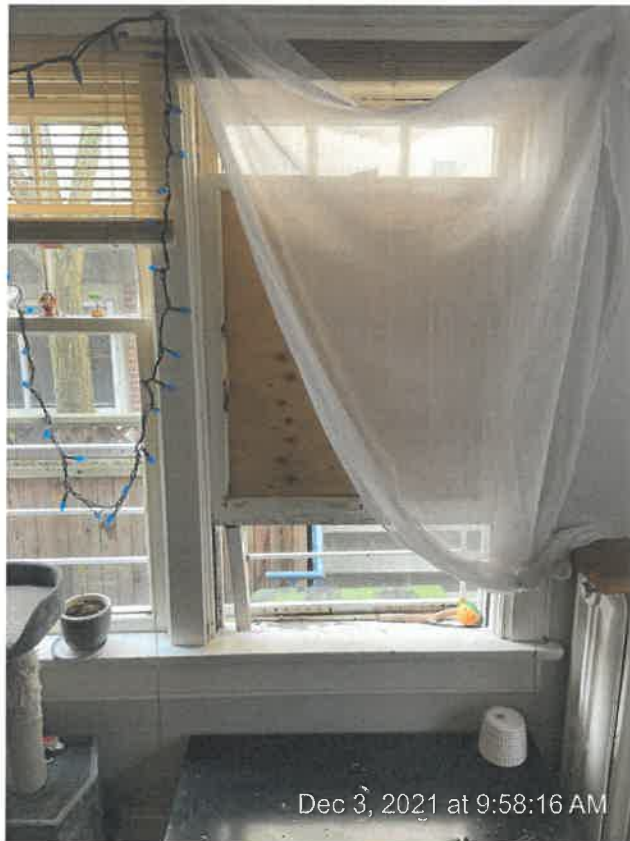
Photo 4: Boarded window requires repair.

- Kitchen faucet is loose and needs to be secured (photo #3).
- A boarded window in living room needs a glass panel (photo #4).
- Tub water tap is leaking and needs to be fixed (photo #5).
- Caulking is required around the bath tub (photo #5).

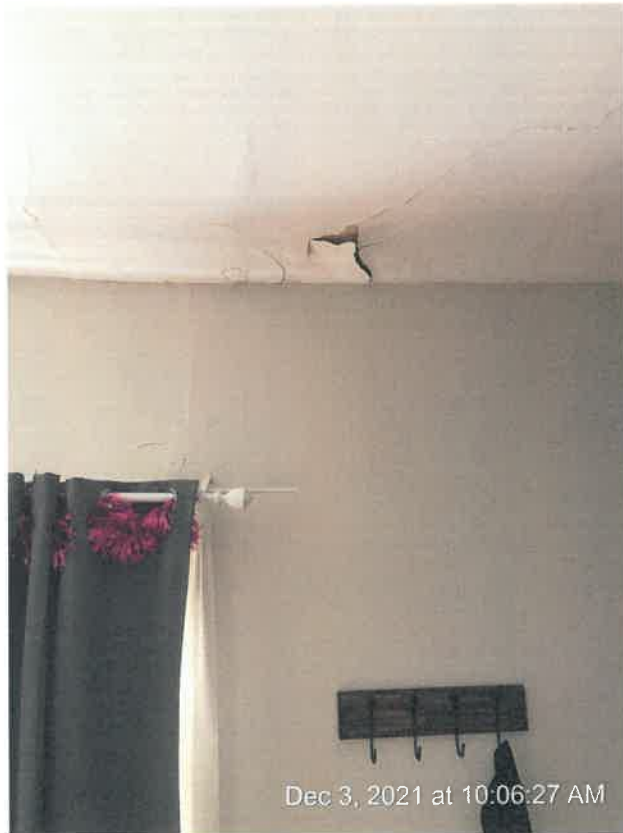
Photo 9: Living room roof is peeling and requires repair.

- A hole in the bathroom ceiling needs to be fixed (photo #8).
- Bedroom ceiling and wall is peeling and needs to be fixed (photo #9).
- Hallway closet door knob is missing. Replace or disable hardware so someone can't get trapped in the closet.

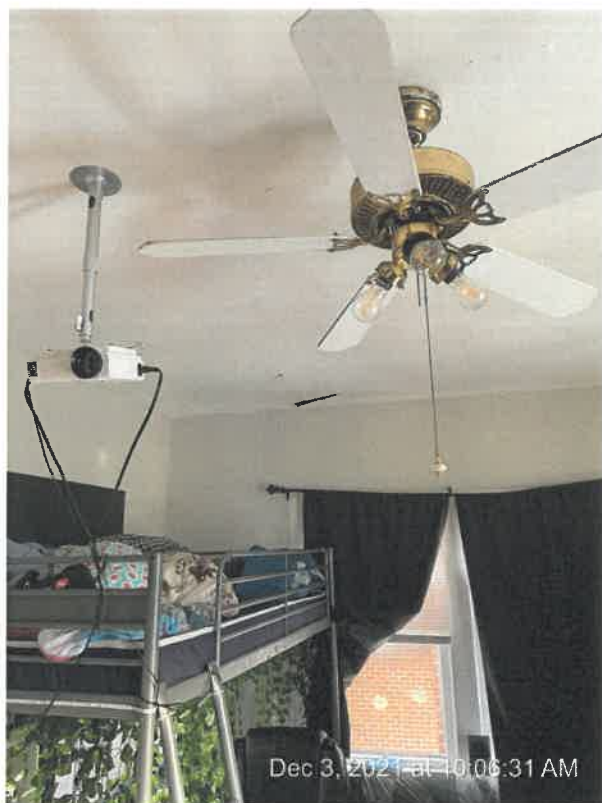
Photo 10: Roof peeling and requires repair.

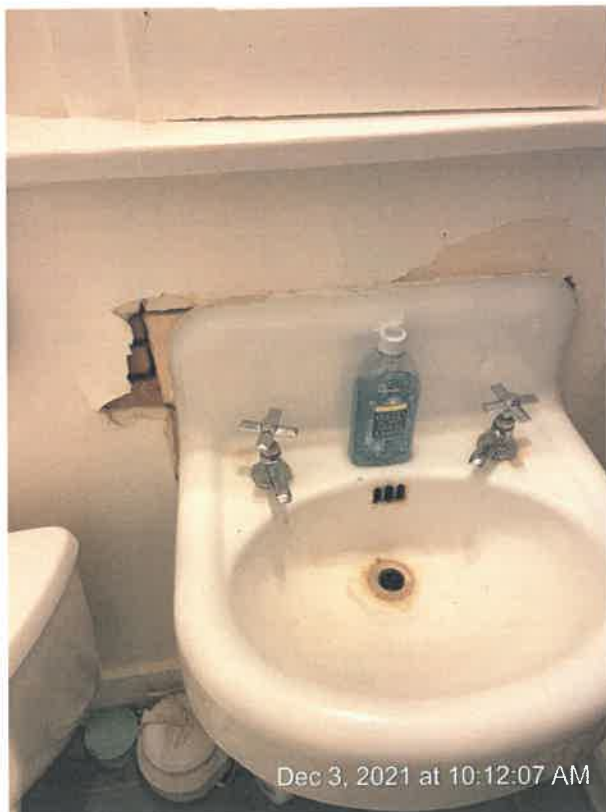
Photo 13: Wall around the sink requires repair.

- Windows not opening in living room and need to be fixed for condensation issues.
- Bathroom back wall area needs to be repaired and painted (photo #13).
- Washroom faucet needs to be fixed (photo #16).
- Living room ceiling is damaged (photo #15).

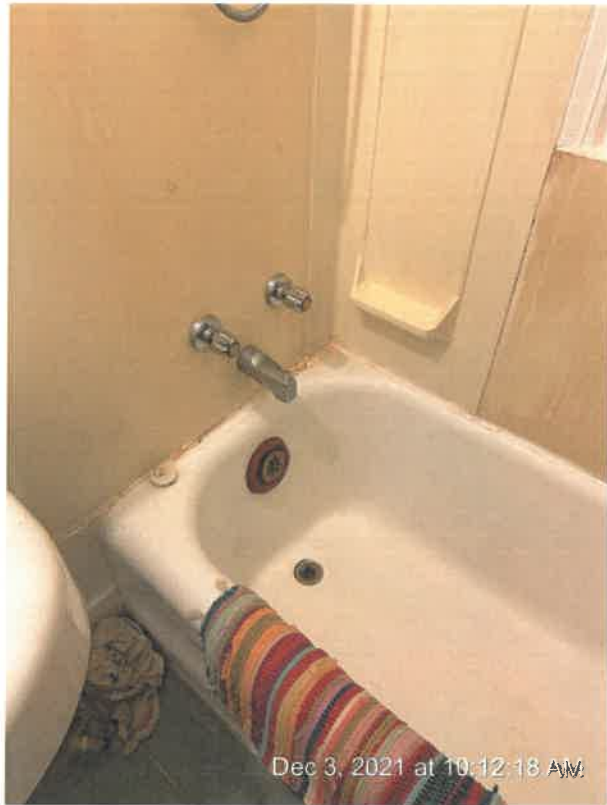
Photo 14: Caulking around the bathtub requires replacement.

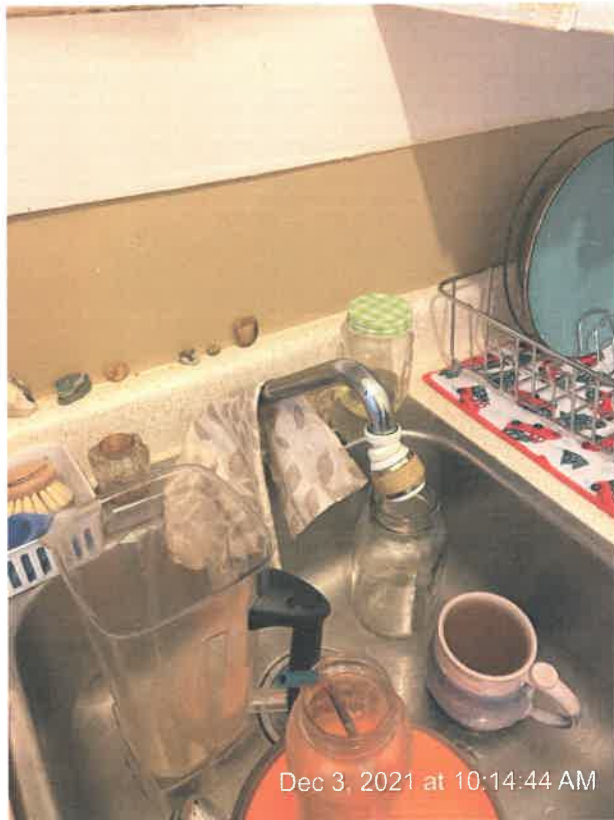
Photo 16: Kitchen faucet needs to be secured.

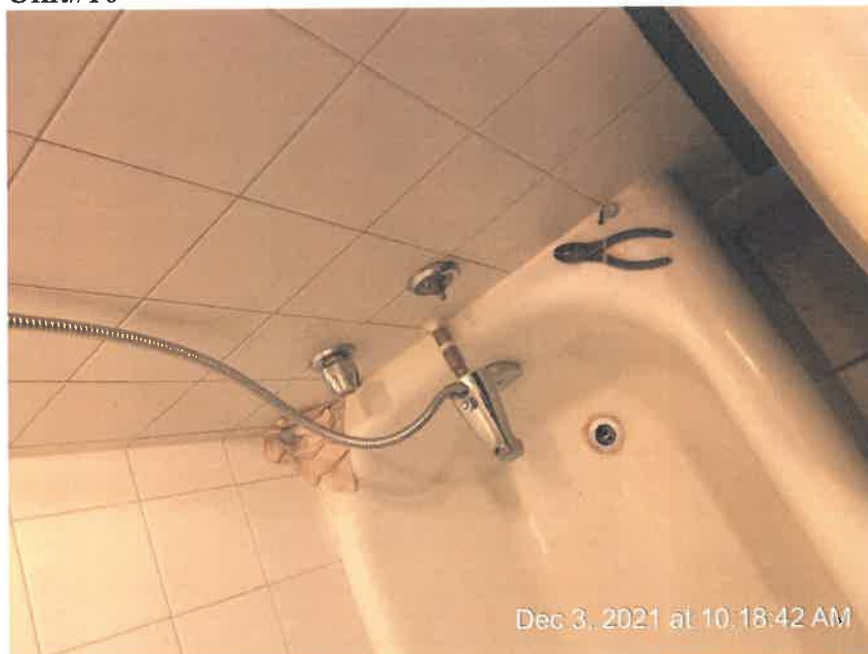
Photo: 17 Washroom tub faucet and handle requires repair.

- Washroom tap missing and needs to be fixed (photo #17).
- Washroom well window has red tape and needs repair (photo #18).
 - The light well appears to be closed and isn't offering light and ventilation as it was designed to do. Investigate condition of light well. It appears possible that the light well has been roofed over which would create a potential for mold within the light well and that would be detrimental to the health of the occupants.

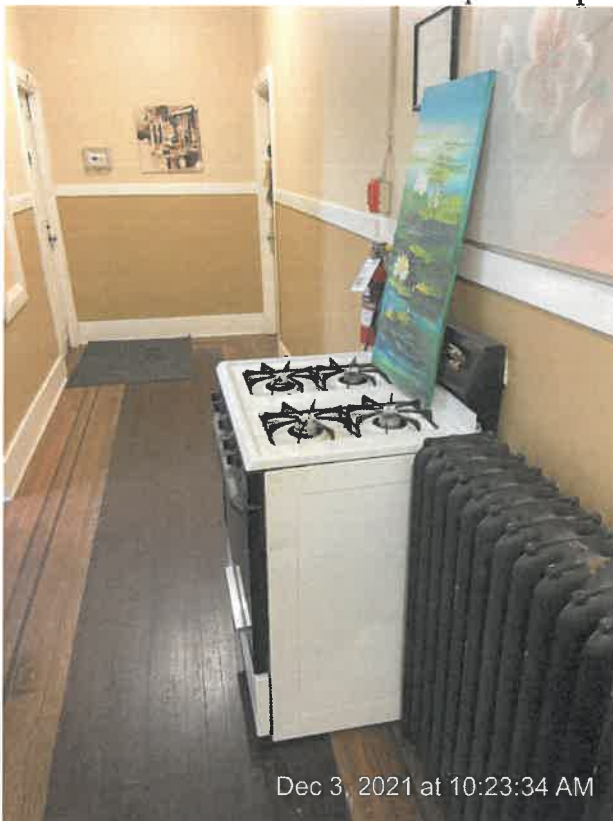
Photo 19: Appliances/TV in common areas need to be removed.

- Appliances and TV need to be removed from the common areas of the building (photo #19).
- Staircase broken window between 2nd and 3rd Floor needs to be fixed (photos #11, #12).
- Mailbox by front door are not secured and missing locks (photo #2).
- Basement exit door lock is broken and needs to be replaced (photo #1A).
- Fire assemblies must be corrected to be intact.
 - There are multiple locations in the building where drywall has been removed to access plumbing or other building services and not properly replaced (photos 24 A & B).
 - The boiler room ceiling, in particular, must be replaced with fire-rated drywall, fully taped and caulked, securely fastened to the ceiling to maintain a 1-hour fire separation. (photo #23).
- Provide a working light in the boiler room.
- Insure Owner has working keys to every unit for inspections.

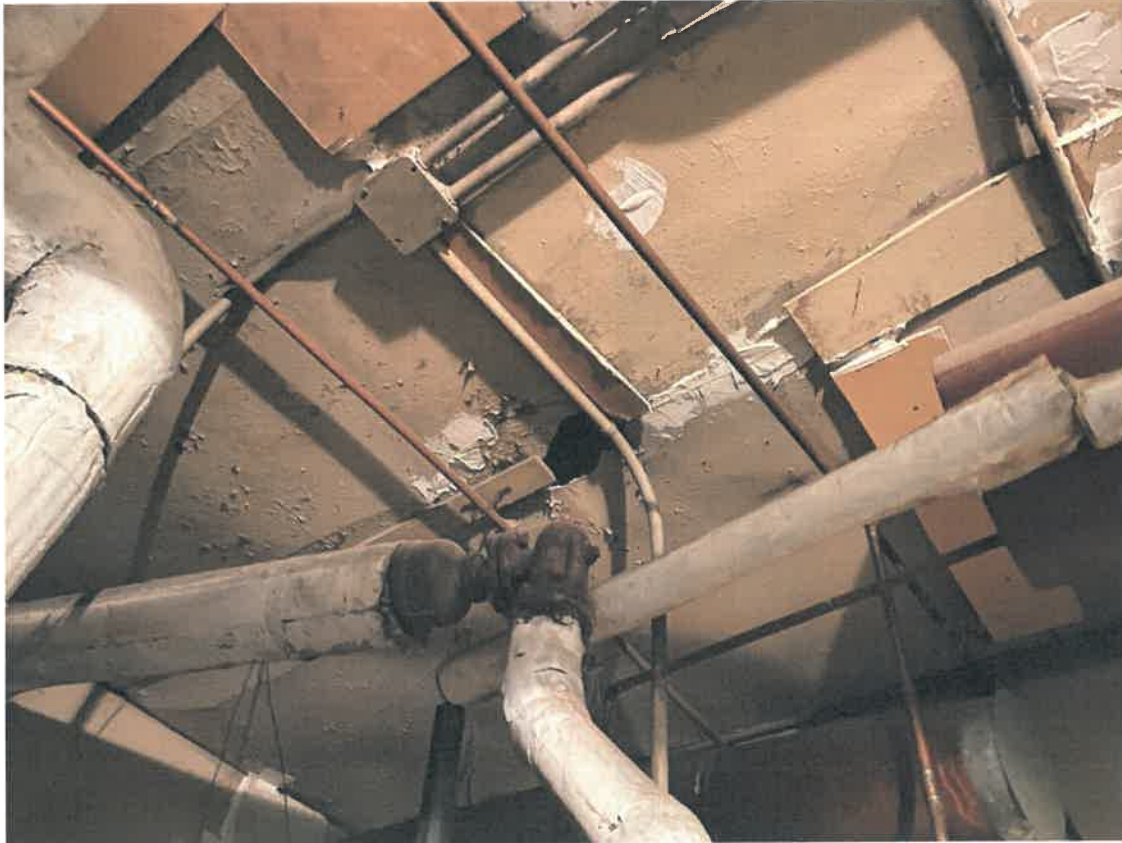
Photo 23: Boiler room ceiling needs to be replaced in its entirety as patch work has degraded the assembly to ineffective.
