Attachment E

349 Cumberland st

349 AND 351 CUMBERLAND ST

ENGINEERING PROPERTY / BUILDING CONDITION ASSESSMENT

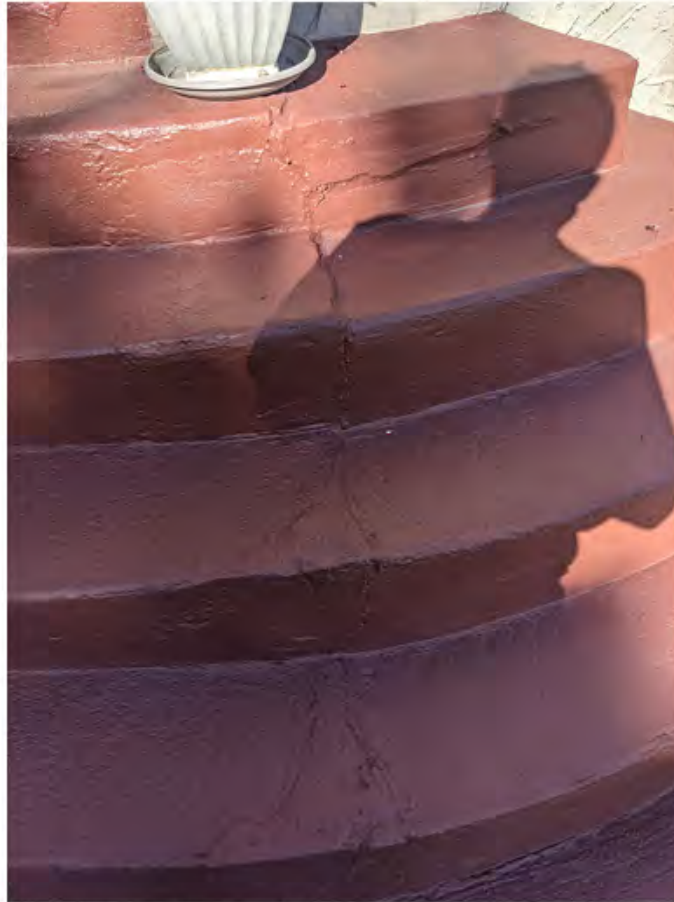
unit 349 - south entryway stairway cracks have increased in depth over the past 15 years.jpg

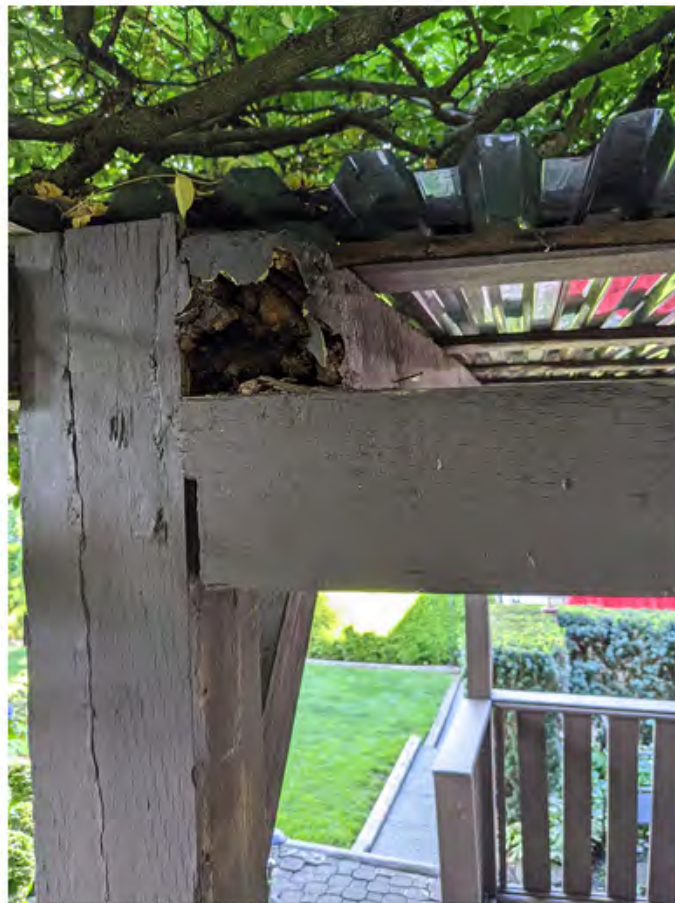
unit 349 - pergola with evidence of extensive rot.jpg

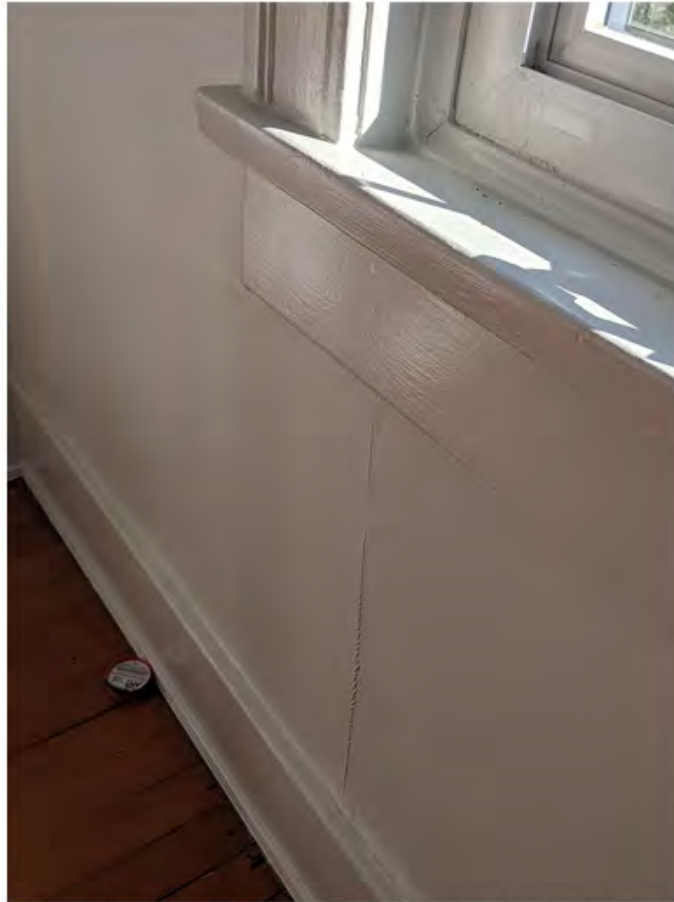
CMG observed evidence all around the Subject Building that would suggest that there is extensive differential settlement in the Subject Building. The water flowing around the foundation walls over the years likely softened the soil in various locations that caused the strip footings to settle, and likely crack. This has adversely affected the foundation so that vertical cracks are all over the walls on the inside and outside of the Subject Building. The south-east corner showed the most

unit 349 - cracks under window in south wall shows evidence of settlement.jpg

Underpinning the foundation would be the only permanent way to fix this issue at approximate cost of \$90 000 (2021) CAD.

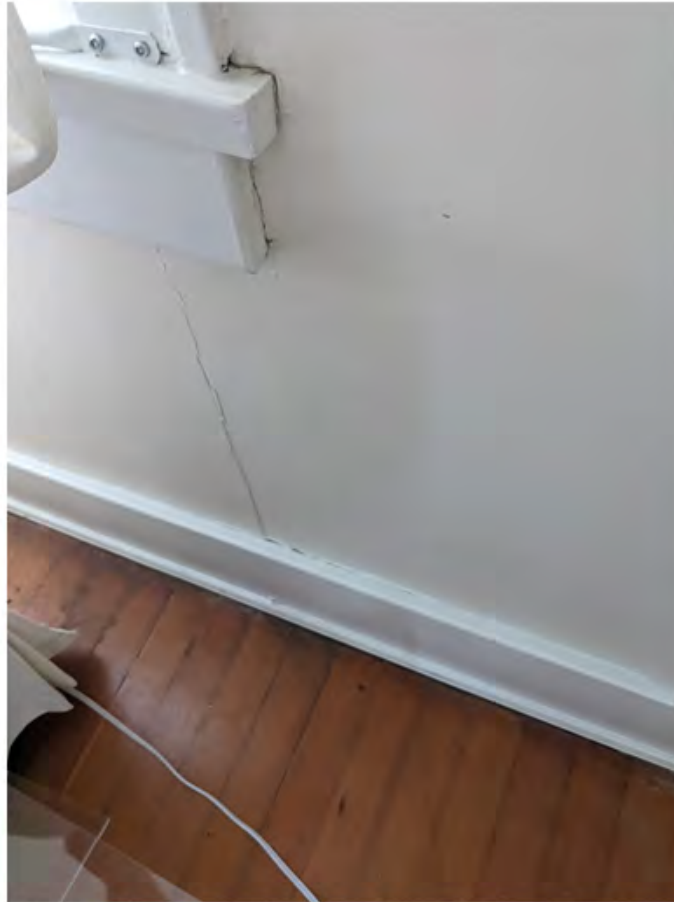
unit 351 - evidence of foundation settlement on south wall below window on main level.jpg

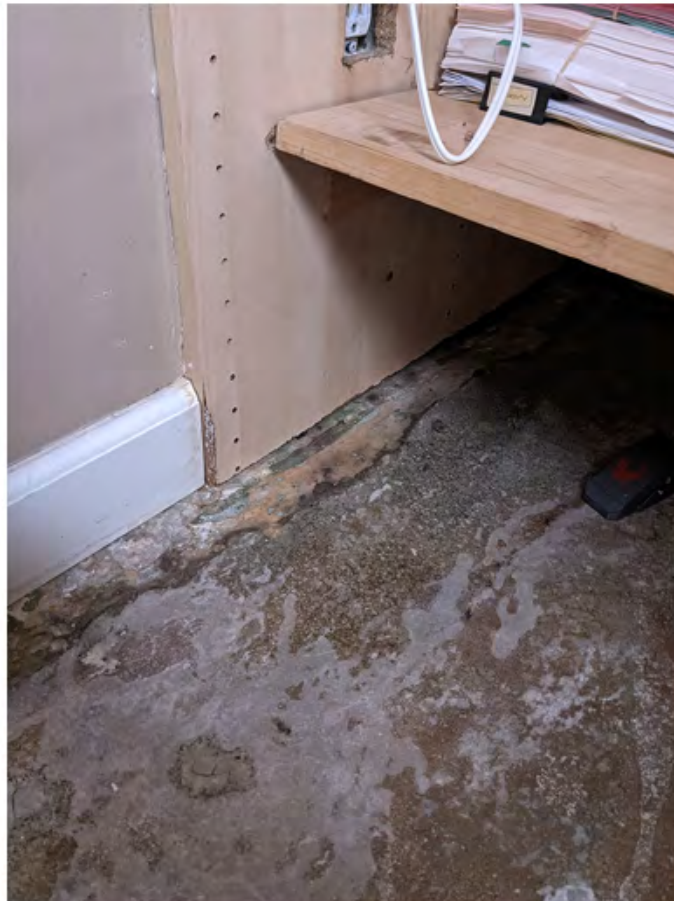
This condition will not likely ever change, and the structure will continue to move and shift over time causing water and animal ingress issues. The cracks also affect the stucco's ability to keep water away from the inner walls and CMG observed recent evidence of moisture damage to internal walls in unit 351 lower level.

unit 351 - location of major water ingress in lower level on north wall east side.jpg

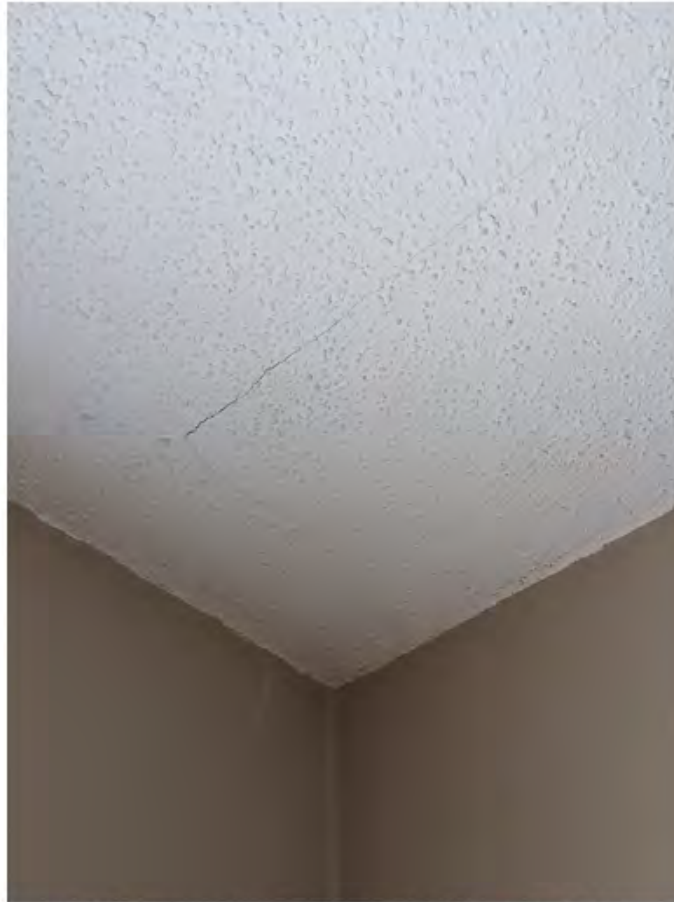
unit 351 - new crack on ceiling outside WC on main level.jpg

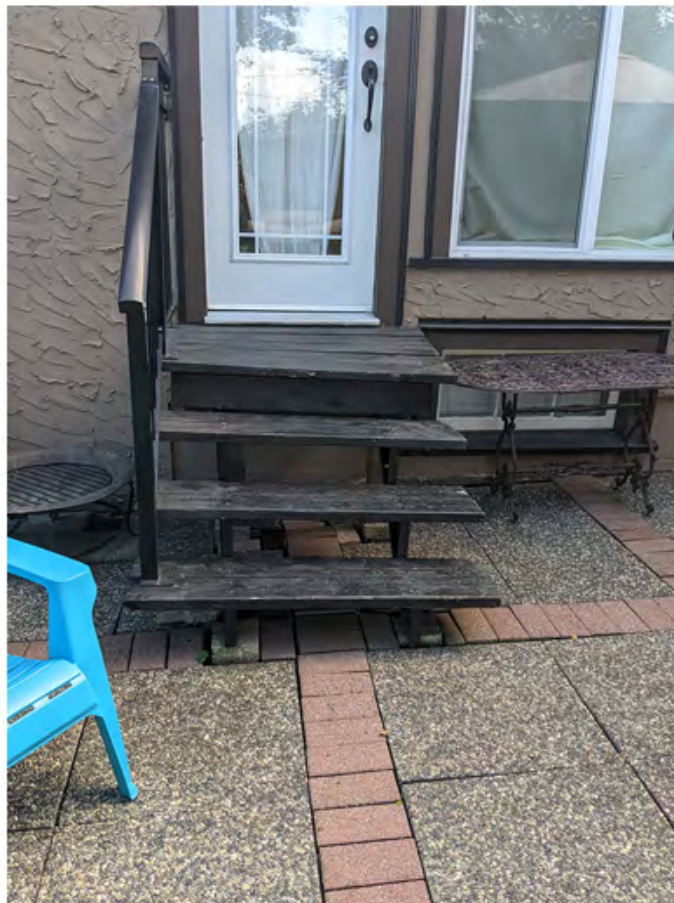
unit 351 - settlement in north entryway stairway.jpg

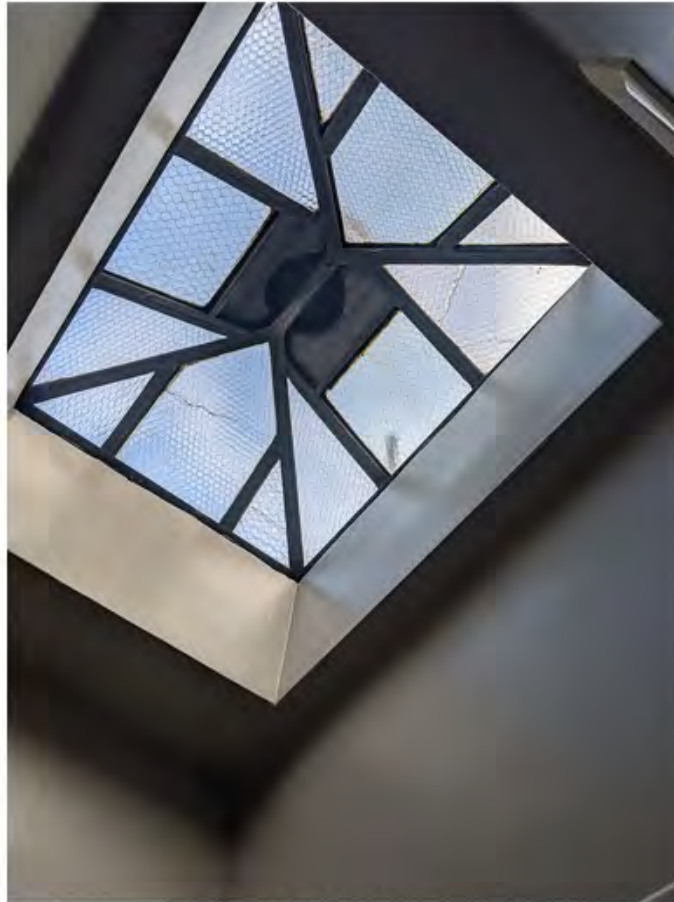
The skylights were cracked, and this will likely continue as long as the building keeps shifting. The cost to replace the 2 central skylights with a similar vented style after underpinning has been completed would be approximately \$10 000 (2021) CAD.

unit 351 - skylight with cracking.jpg

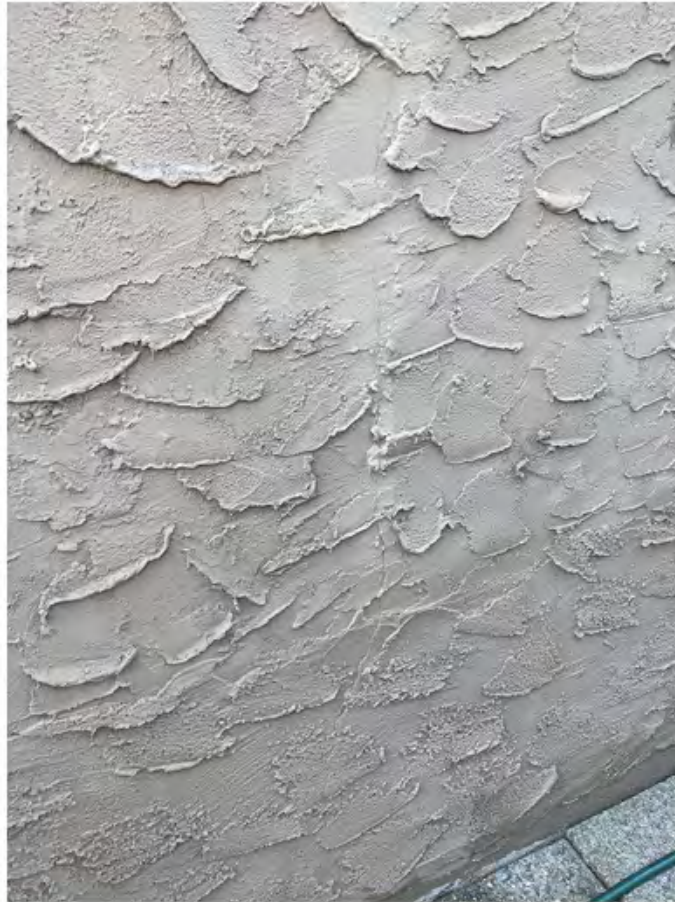
crack in stucco on east wall just north of lower level crawl space door.jpg

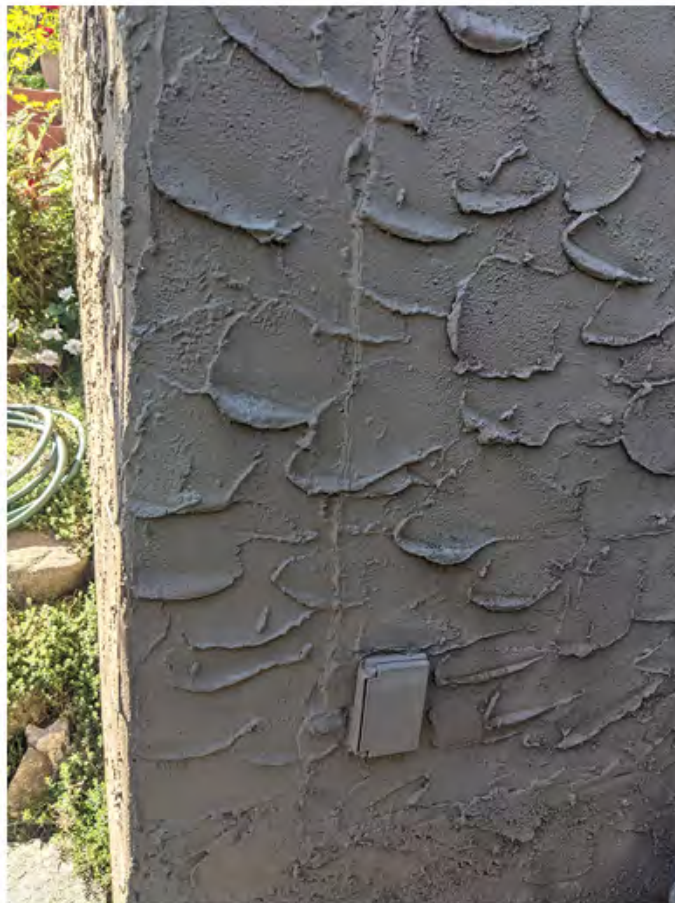
crack in stucco on east wall south side.jpg

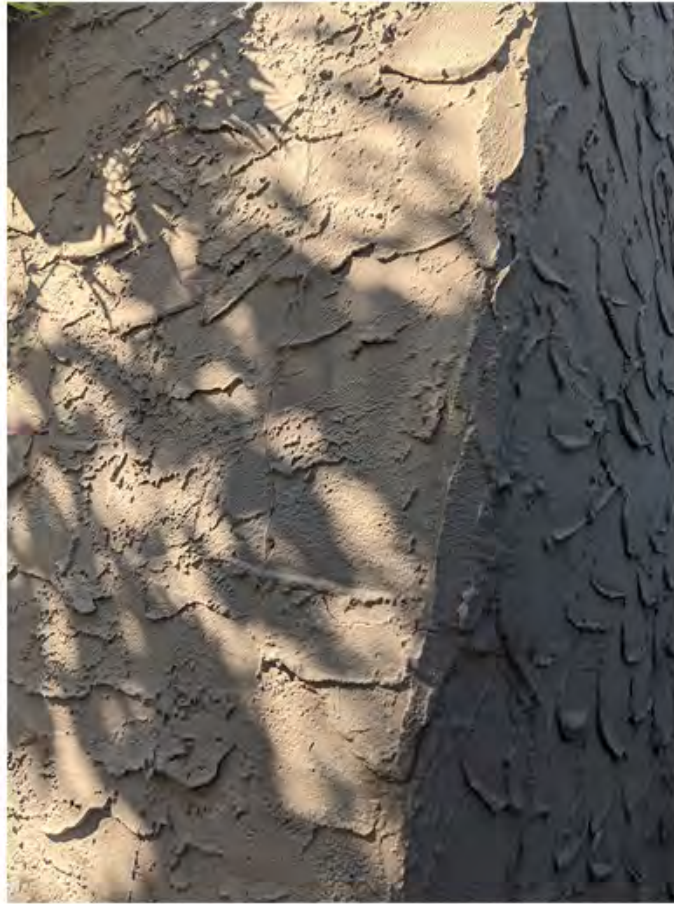
crack in stucco on south wall east side.jpg

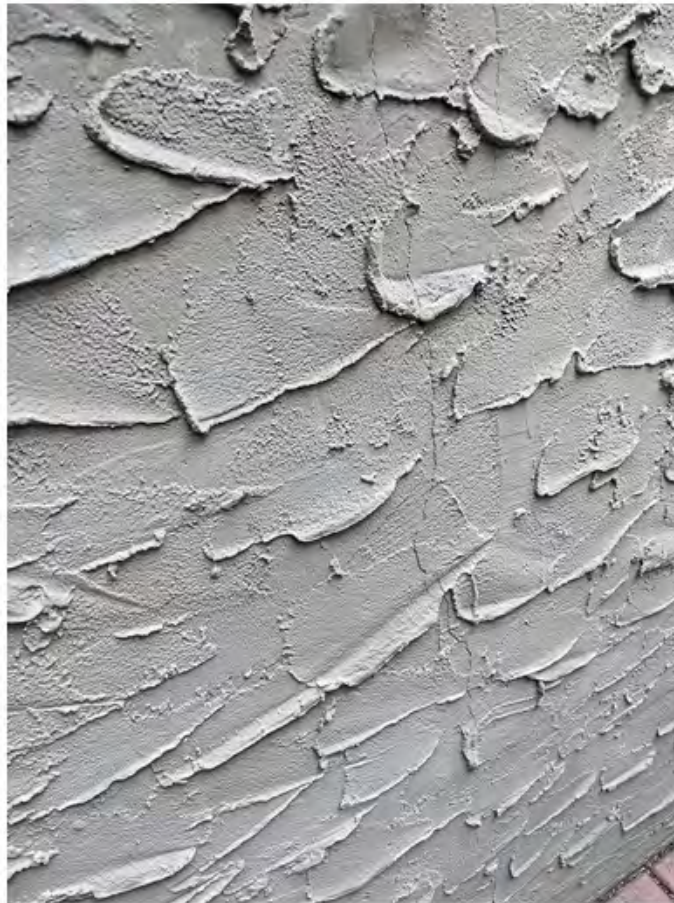
crack in stucco on west wall central area.jpg

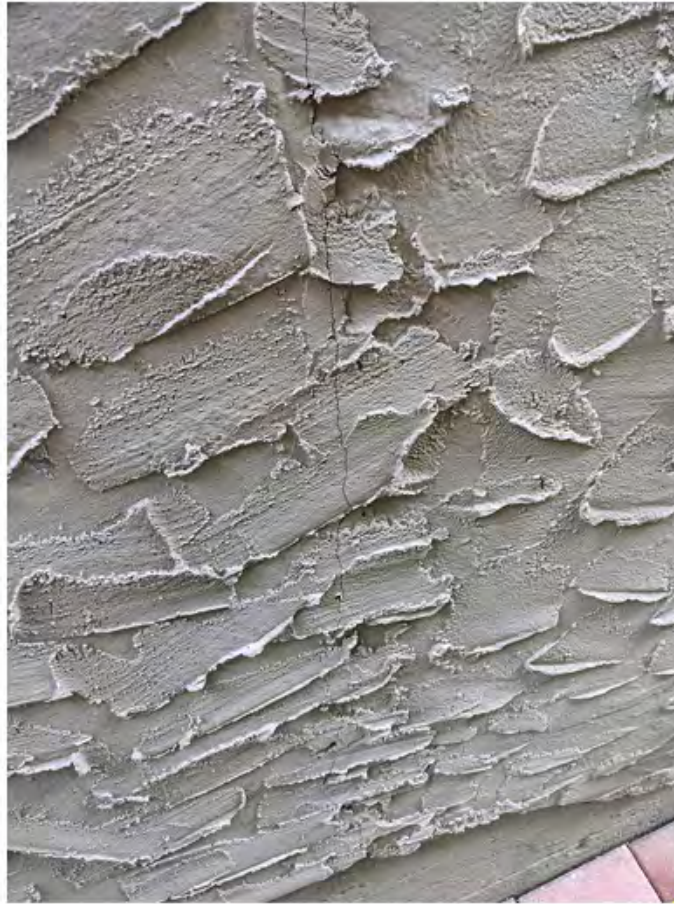
crack in stucco on west wall north side.jpg

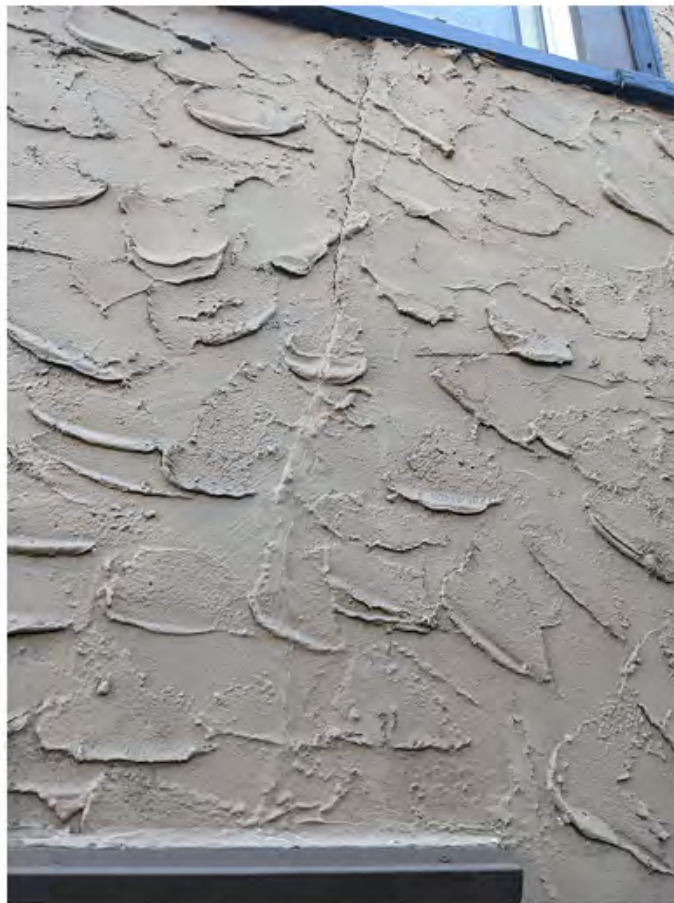
recently opened crack in stucco on east wall above crawl space access door.jpg

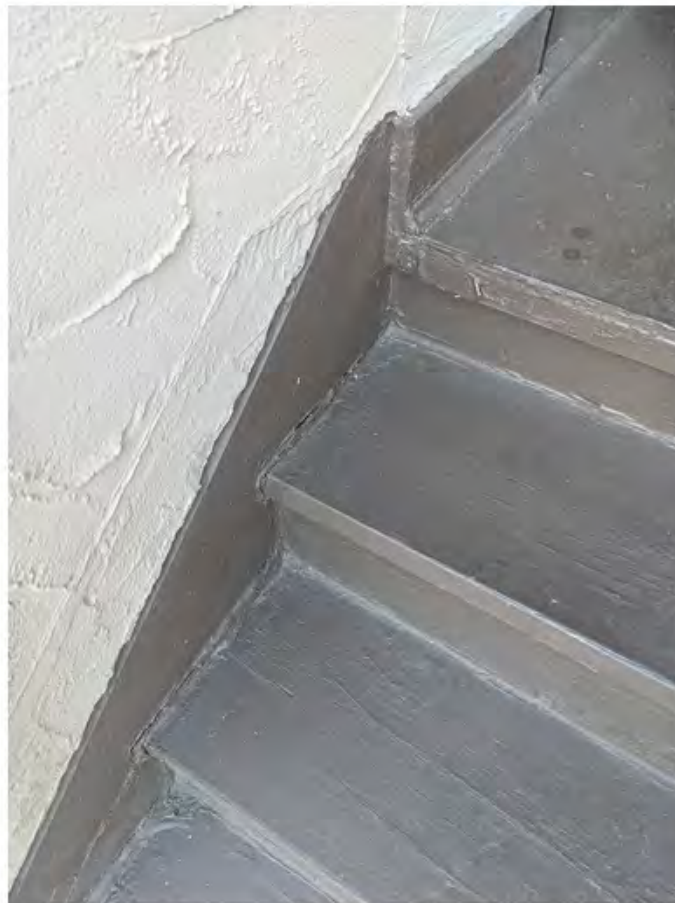
unit 349 - cracks in stairwell up to south egress doorway.jpg

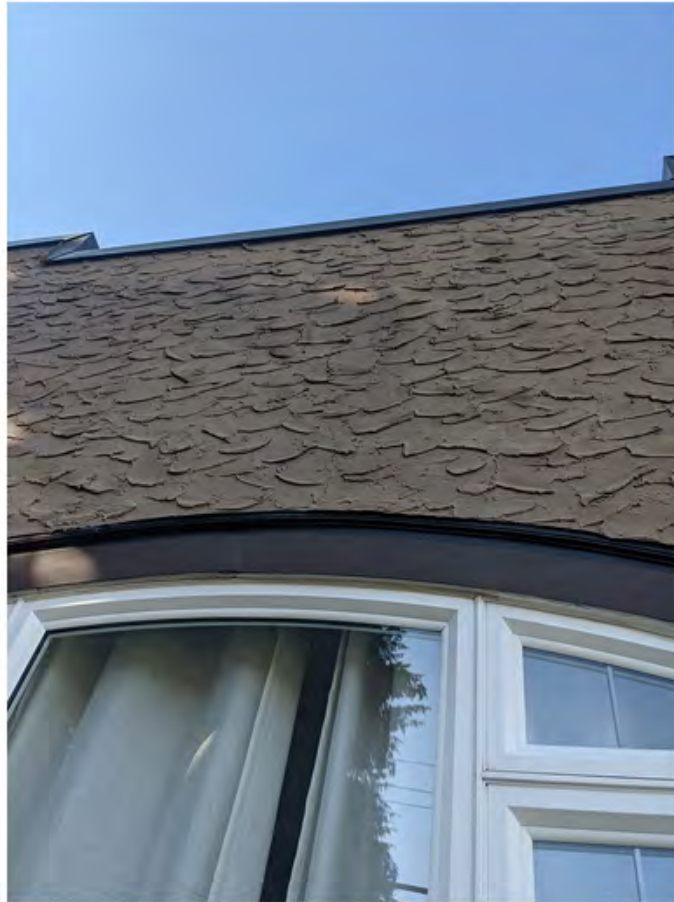
unit 349 - cracks in stucco above window.jpg

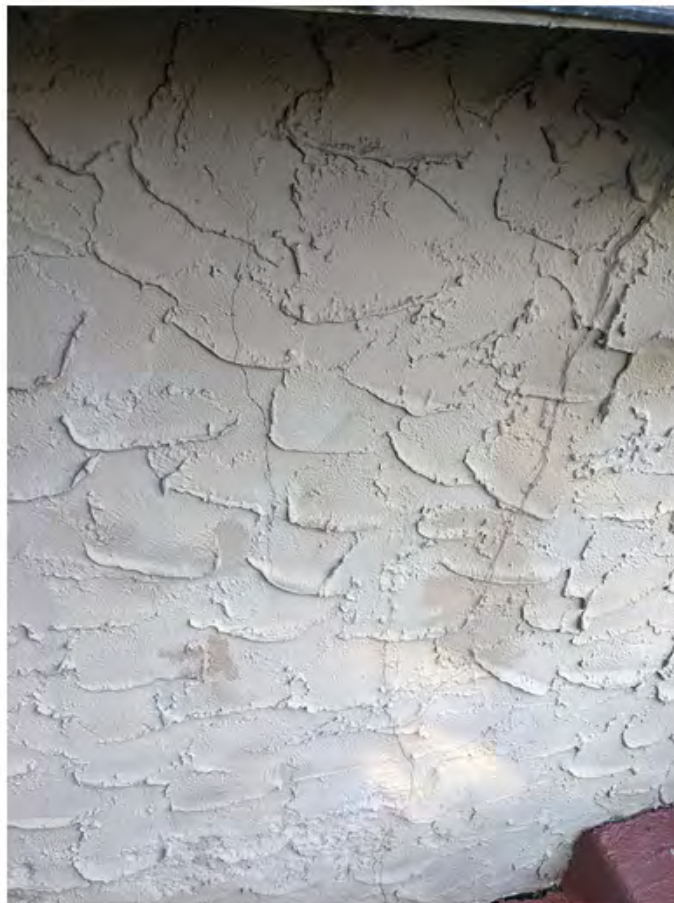
unit 349 - cracks in stucco on south wall justt west of entryway door.jpg

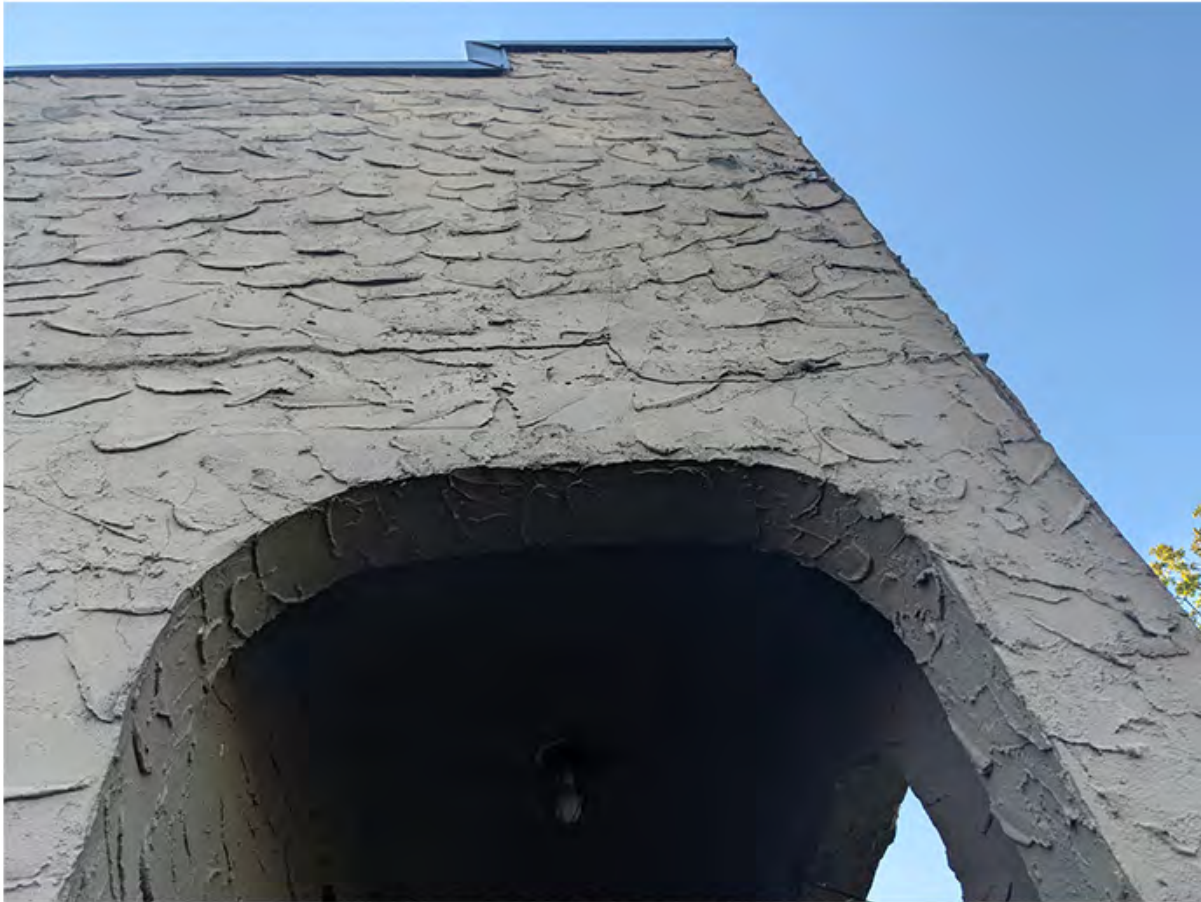
unit 349 - cracks in wall above east wall entryway.jpg

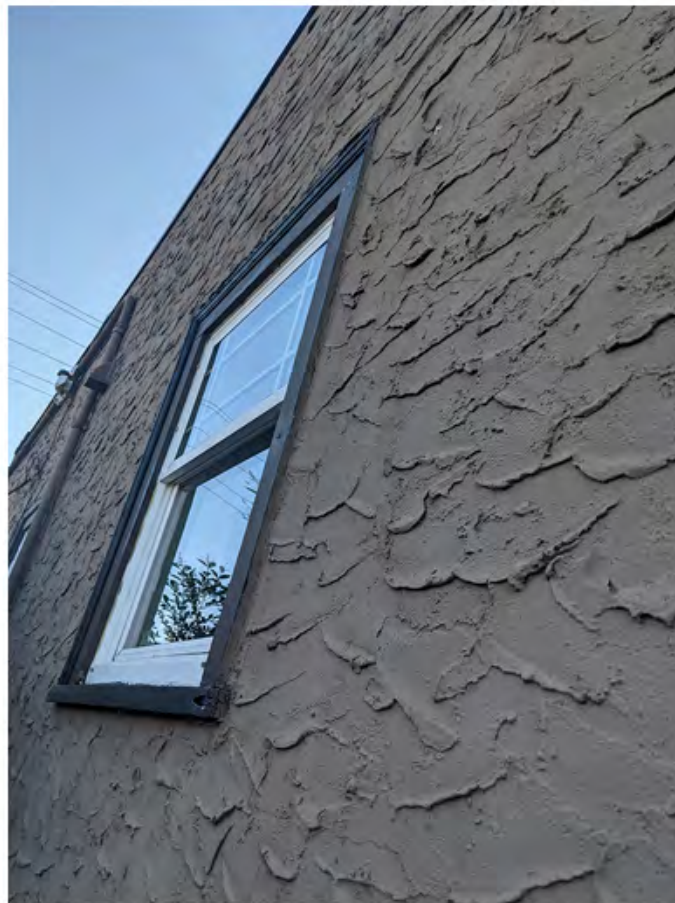
CMG observed 7 wood framed windows in unit 351 and 4 wood framed windows in unit 349. These windows were all in poor condition- not able to be opened and providing poor insulation quality. The main entryway door to unit 349 was also in poor condition and was binding, likely due to differential settlement. The cost to replace the 11 windows and a door would likely be approximately \$12 000 (2021) CAD and this should be completed before the reapplication of the outer wall envelope system so that the windows are properly detailed with drip guards and weep screeds to reduce the chance of moisture ingress around the windows.

unit 349 - east wall window with no drip guard flashing above or below.jpg

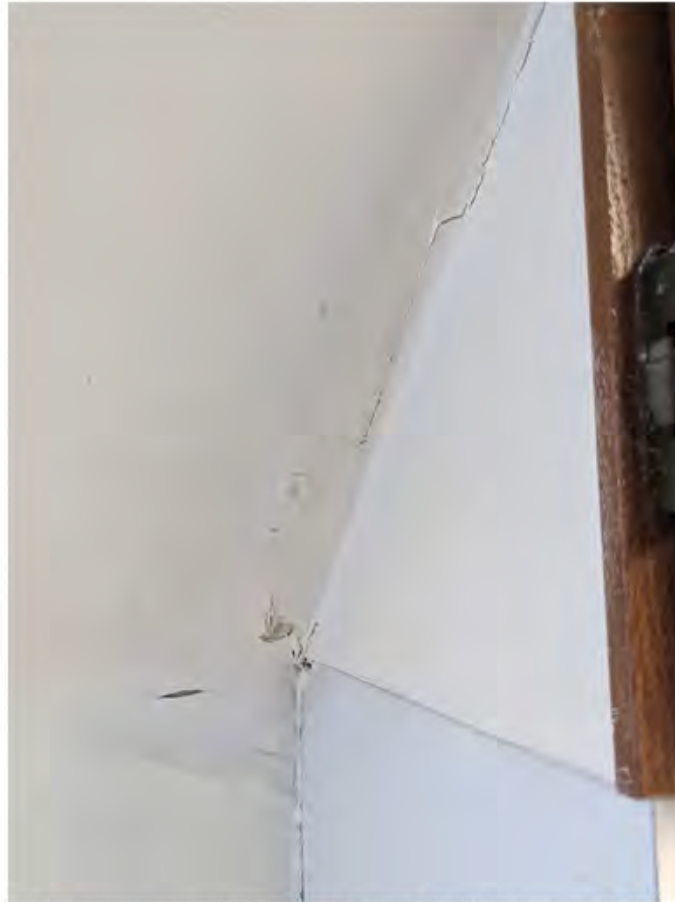
unit 349 - evidence of moisture ingress above stove in lower level likely from building envelope failure.jpg

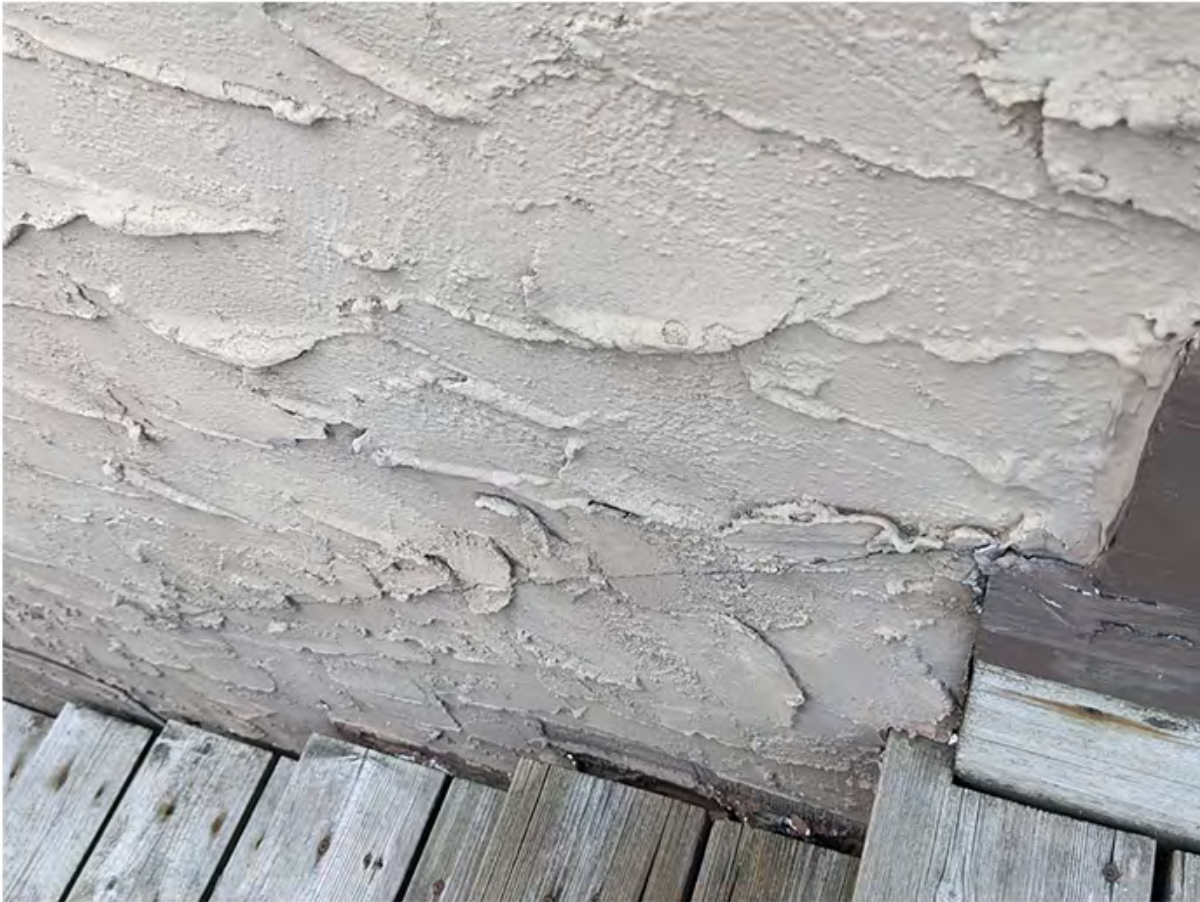
unit 349 - outer east wall stairway with evidence of settlement cracks.jpg

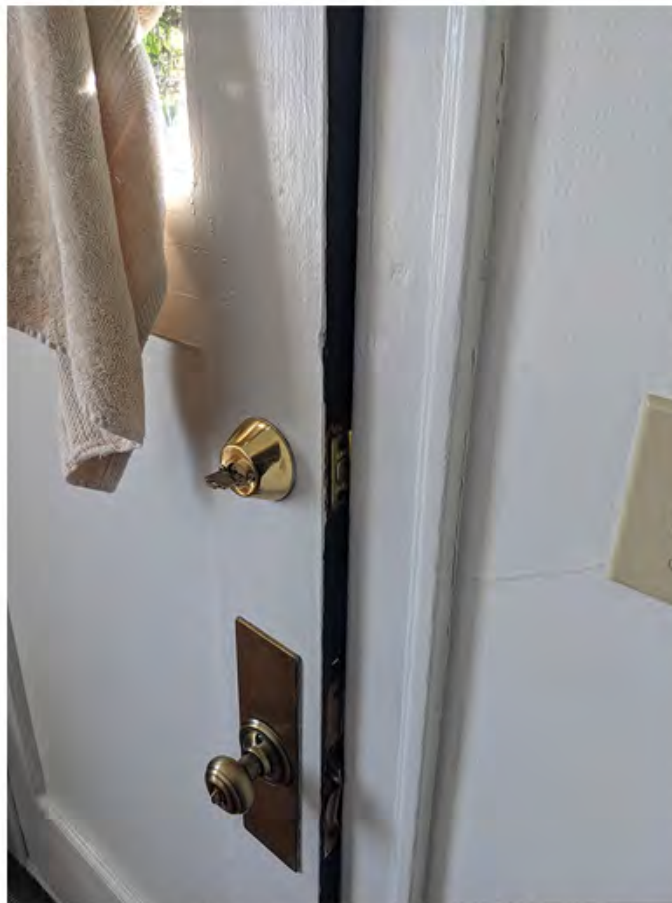
unit 349 - south doorway binding on open and closure.jpg

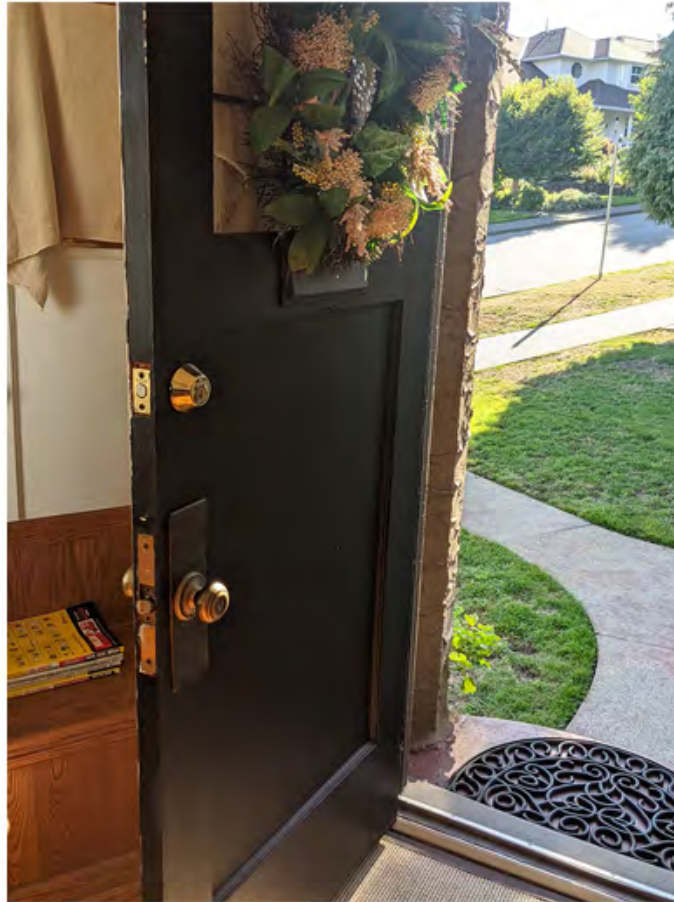
unit 349 - south doorway needs to be replaced due to settlement and faulty hardware.jpg

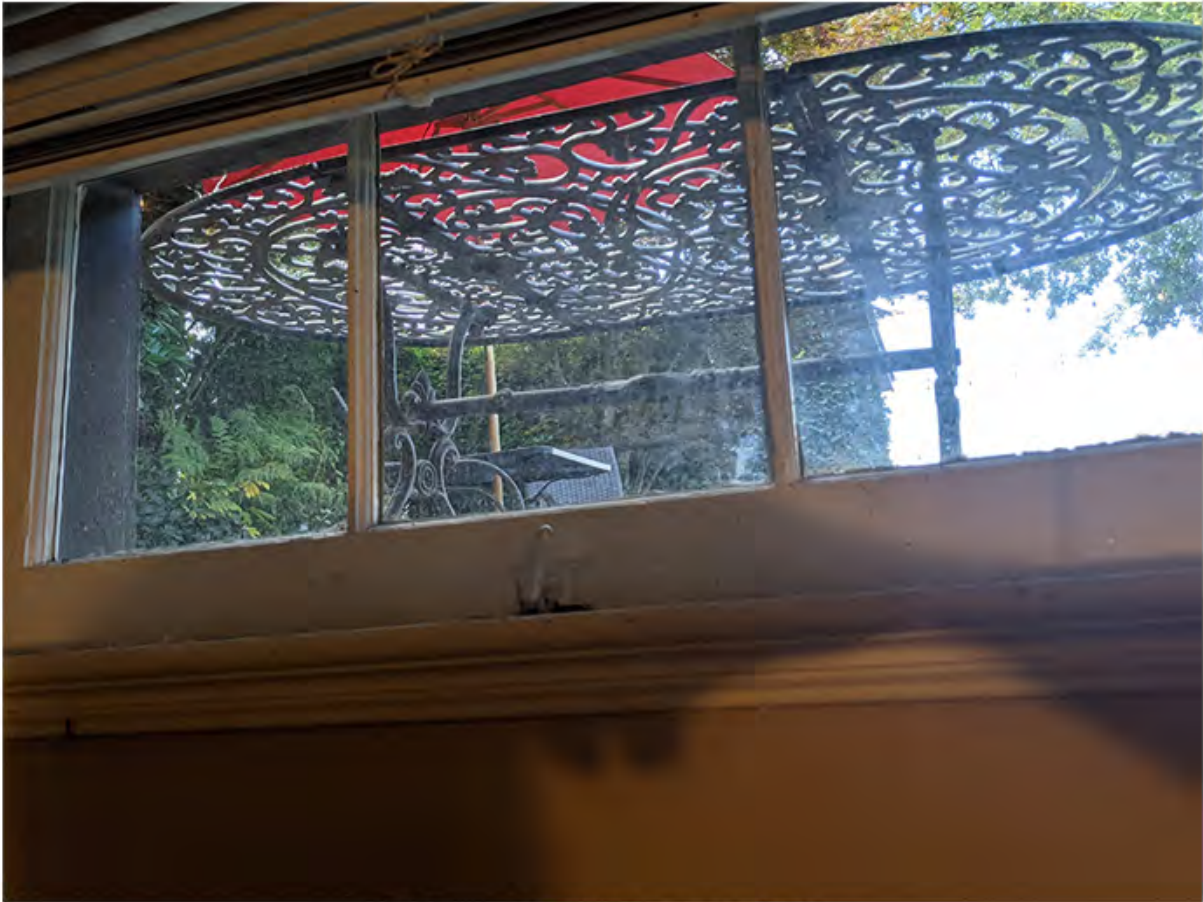
unit 351 - wood framed window in lower level.jpg

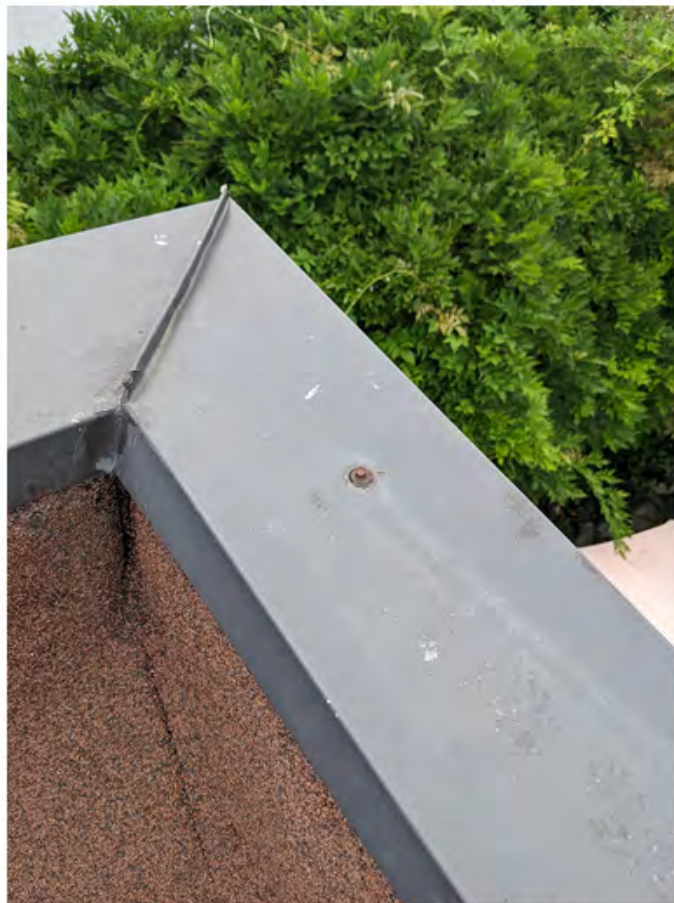
cap flashing fasteners rusting and at end-of-life.jpg

The fasteners on the cap flashing were rusted, and this should also be replaced at an approximate cost of \$2 500.

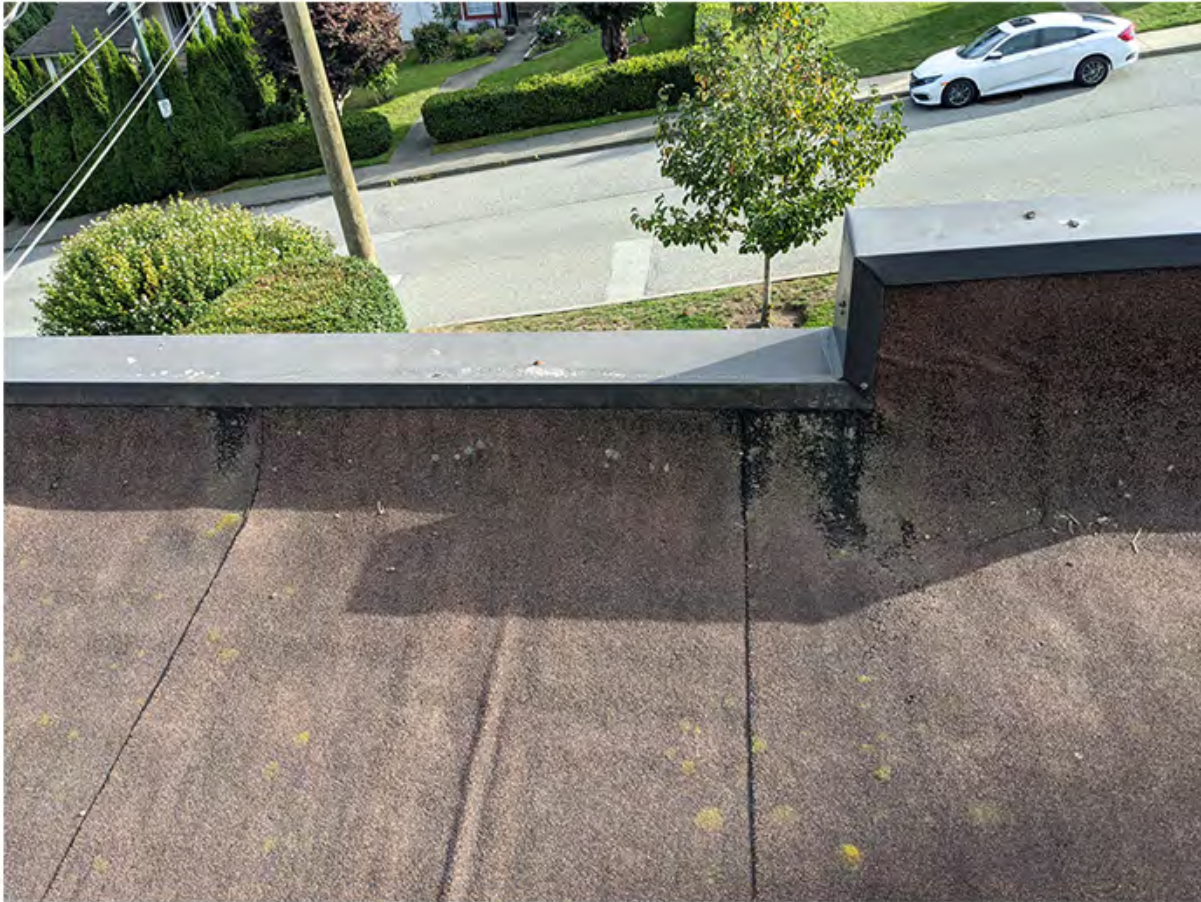
degraded granular material on south parapet.jpg

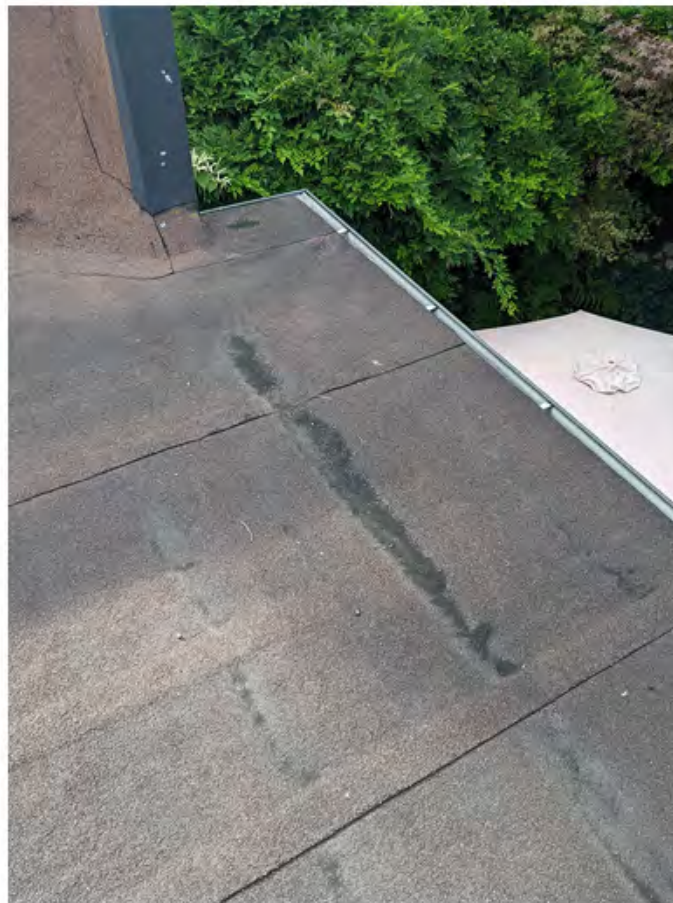
degraded rolled asphalt due to ice damming.jpg

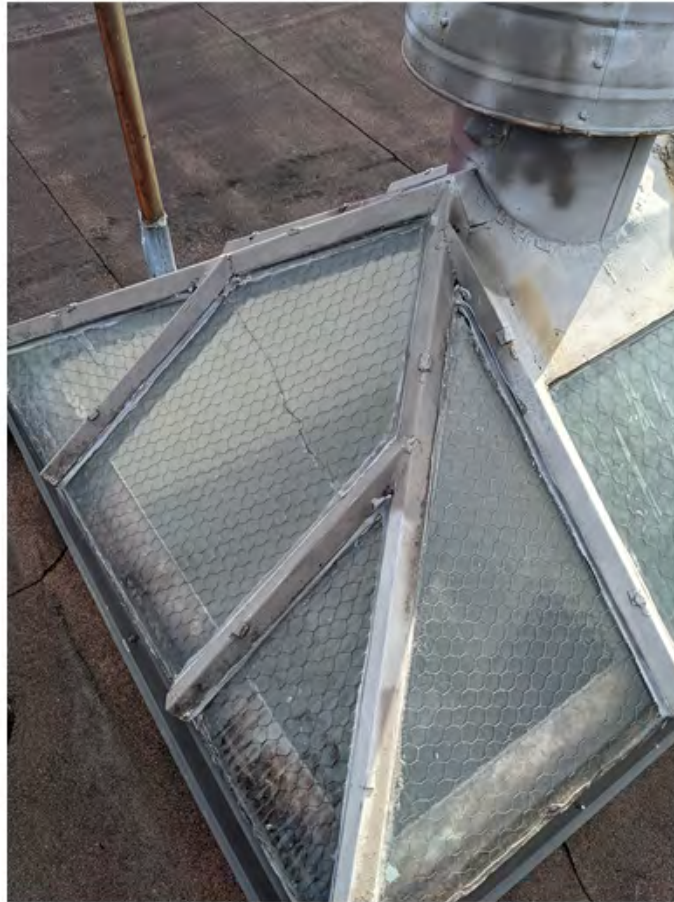
recent crack in skylight above unit 351.jpg

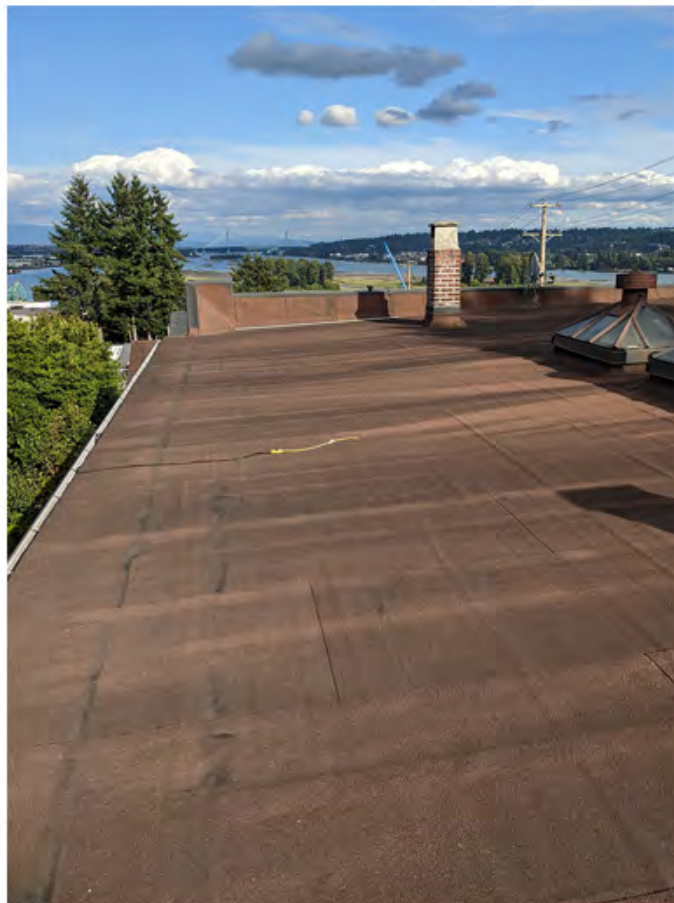
CMG observed a lack of granular material on the rolled asphalt surface. The surface also had raised folds in it that was evidence of further degradation. Based on this evidence, the roof surface was in critical condition and should be replaced in the next year at a rate of \$200 / m² that will also add an insulation package to reduce the slope of the roof so that the eavestroughs can do their job and reduce storm water next to the north foundation wall. The rate will also include replacement of any rotten roof sheeting and any rotting structural wood in the roof support system. Based on an approximate rooftop surface of 170m², the cost to resurface the roof will be \$200/m² * 170m² = \$34 000 (2021) CAD.

rolled asphalt no longer laying flat.jpg

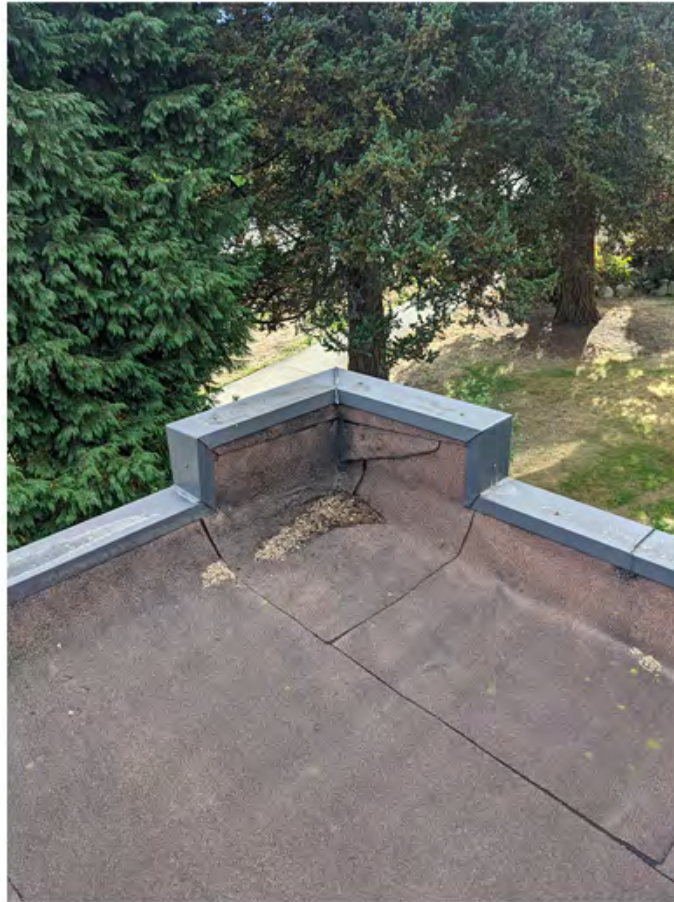
rolled asphalt seams degraded.jpg

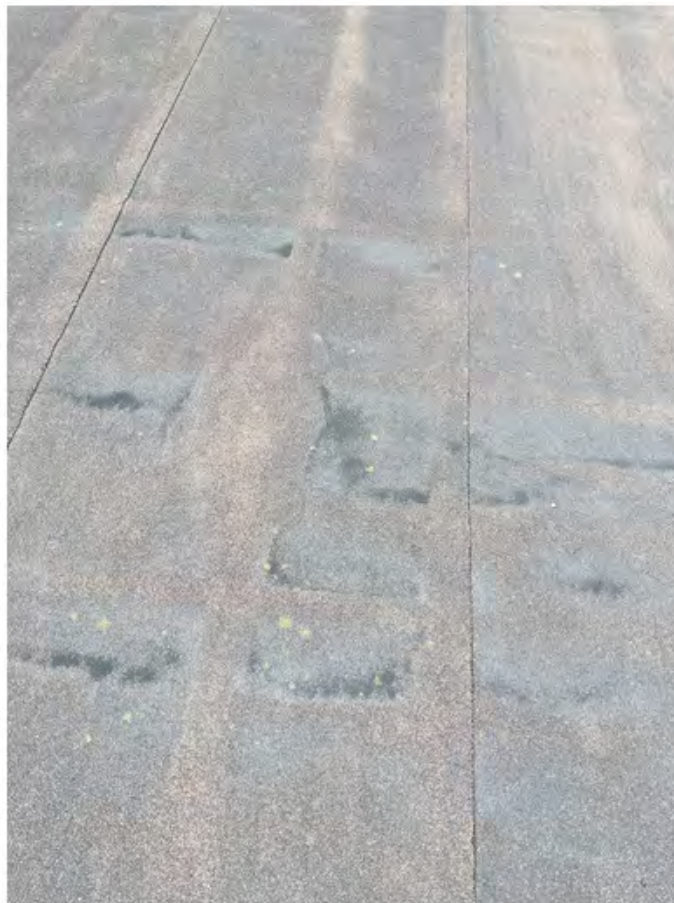
roof surface with degraded granular material.jpg

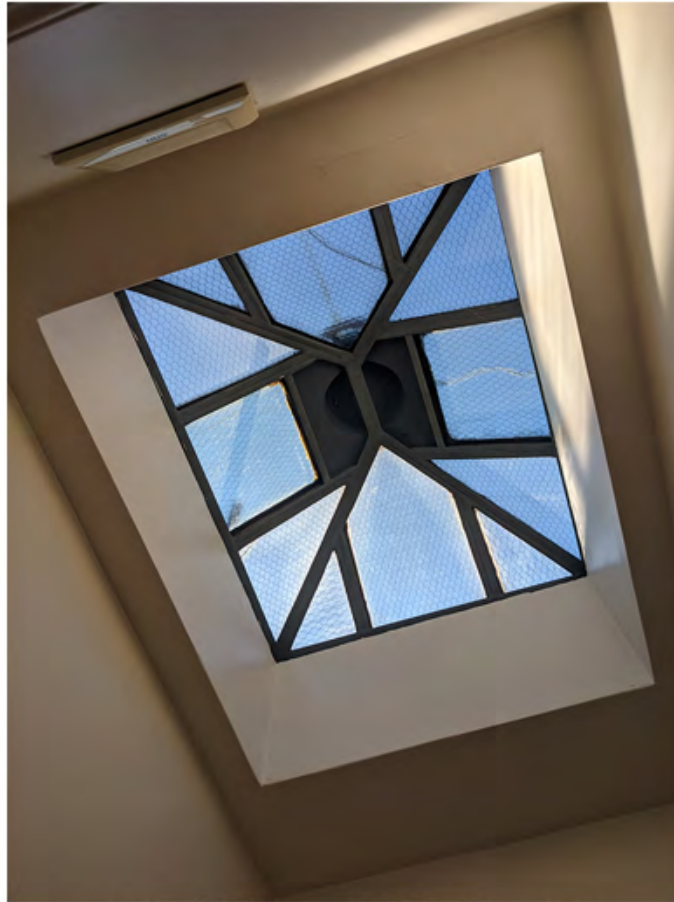
unit 349 - sky light in upper level WC with cracks.jpg

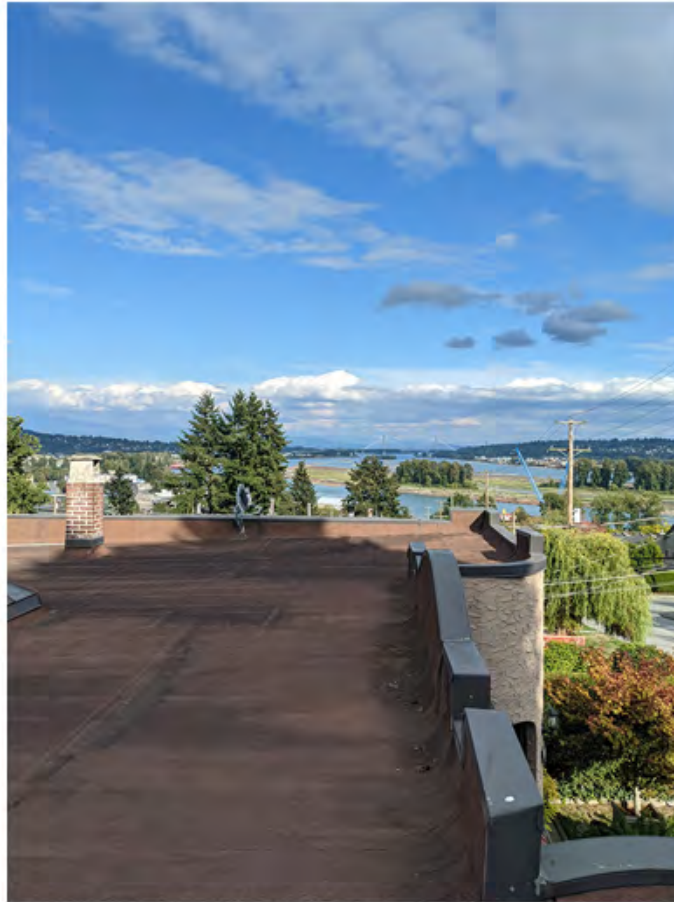
view of degraded rolled asphalt surface looking east.jpg
