Attachment E

349 Cumberland st

349 AND 351 CUMBERLAND ST

ENGINEERING PROPERTY / BUILDING CONDITION ASSESSMENT

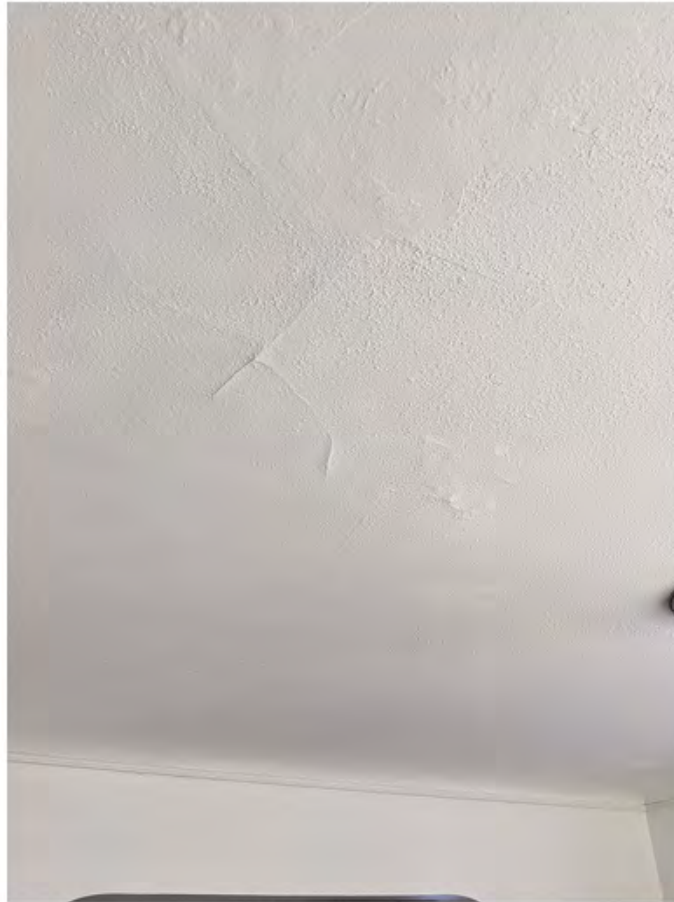
unit 349 - ceiling cracks.jpg

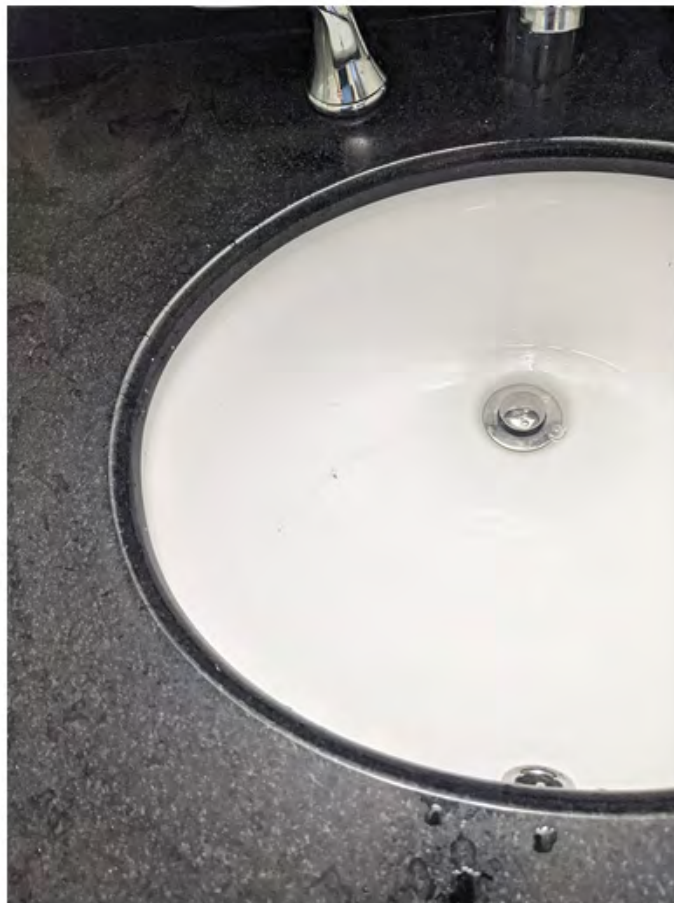
unit 349 - lower level bathroom sink needs replacement.jpg

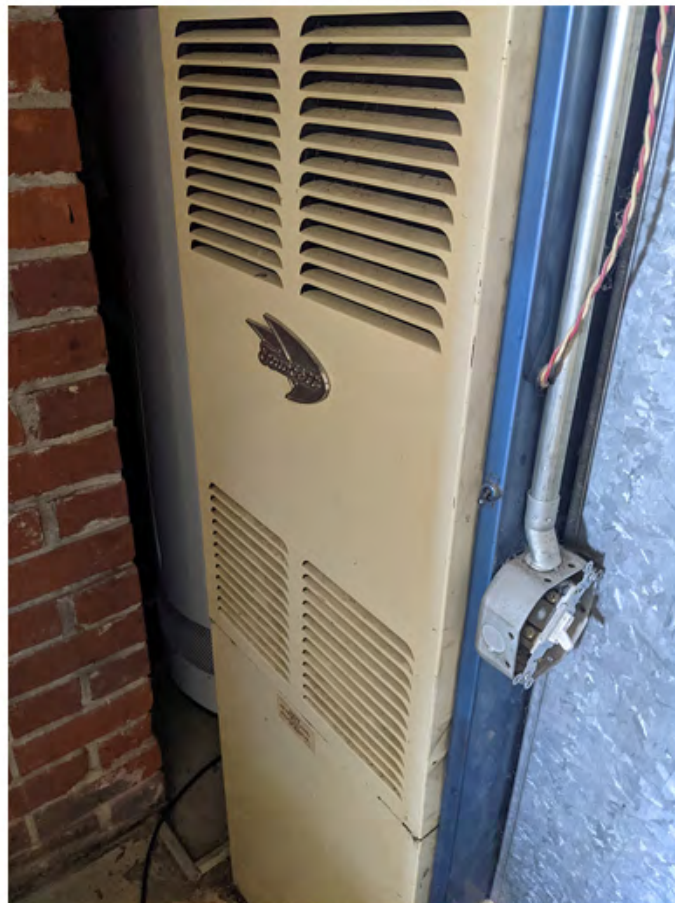
unit 349 - mid efficiency furnace likely at end-of-life with no replacement heat exchanger possible.jpg

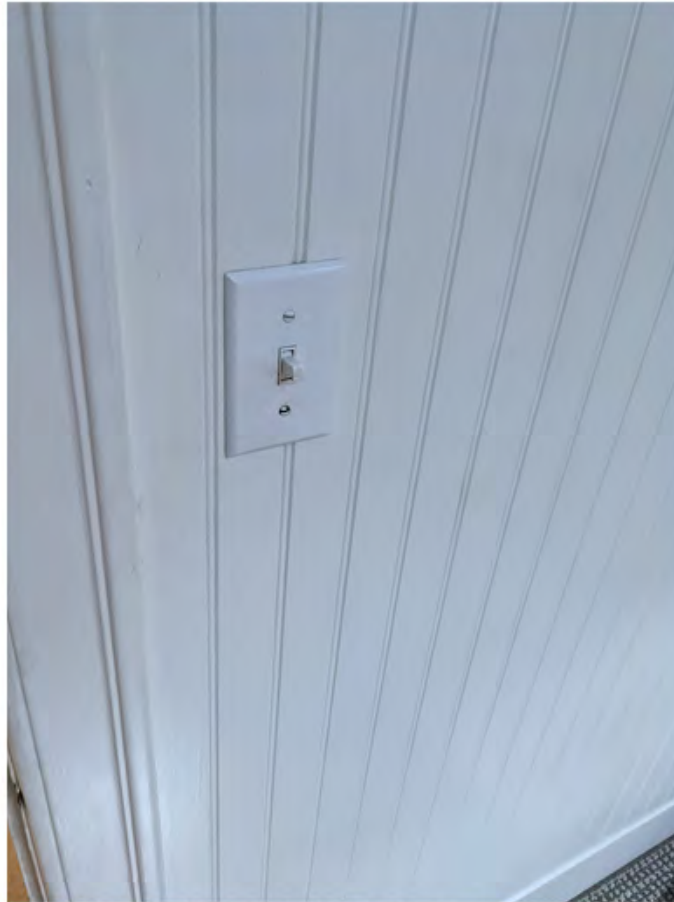
unit 351 - light switch likely requires replacement.jpg
