Appendix E  
*Arborist Report*

## Arborist Report

### 203 Pembina St

**Re: Arboricultural Assessment, Tree Risk Assessment**

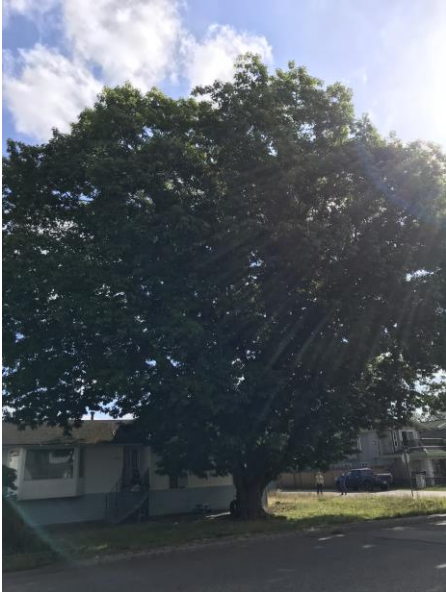
| <p>Photo 1: Tree 202 in its surroundings</p> | <p>Photo 2: Ditch in CRZ</p> |

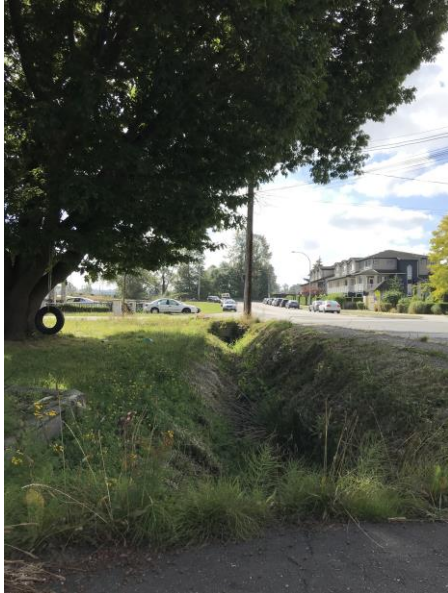
- An open ditch is located within the critical root zone of the oak tree at an approximate distance of 4.5 m from the base of the tree. The homeowner intends to culvert the ditch as part of the construction works. **Arborist supervision is recommended for ditch infill works within the critical root zone.**

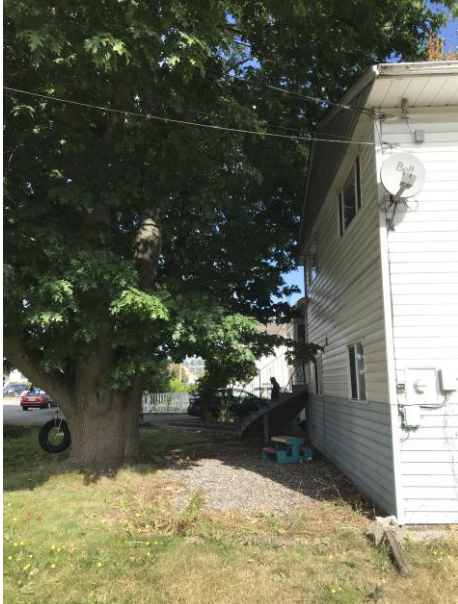
| <p>Photo 3: Proximity of tree to existing structure approximately 4.0 m.</p> | <p>Photo 4: Chain embedded in base of tree, does not appear to be girdling</p> |

- The existing residence is located approximately 4.0 m from the base of the tree. Root activity is expected to have been suppressed by the foundation of the existing house, which should serve as an acceptable limit of excavation for any new residences. **Arborist supervision is recommended for the demolition of the foundation, to provide root pruning and mitigation if roots are encountered. L-shaped footings are recommended for any structures abutting the tree protection area.**

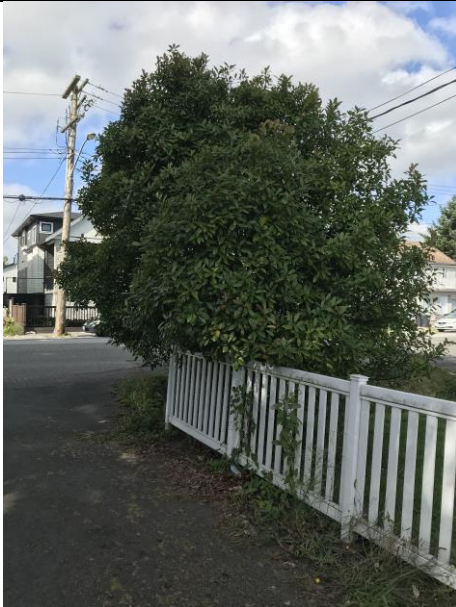
Photo 5: Neighbour's photinia shrub slightly overhanging property line

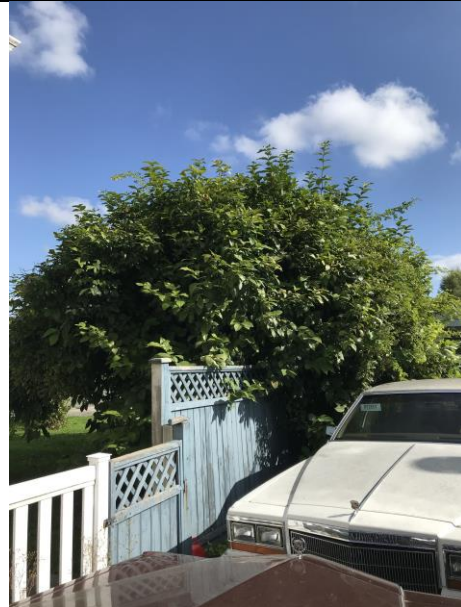
Photo 6: Neighbour's dogwood? Tree slightly overhanging property line

- The neighbour's dogwood tree overhangs the property line, and likely has some minimal rooting activity on the subject site. We expect that root activity has been suppressed by the existing driveway, but a small tree protection zone has been specified for the tree.

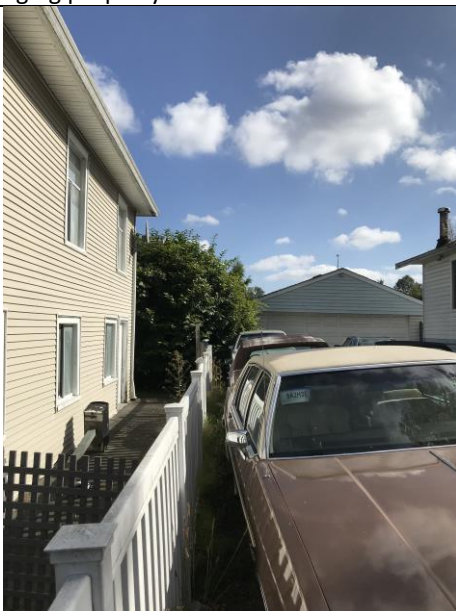
Photo 7: Neighbour's dogwood, can be pruned away from property line
