Heritage Conservation Plan

Holy Eucharist Cathedral - 501 4 Avenue - New Westminster, BC

Elana Zysblat, CAHP - heritage consultant - Ance Building Services

December 2021

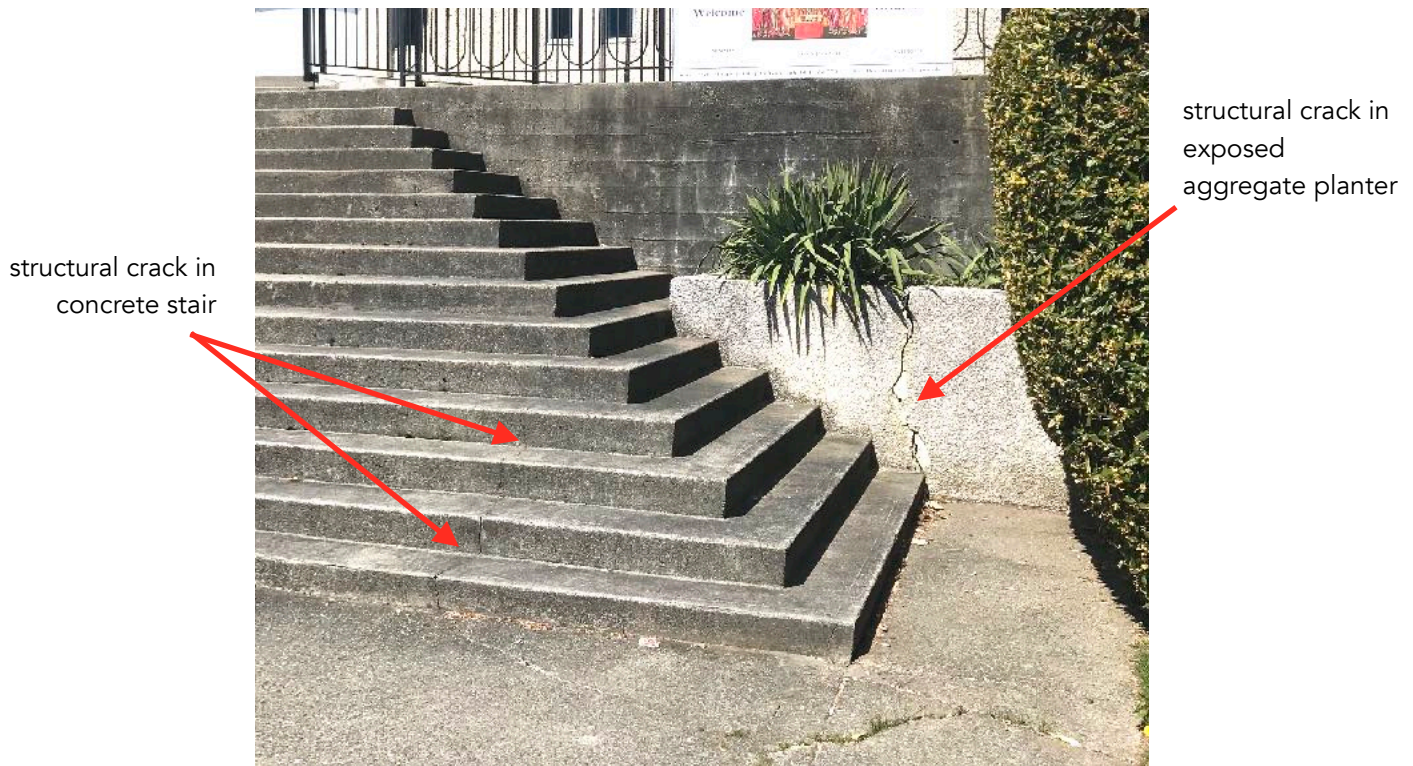
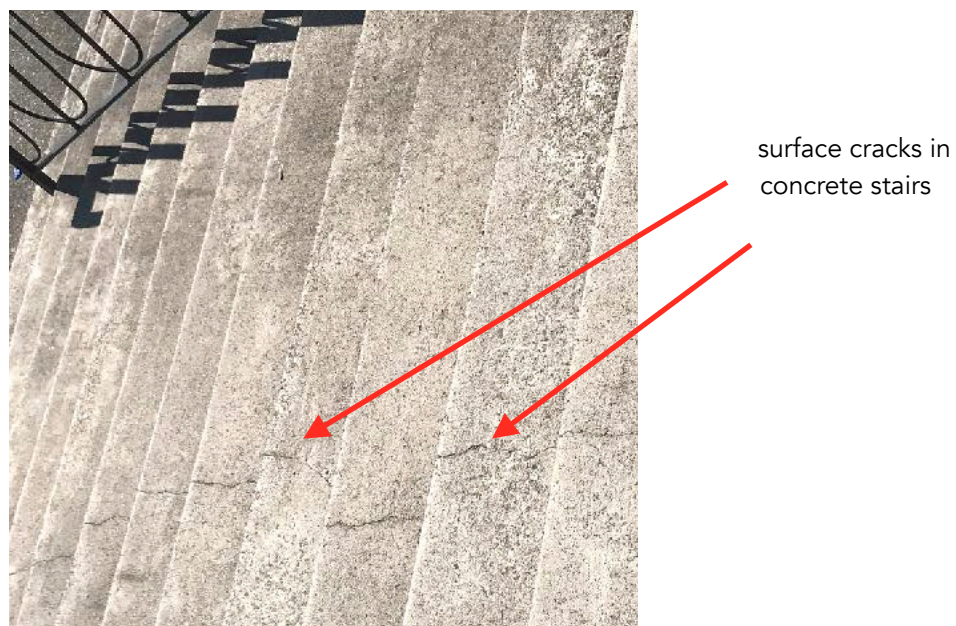
Front stairs and entrance podium

The original poured concrete stairs and hollow podium, with exposed aggregate end walls and planters, are in fair to good condition, but exhibiting wear as well as some cracks - both structural cracks and surface cracks.

Reconstruct the podium and grand stair in their current dimensions and 1960s finishes while adapting the interior of the large hollow podium to a finished, useable space (in this case an Accessible entrance and lobby to the church hall). The only proposed change to the stair and podium design would be the elimination of the final three stairs (circled in the existing photo, right) to the church doors, which would eliminate another Accessibility obstacle, making the walkway connecting the new mixed-use building to the now completely level church podium an Accessible route to both buildings. This rebuilding opportunity also eliminates the need to repair the many structural and surface cracks on the existing concrete structure.

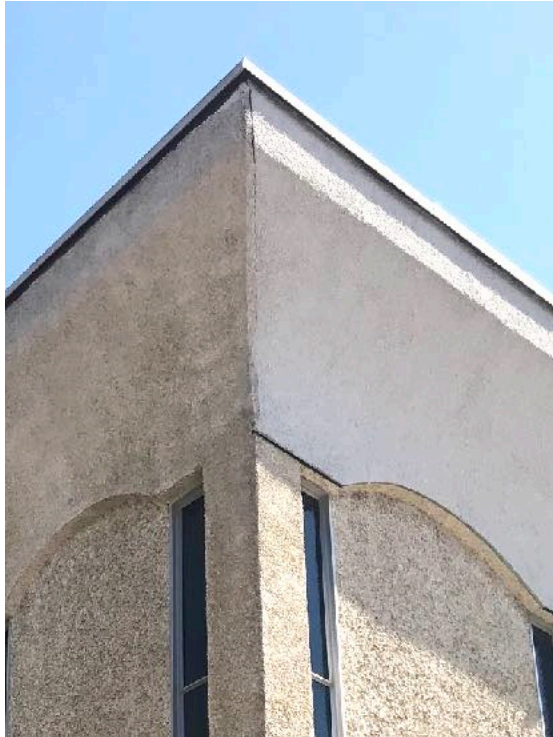
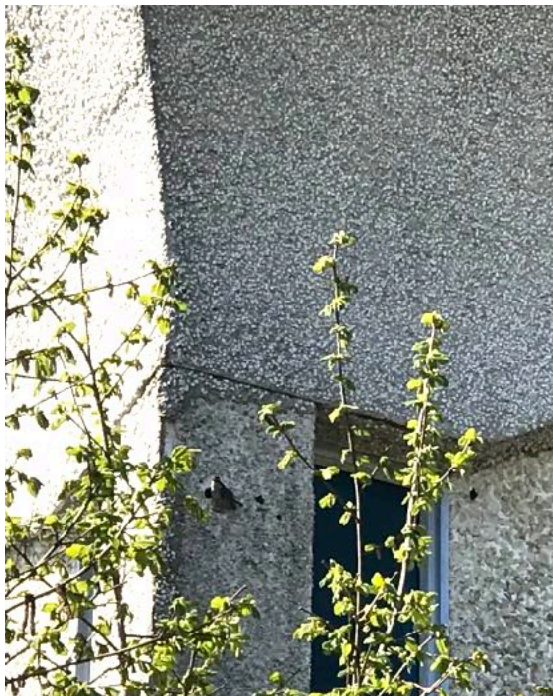
Stucco damage

The stucco is generally in good condition but several areas of minor damage (staining, cracks or failure) have been identified, mostly at the cornice corners.

Above left: Cornice at corner of parking lot and lane showing a crack in the stucco.

Above right: Cornice at corner of lane and yard showing missing/failing stucco just below an new roof drain installed 13 years ago. **Below left:** Cornice at corner of front and yard showing stucco damage caused by woodpeckers **below Right:** Evidence of moisture staining on stucco below windows at parking lot.

Address the sources of damage to the exterior stucco finish (woodpeckers and faulty roof drainage) and spot repair the stucco by matching the specific original texture. Trade hiring and repair supervision to be guided by a heritage professional.

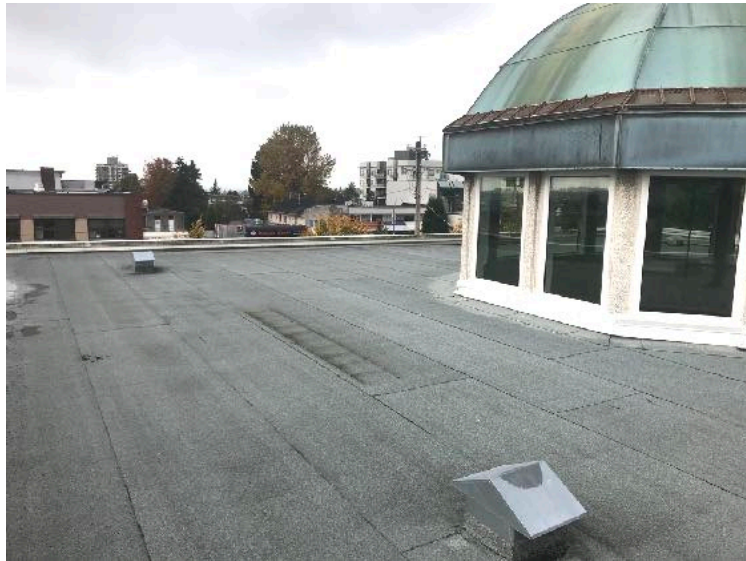
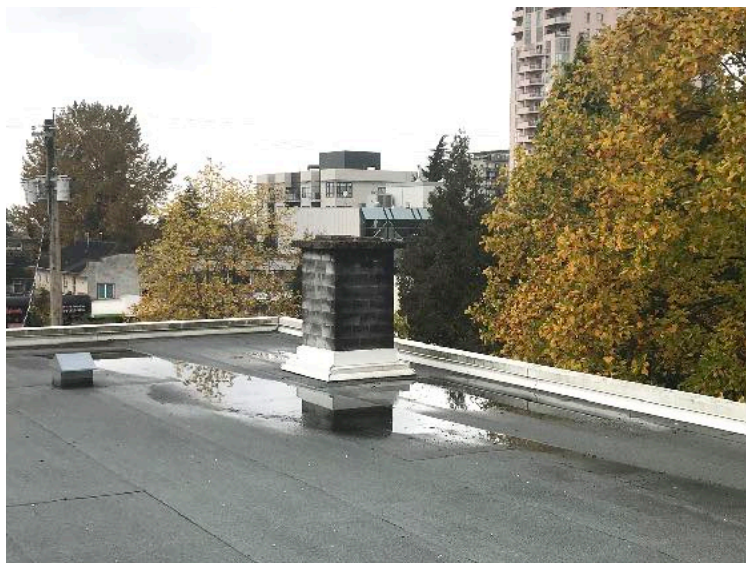
Roof and rainworks

The cathedral has a flat, torch-on roof which appears to be in good condition and reasonably vented. The drainage however, isn't functioning optimally as after a rainfall there are areas where water pools. Especially near the edges, as seen in the photos below. The downspouts on the cupola appear to be inconsistent and in need of some adjustments or replacement. There is evidence of water staining on the stucco at the cupola eaves.

Assess flat roof drainage, venting, edge coping and cupola downspouts and make adjustments to repair and optimize the shedding of water off the cupola and off the roof in a manner that doesn't allow water pooling on the roof nor dripping down the side elevations.

Improve access to roof hatch so that congregation members can regularly and safely access the roof for periodic inspection (twice a year, before and after winter). Keeping a regular eye on the functionality and condition of the flat roof is crucial. See Maintenance Plan.

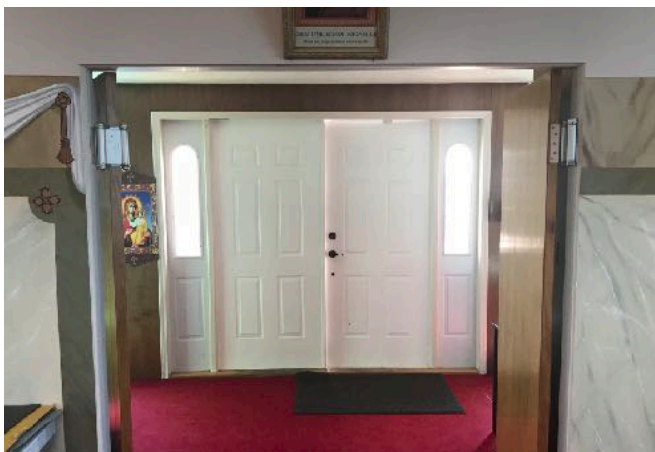
Doors

The current front door assembly (below) is of insulated steel, however it is not properly sealed in its frame. There is noticeable air leak around the entire assembly in winter time. The design, colour and material of this door are not in keeping with the original 1960s door which was solid, carved wood with a lacquered finish and full height blue glass sidelights on either side (see above archival photo). The incompatible appearance of the current door, which was installed in recent decades, diminishes the authentic design of the facade elevation.

Restore a solid carved, unpainted wood door assembly with glazed sidelights to the front entrance, as per the original 1968 design, and based on the earliest colour photographs of the church upon completion. The sidelights can be of textured blue glass or match the blue-toned stained glass sidelights above the door depicting traditional Ukrainian octagonal stars. Final design, intervention plans and construction supervision to be guided by a heritage professional.
