# *Heritage Conservation Plan and Statement of Significance*

# Heritage Conservation Plan

328 Second Street, New Westminster BC :: H.H. & Jane Mackenzie House - 1889

Prepared by Elana Zysblat, CAHP :: Ance Building Services :: February 2021

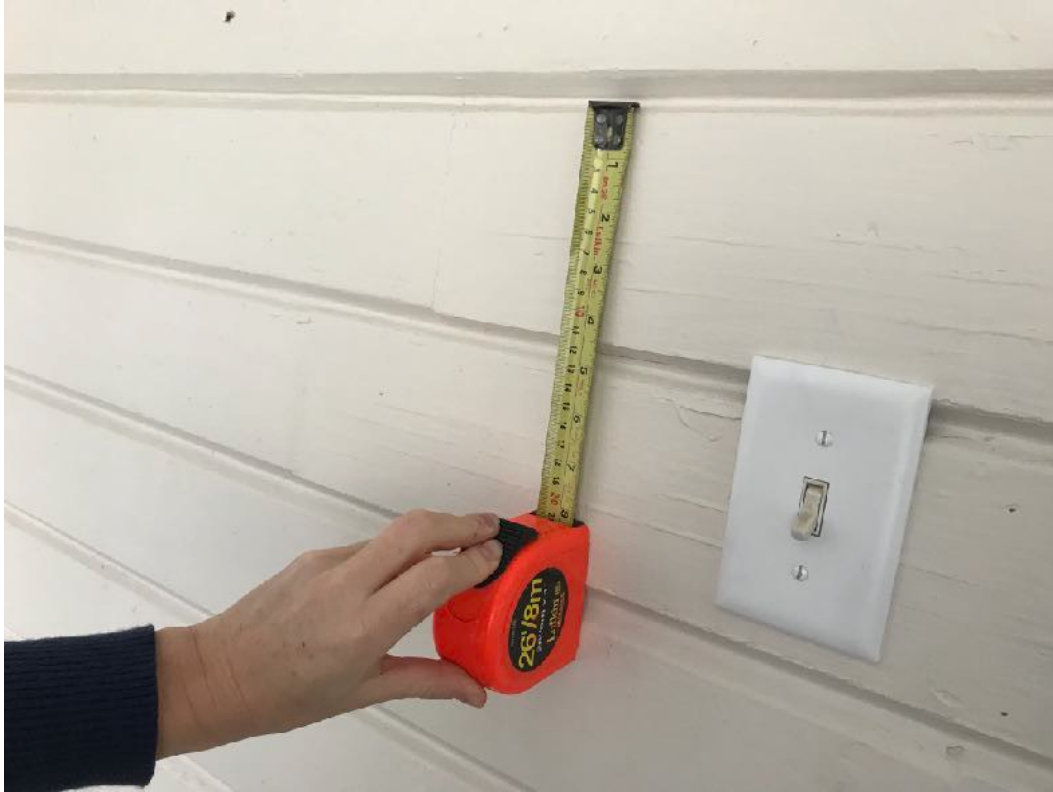
**Above:** the original exterior wood cladding within the enclosed porch, which likely survives underneath the stucco.

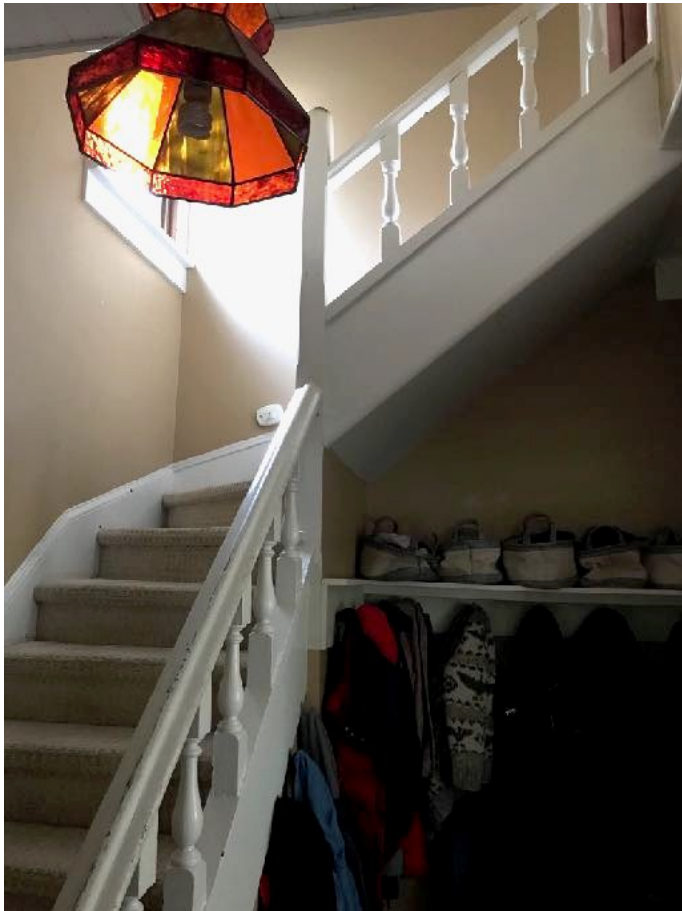
**Left:** the original 1889 banister leading upstairs.

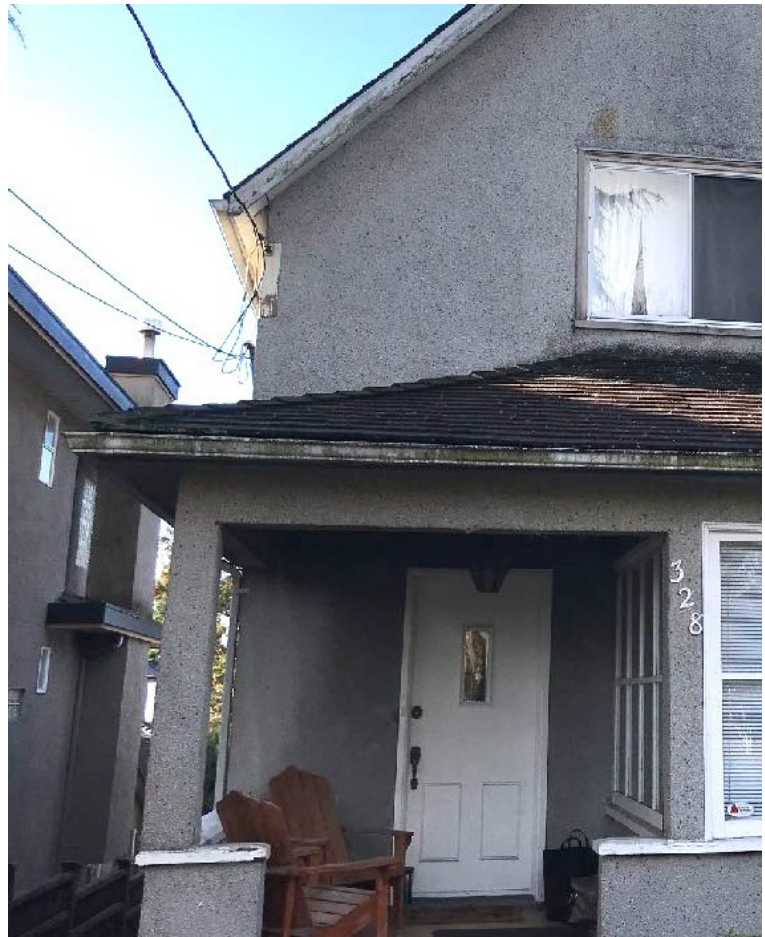
The bottle-dash, unpainted stucco cladding, which was likely introduced in mid-century (the earliest documentation of its presence is in 1967, in a City field inspection report) is showing signs of moisture ingress at various points around the building and is thus considered to be in **fair** condition. The spot deterioration of the stucco will have allowed

moisture into the wood siding and shingles below, in certain areas, so it is assumed the earliest wood cladding will likely exhibit **fair** condition when exposed.

Stucco to be removed entirely from the building. Heritage consultant to meet on site with contractor BEFORE stucco removal begins to inspect together test removal areas to understand and document how the stucco was applied (with or without mesh for example) and how thick it is. Whether the removal process is to be conducted by a demolition crew or by experienced carpenters, on-site guidance of the trades by heritage consultant must happen first to determine the appropriate tools and removal process. Stucco removal is to be conducted with extreme caution so that the wood cladding below is not damaged. Part of the removal process will involve the documentation, assessment and measuring of the original wood cladding below, whether it is siding or shingles. Look for and document evidence of trim board widths and trim board design, likely visible in the form of shadows on the wood cladding under the stucco. Consult again with heritage consultant once all stucco is removed to determine the final conservation treatment (preservation or restoration) for the surviving 1889 wood drop siding, any wood shingles the gable, front porch columns and front porch ceiling and to finalize the design and dimensions for trim boards, water table board, brackets and other exterior wood details identified for restoration.

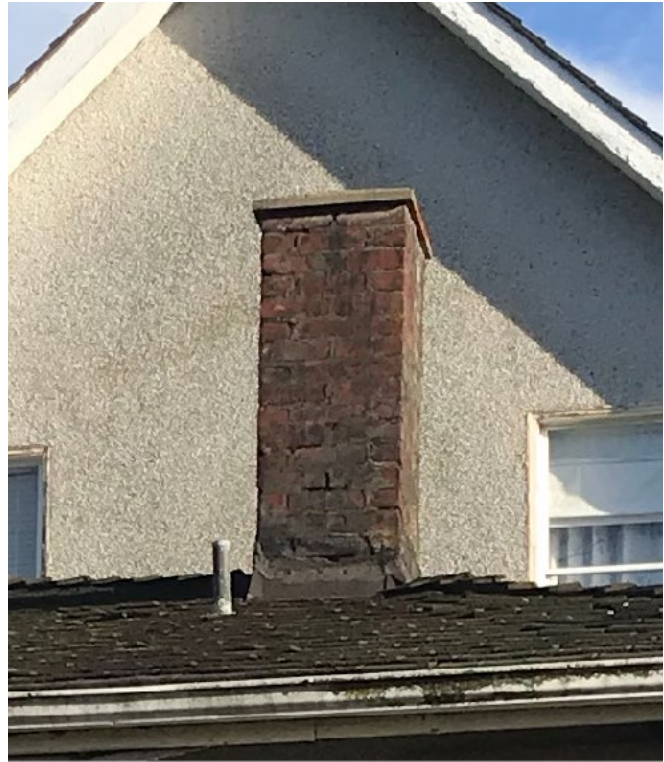
One interior brick chimney which survives in the rear single-storey kitchen area, is in **poor** condition, showing evidence of moisture in the mortar joints, the use of incompatible mortar and structural failure. This chimney has never been visible from the street.

Remove surviving rear chimney for its deteriorated condition and obsolete function.

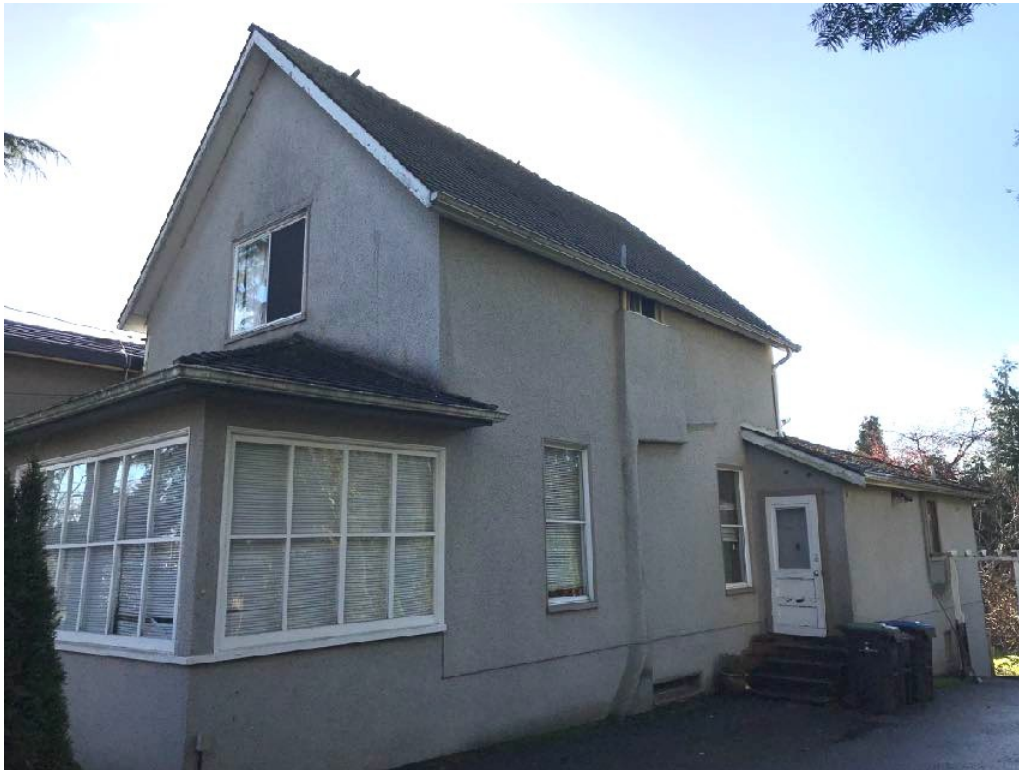
All of the window and door openings appear to be original or early (tall vertical openings in Victorian-era dimensions), except for the front gable window and the front porch windows which are not of 1889 proportions and were likely altered at the time the stucco was applied to the house. Wood window sills survive throughout, but the window sashes themselves have been replaced either with aluminum or vinyl sashes. All the window sashes are in **fair** condition, towards the end of their life expectancy. The glazed wood enclosure of the front porch dates from post 1982 and is in **good** condition. The front, side and back door openings are early or original but all the doors themselves are replacement doors from recent decades.

Restore replica wood sash horned double-hung windows in the below original openings:
