To: Community Heritage Commission Date: April 7, 2021

Subject: 82 First Street & 112 Royal Avenue: Heritage Revitalization Agreement
Application

E. M. N. Woods House ~ 1890

Elana Zysblat, CAHP :: Ance Building Services :: October 2019

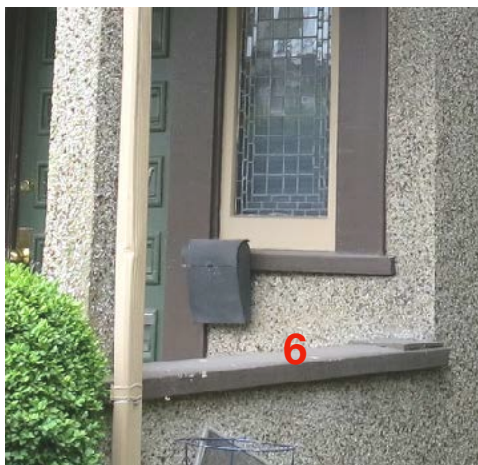
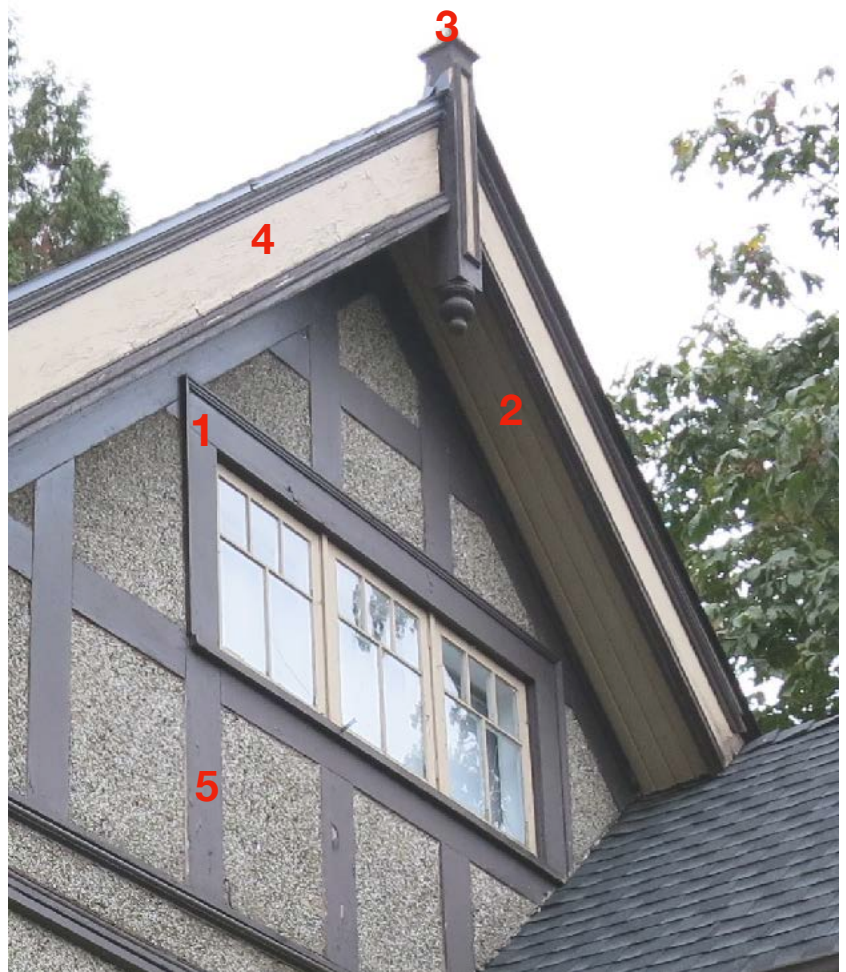
Exterior wood elements - window and door trim boards, tongue & groove soffits and gable finials are all in good condition. Facia boards, half timbering in gables and front porch railing cap are in fair condition as they appear to have lacked paint maintenance. There is no evidence of wood rot, damage or missing parts in any of the above mentioned elements.

6 railing cap

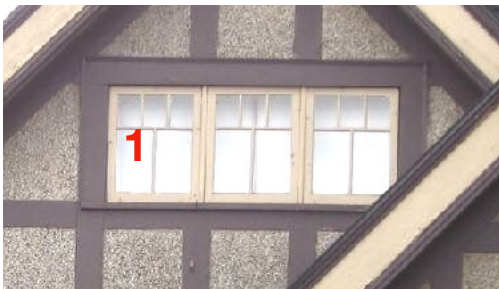
facade (east elevation)

1 gable triple-assembly window

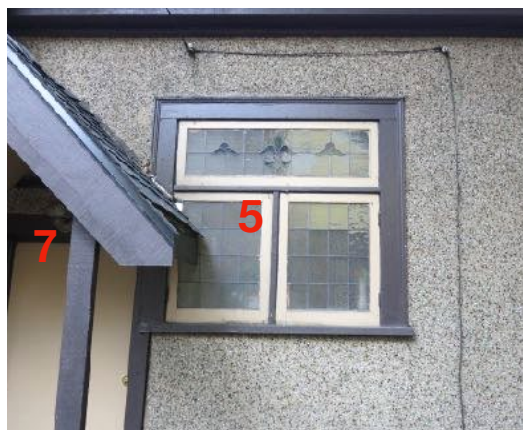
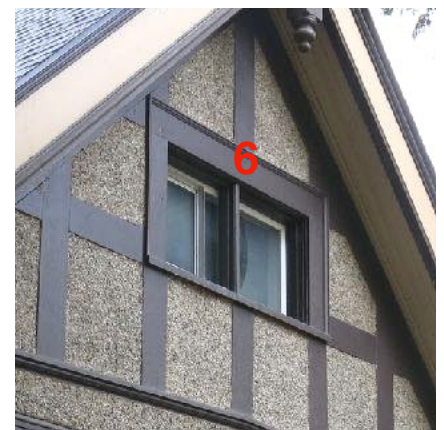
6 gable window opening, missing original sash

7 original side door opening, missing original door

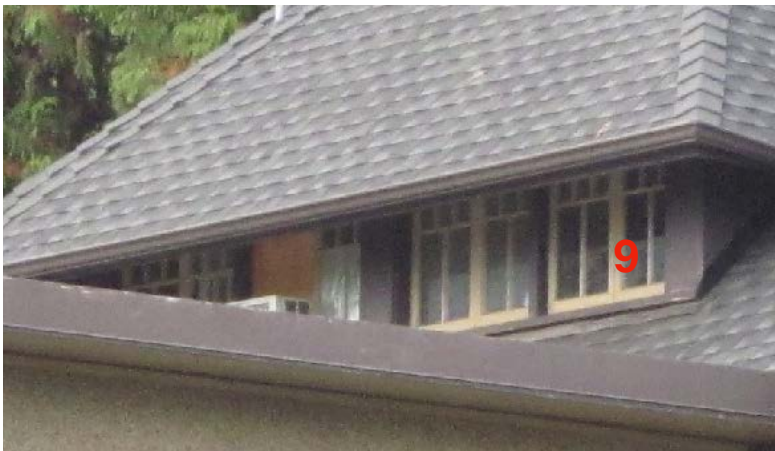
side (south elevation)

9 dormer double assembly windows. One sash is missing where an air conditioning unit was installed.

All original window sashes and doors require further assessment but in general are in good, repairable condition.

Systematically and thoroughly repair all the original wood windows as identified on pages 14-15 with the aid of a specialized wood window carpenter. Wood windows need to be individually assessed for putty and glass repair, and for hardware integrity and operability. All windows need thorough paint preparation and repainting.

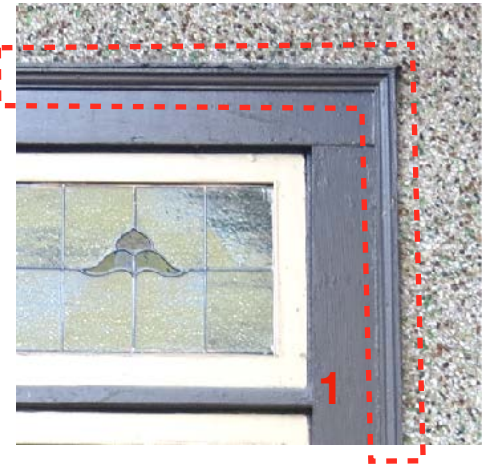
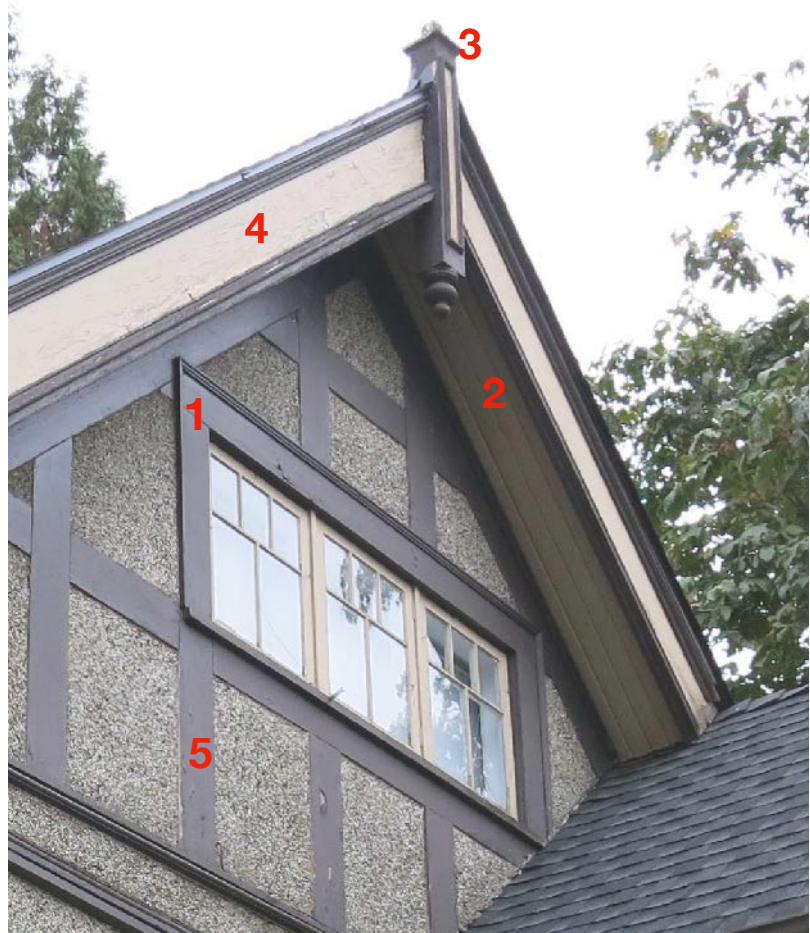
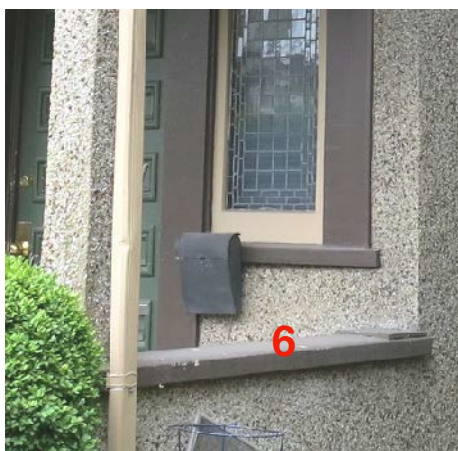
2 soffits, **3 gable finials**, **4 fascia boards**, **5 half timbering**
6 railing caps.

Repair any of the above wood elements with a thorough paint preparation (sanding down to sound paint layer, caulking and priming).

Only replace (in-kind) any individual element or portion of element that is identified as damaged beyond repair - with like species, dimensions and profiles of wood. At this time no visible wood elements are observed to be damaged beyond repair.

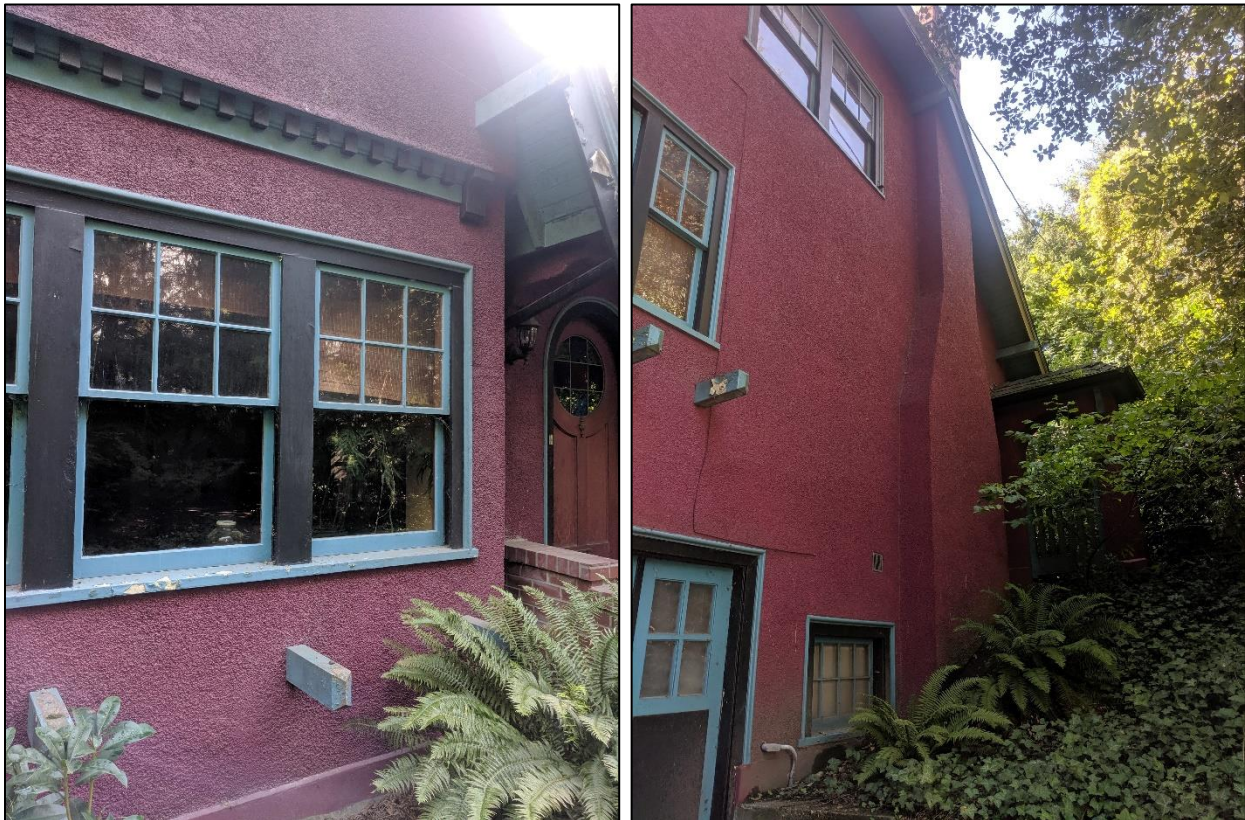
Overall, the condition of the walls and building envelope of Henderson House, from roof to foundation, appears to be good and having aged well. In particular, there are no major cracks visible in either the stuccoed walls or foundation (Figs. 13 and 14). Please note an interior inspection was not conducted. A structural engineer should conduct a thorough investigation of the structure and foundations prior to the house being moved to ensure its structural stability.

Figs. 13 and 14: Left (Fig. 13) shows a partial view of the front of Henderson House at 112 Royal Avenue, highlighting the overall good condition of the walls and foundation. Right (Fig. 14) shows a partial view of the eastern side, beside Windsor Street, again highlighting the good condition. (Sources: Cummer)

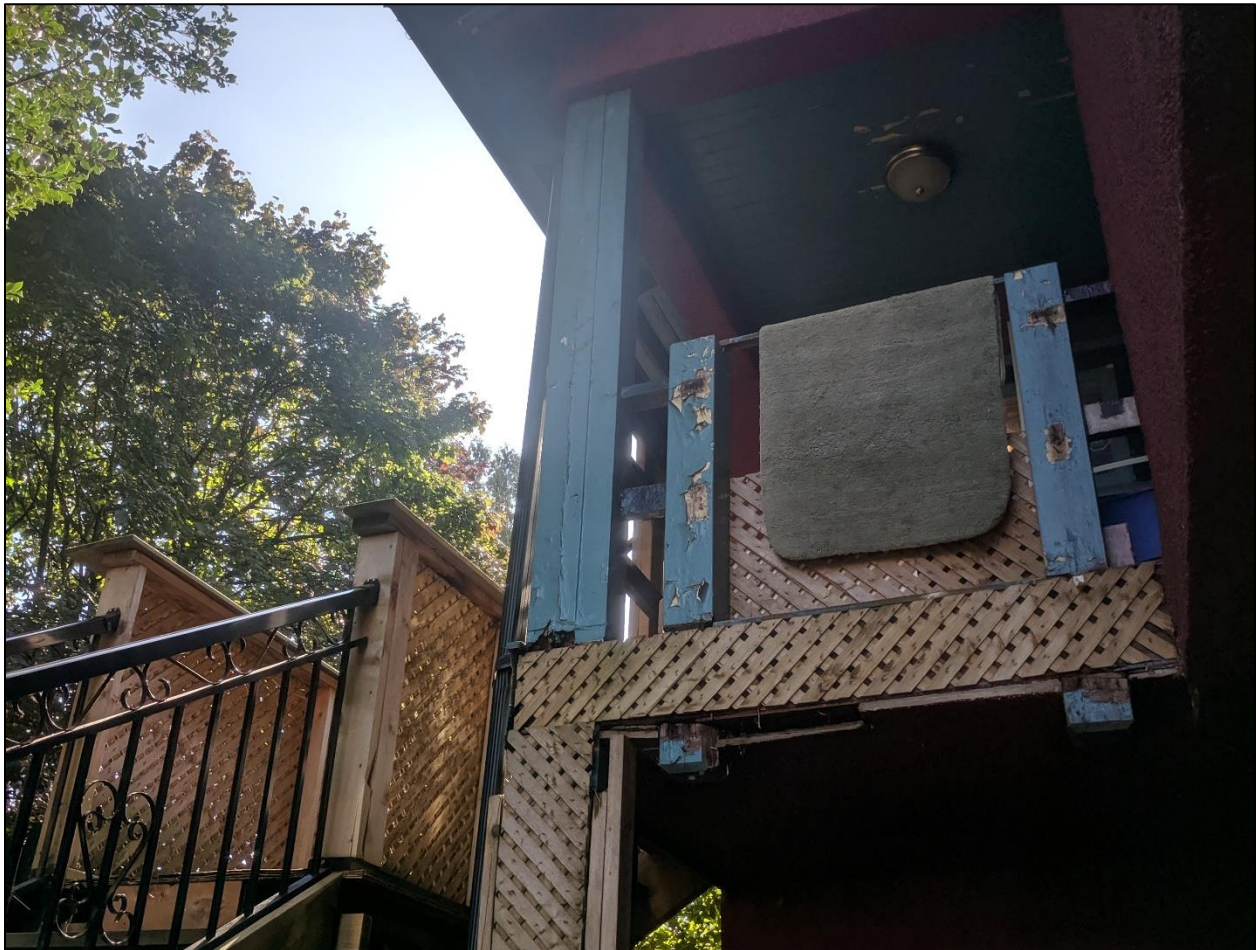
Fig. 15: Southeastern view of the back of Henderson House at 112 Royal Avenue, 2019, illustrating some of the deterioration of the house's back porch. (Source: Cummer)

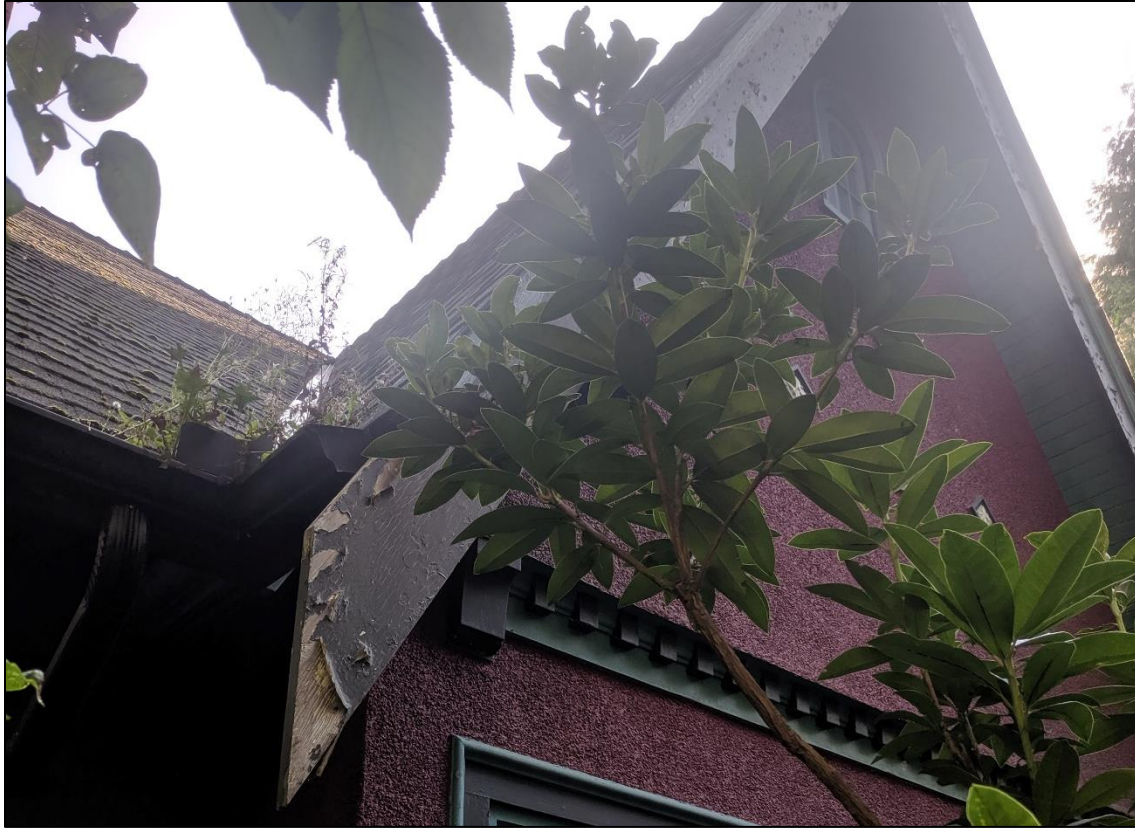
Although the roof is in fair condition, overall, there are areas in need of repair and maintenance. As mentioned above, there are fascia boards in need of repainting (Fig. 16) and sections of the roof and gutters in need of cleaning and clearing (Fig. 17).

Fig. 16: Northeastern view of Henderson House at 112 Royal Avenue, 2019, illustrating the roof fascia deterioration in the front offset gable, as well as some plant growth in the house's gutters. (Source: Cummer)

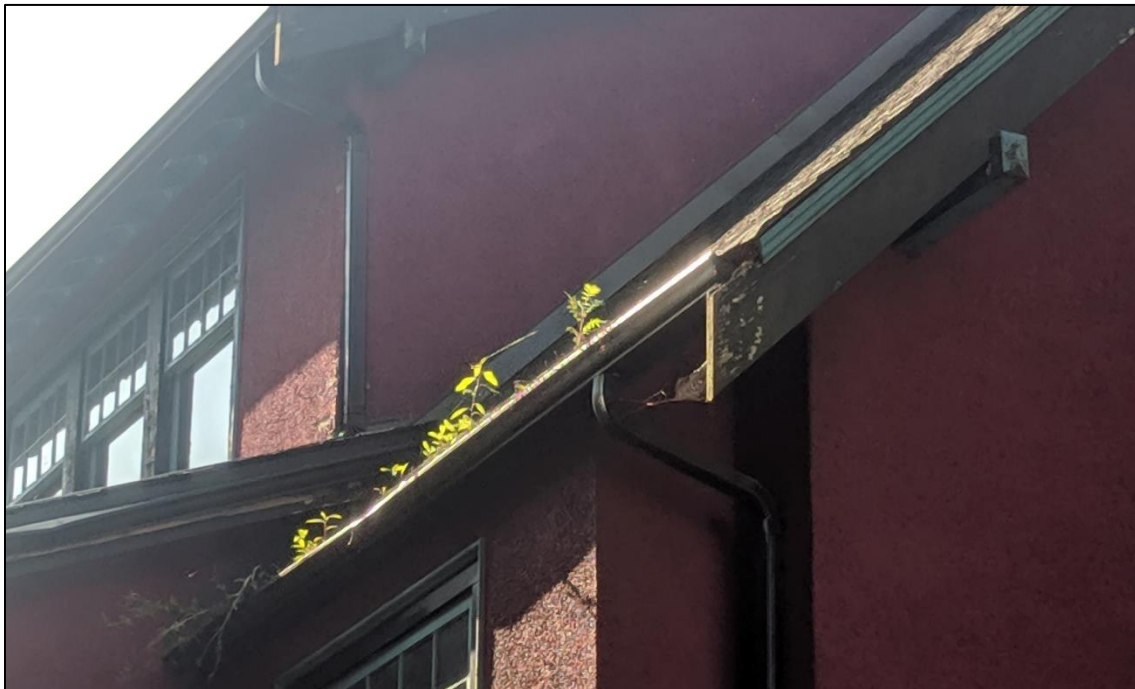
Fig. 17: Southeastern view of Henderson House at 112 Royal Avenue, 2019, illustrating another fascia board deterioration as well as additional plant growth in the house's gutters. (Source: Cummer)

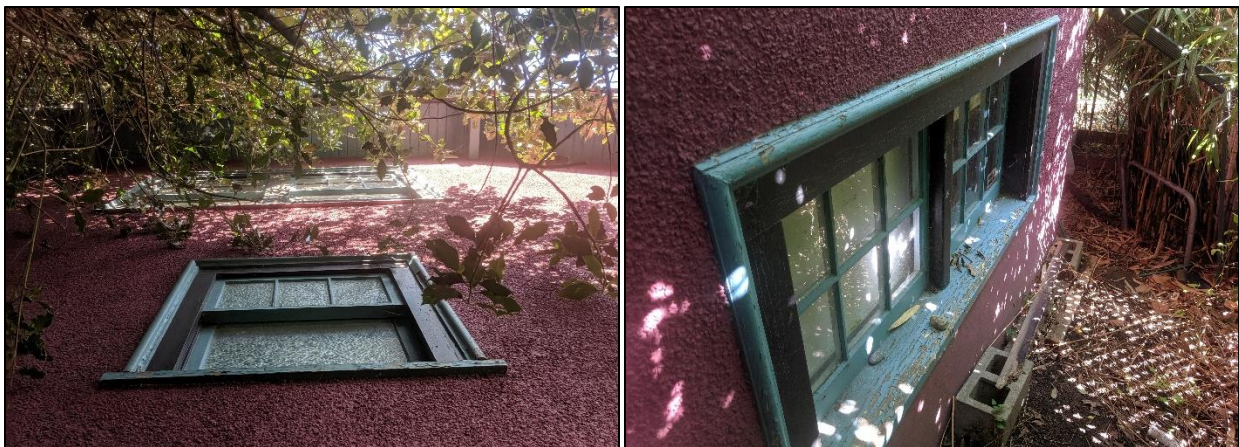
Considering the age of the building, the windows and doors are in quite good condition (Figs. 20 to 26). The only condition concerns appear to be cosmetic with paint peeling in places. Most (if not all) of the windows (their frames, sashes and hardware) appear to be the original ones from 1930, particularly the double-hung divided-light wood windows. The arched wooden front door, with round multi-coloured stained-glass window, also appears to be original and in good condition (Fig. 27), as do the other doors on the property, including the four-panel set of doors along the eastern façade (Fig. 28).

Figs. 22 and 23: Left (Fig. 22) shows a frosted double-hung, divided-light wood window along the western side of the building. Right (Fig. 23) shows a lower window along the same side with visible paint peeling. (Sources: Cummer)

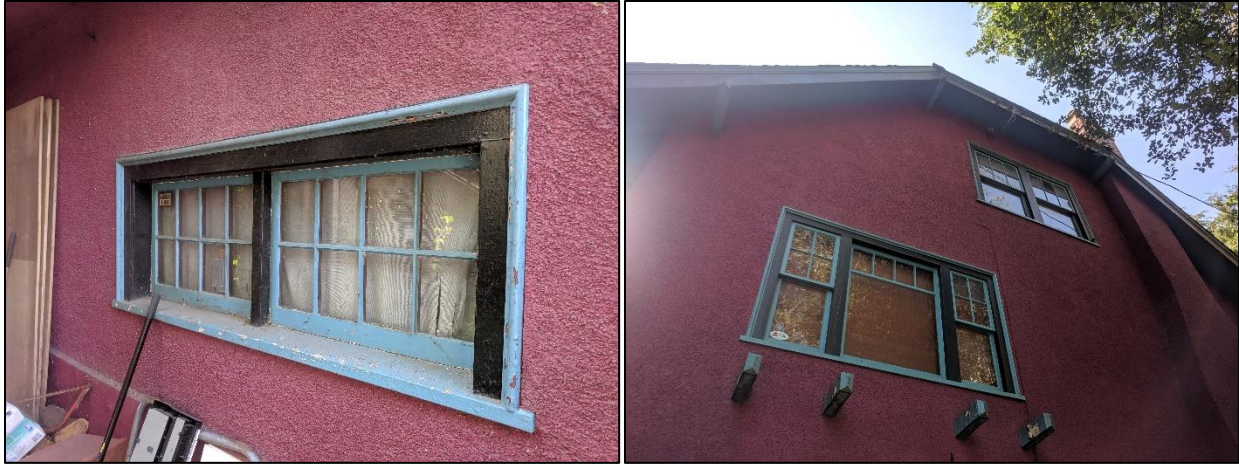
Figs. 25 and 26: Left (Fig. 25) shows a divided-light wood window at the back of Henderson House at 112 Royal Avenue, 2019, illustrating some deterioration. Right (Fig. 26) shows the eastern side of the property and its double-hung, divided-light wood windows. Again, note the supports for the missing window boxes. (Sources: Cummer)

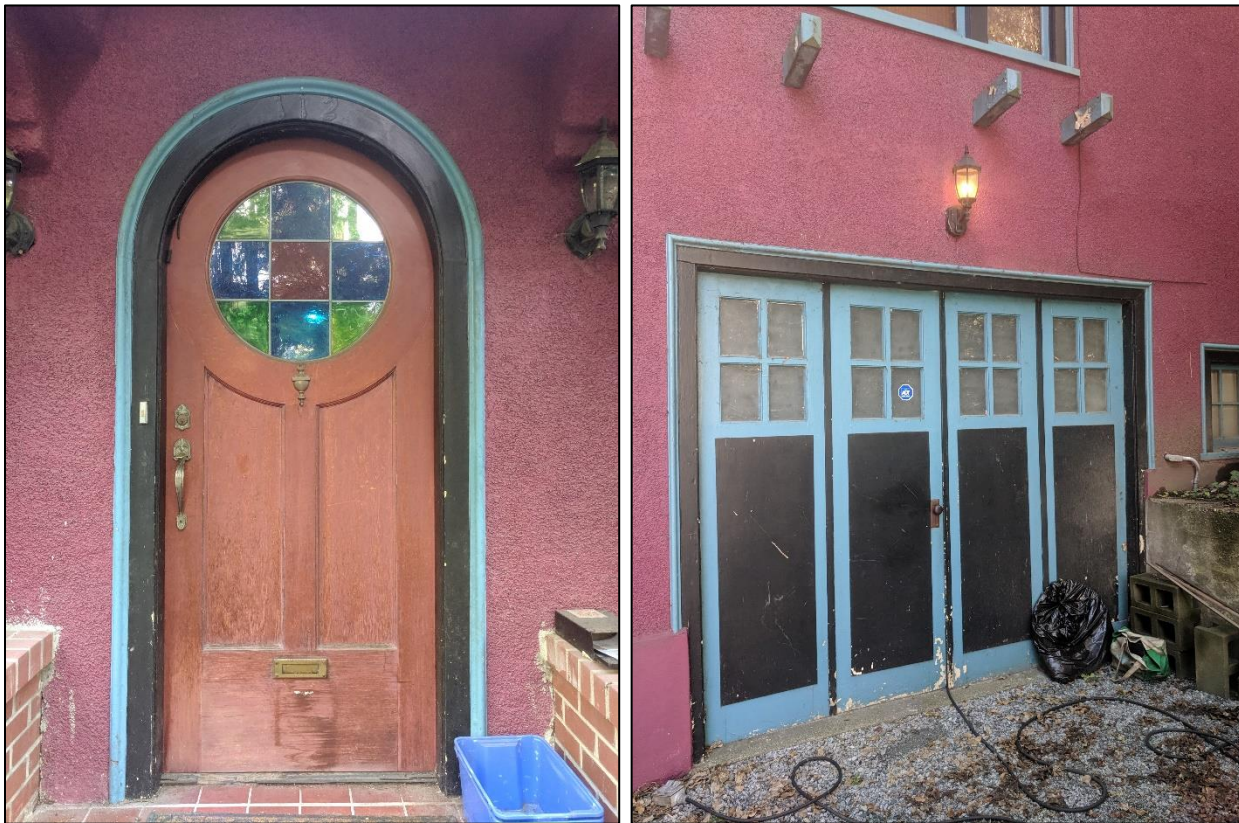
Figs. 27 and 28: Left (Fig. 27) shows the front door of Henderson House at 112 Royal Avenue, 2019, illustrating its largely good condition, minus some weathering at the bottom of the door, along with its intact, multi-coloured stained-glass window. Right (Fig. 28) shows the four-panel set of doors along the eastern façade of the house. It is also in good condition, minus some paint peeling near the bottom of some of the panels. (Sources: Cummer)
