Letter of Understanding for Esplanade
Boulevard Trees fronting 12 K de K Court

Letter of Understanding for Esplanade Boulevard Trees fronting 12 K de K Court
between
City of New Westminster and Dockside Strata (NW2459)

BC Plant Healthcare Inc. Arborist Report
As prepared for Strata Plan NWS2459
August 28, 2023
(Doc. # [2350295](#))

ARBORIST REPORT

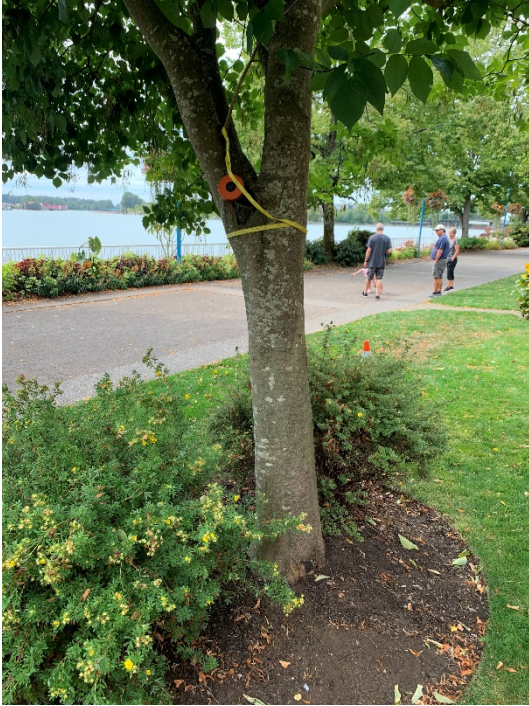
Photo 3. Tree 2 - 28 cm DBH measured 1.4 m above grade.

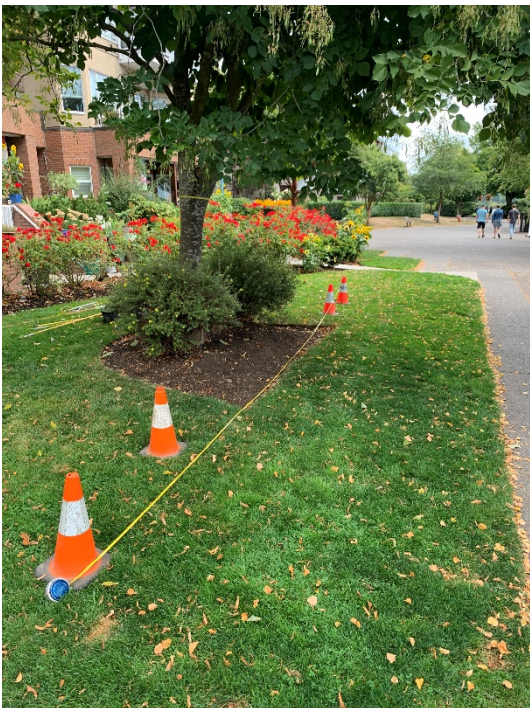
Photo 7. Tree 2 - 6.8 m canopy spread east to west.

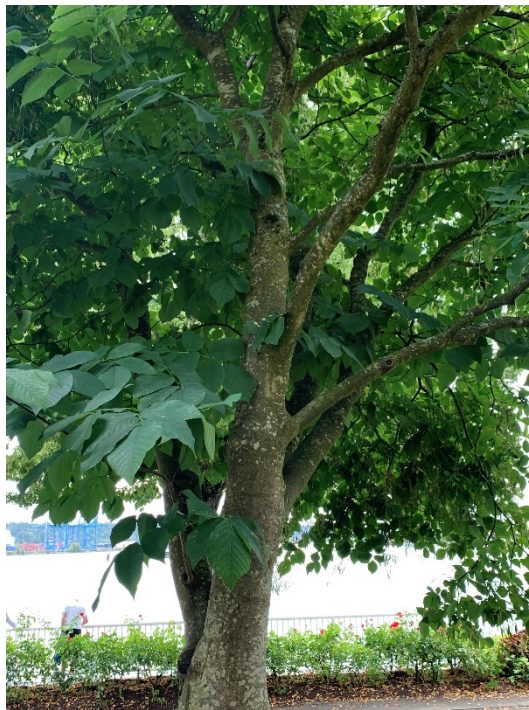
Photo 12. Tree 2 - slender central branch architecture, previous pruning cuts at lowest junction.

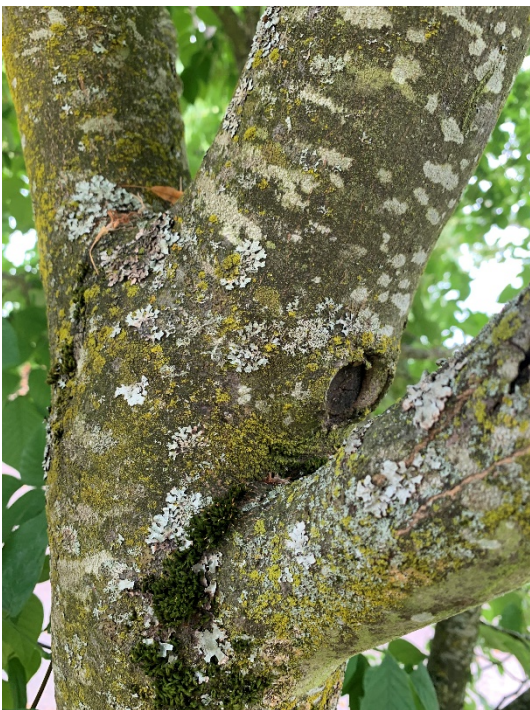
Photo 13. Tree 2 - previous pruning cut.

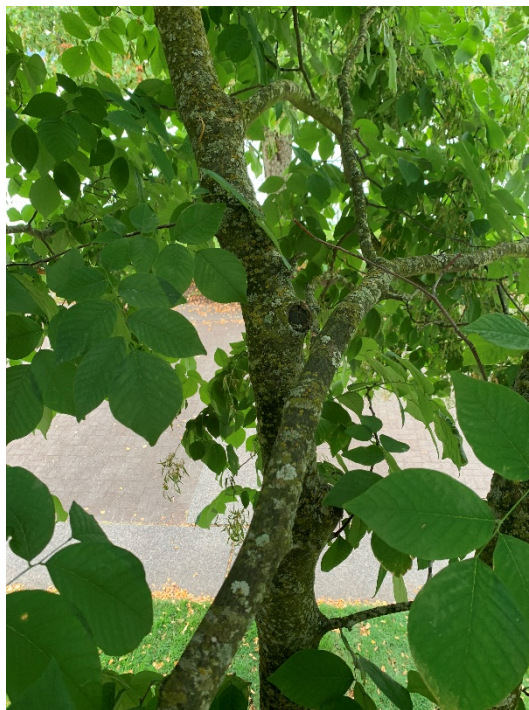
Photo 14. Tree 2 - previous pruning cut.

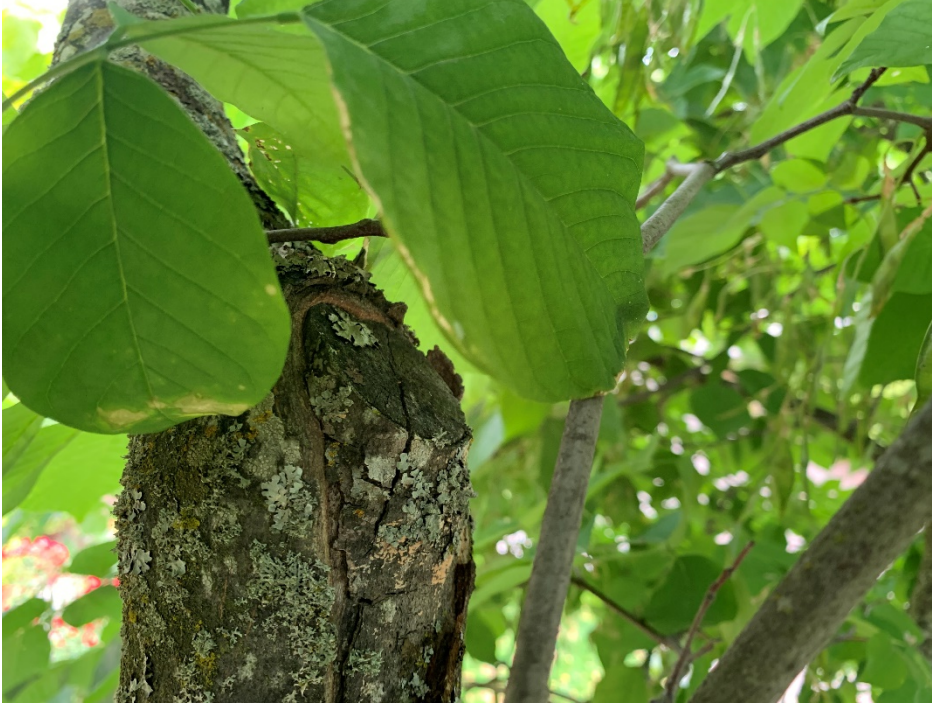
Photo 15. Tree 2 – previous subordination pruning cut.

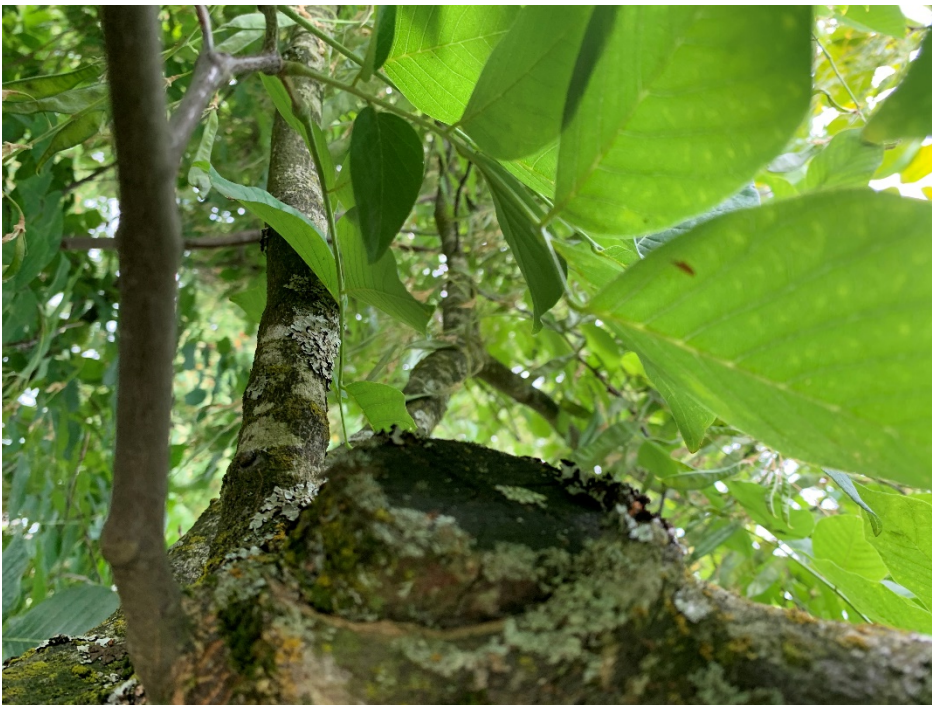
Photo 16. Tree 2 – previous subordination pruning cut.

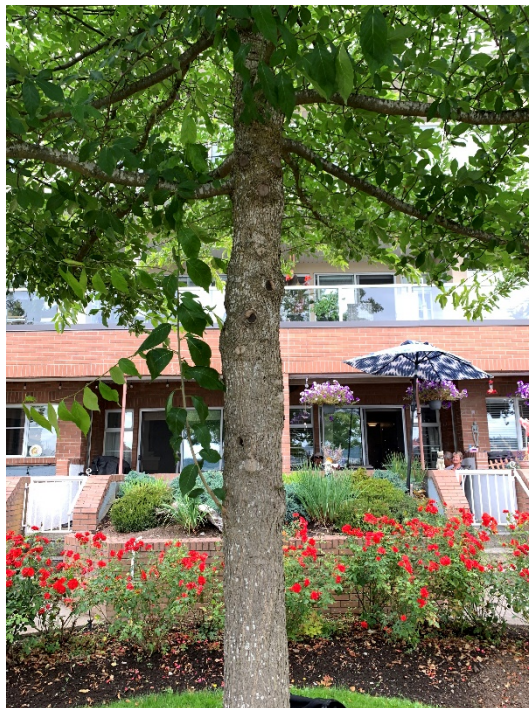
Photo 29. Tree 3 - previous pruning cuts.

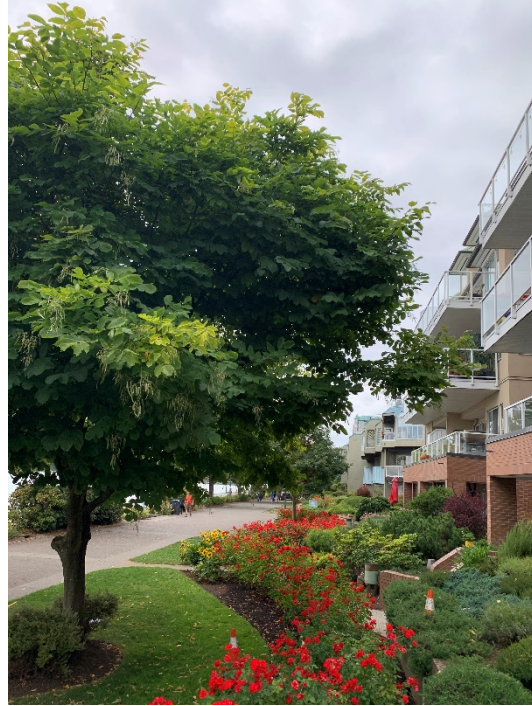
Photo 43. Tree 4 - canopy encroachment towards building.

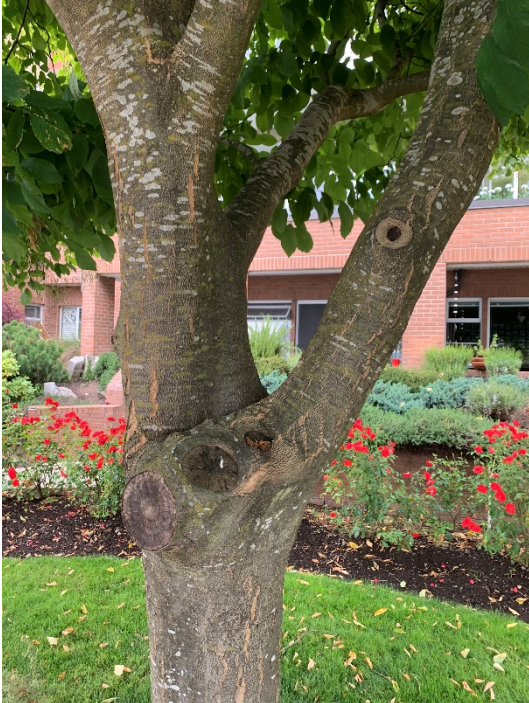
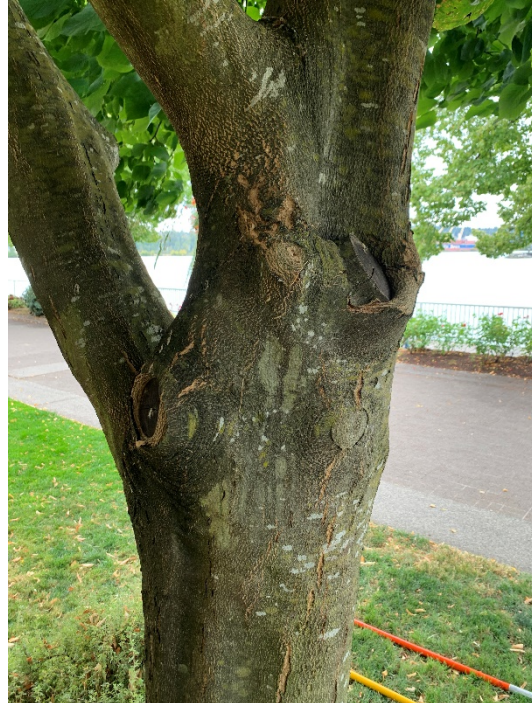
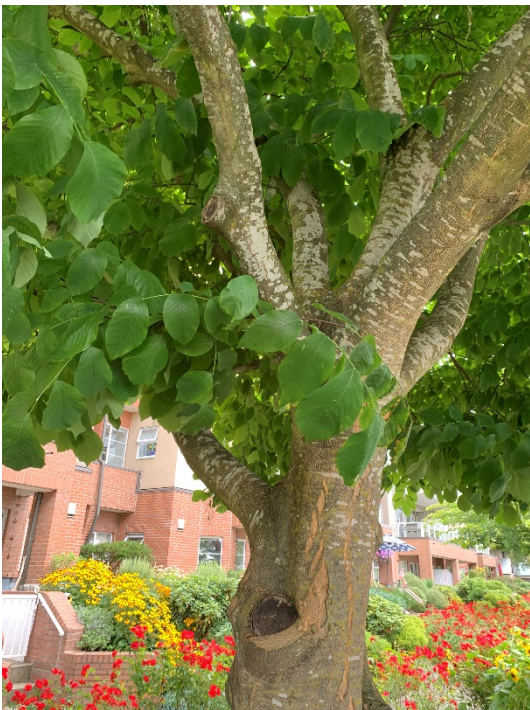
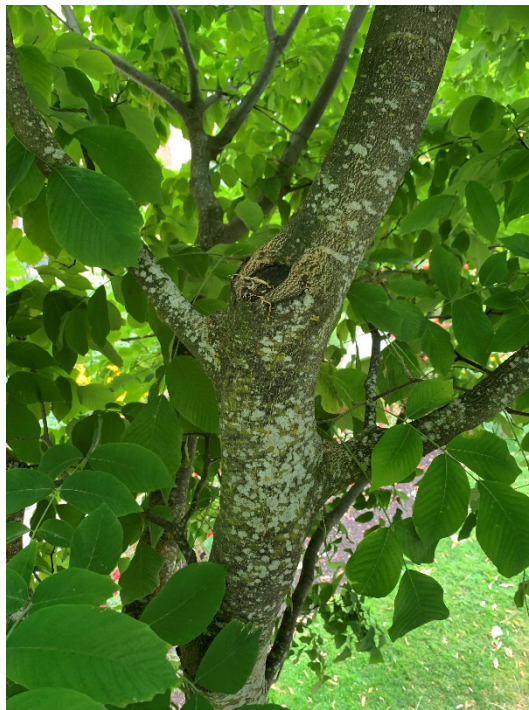
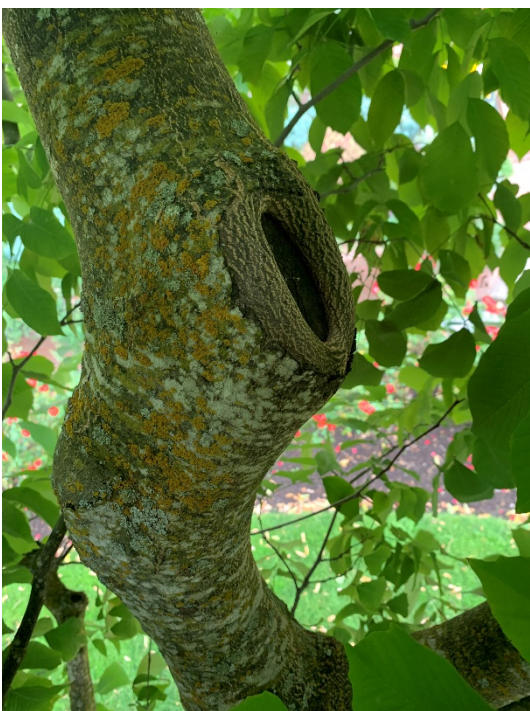
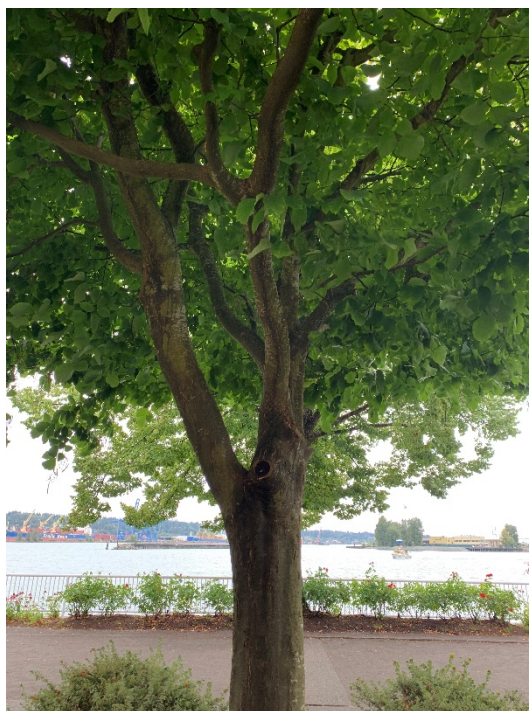
Photo 44. Tree 4 - previous pruning cuts.

Photo 45. Tree 4 - previous pruning cuts.

Photo 46. Tree 4 - previous pruning cuts.

Photo 47. Tree 4 - previous pruning cuts.

Photo 48. Tree 4 - previous pruning cuts.

Photo 49. Tree 4 - previous pruning cuts.

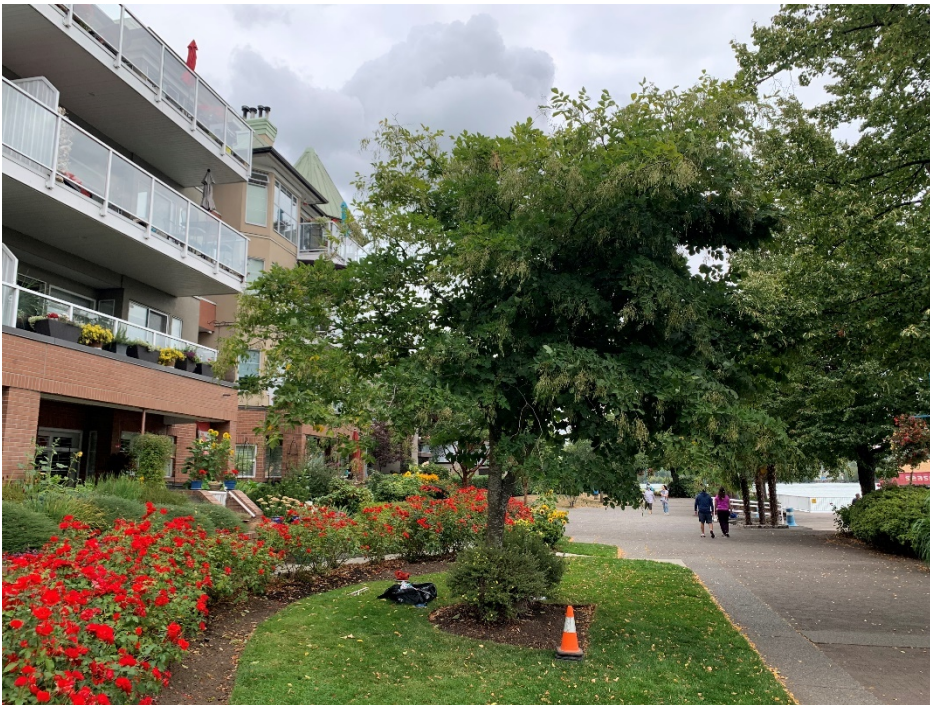
Each of the three trees is positioned approximately 7.7 m south of the building foundation wall, the position of which was shown to me by the client. Given the proximity of each tree to the foundation wall of the building, it is very unlikely that roots have grown to the extent that they would be approaching the foundation wall. Furthermore, there is a garden bed retaining wall that is constructed between the trees and the foundation wall, approximately 4.8 m from the base of each tree. Given the restrictions to root growth, it is very unlikely that future root growth would pose a conflict with building foundation infrastructure.

Photo 67. Tree 2 - proximity to garden bed retaining wall and foundation wall.

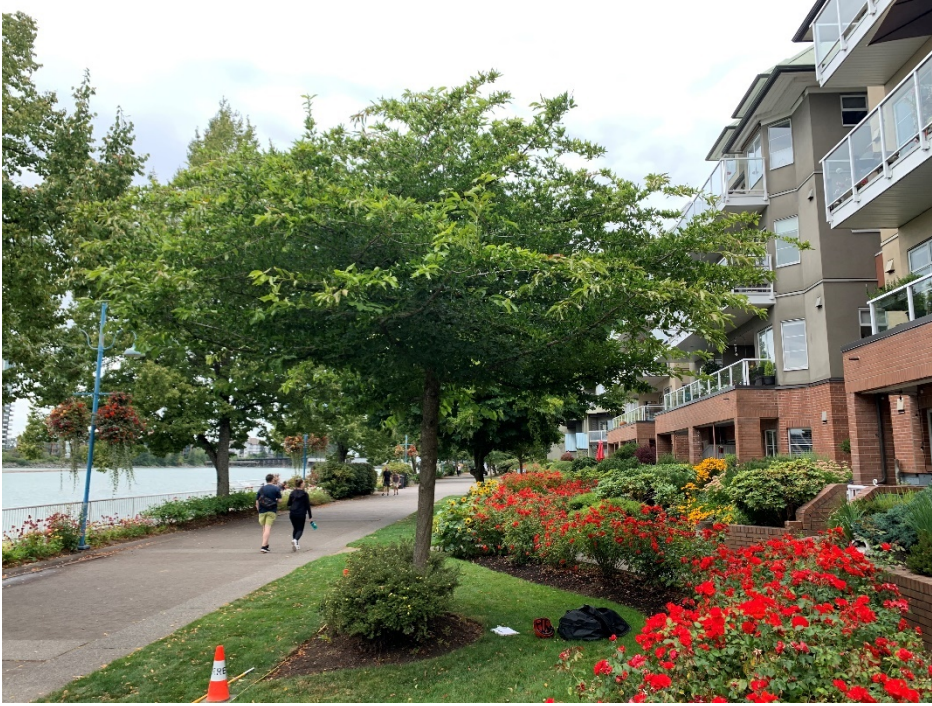
Photo 68. Tree 3 - proximity to garden bed retaining wall and foundation wall.

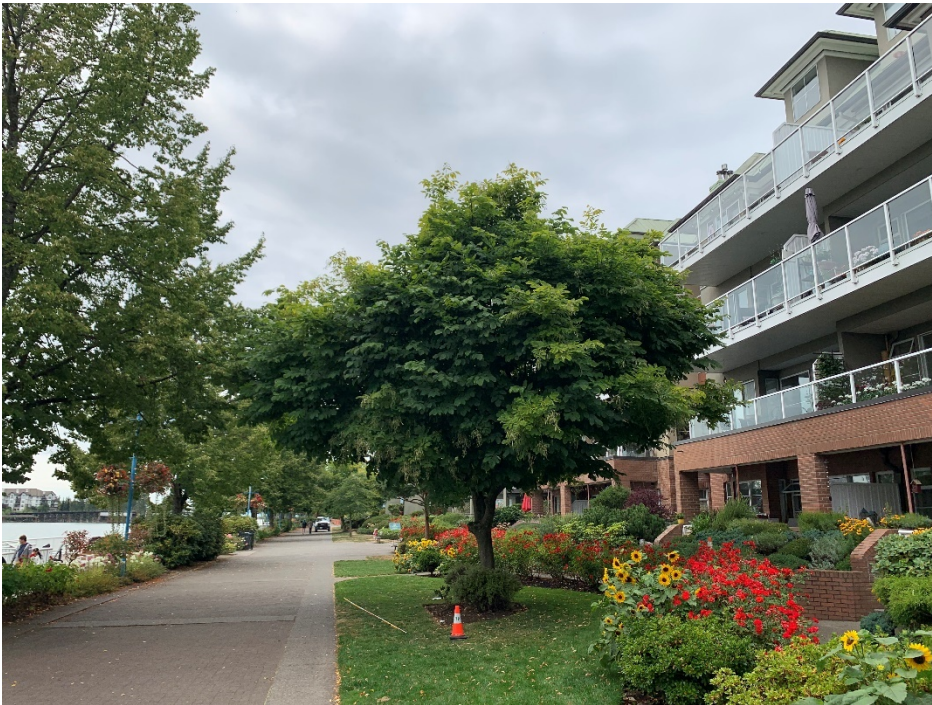
Photo 69. Tree 4 - proximity to garden bed retaining wall and foundation wall.
