**COMMUNITY HERITAGE COMMISSION
AGENDA**

Wednesday, July 6, 2022, 6:00 p.m.

This report is a heritage assessment and evaluation of two buildings located at 1509 and 1513 6th Avenue, located in the south-west area of New Westminster (Figure 1). Collectively, they are referenced in this report as the Rowson and Ritchie Residences.

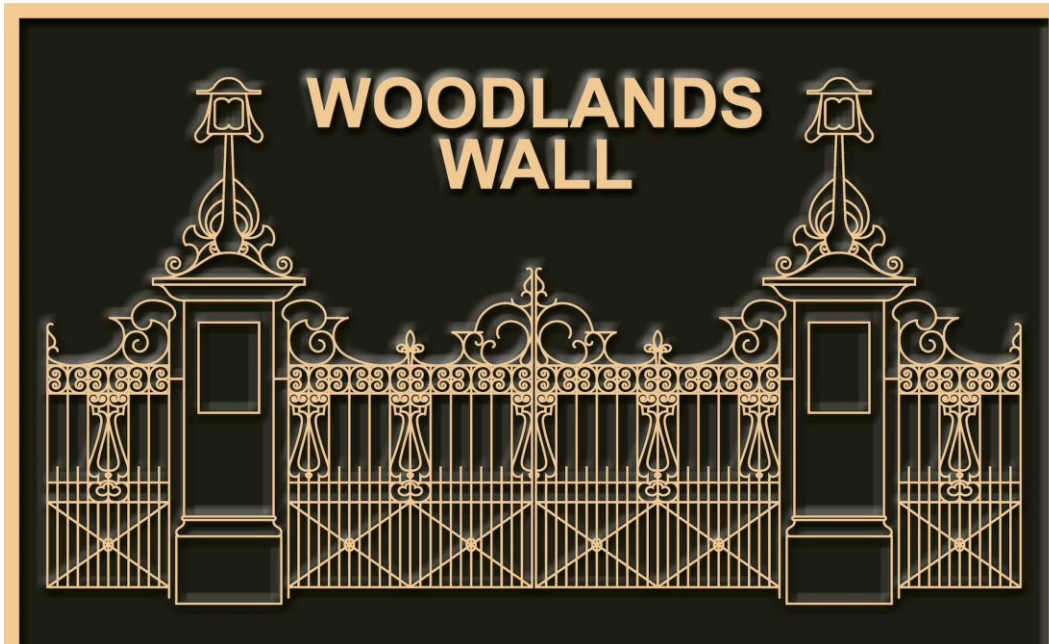
Heritage plaque: Preview

- Note: Unknown if the fine details of the proposed raised image can be engraved on the plaque.

Width: 25cm
Height: 54cm

Raised text, image, and border finished in natural brushed bronze.

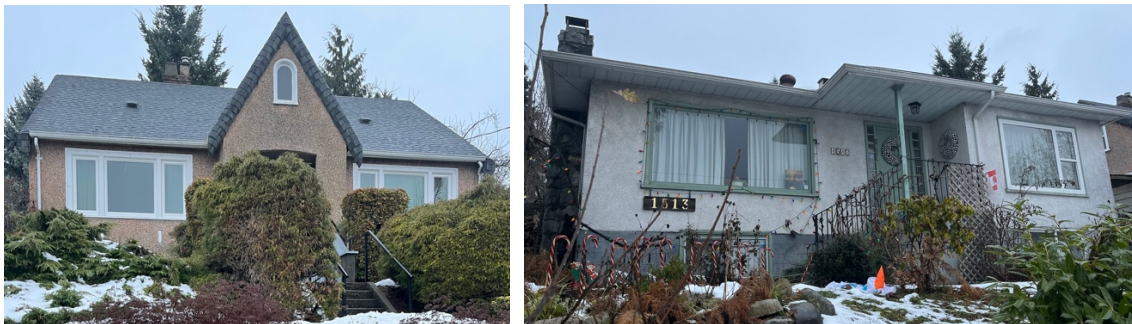
Figure 2: Rowson Residence, 1509 6th Avenue (left); Ritchie Residence, 1513 6th Avenue (right)

For the purposes of this report, the Rowson Residence at 1509 6th Avenue and the Ritchie Residence at 1513 6th Avenue are illustrated below (Figure 2).

The property on which the Rowson Residence is located, at 1509 6th Avenue, comprises 712 sq.m. (7,663 sq.ft.). The adjacent property on which the Ritchie Residence is located, at 1513 6th Avenue, comprises 666 sq.m. (7169 sq.ft.). These sites are situated in the West End neighbourhood fronting 6th Avenue, set on a long block between 14th and 16th Street (Figure 3). There are houses of a similar vintage set on either side, and in the wider context, houses are located both on the north and south sides of 6th Avenue.

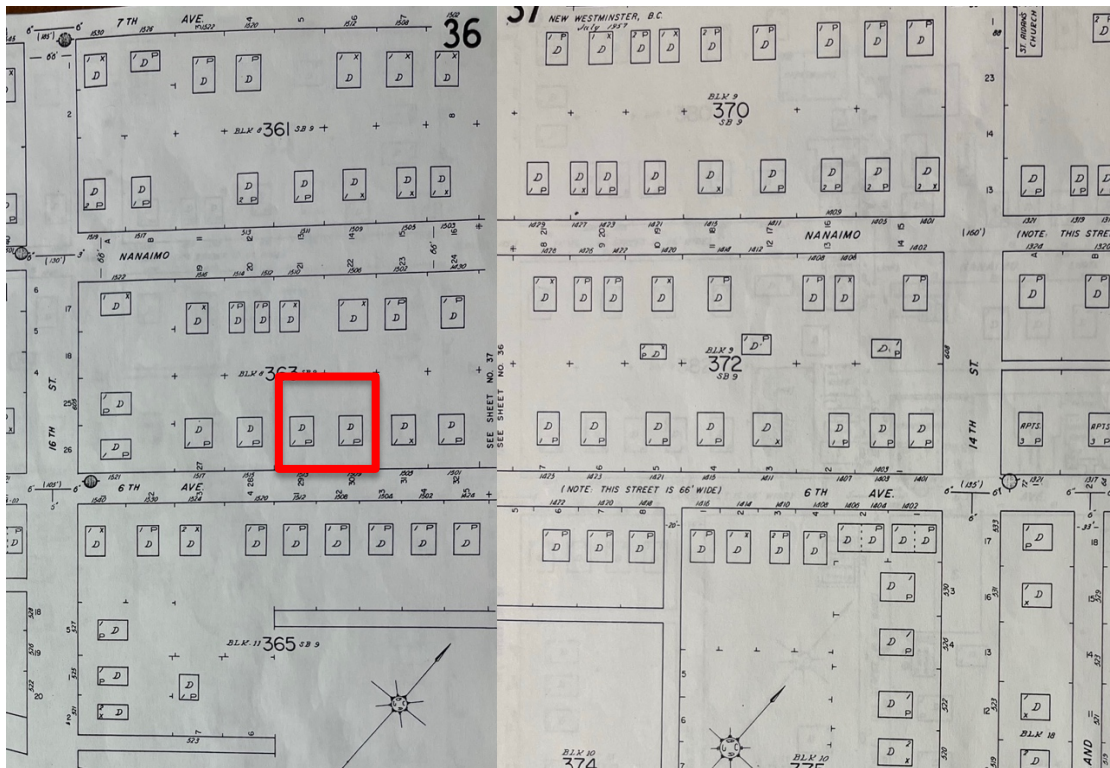
Figure 6: Fire Insurance Plan, April 1957, with 1509 and 1513 6th Avenue outlined (plates 36 and 37 combined).

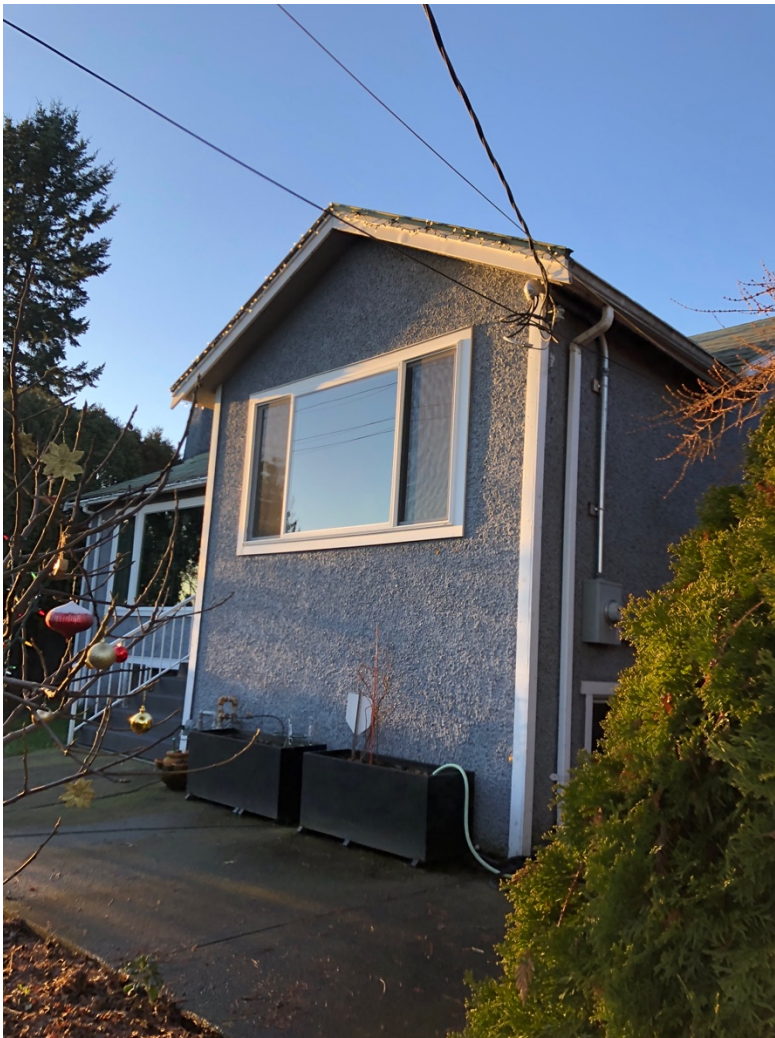
Figure 9: 1515 6th Avenue (1946)

The other single-family dwellings on the north side of 6th Avenue, flanking either side of the Rowson and Ritchie Residences, are from the post-war development boom, between 1946 and 1950, and are generally of a more modern post-war bungalow style that continued well into the late 1950s, although some are also more transitional in style. A good example of this transitional nature is 1515 6th Avenue, immediately west of the Ritchie Residence (Figure 9). Although it was built in 1946, the same year as the Ritchie Residence, its style is more akin to those from the late 1930s.

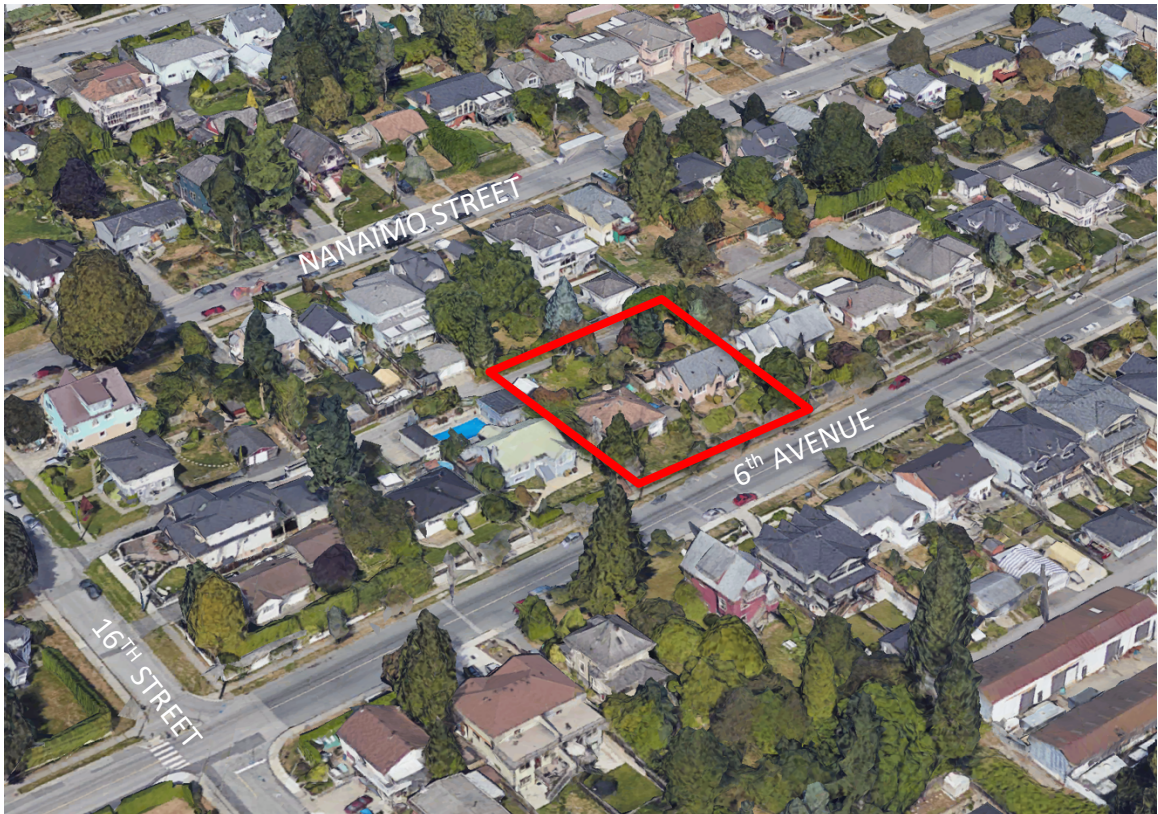
Figure 12: Front of 1509 6th Avenue (right) and 1513 6th Avenue (left), looking north

The Rowson and Ritchie Residences are located side-by-side on the north side of 6th Avenue, a long block situated between 14th Street and 16th Street (Figures 12 and 13).

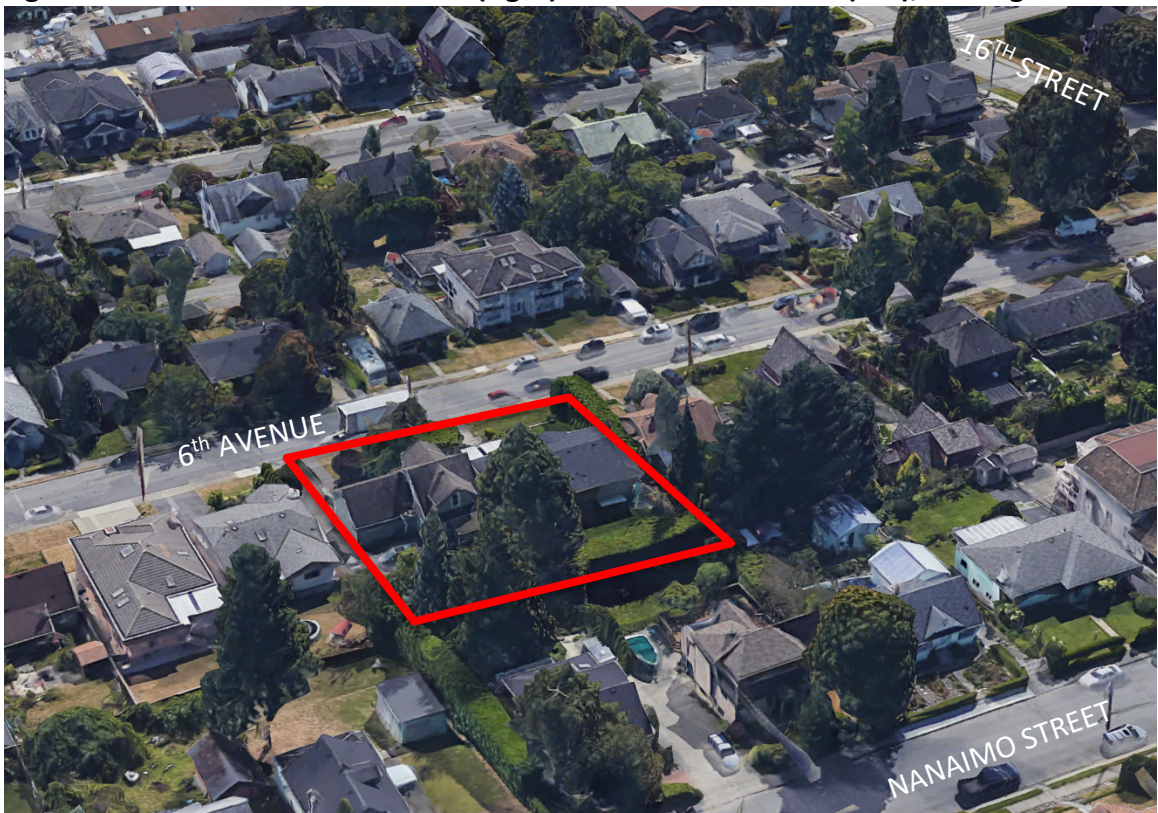
Figure 13: Rear of 1509 6th Avenue (left) and 1513 6th Avenue (right), looking south

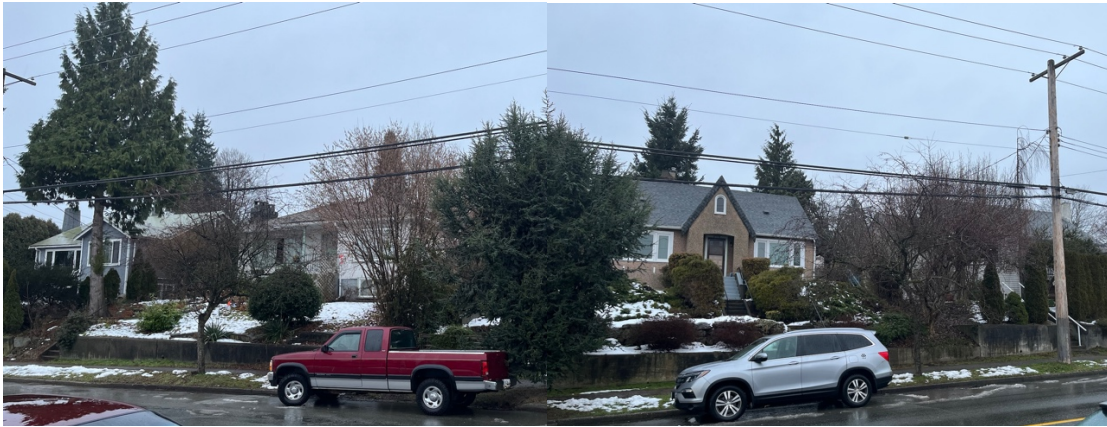
The site slopes up from south to north, providing a panoramic view of the Fraser River to the south. The slope also results in the placement of both houses moderately above street grade, each of which is accessed by a series of stairs and terraced or sloping front gardens with retaining walls (Figure 14).

Figure 14: Context of the two houses as seen from 6th Avenue

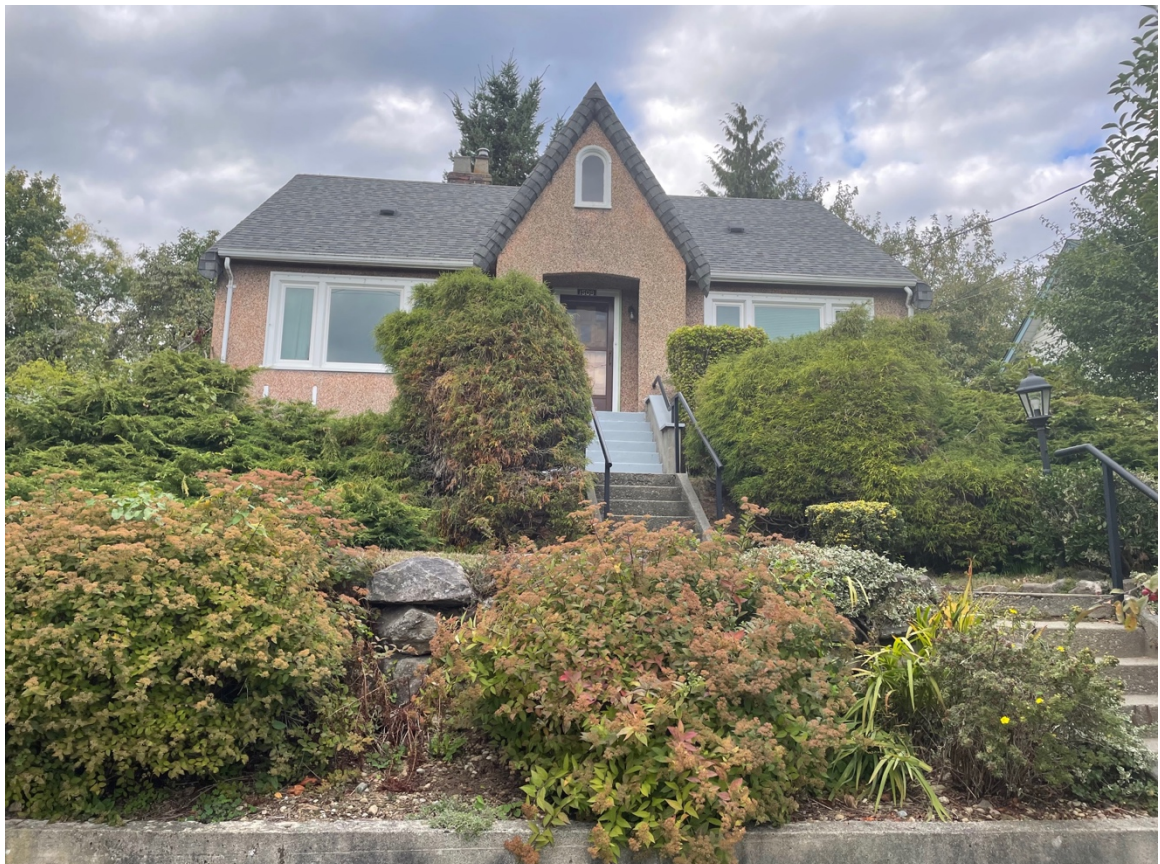
The front of the house is presented as a stepped up terrace to the main entry, well above street level, in response to the significant slope of the property from south to north.

Front of Rowson Residence, 1509 6th Avenue

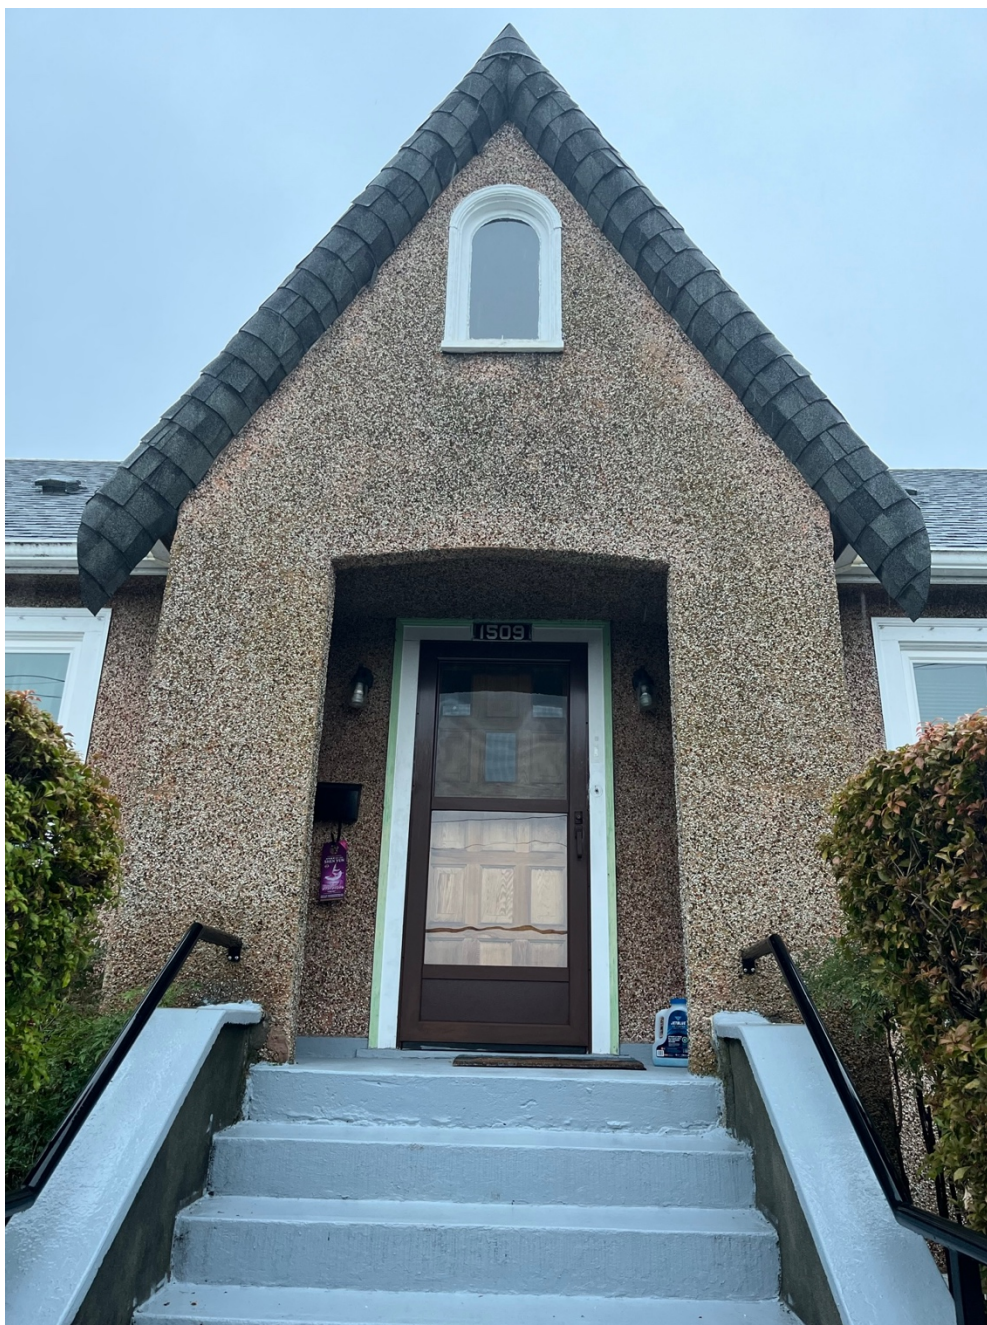
The main entry is balanced as the main architectural element, a steep gable form framing the slightly recessed, centrally-set entry. The left and right sides of the house are equally proportioned as extensions from the gabled entry, with large three-set fixed and casement windows of equal size.

Front recessed entry of Rowson Residence, 1509 6th Avenue

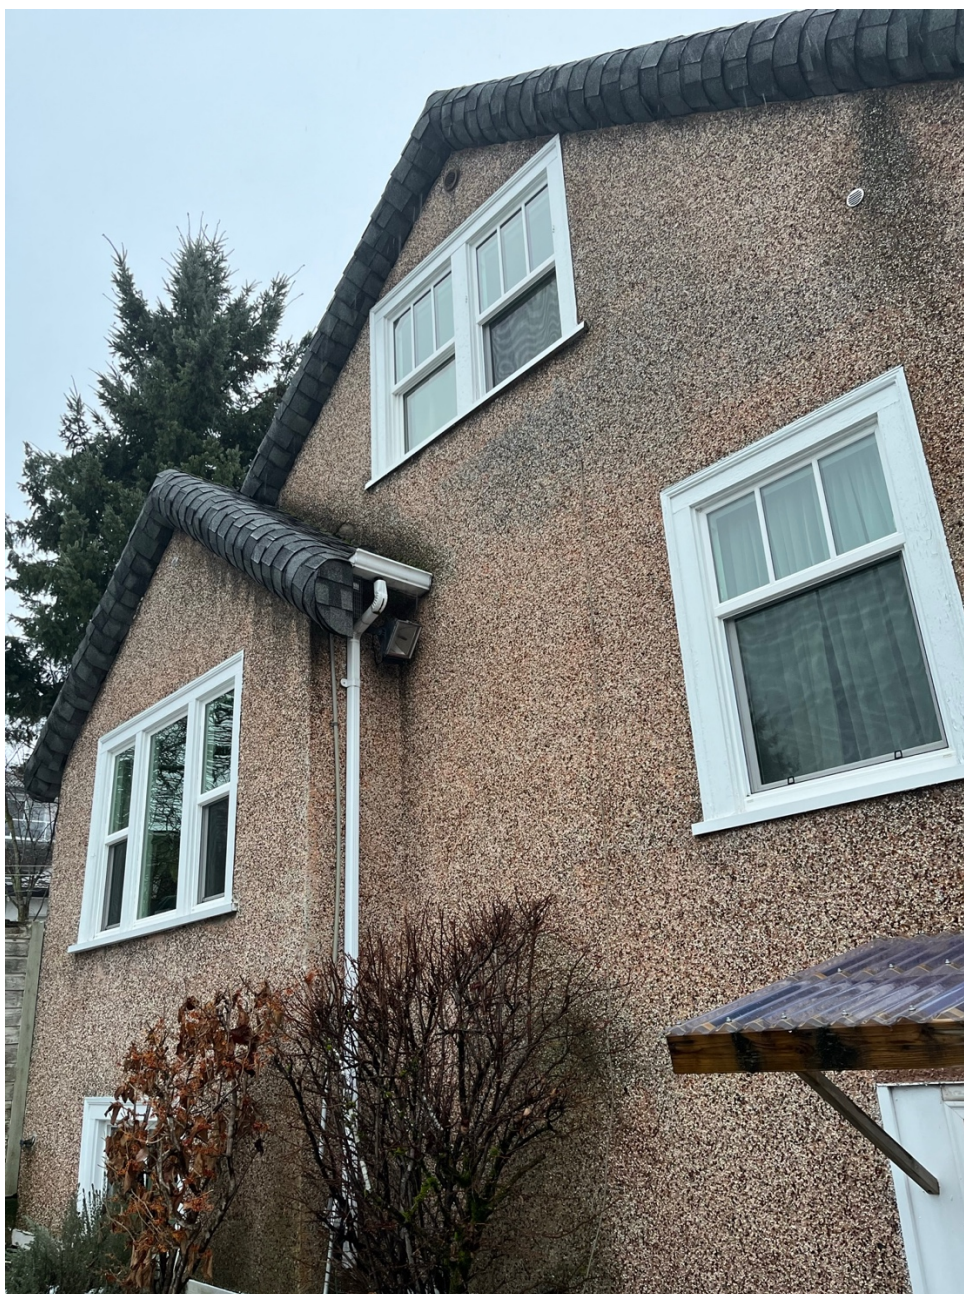
The west side of the house has a lower level entry, and a small protruding gabled bay towards the rear.

Partial view of the west side of Rowson Residence, with protruding gabled bay

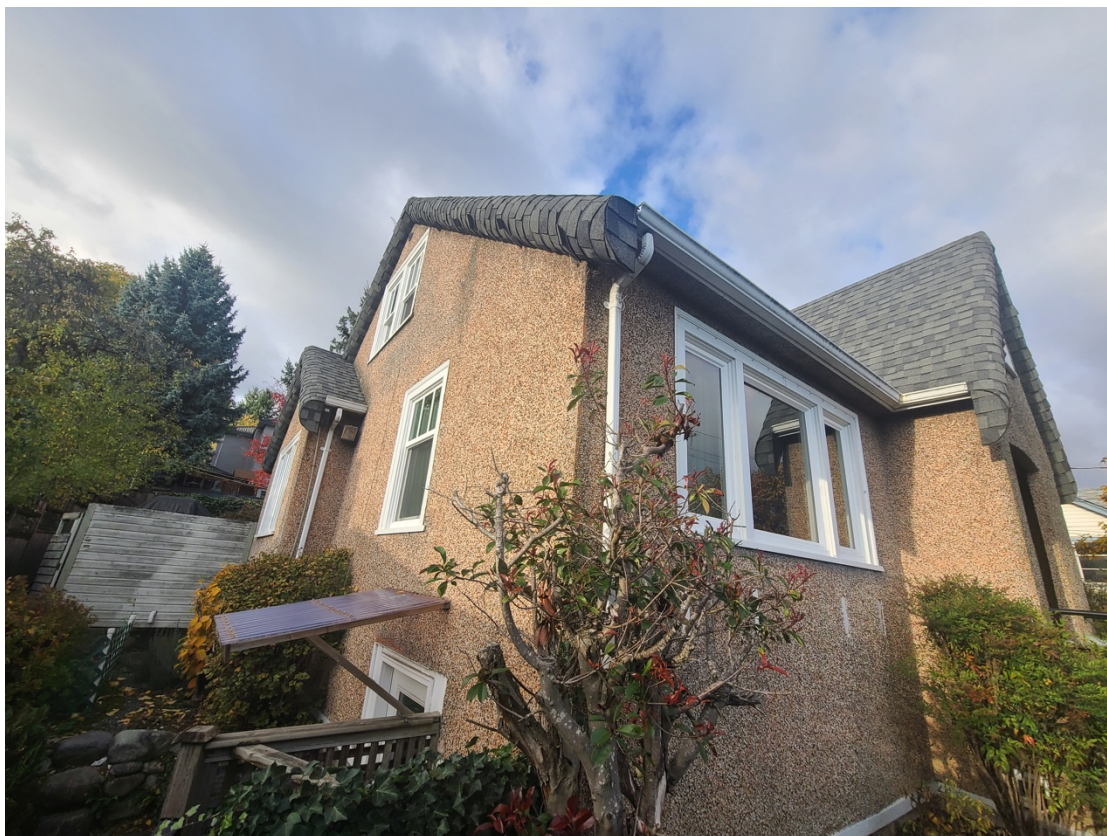
The windows on the main and upper floor are either single-set or paired in the bay and upper gable, all as double-hung with muntins in the upper sash. The gable ends feature a wrap-around roof edge with minimal overhang. Similar to the rest of the house, it is clad with glass bottle stucco.

Full view of west side of Rowson Residence, 1509 6th Avenue

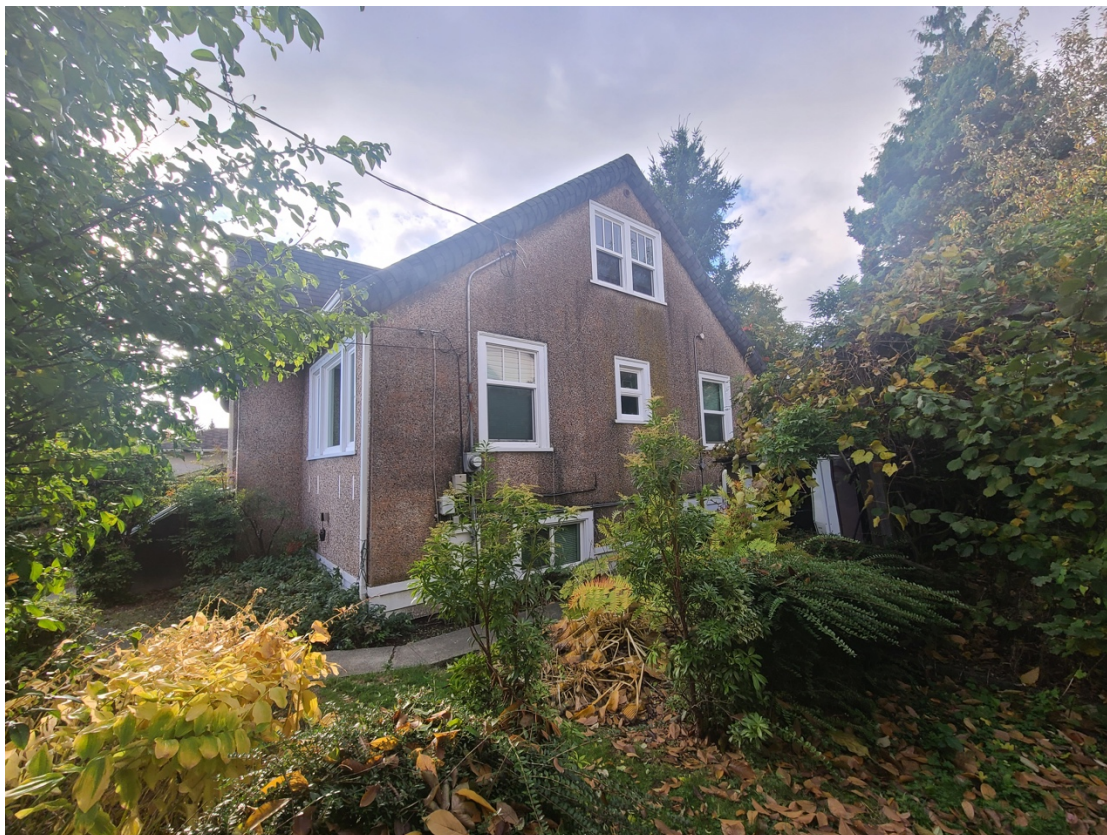
The east side of the house is the least decorative of any side, with simple placement of small-scale double-hung windows, which are single-set except for those on the upper floor which is paired. The paired windows, and one on the main floor, have muntins in the upper sash. The basement windows are sliders. Similar to the rest of the house, it is clad with glass bottle stucco. The gable ends feature a wrap-around roof edge with minimal overhang.

East side of Rowson Residence, 1509 6th Avenue

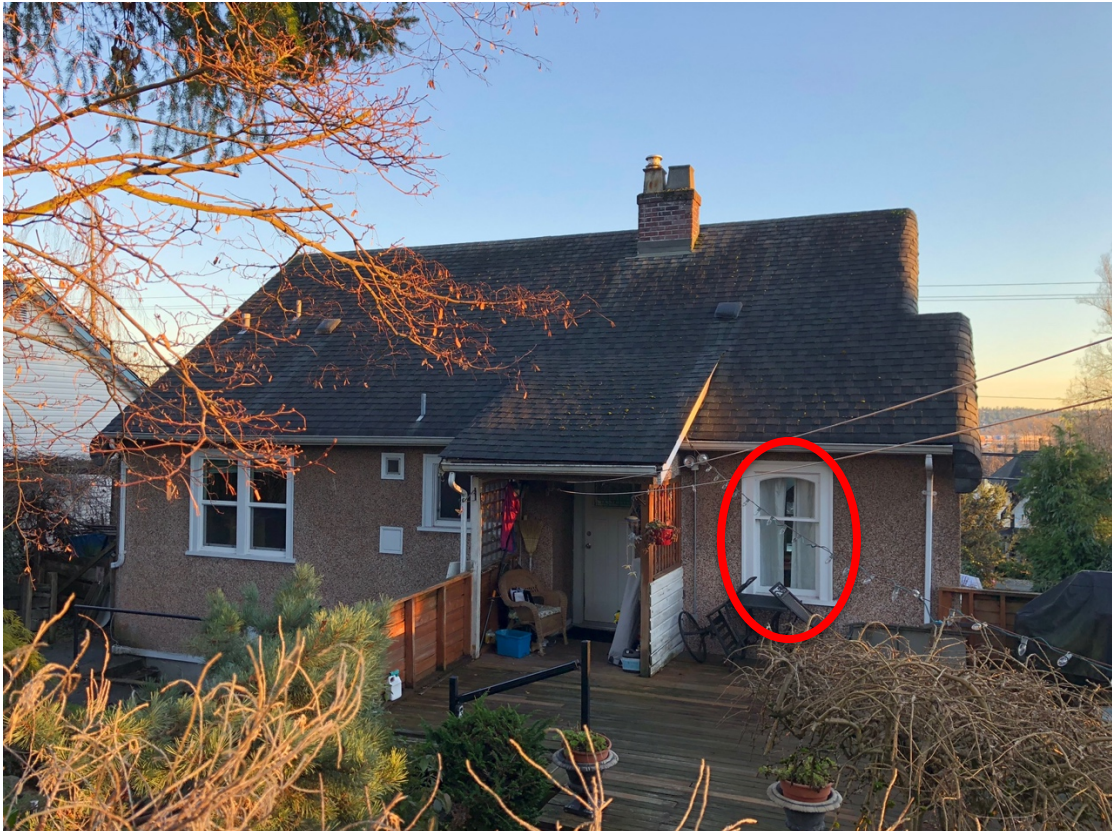
The north side of the house is similarly quite simple, with double-hung windows set as a pair and single with an arched top sash. This is highlighted on the photograph on the following page. That arched top sash provides a clue as to the style of windows that would have been situated throughout the house and suggests that the other windows have been replaced at some earlier time.

North side (rear) of Rowson Residence, 1509 6th Avenue – original window circled

Assessment: The house has had minor alterations, primarily replacement of some windows, suggested by variation in the upper sashes – some have muntins, some do not. These alterations have a minor impact on the historic character, but the openings remain intact and the material (wood) and profile is consistent.	
Grading: A building with one or more alterations, the effect of which is recognizable but does not significantly detract from the style, design, construction or character.	Very Good
Scoring:	-5

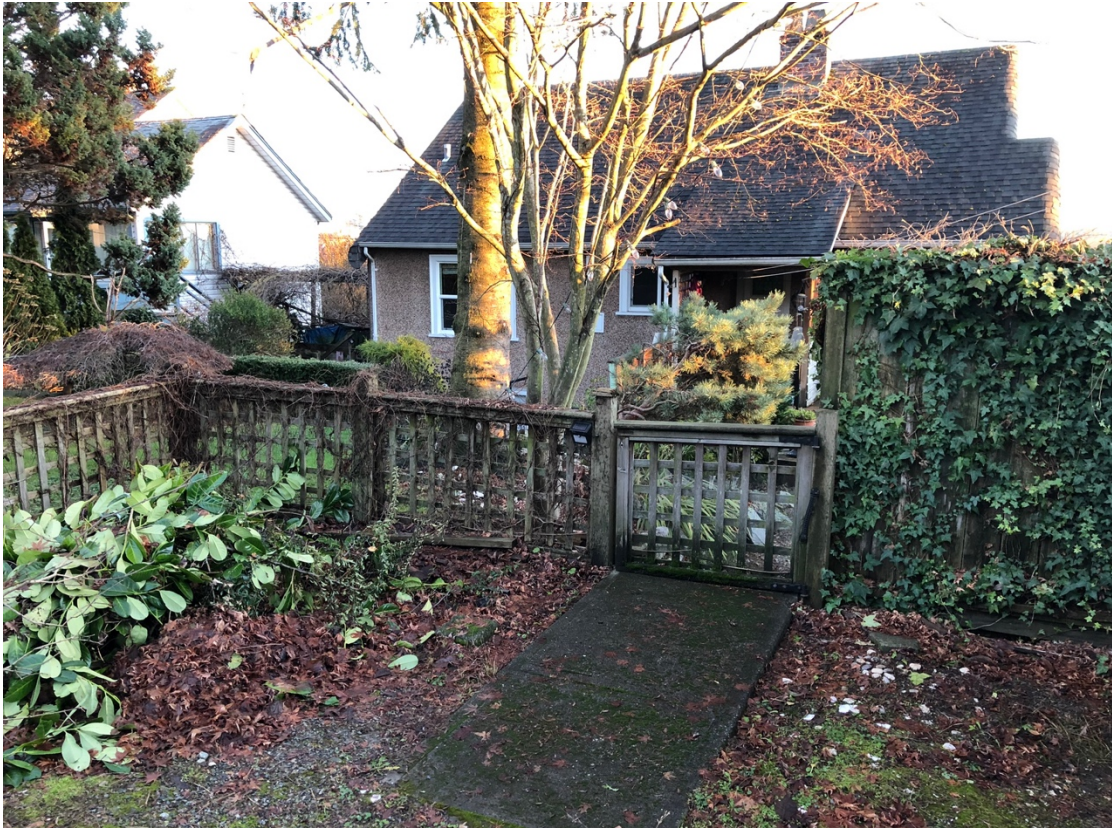
Rear yard, landscaping and parking accessed from the lane

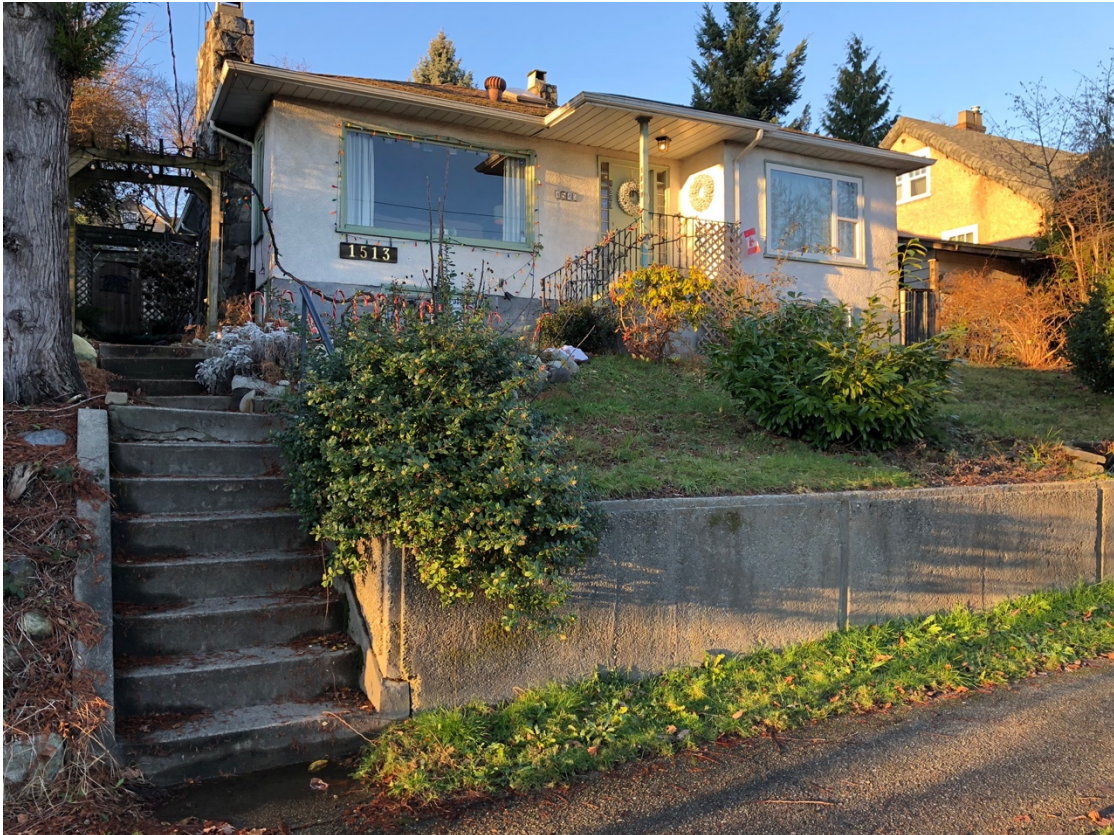
In response to the slope of the property from south to north, the front of the house is presented as a sloped garden with the main entry well above street level. The main entry is presented as the primary architectural element, a modest size porch with a wide overhang continuing from the soffit, supported by a single post. The entry door is flanked by a more modern interpretation of the traditional sidelights, done in square glass block. The left side of the house is proportioned as the larger face spanning roughly two-thirds of the front, recessed to be flush with the entry porch and door, with the right side extending forward to frame the entry porch. Both front windows are large fixed and casement windows of equal size.

South side (front) of Ritchie Residence, 1513 6th Avenue

Assessment: While the form of the house is intact, it has had alterations, primarily replacement of front and basement windows with vinyl windows and the large front fixed picture window would originally have been casements flanked by a fixed middle window. These alterations have had negative impact on the historic character, but the proportions (e.g. window and door openings) along with most of the side and rear windows appear to remain intact.	
Grading: A building with one or more alterations, the effect of which is recognizable but does not significantly detract from the style, design, construction or character.	Very Good
Scoring:	-5

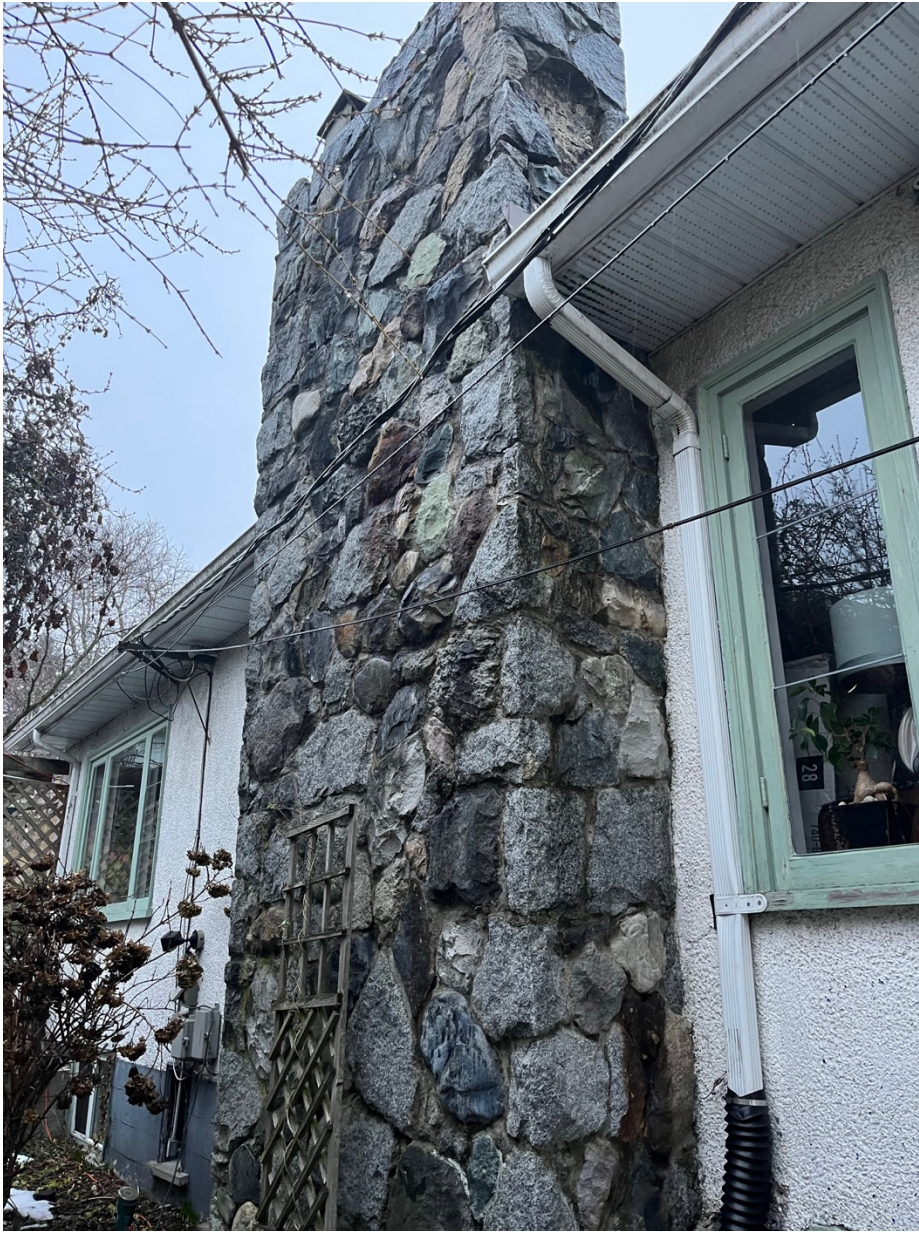
The west side of the house is set back from the property line allowing access along and through to the rear. It features a large stone chimney, vertical piano windows on either side with horizontal leaded muntins and a large picture window flanked by tall casement windows towards the rear.

West side of Ritchie Residence, 1513 6th Avenue

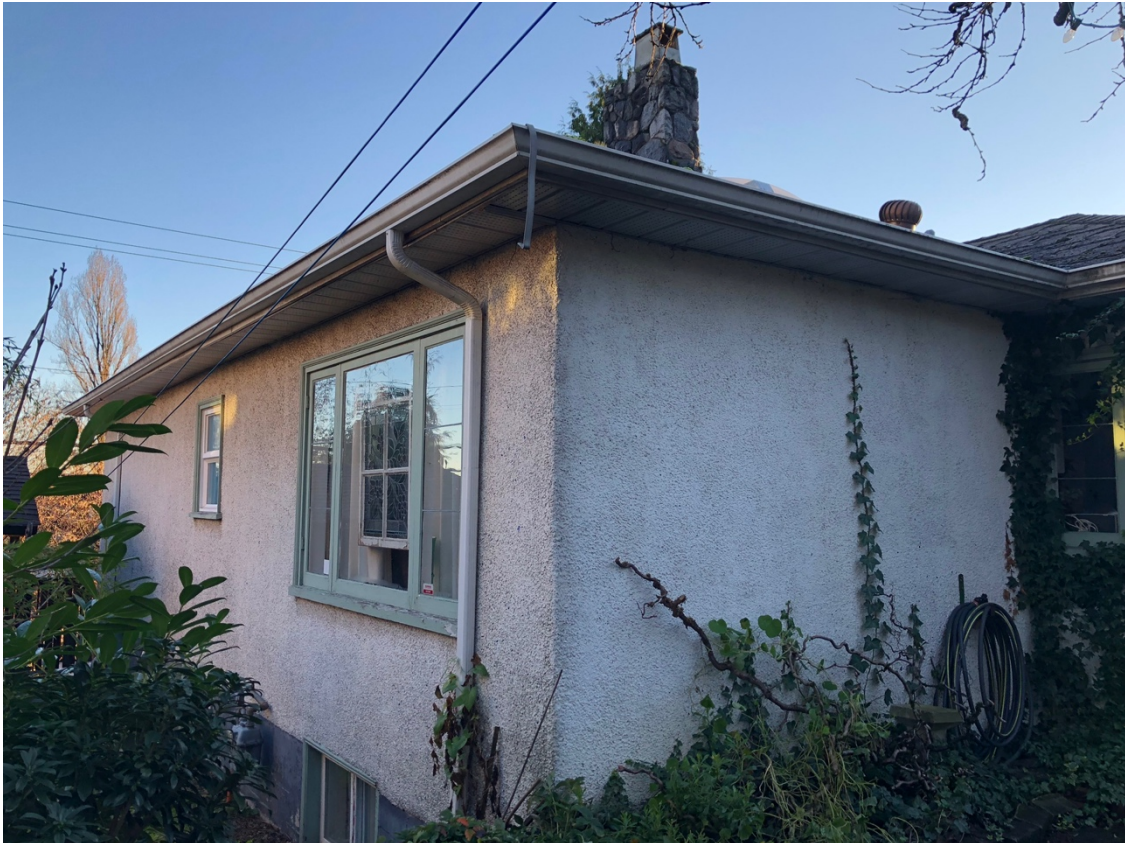
The east side of the house is set closer to the side yard and as such does not have the same access and visibility as the west side. Similar to the west side there is a large picture window flanked by tall casement windows and one small replacement window in vinyl.

East side of Ritchie Residence, 1513 6th Avenue

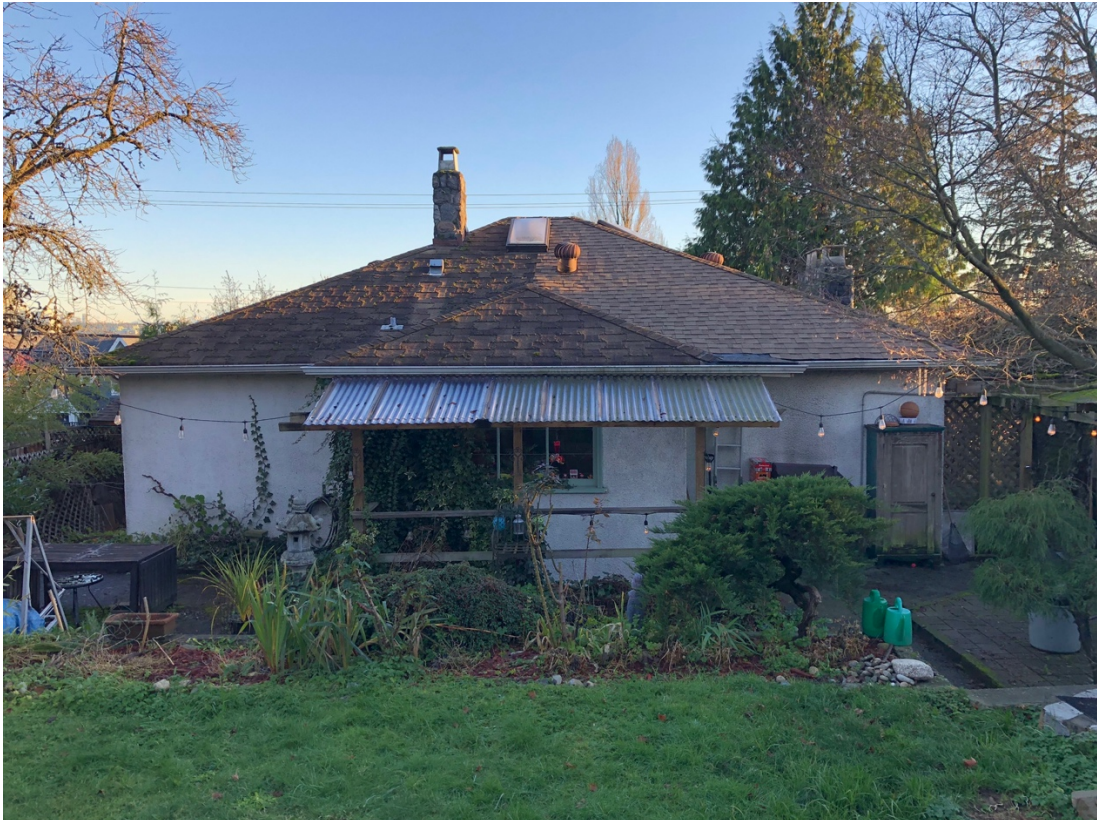
The north side of the house has minimal design attributes, as is the case with most modest houses of this era. Its windows are similar to those on the side – centre fixed wood window with flanking casements and horizontal leaded muntins – and it has a modest rear door with inset glazing.

North side (rear) of Ritchie Residence, 1513 6th Avenue

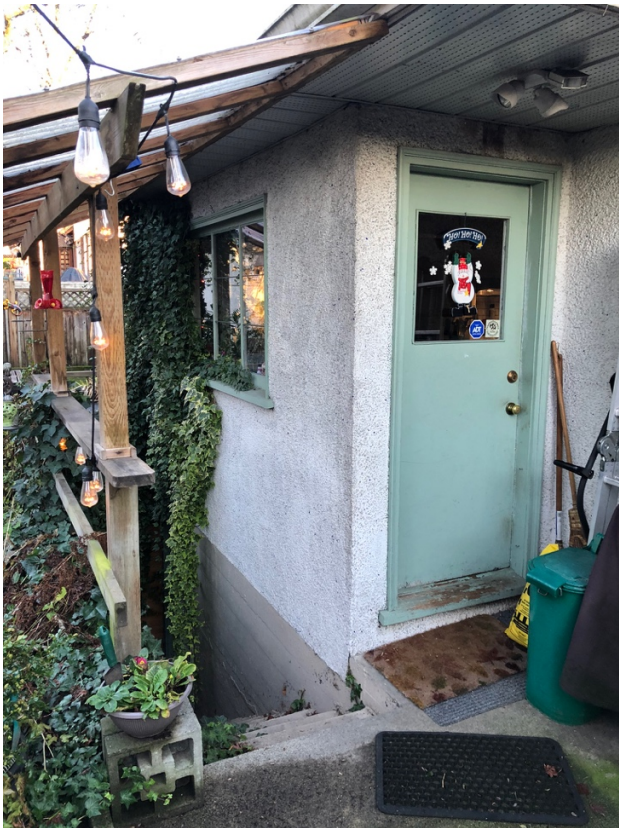
Rear wall with stairwell and rear door (facing west)

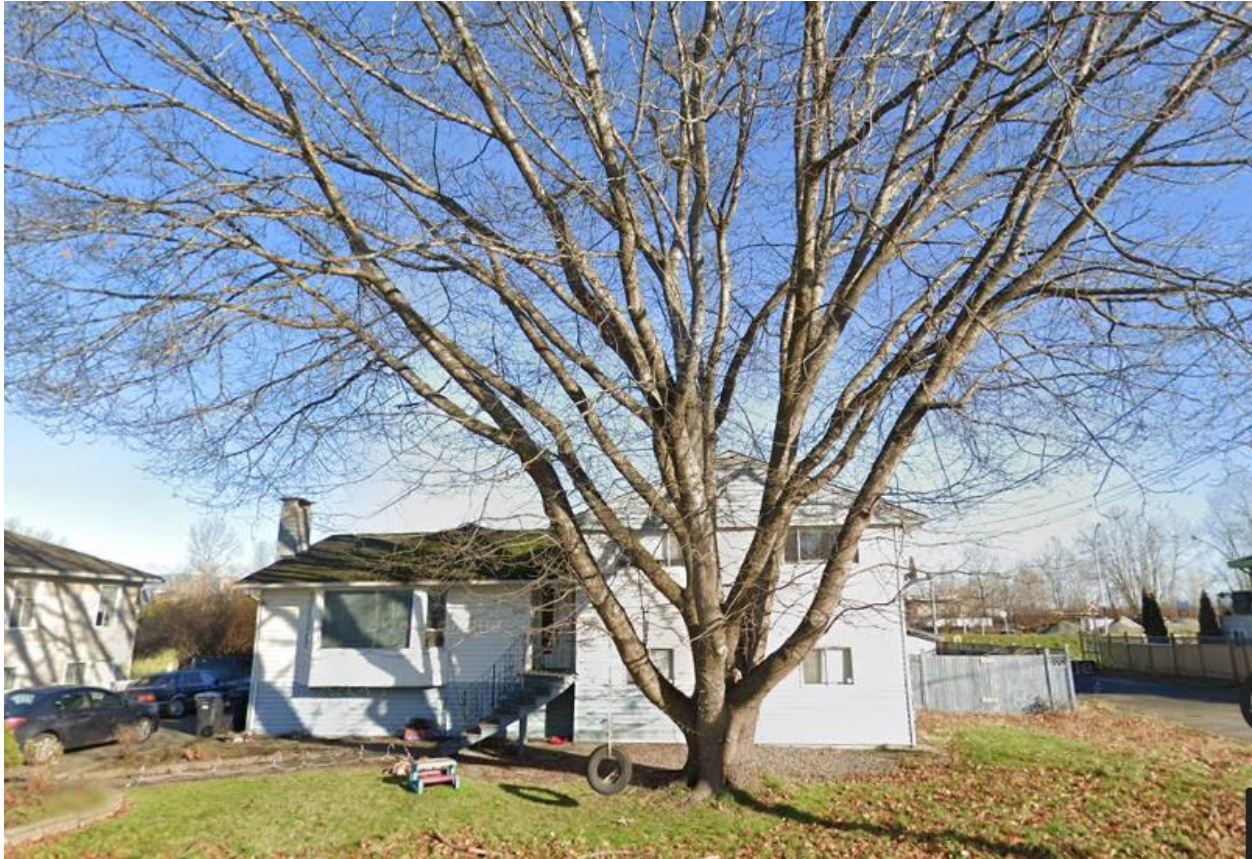
Figure 1: Existing House and Oak Tree

203 Pembina Street is a corner property in Queensborough. There are two street frontages (Salter and Pembina Streets) as well as an existing unconstructed lane at the rear. A site context map, aerial image, and information on the surrounding sites is provided in Appendix A. The overall site is 1,072 sq.m. (11,543 sq.ft.) in size. There is a 1966 two storey house on site, with an area of 309 sq.m. (3,322 sq.ft.). A 59 year old Oak Tree is located near the front of the property in the southwest corner along Pembina Street. See figure 1 below of the existing house and Oak Tree captured in December, 2020.

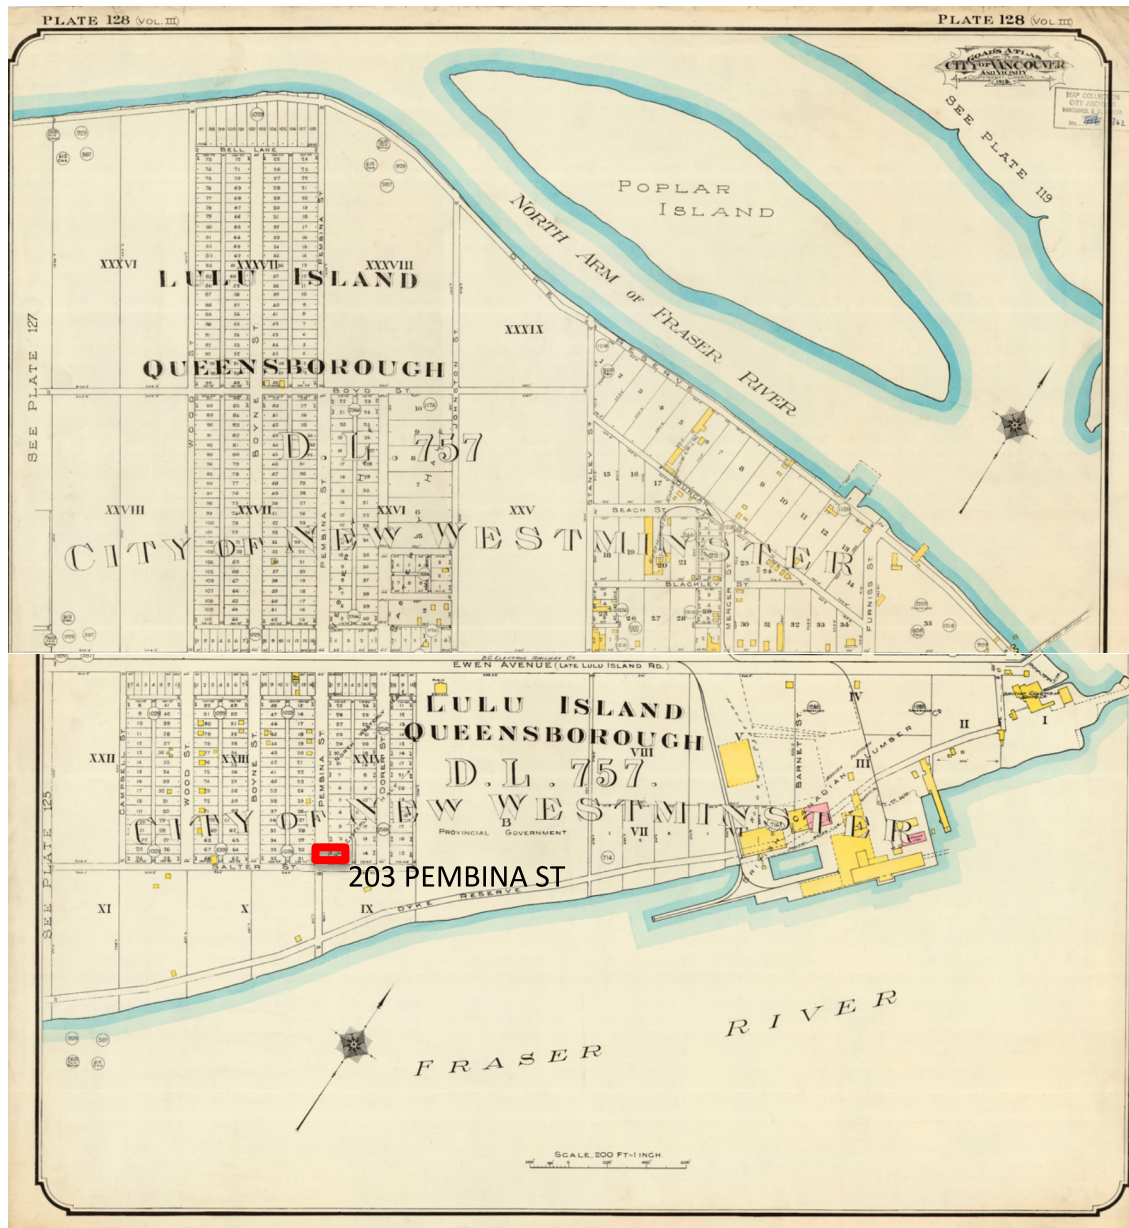
The immediate area evolved gradually, which around the turn of the century represented the outlying fringe of New Westminster. Development was restricted by the limited access to the area: there was one bridge across the North Fraser River along which the BCER ran a line through the area (Figure 8).

Figure 8: 1913 Fire Insurance Plans (superimposed), illustrating the east section of Queensborough with the property now addressed as 203 Pembina Street outlined in red. City of Vancouver Archives, Item 1972-472.15, Plates 126 and 128.

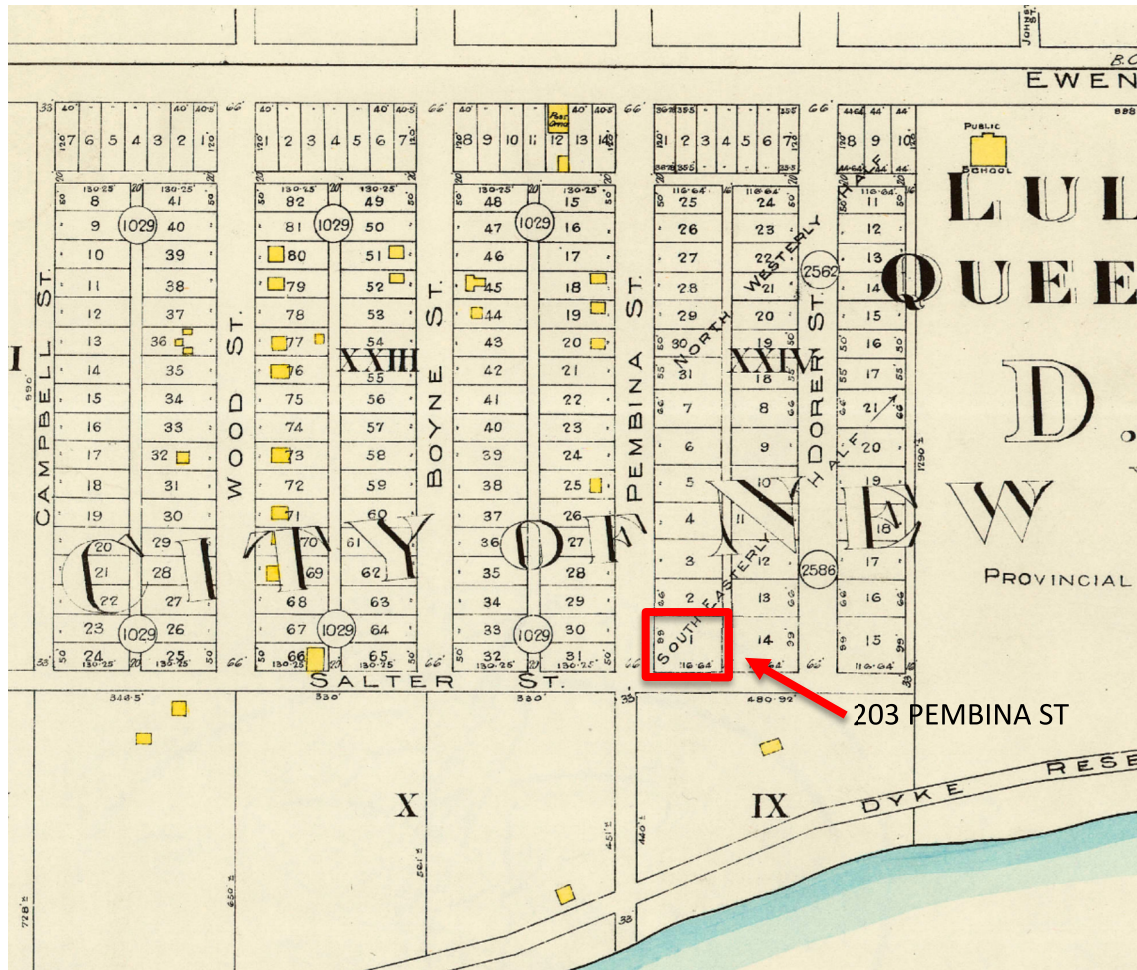
Pembina Street and both sides of Dorer Street (now Fenton Street) (Figure 9). Further detail on the historical pattern of development along Pembina Street is provided in Section 3.1 of this report.

Figure 9: 1913 Fire Insurance Plan, 203 Pembina Street (Lot 1) outlined.
