**COMMUNITY HERITAGE COMMISSION
AGENDA**

Wednesday, July 6, 2022, 6:00 p.m.

This report is a heritage assessment and evaluation of two buildings located at 1509 and 1513 6th Avenue, located in the south-west area of New Westminster (Figure 1). Collectively, they are referenced in this report as the Rowson and Ritchie Residences.

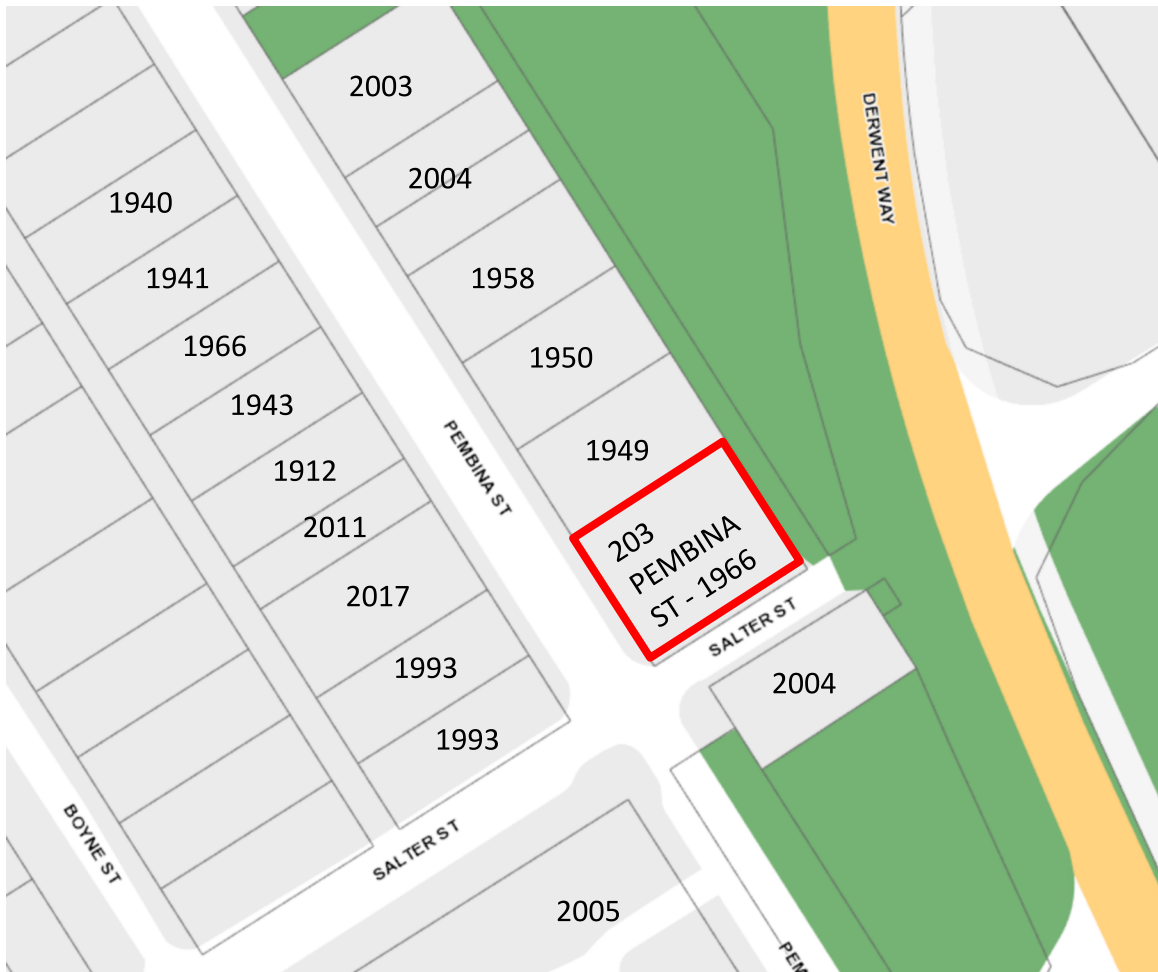
The area around 203 Pembina Street is made up of a various residential forms and density: single-family houses of a similar modest scale to the north and south, larger houses on the west side and low-rise apartments to the southwest. The development trends are partly evident in the ages of houses. While those that were redeveloped in the last two decades cannot illustrate the original development pattern, it is the ages of the original houses such as those as early as the mid-1910s, and groupings of 1940s and 1950s houses that give some insight into the development of the block (Figure 13).

Figure 13: Age of Dwellings Surrounding 203 Pembina Street

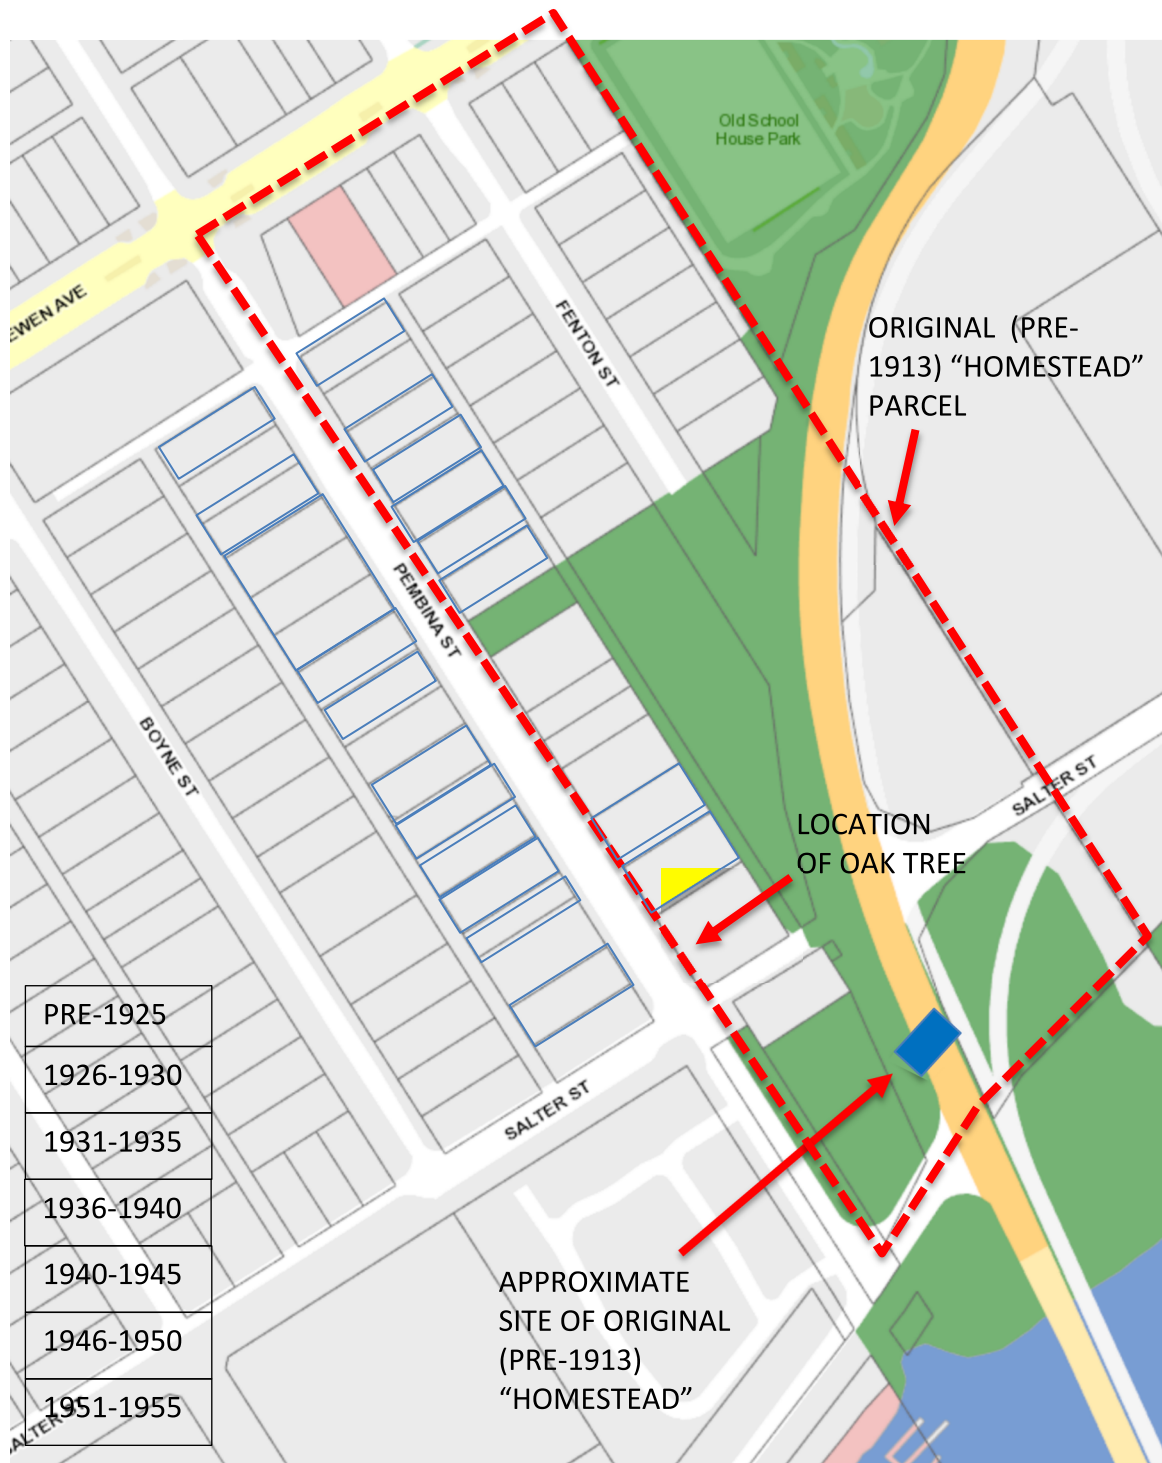
The ages of original houses more accurately illustrate the pattern of early development – as opposed to the ages of houses that are currently in place. Based on listings in City Directories, a pattern becomes more evident along the 200 block (Figure 16). The years when development on the west side of the 200 block of Pembina Street was most active was prior to 1950, and notably, five houses built prior to 1925. Similarly, the north half of the east side of the 200 block of Pembina Street, was nearly entirely developed prior to 1945. By contrast, the south half of the east side of Pembina Street experienced almost no development until after 1955, with only two houses built by 1951.

As such, 203 Pembina Street, for which records indicate construction in 1966, did not have a house situated on the property prior to that date (i.e. no house was demolished to make way for the existing dwelling). Based on that observation, and in conjunction with the arborist report, it can be concluded that the oak tree was planted well before development began to take place from the late 1940s through the 1960s and therefore it has no association with any of the houses on the east side of the south half of the 200 block. A plausible explanation for its planting is its earlier association with the pioneer homestead situated on South Dyke Road.

Figure 16: Dates of original houses on Pembina Street – east side as part of original “homestead” parcel (dash line), compared to west side of Pembina

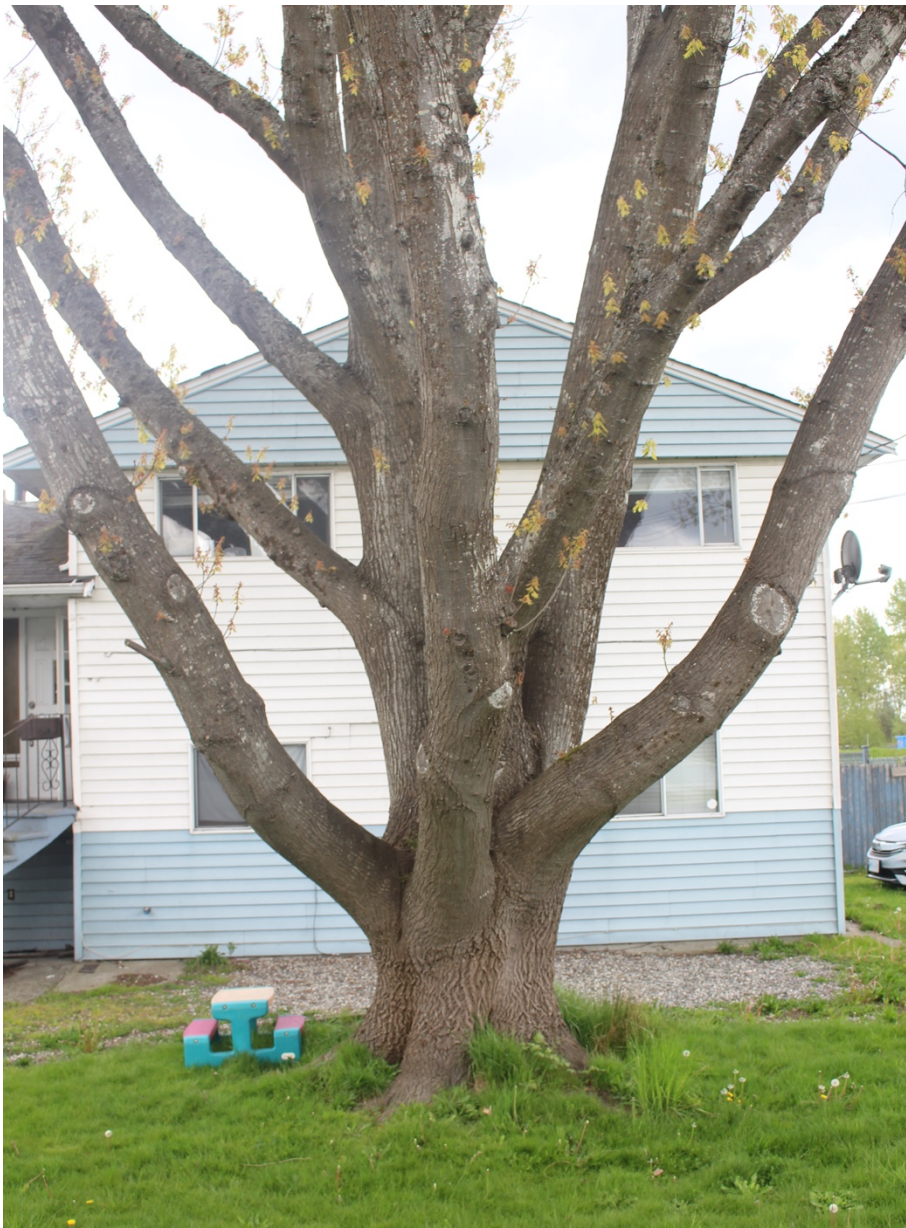
Figure 17: Base of tree with multiple stems extending up and outward from the main trunk

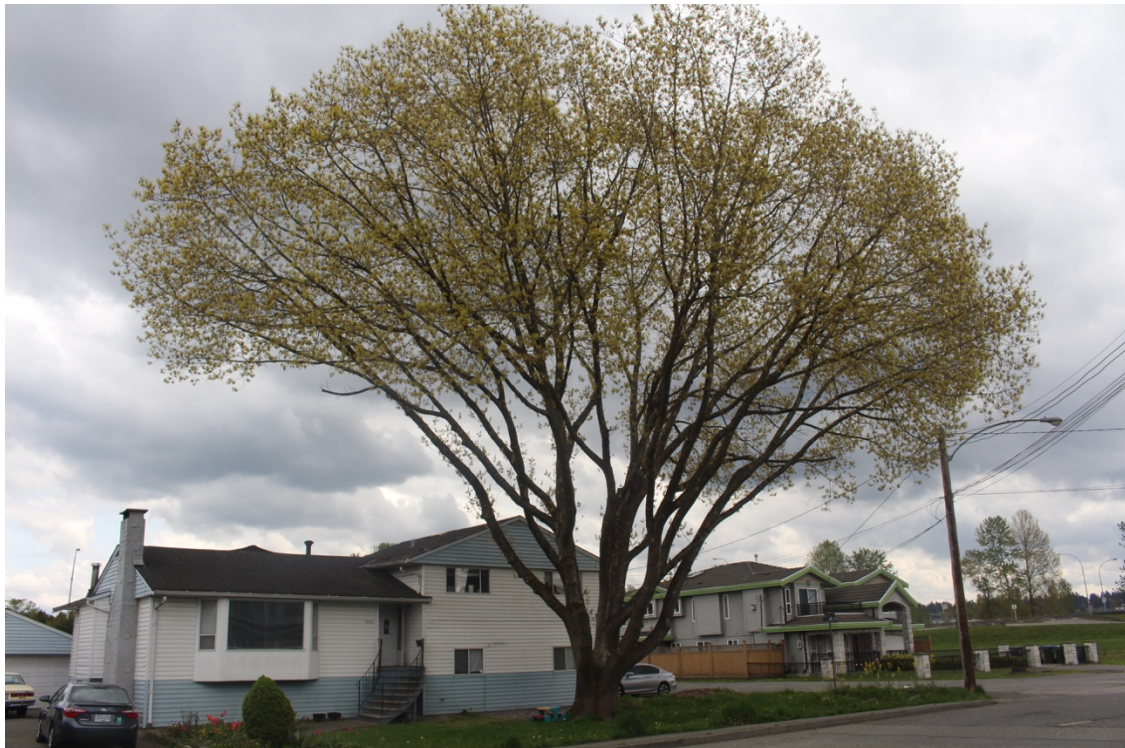
The front of the property is open to the street, with a shallow drainage ditch running along the edge adjacent the sidewalk (Figure 18). This is the most prominent siting of the tree, given that it is set only 15 feet from the edge of the ditch, and the same distance to the front of the house. The canopy of the tree extends well beyond the roofline of the house, with six primary stems leading off from the lower trunk, each of which forms an expansive crown.

Figure 18: West side of property as seen from Pembina Street

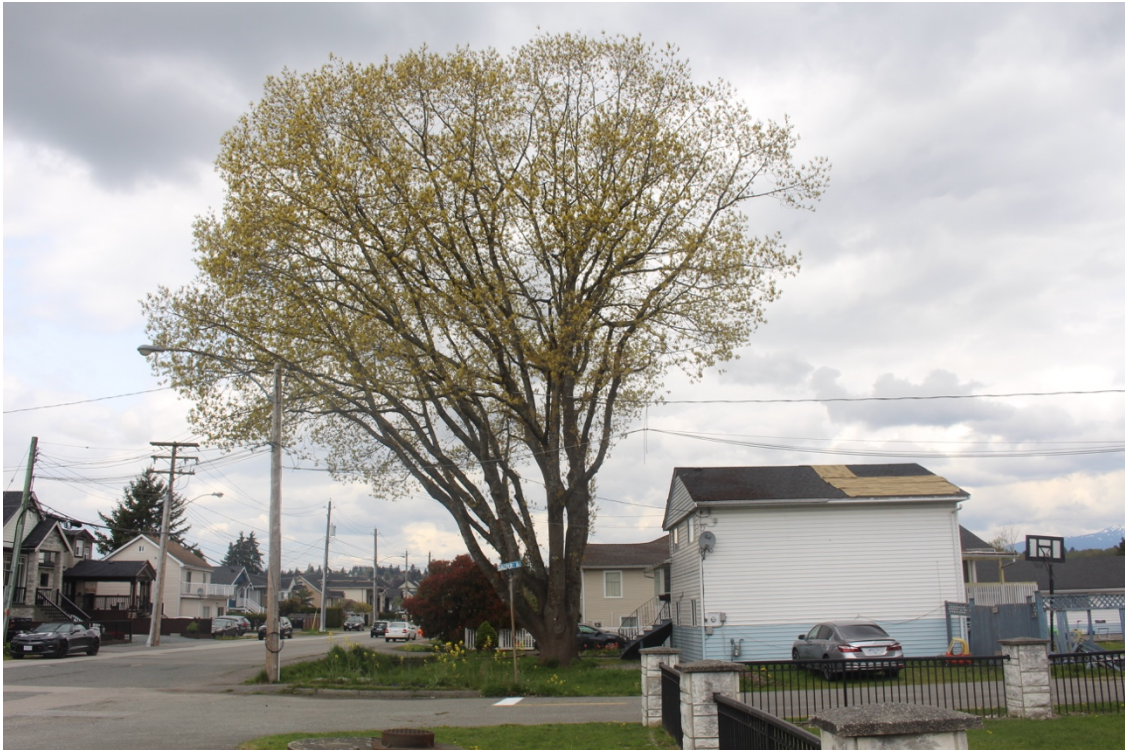
The south side of the property borders Salter Street and is entirely open at the front and side corner. The proximity of the house to the oak tree is evident on this side (Figure 19). Select pruning that has taken place in recent years to reduce the expansive overhang of the tree over the house is evident from this side.

Figure 19: South side of property as seen from Salter Street

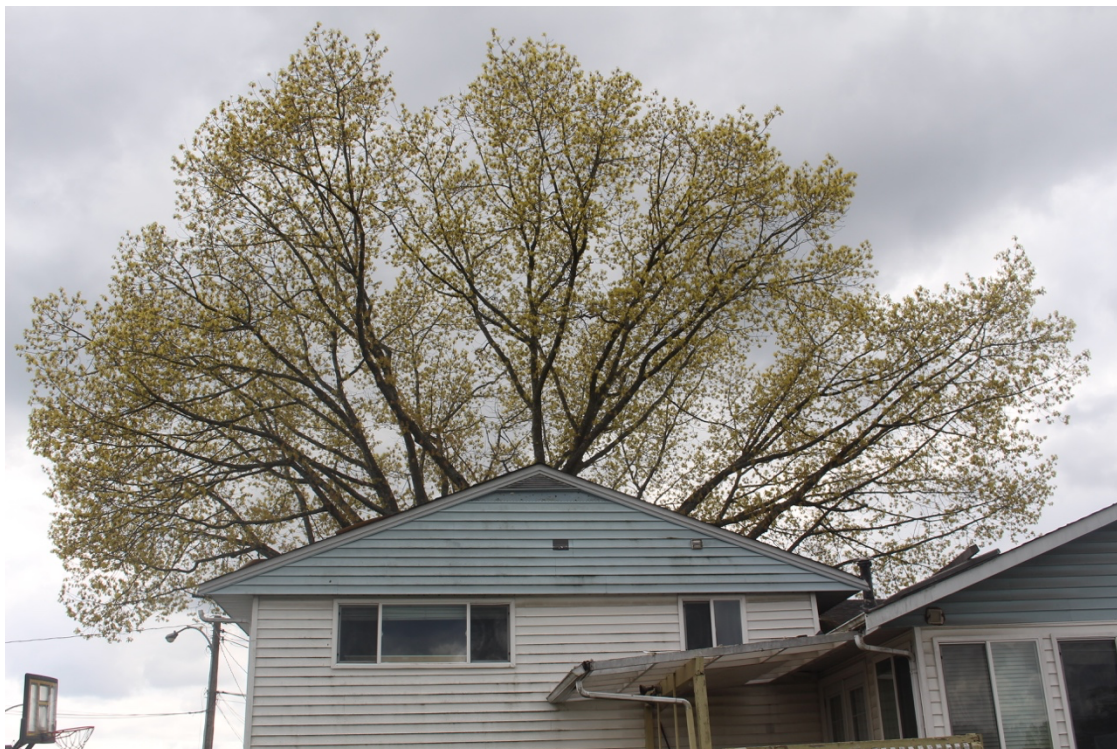
The east side of the property comprises an open yard with a garage extending to the rear, along which is a hedge (Figure 20). The rear yard is fairly large, due to the wide frontage of this property. The oak tree is easily visible even with the house obstructing part of the lower section, with multiple stems extending upward.

Figure 20: East side of site (rear) looking toward Pembina Street

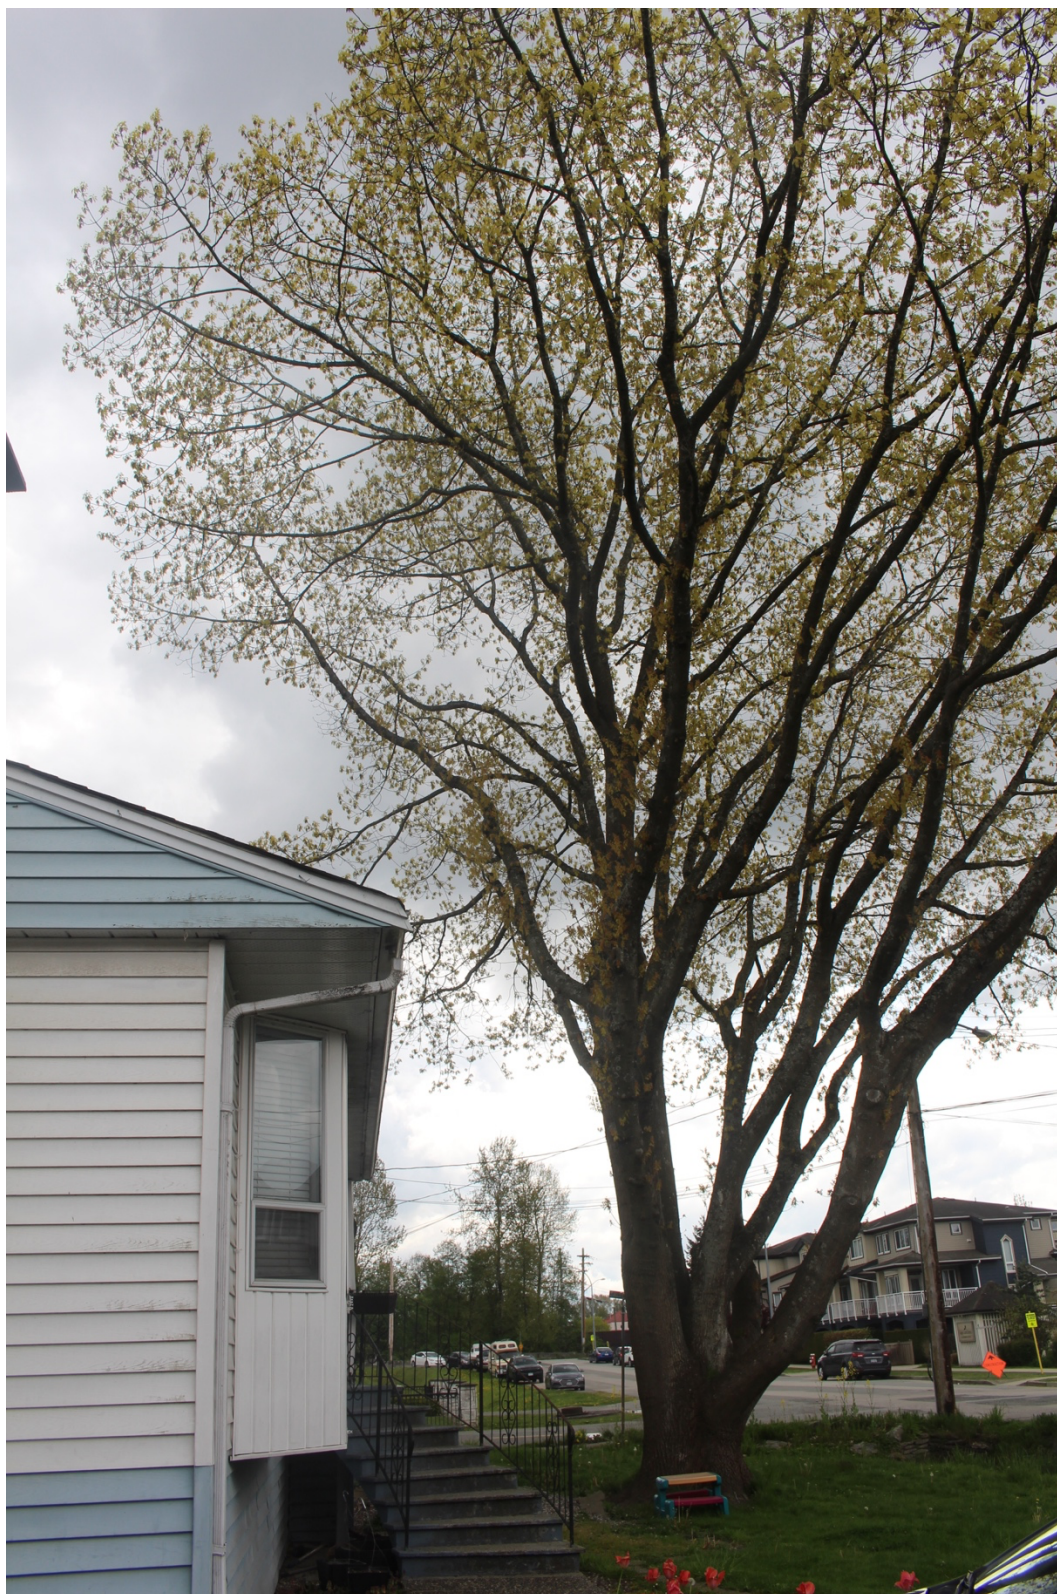
The north side of the property features a driveway between the wall of the house and the property line (Figure 21). Similar to the south side, the view of the oak tree from this side illustrates just how close the tree is to the house, and the select pruning that has taken place to reduce the expansive overhang of the tree over the house.

Figure 21: North side of property, looking toward the corner of Pembina and Salter Street

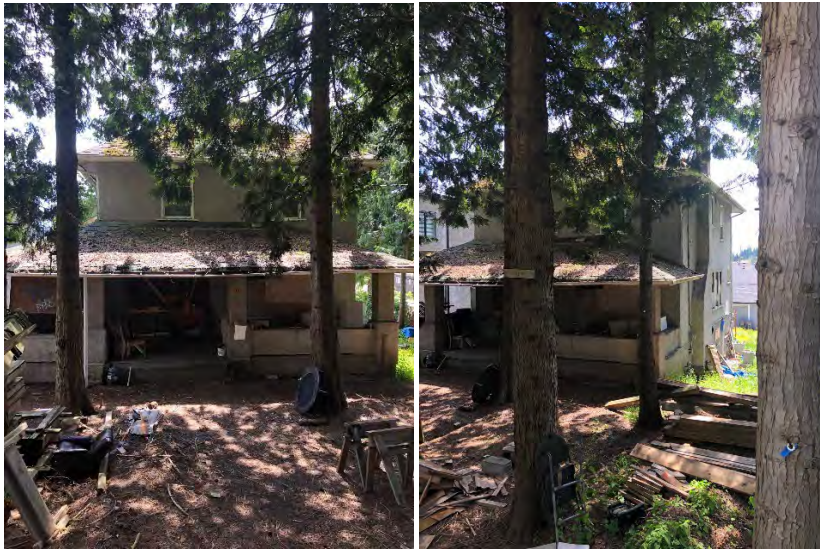
Front (North-facing) elevation

This house has a hipped roof, a full-width front porch, chimney, and little decorative detailing. The historic fenestration pattern and trim appears to have been retained with the addition of aluminum and vinyl replacement windows. The exterior cladding is a pebble dash stucco; it is unknown whether the original wood siding was removed or is still present underneath the stucco.

Based on current photos and heritage assessment (Appendix B), it's clear the house's overall form and massing has been retained though the building's exterior has been altered with the application of pebble dash stucco on the entire building and the replacement of original windows. The exterior surfaces of the house show evidence of deterioration of materials, in particular, the roof and porch. Overall the house appears to be in fair condition.

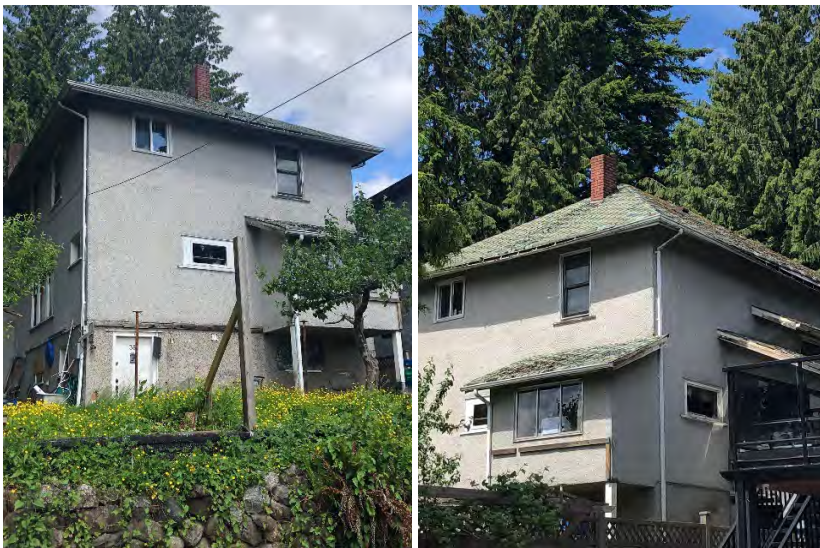
Rear (South-facing) elevation
