**COMMUNITY HERITAGE COMMISSION
AGENDA**

Wednesday, April 6, 2022, 6:00 p.m.

Heritage Assessment

373 Hospital Street – 1915

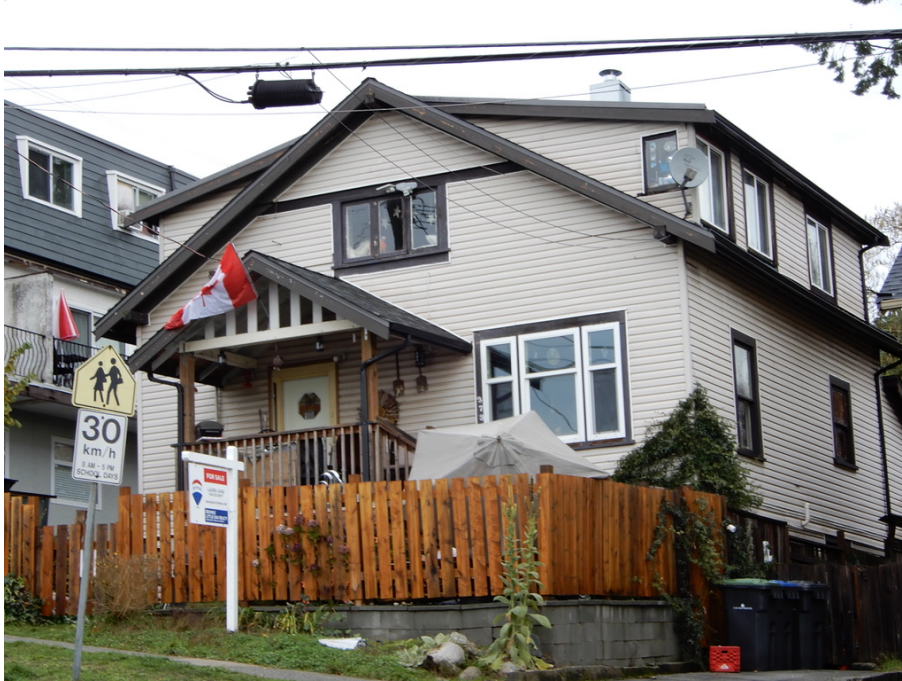
South elevation

c. Overall exterior condition of structure and materials.	6/10	Building is generally in fair condition and moderately maintained. The condition of wood cladding was not assessable. The remaining original wood windows appear in decent condition; however, the vinyl window assemblies appear in poor condition, poorly installed and in need of replacement.
Summary: 51%	74/145	<p>The building has low historical, cultural and architectural significance. While the house could potentially be conserved through a combination of restoration, preservation and reconstruction, in its current condition it does not merit a Protected Status. If the building is to be demolished it is recommended that mitigations are taken through the two following proposed heritage actions:</p> <ul style="list-style-type: none"> • Professional architectural photographic documentation of the exterior with archival-quality prints provided to the New Westminster Museum and Archives. • Deconstruction, which will provide for the salvage and/or recycling of architectural elements, lumber, wood flooring, historic windows and other materials.

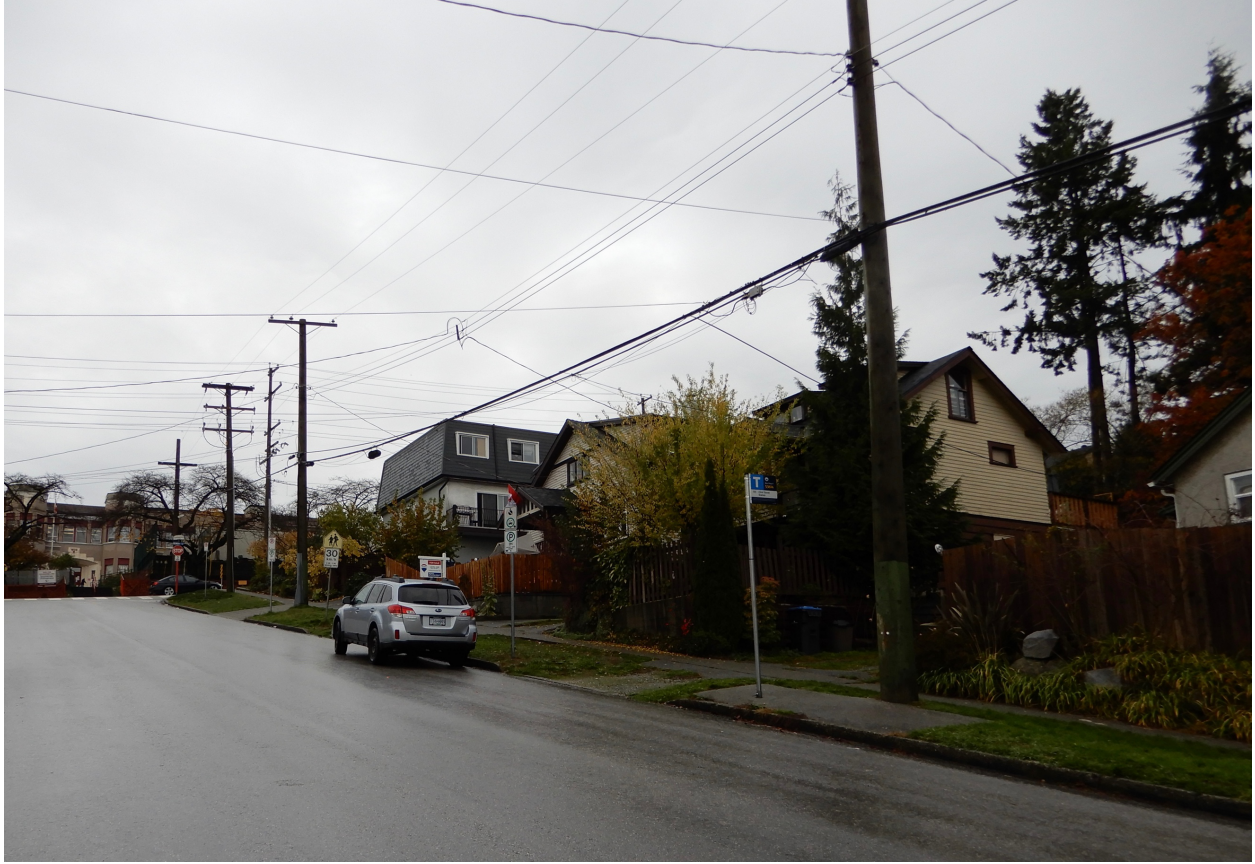
Adjacent buildings.

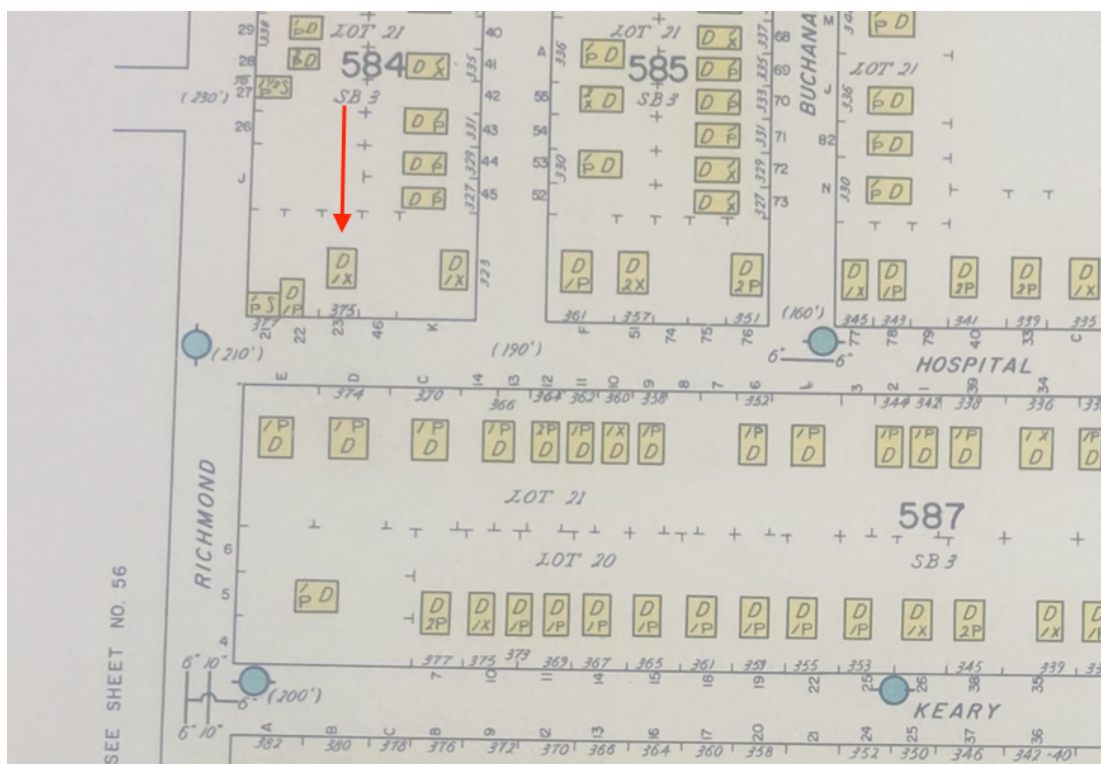
1957. Fire Insurance Plan. (Note: 371 Hospital Street, the adjacent property to 373 is not on this map however the Public Development Site Report states the building permit (Type- Demo/ House Move) was issued in 1956.)

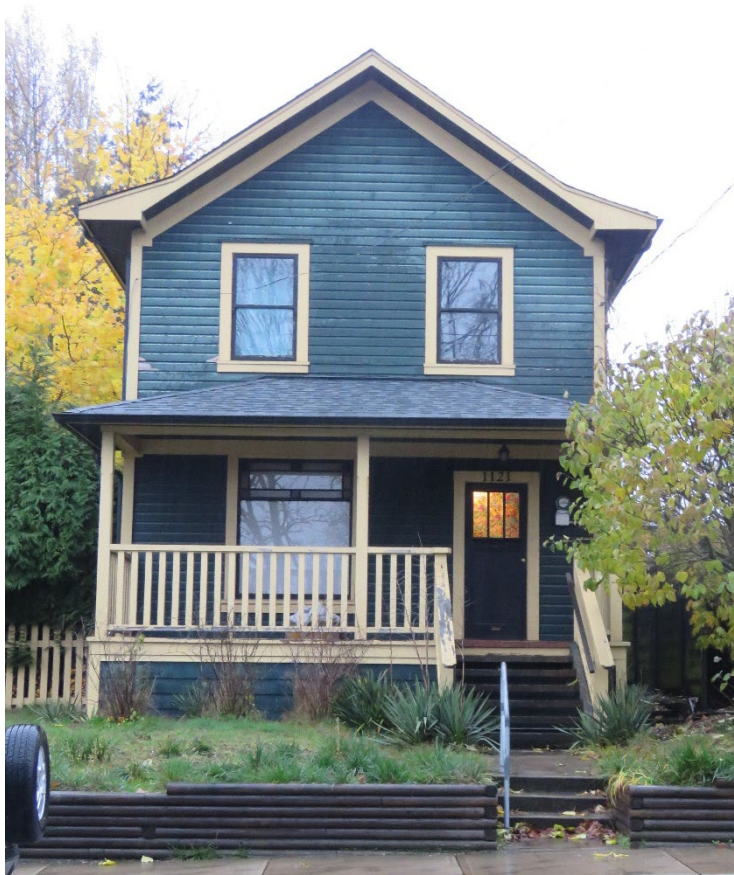
Project South (Front) Elevation

The front elevation is asymmetrical, with the front door on the right side and accessed by wood stairs that are directly in front of it. The front door is a two-panel wood door with a set up triple lights on the upper panel, typical during the period 1911-1931⁶ in North America. There are three windows on the front elevation: a large picture window with a stained-glass transom adjacent to the front door, and two vertical single-hung matching windows on the second storey. The picture window is typical cottage window for the period 1904-1912⁷ in North America.

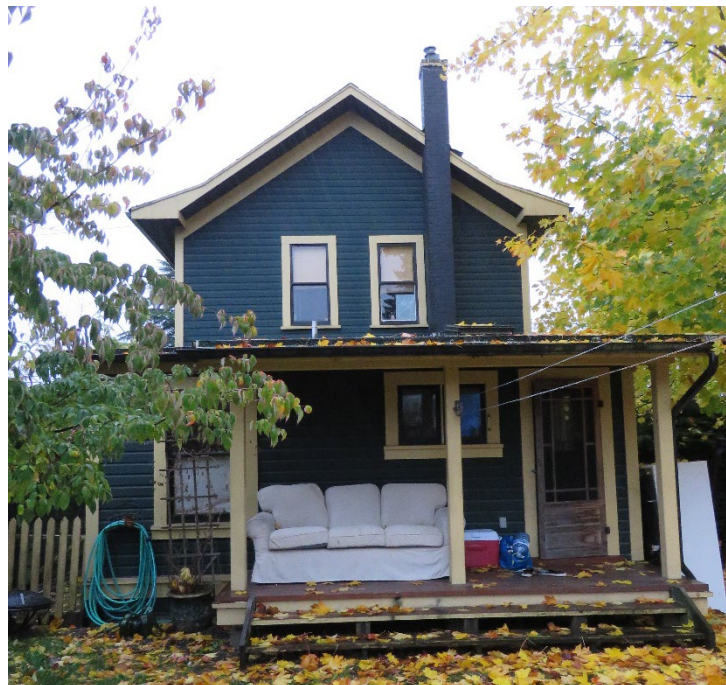
Project North (Rear) Elevation

The rear elevation has a covered porch at-grade supported by three plain and square wooden posts. The roof of this porch is shallow and extends from a roof that also covers a one-storey addition. There are two windows on the upper storey that match those on the front elevation. There is a similar-style vertical window on the lower level and a small horizontal window adjacent to the back door.

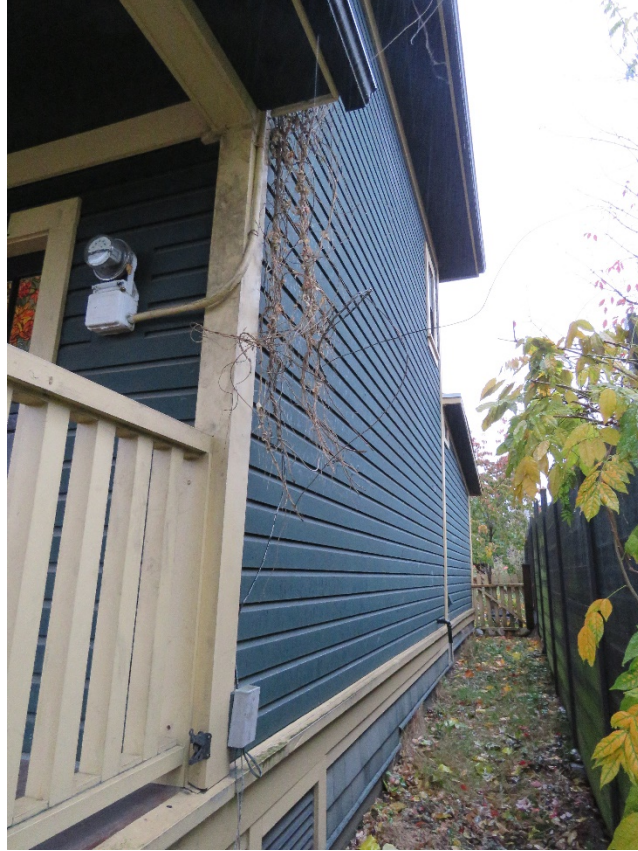
Project East (Side) Elevation

There are few windows on the side elevations. On the east elevation, there is only one vertical single-hung window on the upper level. On the west elevation, there are two vertical single-hung windows.

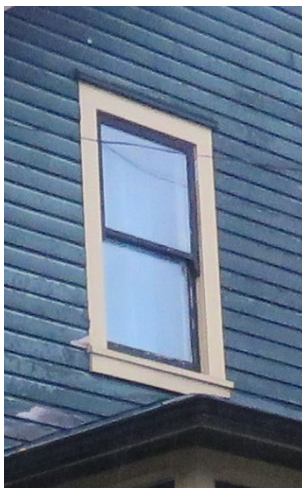
Most all of the windows appear to be original, with wood frames, casings, and sills. Most of the meeting rails in the windows have horns.

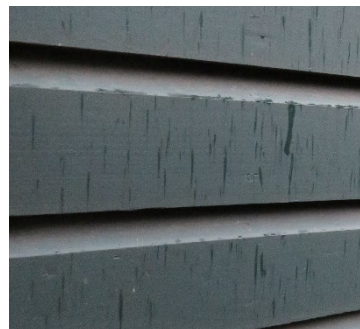
The house is clad, as noted above, in channelled lap wood siding. It has a wood belt course, indicating the level at which the first floor sits. There are corner boards and vergeboards, also all wood. The roof is a medium, front facing gable with bellcast eaves.

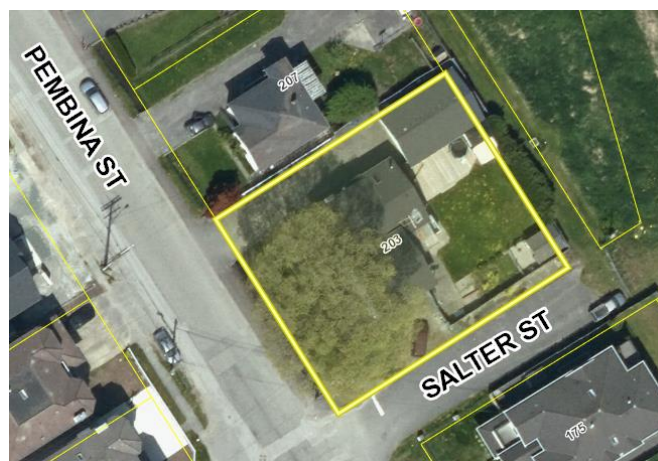
The image above is taken from the City of New Westminster interactive map, and the subject property is outlined in yellow. The subject trees of this report are located on private property, between the civic addresses 203 Pembina St. and 207 Pembina St.

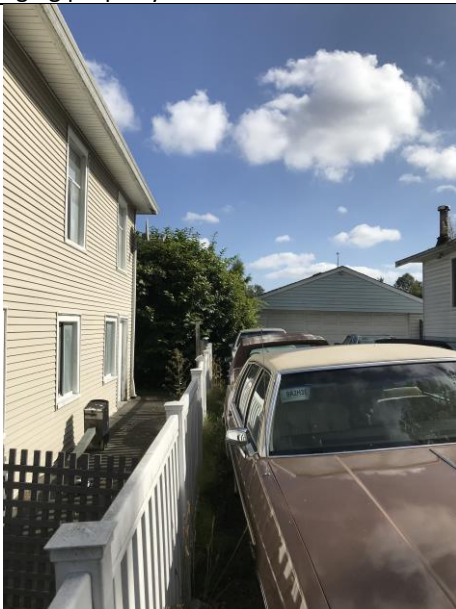
Photo 7: Neighbour's dogwood, can be pruned away from property line
