COMMUNITY HERITAGE COMMISSION AGENDA

- 4.1. Community Heritage Commission Representative to the Social and Cultural Vibrancy Grants Committee
- 4.2. Heritage Revitalization Agreement Application: 501 Fourth Avenue and 408 Fifth Street (Holy Eucharist Cathedral)
- 4.3. Heritage Register Building Mural Proposal: 728 Columbia Street
- 4.4. Heritage Planning Staff Team Update

Heritage Conservation Plan

Holy Eucharist Cathedral - 501 4 Avenue - New Westminster, BC

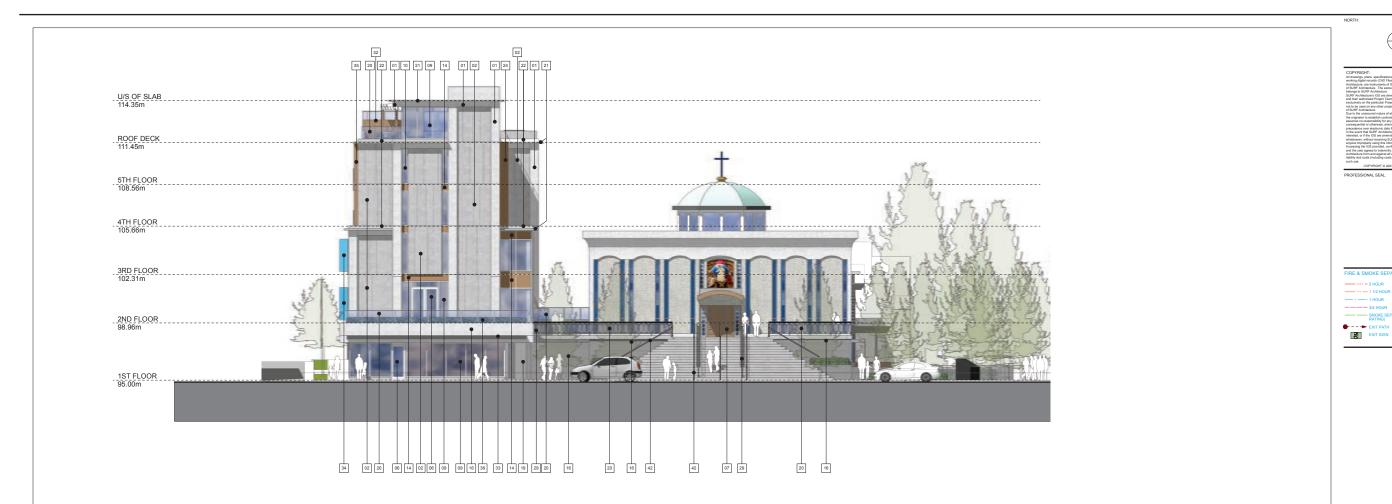
2 SOUTH ELEVATION SCALE: 1/8" = 1'-0"

1 EAST ELEVATION SCALE: 1/8" = 1'-0"

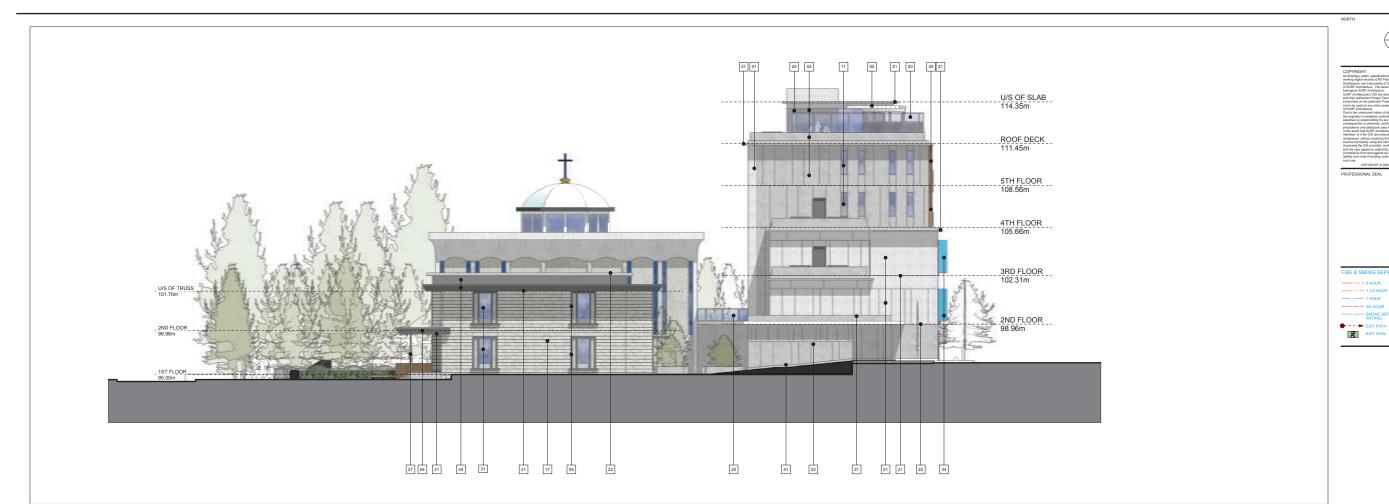
2 NORTH ELEVATION SCALE: 1/8" = 1'-0"

1 WEST ELEVATION SCALE: 1/8" = 1'-0"

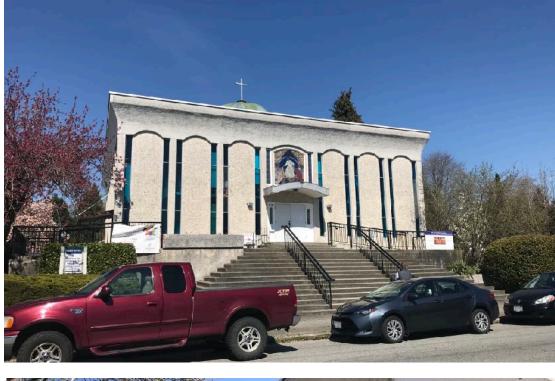
Front view

- Central double-door entrance with arched hood and feature art-glass window above depicting the Resurrection of Jesus Christ, flanked by blue-toned stained glass sidelights depicting traditional Ukrainian octagonal stars.

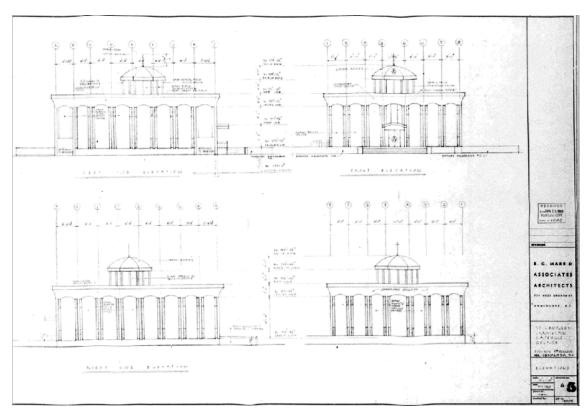
Elevation drawings for St. George's Ukrainian Catholic Church - June 1968. B. G. Marr and Associates. Source: Holy Eucharist Cathedral Parish Archives

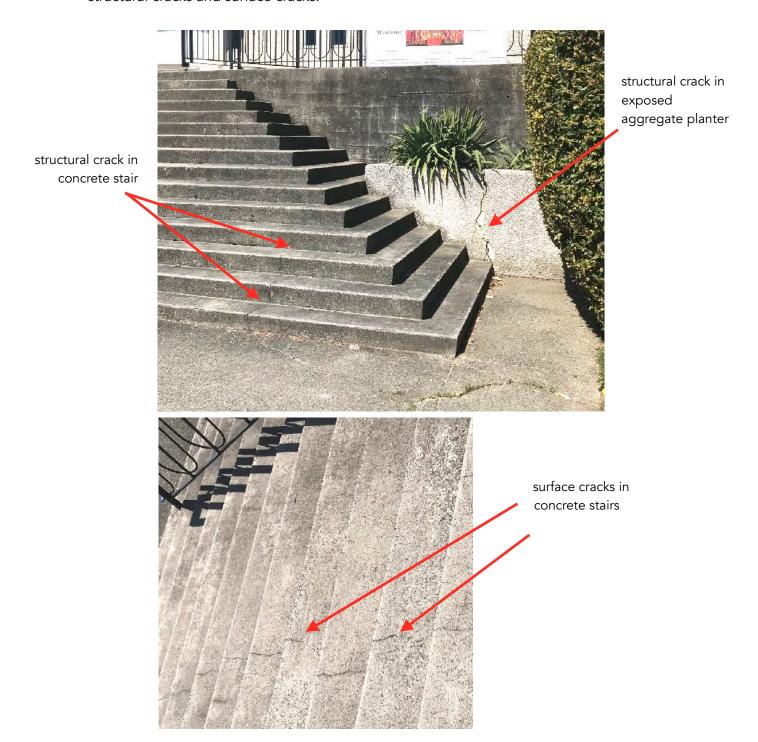
Front stairs and entrance podium

The original poured concrete stairs and hollow podium, with exposed aggregate end walls and planters, are in fair to good condition, but exhibiting wear as well as some cracks - both structural cracks and surface cracks.

Entrance podium - Rehabilitation

Rebuild the entrance podium and stairs to finally resolve the ongoing challenge of the existing lack of Accessibility to both church and hall, increasing and improving both the religious and secular uses of the historic place. In this new configuration, which will not be perceived as different from the street, the basement level hall will now be Accessible at street level from an entrance below the podium (1) and the church will be Accessible via elevators in the new mixed-use building next door (2) that lead onto the reconstructed entrance podium.

Reconstruct the podium and grand stair in their current dimensions and 1960s finishes while adapting the interior of the large hollow podium to a finished, useable space (in this case an Accessible entrance and lobby to the church hall). The only proposed change to the stair and podium design would be the elimination of the final three stairs (circled in the existing photo, right) to the church doors, which would eliminate another Accessibility obstacle, making the walkway connecting the new mixed-use building to the now completely level church podium an Accessible route to both buildings. This rebuilding opportunity also eliminates the need to repair the many structural and surface cracks on the existing concrete structure.

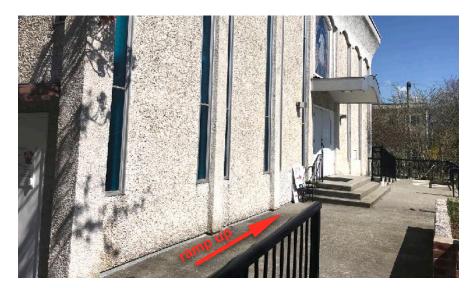
Photo showing the last section of the 'accessibility ramp' arriving at the entrance podium but more stairs at the church entrance doors are left to tackle.

Although the grand entrance and stairs are valued as a prominent feature of the historic place, not all patrons are capable of ascending 18 steps up to the entrance doors (15 stairs plus another 3 from the podium). A poured concrete accessibility ramp which leads from the parking lot to the top of the podium, was installed in 2017 to mitigate this issue, but it falls short of providing fully non-ambulant access to either the church or hall. After ascending the ramp to the church entrance podium, an additional three exterior stairs still need to be climbed, and, although the hall entrance doors are Accessible from the parking lot, once inside, patrons must descend an additional dozen to the hall (basement) level itself. Given the building's large, diverse parish of all ages and abilities, and its robust community rental program, the lack of adequate Accessibility of the current stairs and ramp results in the historic place not being accessible to non-ambulant patrons.

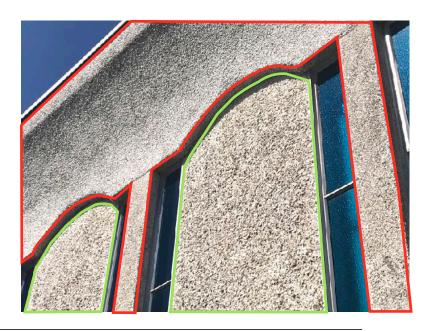
Stucco damage

- 1. Dash Quartz Stone stucco finish on main walls (outlined in green)
- 2. A finer, Granulated stucco finish on cornice and pilasters (outlined in red)

The stucco is generally in good condition but several areas of minor damage (staining, cracks or failure) have been identified, mostly at the cornice corners.

Address the sources of damage to the exterior stucco finish (woodpeckers and faulty roof drainage) and spot repair the stucco by matching the specific original texture. Trade hiring and repair supervision to be guided by a heritage professional.

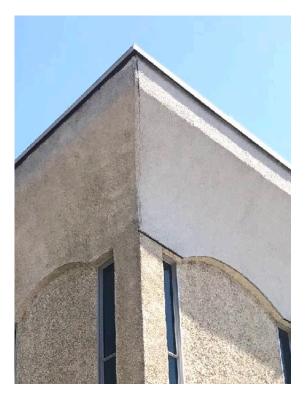
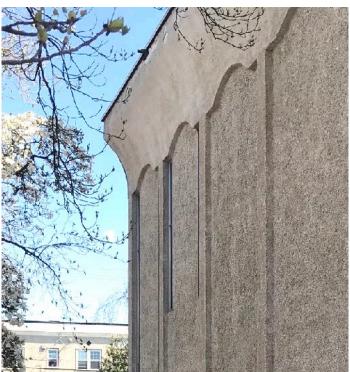
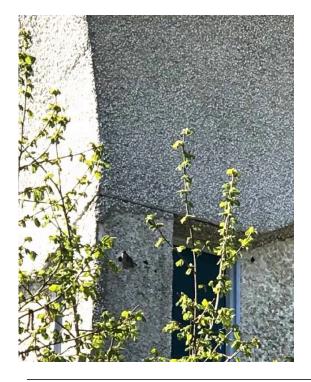
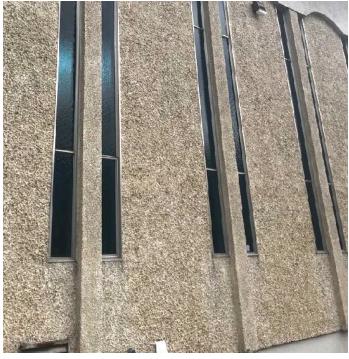
Above left: Cornice at corner of parking lot and lane showing a crack in the stucco. **Above right:** Cornice at corner of lane and yard showing missing/failing stucco just below an new roof drain installed 13 years ago. **Below left:** Cornice at corner of front and yard showing stucco damage caused by woodpeckers **below Right:** Evidence of moisture staining on stucco below windows at parking lot.

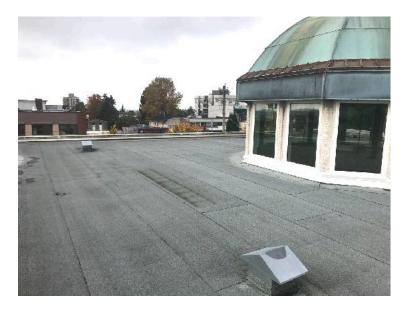
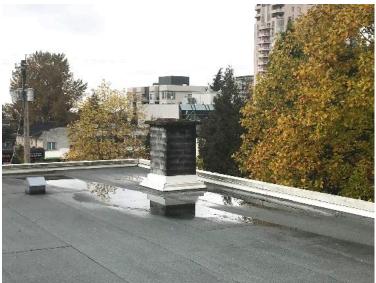
Roof and rainworks

The cathedral has a flat, torch-on roof which appears to be in good condition and reasonably vented. The drainage however, isn't functioning optimally as after a rainfall there are areas where water pools. Especially near the edges, as seen in the photos below. The downspouts on the cupola appear to be inconsistent and in need of some adjustments or replacement. There is evidence of water staining on the stucco at the cupola eaves.

Assess flat roof drainage, venting, edge coping and cupola downspouts and make adjustments to repair and optimize the shedding of water off the cupola and off the roof in a manner that doesn't allow water poling on the roof nor dripping down the side elevations.

Improve access to roof hatch so that congregation members can regularly and safely access the roof for periodic inspection (twice a year, before and after winter). Keeping a regular eye on the functionality and condition of the flat roof is crucial. See Maintenance Plan.

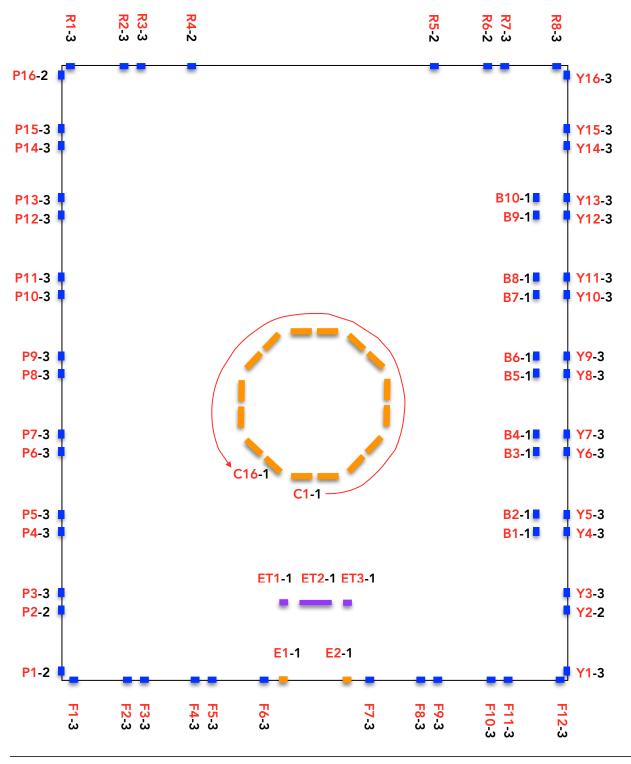
The church has a total of 83 windows as illustrated on the below window map: 17 on the front and entrance (F and E windows), 26 on the yard elevation (Y and B windows), 8 on the rear (R windows), 16 on the parking elevation (P windows) and 16 in the cupola (C windows).

P1-3 (Blue) - blue textured glass P1 - Parking window # 1 (of 16) (Orange) - clear glass **3** - made up of three panes (Purple) - speciality glass (art or stained glass) Windows with opening mechanisms This map shows the 20 windows that were designed to partially open, to provide passive ventilation in the building. The opening lights are all awning windows with two types of hardware mechanisms - 1. A push-out with locking levers where reachable in the choir loft and narthex, 2. cord-operated telescopic screwjacks **B9-1** on the upper transoms in the nave and sacristy. All of these 20 windows do still open, but some only partially, some do not close completely, and some hardware components are either missing, P11-3 damaged or not operating optimally. **■ B7**-1 Y10-3 Bottom too Bottom too **P9-3** Y8-3 ■ **B5-1** P7-3 **Y6-3** B3-1 P5-3 Bottom too **Y4-3** ■ B1-1 Bottom too Left: Fully open transom window in nave, operated by cord-operated telescopic screwjack. Right: Fully open push-out lower window in narthex, which closes with a locking lever.

The original design of facing upper and lower opening windows in the church was intended to enable passive (natural) ventilation in the church and needs to be used regularly and fully (both upper and lower lights) in the summer months. Replace broken window panes in-kind with

textured blue glass and restore the original opening and closing mechanisms of all opening windows to open fully, lock securely and be sealed properly when closed. All opening transom windows (upper windows) will need to be fitted with removable bird screens (ideally with transparent nylon netting to reduce aesthetic impact) to ensure that birds cannot fly into the church when the windows are open. Trade hiring and repair supervision to be guided by a heritage professional.

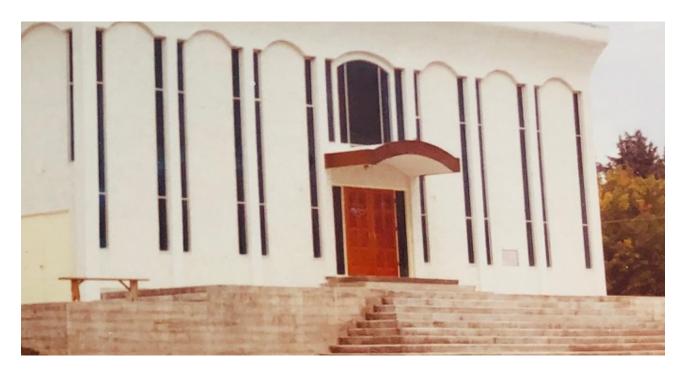
Doors

The current front door assembly (below) is of insulated steel, however it is not properly sealed in its frame. There is noticeable air leak around the entire assembly in winter time. The design, colour and material of this door are not in keeping with the original 1960s door which was solid, carved wood with a lacquered finish and full height blue glass sidelights on either side (see above archival photo). The incompatible appearance of the current door, which was installed in recent decades, diminishes the authentic design of the facade elevation.

Restore a solid carved, unpainted wood door assembly with glazed sidelights to the front entrance, as per the original 1968 design, and based on the earliest colour photographs of the church upon completion. The sidelights can be of textured blue glass or match the blue-toned stained glass sidelights above the door depicting traditional Ukrainian octagonal stars. Final design, intervention plans and construction supervision to be guided by a heritage professional.

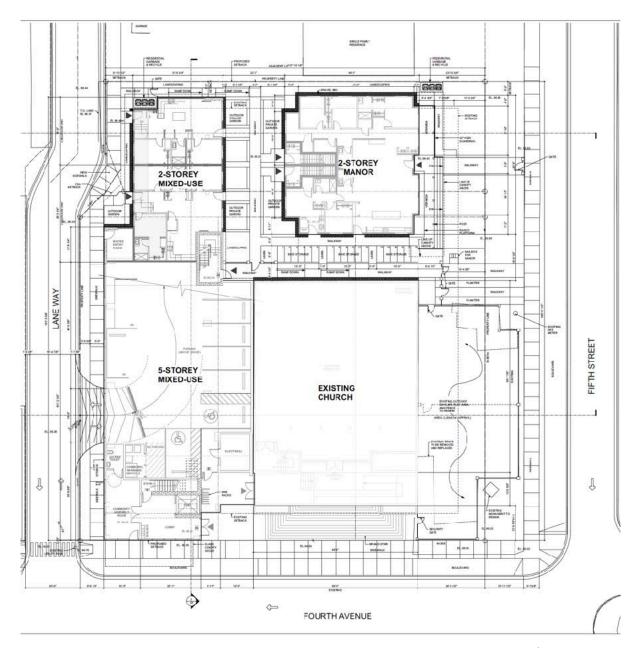
Site Plan

Source: Surf Architecture

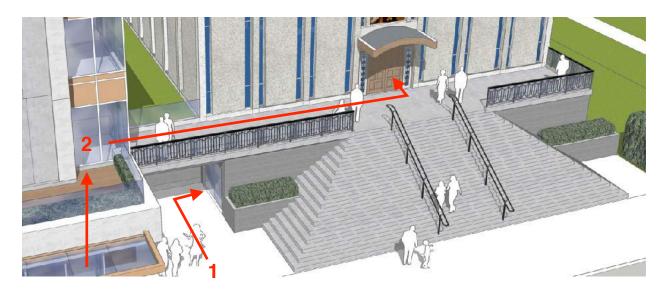
Render of proposed reconstructed and rehabilitated entrance podium and grand stair, and its connection via walkway to the new mixed-use building. Numbered entrances applied by author. Source: Surf Architecture

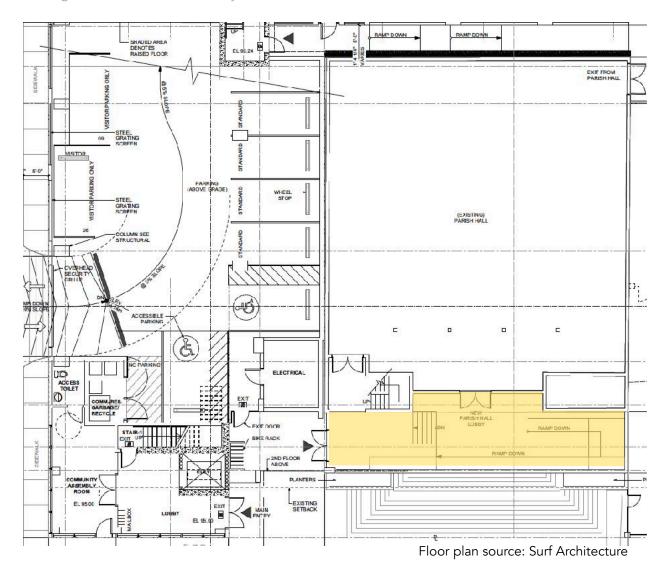
Above: Portion of the level 1 floor plan for the proposed development.

The reconstructed entrance stair will have a total of 16 steps, all in the 'grand stair', eliminating the current separate flight of 3 at the main church doors. The currently hollow, unfinished and unused interior of the podium structure will be rebuilt to serve as a new lobby for the parish hall (highlighted in yellow). The parish hall will now be Accessible both from the street and from the underground parking, while the church entrance will now be Accessible from the street or parking area via the elevator in the new building.

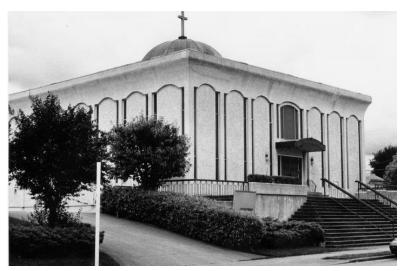
NWPL historic photos database # 2624 c.1970s

The metal railings along the podium at the church entrance had a decorative element to them as seen in this archival photograph, right. Only the front corner portion (at 5th Street) of this historic railing survives while the remainder was replaced with a simple rail when installing the ramp from the parking lot. Restore this railing style consistent across the entire front of the podium, ideally using any stored original sections, or if not by replicating the surviving corner section.

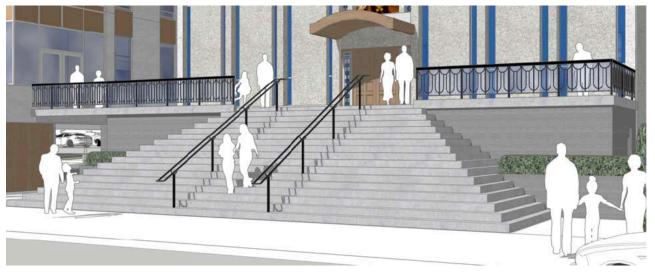
Render of proposed reconstructed and rehabilitated entrance podium and grand stair, with two sections of decorative metal railing - restored (left) and preserved (right). Source: Surf Architecture

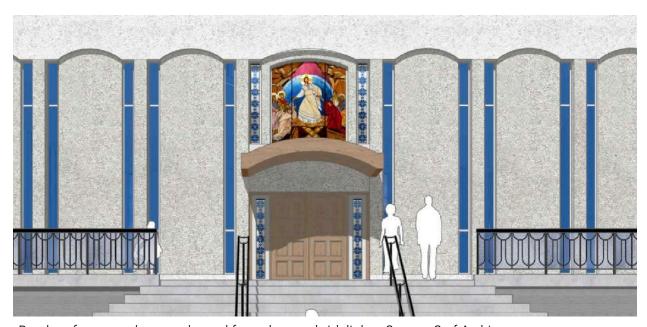
Render of proposed restored wood front door and sidelights. Source: Surf Architecture

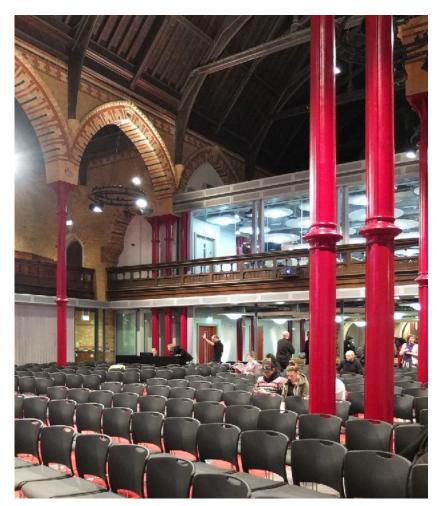
Photograph of the rehabilitated choir loft in St. Jude's Church in Kensington, London. The loft is not only closable with sliding glass doors but and extra layer of blinds can be pulled down to give visual separation. Source: Ellis and Moore Consulting Engineers

Work with a structural engineer to ensure the projecting choir balcony load capacity can sufficiently sustain the new proposed wall of sliding windows. Plan the design and installation with a heritage professional to ensure minimal design impact and disruption of original elements in the church. Design a configuration that is 100% reversible.

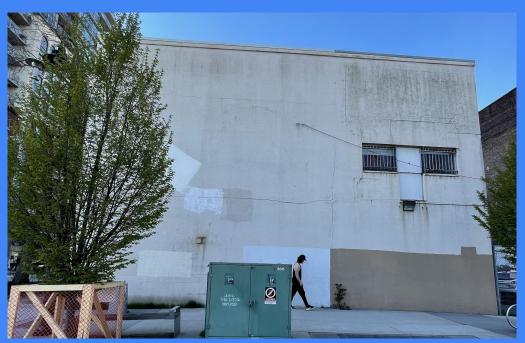
Location: 728 Columbia St, New Westminster, BC V3M 1A9 **Wall Measurements**: 10m x 8m

This wall will get a clean outdoor coat of white paint to help preserve the mural image that will be placed onto the wall.

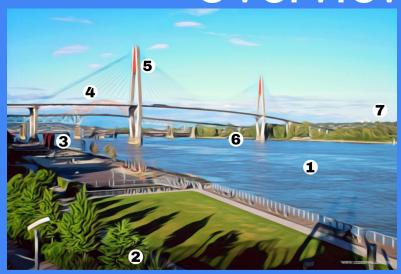
The concept of this mural is to educate individuals about the history of New West. In this photo each number will indicate a scannable QR code. (Ex. The bridge will have its own QR code, once it is scanned with a mobile device it will direct you to information on how the bridge was created). The mural will have 7-10 scannable codes throughout.

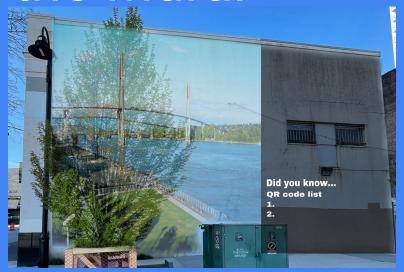
This image above shows a visual of how the finish product will look. All of the cords and windows to the right hand side will be avoided completely and painted around with a black coat of paint to make the "did you know" section pop. Each number located on the mural will correlate with the scannable code in the corner. (These will be painted on at a more suitable scannable height level)
