REPORT

From: Emilie K Adin, MCIP **File:** HER00710
Director of Development Services **Item #:** 45/2021

Subject: **108 - 118 Royal Avenue and 74 - 82 First Street: Heritage Revitalization Agreement and Special Development Permit Applications - Preliminary Report**

Heritage Conservation Plan

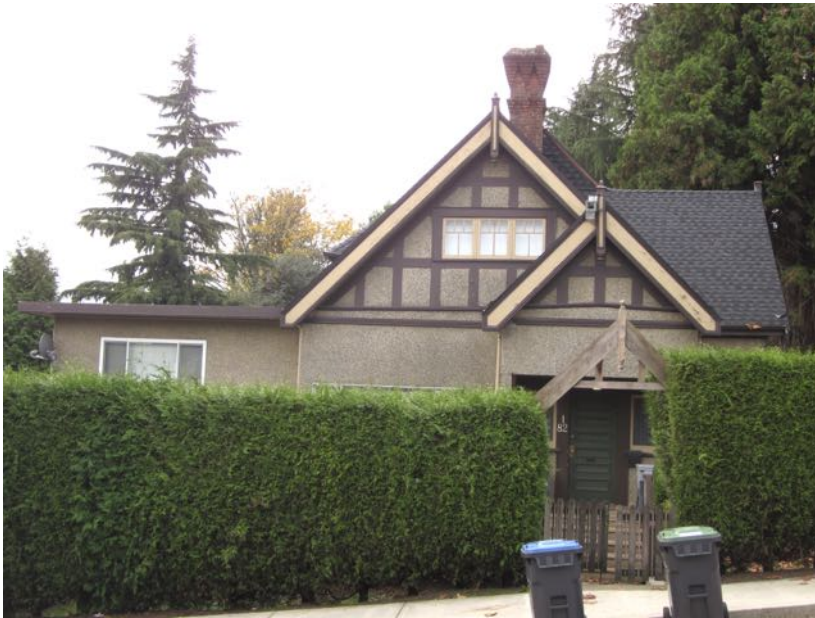
E. M. N. Woods House

The E.M.N. Woods House is a 1 1/2 story, stucco-clad Victorian English Arts & Crafts style house located between Queen's Park and Albert Crescent at the southeast corner of Royal Avenue and 1st Street in downtown New Westminster. A two-storey, flat-roofed rental building is attached to its south side.

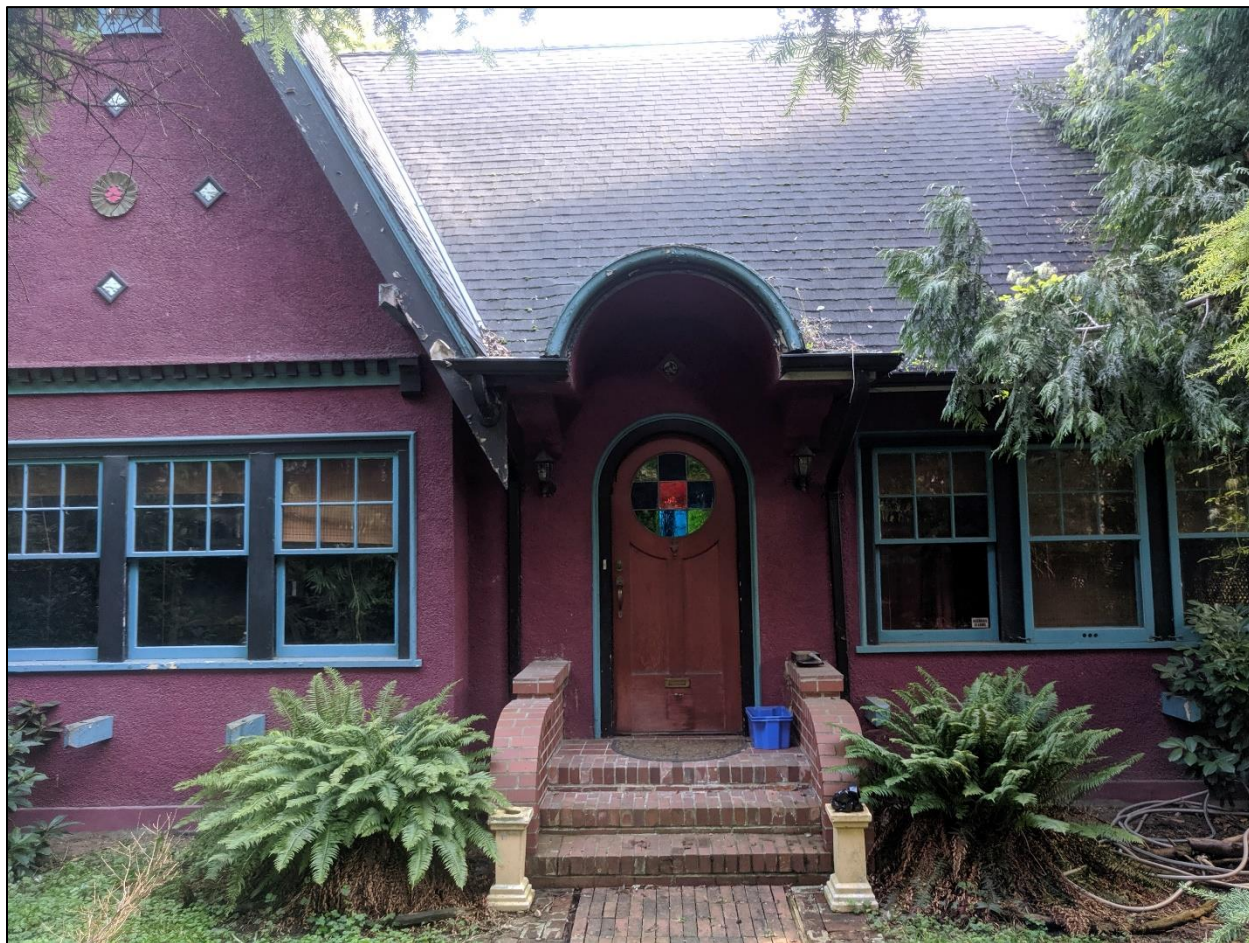
Fig. 1: Partial front view of 112 Royal Avenue, New Westminster, BC, 2019. (Source: Cummer)

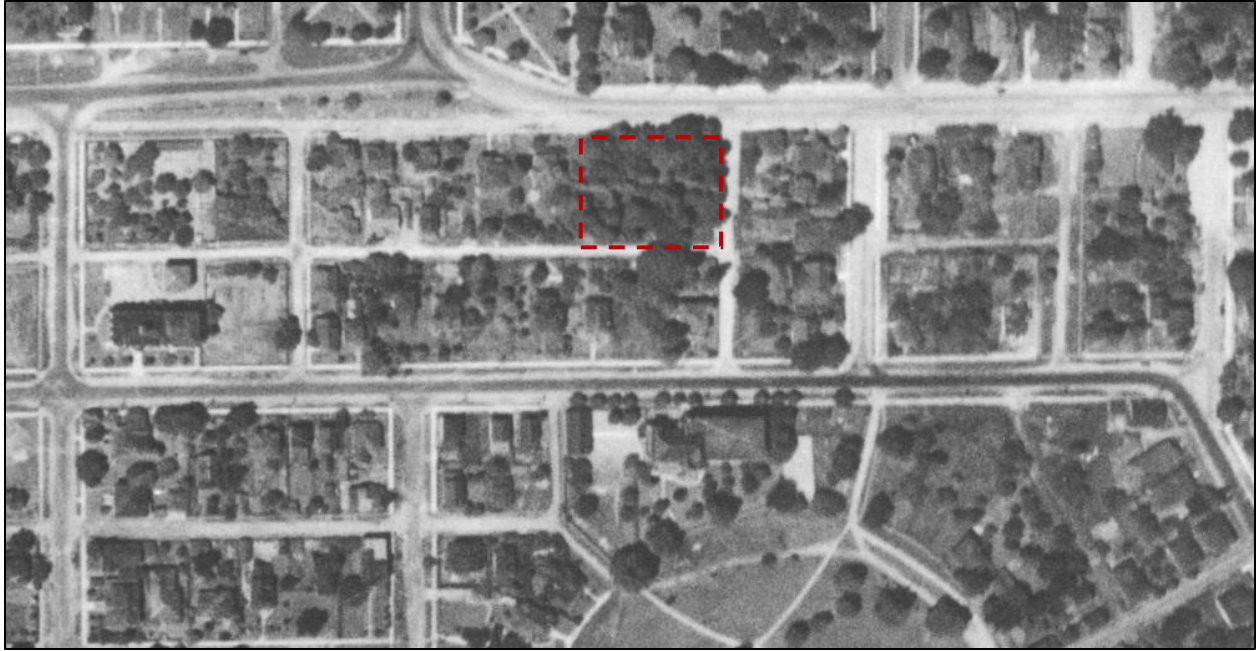
Fig. 6: Section from a Royal Canadian Air Force aerial photograph of New Westminster, 1928. Note the still heavily forested area of 112 Royal Avenue (Lot 15) and its neighbouring lots (Lot 13 and 14), whose approximate area is outlined in red. The uppermost horizontal road at the top of the photograph is Royal Avenue. (Source: Library & Archives Canada, AA287_057)

However, “this block of Royal Avenue in the historic neighbourhood of Downtown was [also] developed in two phases – initially around the turn of the 20th century, during the city-wide building boom, and then during and post World War II when a housing shortage sparked another wave” (Zysblat 2018, p. 2). The house at 112 Royal Avenue is “a bit of an anomaly within the development pattern of the street, as it was the sole development on this block during the inter-war years, erected in 1930” (*ibid.*). This area of Royal Avenue (at the corner of Royal Avenue and Windsor Street) was not developed until the 1930s, as distinctly visible in comparing a 1913 Fire Insurance Map (Figs. 4a and 4b) with one from 1957 (Fig. 5), as well as a 1928 aerial photograph of the area, showing the area still forested and undeveloped (Fig. 6).

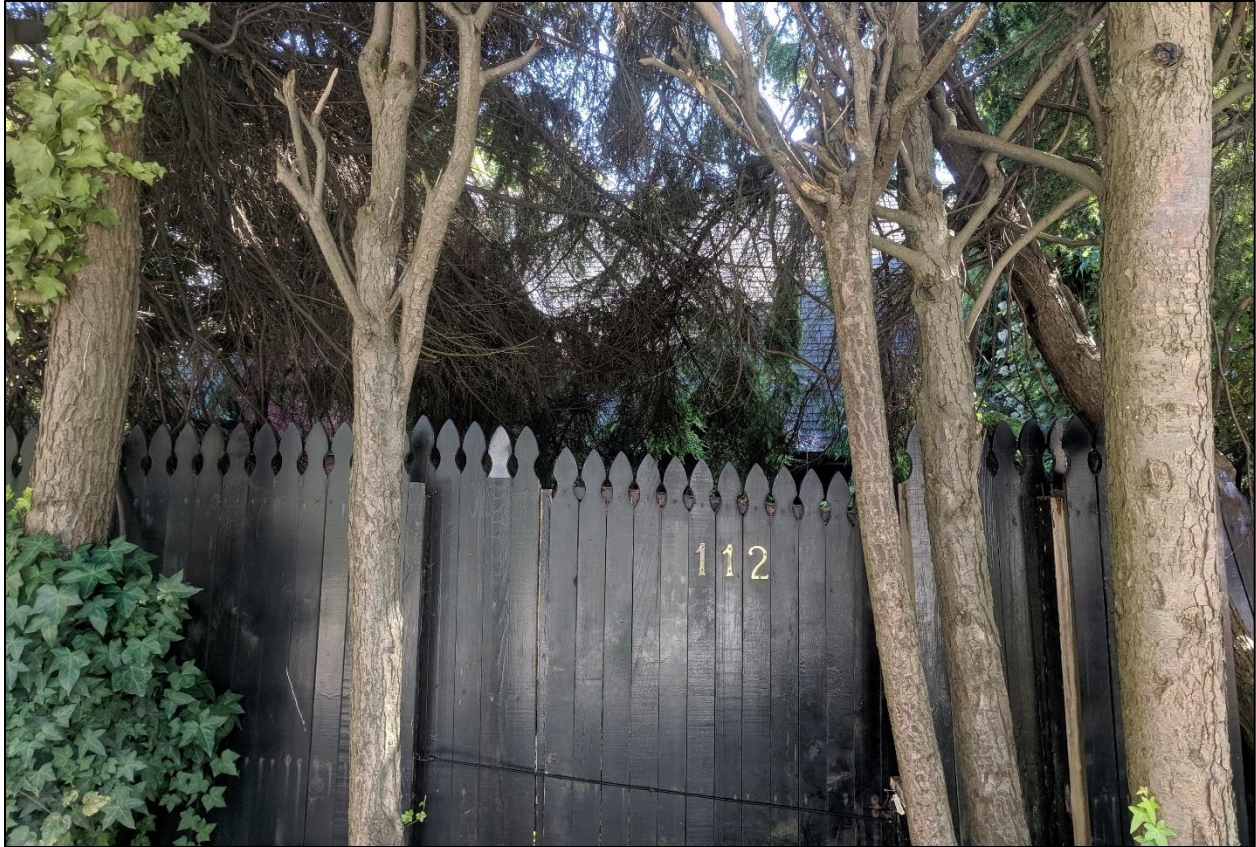
Fig. 7: Front view of Henderson House, at 112 Royal Avenue, from Royal Avenue, showing the property's front gate and foliage blocking out the heavy traffic along Royal Avenue. The house is visible in the background, through the trees. (Source: Cummer, 2019)

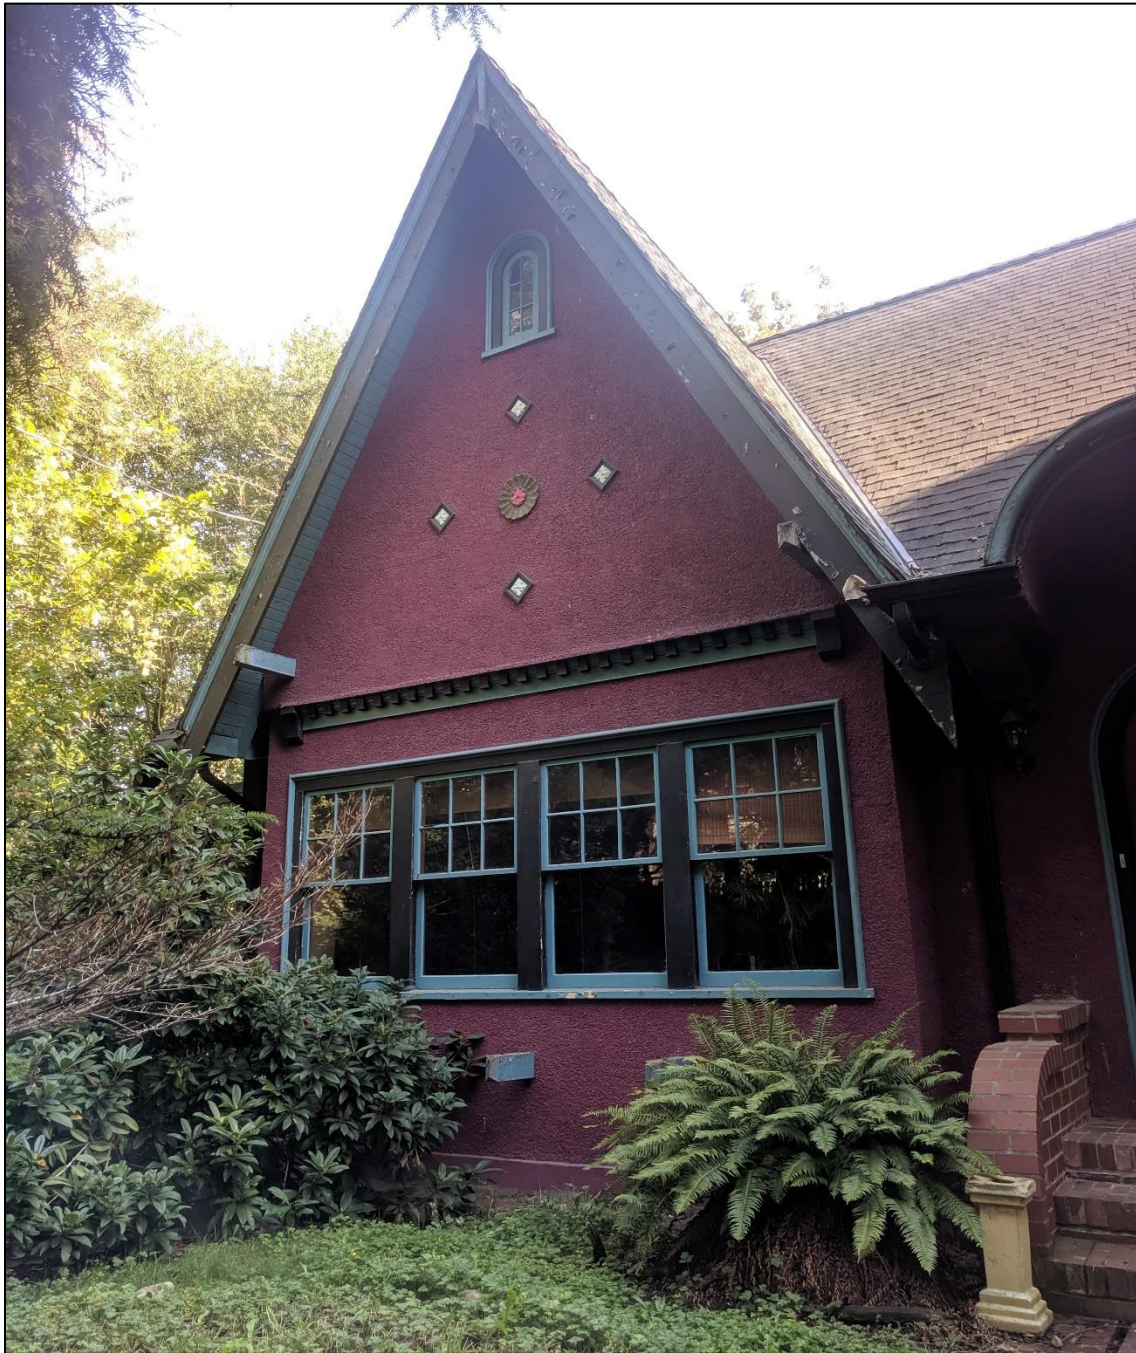
Fig. 9: Partial front view of Henderson House at 112 Royal Avenue, 2019, illustrating the steeply pitched offset front gable with ornamental diamond detailing, floral roundel and small arched window at the top as well as the dentil moulding, with a partial view of the arched roofline over the front door and the arched brick front stairs. Note the surviving window box supports, although the window boxes themselves are missing. (Source: Cummer)

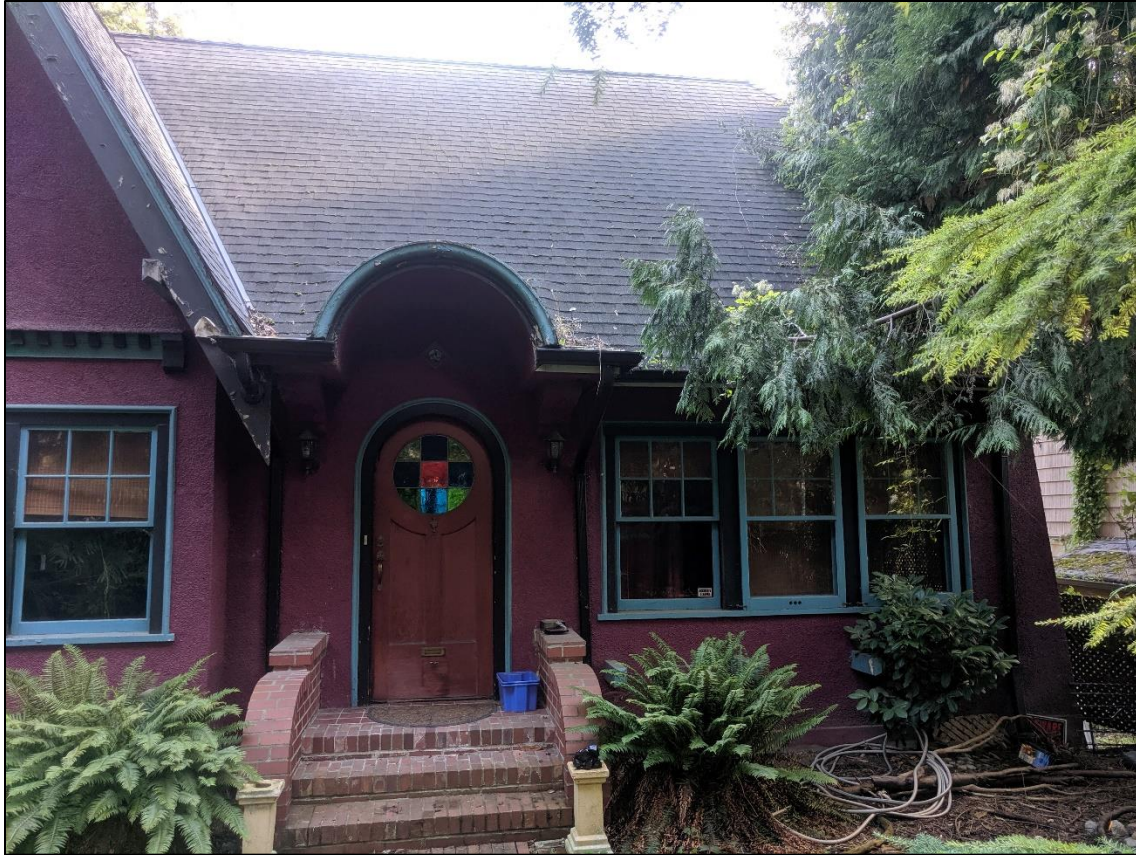
Fig. 10: Partial front view of Henderson House at 112 Royal Avenue, 2019, highlighting the arched roofline over the arched front door with multi coloured stained glass window and the arched brick front stairs, as well as some of the double-hung divided-light wood windows. (Source: Cummer)

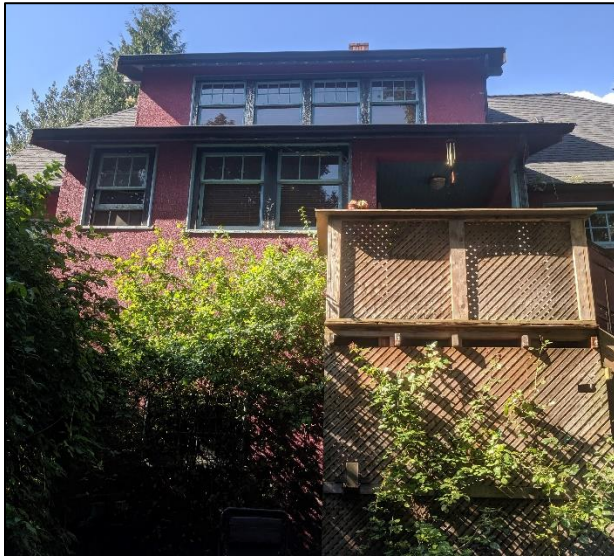
Figs. 11 and 12: Left (Fig. 11) shows the back view Henderson House at 112 Royal Avenue, 2019 and right (Fig. 12) shows the eastern side view, from Windsor Street, 2019. (Sources: Cummer)

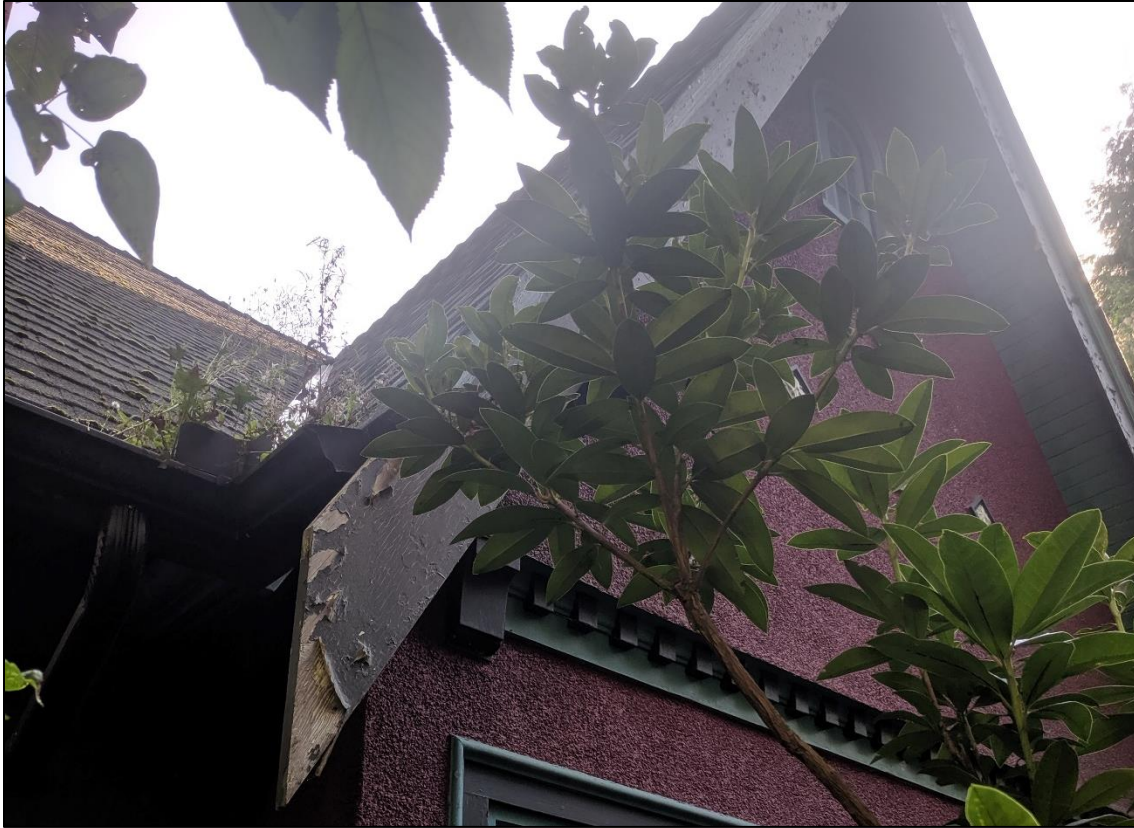
Although the roof is in fair condition, overall, there are areas in need of repair and maintenance. As mentioned above, there are fascia boards in need of repainting (Fig. 16) and sections of the roof and gutters in need of cleaning and clearing (Fig. 17).

Fig. 16: Northeastern view of Henderson House at 112 Royal Avenue, 2019, illustrating the roof fascia deterioration in the front offset gable, as well as some plant growth in the house's gutters. (Source: Cummer)

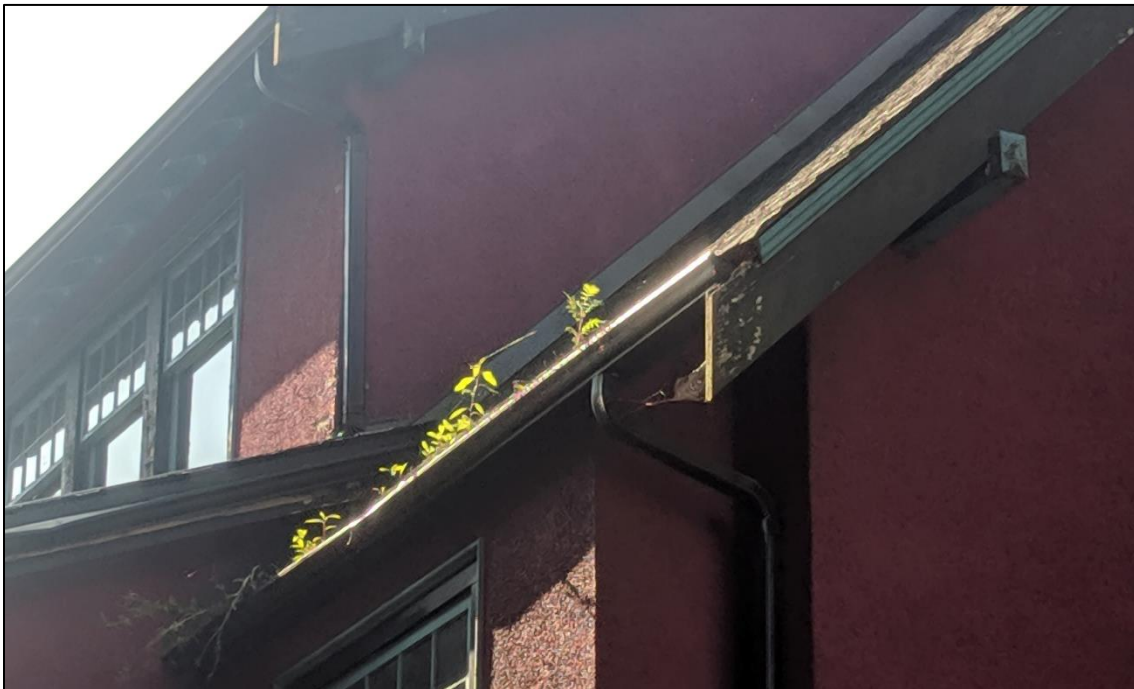
Fig. 17: Southeastern view of Henderson House at 112 Royal Avenue, 2019, illustrating another fascia board deterioration as well as additional plant growth in the house's gutters. (Source: Cummer)

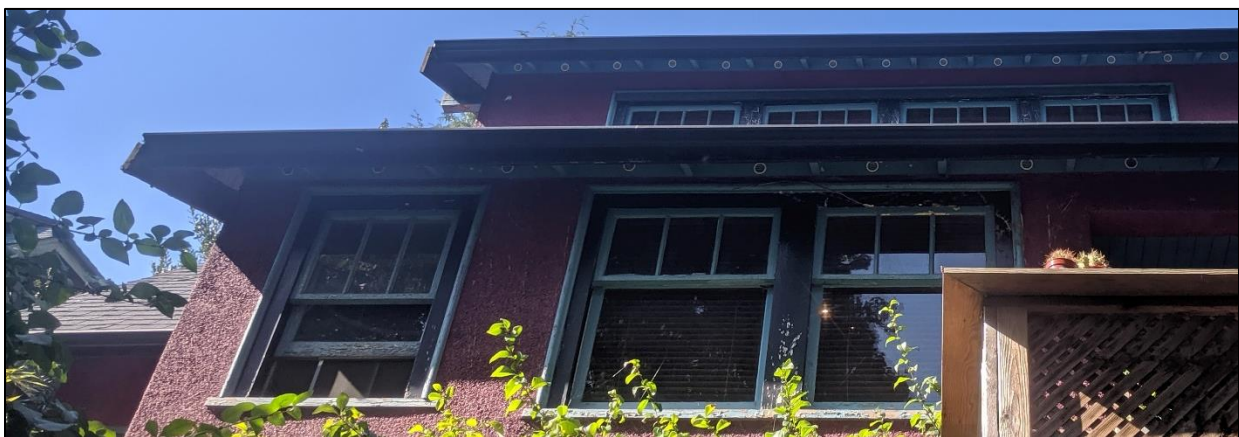
Fig. 24: Shows the windows at the back of Henderson House at 112 Royal Avenue, 2019. (Source: Cummer)

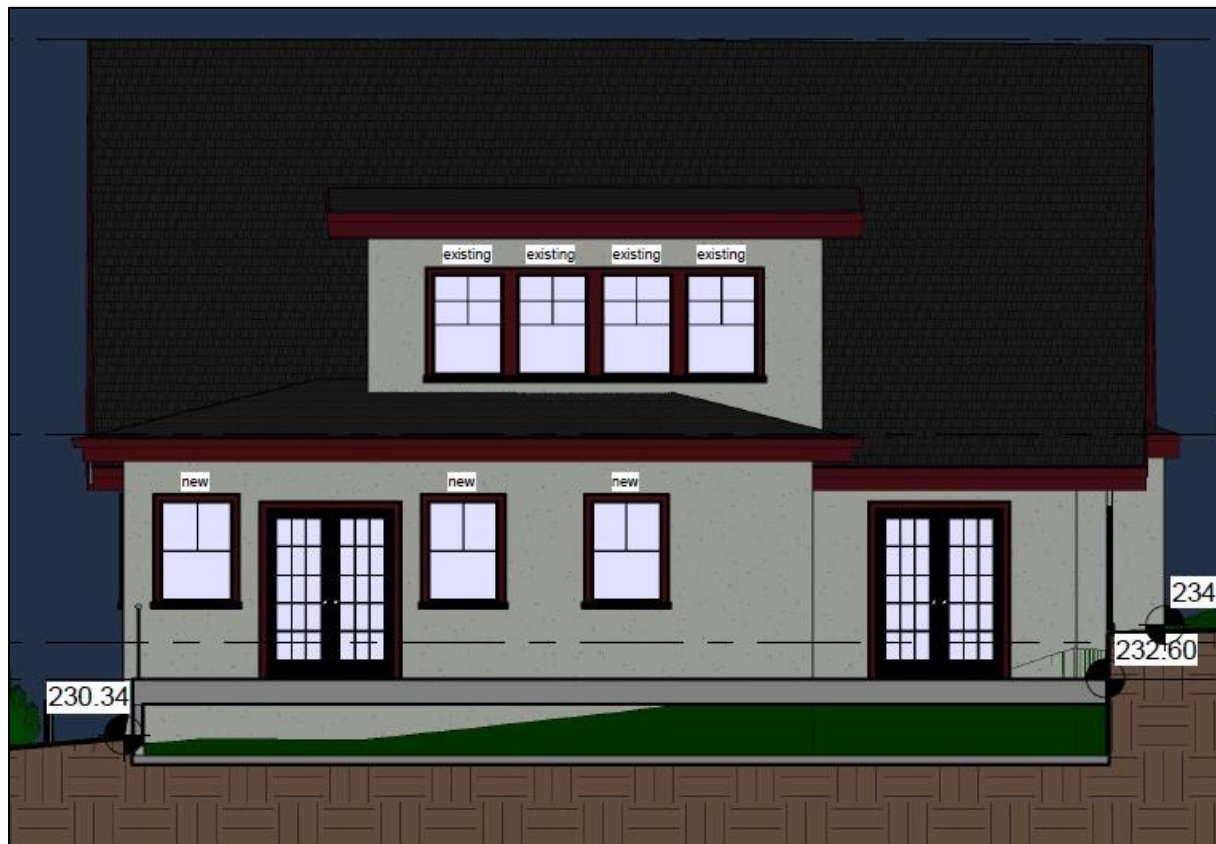
Fig. 30: Rendering of the restored rear façade of Henderson House, 2020. Note the removed back-porch. (Source: D3 Dimension, Drafting and Design Inc.)

- 1) Moving the house to a new location within New Westminster;
- 2) Extending the basement height;
- 3) Preserving, but extending the arched front stairs (Fig. 29); and
- 4) Removing the back-porch addition (Fig. 30).
