REPORT

Report #: 253/2014

Subject: 514 Carnarvon St Heritage Revitalization Agreement & Official
Community Plan Amendment Preliminary Report

DONALD LUXTON
AND ASSOCIATES INC

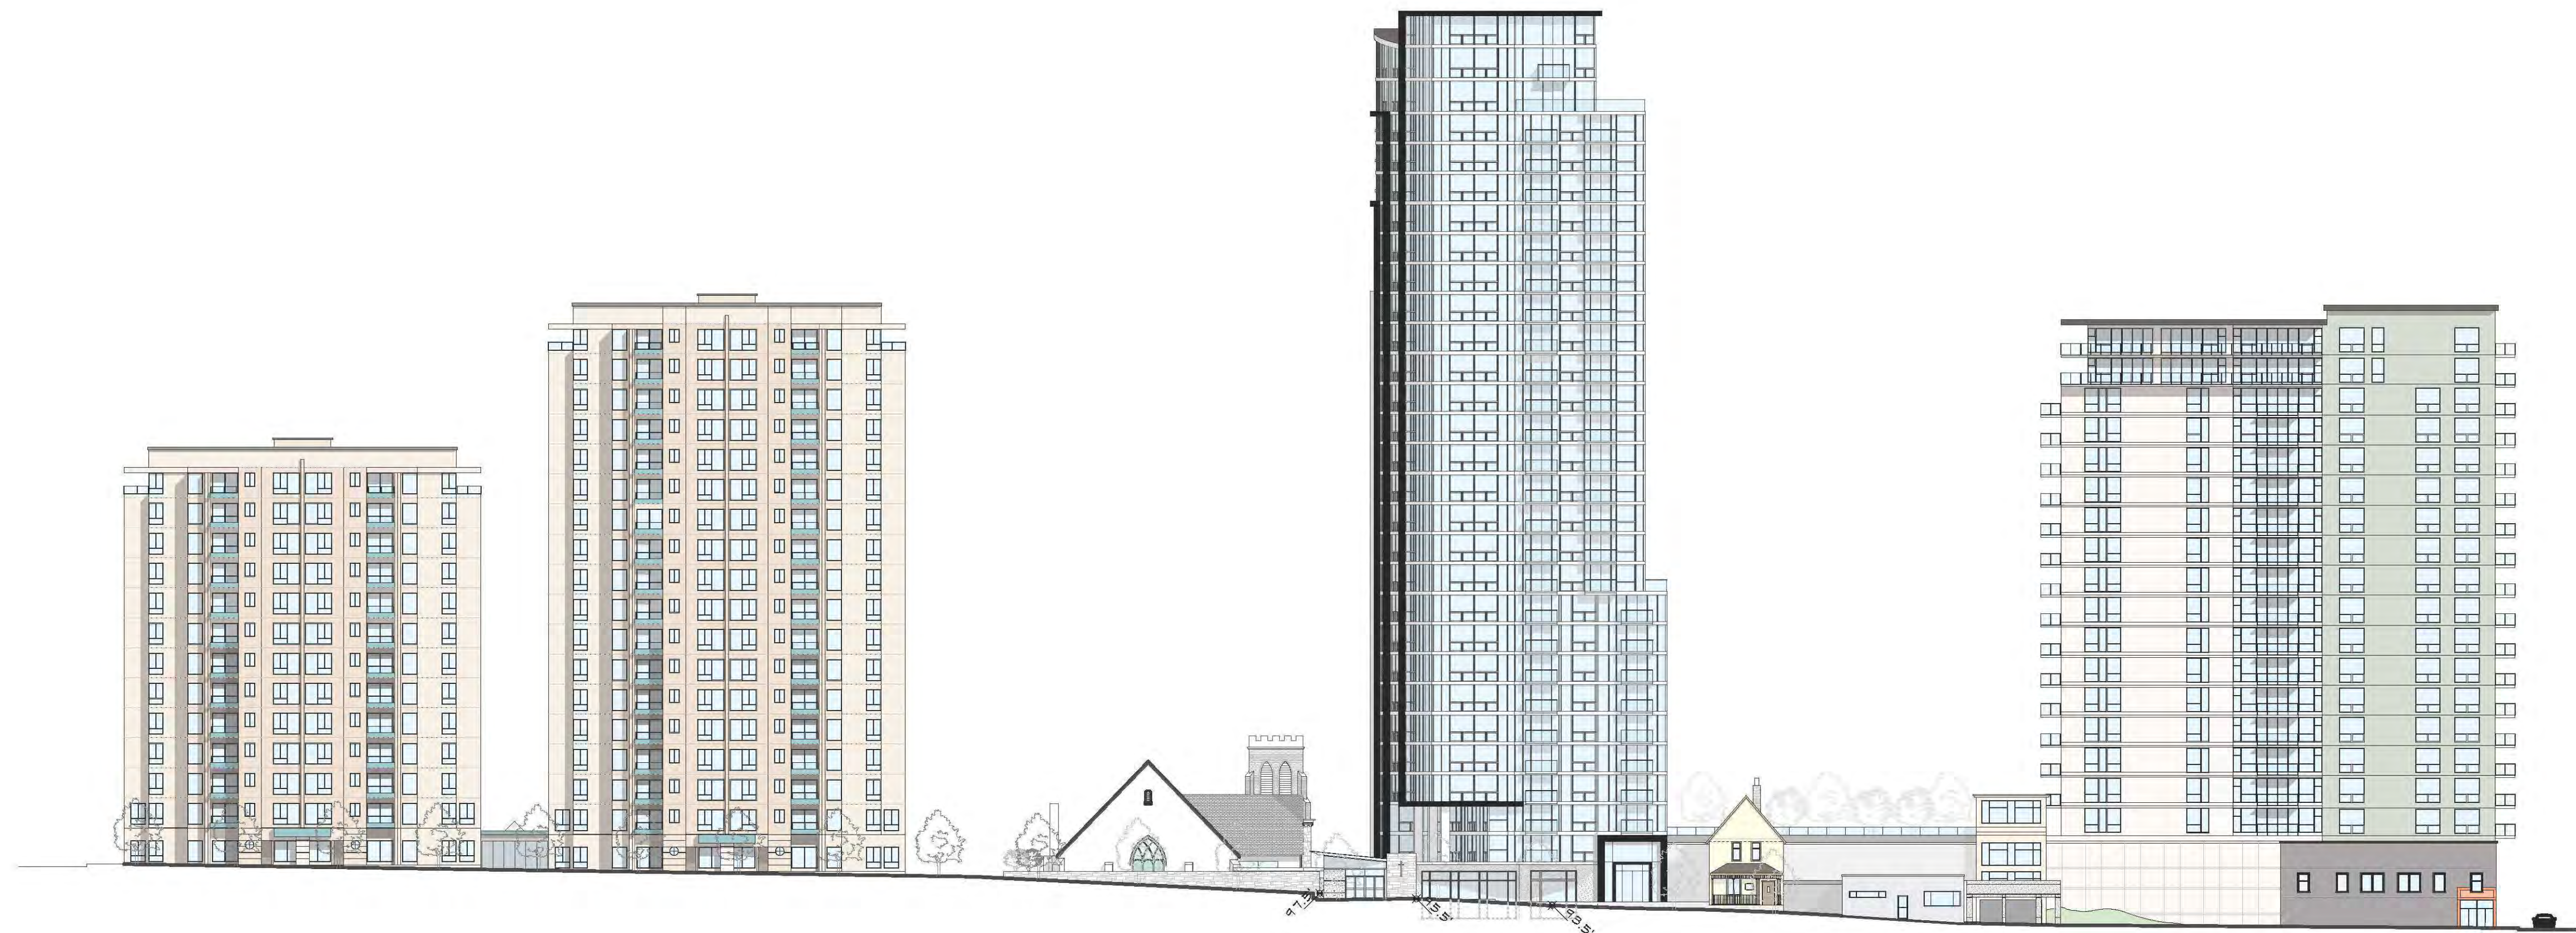
1 NORTH ELEVATION- STREETScape ALONG CARNARVON
SCALE: 1/32" = 1'-0"

- *"Conserve the heritage value of an historic place."* As noted, the heritage value of the Cathedral lies partly in its location on the site, including the space around it and the view of it from both directions on Columbia Street. The proposed tower would overwhelm the Cathedral and become the prominent focus.

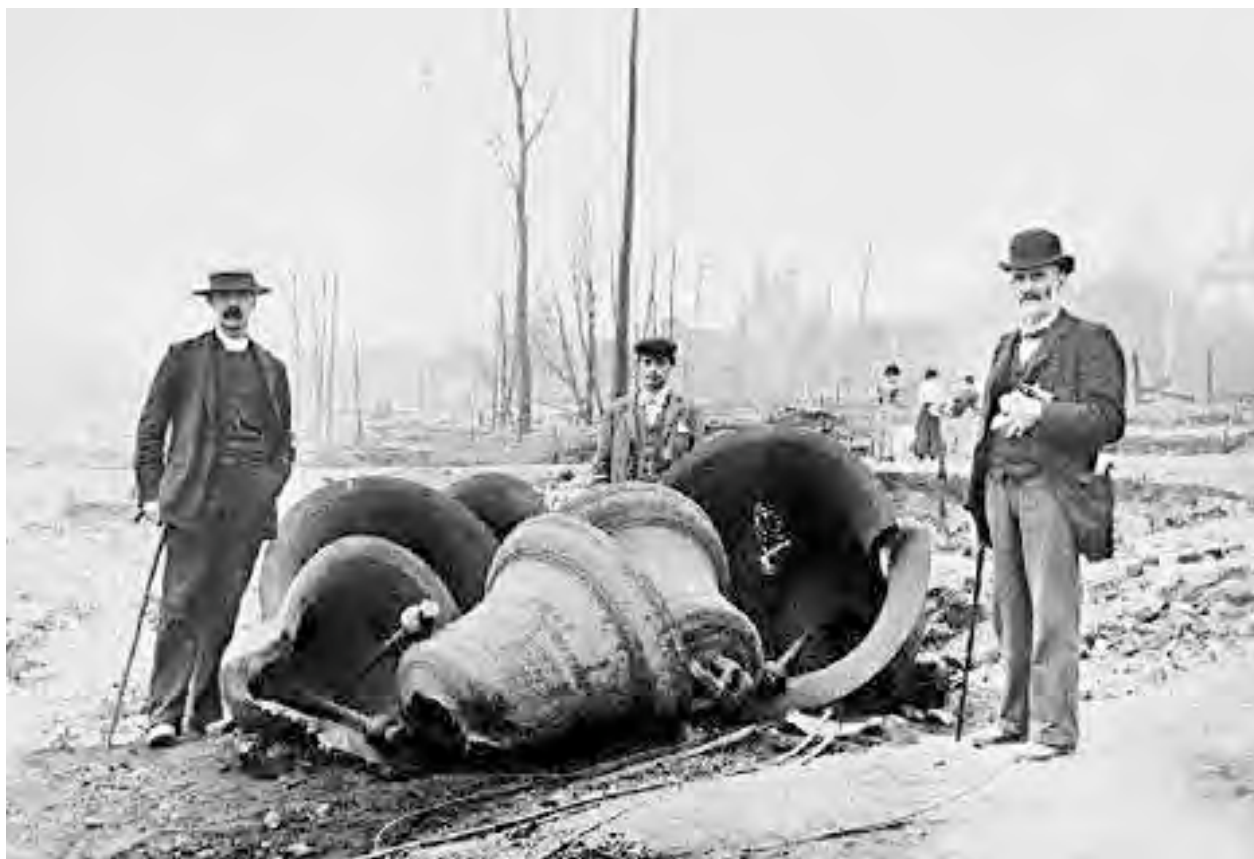
The fire-damaged bells of Holy Trinity Cathedral. [BC Archives A-03362]

cracked beyond repair. Burdett-Coutts refused to donate more bells, so the seven cracked bells were sent to San Francisco to be melted down to provide funds for rebuilding the Cathedral. The one original bell that remained, named "Wisdom," still hangs in the tower.

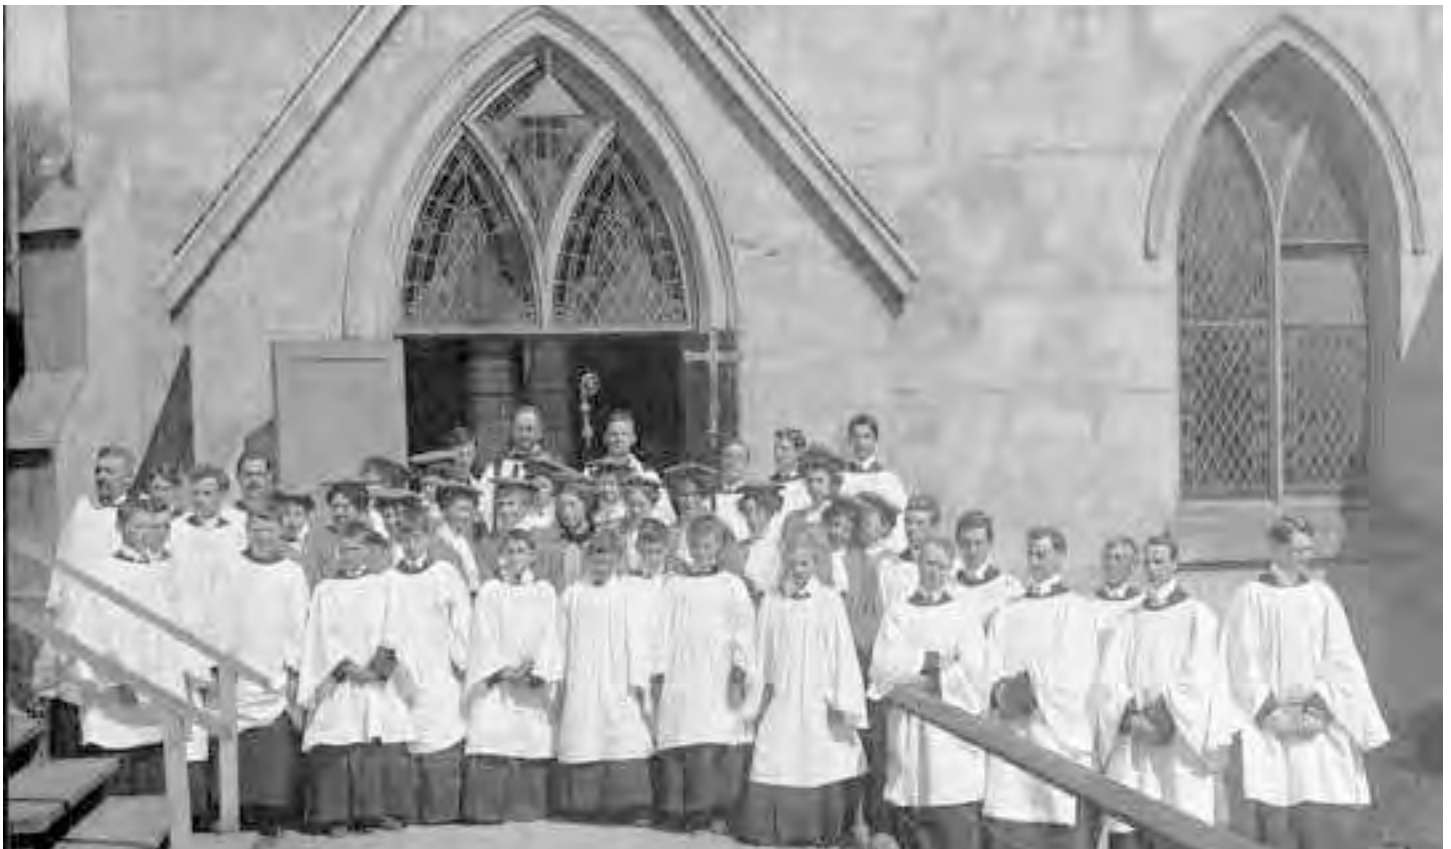
Cement parging on exterior of church, 1900 [NWMA IHP0009]

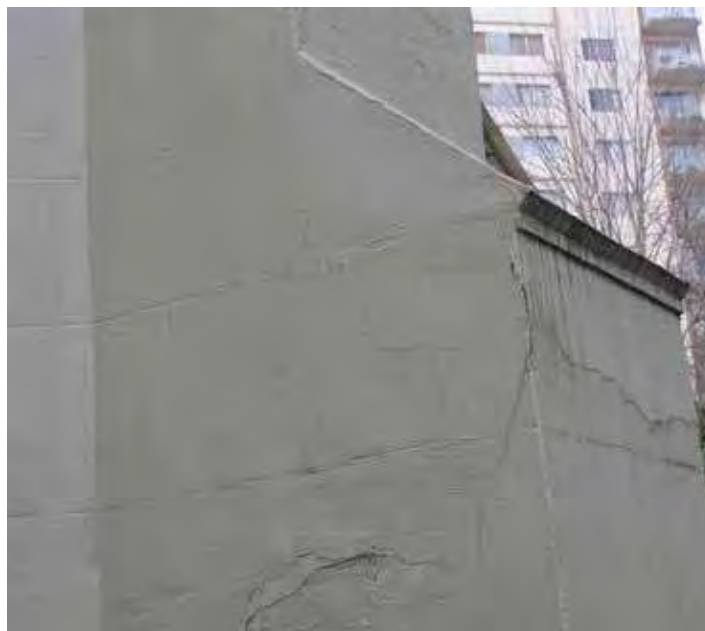
Cracking cement parging on buttress.

- If parging is to be retained, then repair as required and prepare surfaces for repainting. Paint exterior surfaces according to colour schedule devised by Heritage Consultant.

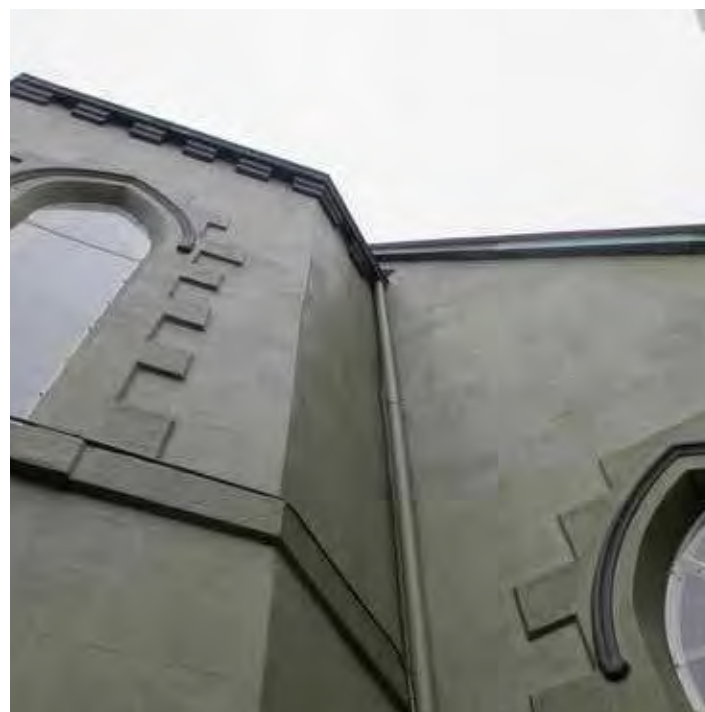
Exterior cement parging.

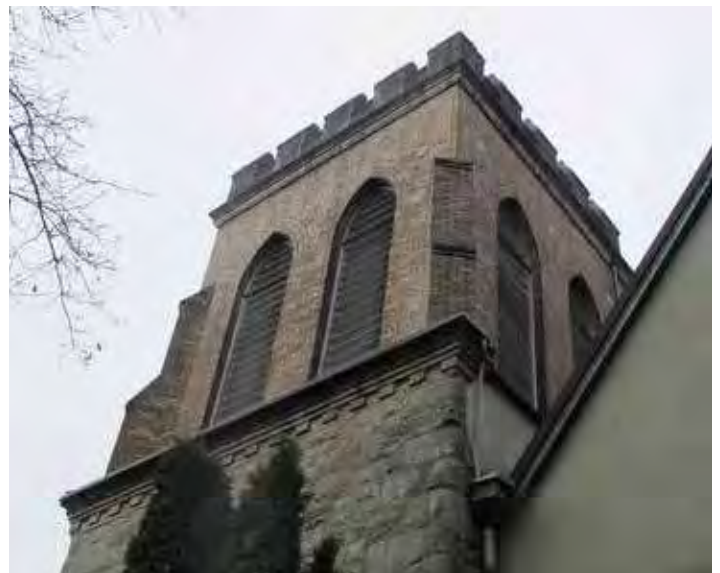
Brickwork on tower.

- Retain sound exterior masonry or deteriorated exterior masonry that can be repaired.

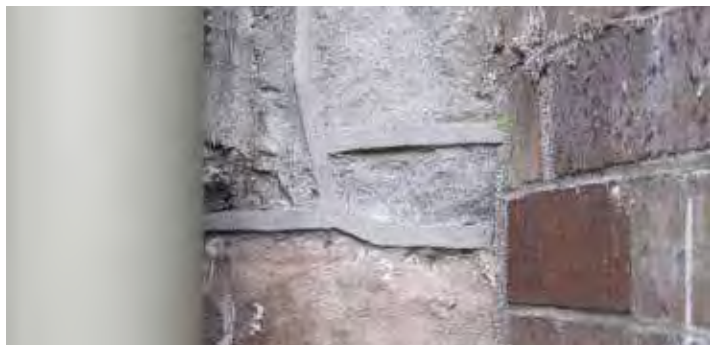
Early pointing.

- If required, repoint the stonework by raking out loose mortar material to a uniform depth. Work should only be undertaken by skilled masons. Do not use power tools to cut or grind joints; hand-held grinders may be used for the initial raking of joints after test samples have been undertaken and only if approved by the Heritage Consultant. Repoint mortar joints with new mortar that matches existing in consistency, composition, strength, colour and pointing profile; note the finely tooled profile of the original mortar joints. The new mortar should match the original tuck pointed mortar joints, which are visible on the narrow north wall of the tower, between the buttress and the west elevation of the church.

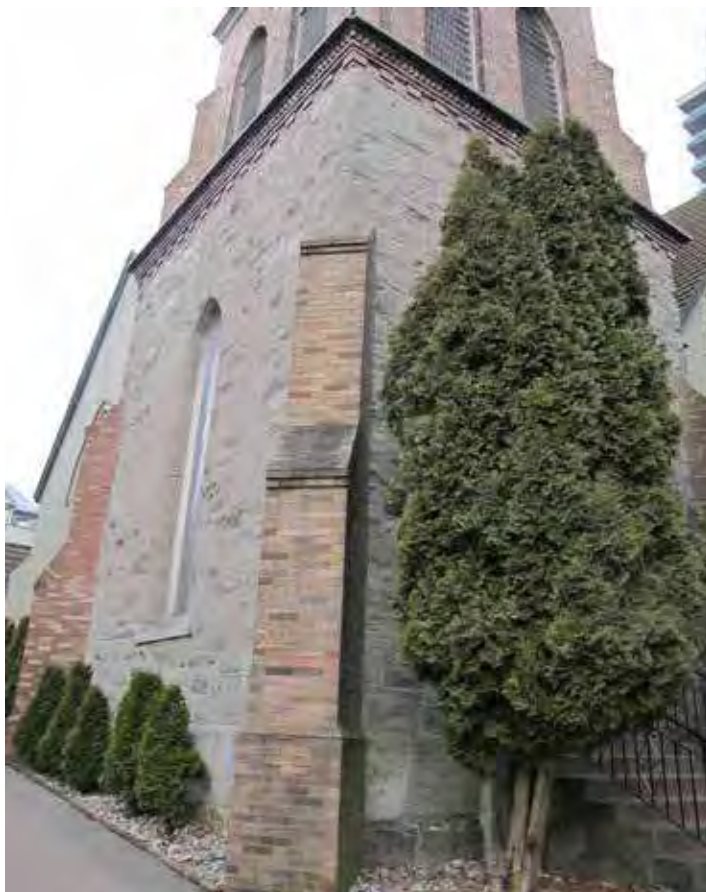
Tower base.

- Preserve the stone tower walls whenever possible, and replace in kind stonework that is too deteriorated for safe use.
- Undertake complete condition survey of all stone surfaces.
- Cleaning, repair and repointing specifications to be reviewed by Heritage Consultant.
- All redundant metal inserts and services mounted on the exterior walls should be removed or reconfigured.
- Any holes in the stone should be filled or replaced to match existing.
- Overall cleaning of the sandstone on the exterior tower walls should be carried out. Use a soft natural bristle brush and mild water rinse. Only approved chemical restoration cleaners may be used. Sandblasting or any other abrasive cleaning method of any kind is not permitted.

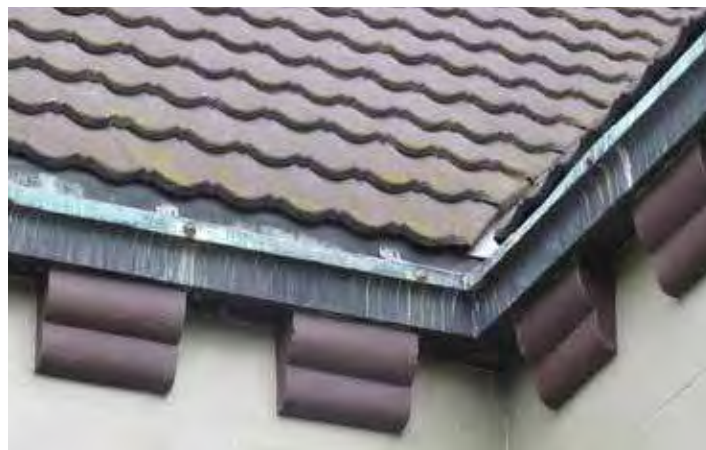
Current roofing tile.

- Design and install adequate rainwater disposal system and ensure proper drainage from the site is maintained. Copper gutters with galvanized steel downspouts are recommended. Paint all drainage system elements according to colour schedule devised by Heritage Consultant, as required.

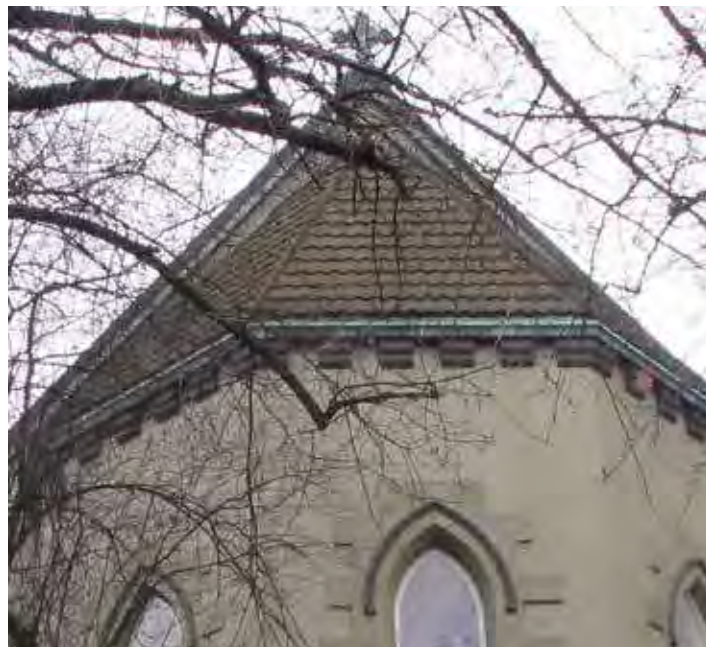
Roof over apse.

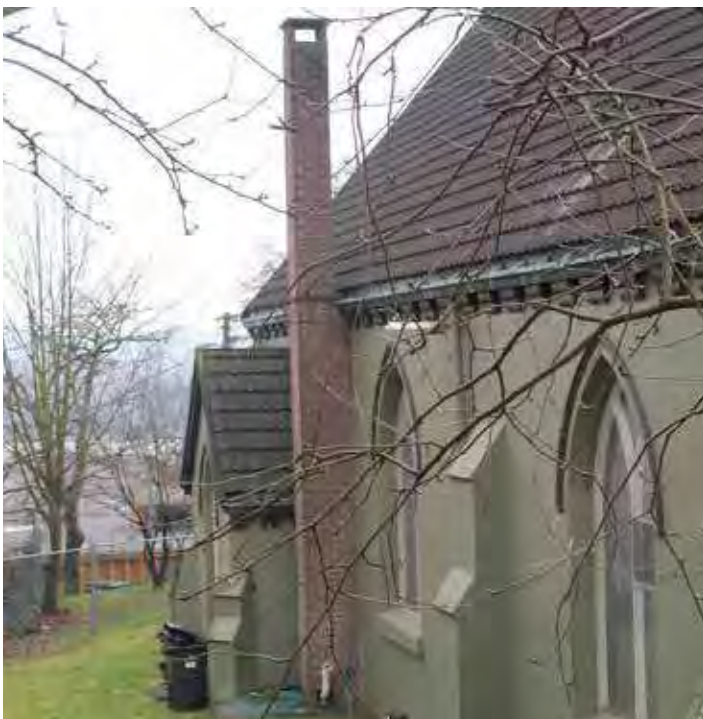
Chimney.

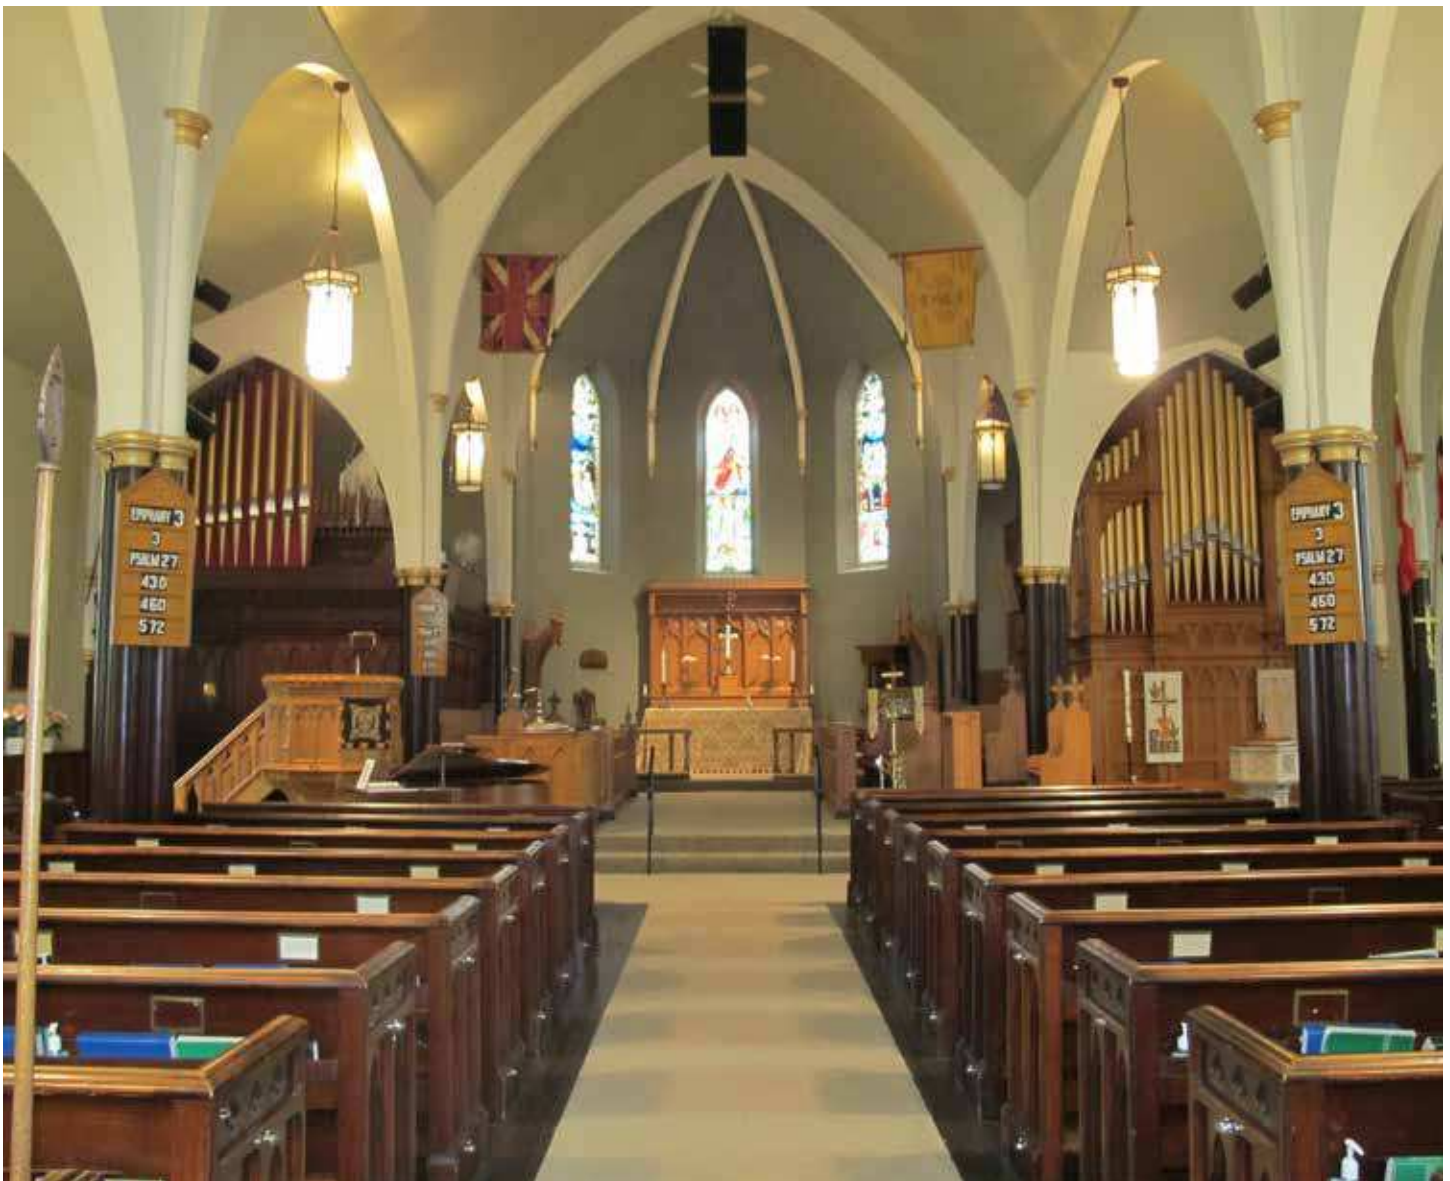
The vaulted sanctuary is supported by the thick exterior walls and two rows of 6 tall timber columns that run parallel through the full length of the church. The columns connect to one another by pointed arches that run both north and south. As the church features unreinforced masonry exterior walls, seismic upgrading will be required to ensure the long-term conservation of the historic church. Seismic upgrading should be sensitive to the historic fabric of the church, and should be concealed within the existing structure as much as possible. Interior walls may be rehabilitated to accommodate additional bracing, but all work should be inconspicuous and sensitive to interior features.

Internal structure, view of apse.
