REPORT

Subject: 514 Carnarvon Street (Holy Trinity): Revised Submission - Preliminary Report

DONALD LUXTON
AND ASSOCIATES INC

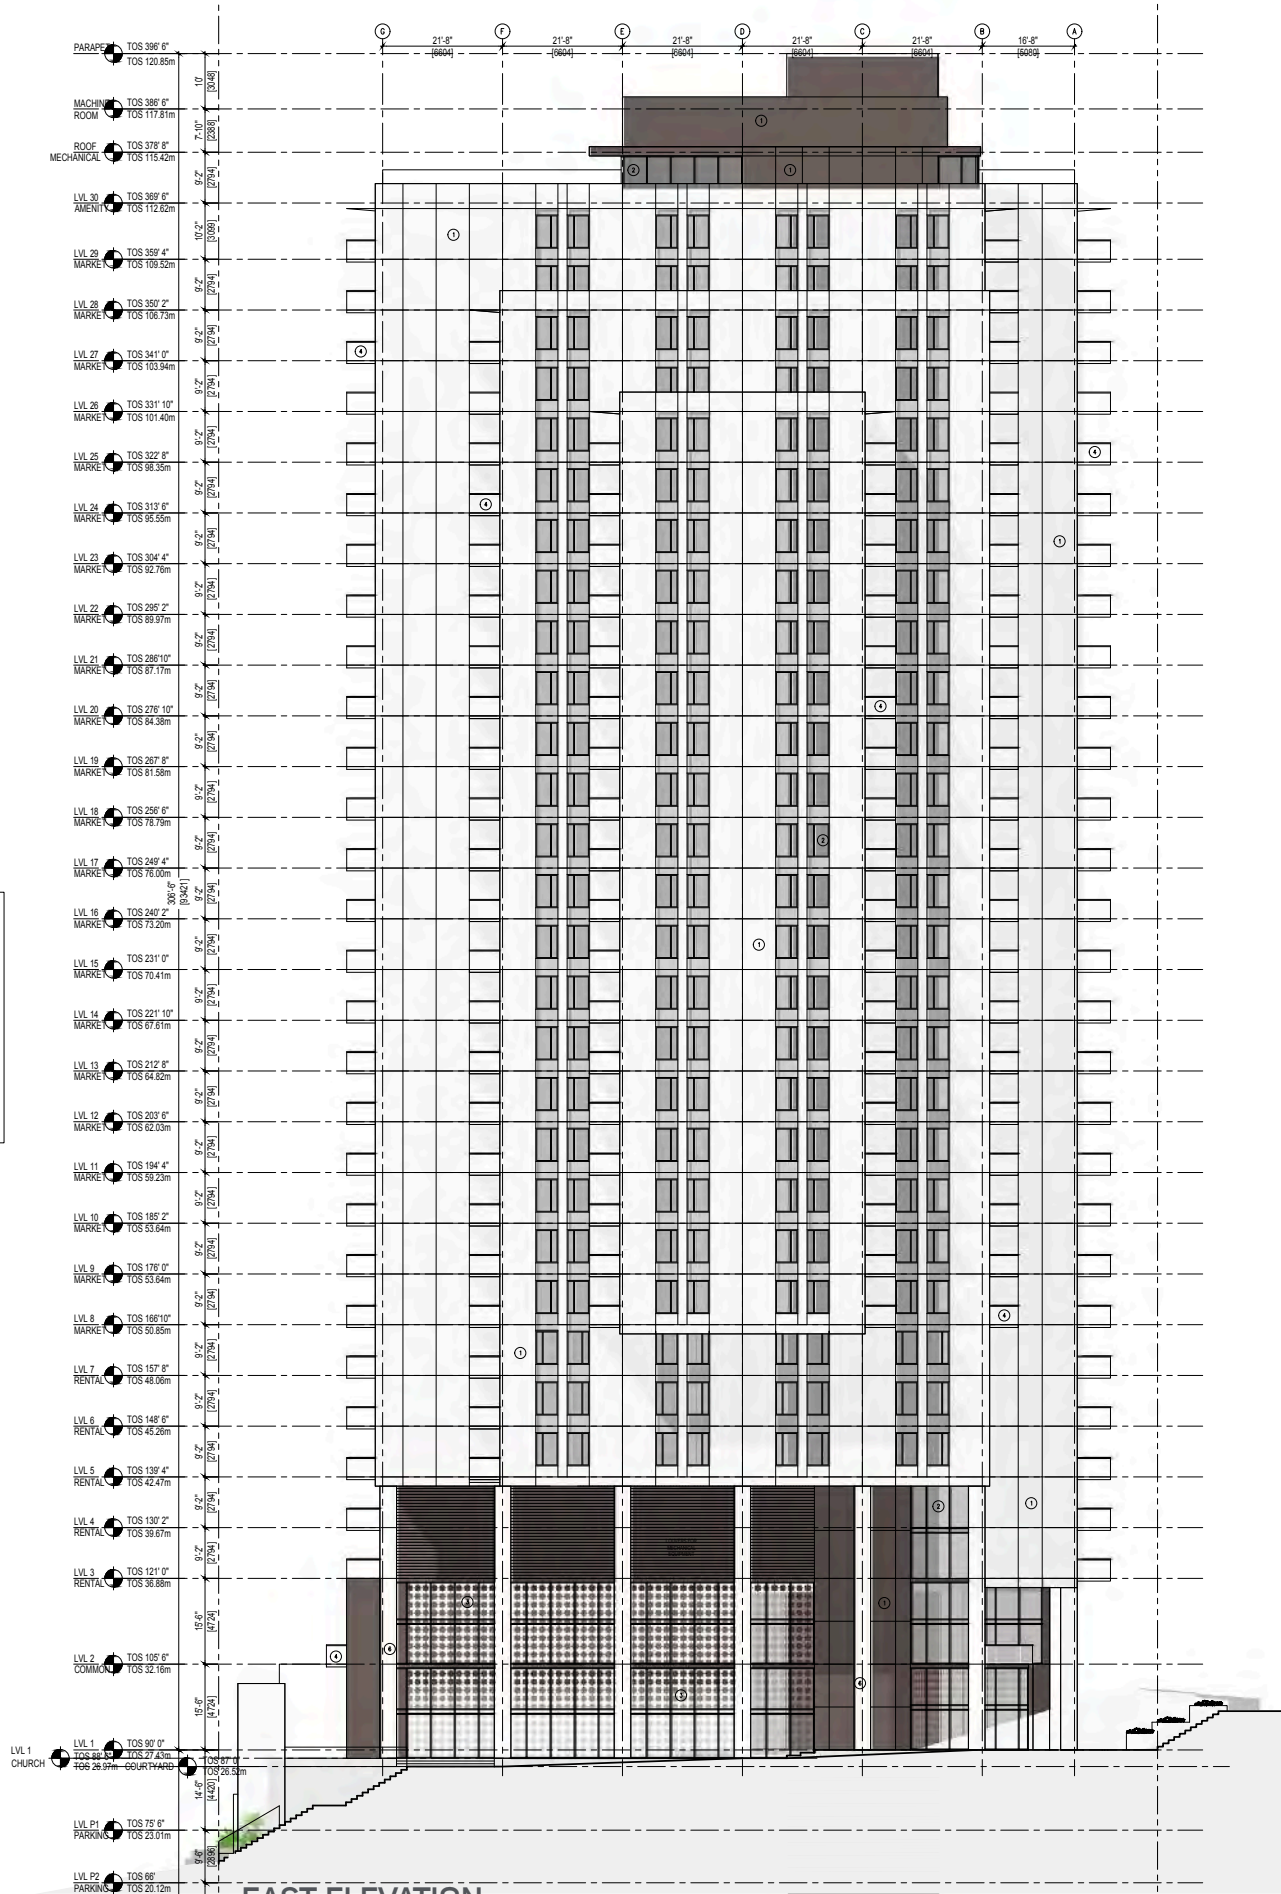
TOWER ELEVATIONS

- 1 CONCRETE SANDWICH PANEL CLADDING SYSTEM
- 2 WINDOW WALL GLAZING SYSTEM
- 3 CURTAIN WALL GLAZING SYSTEM
- 4 ALUMINUM RAILING WITH GLASS GUARD
- 5 ARCHITECTURAL SCREEN
- 6 EXPOSED ARCHITECTURAL CONCRETE

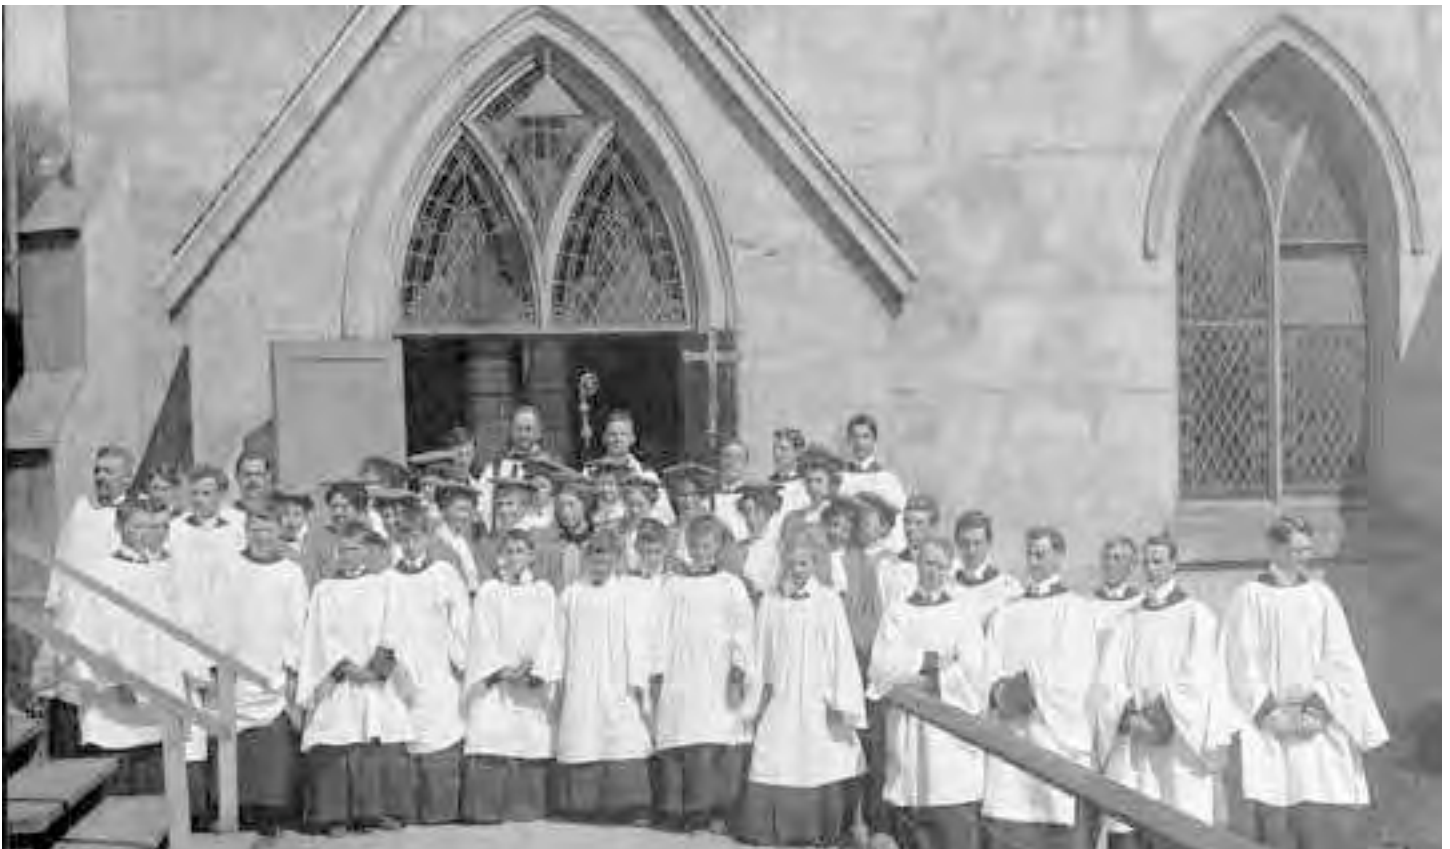
Cement parging on exterior of church, 1900 [NWMA IHP0009]

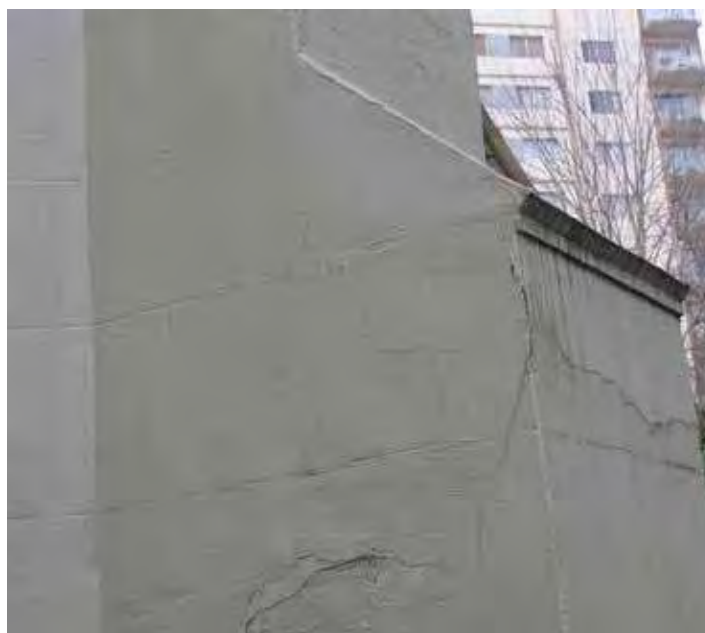
Cracking cement parging on buttress.

- If parging is to be retained, then repair as required and prepare surfaces for repainting. Paint exterior surfaces according to colour schedule devised by Heritage Consultant.

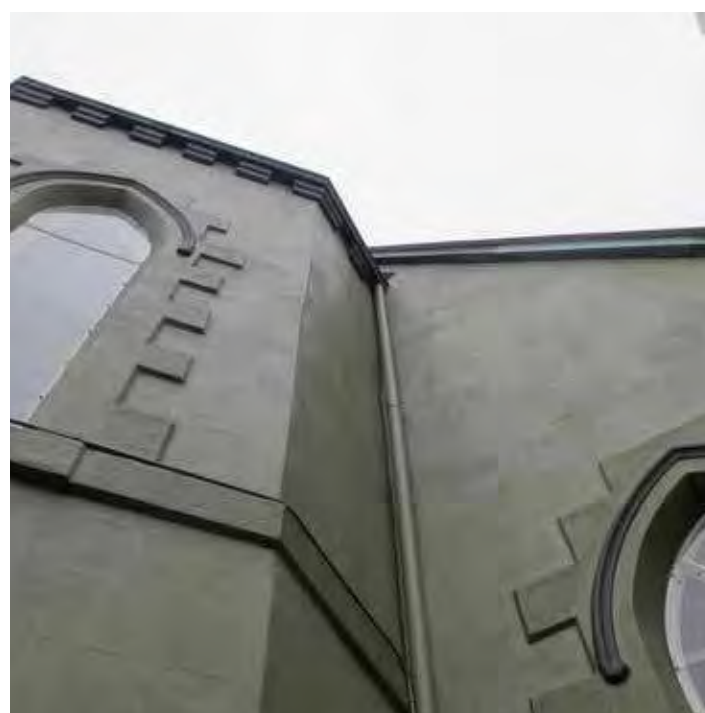
Exterior cement parging.

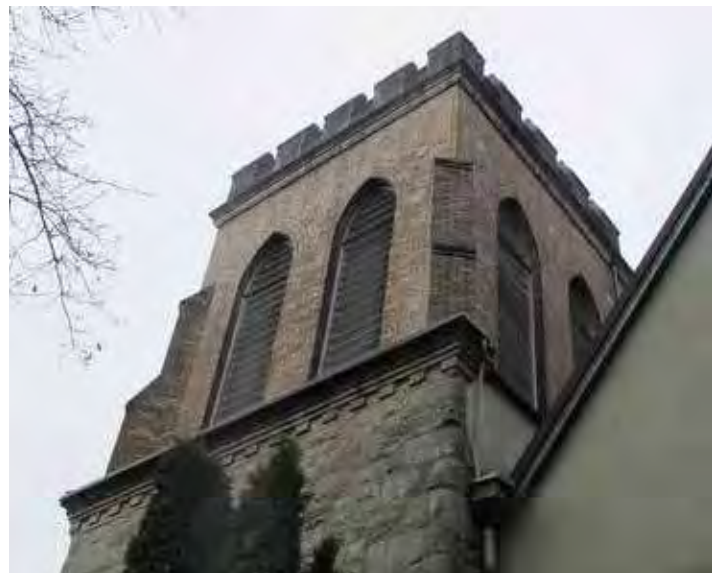
Brickwork on tower.

- Retain sound exterior masonry or deteriorated exterior masonry that can be repaired.

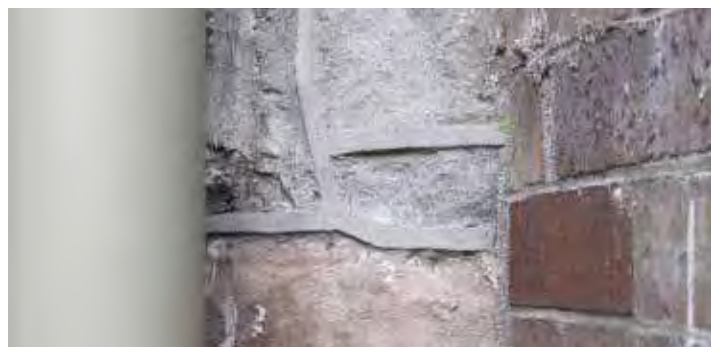
Early pointing.

- If required, repoint the stonework by raking out loose mortar material to a uniform depth. Work should only be undertaken by skilled masons. Do not use power tools to cut or grind joints; hand-held grinders may be used for the initial raking of joints after test samples have been undertaken and only if approved by the Heritage Consultant. Repoint mortar joints with new mortar that matches existing in consistency, composition, strength, colour and pointing profile; note the finely tooled profile of the original mortar joints. The new mortar should match the original tuck pointed mortar joints, which are visible on the narrow north wall of the tower, between the buttress and the west elevation of the church.

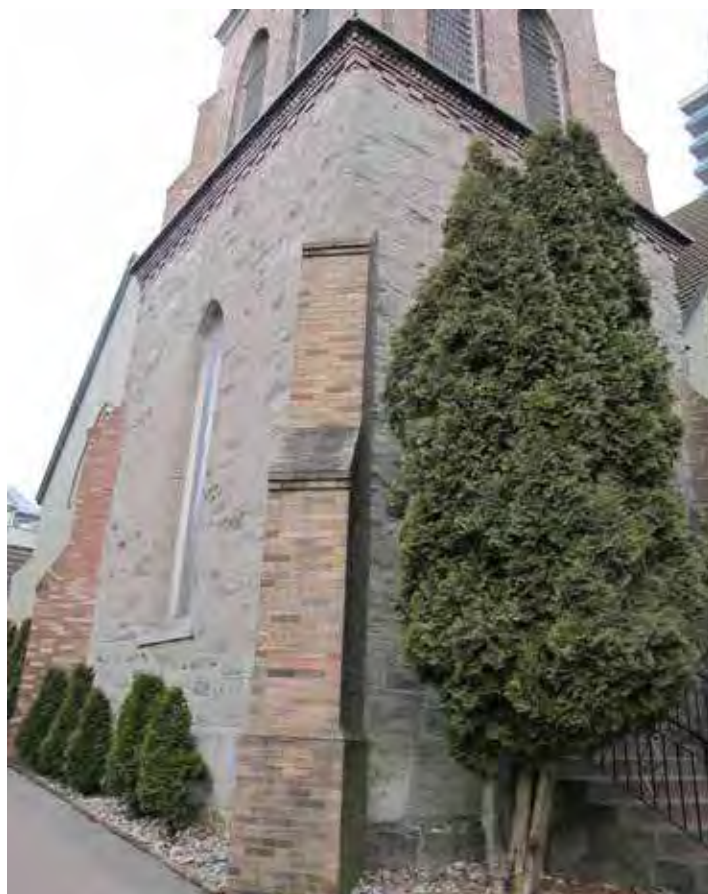
Tower base.

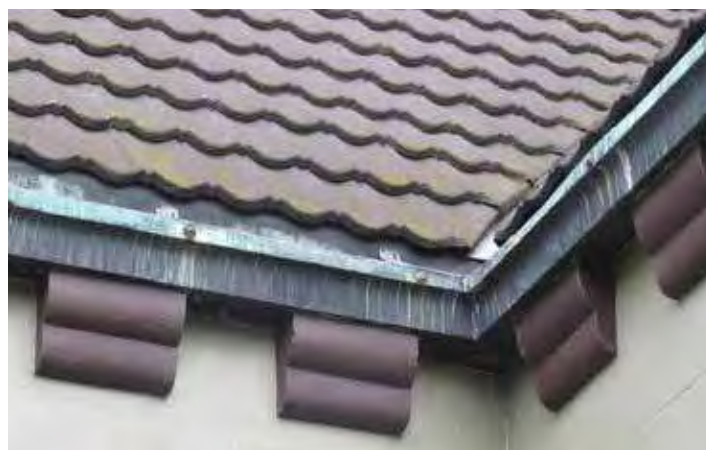
Current roofing tile.

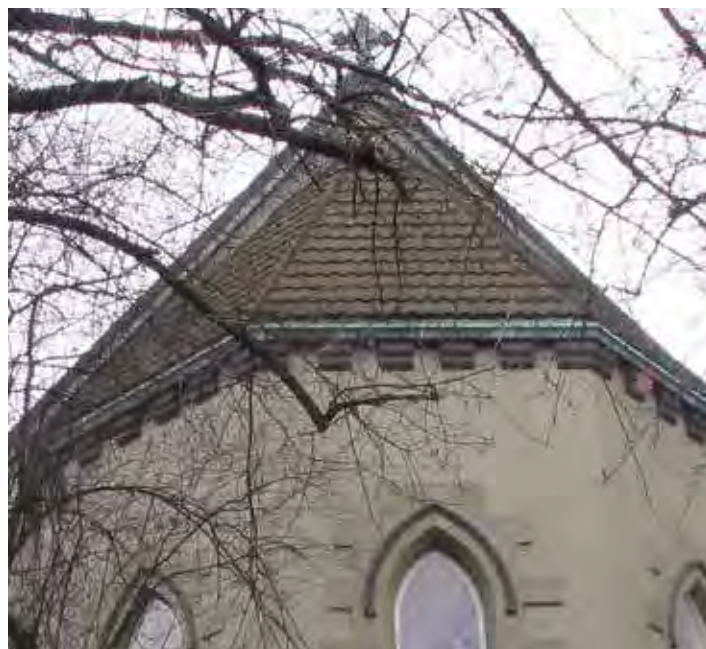
Roof over apse.

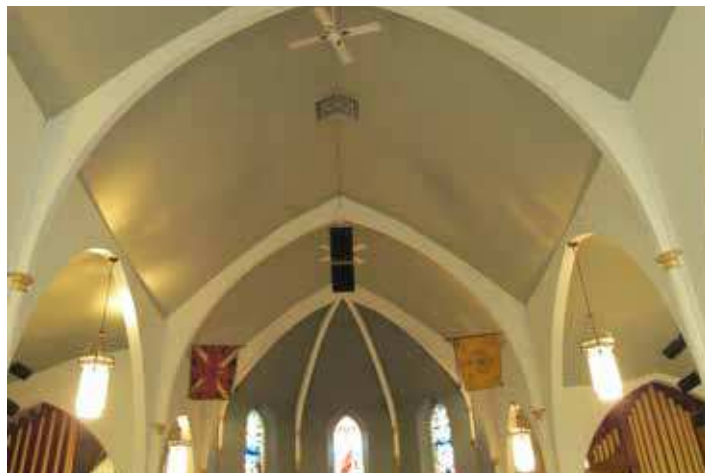
The vaulted sanctuary is supported by the thick exterior walls and two rows of 6 tall timber columns that run parallel through the full length of the church. The columns connect to one another by pointed arches that run both north and south. As the church features unreinforced masonry exterior walls, seismic upgrading will be required to ensure the long-term conservation of the historic church. Seismic upgrading should be sensitive to the historic fabric of the church, and should be concealed within the existing structure as much as possible. Interior walls may be rehabilitated to accommodate additional bracing, but all work should be inconspicuous and sensitive to interior features.

Internal structure, view of ceiling.

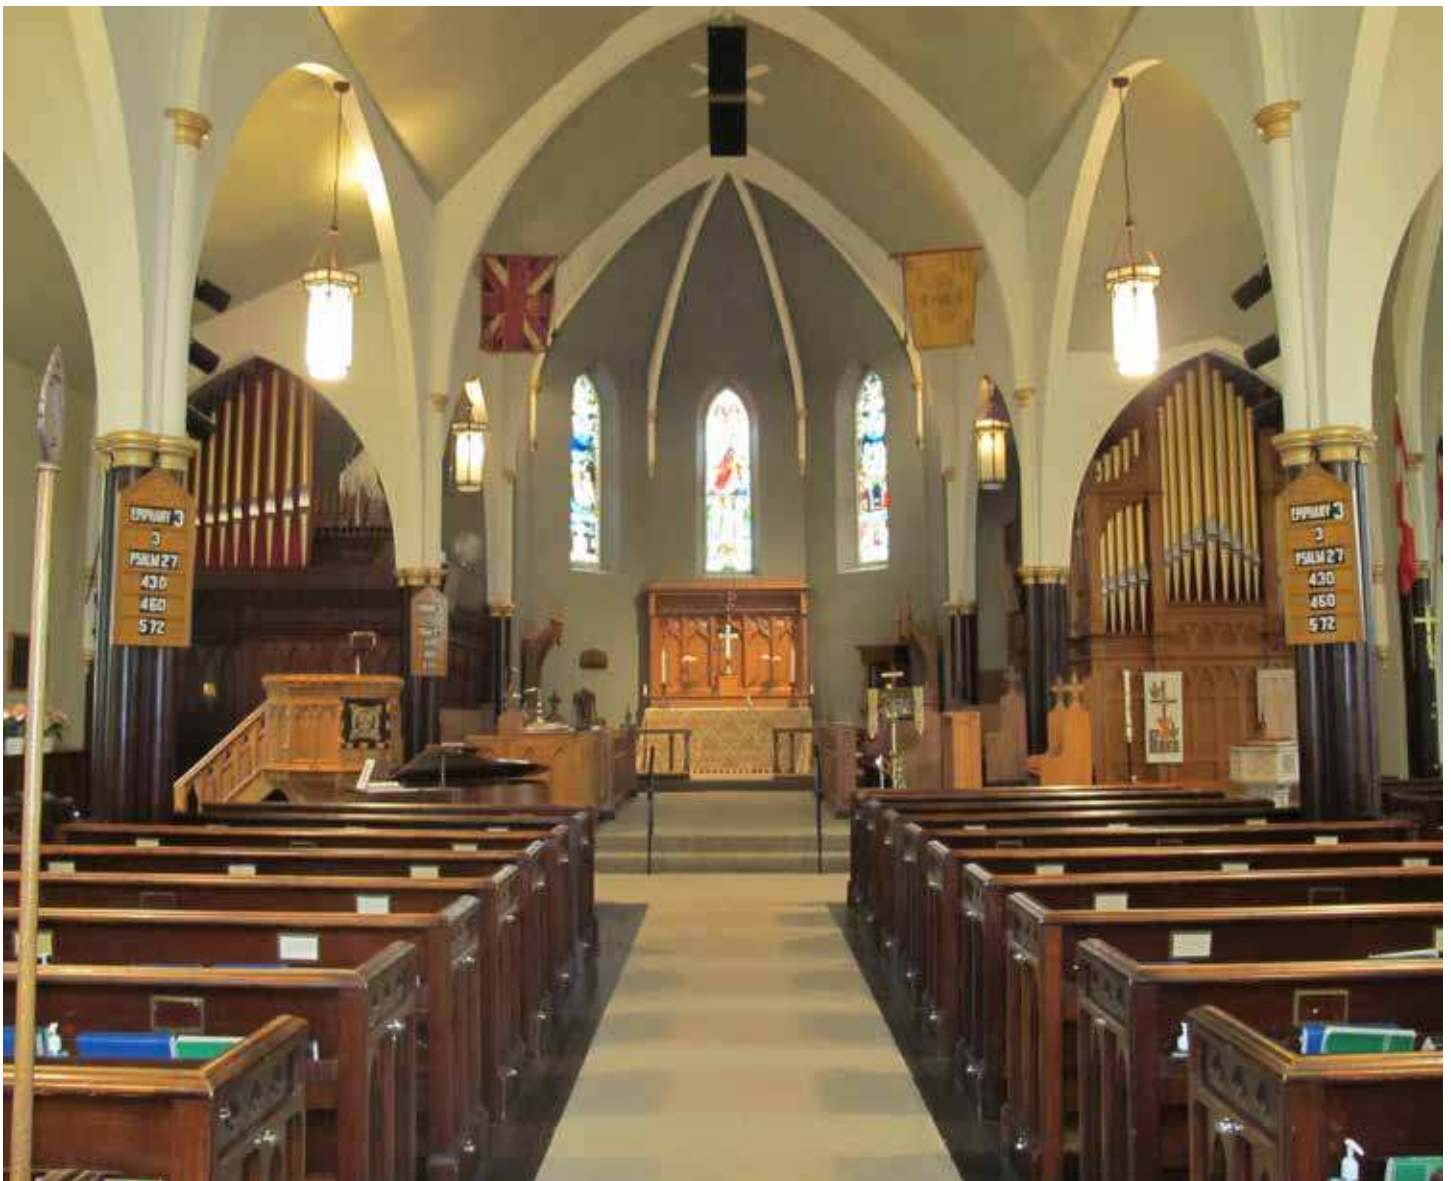
Internal structure, view of apse.

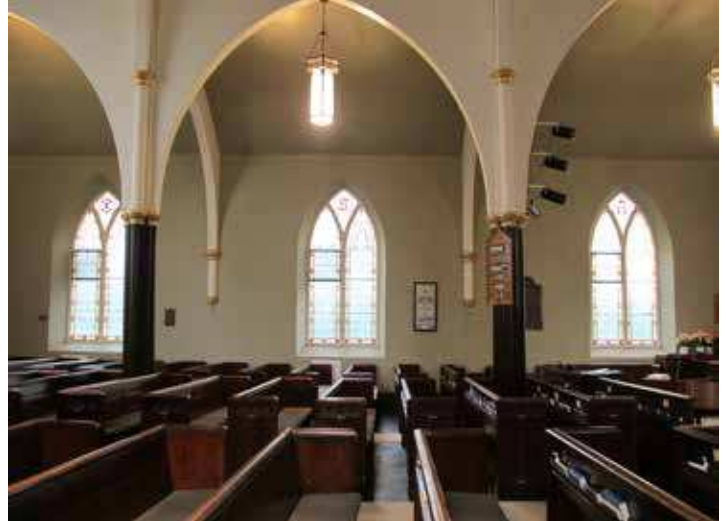
Internal structure, view through arches.

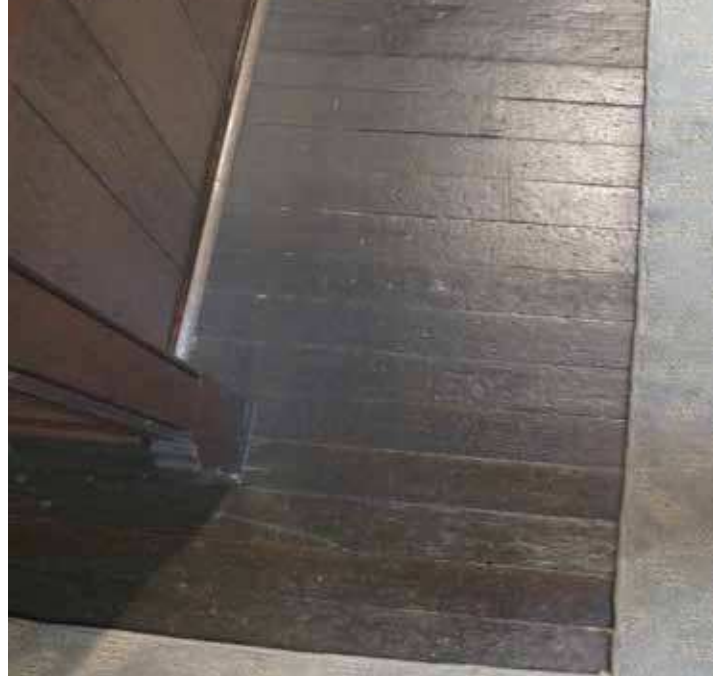
Current condition of floor.

- Inspect the flooring to determine if any boards require repair or replacement. Flooring should be cleaned prior to any repair.
- For high traffic areas, treat the floor with a polish with high content of carnauba polish, mixed with high quality beeswax. A polyurethane varnish may be used if necessary, however it tends to provide an "artificial" appearance.
