Heritage Conservation Plan and Statement of Significance

Heritage Conservation Plan
441 Fader Street
New Westminster, BC

December 2021
(Updated May 2022)

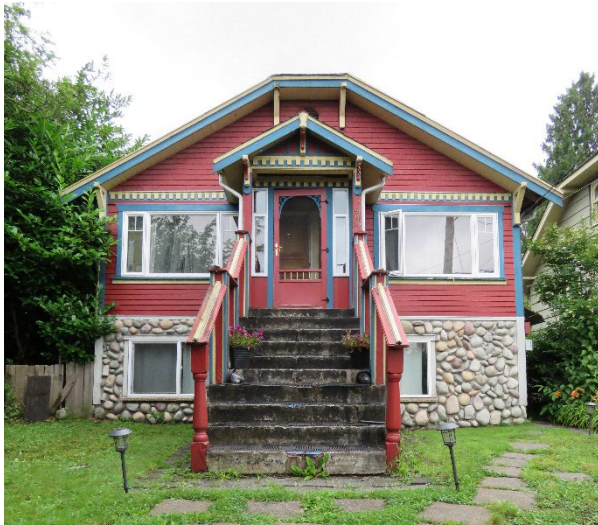
East (front) elevation

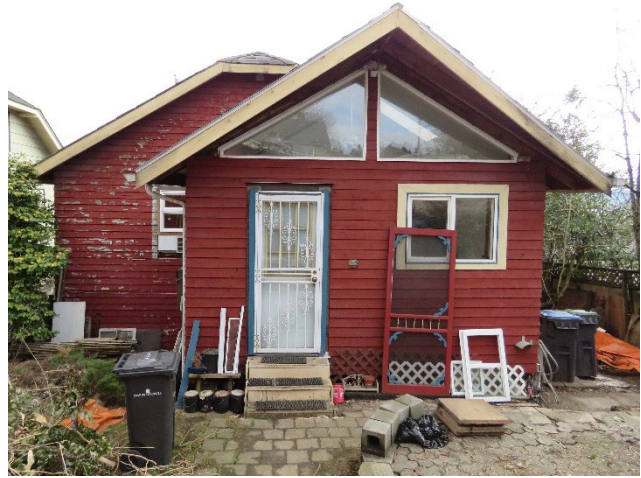
West (rear) elevation

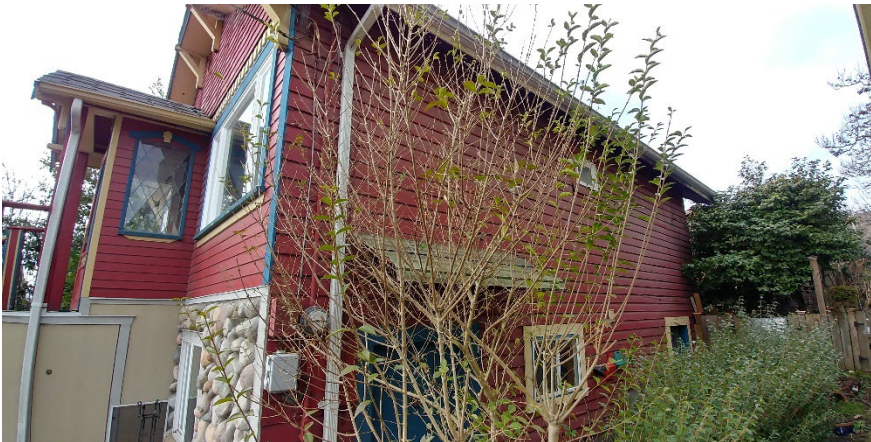
North (side) elevation

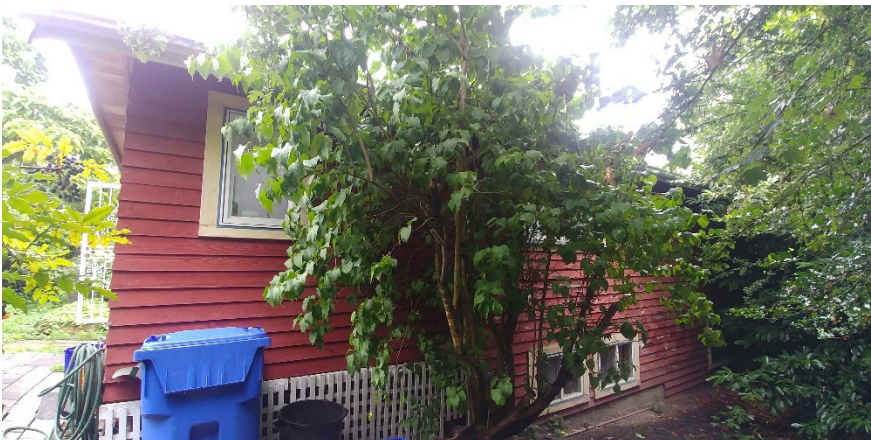
South (side) elevation

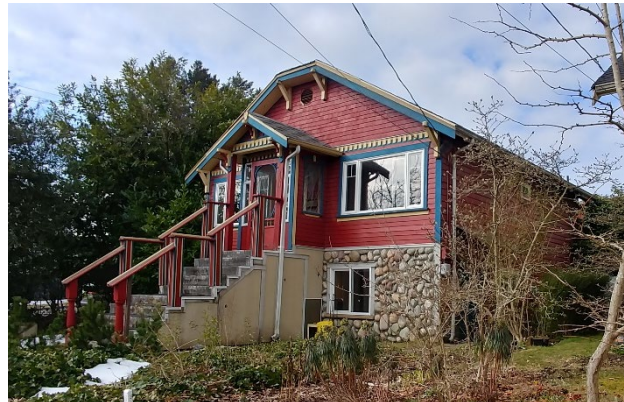
8.3c Roof

The identified character-defining elements will be retained. It was not possible to inspect the condition of the roof for this report, but from the ground the material appears to be in fair condition. However, it likely will require re-cladding soon, at which point using the same asphalt material is appropriate provided it follows the colour scheme included in this report. A qualified person with the proper equipment should inspect the asphalt shingles for wear and tear, damage, and for missing pieces as part of the maintenance routine.

The decorative eave brackets, soffit material, and the hexagonal roof vent should also be assessed, and repairs carried out if necessary. If any pieces are beyond repair, they should be replicated, ensuring that they match the original in terms of design, size, profile, material, and location.

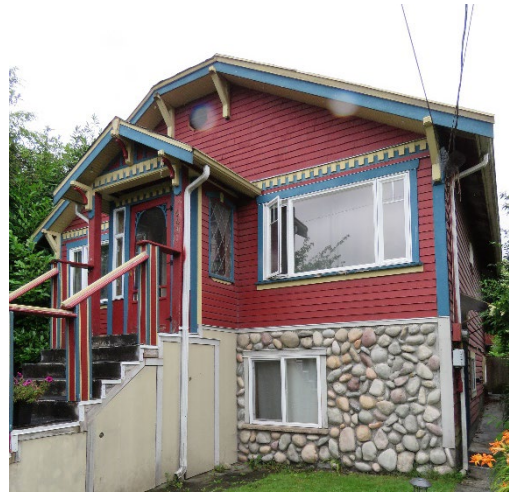
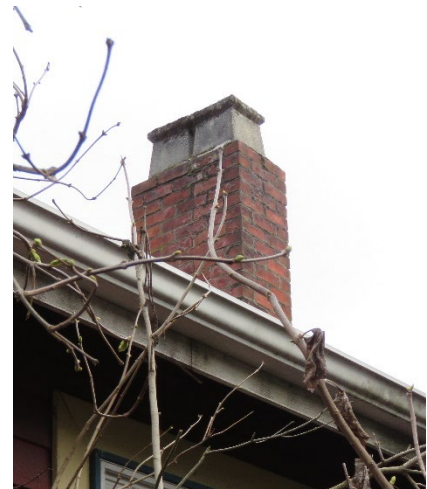
8.3d Chimney

Chimneys are important elements of historic buildings and should be maintained; however, it does not actually need to be a working chimney. The chimney appears to be in good condition, but it should be inspected by a qualified mason who can assess the condition of the bricks, the grout, the flashing, and whether or not there is any moss growth.

Any repointing should match the current in terms of colour, width and consistency. Any new bricks should be of a matching size and colour to the existing. If the flashing needs replacement, ensure that there is a counterflashing. Any moss growth on the chimney should be carefully removed, and if needed, the bricks can be cleaned using a natural bristle brush and a mild rinse detergent. Do not power wash, sand blast or use abrasive cleaning methods.

If the chimney needs to be reconstructed, an accurate record of the existing chimney should be made (photographs, measurements, drawings, location, etc.) so that it can be replicated later.

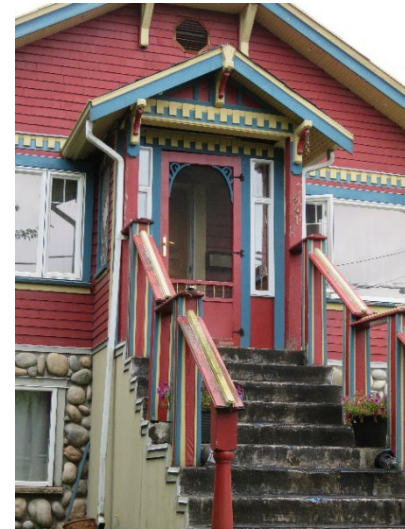
The above-noted character-defining elements should be retained and restored or rehabilitated. The location of the front door should be retained but a new, historically appropriate door may be installed. The oval-lite screen door and door frame should be assessed by the same company that is hired to assess the windows. The screen door and its frame should be retained and restored. The tongue-and-groove wood ceiling and the square porch posts look to be in good condition but should be assessed by the builder. Every effort should be made to retain and (if necessary) repair them. If their condition is irreparable, either now or over time, then they may be replaced provided that the replacement matches the existing in terms of design, size, profile and material. The porch should follow the new and historically appropriate colour scheme.

The mock wood dentils and the Tudor stickwork should be removed. The steps may be replaced with new, preferably comprised of wood. The existing railings should be replaced with a simple wood railing system that is respectful of the era and design of the house.

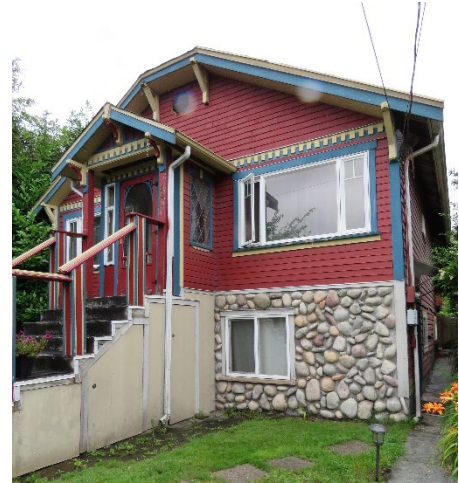
The front gable is clad in wood shingles which appear to be in good condition, but which should be examined by an expert. If individual pieces become damaged or fail in some way over time, it may be possible to repair or replace just those individual pieces. Any replacement shingles should match the existing in terms of design, size, profile and material. The goal is to avoid the appearance of patching.

It is also reasonable to completely replace the shingle siding if – in the future - the overall condition of the shingles eventually becomes too poor to patch and provided that the replacement shingles match the existing in terms of design, size, profile and material. Special attention should be given to the condition of the material underneath to determine if there is any water damage or damage to the underlying material that needs to be repaired or replaced with new.

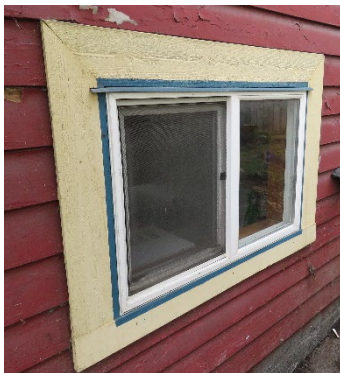
All of the windows have had vinyl inserts installed. It is possible that the size of one of the windows on the front elevation was changed, but the remainder appear to be the original size and location. One small window, on the basement level of the north side, still retains its original casing and trim. All of the other window openings have wood casings and sills that appear to be newer.

Example of new window insert and wood casing.

All of the newer window inserts should be replaced with period-appropriate wood-frame windows on the front and side elevations. Windows on the rear elevation may be vinyl-framed if desired but should match the design of the other windows.

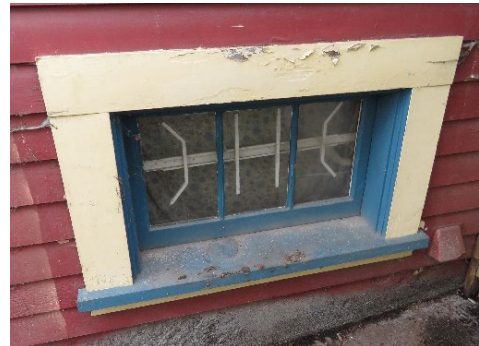
The only original window - at grade on the north elevation.

"The only existing window that has any original components is on the East Basement 3' x 2'. The original Exterior Sill & 1x6 Exterior Casing/Trims remain, but the original sash has been removed & replaced with a vinyl window at some point. All of the rest of the existing windows have been changed to Vinyl with new Exterior Sills & Trims that are not in the style of the original. This heritage home will require all New Wood Windows complete with Heavy Exterior Sills & Exterior Trims."

M. R. Windows recommends new wood windows to replace all of the existing windows and that the new windows have a simple design that are in keeping with the age and design of the house. This

approach is the preferred approach. Trying to save and restore the exterior casing and trim of a small window on the basement of the side elevation is not reasonable. This window may be replaced with new, in the same size and shape as the existing and in keeping with the same design as the other windows.
