Heritage Conservation Plan

806 Eighth Street :: Thomas and Stella Sincock House :: 1929
Moody Park :: New Westminster, BC

Prepared by Elana Zysblat, CAHP :: Ance Building Services :: October 2021

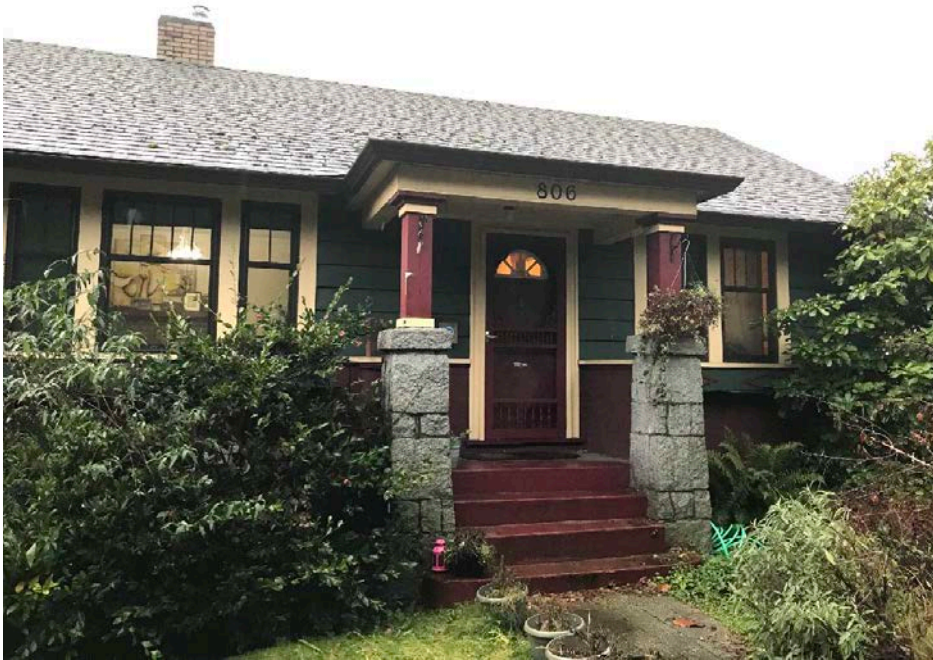
front view
8th street entrance

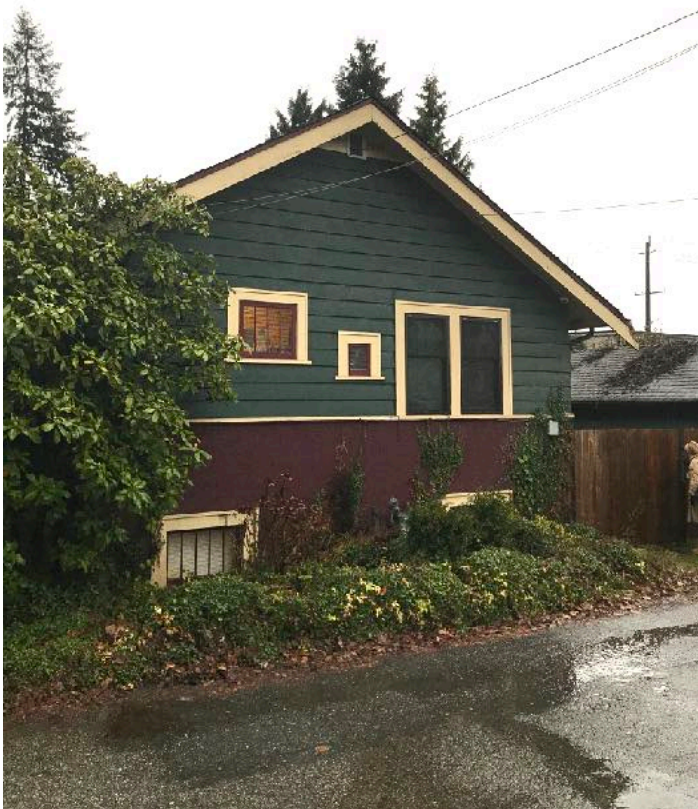
Side view
lane

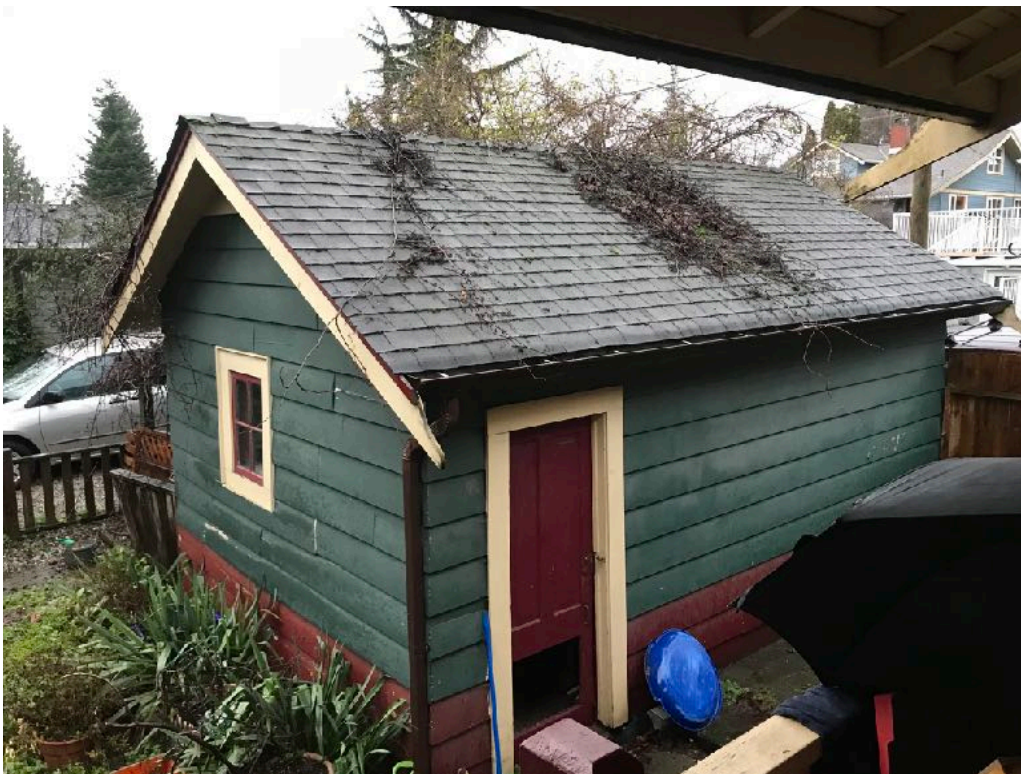
Side and rear view showing rear of garage

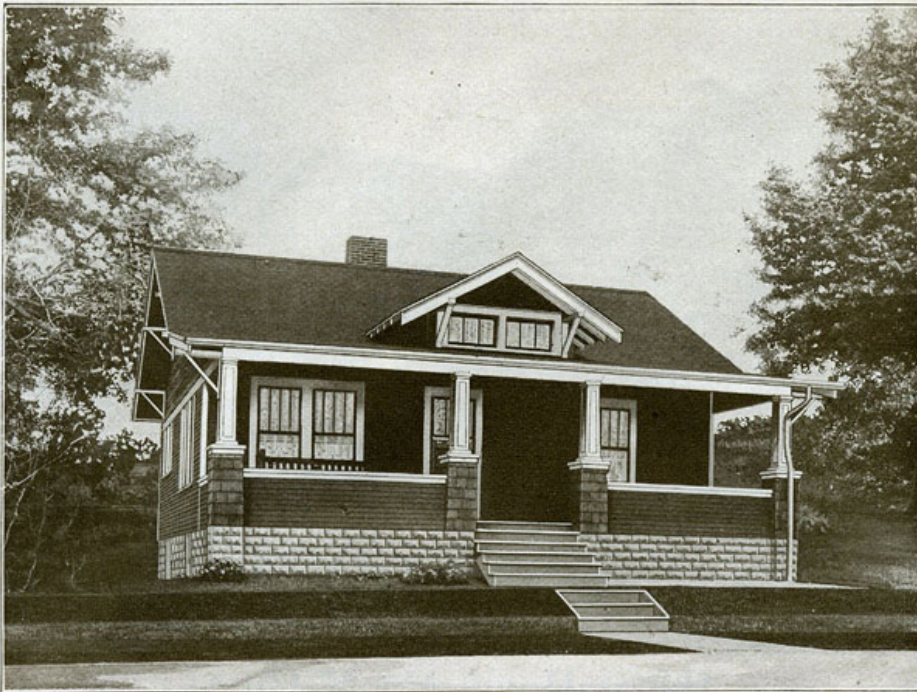
Harris Home No. M-1006

Model M-1006 of the 1920 Harris Homes catalogue - Harris Brothers of Chicago, Illinois. Source: antiquehome.org

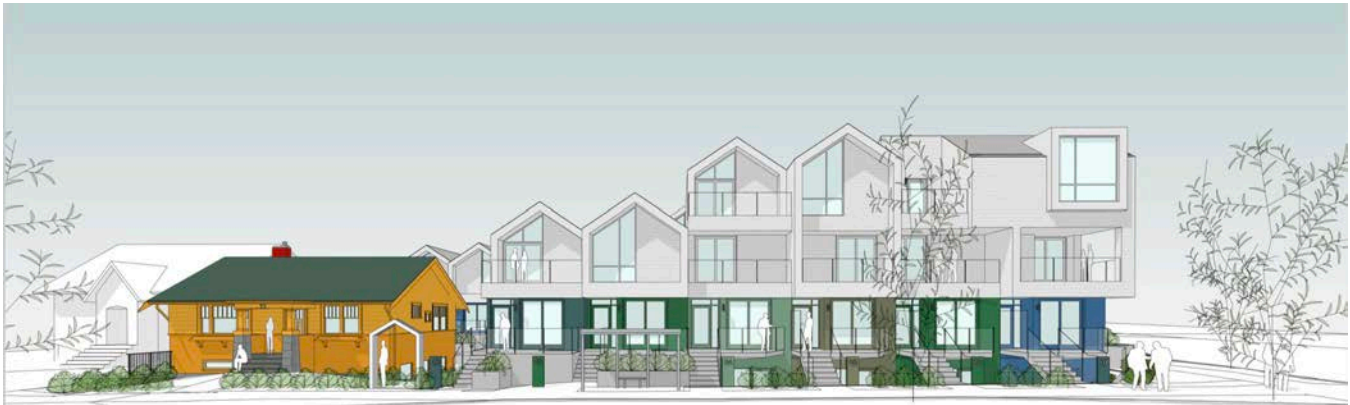
Rendering of the proposed development showing the relocated historic house and the new townhouse along Eighth Avenue. Credit: Grimwood Architecture.

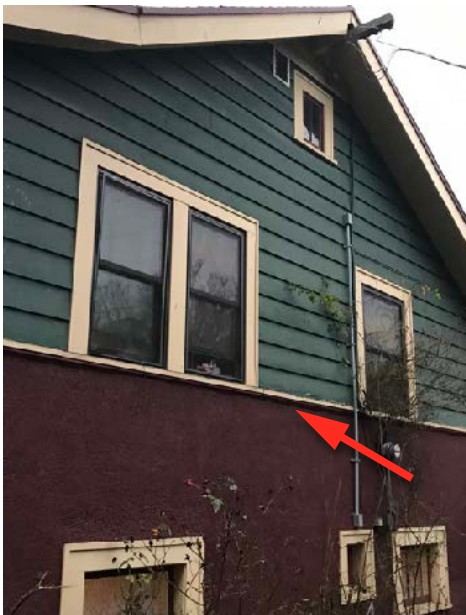
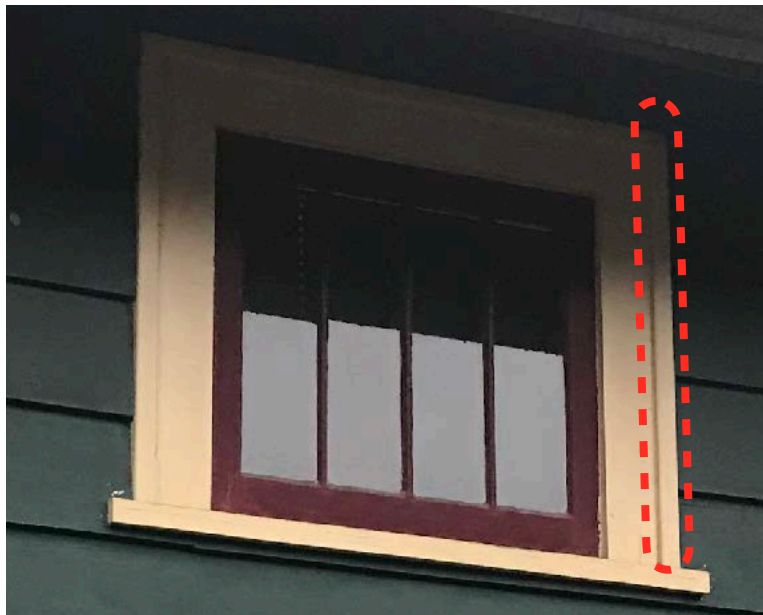
- The building's window and door trim features a 'backband' (outlined in red in the photo below) which was a casing style typical of the Interwar years. The window and door trim is in **good** condition.

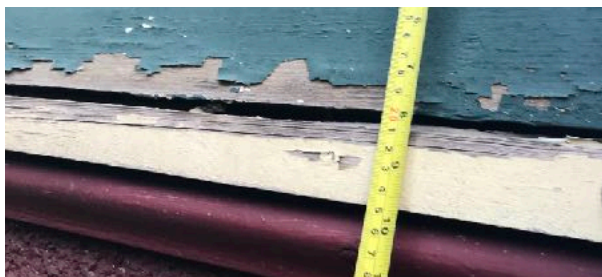
- The building's traditional wood window sills project from the window frame and beyond the trim line. The larger windows on the main floor don't have window sills, but the wood belt course acts as a sill (drip cap) for them. The belt course wraps the entire house, and is essentially a square sill with a moulding below. It is marked with a red arrow on the above left photo. Sills and belt course are generally in **good** condition with certain areas assessed as **fair** for lack of paint and exposure to weather (see below), however no areas have been identified as damaged beyond repair.

left: photo showing the wood belt course (cream), lap siding (green) and belt course moulding (maroon) on the south elevation. The paint where the siding and belt course meet has dried up and flaked off leaving these wood elements exposed to weather but likely repairable.

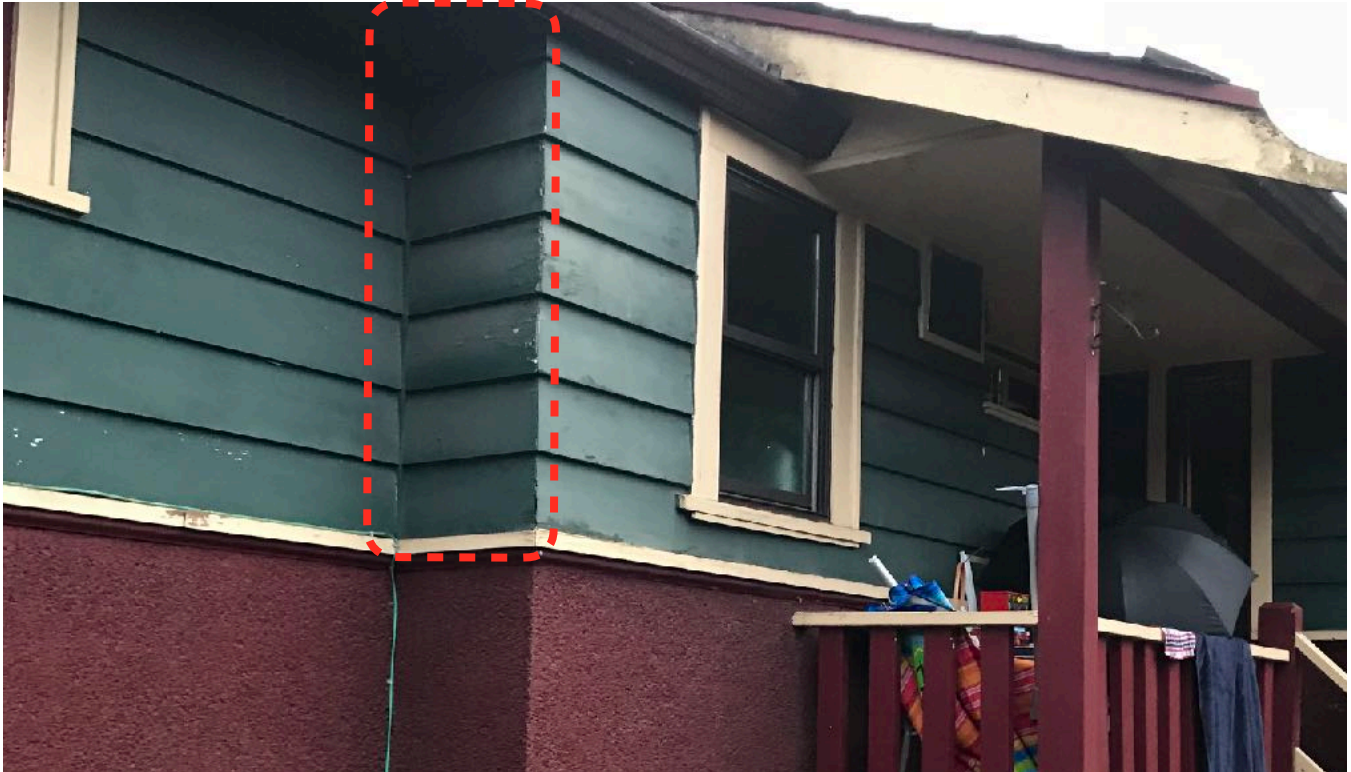
- Wide lap wood siding (8" exposure). For the most part this siding is in **good** condition however the paint is flaking off in small areas and a small section appears to be buckling at the rear (outlined in red).

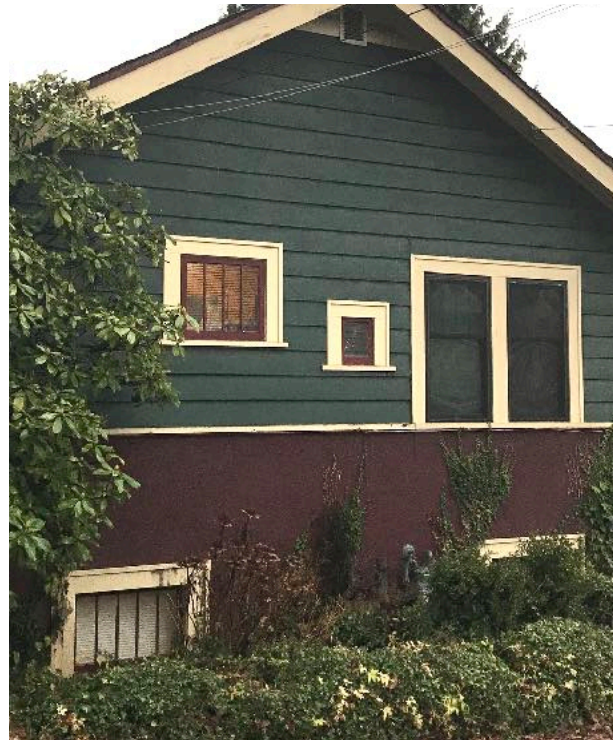
The windows are in **good** condition and all operable. Each unit is in need of minor maintenance (putty and hardware inspection and repainting)

The photo on the right shows the (north) side elevation with two double-hung wood windows (behind screens) and four casement or fixed wood windows with vertical lights.

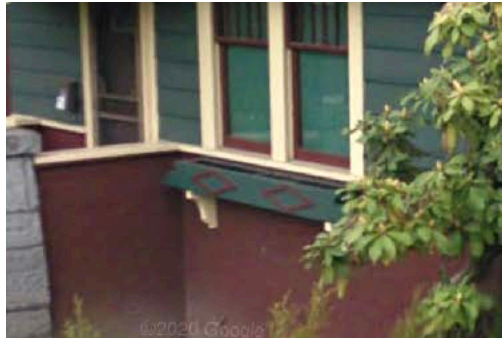
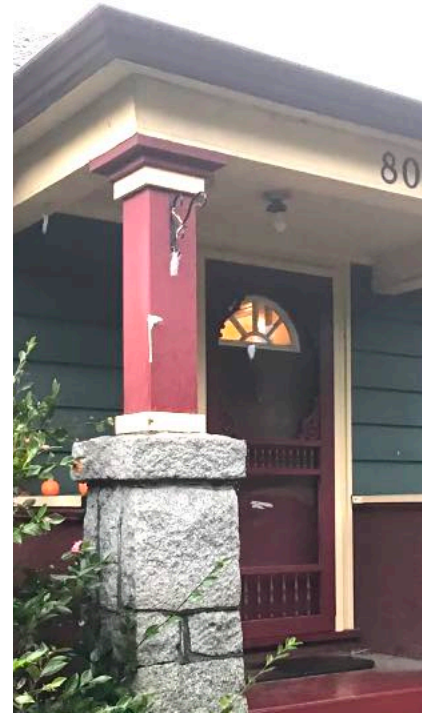
Doors - Although front and back door openings are unchanged since 1929, the doors themselves do not survive. The front and back doors are metal/hollow wood replacements. The photo to the right shows the replacement front door with a stylized wood screen door, neither are original to the 1929 design.

Two original wood flower boxes with diamond reliefs are held up by brackets and hang below the facade picture windows. They are in **fair-good** condition.

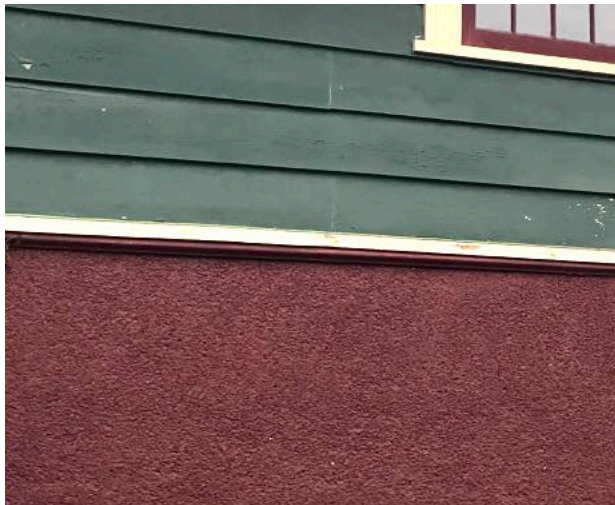
A 1931 fire insurance map for New Westminster notes the subject building as being clad in Rough Cast (R.C) stucco (see below). The existing stucco texture (photo left) is consistent with other buildings of the 1920s and 1930s era. The stucco clads the basement level and front porch walls, and is in **good** condition. No cracks or evidence of moisture infiltration have been identified.

2. Preserve 1929 rough cast stucco in situ on front and side elevations. Repair/patch only where damaged due to relocation or reconnection to new foundation. Replicate existing rough cast stucco when patching.

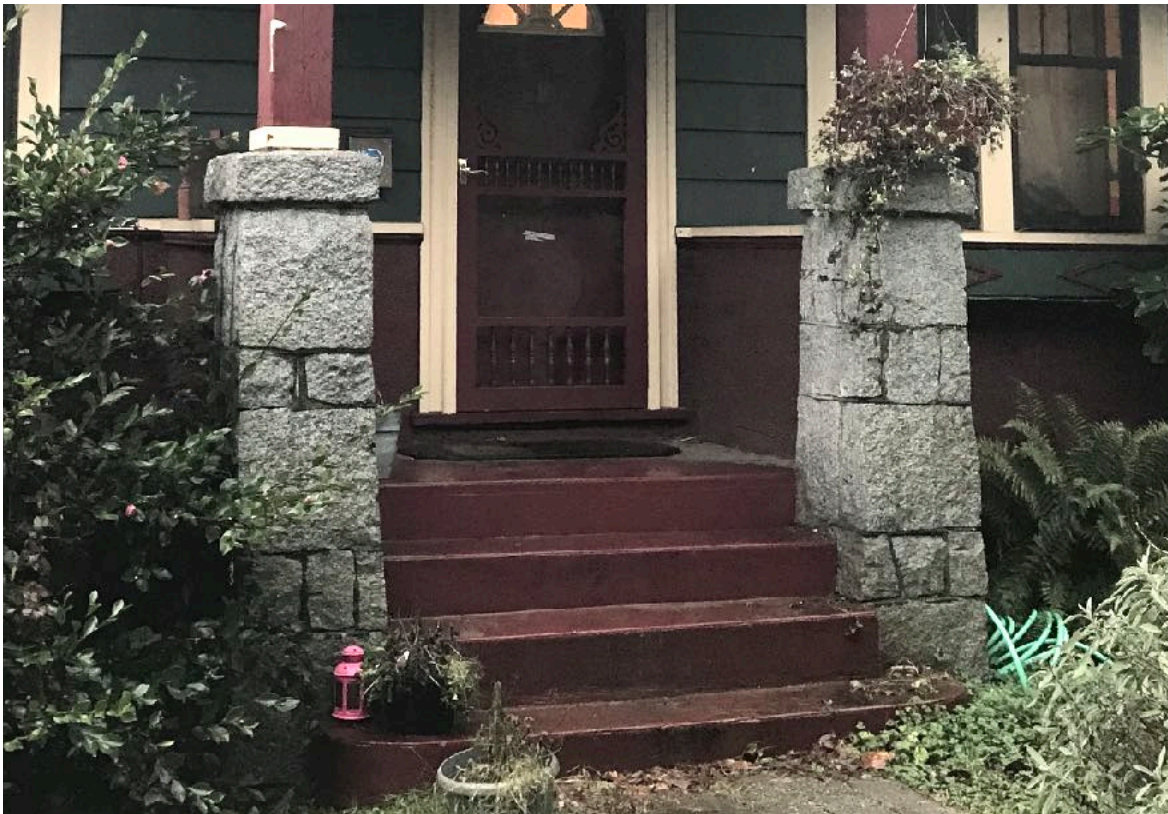
The front porch columns are placed on a pair of capped, flared granite piers featuring a rock-face coursed ashlar pattern of alternating large and small stone rows. The piers are in **good** condition, requiring typical maintenance of mortar inspection and repointing.

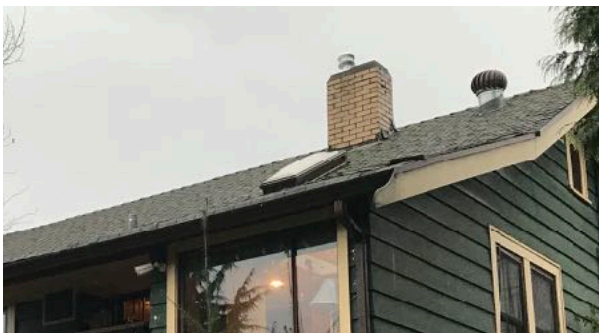
A single, internal brick chimney at the roof peak features a rose/ochre coloured brick. The condition appears **good** but requires closer inspection (including flagging and capping) and likely routine maintenance (repointing).

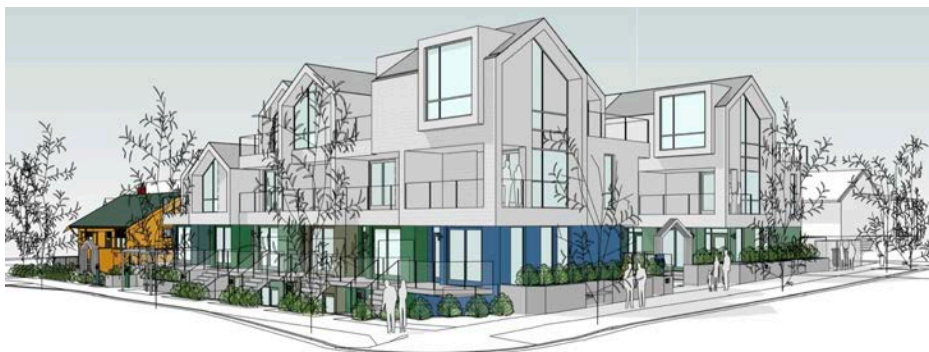
Rendering of the proposed townhouse development. The historic Sincok House is painted in yellow and gold.

The former location of the historic house will be developed through the introduction of higher-density townhouses as per the dominant development form along the southern blocks of Eighth Street, from this intersection towards the river. The townhouse height closest to the historic house is intentionally lowest (two stories), as the scale of the new buildings intensifies towards the busy corner of Eighth and Eighth. The colour placement on the ground level of townhouses, as well as the gable roofs and use of individual unit entrances and porches, echoes the single-family character of Moody Park and helps in achieving compatibility with the historic streetscape.

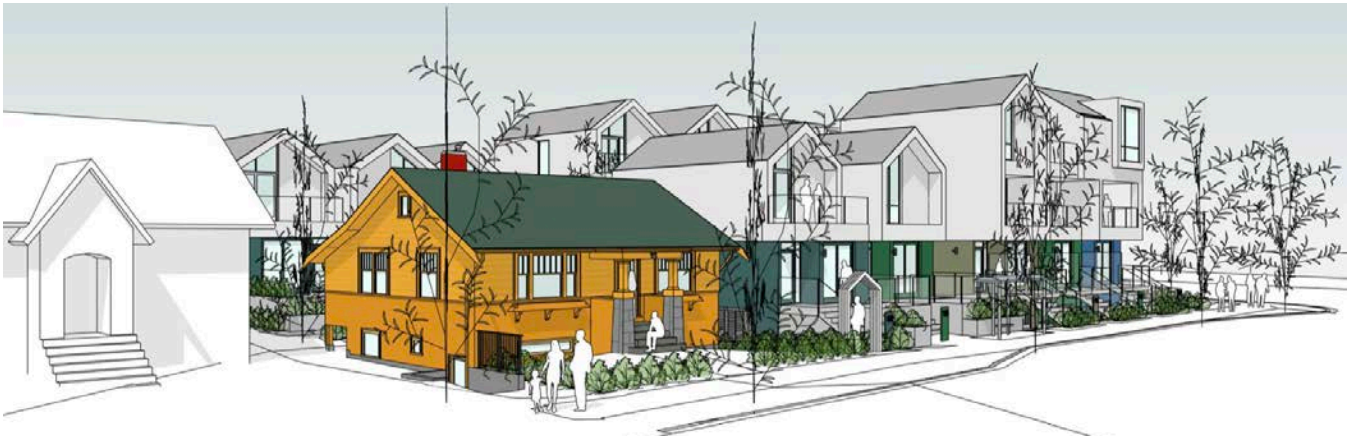
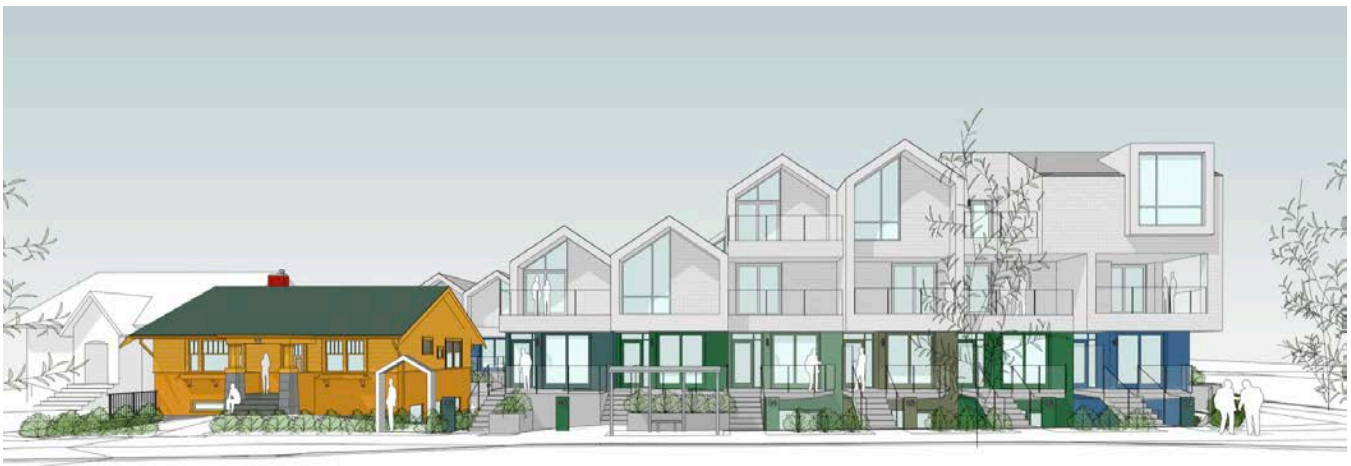
Standard 11 for Rehabilitation, in the Standards and Guidelines for the Conservation of Historic Places in Canada, requires new additions to historic places to be *subordinate*, *distinguishable* and *compatible*. The proposed townhouse design, form and siting achieves this by incorporating traditional bungalow elements in their gabled roofs and front porches as well as a painted ground level colour (compatibility); Clear contemporary design and finishes (distinguishability); General minimal texture and architectural ornamentation (for example - lack of trim boards and columns). The townhouses themselves will be mostly clad in smooth stucco panels. The stories above ground level will not be painted in colour, to minimize the impact of their volume and keep the eye at street level where the multi-textured historic bungalow remains the feature of the development (subordinate).

The two renderings of the proposed townhouse development show the historic Sincok House painted in yellow and gold while the bases of the townhouses are painted in other 1920s colours taken from the same 1926 Gordon Van Tine catalogue the original/found yellow and gold bungalow colours were matched to.

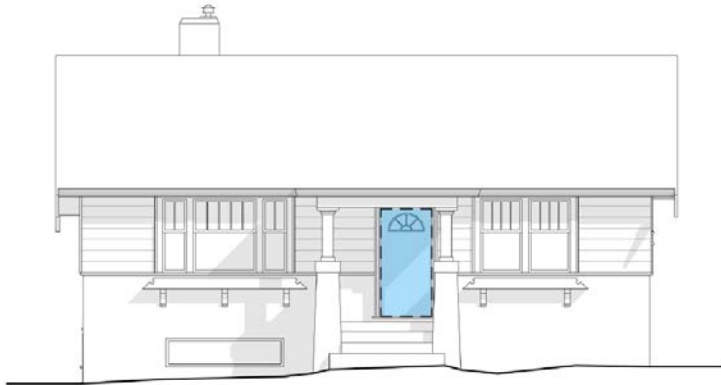
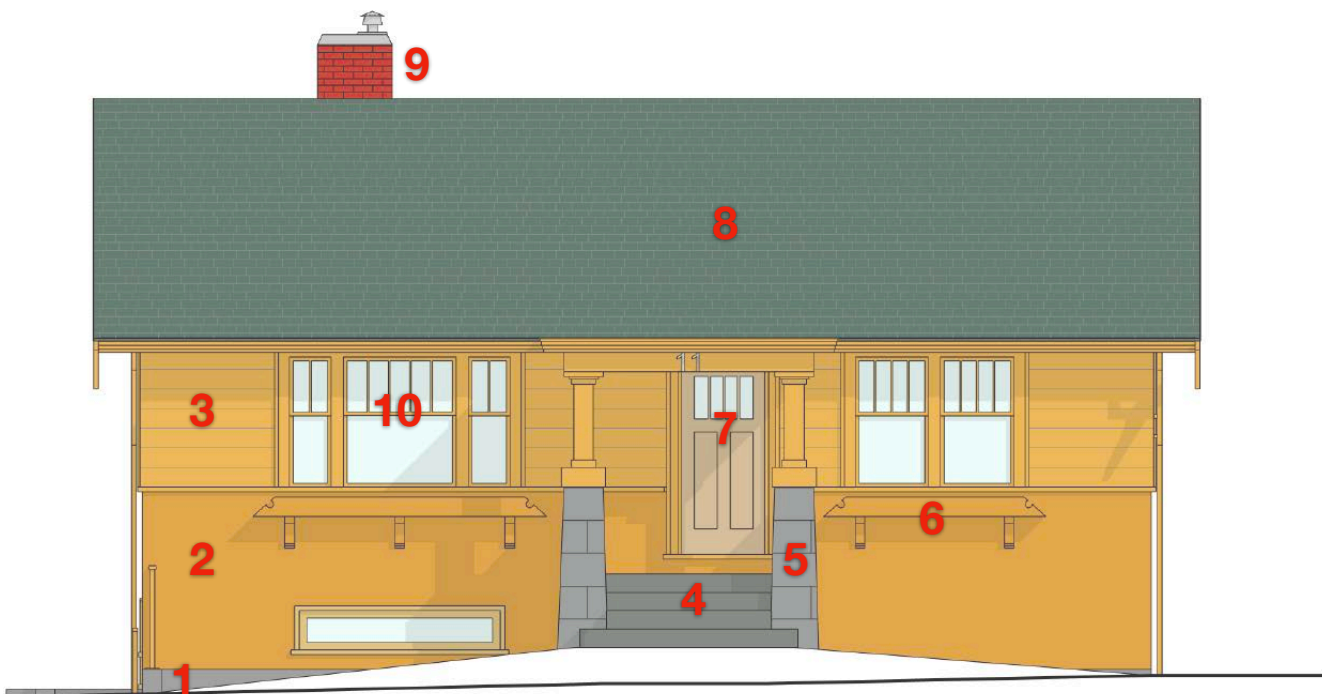
Proposed south elevation (front)

*Elements in blue to be removed/
replaced to achieve conservation
objectives, see below.*

1. Construct new concrete, seismic foundation and hardscaping elements at new location, excavated below grade, allowing the building's height and relationship to grade to remain similar to its current (historic) conditions (rehabilitation).

10. Preserve original wood windows in situ, on front and side elevations as noted on plans. Repair and maintain as needed.

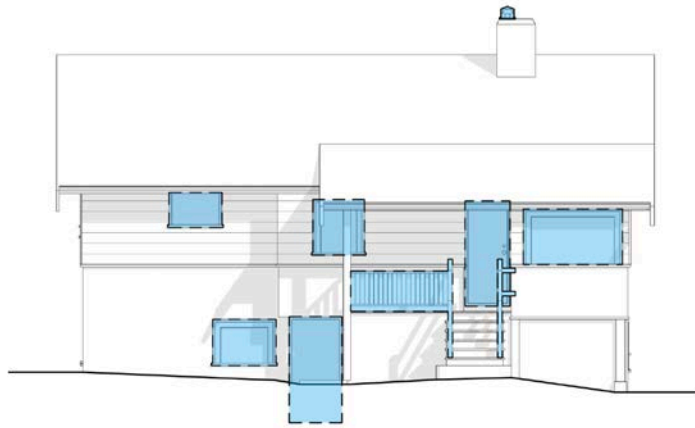
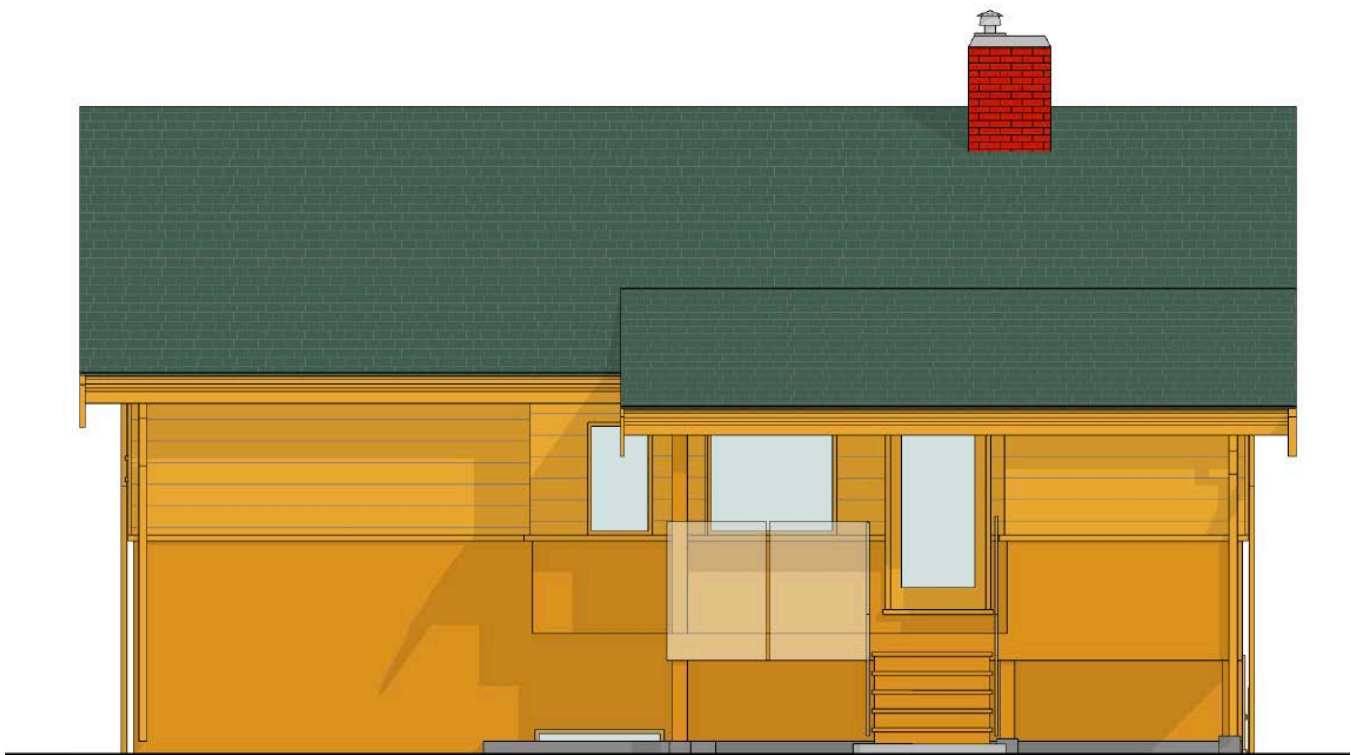
Proposed north elevation (rear)

*Elements in blue to be removed/
replaced to achieve conservation
objectives, see below.*

Preserve massing of roof forms and elevation at rear, including rear porch extension and roof.
Preserve rear open porch and stair locations

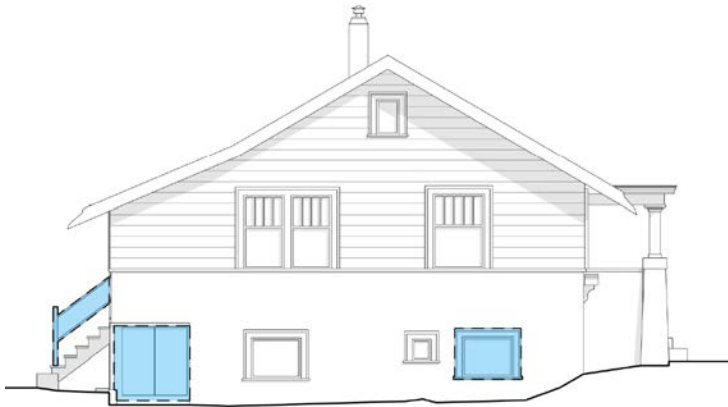
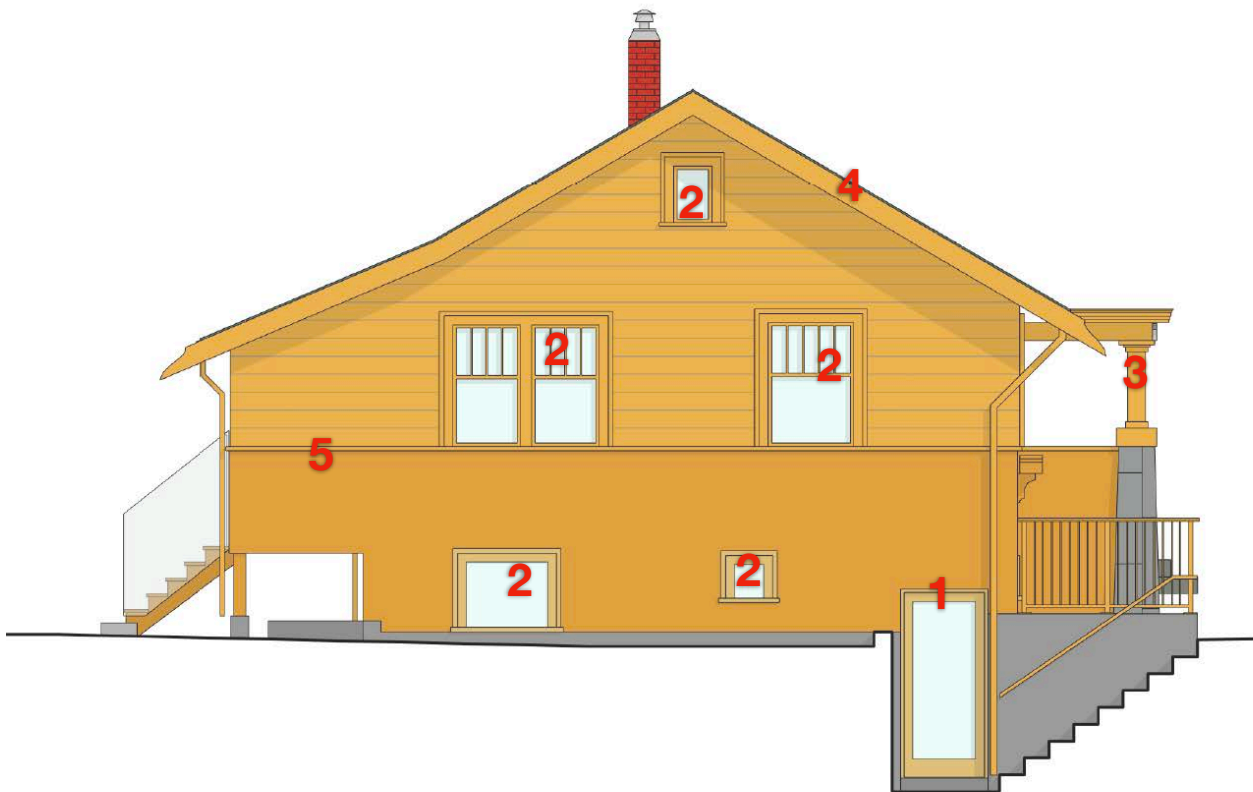
Proposed west elevation (side)

*Elements in blue to be removed/
replaced to achieve conservation
objectives, see previous page and
below.*

- 1.** Increase basement height through excavation, making the basement living space higher and more liveable. Introduce new contemporary door opening here for basement level.
- 2.** Preserve all original windows on this elevation but one which will be replaced with the new door opening.
- 3.** Preserve front porch wood columns in situ (brace for relocation)
- 4.** Preserve fascia boards and all trim board in situ (for all elevations).
- 5.** Preserve wood belt course and moulding in situ (for all elevations).

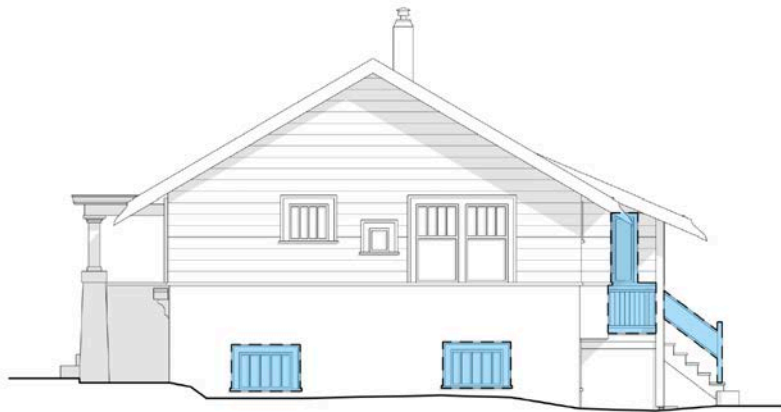
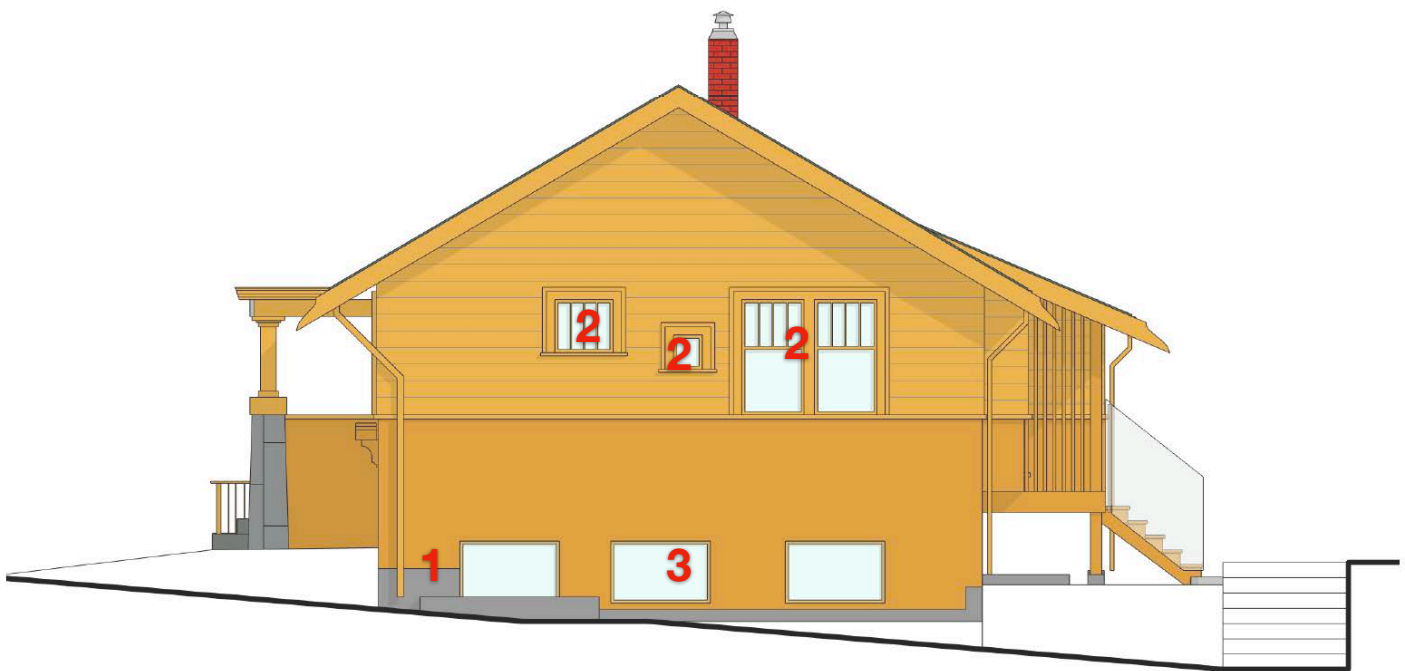
Proposed east elevation (side)

Elements in blue to be removed/ replaced to achieve conservation objectives, see previous page and below.

- 1.** Expand basement level through excavation, making the basement living space higher and liveable. Introduce new contemporary window openings here for the basement level, replacing two small wood basement windows.
- 2.** Preserve 1929 wood windows on main level in situ.
- 3.** Rehabilitate basement level windows by adding one to improve light and liveability at this level.

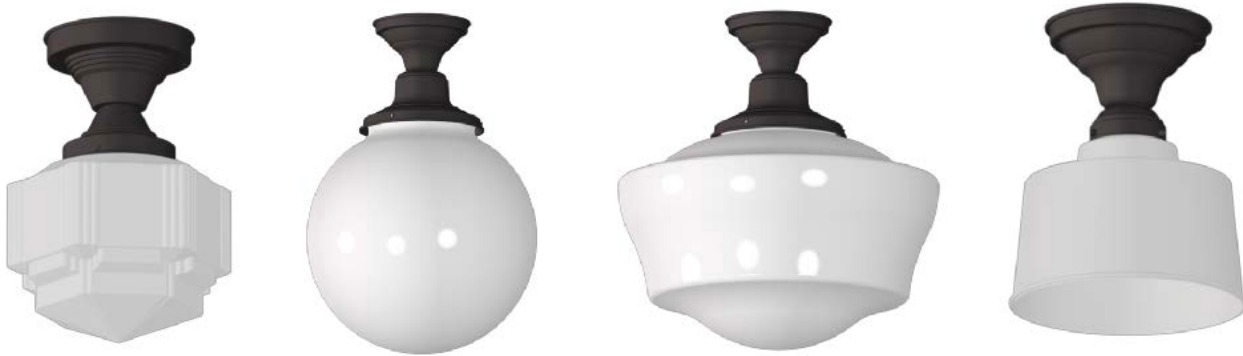
Hollywood 4" or Rose City 3 1/4 " fitters with various shade shapes: Opal Art Deco, Globe, Schoolhouse and Opal Cylinder. Source: rejuvenation.com

Front Porch: Restore the original semi-flush, front porch light fixture which has lost its shade by either rewiring it and replacing the glass shade, or installing a new replica fixture like one of the below traditional choices from Rejuvenation Lighting:
