Attachment # 1

**Recommended Short Term
Safety Measures**

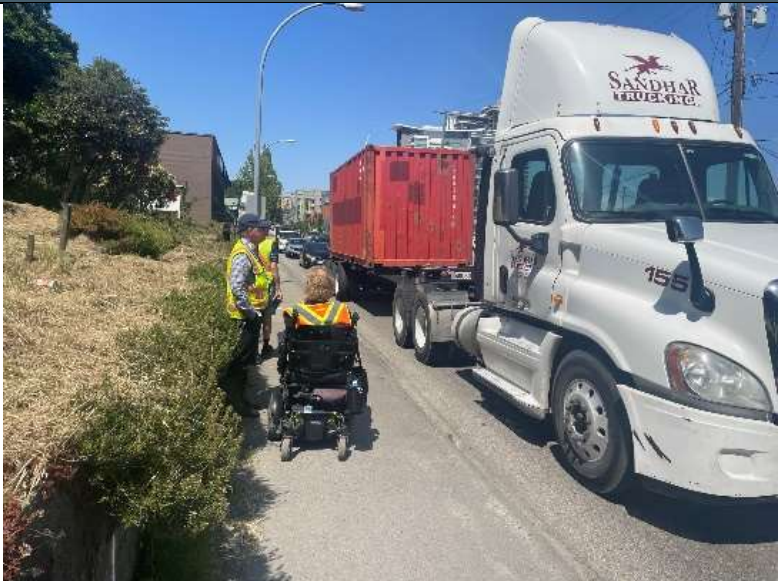
Issues	Safety Issue Name	Illustration/Photo	Short-Term Mitigation Measures
1.7	Narrow sidewalk adjacent to roadway

<ul style="list-style-type: none"> - Remove or trim vegetation at narrow points (encourage owners to do so if on private property) - Conduct a review of potential fence options for context with limited space - Work with property owner of 303 Cumberland Street to remove three trees within private property to provide multi-use pathway - Remove landscaping adjacent to retaining wall and widen multi-use pathway to edge of retaining wall
1.9	Narrow sidewalk on Debeck

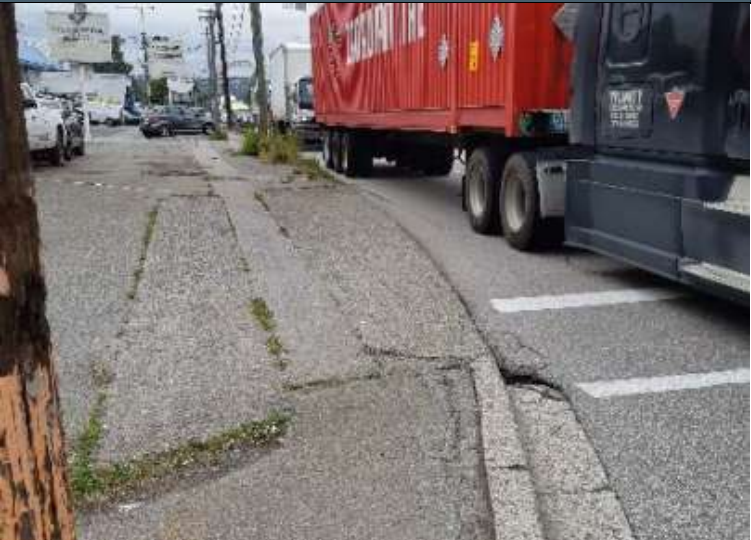
Issues	Safety Issue Name	Illustration/Photo	Short-Term Mitigation Measures
2.2	Missing curb letdown

<ul style="list-style-type: none"> - Upgrade sidewalk and crosswalk interface and install accessible curb letdown with Tactile Attention Indicator
2.4	Sidewalk termination

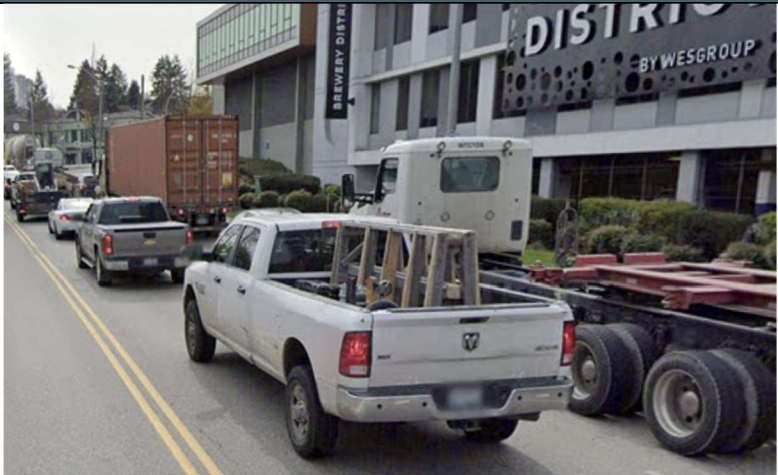
Issues	Safety Issue Name	Illustration/Photo	Short-Term Mitigation Measures
3.2	Excessive lane changing and overtaking on Brunette

<ul style="list-style-type: none"> - Provide lane designation signage
3.4 3.13	Aggressive driving and Speeding Expectation of intersection (from westbound approach)

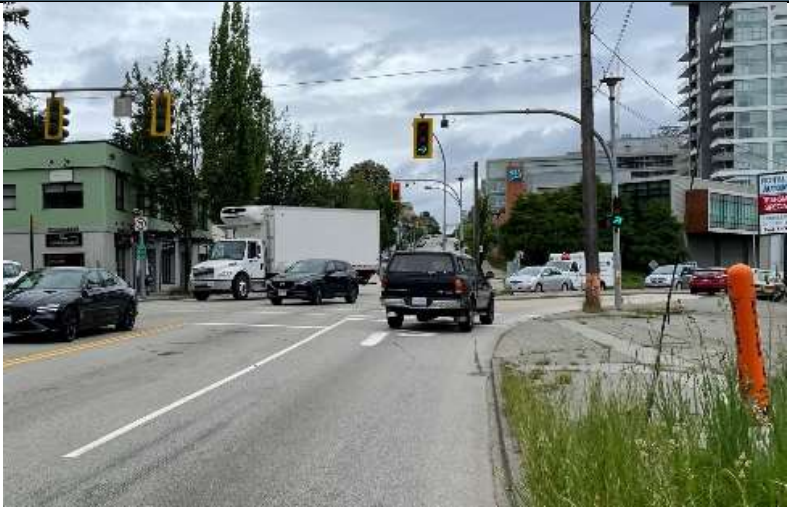
Issues	Safety Issue Name	Illustration/Photo	Short-Term Mitigation Measures
3.5	Northbound right turn on red

<ul style="list-style-type: none"> - Install prominent No RTOR signage - Conduct enforcement

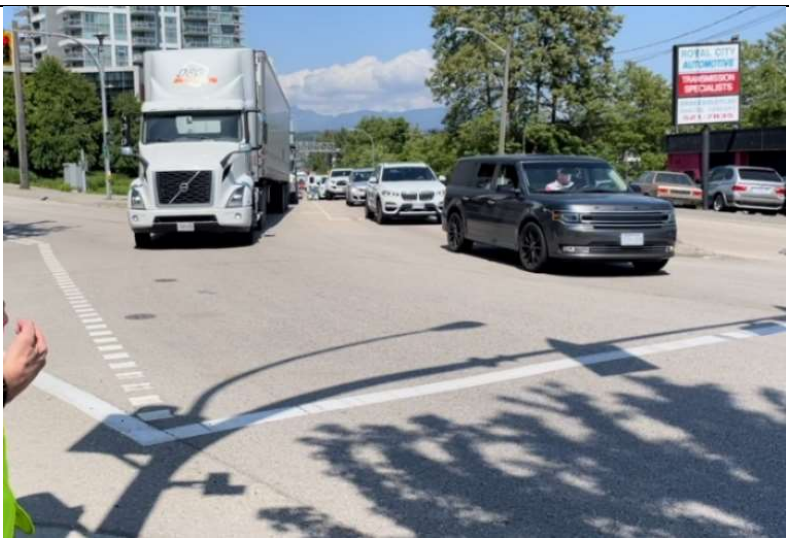
3.6	Westbound truck turning paths conflict with crossside

<ul style="list-style-type: none"> - Provide guidance markings through intersection - Provide advance warning of horizontal curve through intersection

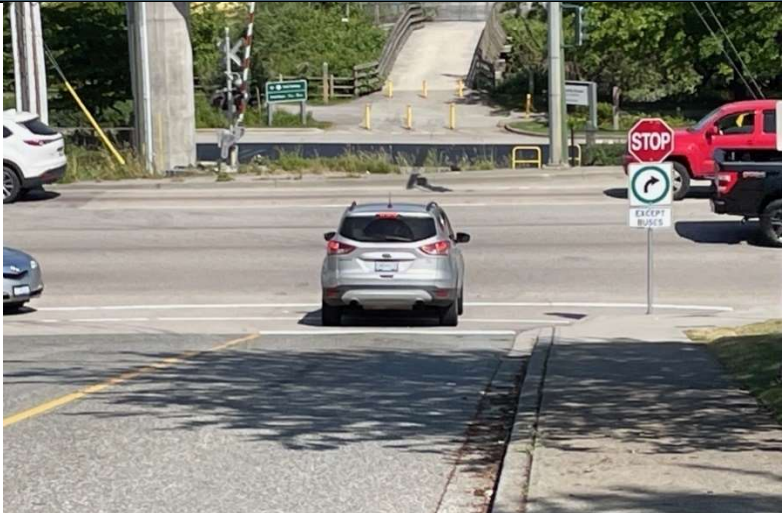
Issues	Safety Issue Name	Illustration/Photo	Short-Term Mitigation Measures
3.8	Non-compliance with Left Turn Restrictions at Cumberland

<ul style="list-style-type: none"> - Replace right turn only sign with “no left turn” sign - Conduct Enforcement
3.9	Visibility of yield signage from Cumberland

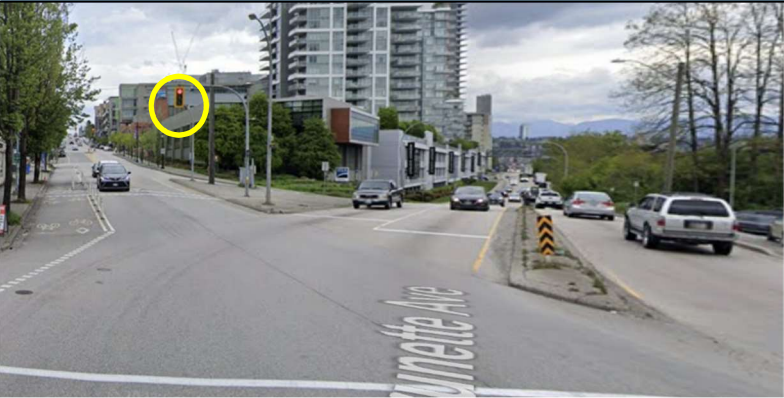
Issues	Safety Issue Name	Illustration/Photo	Short-Term Mitigation Measures
3.12	Visibility of traffic signal displays

Provide near-side signal displays
1.3 4.2 4.3	Lack of pedestrian space on east crosswalk Vehicles driving along sidewalk Narrow through/dooring zone between parked vehicles and heavy trucks	 	- Post parking restrictions - Enforcement

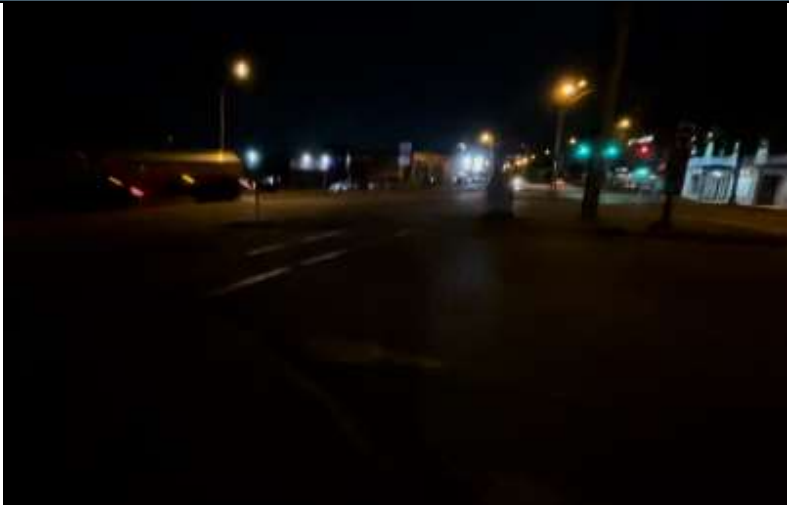
Issues	Safety Issue Name	Illustration/Photo	Short-Term Mitigation Measures
<p>5.2 5.3 5.4 5.5 5.6</p>	<p>Inadequate night-time visibility on right-turn island and along sidewalks in the area</p>

<ul style="list-style-type: none"> - Conduct lighting review - Paint island face of curb
<p>5.7</p>	<p>Crosswalk trip hazards</p>
