**HERITAGE REVITALIZATION AGREEMENT (203 PEMBINA STREET)  
BYLAW NO. 8425, 2024**

**A Bylaw to enter into a Heritage Revitalization Agreement under  
Section 610 of the *Local Government Act***

Queensborough Northern Red Oak Tree – 203 Pembina Street, New Westminster

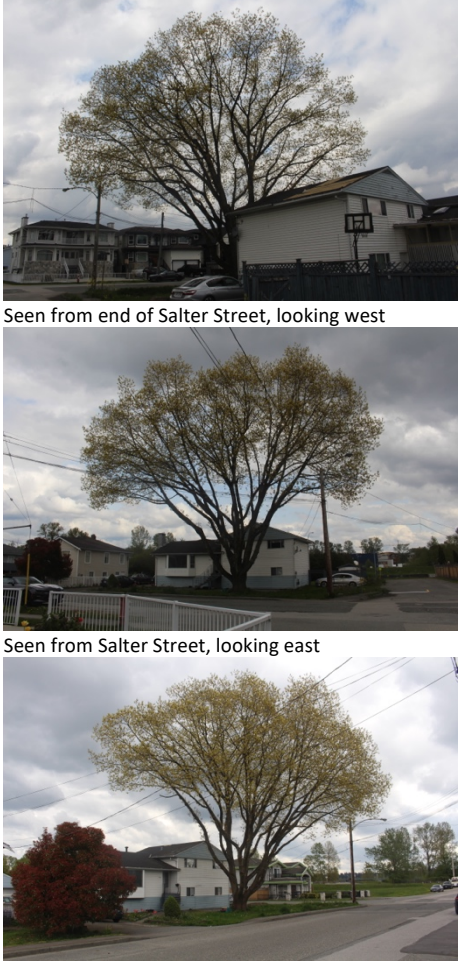
DESCRIPTION AND CONDITION	PHOTO DOCUMENTATION
<p><b>5.1 CONTEXT</b></p>	<p>The Queensborough Northern Red Oak tree is situated on the east side of Pembina Street, immediately north of Salter Street in the Queensborough neighbourhood. The tree is set in close proximity to the front property line, 5 m from the existing ditch (swale), and on a flat surface. It has a strong street presence on this lot, and commands a dominant view along the entire streetscape. The tree exposure class (TEC) is described as “dominant” meaning it is open grown and free from competition.</p> <p>Condition assessment from the arborist’s report is described as “good”. The tree has a DBH (diameter) of 132 cm and a height of 18 m. The contribution value of the tree on the site, as measured by the arborist, is “high”.</p>

<p>Seen from end of Salter Street, looking west</p> <p>Seen from Salter Street, looking east</p> <p>Seen from Pembina Street, looking south</p>

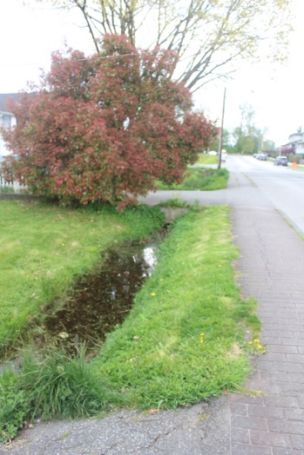
<p>Swale or small ditch situated along the front of properties to the north on Pembina Street</p>

DESCRIPTION AND CONDITION	PHOTO DOCUMENTATION
<p><b>5.2 ROOTS AND DRIP ZONE</b></p>	<p>The Queensborough Northern Red Oak tree has expanded to encompass much of the front yard, based on its canopy that extends out over the road and the house.</p> <p>The critical root zone (CRZ), denoting the area of undisturbed natural soil around the tree defined by a concentric circle with a radius equal to the distance from the trunk to the outermost circle of the dripline, is 8 m. There is also an open ditch located roughly 4.5 m from the tree alongside Pembina Street, within the critical root zone. The driveway to the north and roadway to the west and the house foundation to the east have likely suppressed the root activity.</p> <p>The roots are not visible to determine any degree of deterioration or damage.</p> <p>The east side root system is expected to be suppressed by the existing main building (i.e. the house) and to a lesser degree, the ditch.</p>

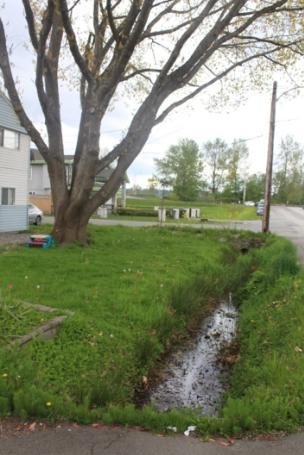
<p>Swale or small ditch situated along the front of the property</p>

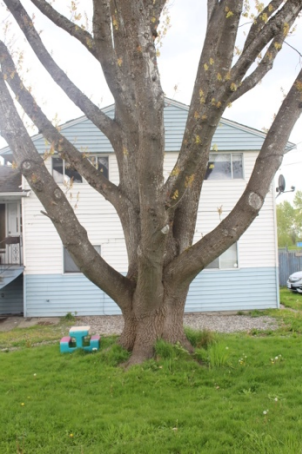
<p>Base of the tree showing the trunk and codominant stems.</p>

DESCRIPTION AND CONDITION	PHOTO DOCUMENTATION
<p><b>5.3 TRUNK</b></p>	<p>The trunk has a large number of codominant stems.</p> <p>The trunk is in generally good condition. Much of the pruning took place on the east side (facing the house). There is an indeterminant number of old pruning wounds with good compartmentalization. There is also a chain embedded in the trunk but it does not appear to be girdling.</p>

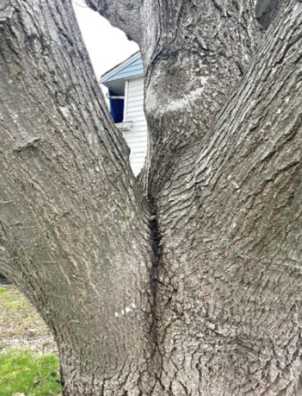
<p>Codominant stems and pruning wounds</p>

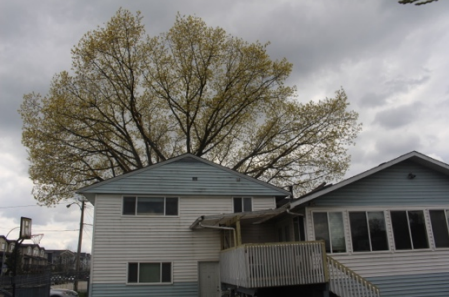
<p>Canopy as seen from rear</p>

DESCRIPTION AND CONDITION	PHOTO DOCUMENTATION
<p><b>5.4 CANOPY AND FORM</b></p>	<p>The canopy is expansive, extending to the north, south and west, and less so to the east due to pruning. The spread radius is 9 metres.</p> <p>There is a live crown ratio (LCR) of 70%, measured as percent of live crown observed in relation to a tree of normal form and with a full crown.</p> <p>Despite the fact that the trunk has a large number of codominant stems, the branches that run from those to create the canopy appear to be in good condition.</p>

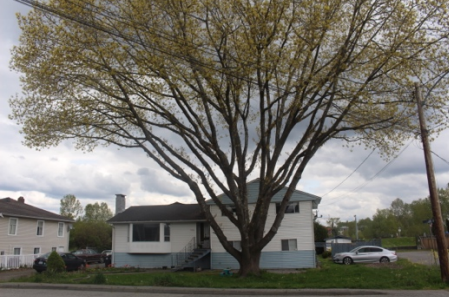
<p>Expansive canopy seen from front.</p>

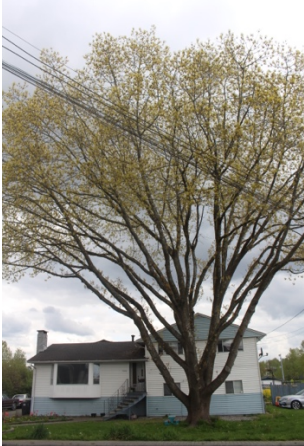
<p>Emerging foliage as seen in spring</p>

DESCRIPTION AND CONDITION	PHOTO DOCUMENTATION
<p><b>5.5 FOLIAGE</b></p>	<p>The spread radius of the branches and foliage (dripline) is 9 m, measured from the face of the tree to the furthest extent of the tree’s canopy as measured or estimated by an arborist.</p> <p>The tree is described by the arborist as having good vigour and dense crown, and an absence of nesting birds.</p>
