**THE CORPORATION OF THE CITY OF NEW WESTMINSTER
HERITAGE REVITALIZATION AGREEMENT (515 St George Street)
BYLAW NO. 8262, 2021**

HERITAGE REVITALIZATION AGREEMENT (515 St George Street)

Heritage Conservation Plan

Adams House, 515 St George Street, New Westminster, BC
 September 21, 2021

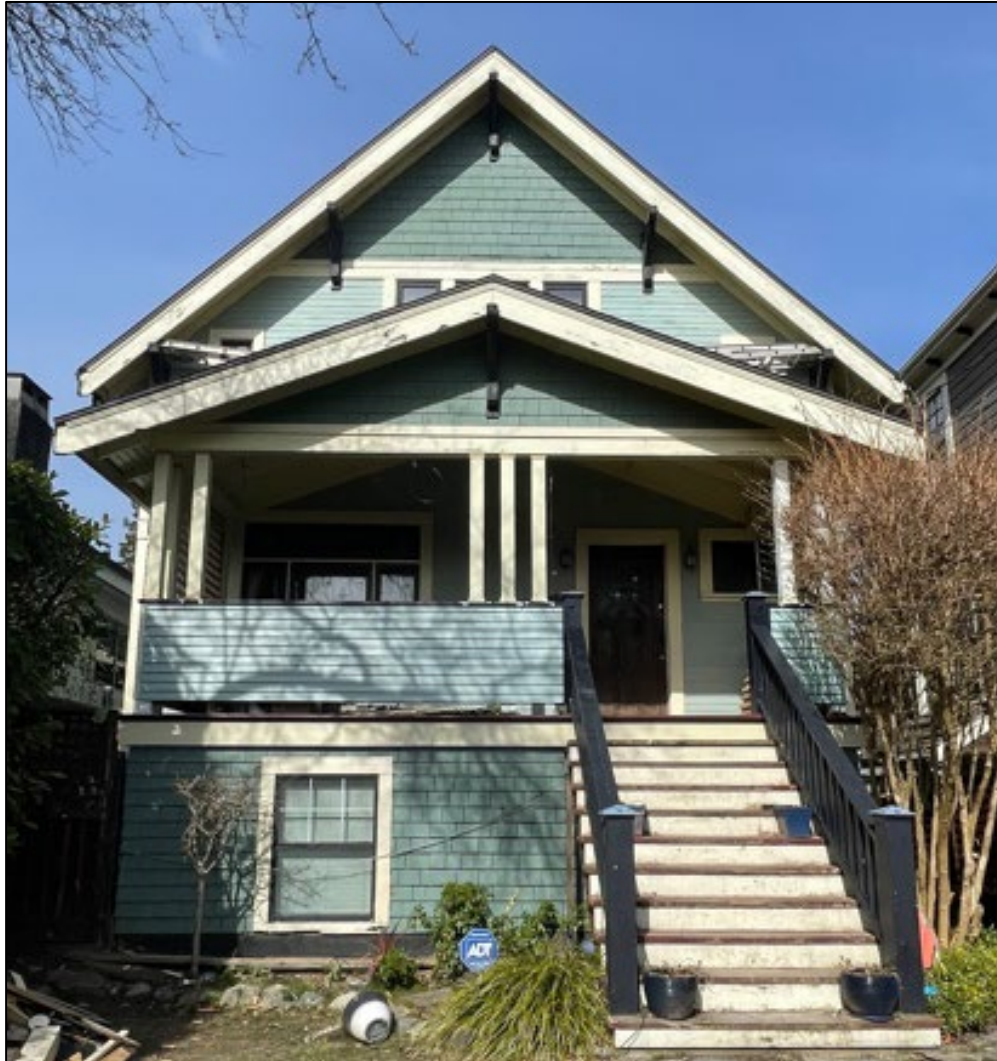
Fig. 1: Front view of Adams House at 515 St George Street, New Westminster, BC, 2021. (Source: Marino)

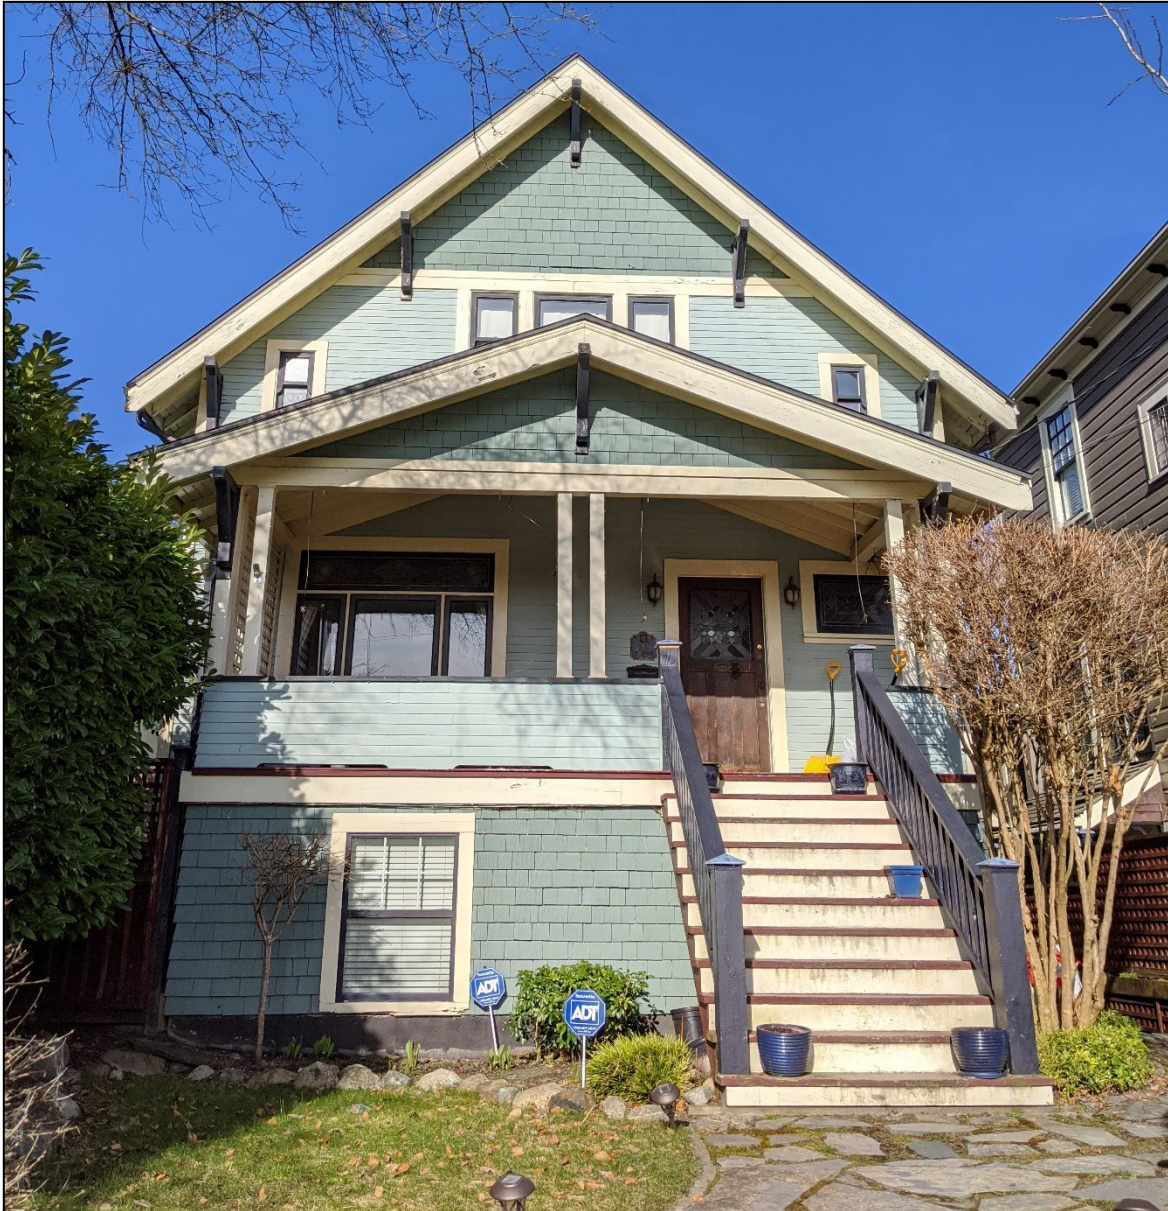
Fig. 7: Front view of Adams House at 515 St George Street, 2020, illustrating the front gable and gabled front verandah, along with other Craftsman style details, such as the square porch posts and brackets. (Source: Cummer)

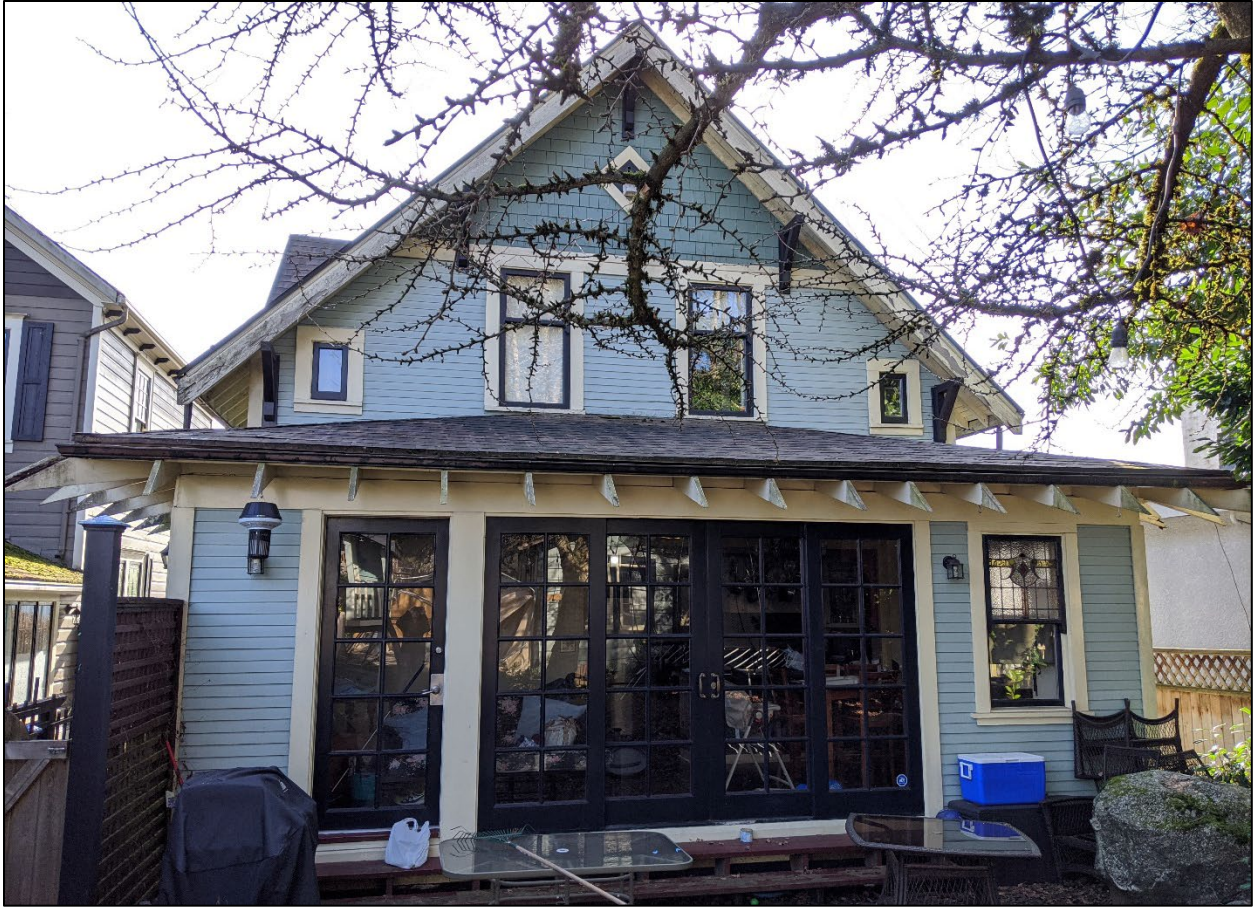
Fig. 8: Back view of Adams House at 515 St George Street. Note the brackets and range of windows, including a double hung horned stained-glass window on the right as well as two other double hung horned wood windows in the upper middle along with a diamond shaped window in the rear gable. (Source: Cummer)

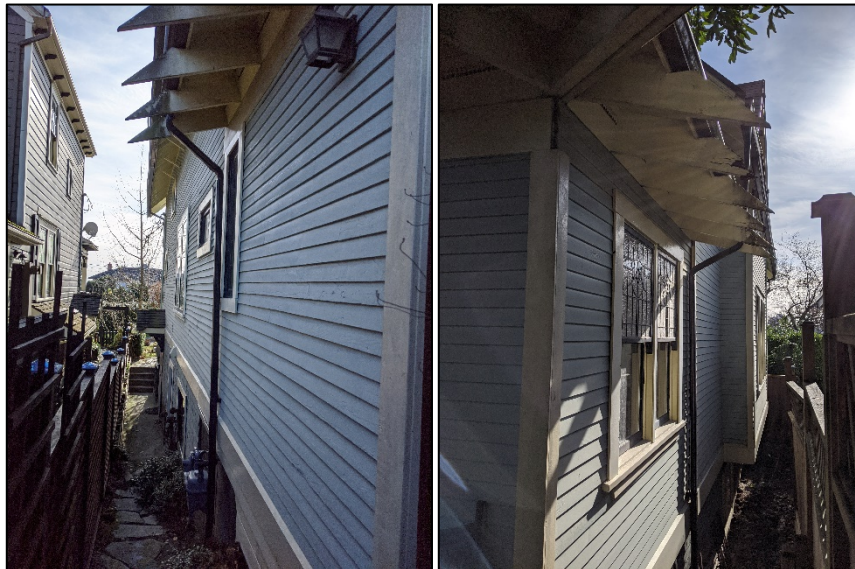
Figs. 9 and 10: Side views of Adams House at 515 St George Street. Left (Fig. 9) shows the eastern side and right (Fig. 10) shows the western side. (Sources: Cummer)

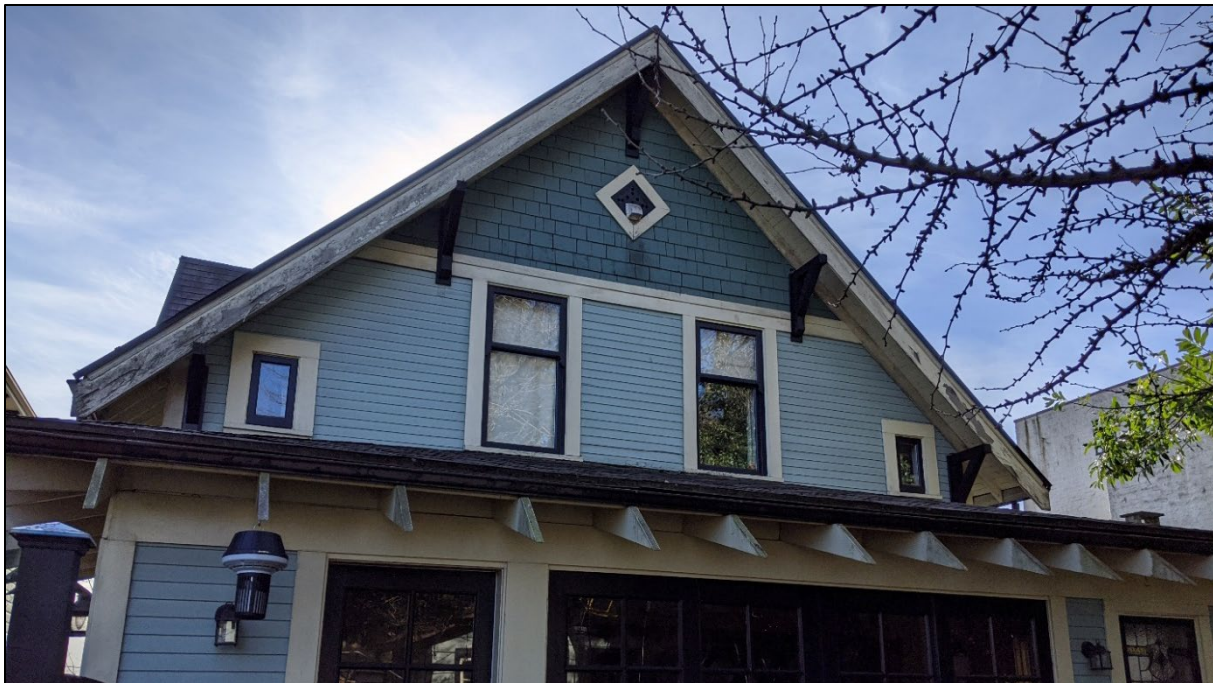
Although the roof is in good condition, overall, there are certain areas in need of repair and maintenance. As mentioned above, there are fascia boards, soffits and rafter tails that are in need of cleaning and repainting, as well as repair in sections (Figs. 11 to 12).

Fig. 11: Back gable of Adams House at 515 St George Street, showing the dirty rafter tails and soffits as well as the peeling fascia boards, in need of repainting. (Source: Cummer)

- The house's current paint is, for the most part, in good condition with just certain areas in need of cleaning and touching up (such as the front stairs, certain trims, the fascia boards, soffits and rafter tails). These should be cleaned and **rehabilitated**, as needed.

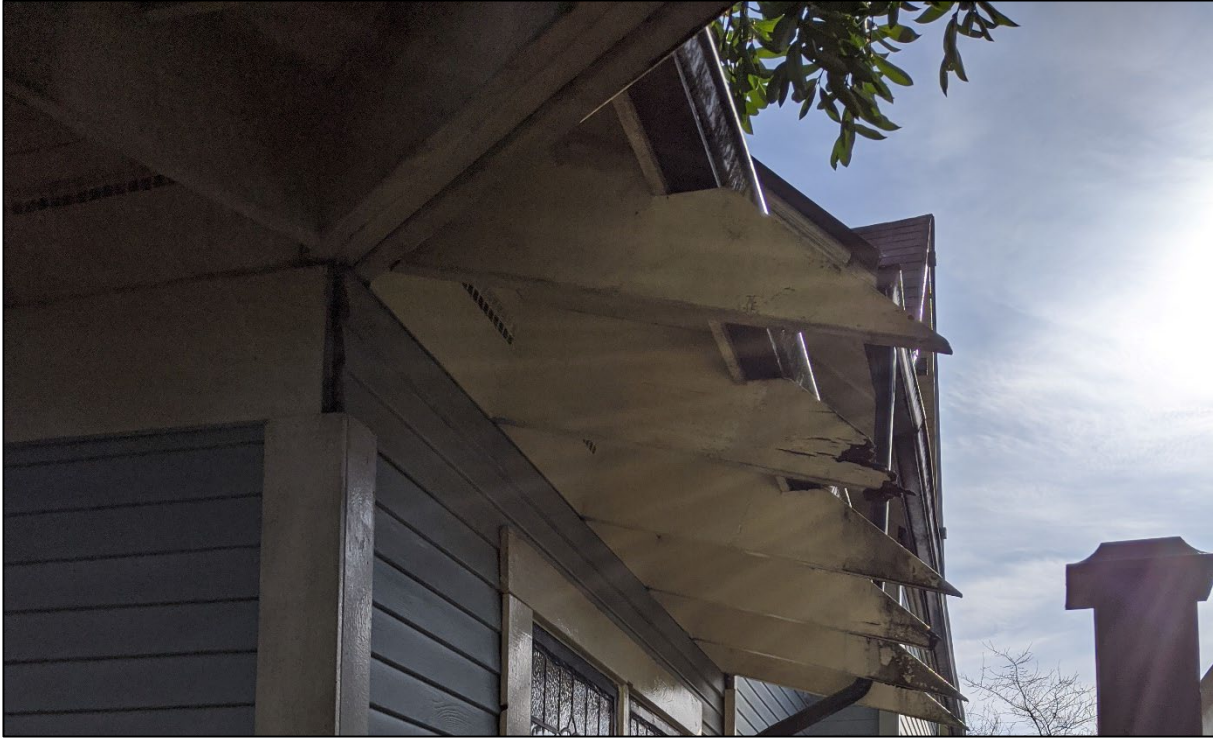
Fig. 12: Western side of Adams House at 515 St George Street, showing the dirty rafter tails, in need of cleaning and repainting, as well as ones in need of repair. (Source: Cummer)

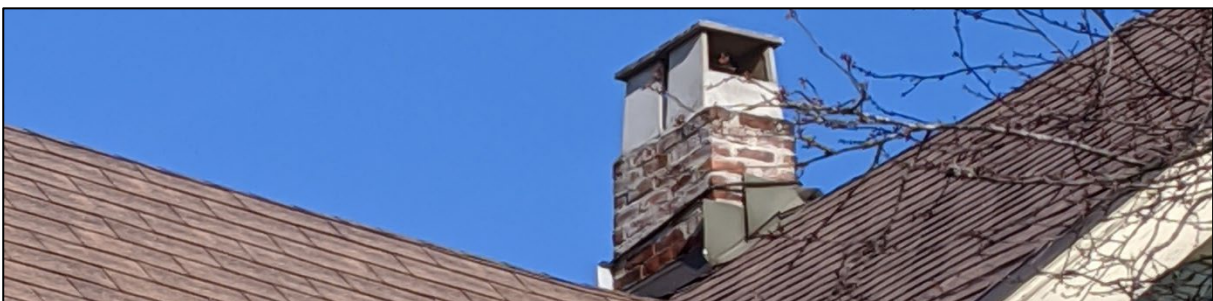
The small chimney, located in the middle of the roof, appears to be in good condition (Fig. 13). As recommended by an earlier draft of this HCP, consultation with a chimney sweep was carried out on July 8, 2020 with Santa's Chimney Services. It was determined that there is "no moisture or damage in the attic or outside of the house. However, it needs to be caulked because of cracks caused by old age" (personal communication, 2020). This re-caulking will be addressed as part of the conservation work.

Fig. 13: The chimney and partial roof of Adams House at 515 St George Street. (Source: Cummer)

- The chimney should be **rehabilitated**, in particular cleaned and repointed. If any bricks need to be replaced, they should be replaced in-kind.

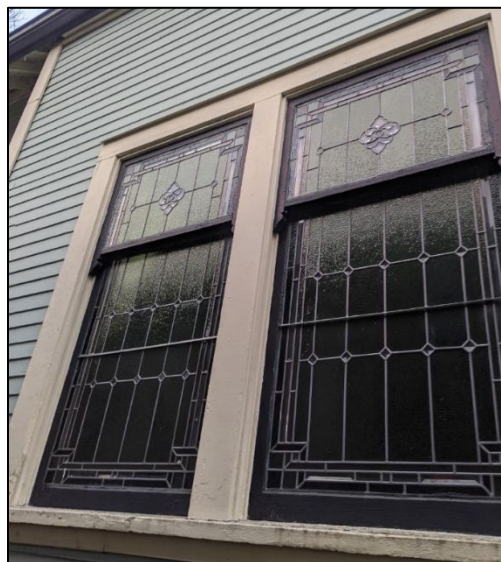
Overall, the windows and doors are in good condition. The front door is showing some signs of weathering (Fig. 14), particularly at the bottom, however this is largely cosmetic. The rest of the door is in good condition, including its stained-glass window (Fig. 15). The majority of the windows throughout the property are original and in good condition. The only condition concerns appear to be cosmetic with paint peeling in places and areas in need of cleaning (Fig. 16).

Fig. 16: Illustration of some of the original windows of Adams House, in this case a pair of double-hung horned wood stained-glass windows, showing a dirty sill that can be easily addressed. (Source: Marino)

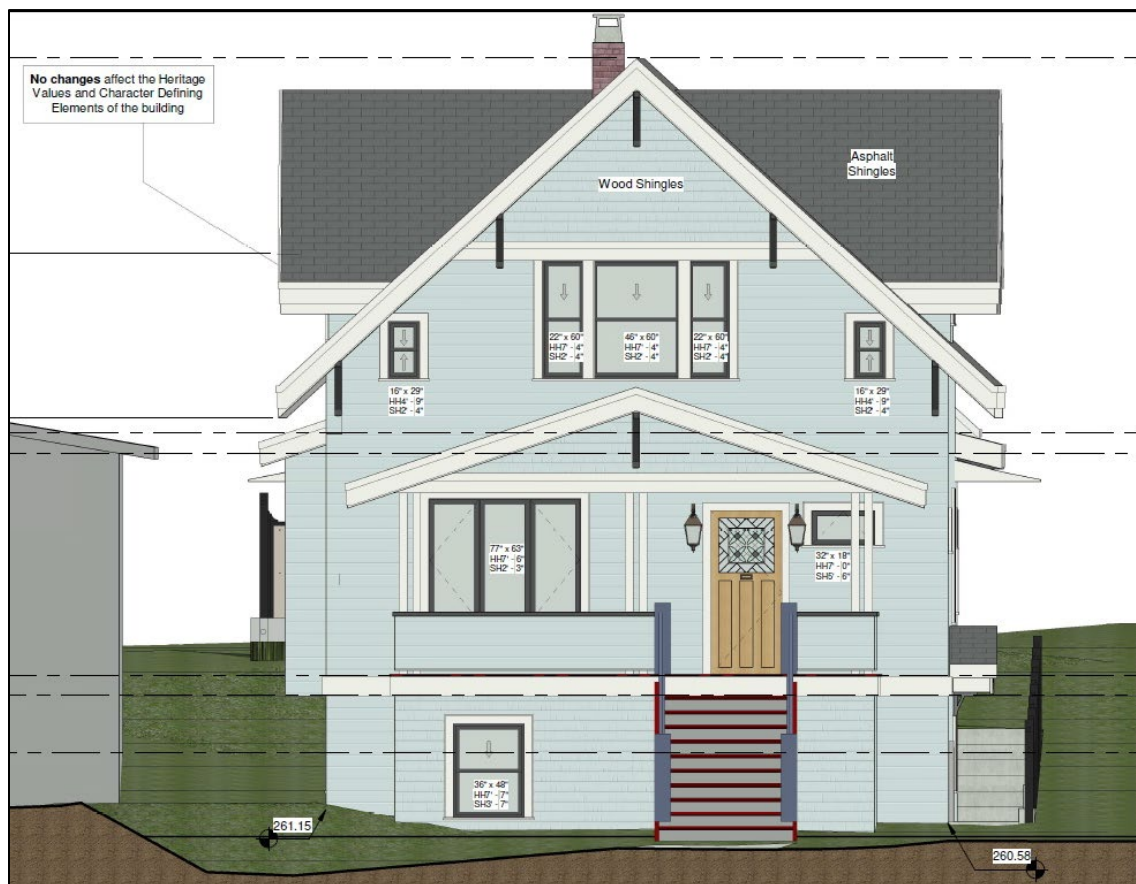
The proposed changes to this house are minimal (Fig. 18), it is simply being rehabilitated in the few areas requiring repair and maintenance. Otherwise, a shed at the back of the property is being demolished to make way for a Laneway House (Fig. 19). The proposed changes are considered a reasonable intervention given generally accepted conservation standards, rehabilitation needs and site conditions. The proposed change does not affect the Heritage Values and Character Defining Elements of the building.

Fig. 18: Illustration of the preserved front façade of Adams House, 2021. (Source: D3 Design)

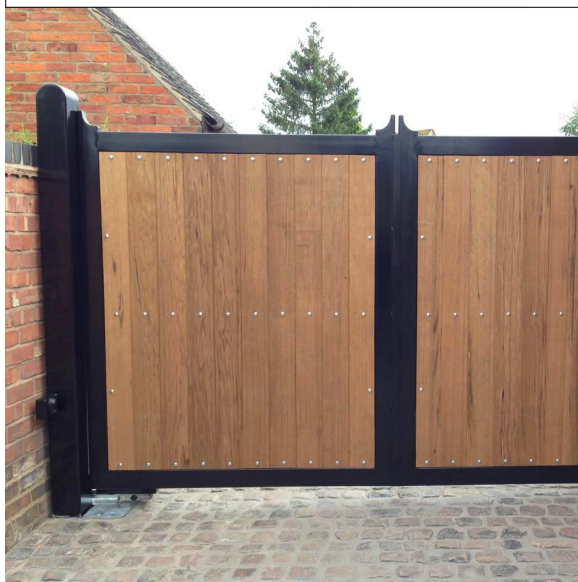
In-swing gate, 4'-1" (1.25m) high

Replica fence to emulate historical fences of Queen's Park. Though used as a gate in front of a driveway, its material and height mask its function. Material of rod iron and natural finish composite wood

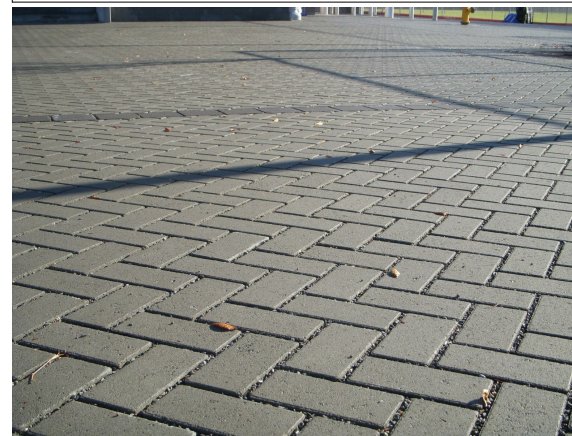
Permeable pavers for driveway

Permeable pavers allow commonly recurring rainstorms to infiltrate through a permeable concrete paving stone surface into a clear crushed open-graded aggregate base before being released into storm sewers or watercourses. Known as permeable interlocking concrete pavement, the system acts as an infiltration facility for the storage, treatment, and improvement of released water.

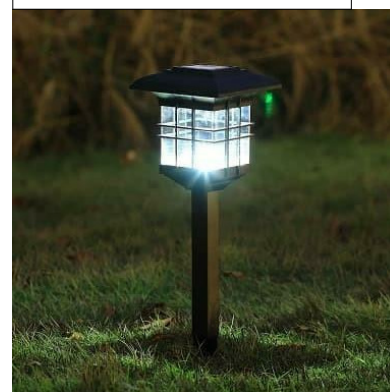
Pathway Lighting

Low energy use solar powered lights to be placed along exterior pathways
