**THE CORPORATION OF THE CITY OF NEW WESTMINSTER
HERITAGE REVITALIZATION AGREEMENT (208 Fifth Avenue)
BYLAW NO. 8271, 2021**

HERITAGE REVITALIZATION AGREEMENT (208 Fifth Avenue)

APPENDIX 2
CONSERVATION PLAN

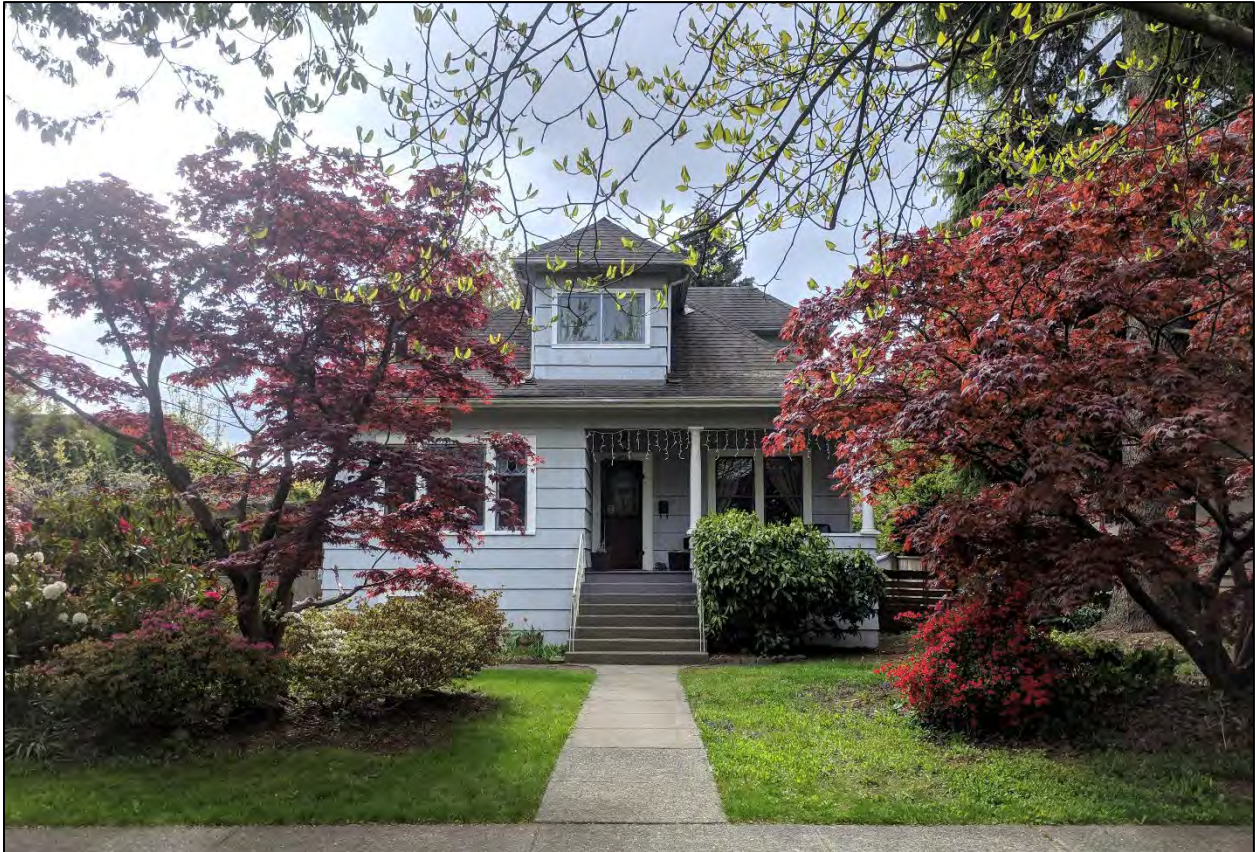
Fig. 1: Calbicks House, 208 Fifth Avenue, New Westminster, BC, 2019. (Source: Cummer)

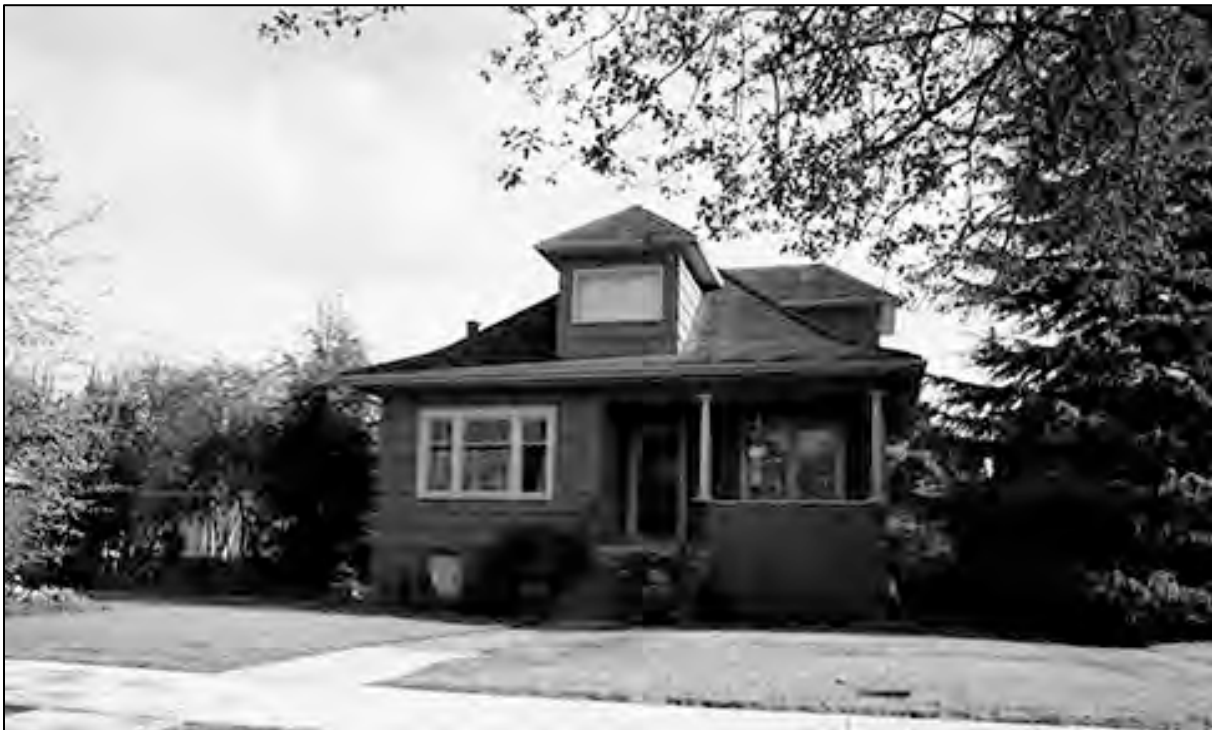
Fig. 7: The only available historical photograph of 208 Fifth Avenue, 1982. (Sources: New Westminster Archives, IHP14546)

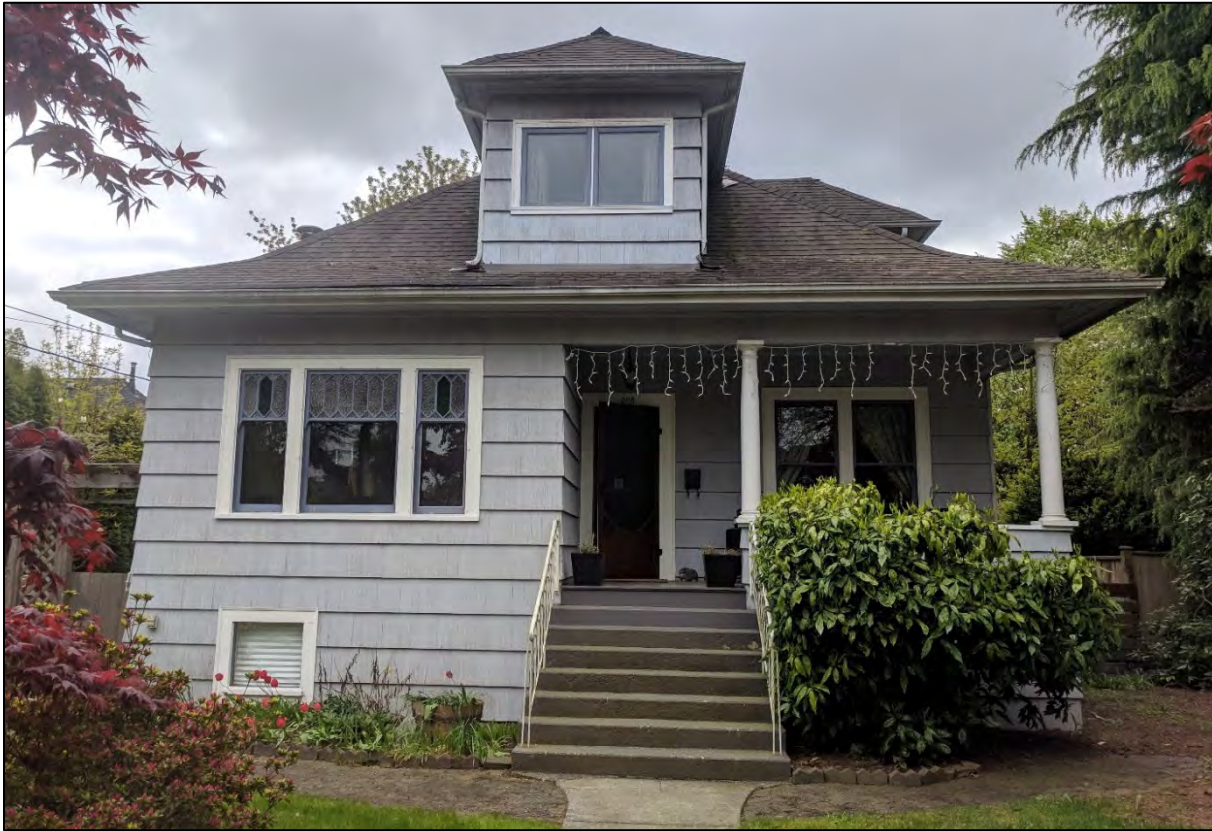
Fig. 8: Front view of Calbicks House at 208 Fifth Avenue, 2019, illustrating the hipped dormer, hipped roof with slight bell-cast flared eaves, the partial-width porch and classical columns, with centred front door. (Source: Cummer)

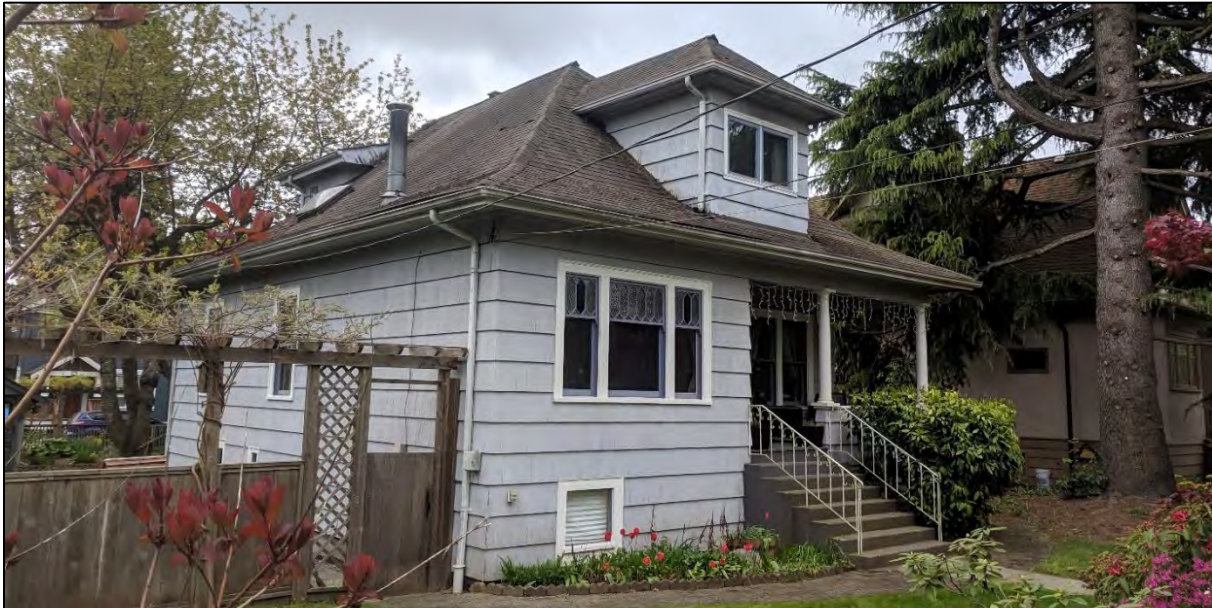
Fig. 9: Partial front and eastern side view of Calbicks House at 208 Fifth Avenue, 2019, highlighting its hipped roof. (Source: Cummer)

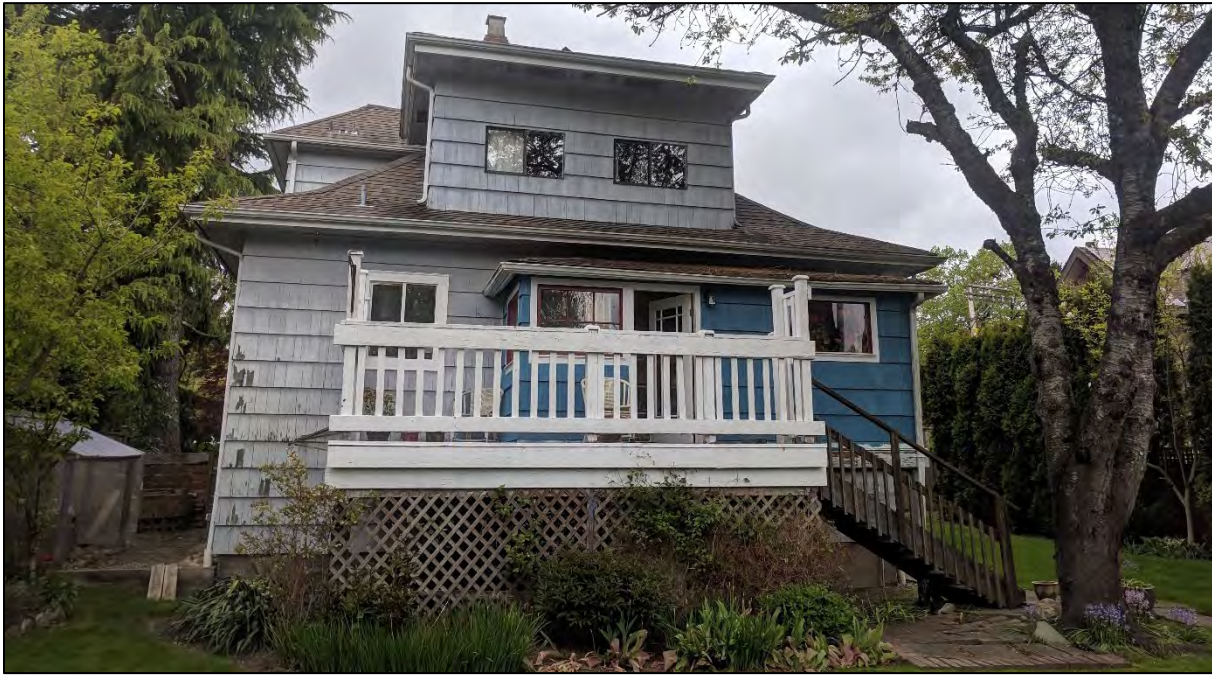
Fig. 10: Back view of Calbicks House at 208 Fifth Avenue, 2019, showing the later addition that will be removed. (Source: Cummer)

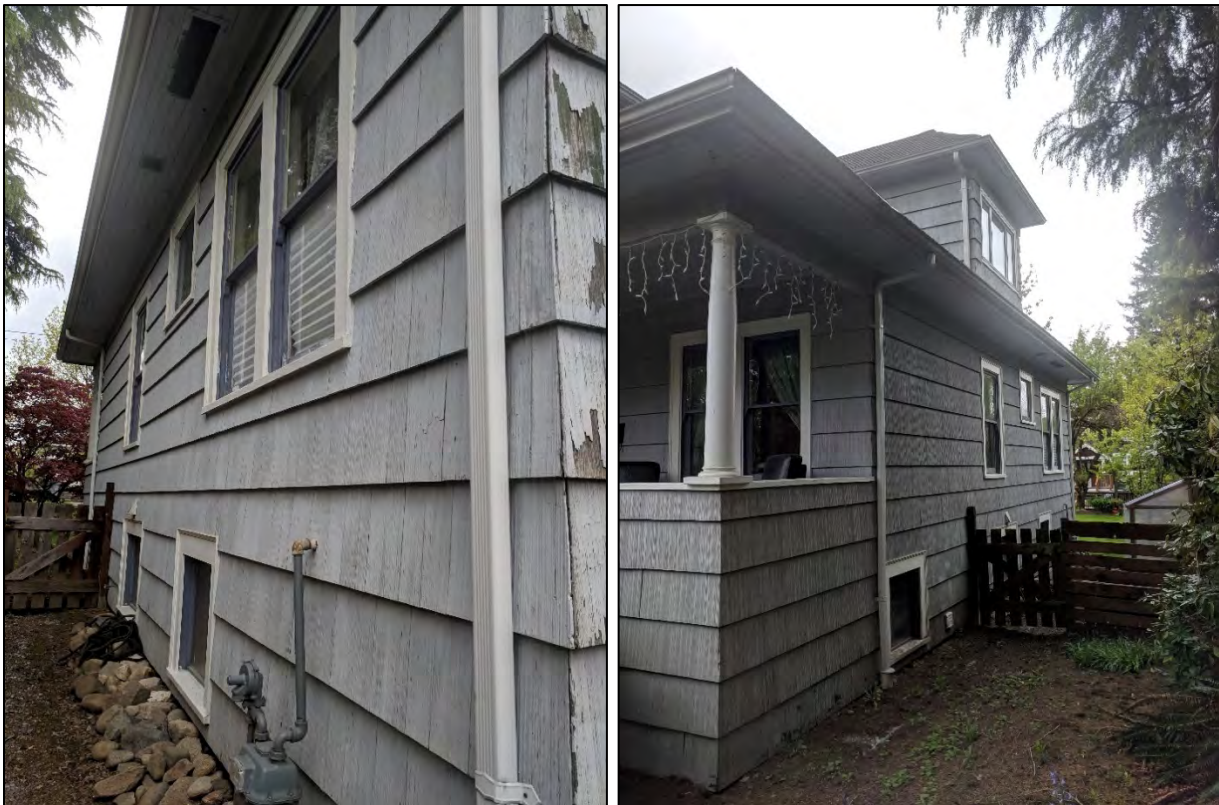
Figs. 11 and 12: Western side view of Calbicks House at 208 Fifth Avenue, 2019, from the back (left, Fig. 11) and the front (right, Fig. 12). Note the double-hung horned wood windows and the square wood windows. (Sources: Cummer)

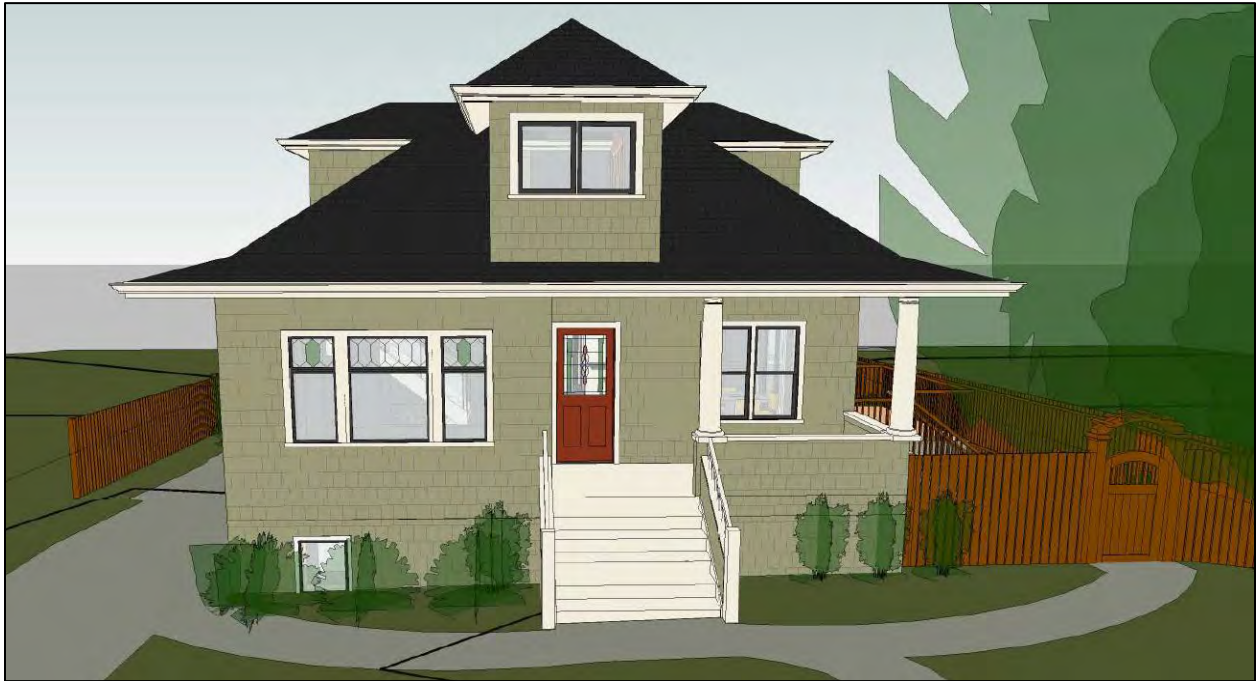
Fig. 14: Proposed revitalization of Calbicks House, at 208 Fifth Avenue, 2021. (Source: D3 Dimension, Drafting and Design Inc.)

Calbicks House, at 208 Fifth Avenue, will be moved slightly northeast within its property lines (Fig. 13a) to allow for its lot to be subdivided for a sympathetic new build at the back (Fig. 13b), with restoration and rehabilitation work carried out on the heritage house (Fig. 14). An additional rear dormer will be added at the back, adding continuity and unifying the back roofline, as well as an additional eastern side dormer to match the existing western side dormer, adding symmetry to the property. These additions will maintain and respect its characteristic boxy exterior. The proposed work would allow for a continued residential use, with improved living space at the back, and does not affect the Heritage Values nor the Character Defining Elements of this historic place.

Preservation, Restoration and Rehabilitation are the conservation objectives for the building. Specifically, preservation of the windows, restoration of the lower back configuration of the building by removing the later addition and rehabilitation of the siding and soffits.

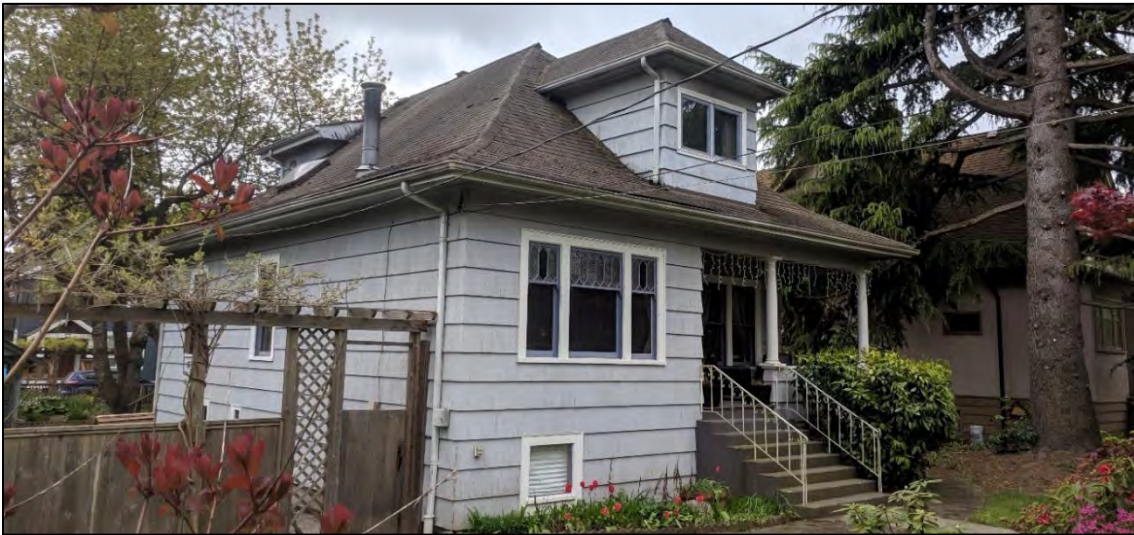
Fig. 15: Partial front and eastern side view of Calbicks House at 208 Fifth Avenue, 2019, illustrating its overall good condition. (Source: Cummer)

The front exterior of Calbicks House appears to be in good condition (Fig. 15), however, the back addition is in somewhat poor condition, with some levels of deterioration visible (Figs. 16 and 17). Considering the back addition will be removed as part of this conservation work, the poorer condition of this aspect of the building is of less concern.

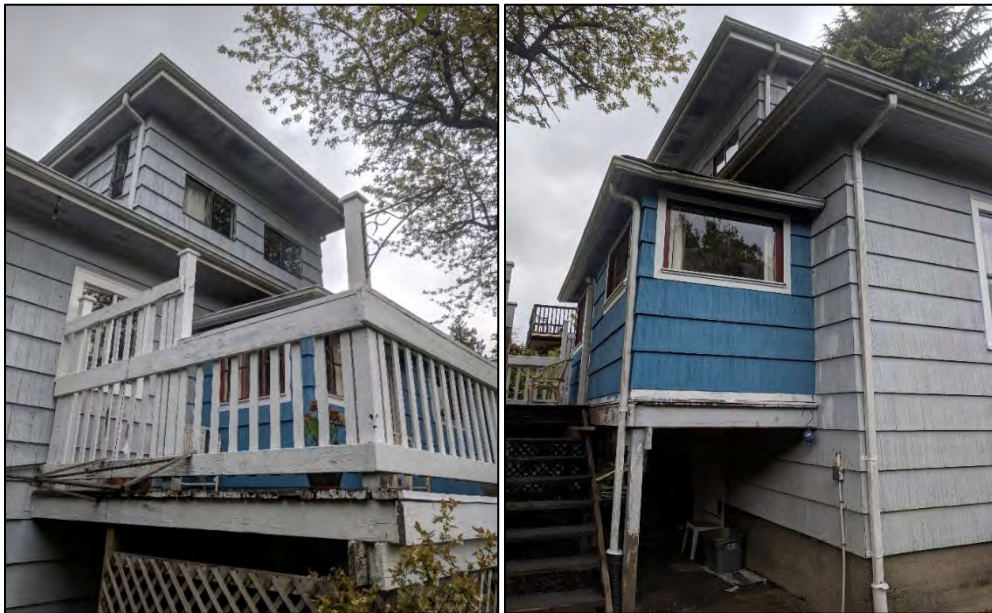
Figs. 16 and 17: Fig. 16 (left) shows the southwestern back view of Calbicks House at 208 Fifth Avenue, 2019, and Fig. 17 (right) shows the southeastern back view, illustrating some of the deterioration. (Sources: Cummer)

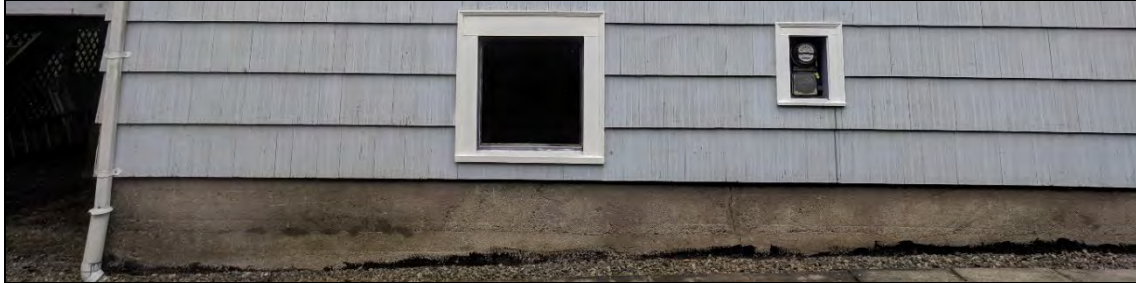
Fig. 18: Eastern side view of Calbicks House at 208 Fifth Avenue, 2019, illustrating its foundation. (Source: Cumber)

Overall, the condition of the walls and building envelope, from roof to foundation, appears to be good (Fig. 18). Please note an interior inspection was not conducted. It is understood that the house will be put on a new foundation following its relocation.

- It is understood that due to the house's relocation it will be moved onto a new foundation.

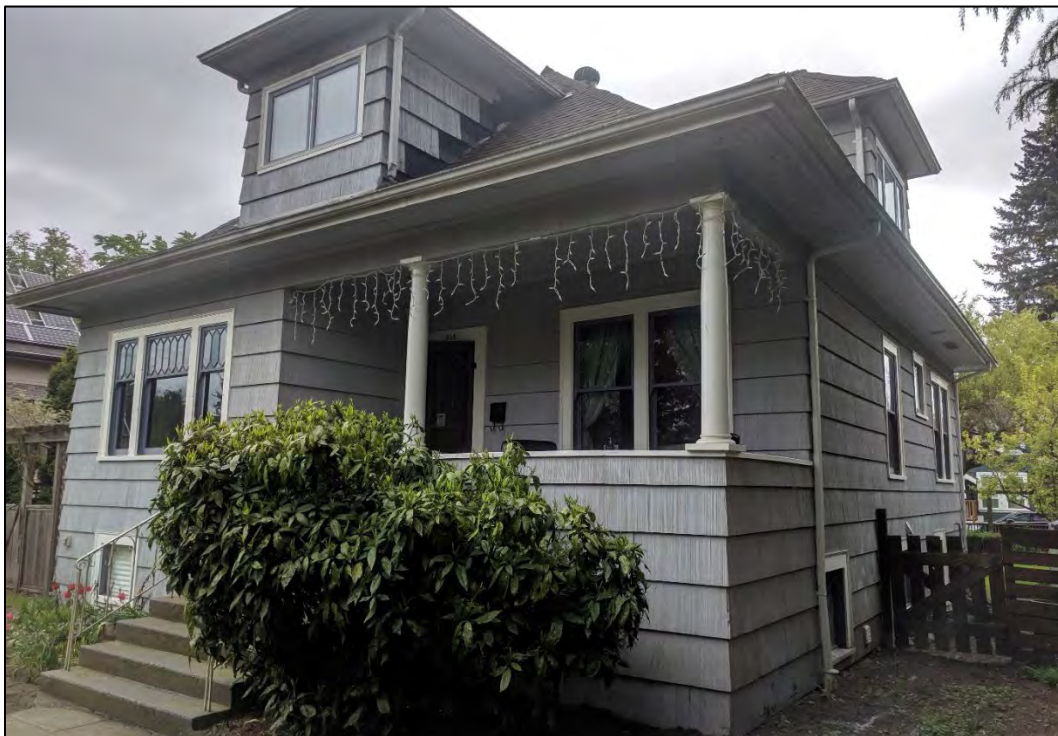
Fig. 19: Northwestern front and side view of Calbicks House at 208 Fifth Avenue, 2019, illustrating the overall good condition of its exterior wood elements. Note the landscaping possibly growing too close to the foundations, as discussed in section 9.9 below. (Source: Cumber)

The visible, exterior wood elements of the front porch, windows and siding are, for the most part, in good condition (Fig. 19). There are simply some sections of the siding in need of repair and/or maintenance, as discussed in the relevant section below. Please note an internal inspection was not conducted to inspect the internal timber elements. These should also be inspected by a structural engineer to confirm their integrity and stability, prior to moving the house.

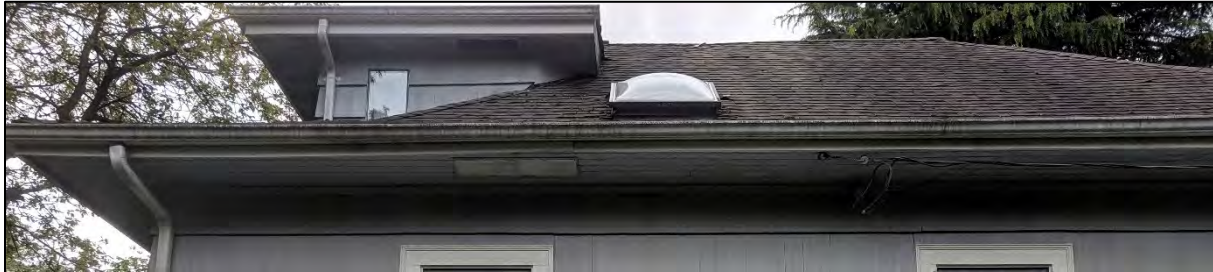
Fig. 20: Eastern side view of the roof of Calbicks House at 208 Fifth Avenue, 2019, with the unsympathetic skylight visible in the middle. (Source: Cummer)

The average roof life is approximately 15 years, with the potential to last 30 years with proper care and maintenance. The current roof is in fair condition. It is recommended to replace the current roof and to ensure the gutters are cleaned and in good operation (if they are not also replaced at the same time). It is also encouraged that during this work, the unsympathetic skylight be removed (Fig. 20).

- On account of its age, the roofing should be replaced. The unsympathetic skylight on the eastern side of the house should be removed, **restoring** the original look of the roof.

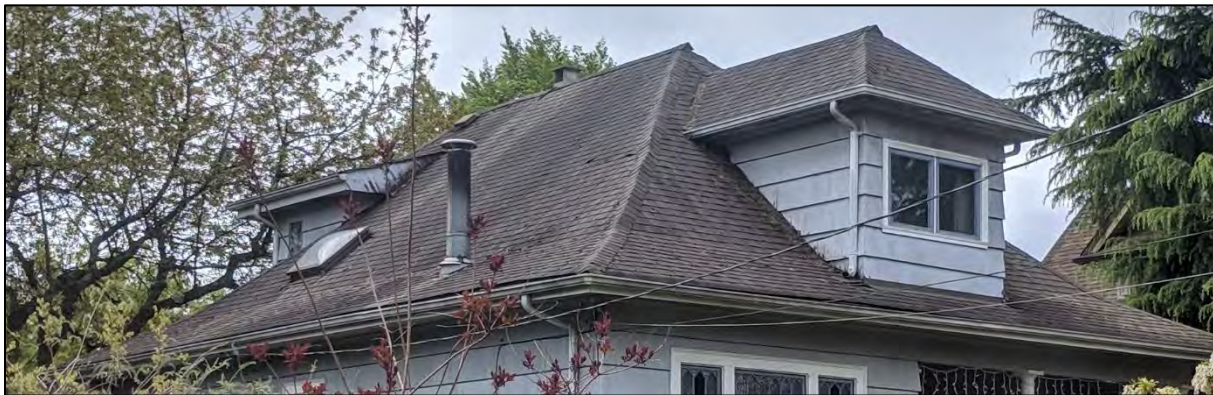
Fig. 21: Front view of the roof of Calbicks House at 208 Fifth Avenue, 2019, with the taller chimney visible in the foreground and the smaller along the roof line. (Source: Cummer)

It appears there are two chimneys currently on the house and they seem, externally, in good condition. On the eastern side of the house, there is a fairly tall and prominent metal chimney stack on the outer edge of the building's roof plane and a smaller one with intact chimney cap nearer the back, in the middle of the hipped roof line (Fig. 21).

- The original brick chimney, with intact chimney cap, should be **preserved**, if possible (or, if needed, rebuilt after the house is moved). If the latter is required, the chimney should be dismantled to the roofline and the bricks should be cleaned to be re-used for rebuilding the chimney with its original bricks, as much as possible.
- The metal chimney stack will be removed, due to condition concerns and an aesthetic preference to simplify the look of the house from the front. This is deemed acceptable since it is unlikely this metal chimney stack is original.

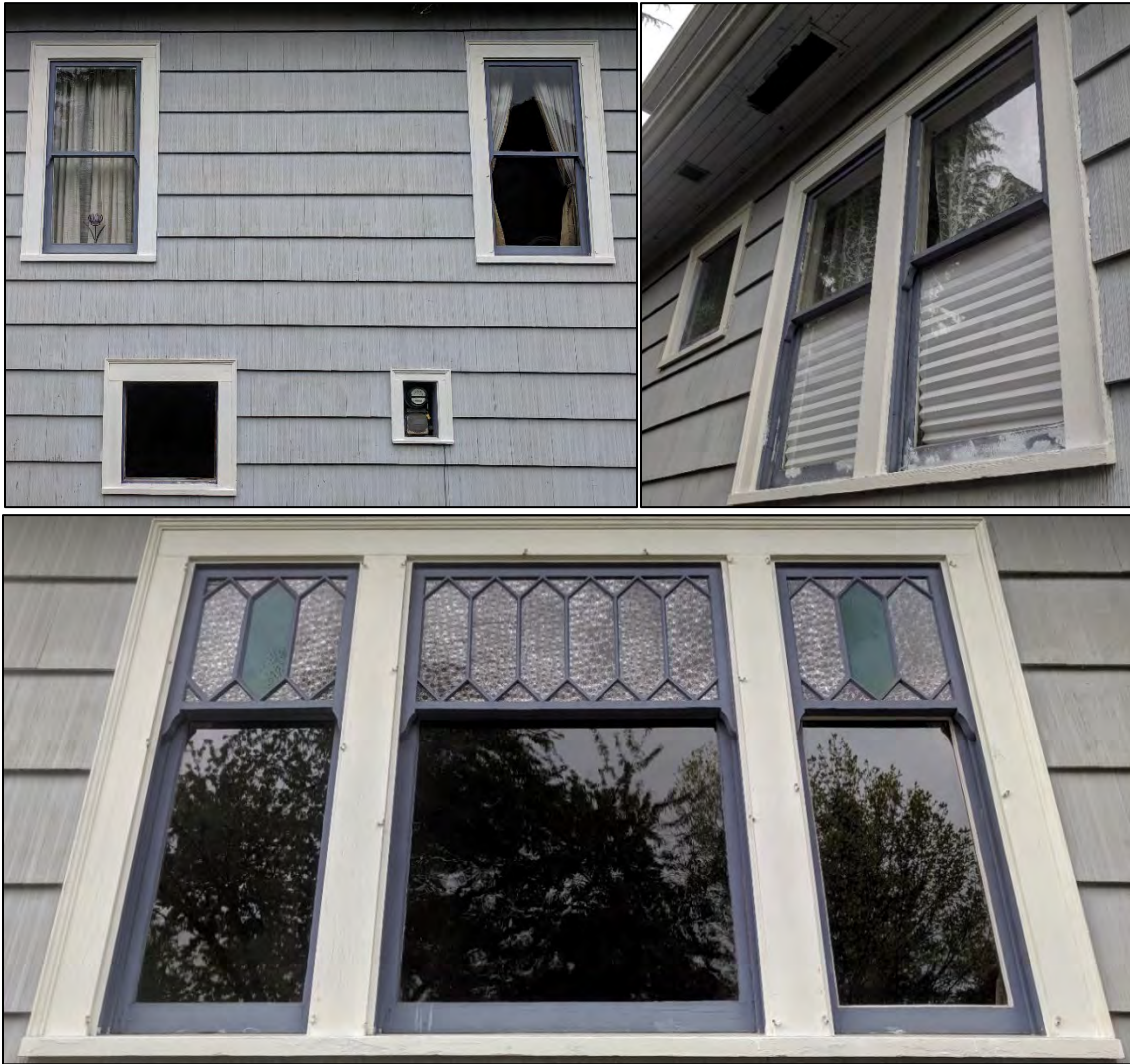
Figs. 22 to 24: Fig. 22 (upper left) shows the eastern side windows of Calbicks House at 208 Fifth Avenue, 2019; Fig. 23 (upper right) shows some of the western side windows; Fig. 24 (bottom) shows the triple window assembly of double-hung horned wood windows with decorative upper sashes at the front of the house. (Source: Cummer)

Considering the age of the building, the windows and doors are in good condition, overall. Most of the windows (their frames, sashes and hardware) appear to be the original ones from 1910, particularly the double-hung horned wood windows (Figs. 22 to 24) and some of the square ones (Figs. 25 and 26). While the condition of the windows is, for the most part, good, there are areas that could be touched up and repaired, such as the upper casing of the square windows on the western side of the building, as illustrated in Fig. 25 below.

- The double-hung horned wood windows of Calbicks House are the original 1910 windows and should be **preserved**.
- The square wood windows, particularly with the frosted glass, also appear to be original and should be **preserved**, where possible.
- With some of the proposed changes to the building (such as the back restoration and the new deck), the current placement of the windows are impacted. These windows will be installed elsewhere on the building (as opposed to installing new windows throughout). This allows for these original elements to be repurposed and **preserved** on their original building (as opposed to being salvaged/recycled for another project/building or, worse, ending up in a landfill). The following figures outline the proposed location and placement of the repurposed and preserved windows (Figs. 31 to 34).

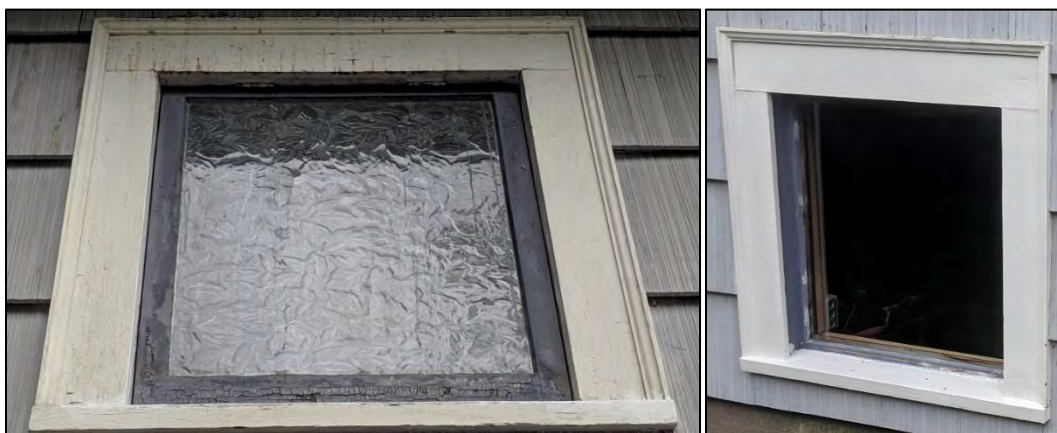
Figs. 25 to 26: Fig. 25 (left) shows one of the western side frosted glass square windows of Calbicks House at 208 Fifth Avenue, 2019; Fig. 26 (right) shows one of the eastern side square windows, with possibly replaced glass. (Sources: Cummer)

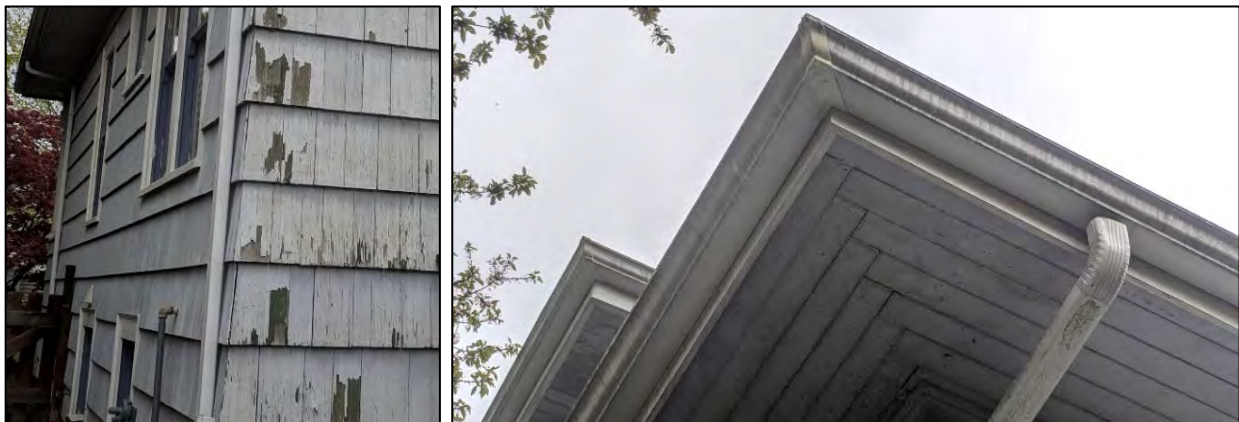
Figs. 29 and 30: Fig. 29 (left) shows the southwestern corner of Calbicks House at 208 Fifth Avenue, 2019, illustrating one area of the wood siding in need of repair; Fig. 30 (right) shows the southeastern corner soffit and fascia boards in need of minor maintenance. (Sources: Cummer)

As mentioned above, some sections of the wood siding are in need of repair and maintenance (Fig. 29), particularly at the back of the building. This is also the case for some of the fascia boards and soffits (Fig. 30). They are not in terrible condition, currently, but should be addressed in a timely manner.

- The horizontal, bevelled and combed cedar siding should be **preserved** as much as possible and **rehabilitated** in the few areas requiring repair.
- Similar to the windows, the original siding should be salvaged and repurposed as much as possible from the areas that will be altered, such as with the removal of the later back addition. These materials can be used to rehabilitate the areas requiring attention, such as at the back of property, as well as for the additional, matching side dormer.

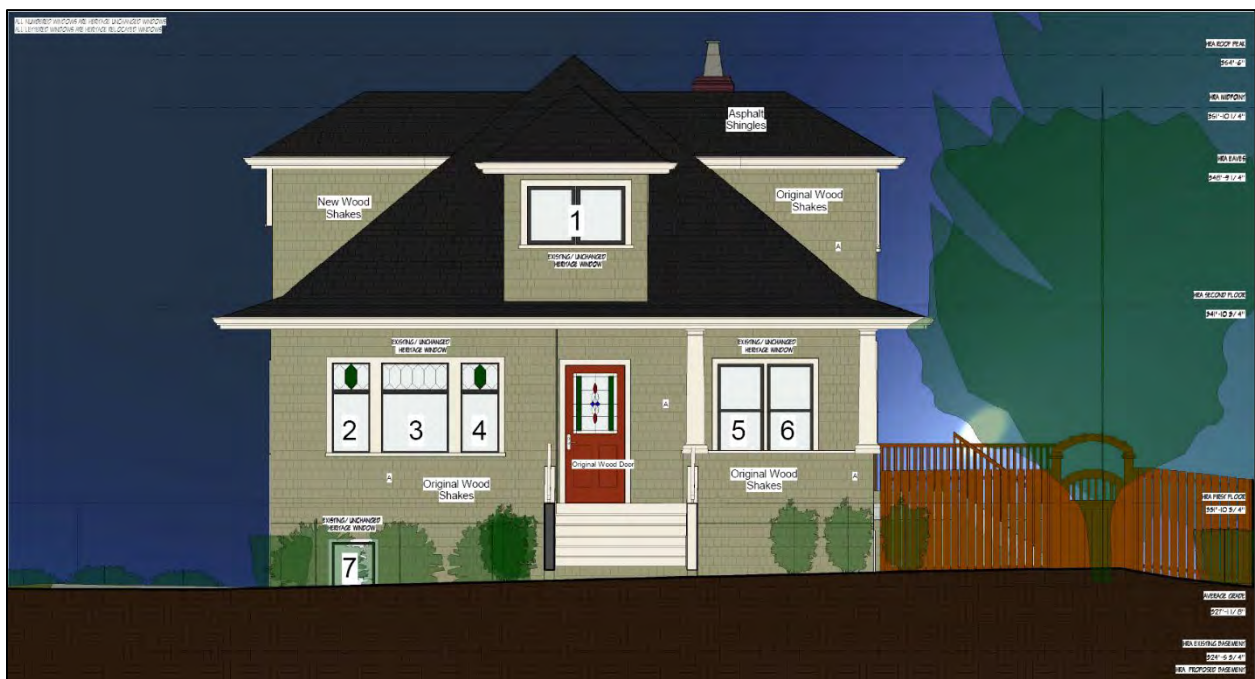
Fig. 31: Front view of Calbicks House, at 208 Fifth Avenue, 2021, highlighting the window proposal for this façade. Note the numbered windows are those that will be unchanged and preserved in-situ. (Source: D3 Dimension, Drafting and Design Inc.)

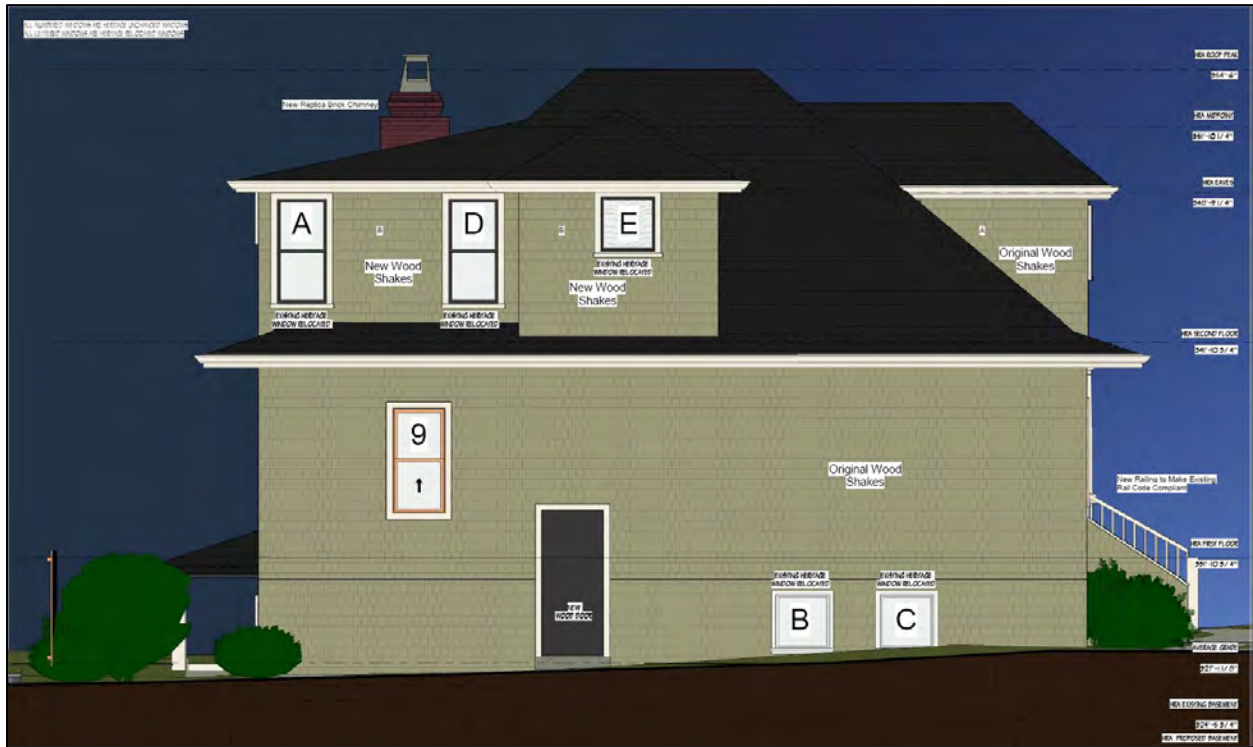
Fig. 32: Eastern side view of Calbicks House, at 208 Fifth Avenue, 2021, highlighting the window proposal for this façade. Note the lettered windows are those that will be preserved, but relocated. (Source: D3 Dimension, Drafting and Design Inc.)

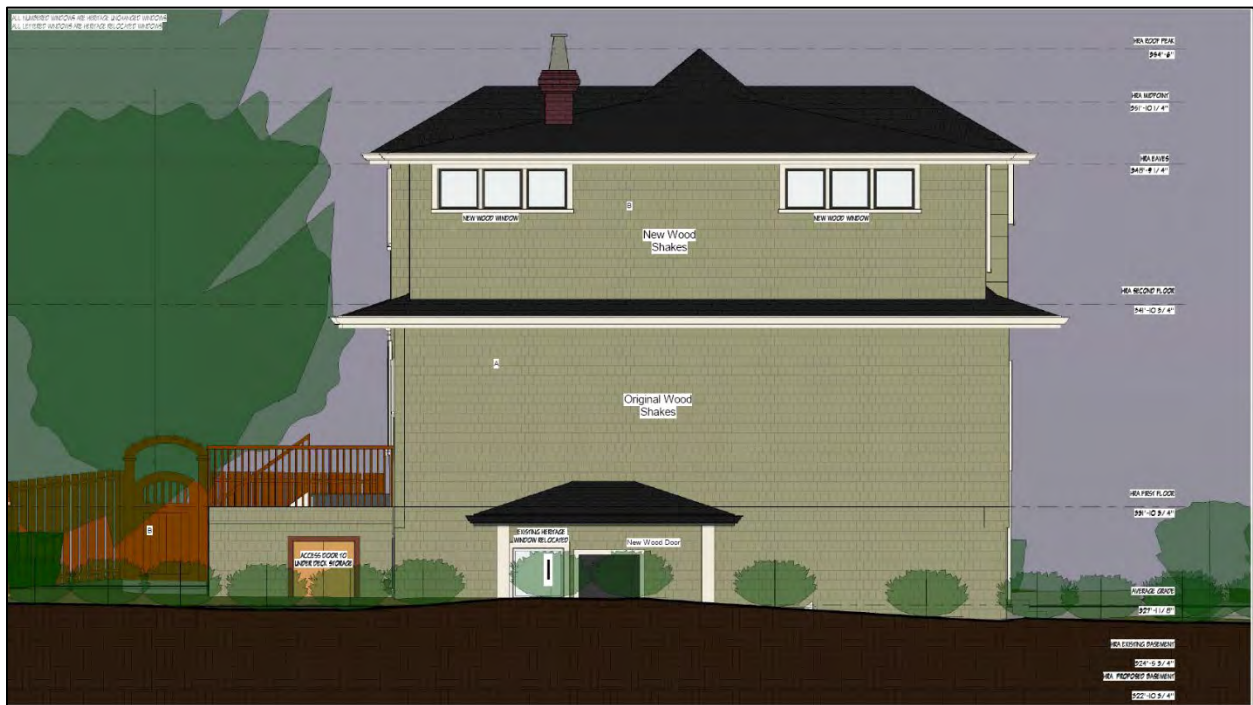
Fig. 33: Back view of Calbicks House, at 208 Fifth Avenue, 2021, highlighting the window proposal for this façade. Note the lettered windows are those that will be preserved, but relocated. (Source: D3 Dimension, Drafting and Design Inc.)

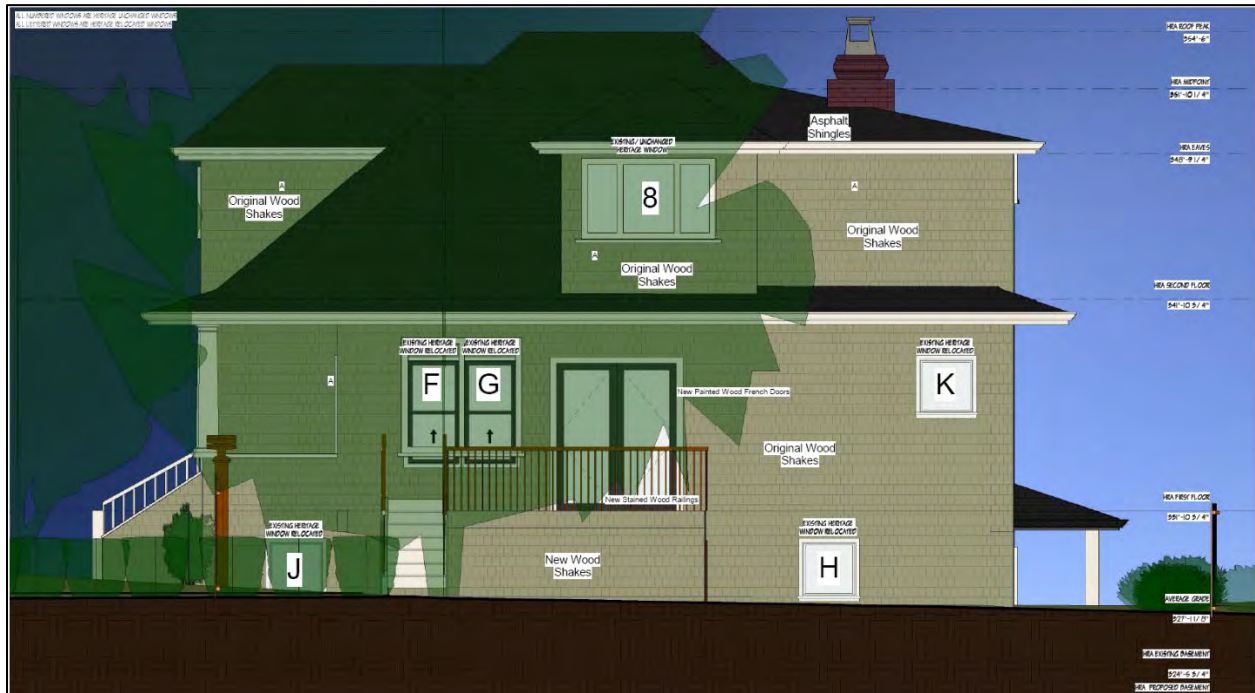
Fig. 34: Western side view of Calbicks House, at 208 Fifth Avenue, 2021, highlighting the window proposal for this façade. Note the numbered windows are those that will be unchanged and preserved in-situ and the lettered windows are those that will be preserved, but relocated. (Source: D3 Dimension, Drafting and Design Inc.)

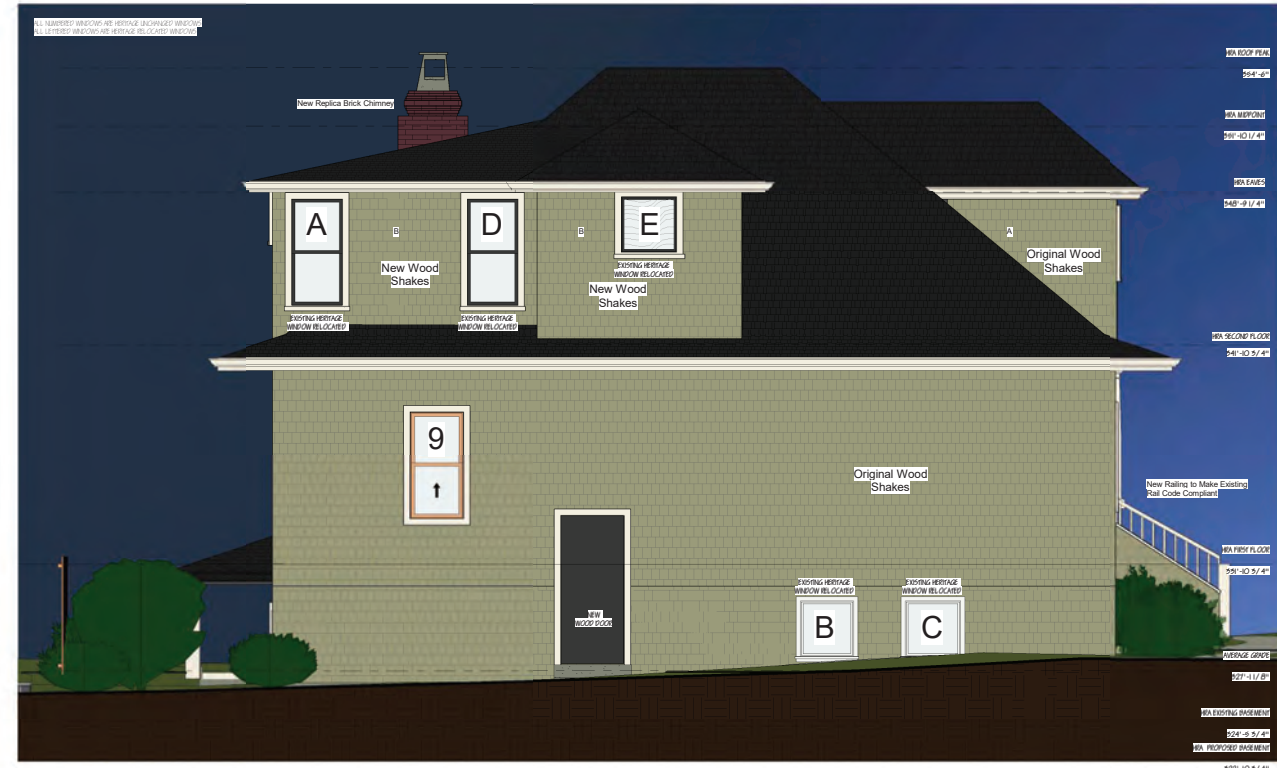
② Heritage Left Elevation
1/4" = 1'-0"

Trim, eaves, and window sills- Oxford Ivory VC-1
Finish- Satin Pearl

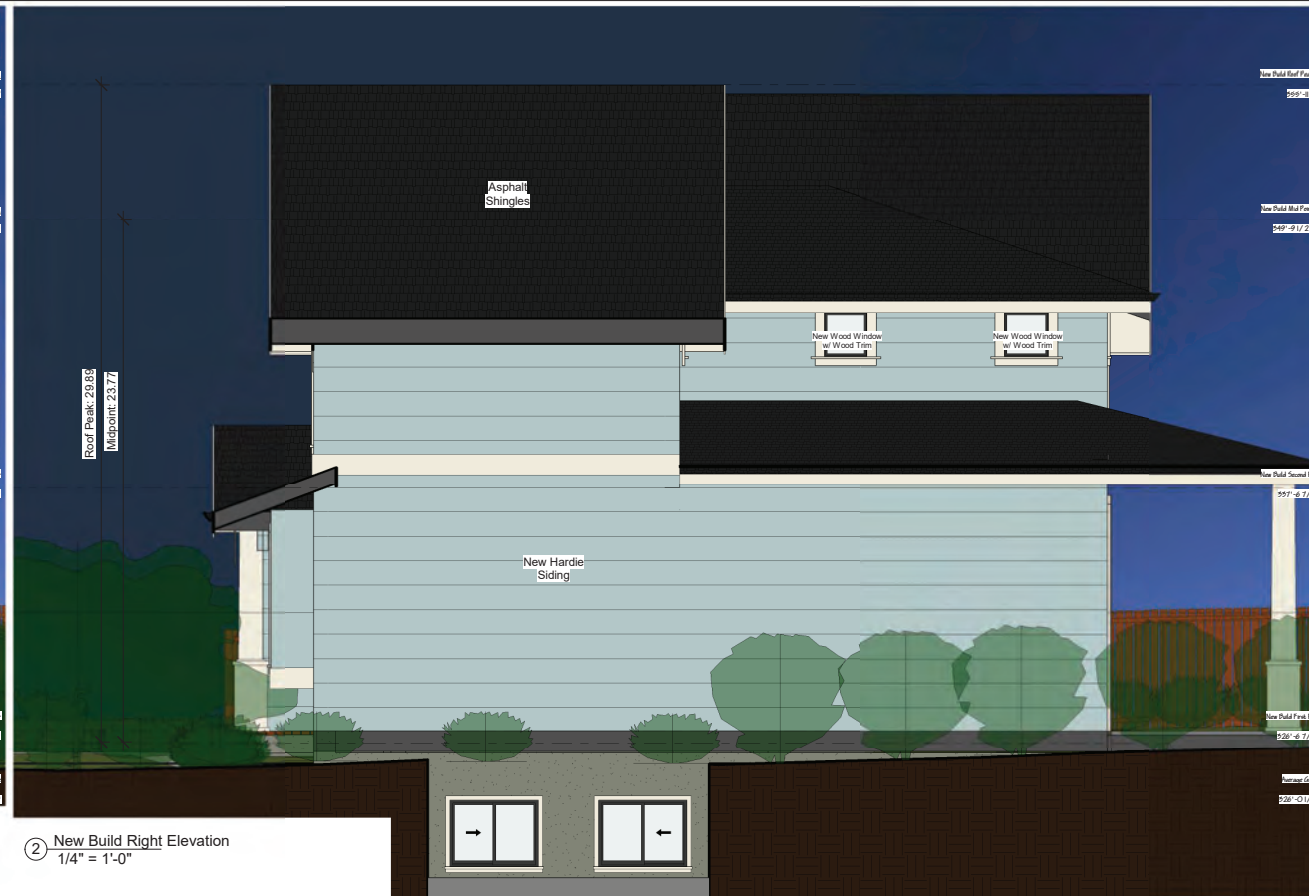
① New Build Front Elevation
1/4" = 1'-0"

Trim, eaves, and window sills- White Dove OC-17 Benjamin Moore Finish- Satin Pearl		Sash- Black HC 190 Benjamin Moore Finish- Satin Pearl		Front Door- Black 190 Benjamin Moore Finish- High Gloss		Body- Silver Half Dollar 2121-40 Benjamin Moore Body- Low Luster
--	---	--	--	--	--	--	---

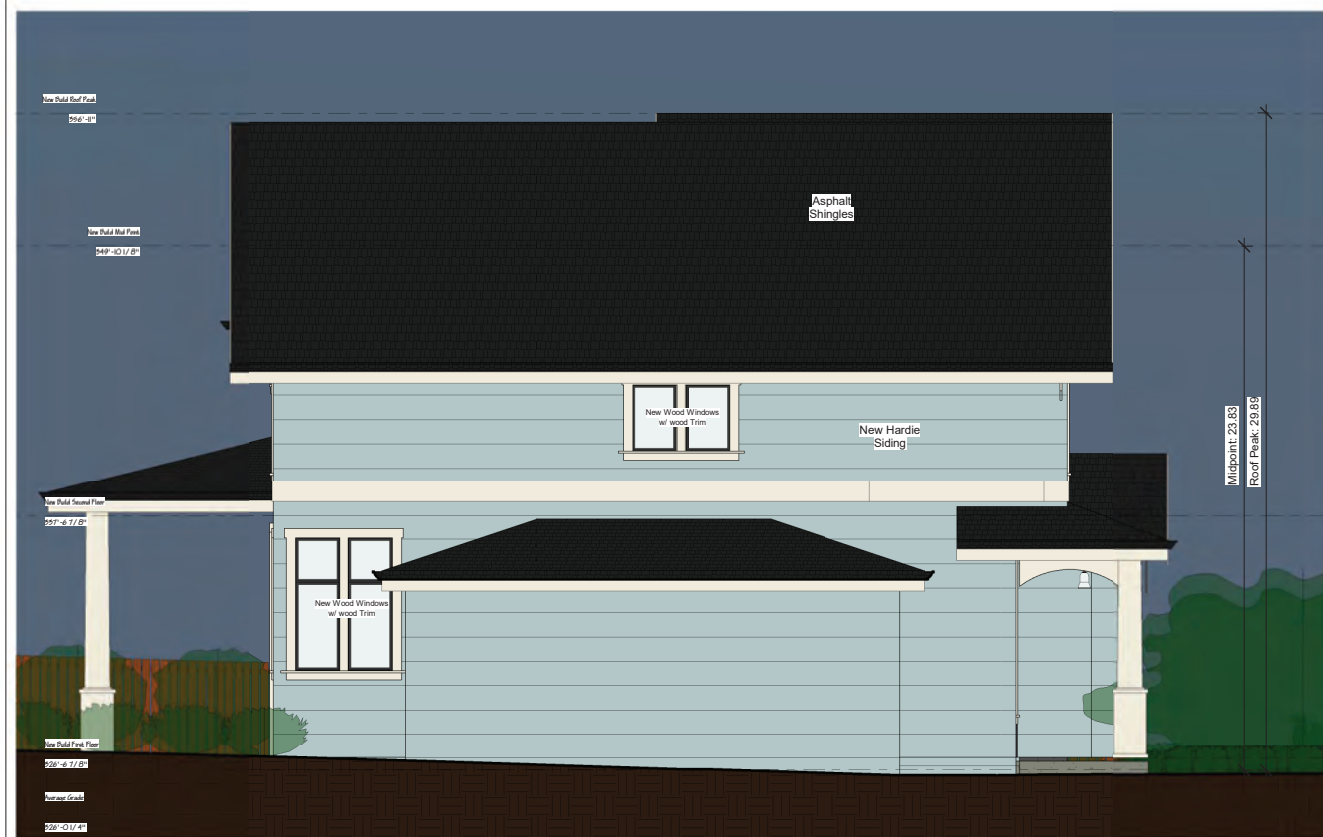
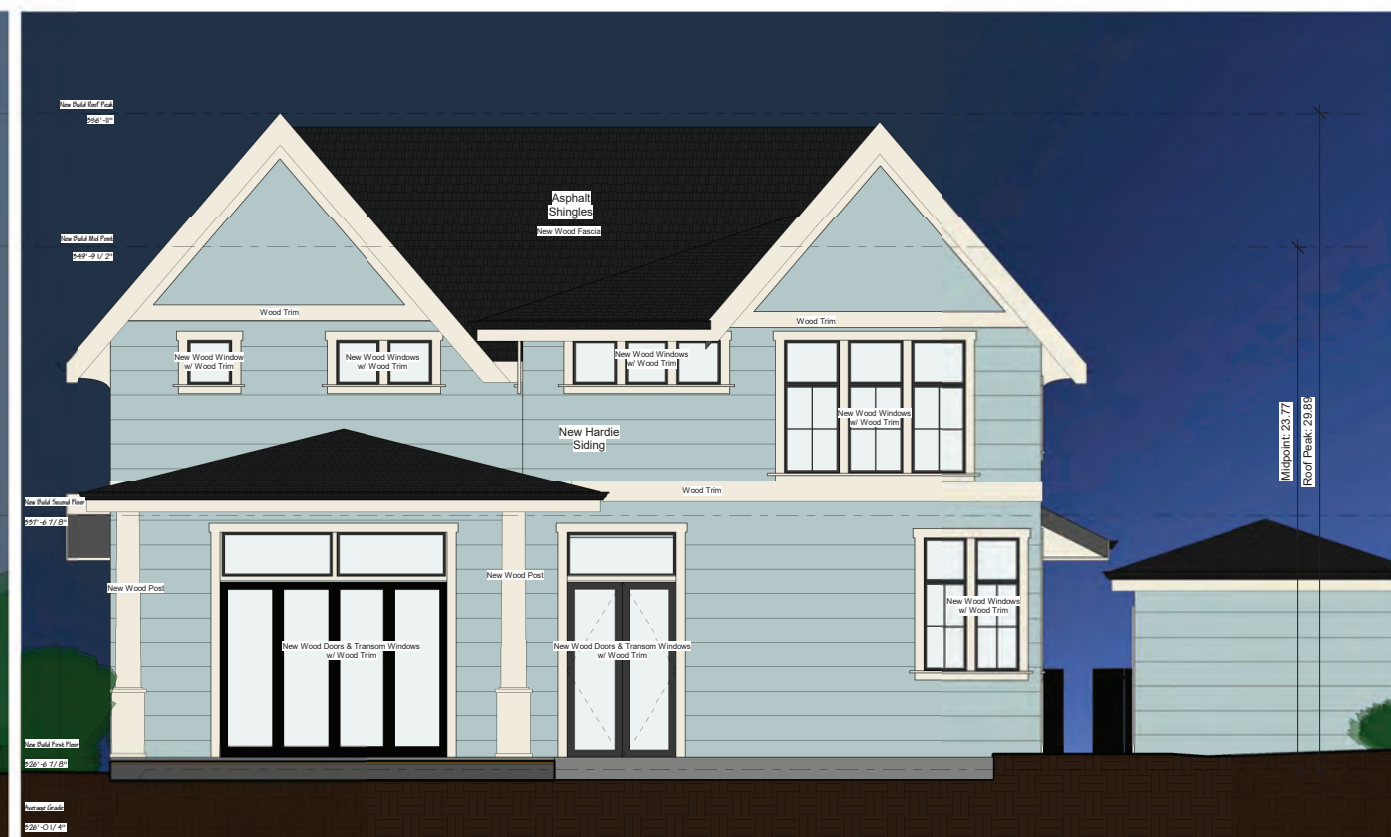
④ New Build Left Elevation
1/4" = 1'-0"

③ New Build Rear Elevation
1/4" = 1'-0"
