**THE CORPORATION OF THE CITY OF NEW WESTMINSTER
HERITAGE REVITALIZATION AGREEMENT (323 Regina Street)
BYLAW NO. 8304, 2022**

HERITAGE REVITALIZATION AGREEMENT (323 Regina Street)

Edgar House, 323 Regina Street, New Westminster, BC

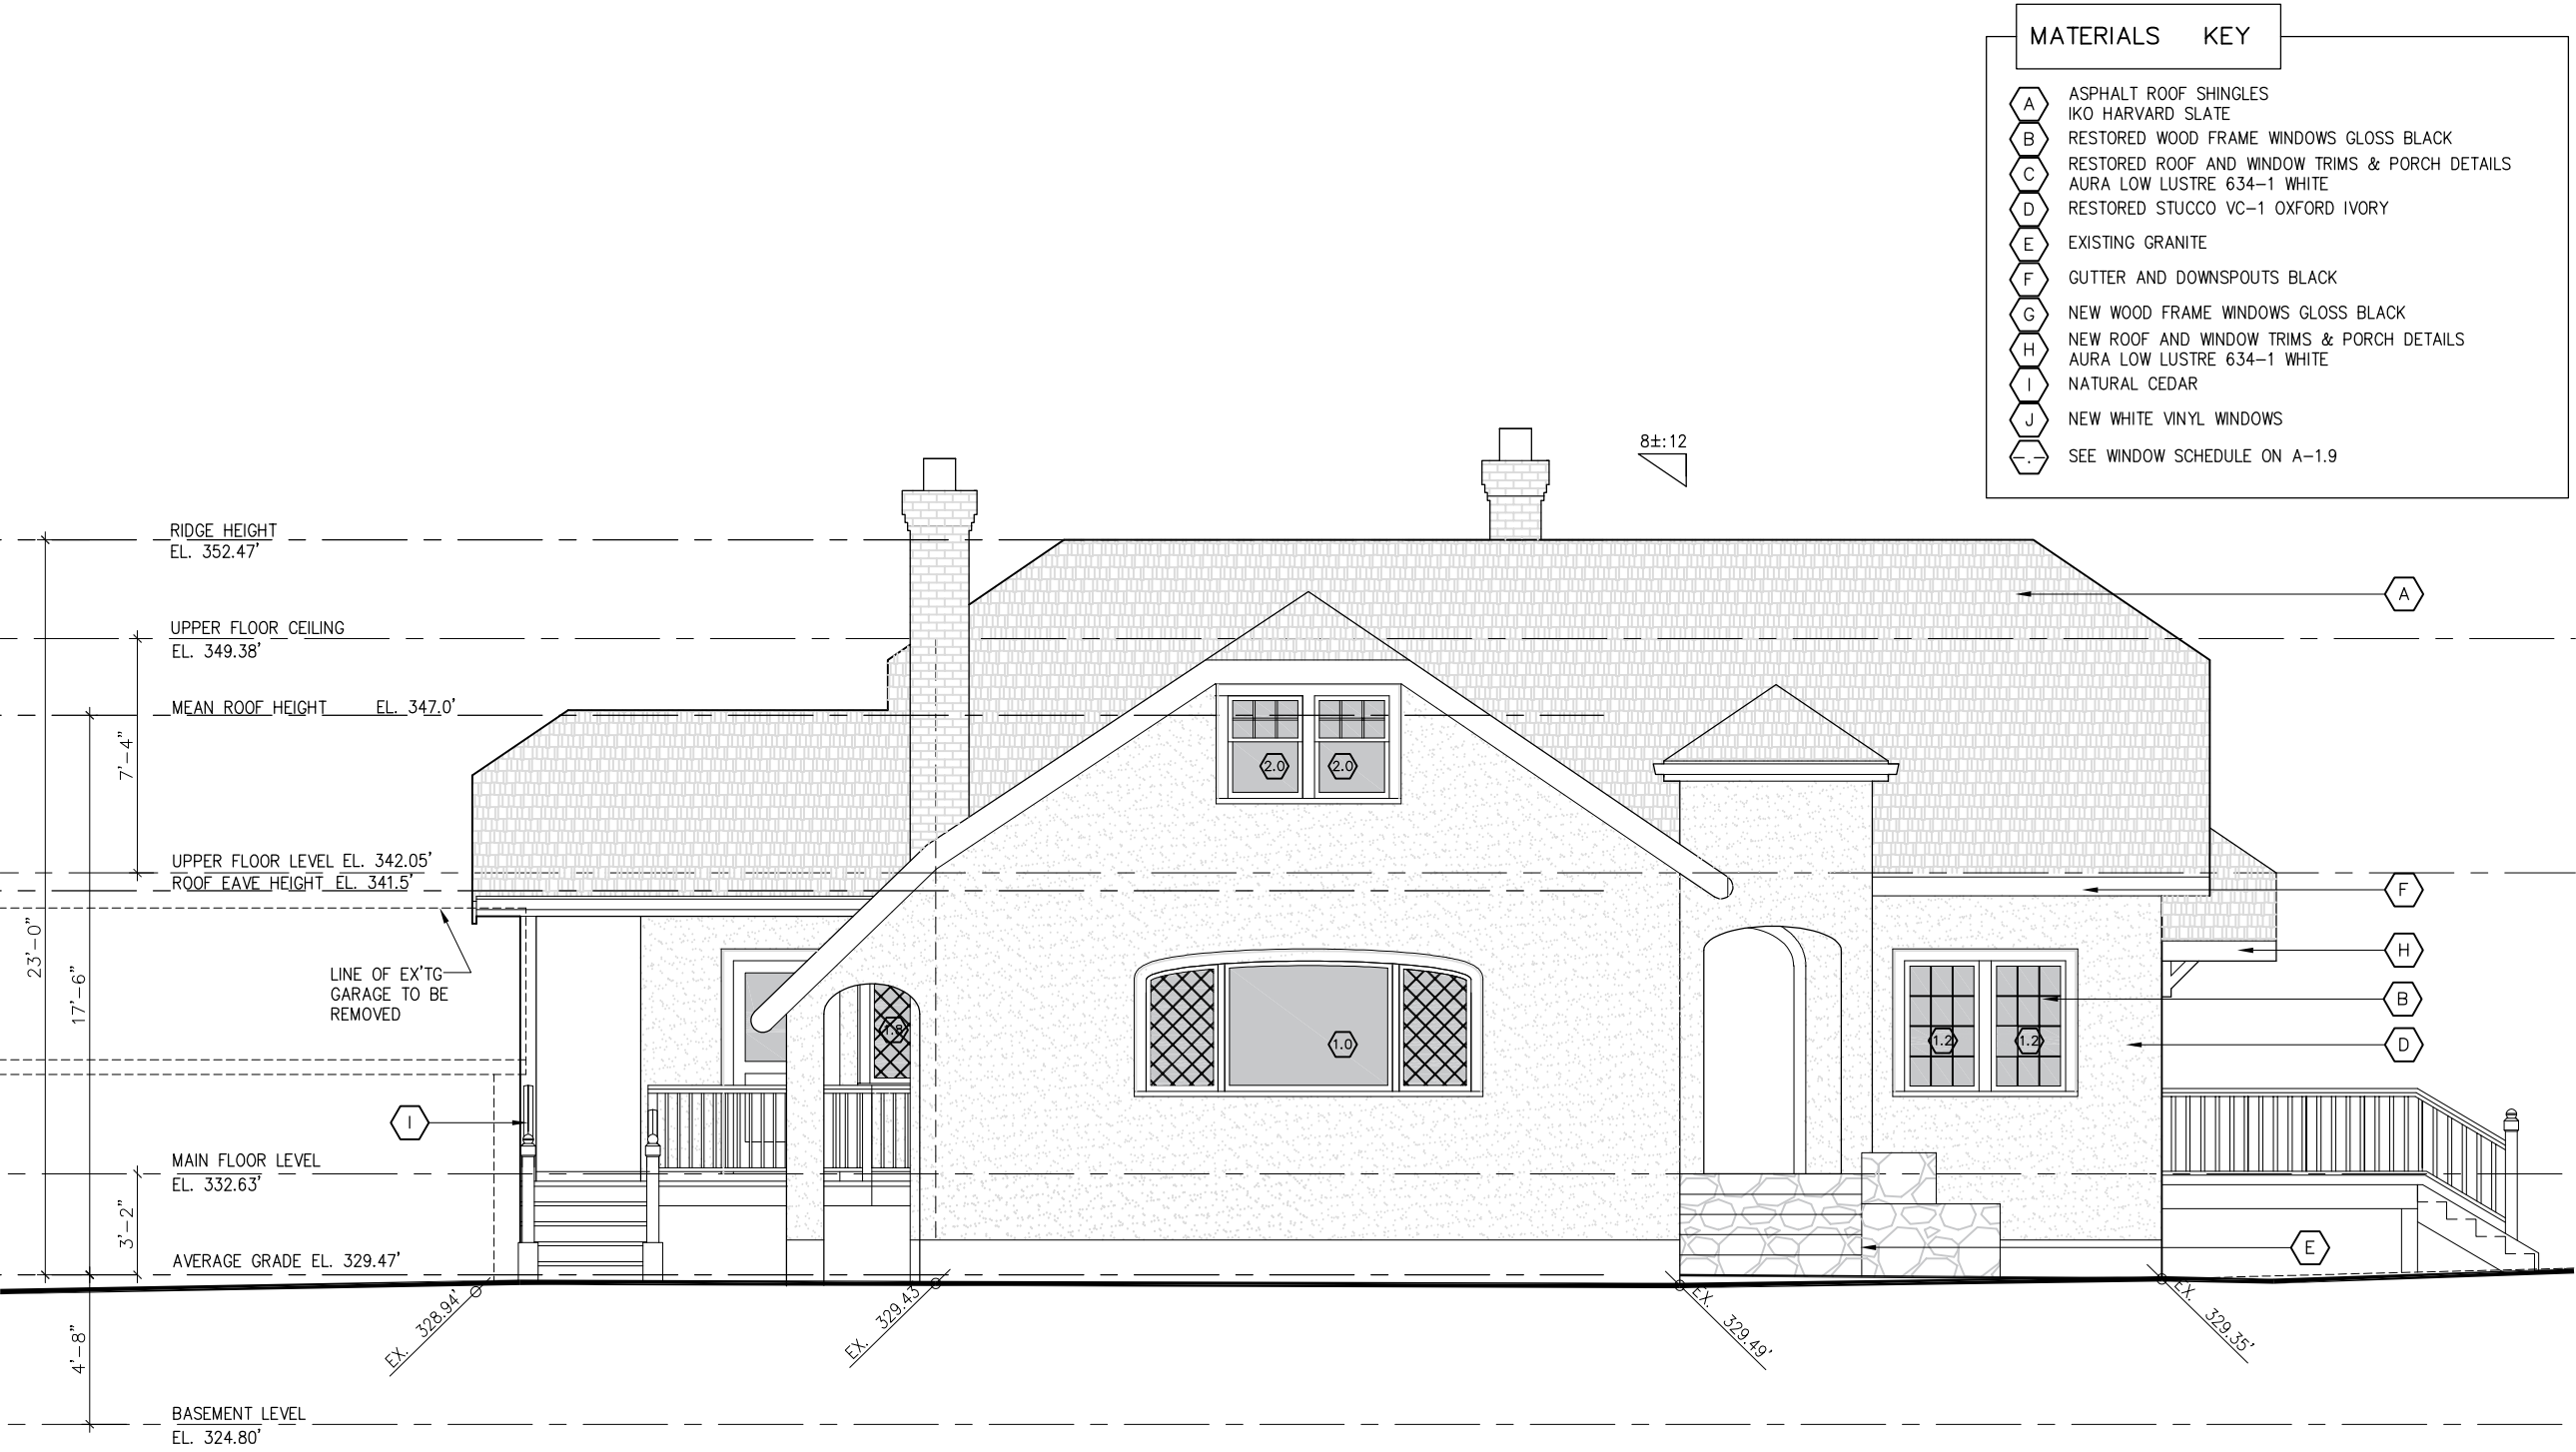
1 4TH ST (WEST) ELEVATION
— SCALE: 3/16" = 1'-0"

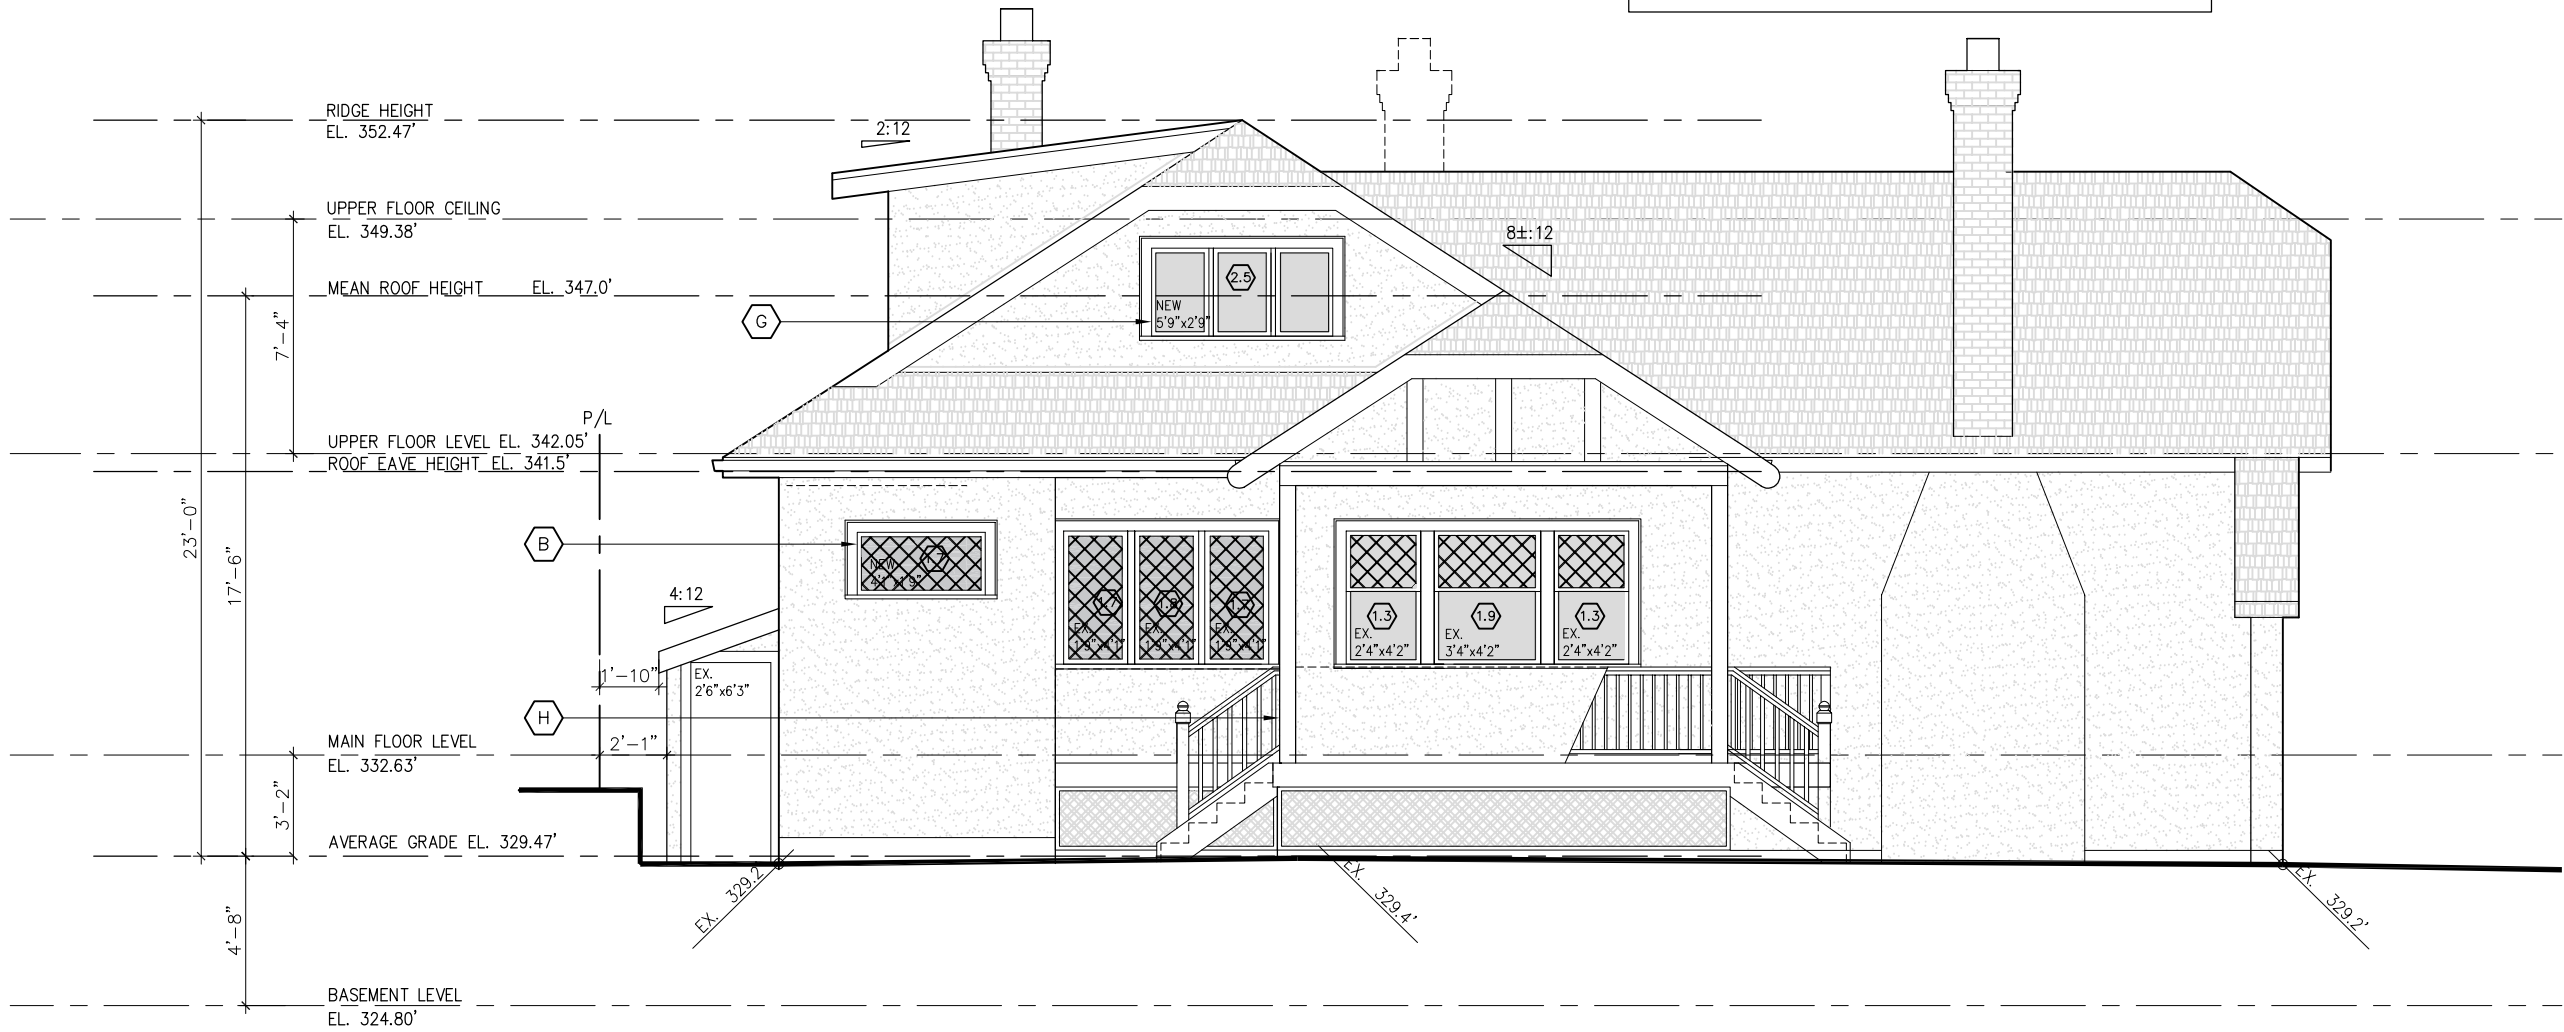
1 NORTH ELEVATION
— SCALE: 3/16" = 1'-0"

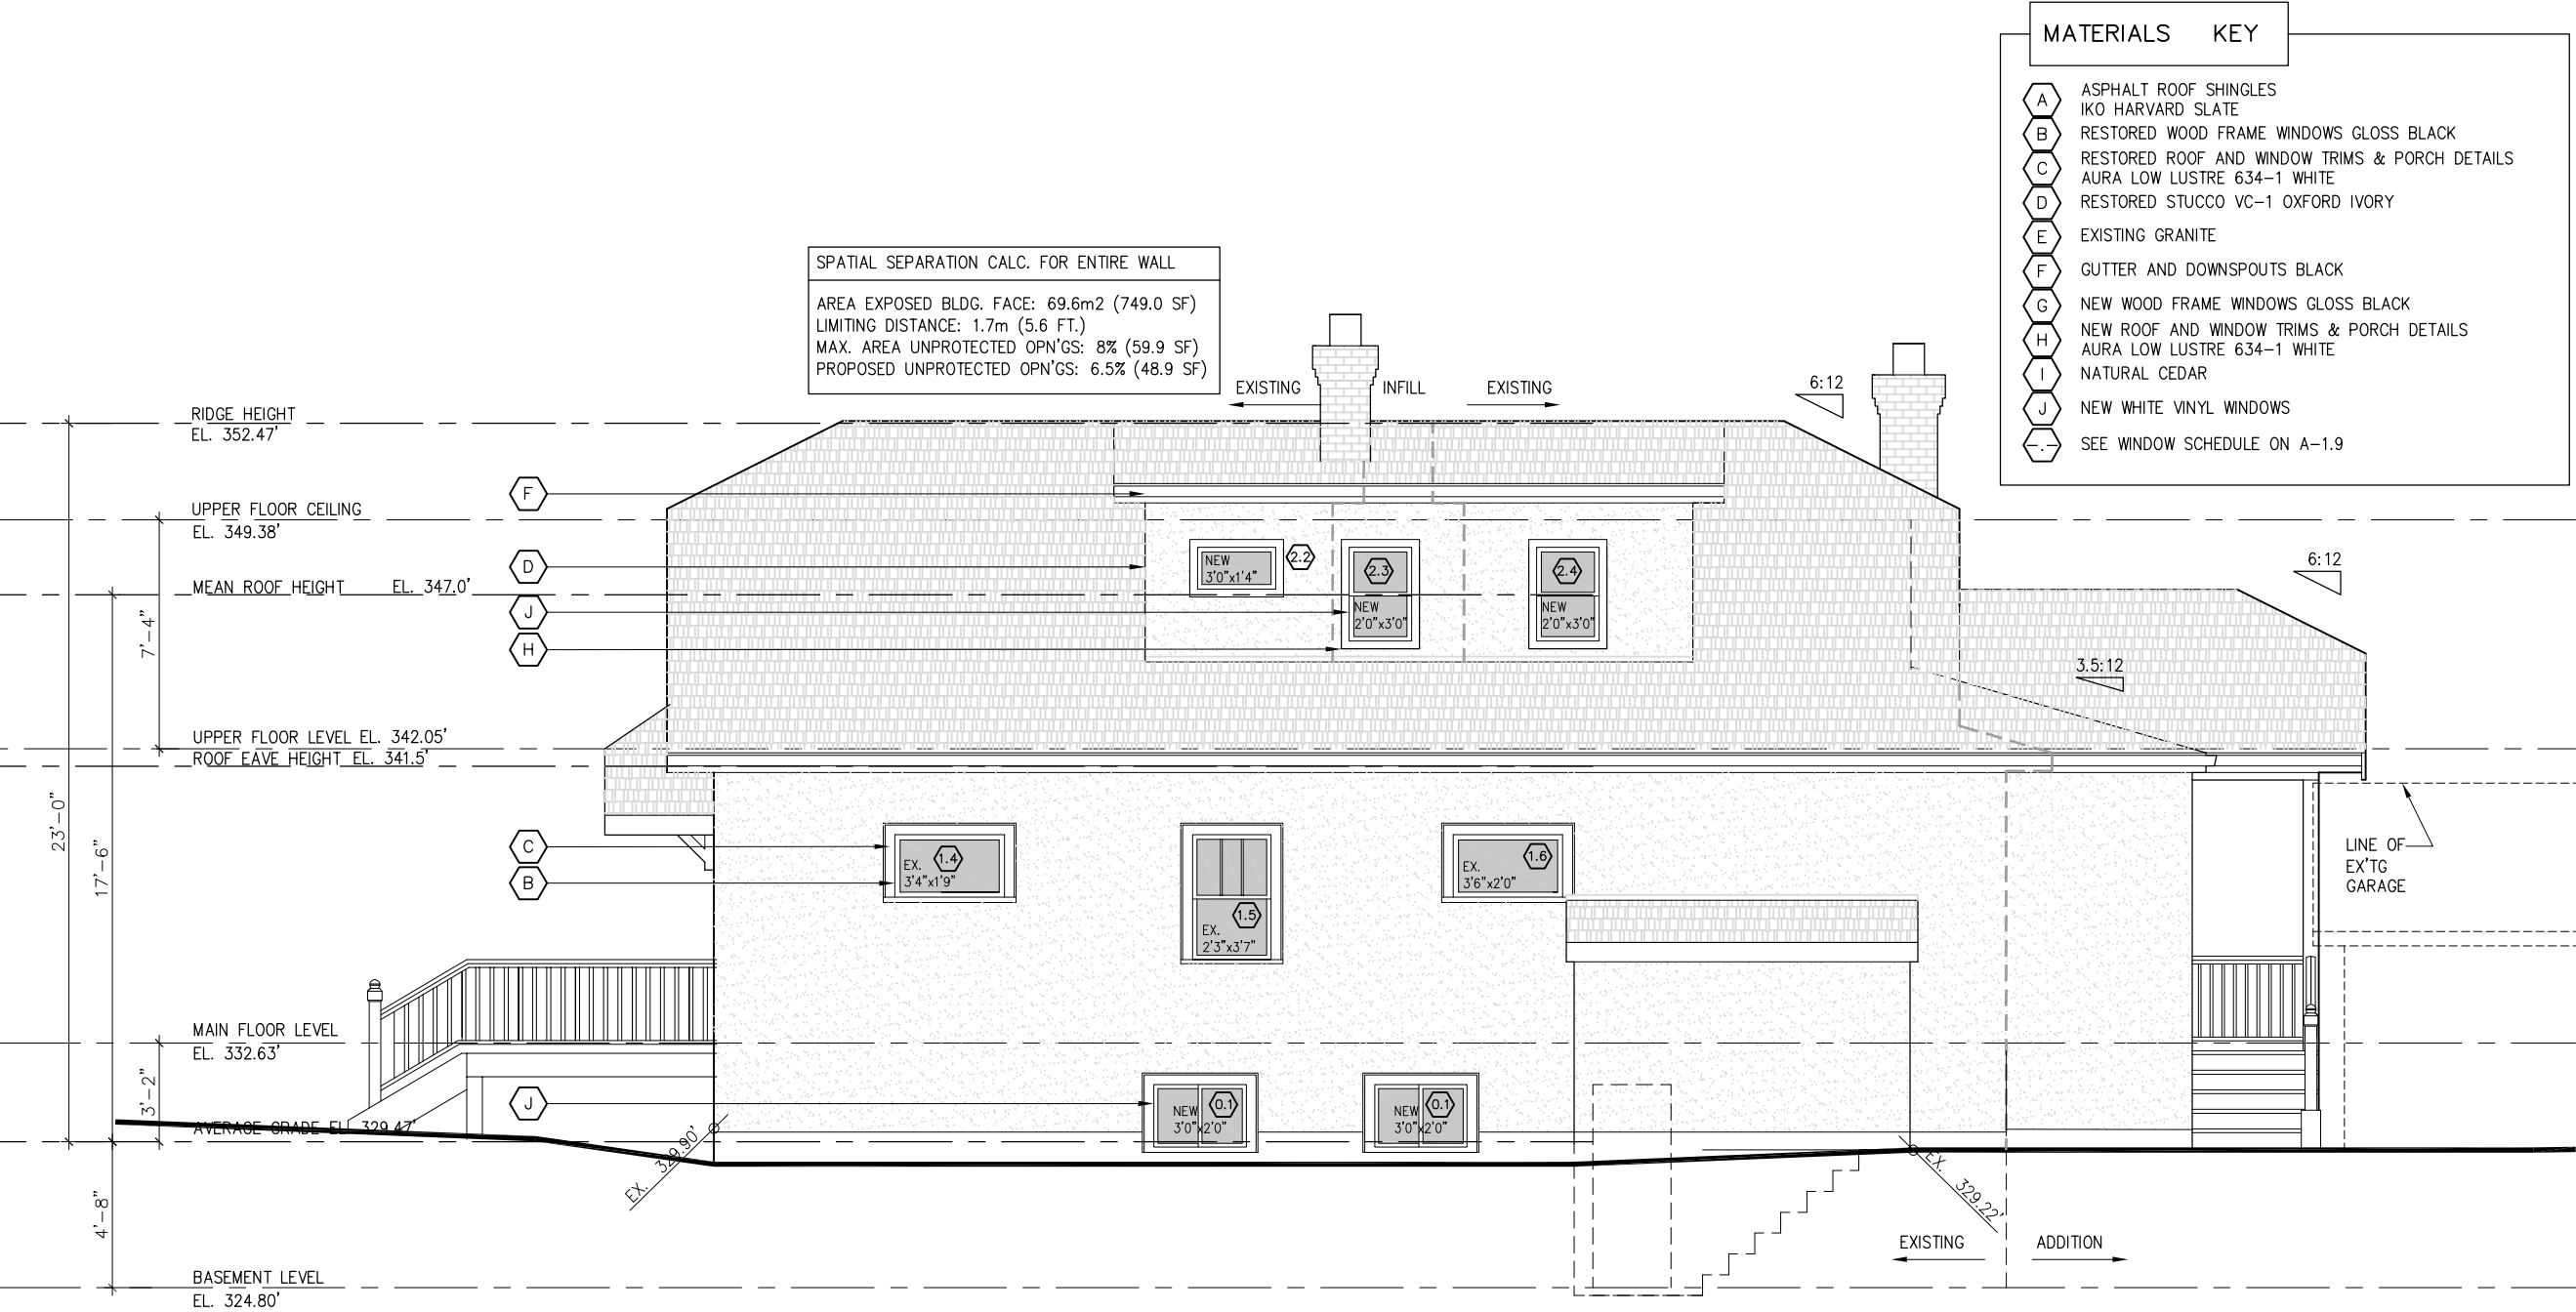
A-1.8

1 EAST ELEVATION
 - SCALE: 3/16" = 1'-0"
