**THE CORPORATION OF THE CITY OF NEW WESTMINSTER
HERITAGE REVITALIZATION AGREEMENT (323 Regina Street)
BYLAW NO. 8304, 2022**

HERITAGE REVITALIZATION AGREEMENT (323 Regina Street)

Edgar House, 323 Regina Street, New Westminster, BC

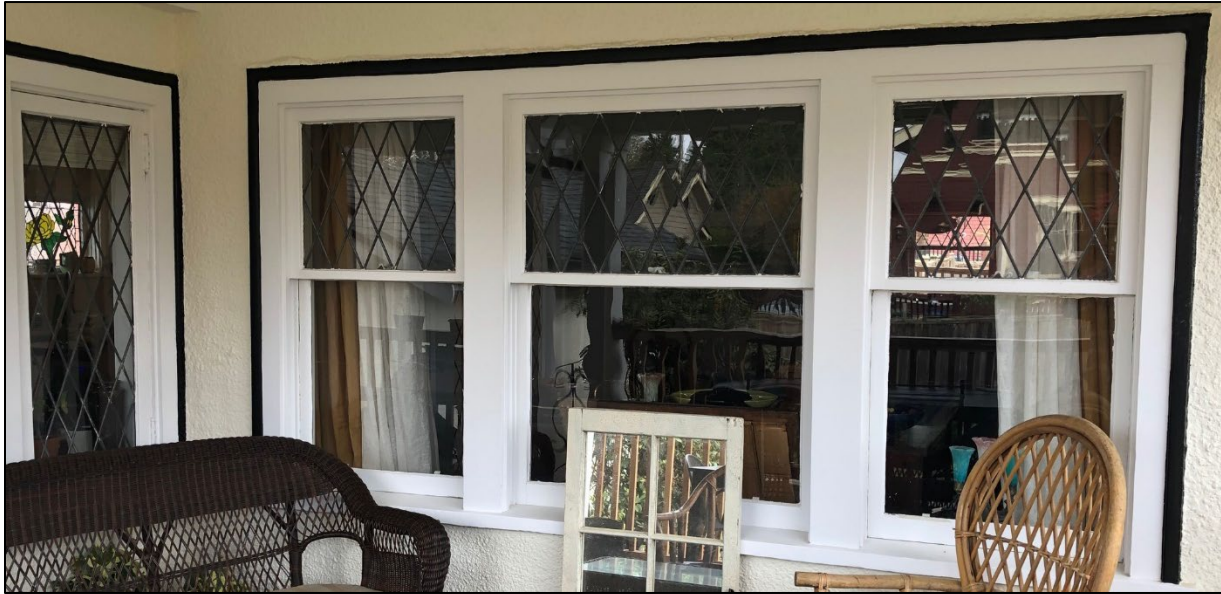
Some of the windows of the house have been replaced (or repurposed on site), although many are still original and, considering the age of the building, these intact windows and doors are in good to very good condition (as visible in Figs. 13 and 14 above and Fig. 22 below).

Fig. 22: The back deck of Edgar House at 323 Regina Street, 2020, illustrating the good condition of its original windows, with diamond patterned panes. (Source: Holisko)

- The arched front door should be carefully **rehabilitated** (sanded down and re-stained) and **preserved**.
- All remaining original wood windows should be **preserved**.
