**THE CORPORATION OF THE CITY OF NEW WESTMINSTER  
HERITAGE REVITALIZATION AGREEMENT (323 Regina Street)  
BYLAW NO. 8304, 2022**

**HERITAGE REVITALIZATION AGREEMENT (323 Regina Street)**

Edgar House, 323 Regina Street, New Westminster, BC

## 528.0 Introduction

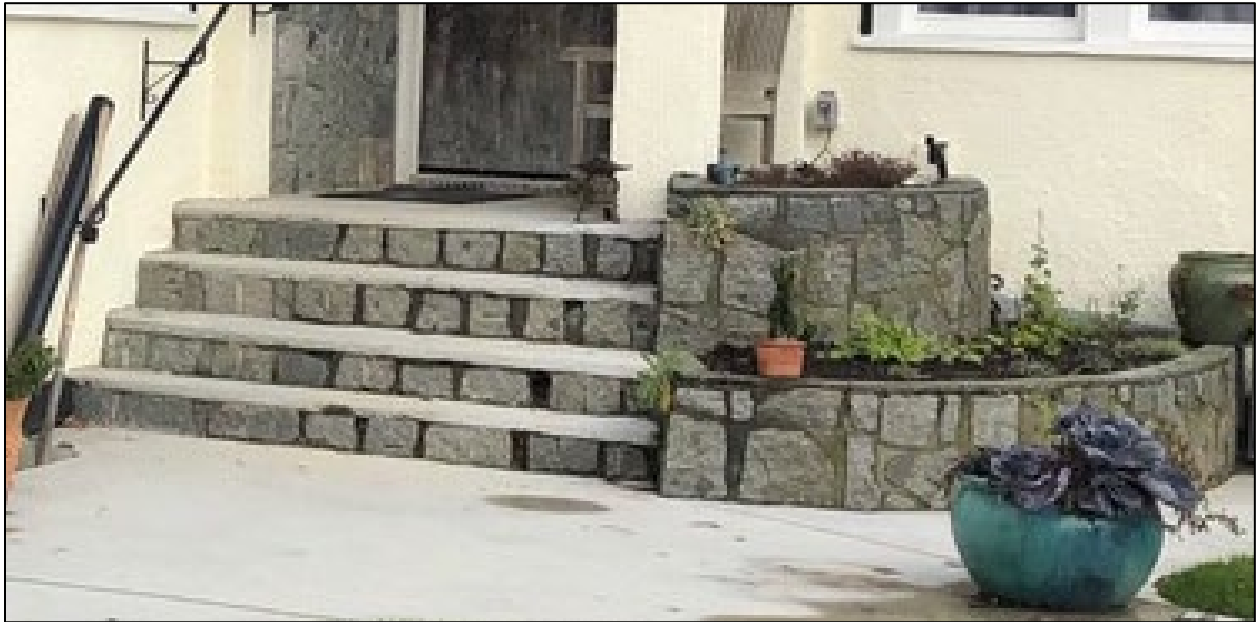
Fig. 18: Front stone steps and planter of Edgar House at 323 Regina Street, 2020, illustrating the minor maintenance concerns, such as moss growth and other plants growing between the stone slabs. (Source: Holisko)

Overall, the condition of the walls and building envelope of Edgar House, from roof to foundation, appears to be good and having aged well. In particular, there are no major cracks visible in either the stuccoed walls or foundation. One small area of concern is the stone front steps that appear they could benefit from some minor cleaning and maintenance (Fig. 18) such as to remove moss/algae growth.

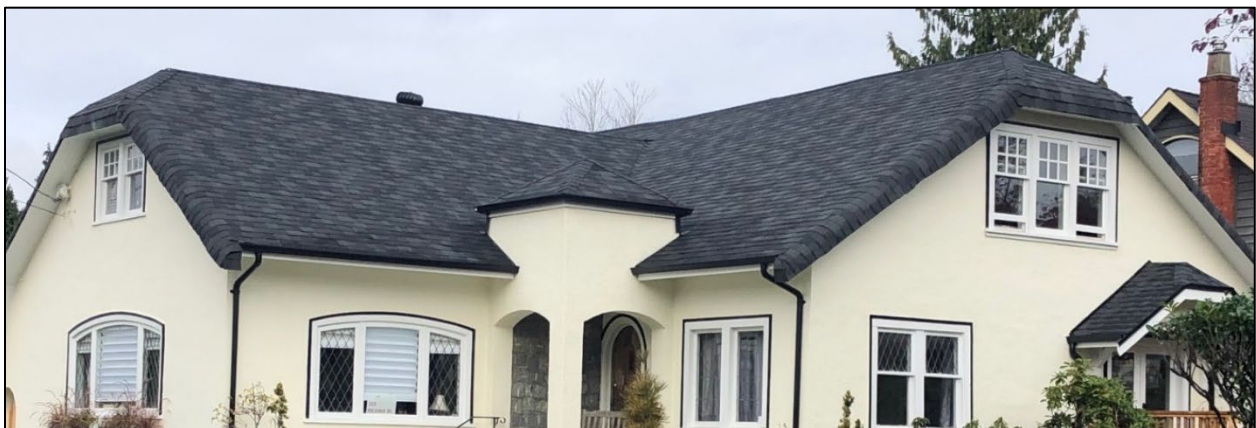
Fig. 19: Front view of Edgar House at 323 Regina Street, 2020, illustrating the good condition of its roof. (Source: Holisko)

The roof is in very good condition, overall (Figs. 19 and 20). It is difficult to determine the condition of the waterworks system from photographs, however, it is understood that these were recently replaced (with rounded aluminium ones to resemble the older more traditional style) and should therefore be in good working order. They should be checked regularly to ensure their continued efficient functioning.
