**THE CORPORATION OF THE CITY OF NEW WESTMINSTER  
HERITAGE REVITALIZATION AGREEMENT (323 Regina Street)  
BYLAW NO. 8304, 2022**

**HERITAGE REVITALIZATION AGREEMENT (323 Regina Street)**

Edgar House, 323 Regina Street, New Westminster, BC

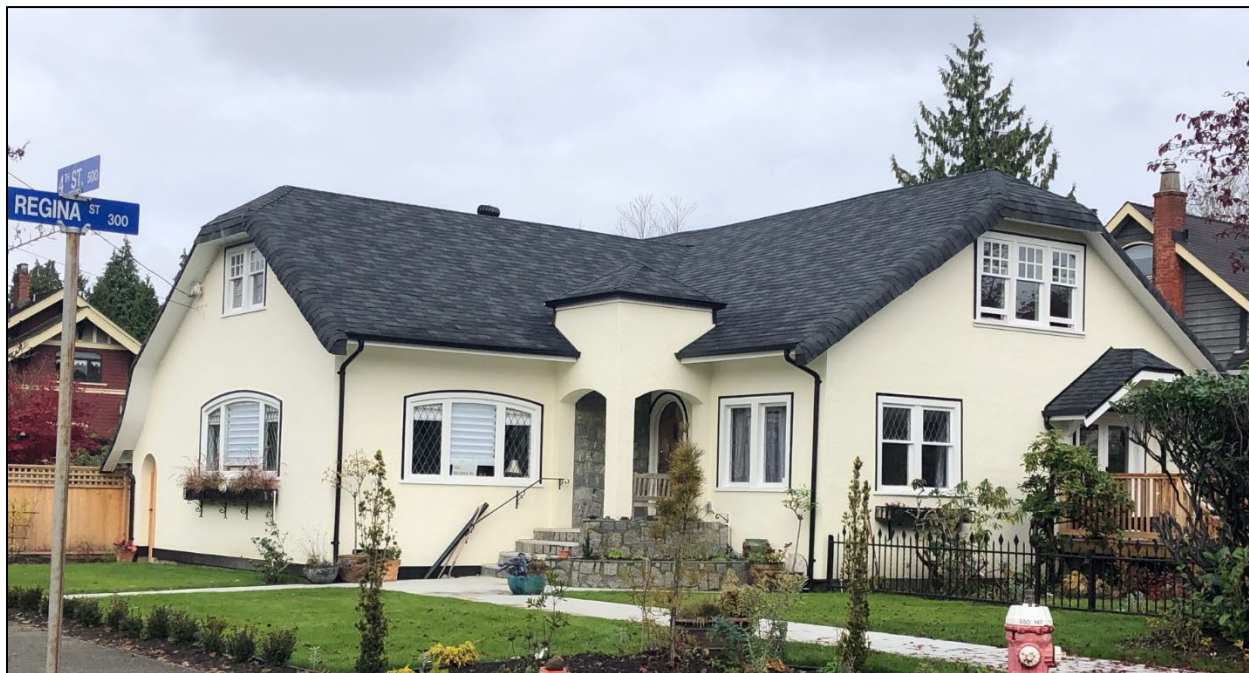
Fig. 1: View of the front of Edgar House at 323 Regina Street, New Westminster, BC, 2020, as visible from the corner of Regina Street and Fourth Street. (Source: Holisko)

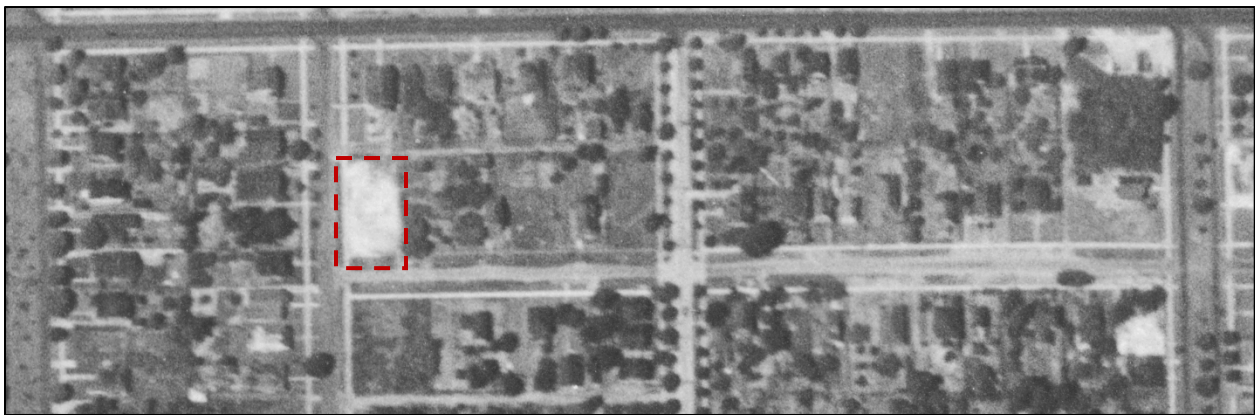
Fig. 7: Section from a Royal Canadian Air Force aerial photograph of New Westminster, 1928. Note that 323 Regina Street has been cleared for development, however, no structure is yet built on the lot. (Source: Library & Archives Canada, AA287\_058)

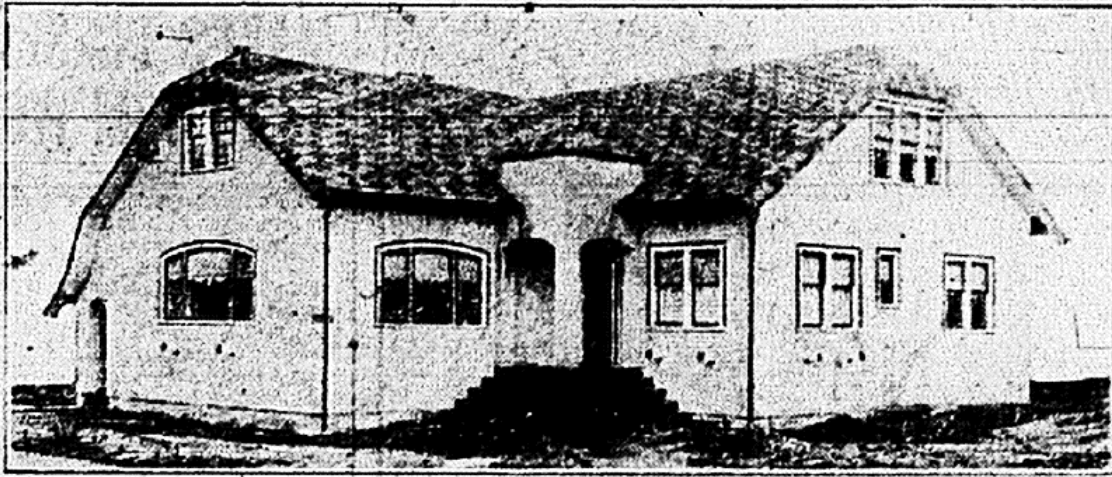
## PRESENTS ATTRACTIVE APPEARANCE

Embodying many of the latest modern features and ideas, with both the interior and exterior very attractively designed, and exceptionally well built throughout, the spacious new residence of E. A. Edgar, local manager of the Tip Top Tailors, at the corner of Fourth and Regina streets, is a splendid addition to the large list of imposing new homes which have been built in New Westminster. The dwelling is of the semi-bungalow type and was built to plans prepared by Mr. Edgar and K. R. Matheson, the contractor.

A striking feature of the dwelling is the use of arches and graceful curves to replace the usual sharp angles, which adds greatly to its attractiveness. The curve effect is not only carried out in the interior but also on the outside walls and on the roof, which has a rounded edge.

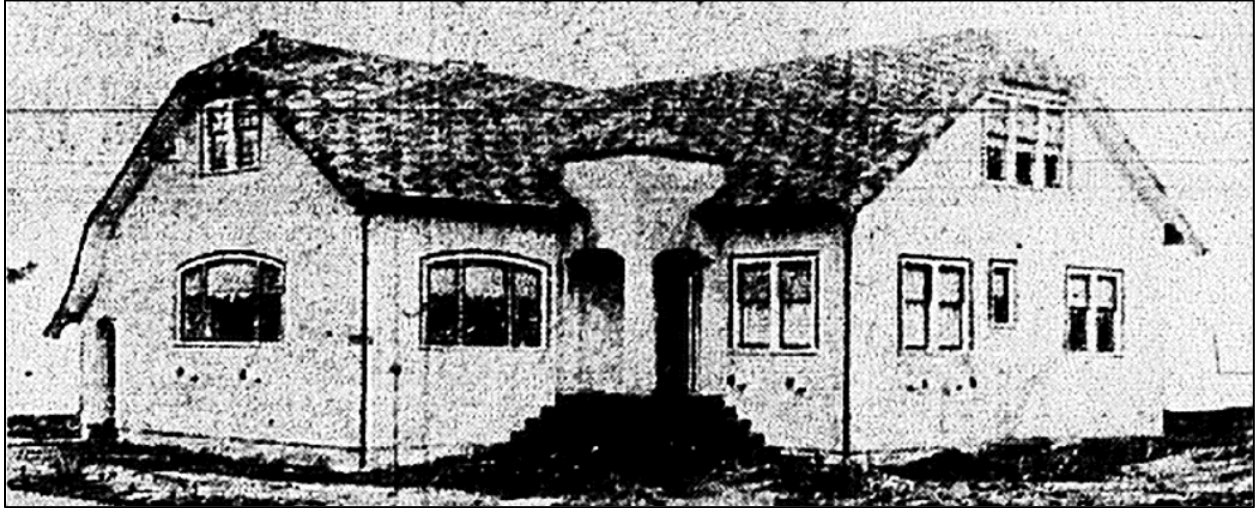
Unfortunately, no other historical photographs of the property were available beyond the 1928 newspaper article (Fig. 11) and the accompanying photograph of the 1989 heritage inventory description (Fig. 12). It is interesting to note the few changes to the property, such as the addition of a window box on the front window, which was apparently done shortly after the house was built in 1928 by a local ironworker. Other changes of note are the switch of the front entry staircase from being double-sided to single-sided and the addition of a chimney on the southeast corner, which has since been removed.

Fig. 11: Historical photograph of 323 Regina Street, 1928, extracted from the newspaper article on the property. (Source: The British Columbian, October 8, 1928, p. 7)

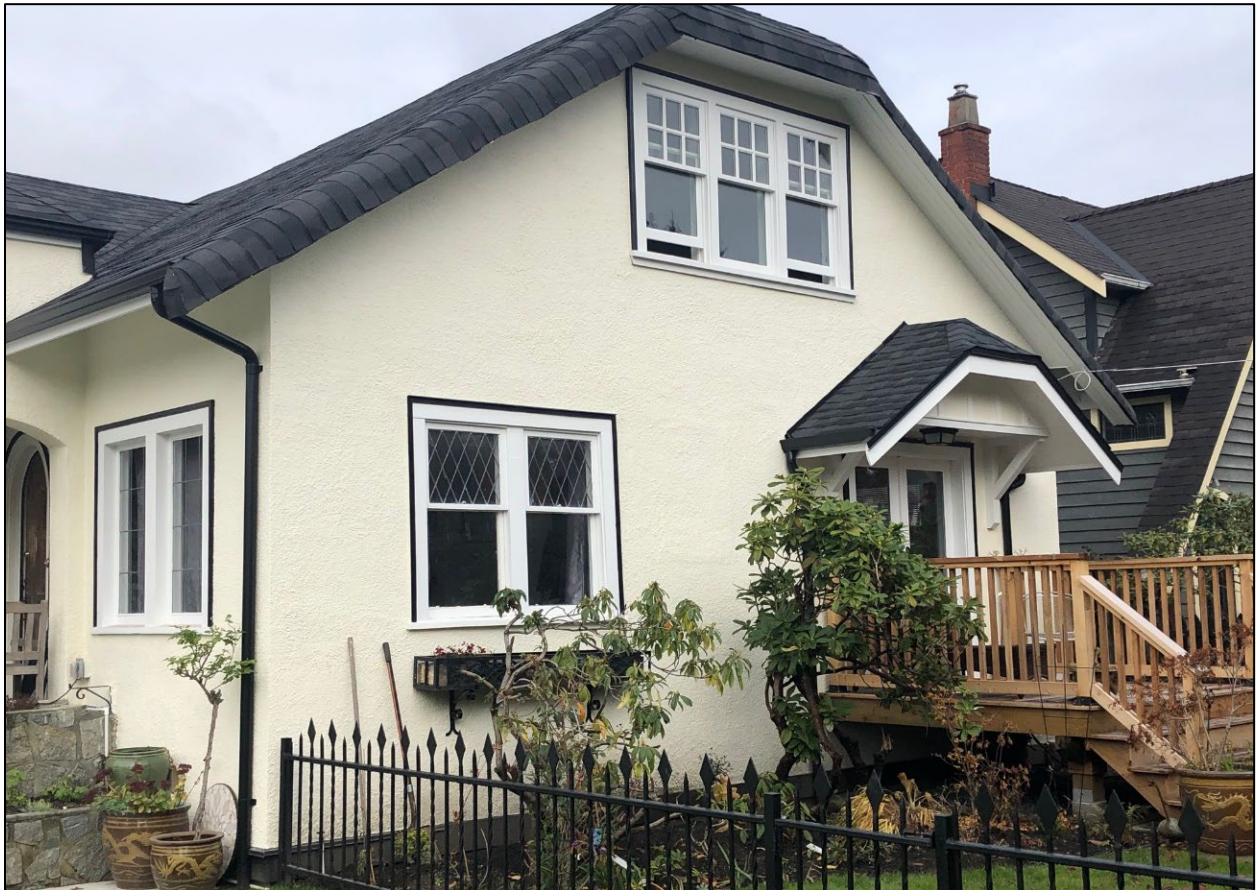
Fig. 14: Eastern corner view of Edgar House at 323 Regina Street, 2020. (Source: Holisko)

Some of the windows of the house have been replaced (or repurposed on site), although many are still original and, considering the age of the building, these intact windows and doors are in good to very good condition (as visible in Figs. 13 and 14 above and Fig. 22 below).

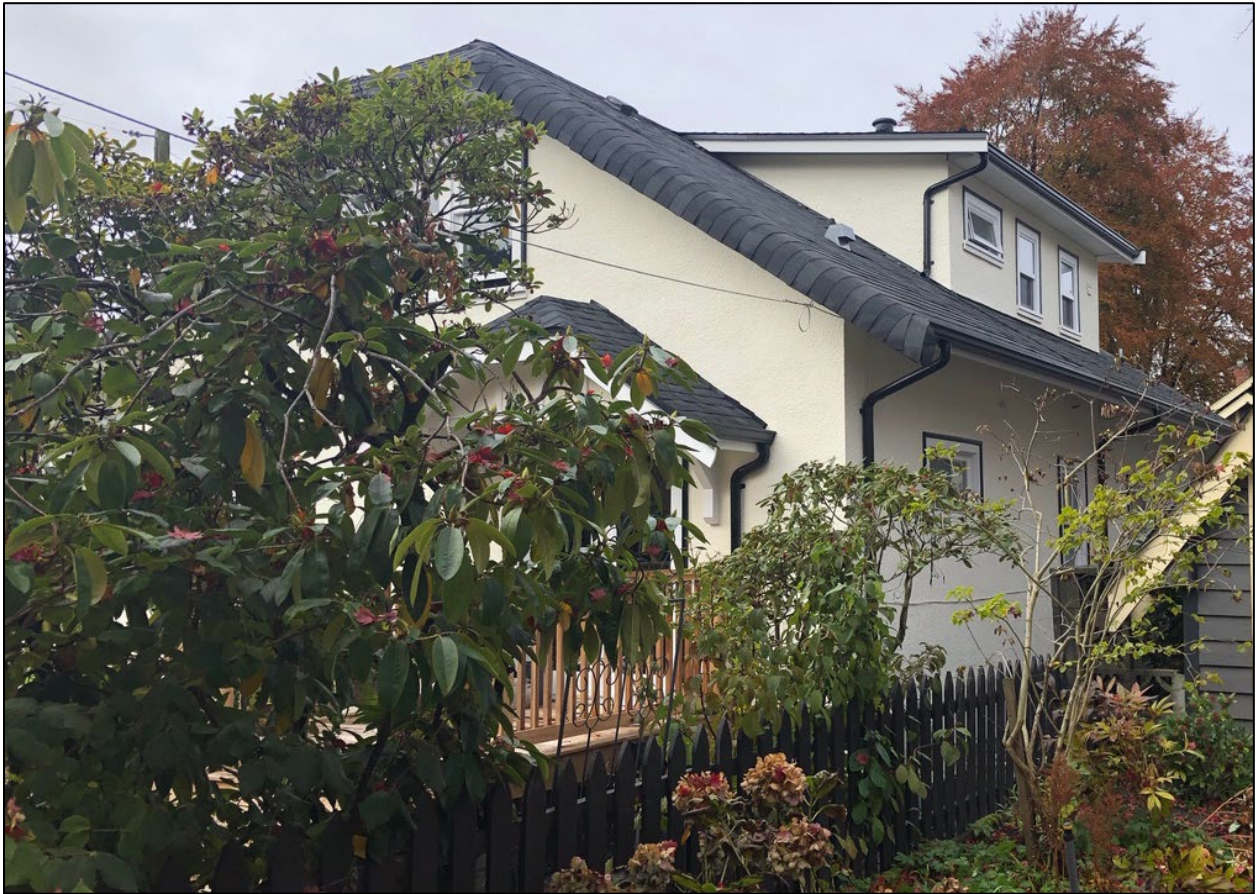
Fig. 15: Northeastern side of Edgar House at 323 Regina Street, BC, 2020. (Source: Holisko)

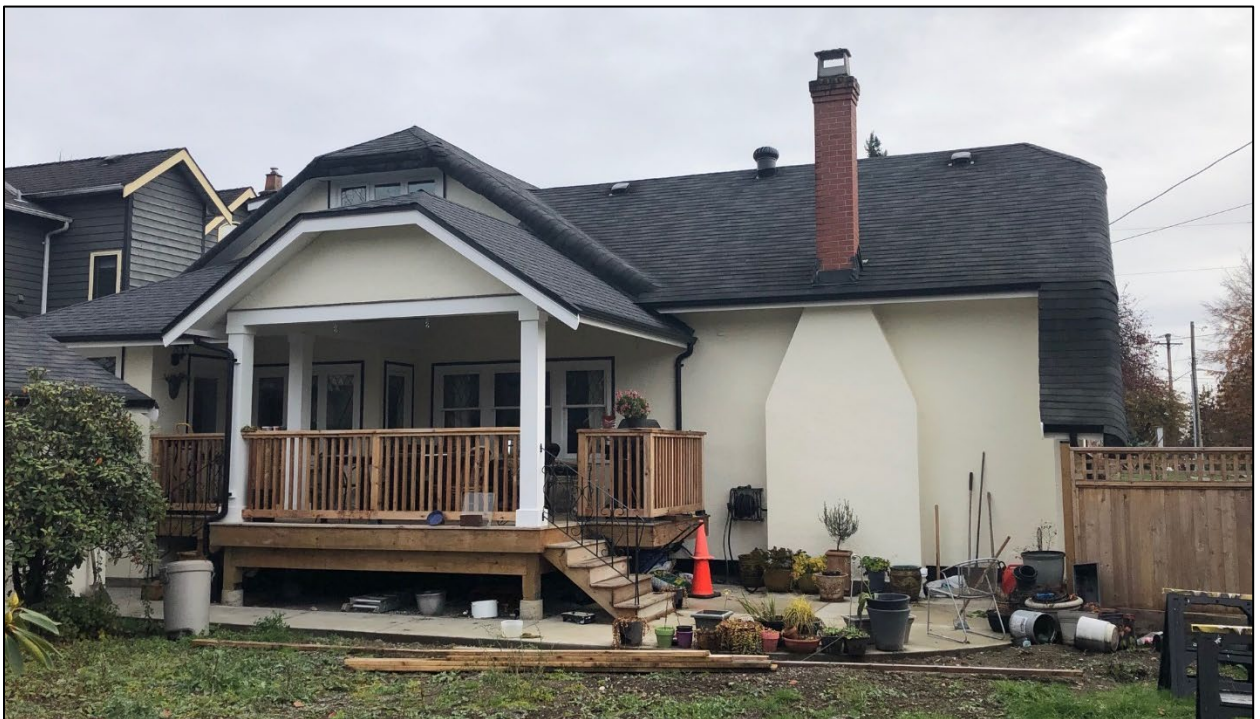
Fig. 16: Northwestern side of Edgar House at 323 Regina Street, 2020. (Source: Holisko)

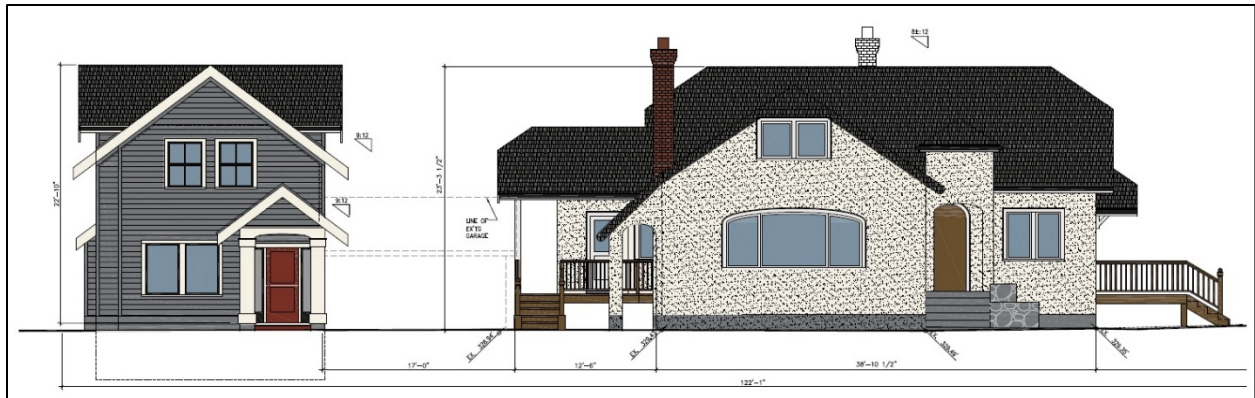
Fig. 25: Elevation from Fourth Street of Edgar House (on the right) and its proposed laneway house (on the left), 2021. (Source: Dheilly)

- 1) Building a laneway house on the property (Figs. 24 and 25); and
- 2) Stratifying the property.

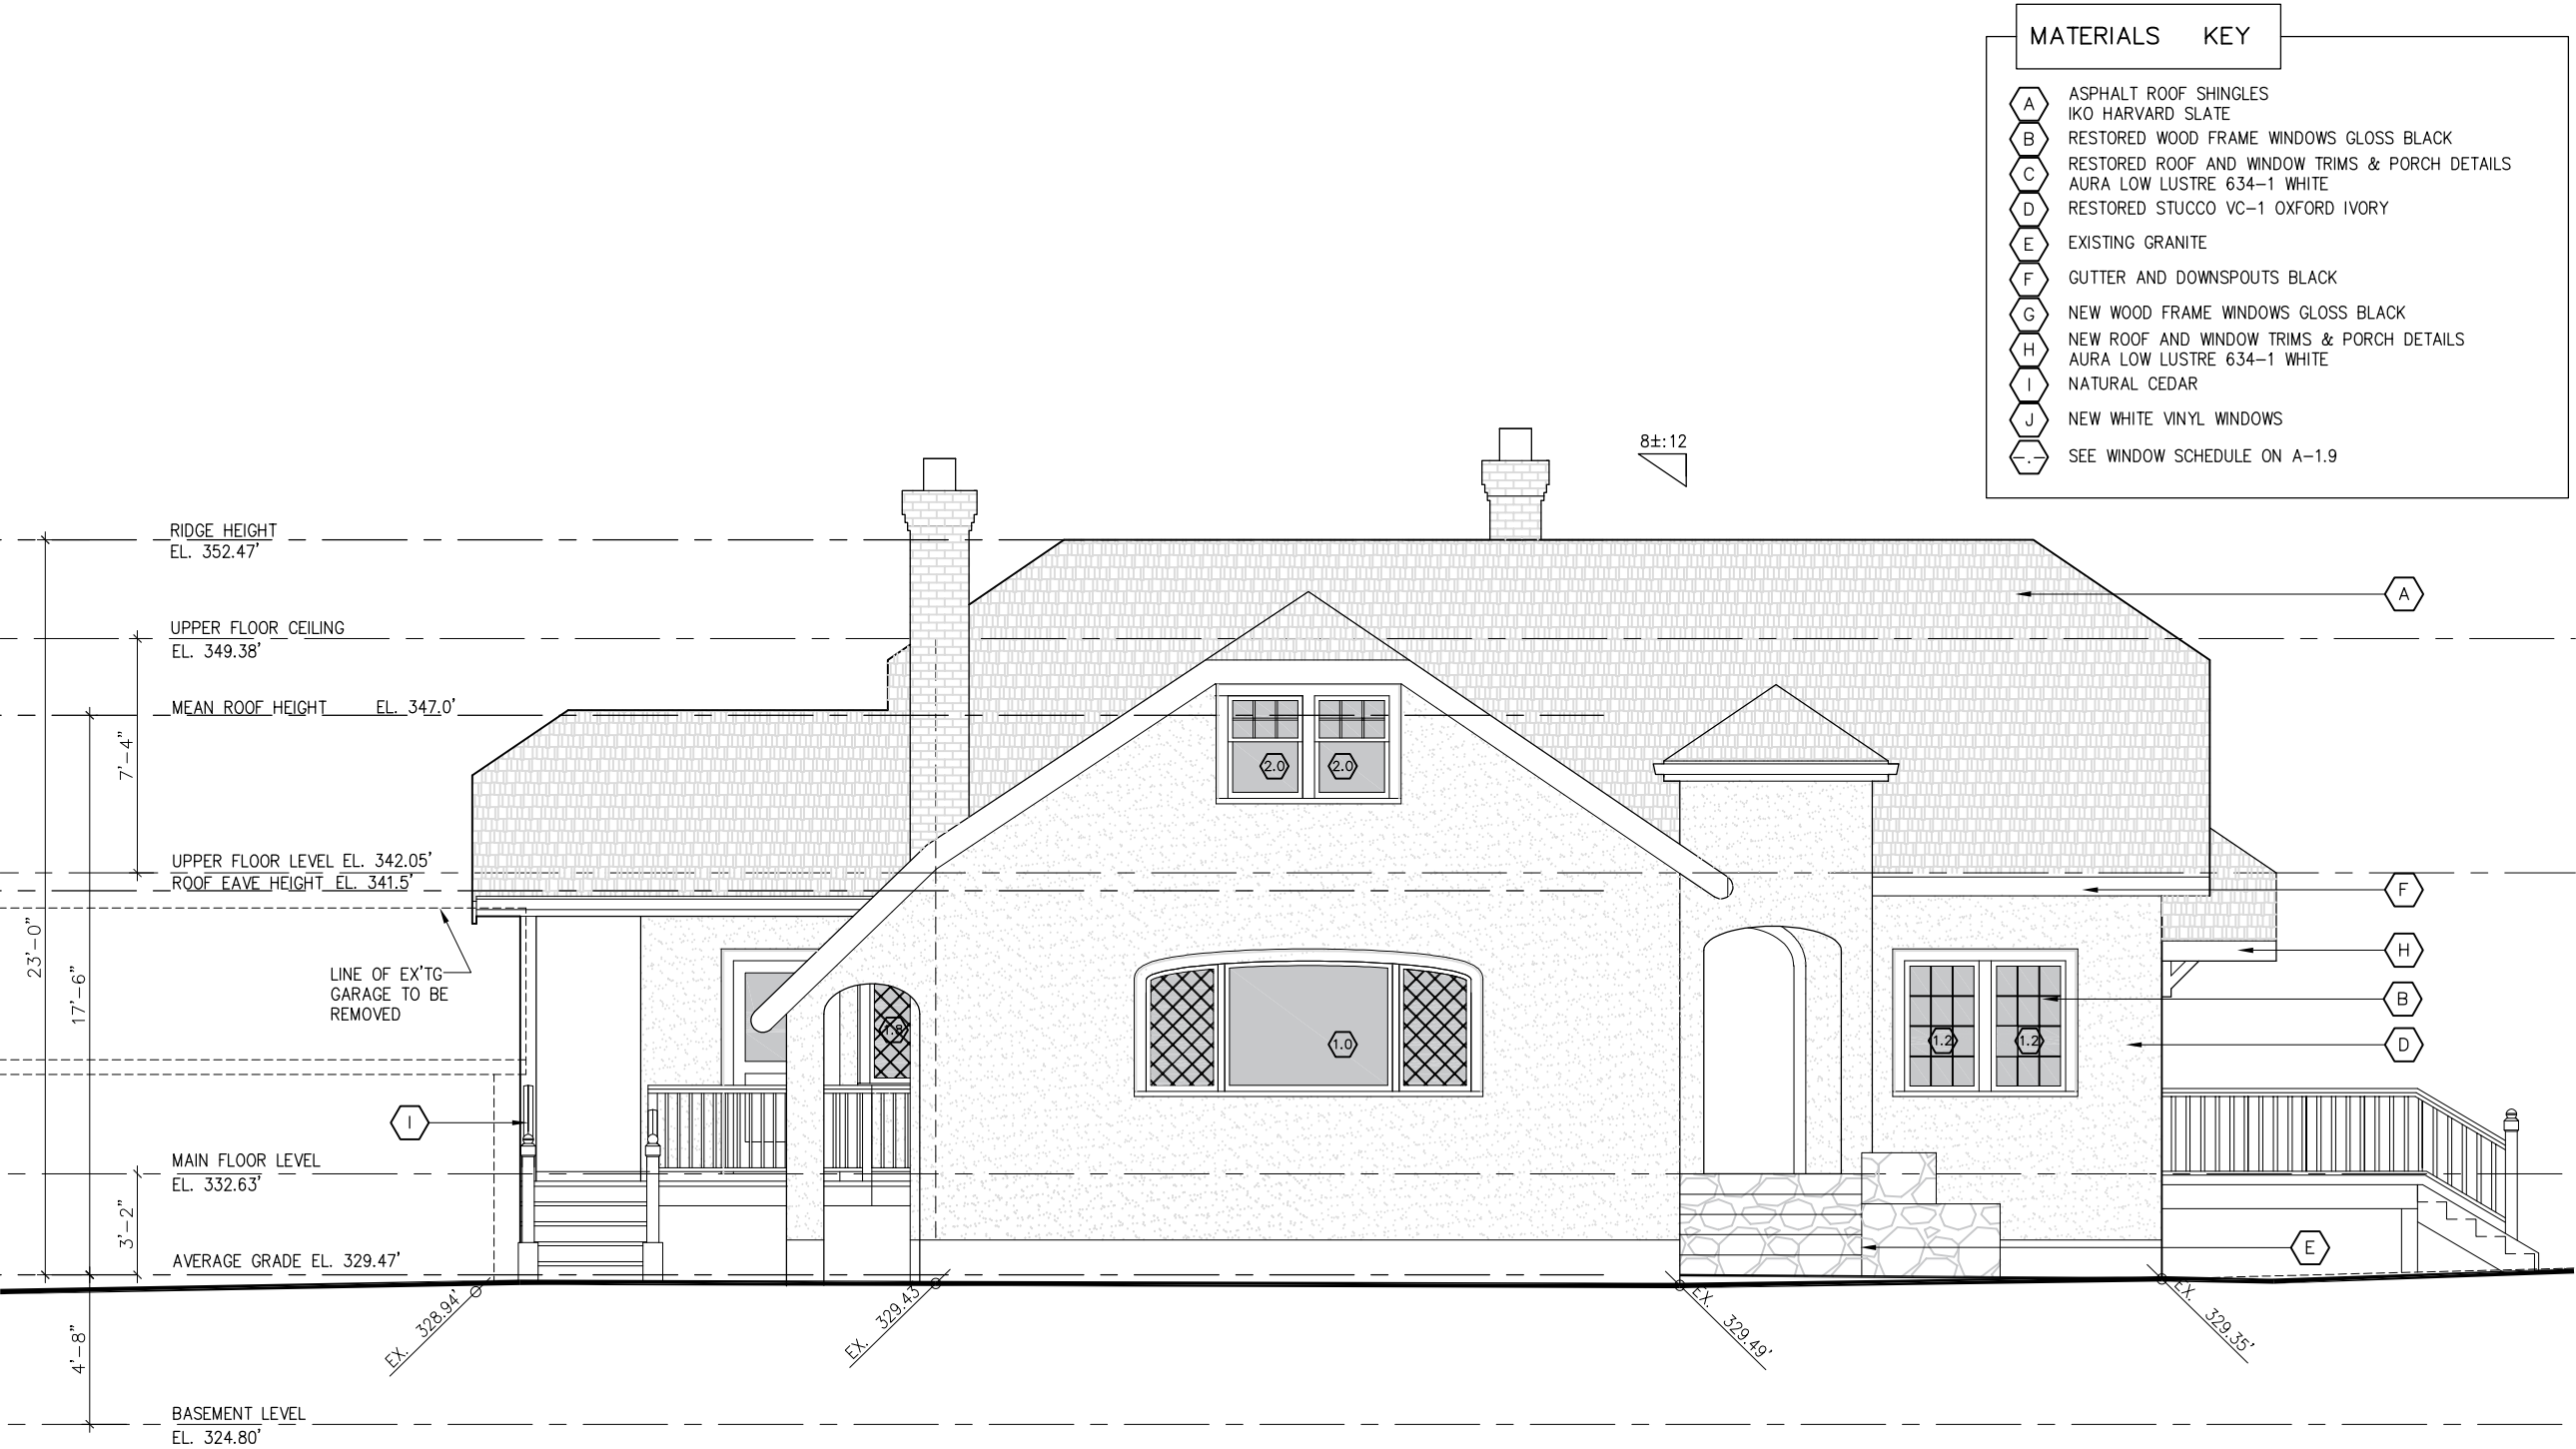
**1** 4TH ST (WEST) ELEVATION  
— SCALE: 3/16" = 1'-0"

- A ASPHALT ROOF SHINGLES  
IKO HARVARD SLATE
- B RESTORED WOOD FRAME WINDOWS GLOSS BLACK
- C RESTORED ROOF AND WINDOW TRIMS & PORCH DETAILS  
AURA LOW LUSTRE 634-1 WHITE
- D RESTORED STUCCO VC-1 OXFORD IVORY
- E EXISTING GRANITE
- F GUTTER AND DOWNSPOUTS BLACK
- G NEW WOOD FRAME WINDOWS GLOSS BLACK
- H NEW ROOF AND WINDOW TRIMS & PORCH DETAILS  
AURA LOW LUSTRE 634-1 WHITE
- I NATURAL CEDAR
- J NEW WHITE VINYL WINDOWS
- SEE WINDOW SCHEDULE ON A-1.9
