**THE CORPORATION OF THE CITY OF NEW WESTMINSTER  
HERITAGE REVITALIZATION AGREEMENT (323 Regina Street)  
BYLAW NO. 8304, 2022**

**HERITAGE REVITALIZATION AGREEMENT (323 Regina Street)**

PROJECT TITLE.  
**HERITAGE RESTORATION  
AGREEMENT,**  
323 REGINA ST.,  
NEW WESTMINSTER, B.C.

Edgar House, 323 Regina Street, New Westminster, BC

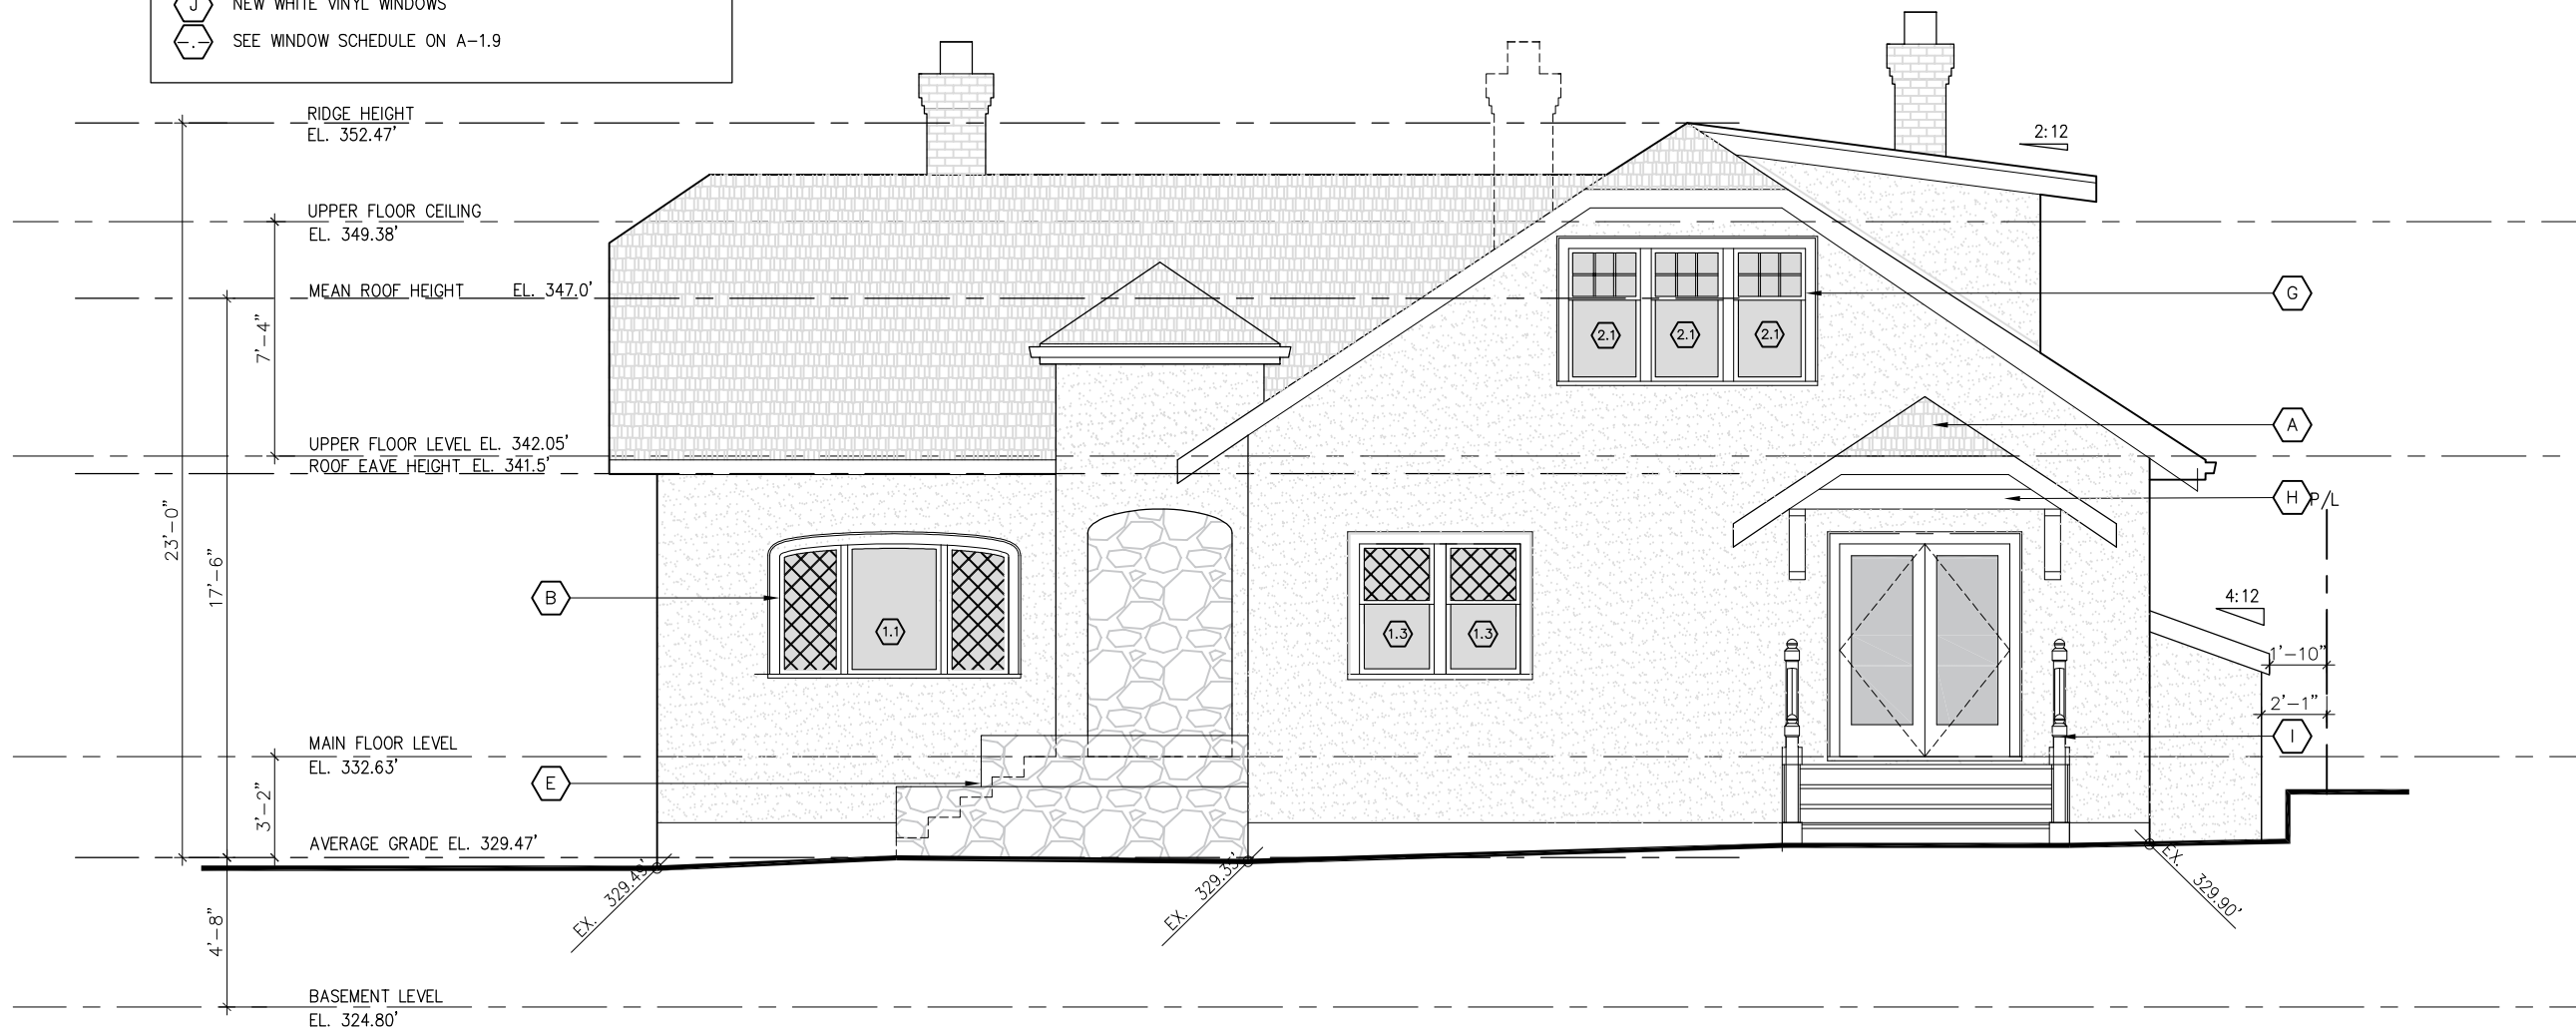
1 REGINA (SOUTH) ELEVATION  
— SCALE: 3/16" = 1'-0"

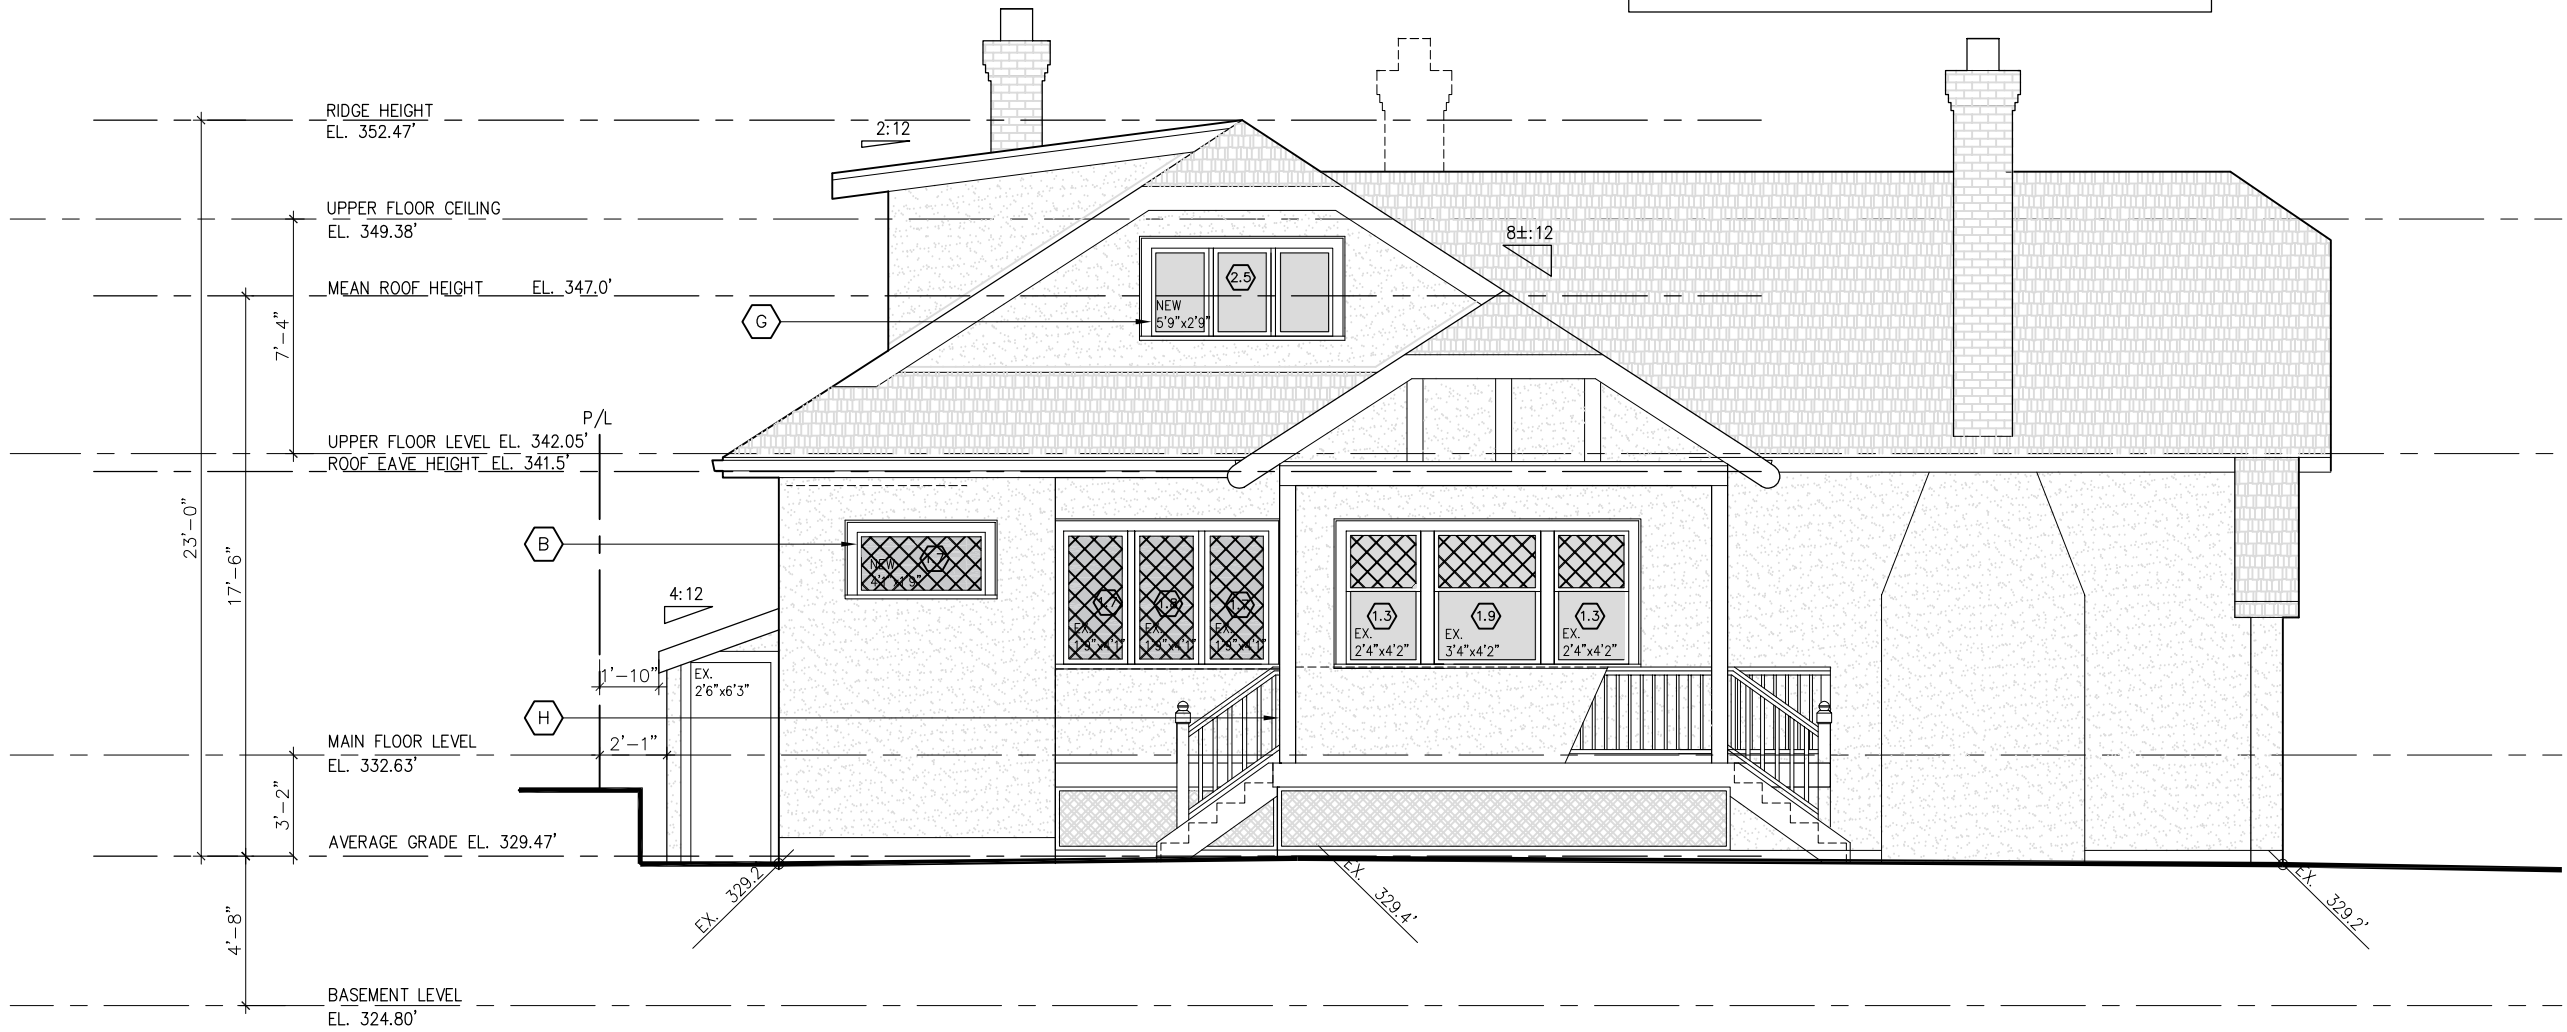
- A ASPHALT ROOF SHINGLES  
IKO HARVARD SLATE
- B RESTORED WOOD FRAME WINDOWS GLOSS BLACK
- C RESTORED ROOF AND WINDOW TRIMS & PORCH DETAILS  
AURA LOW LUSTRE 634-1 WHITE
- D RESTORED STUCCO VC-1 OXFORD IVORY
- E EXISTING GRANITE
- F GUTTER AND DOWNSPOUTS BLACK
- G NEW WOOD FRAME WINDOWS GLOSS BLACK
- H NEW ROOF AND WINDOW TRIMS & PORCH DETAILS  
AURA LOW LUSTRE 634-1 WHITE
- I NATURAL CEDAR
- J NEW WHITE VINYL WINDOWS
- SEE WINDOW SCHEDULE ON A-1.9

1 NORTH ELEVATION  
— SCALE: 3/16" = 1'-0"

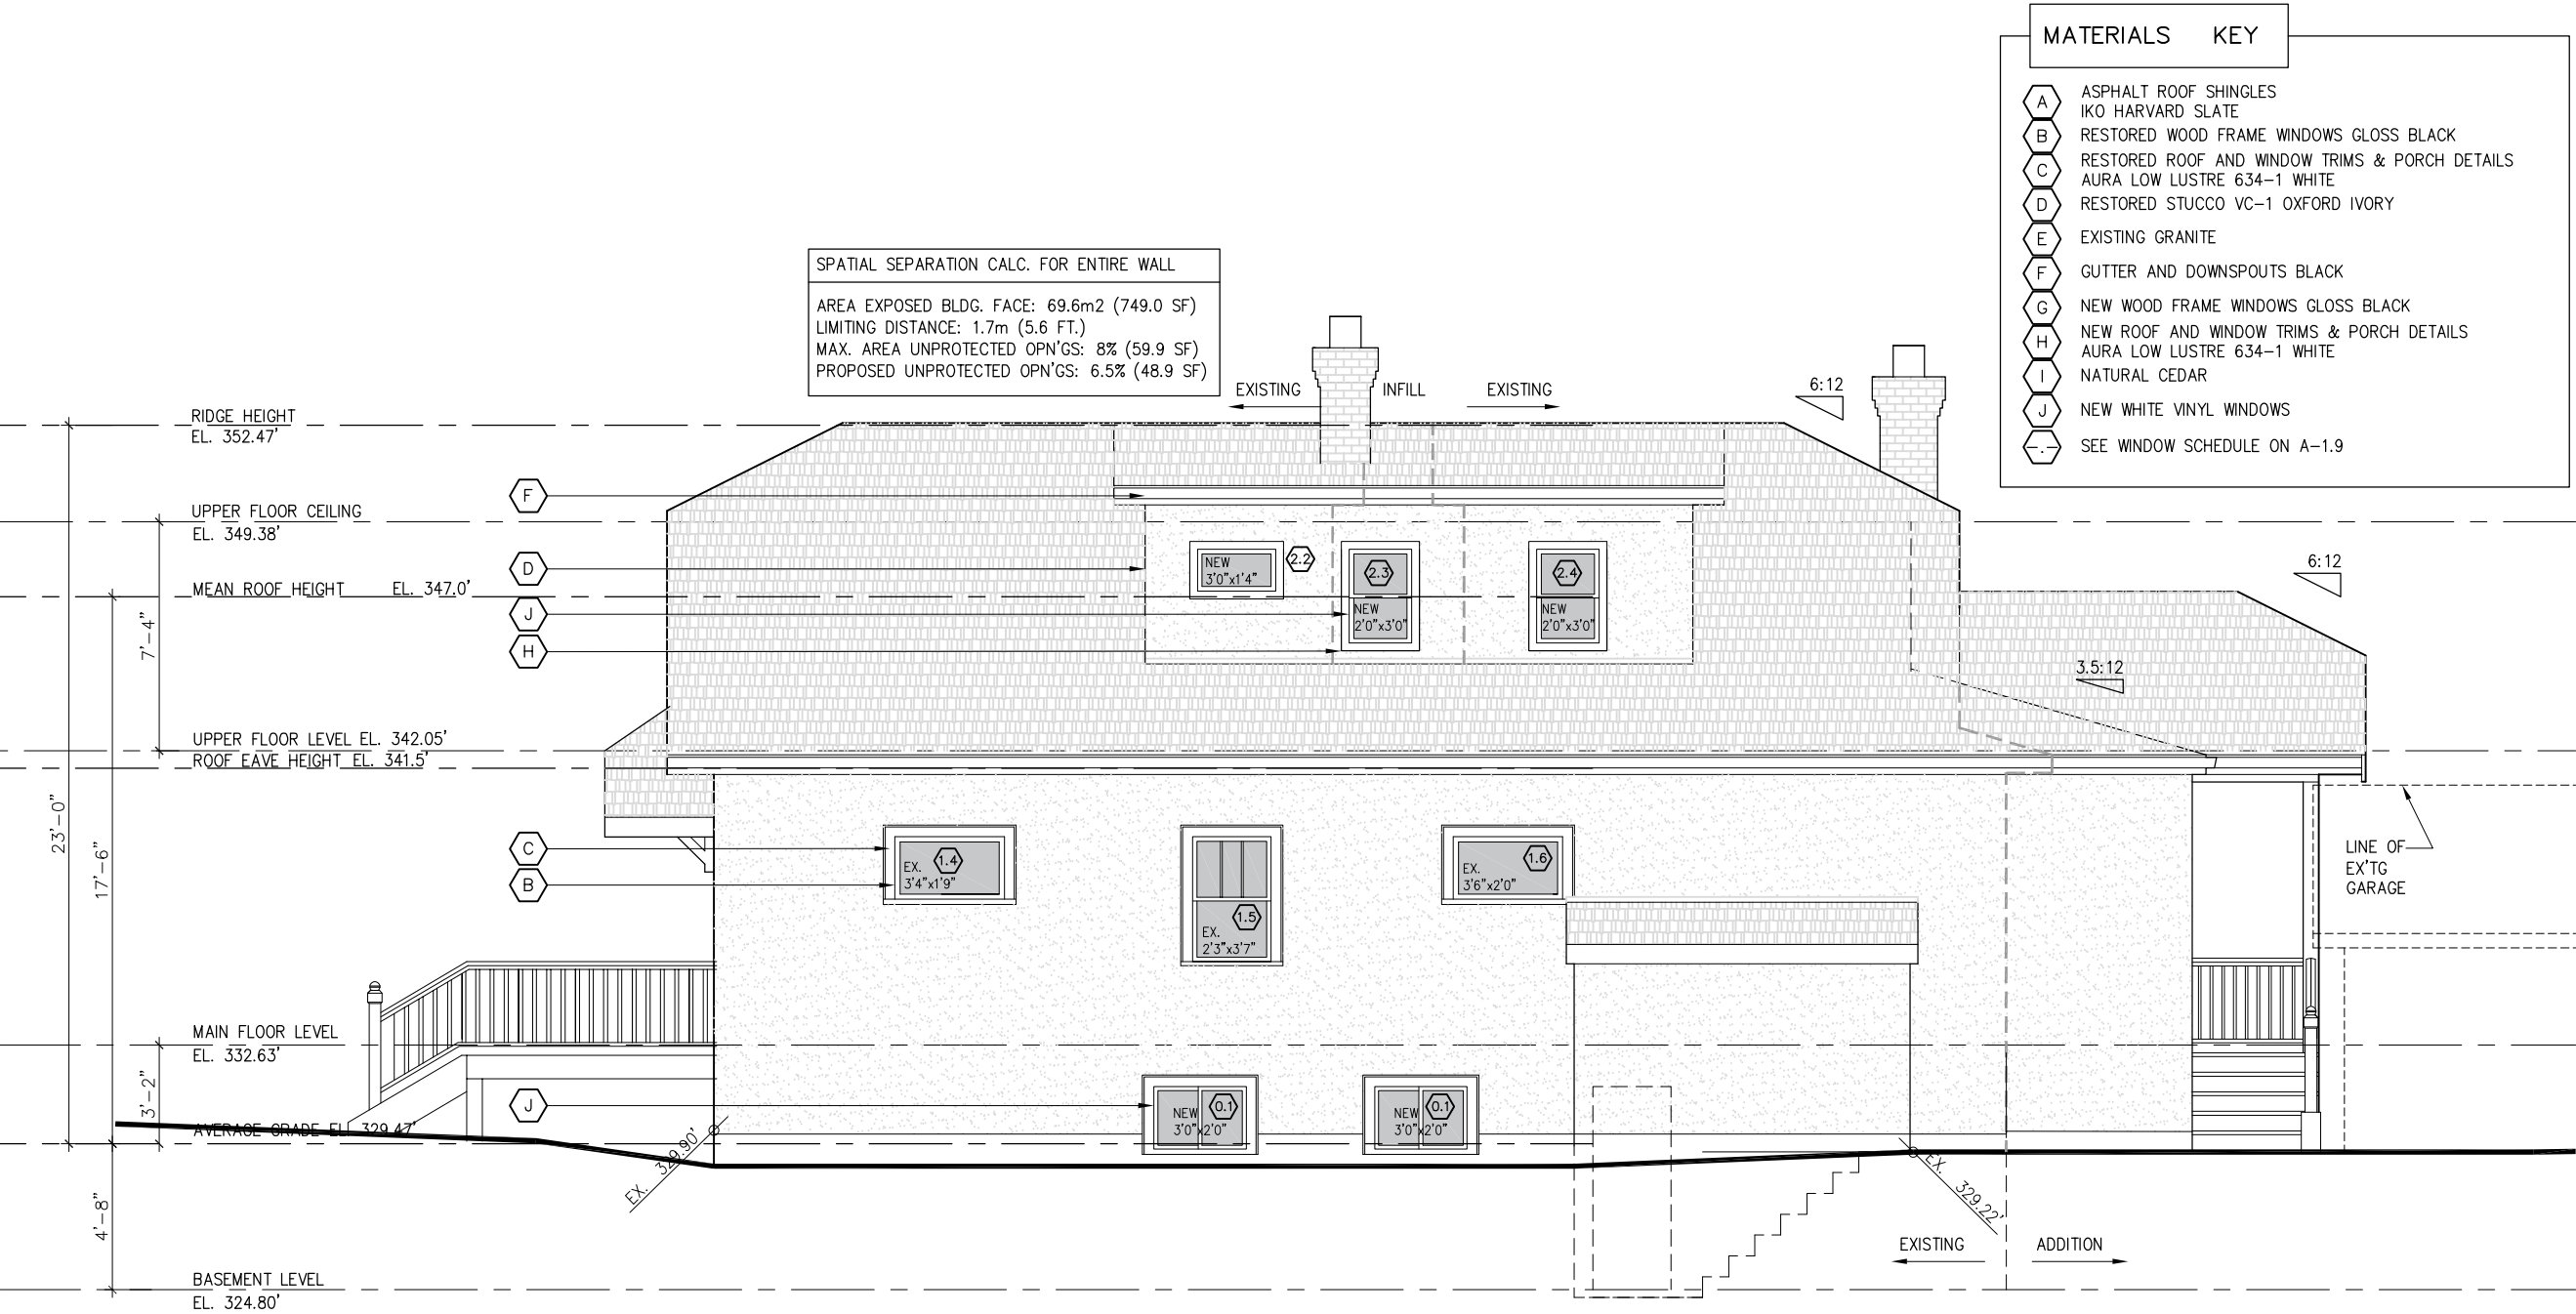
**A-1.8**

1 EAST ELEVATION  
— SCALE: 3/16" = 1'-0"

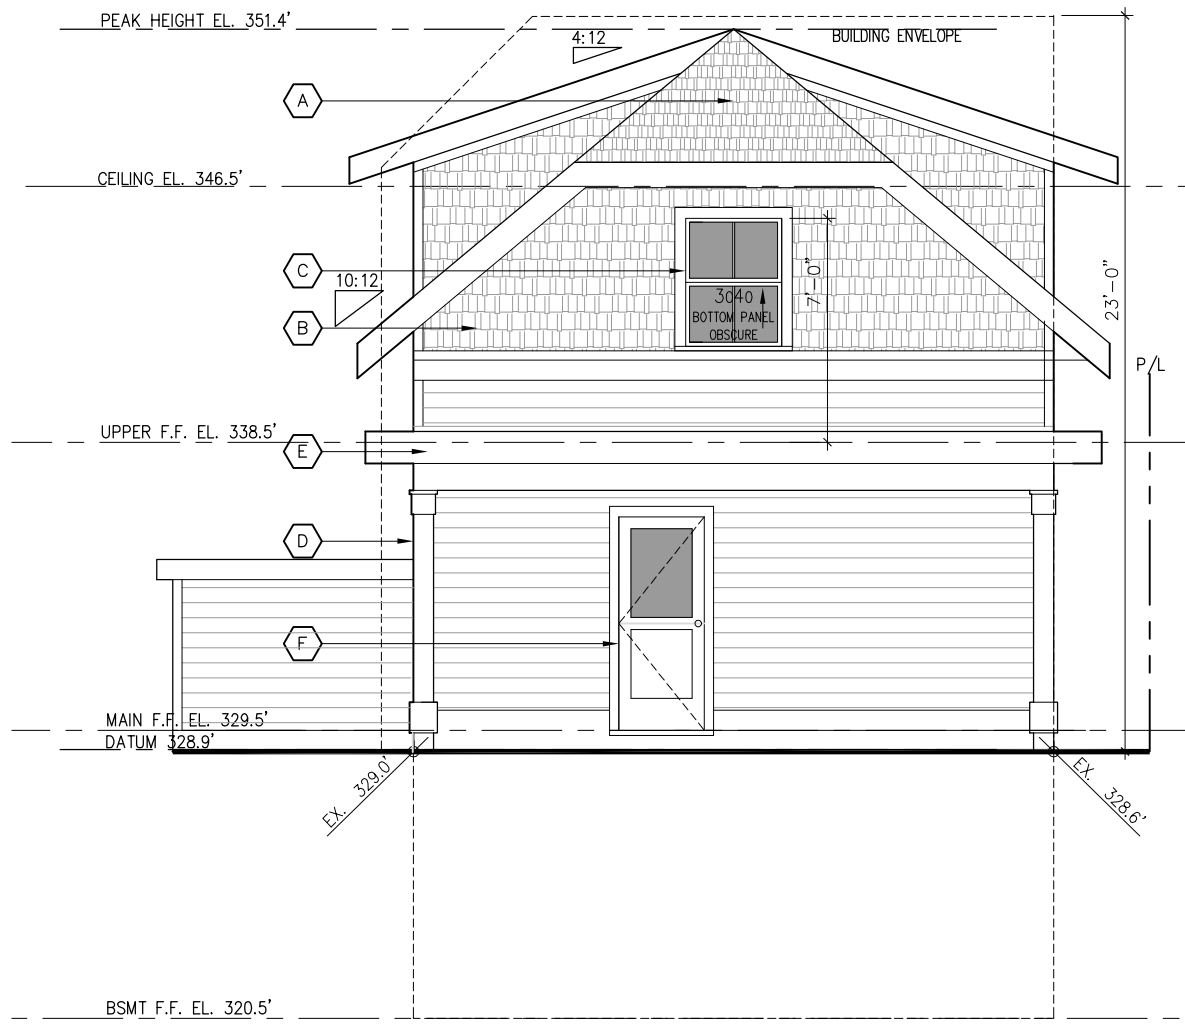
- A ASPHALT ROOF SHINGLES  
IKO HAVARD SLATE
- B FIBRE-CEMENT SIDING W/5 1/2" EXPOSURE HARDI  
SIDING/SHINGLES - POINT GREY (BM VC-24)
- C DBL. GLAZED LOW-E WOOD WINDOWS  
REGAL SOFT GLOSS K404-80 BLACK
- D ROOF & PORCH TRIMS & GUARDRAILS  
WOOD PAINTED AURA LOW LUSTRE 634-1 WHITE
- E GUTTERS AND DOWNSPOUTS  
BLACK
- F FRONT DOOR-MELLISH RUST (BM VC-28)

1 WEST ELEVATION  
SCALE: 3/16" = 1'-0"

2 EAST ELEVATION  
SCALE: 3/16" = 1'-0"

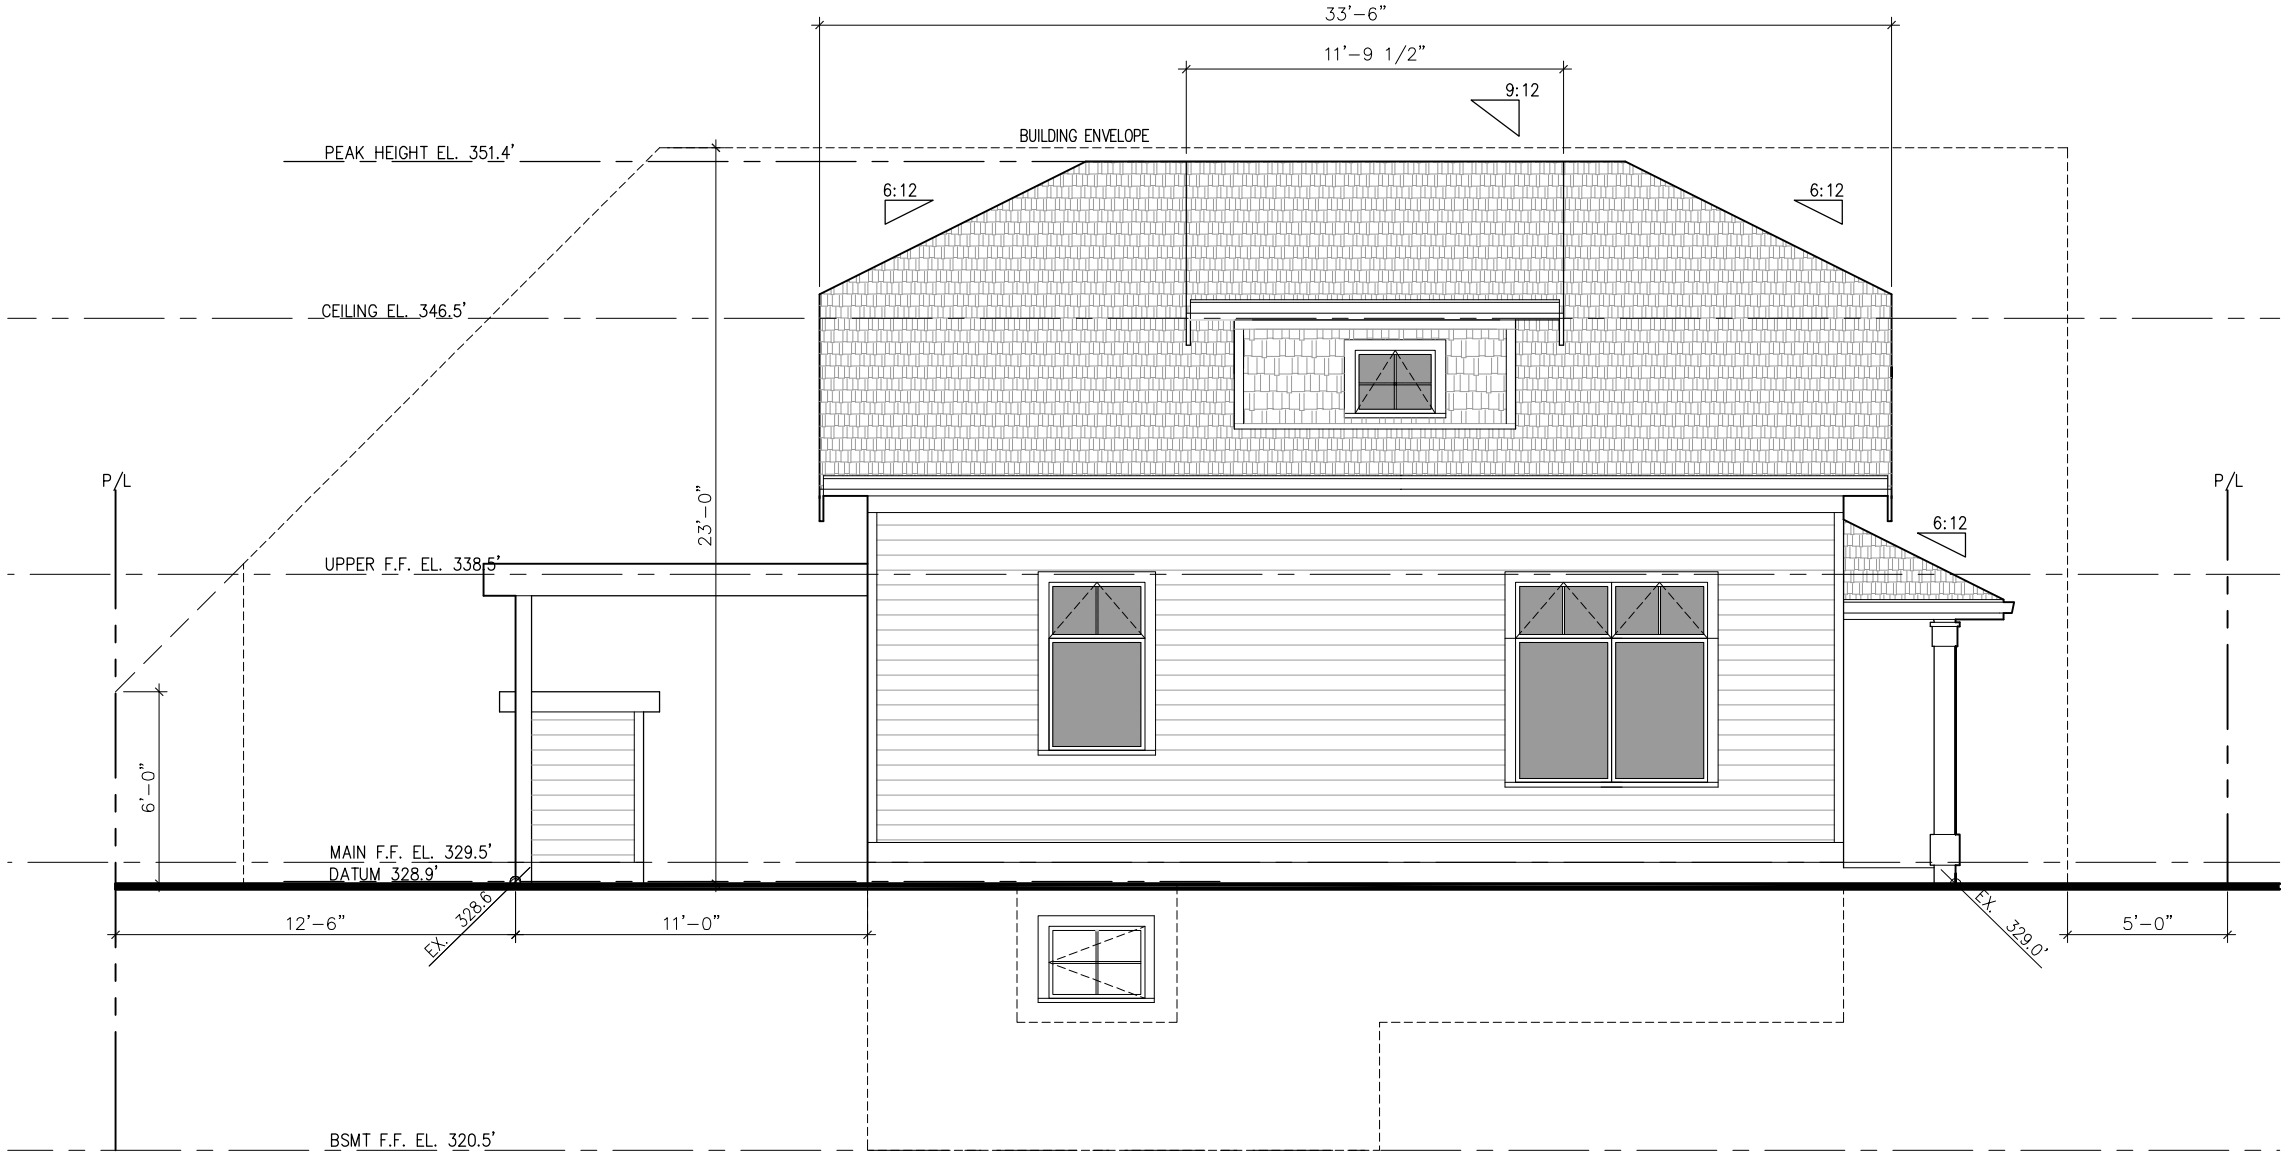
**A-2.6**

**1** NORTH ELEVATION  
— SCALE: 3/16" = 1'-0"

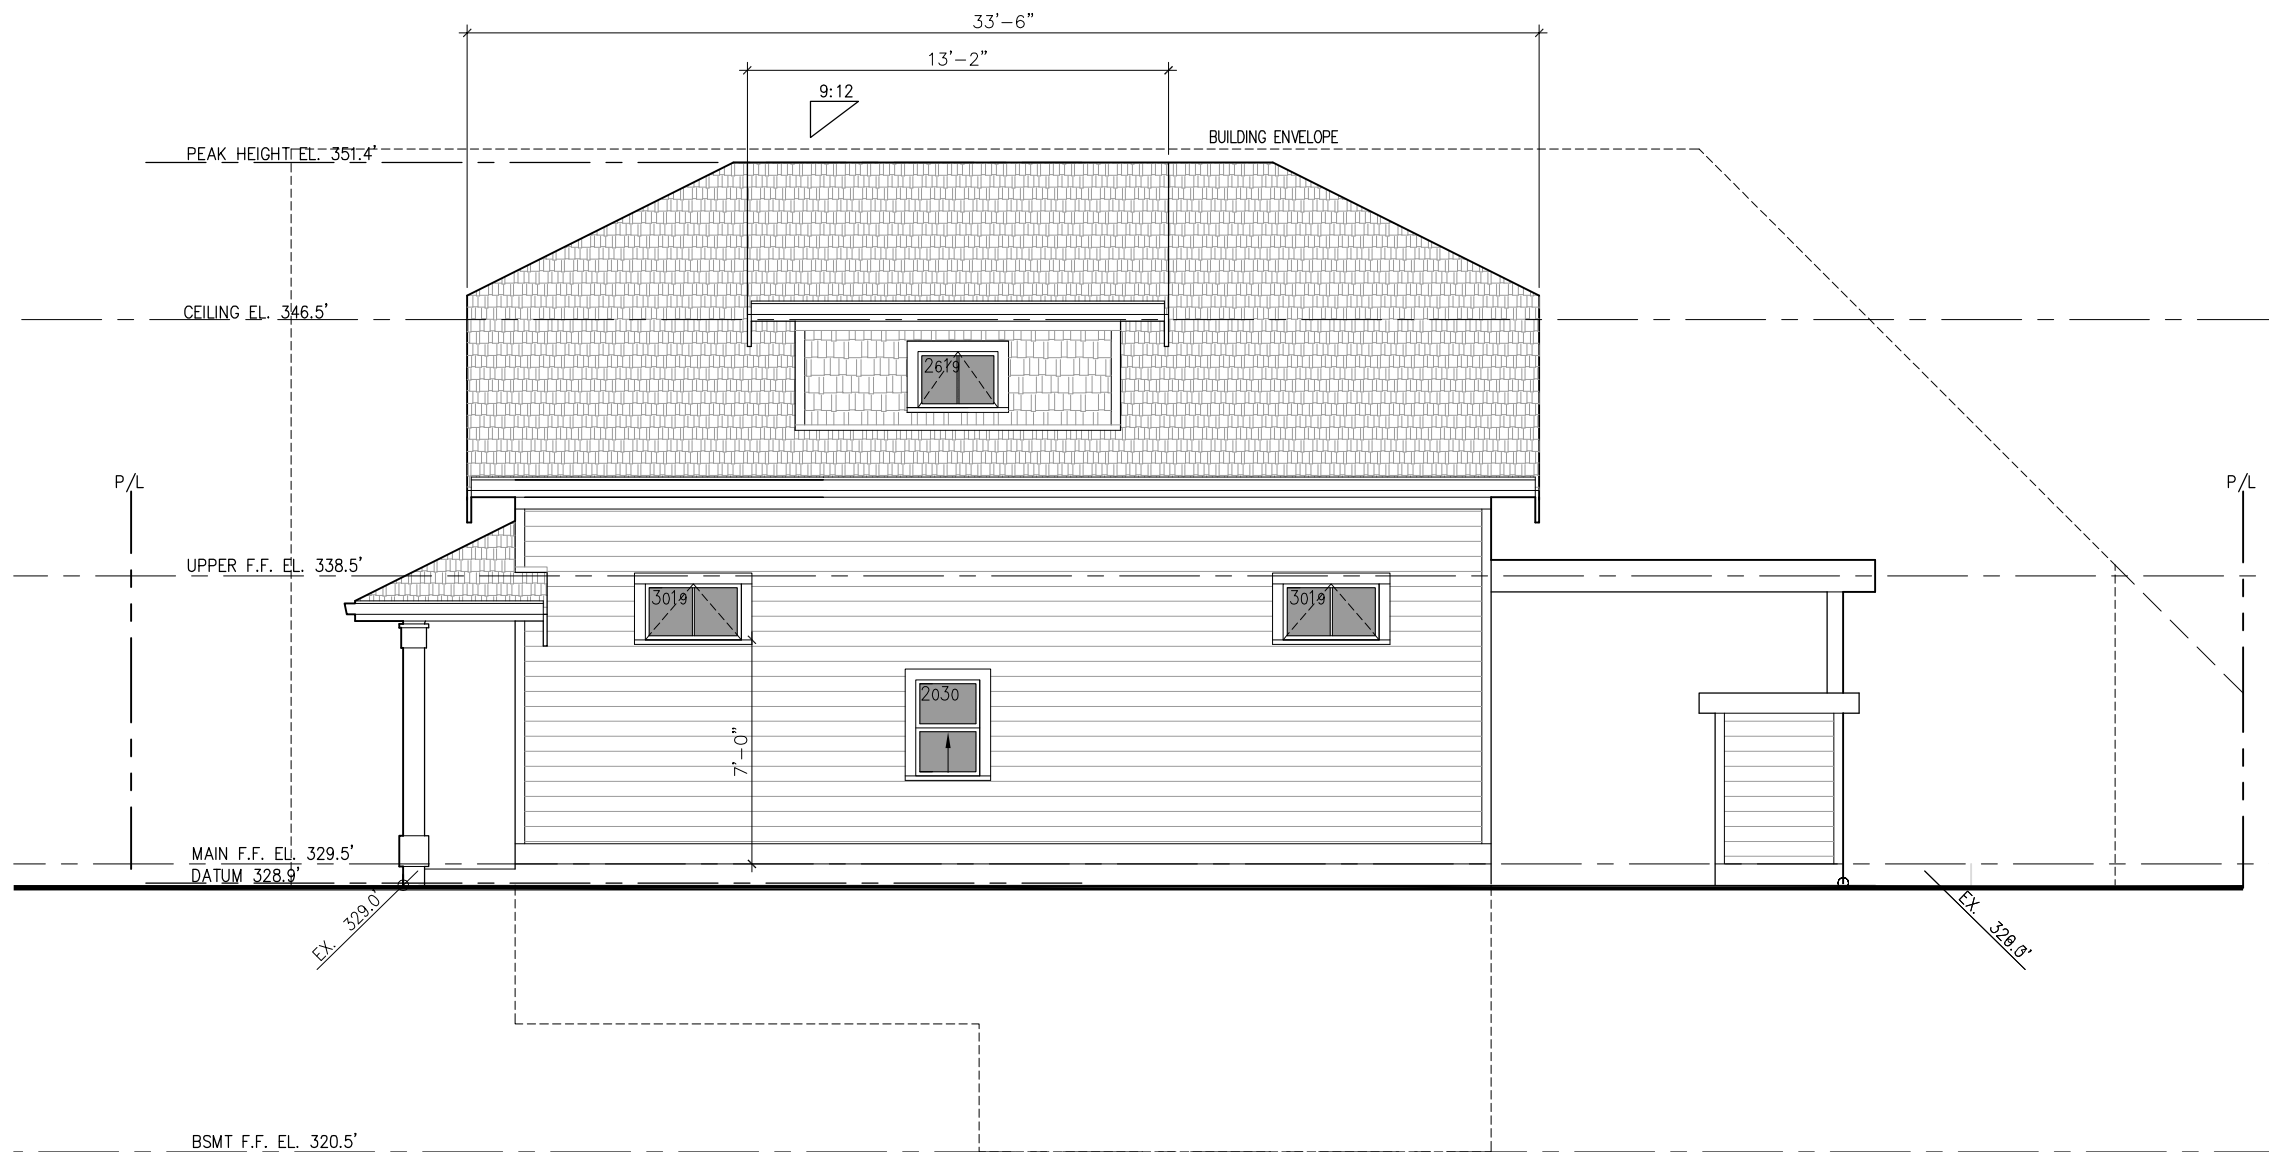
1 SOUTH ELEVATION  
— SCALE: 3/16" = 1'-0"
