# Heritage Assessment

373 Hospital Street – 1915

Sapperton- New Westminster, BC

Prepared By: Susan Medville, MA, CAHP  
November 8, 2021

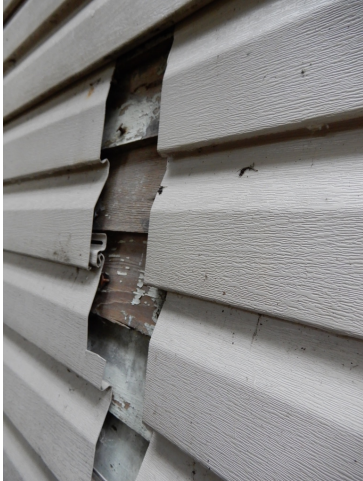
Wood lap siding on north elevation under vinyl siding.

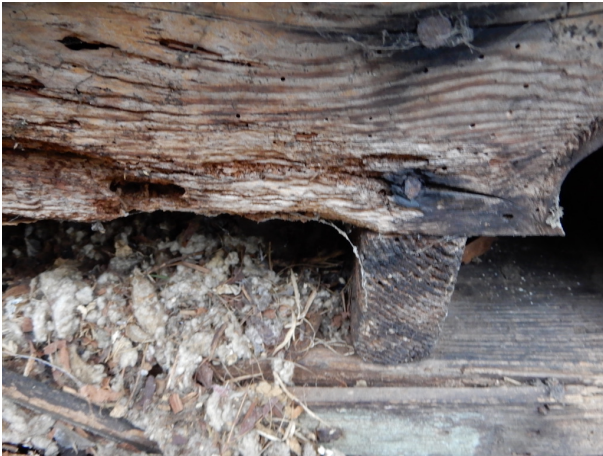
Animal nest in wall on west elevation.

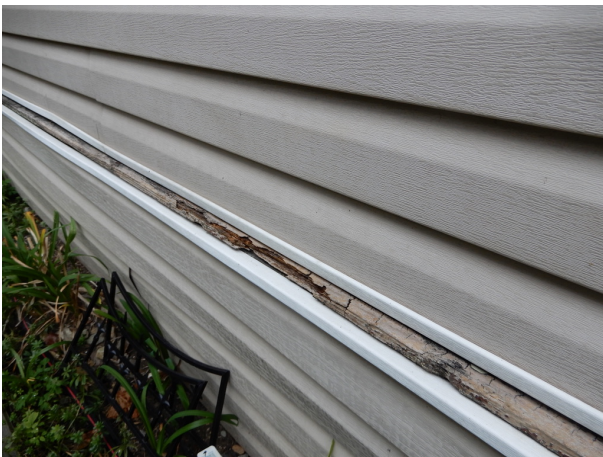
Exposed deteriorating trim board.

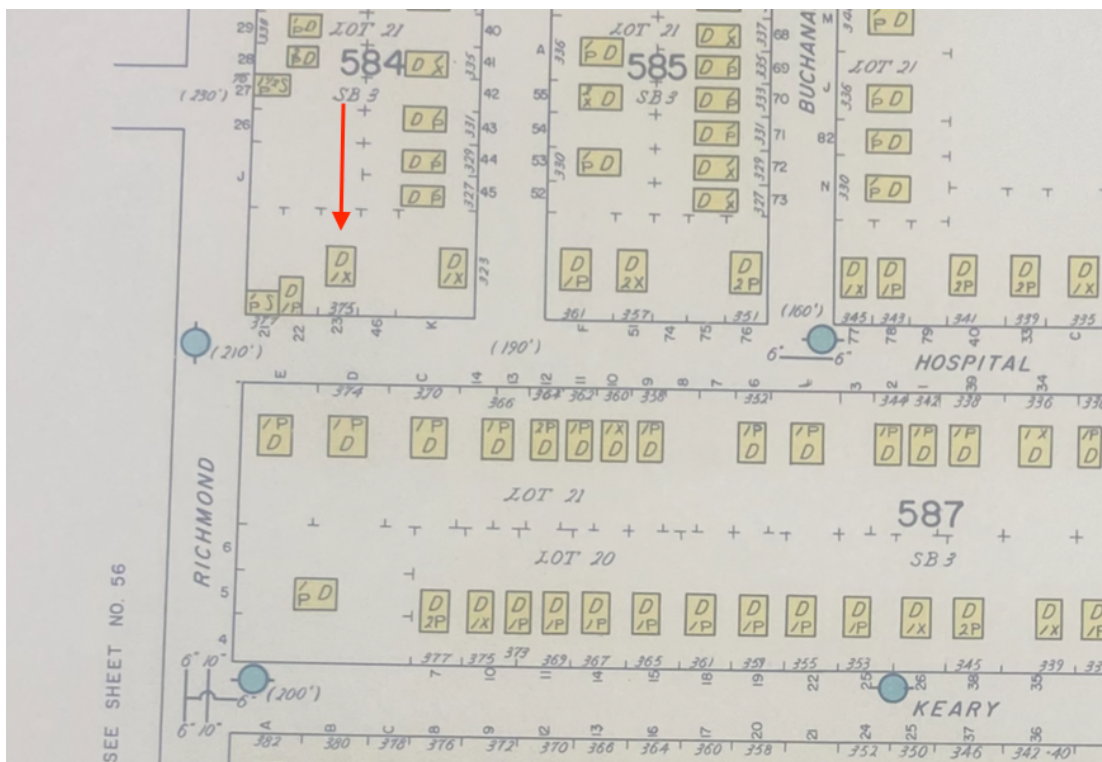
1957. Fire Insurance Plan. (Note: 371 Hospital Street, the adjacent property to 373 is not on this map however the Public Development Site Report states the building permit (Type- Demo/ House Move) was issued in 1956.)

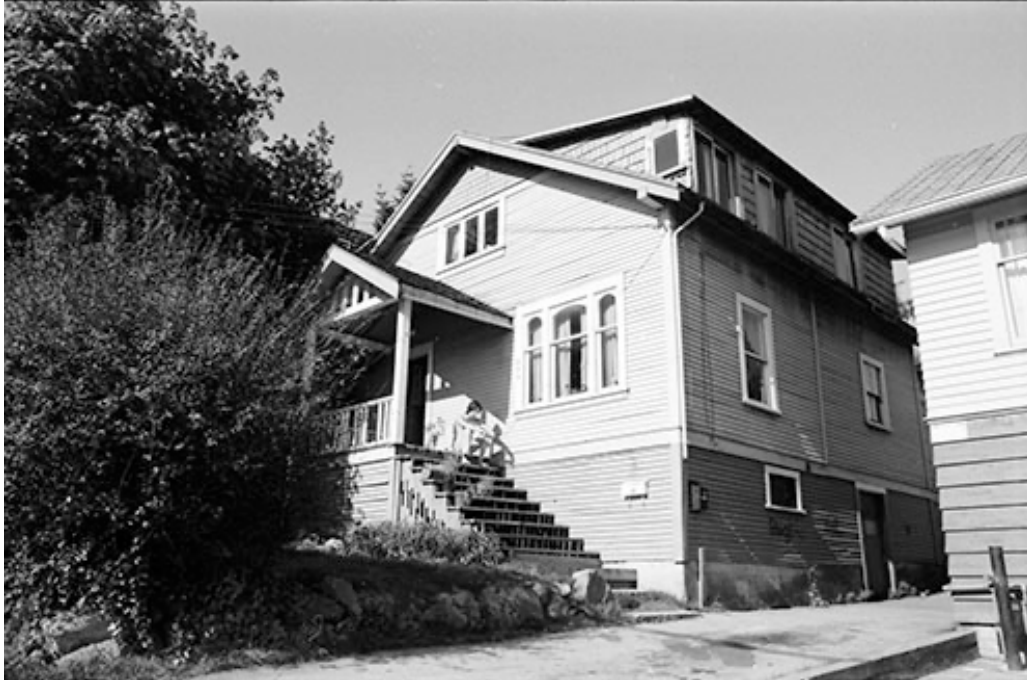
1982. New Westminster Archives – IHP14683

(Note: original cladding and arched window combination. 1945 dormer addition has what appears to be metal or vinyl windows.)

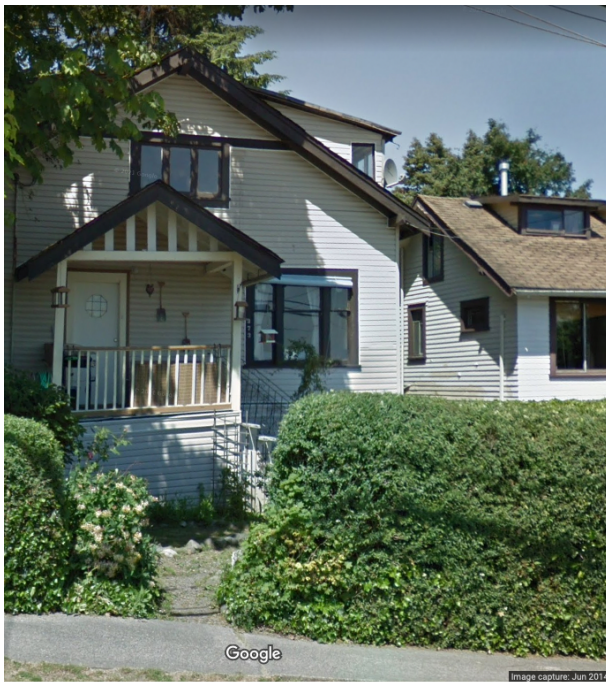
2015. Google. (Note: front porch intact and window combinations intact, original front door has been replaced. No other visible changes since the 2009 Google images.)

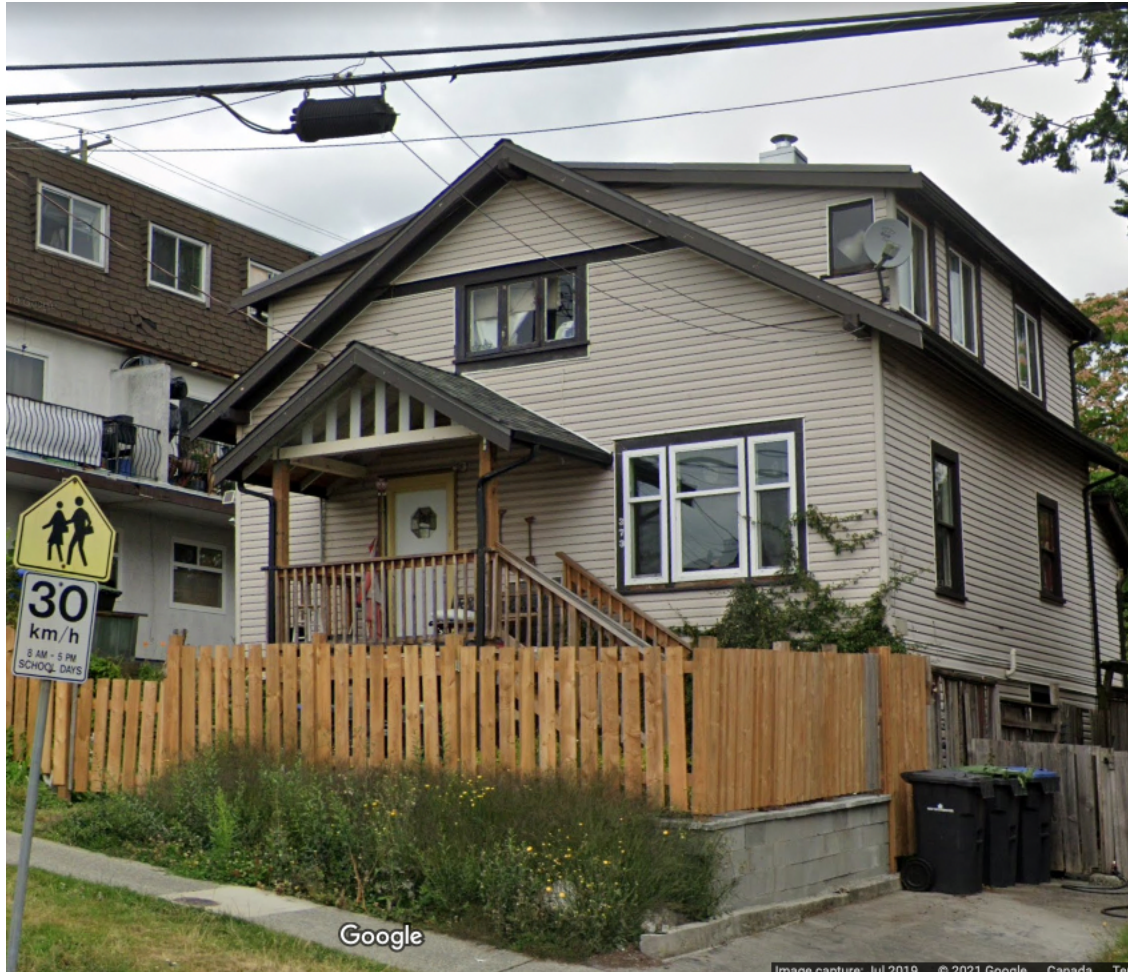
2019. Google. (Note: Front porch partially rebuilt, wood transomed window combination replaced with vinyl windows, brick chimney replaced with metal chimney.)
