## Attachment 2

### *Woodlands Wall Statement of Significance*

## **Statement of Significance**

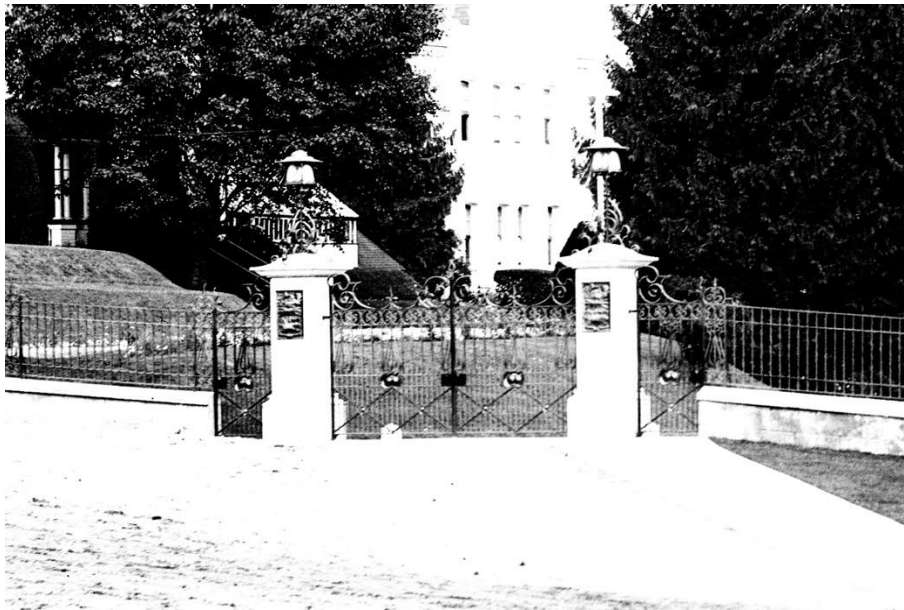
**Photo B-2:** Detail of Woodlands Wall gate columns, 1909 (Vancouver Public Library 7553).

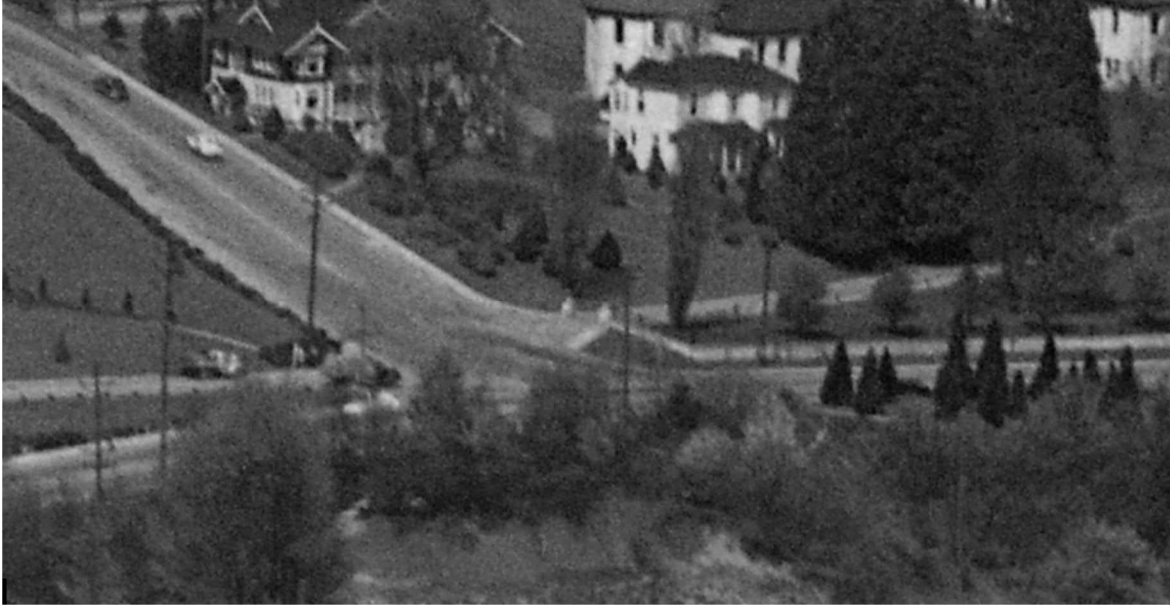
**Photo B-5:** 1948 oblique aerial with gate columns visible (Vintage Air Photos BO-48-2862).

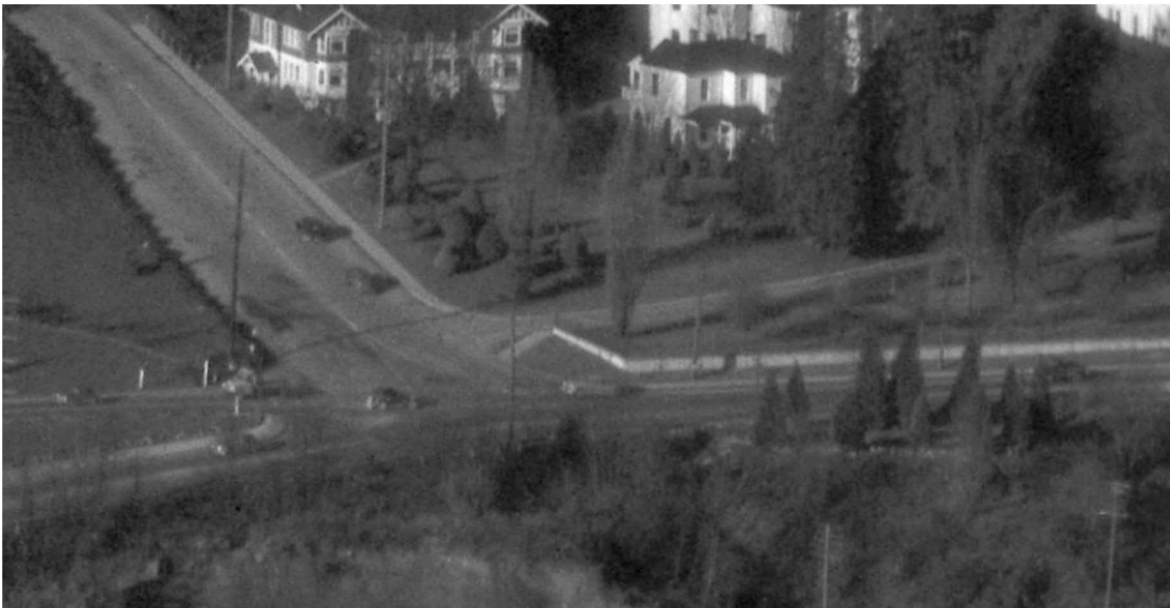
**Photo B-6:** 1951 oblique aerial with gate columns removed (Vintage Air Photos 1-9).
