To: Community Heritage Commission Date: April 7, 2021

Subject: 82 First Street & 112 Royal Avenue: Heritage Revitalization Agreement
Application

E. M. N. Woods House ~ 1890

Elana Zysblat, CAHP :: Ance Building Services :: October 2019

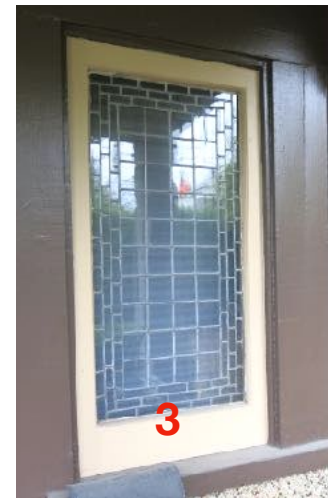
2 & 3 front door leaded side lights

4 panelled front door

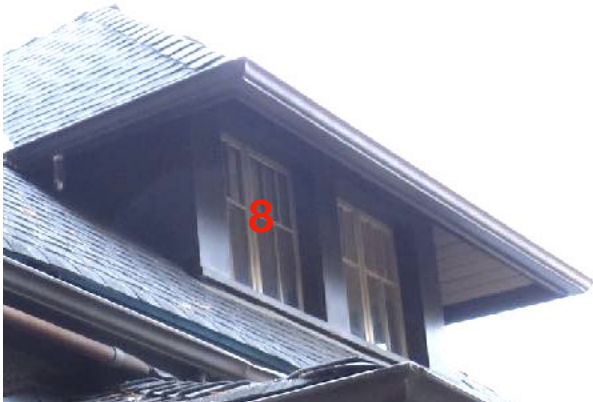
rear (west elevation)

8 dormer double assembly windows

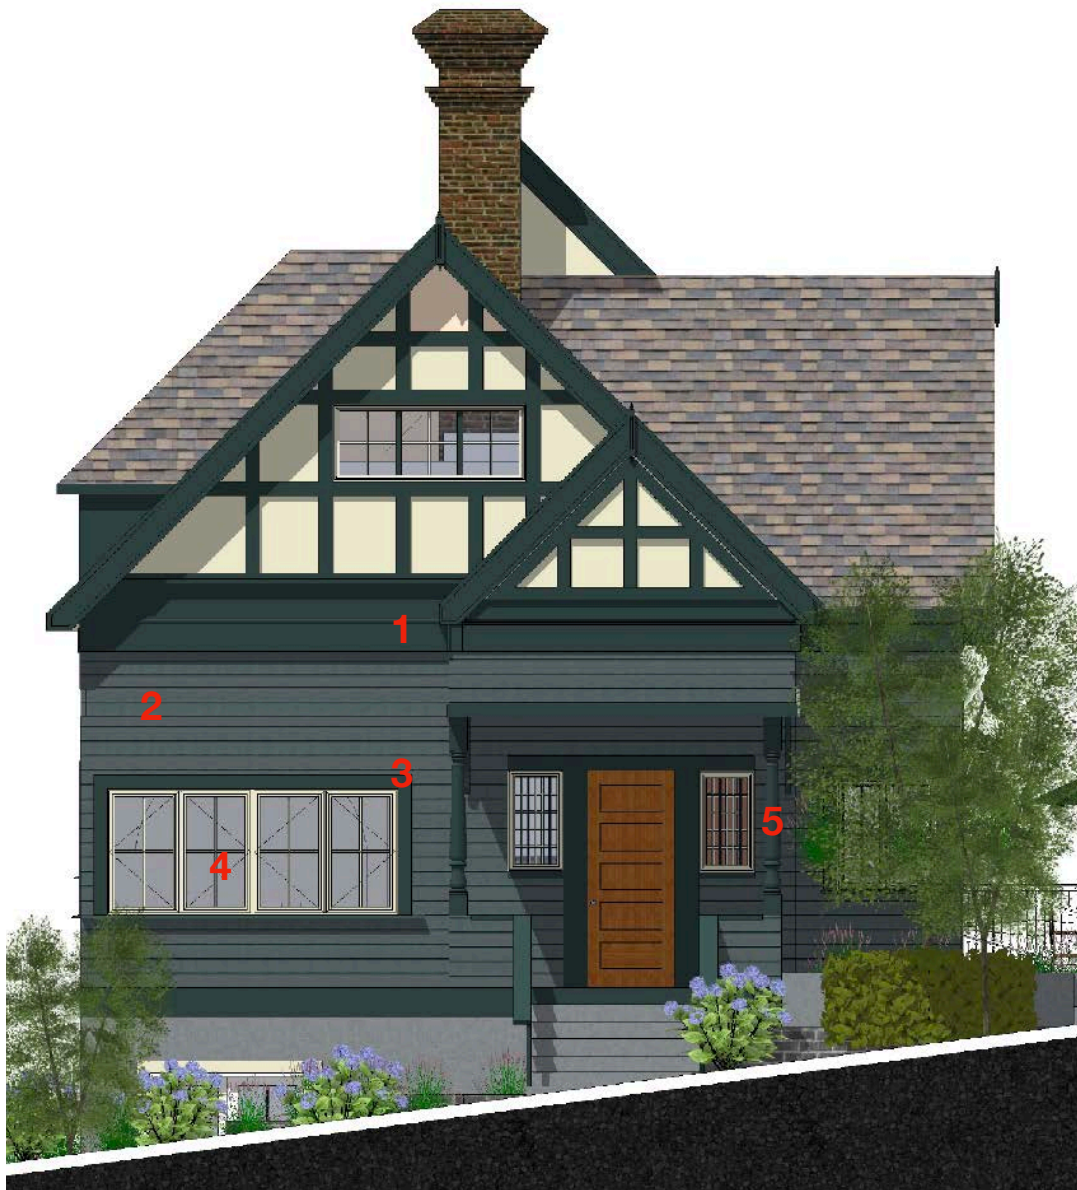
- 1** gable boards restored to wood
- 2** stucco removed and wood cladding repaired
- 3** window trim restored to historic dimensions and materials
- 4** window sash restored to historic dimensions and materials
- 5** turned wood columns exposed and restored

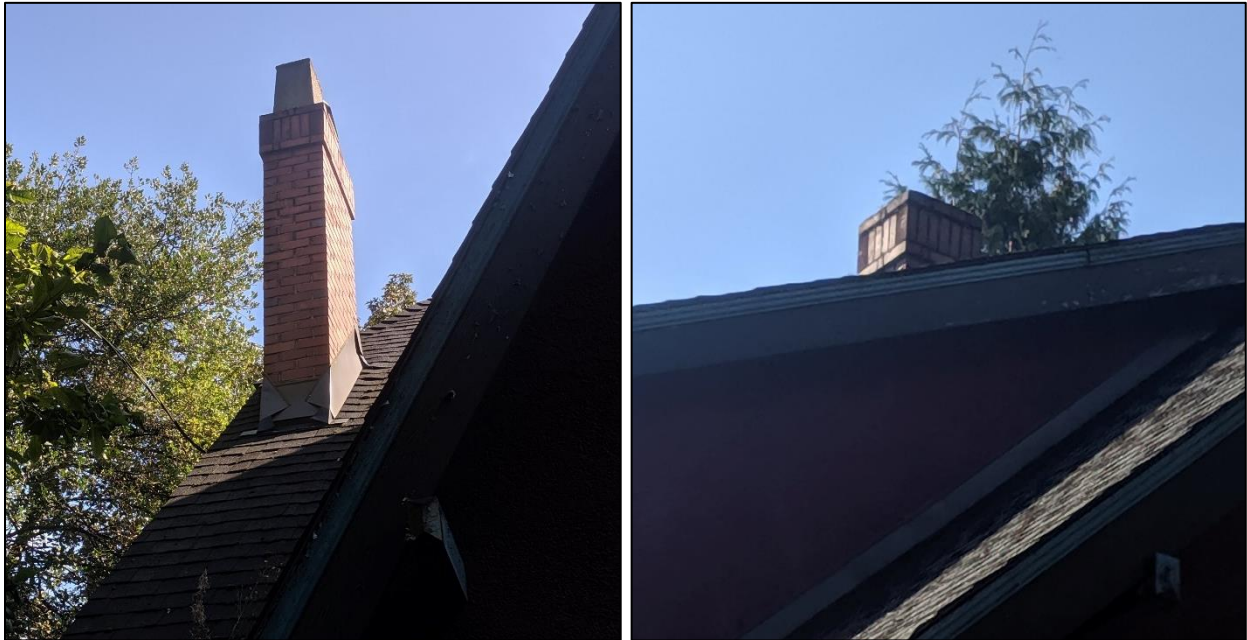
It appears there are two chimneys currently on the house and they seem, externally, in good condition. On the eastern side of the house, there is a tall and prominent brick chimney stack (Fig. 18) and another smaller one nearer the back, in the middle of the roof line (Fig. 19).

Figs. 18 and 19: Left (Fig. 18) shows the northeastern view of Henderson House at 112 Royal Avenue, 2019, illustrating its well conditioned taller chimney. Right (Fig. 19) shows the smaller chimney located nearer the back, closer to the roof line. (Sources: Cummer)

- The chimneys should be **preserved**, if possible, or **restored** (rebuilt with the original bricks, if possible, or replaced in-kind) following the relocation of the house.

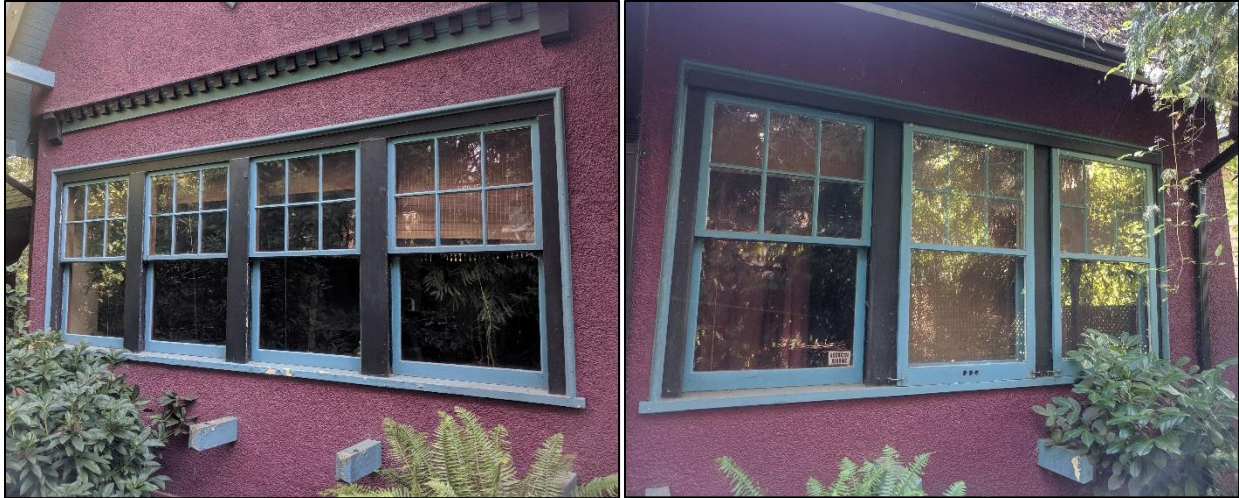
Considering the age of the building, the windows and doors are in quite good condition (Figs. 20 to 26). The only condition concerns appear to be cosmetic with paint peeling in places. Most (if not all) of the windows (their frames, sashes and hardware) appear to be the original ones from 1930, particularly the double-hung divided-light wood windows. The arched wooden front door, with round multi-coloured stained-glass window, also appears to be original and in good condition (Fig. 27), as do the other doors on the property, including the four-panel set of doors along the eastern façade (Fig. 28).

Figs. 20 and 21: Left (Fig. 20) shows the front windows beneath the offset side gable of Henderson House at 112 Royal Avenue, 2019. Right (Fig. 21) shows the front windows on the other side of the front door (the western side of the building). All appear to be in good condition. Note the visible supports of where the window boxes used to be. (Sources: Cummer)

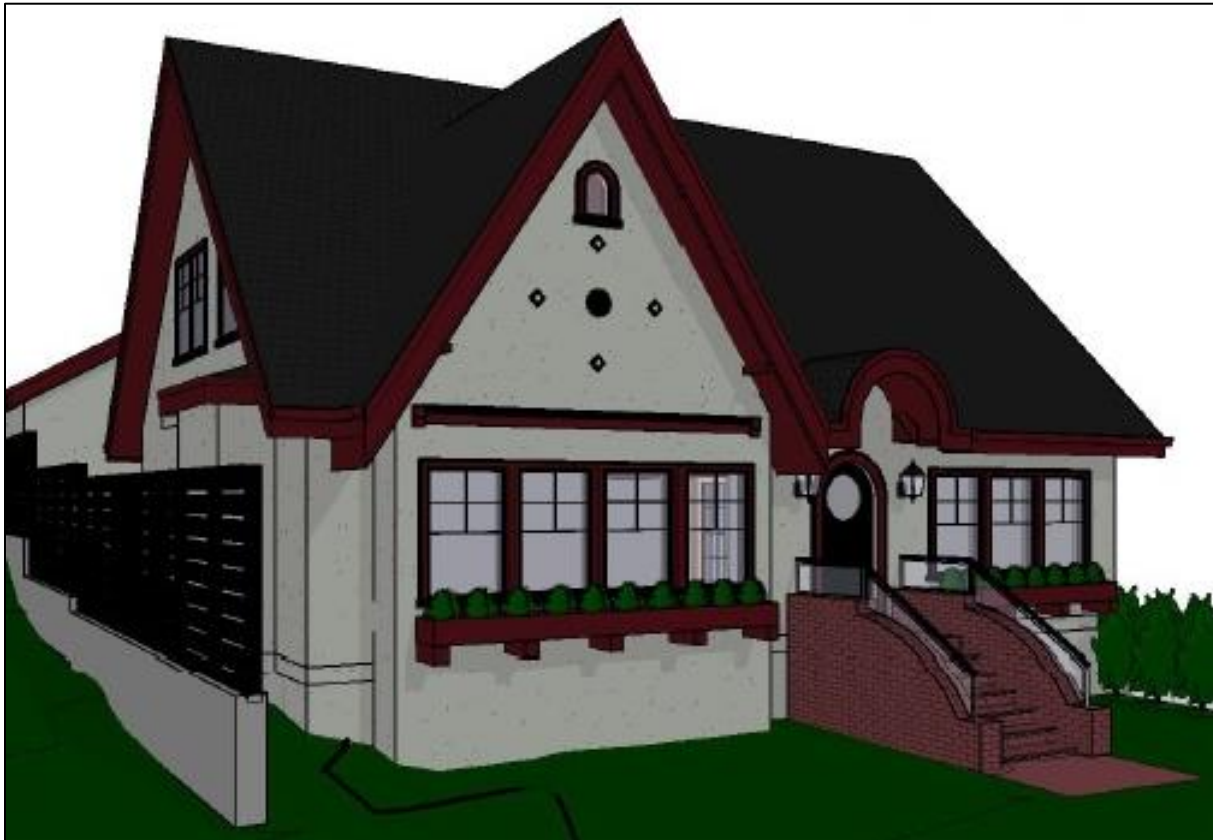
- 1) Moving the house to a new location within New Westminster;
- 2) Extending the basement height;
- 3) Preserving, but extending the arched front stairs (Fig. 29); and
- 4) Removing the back-porch addition (Fig. 30).

Fig. 29: Rendering of the restored front façade of Henderson House, 2020, including the restored window boxes. Note the extended height for the basement, and the resultant extended front staircase, still maintaining its brick and arched form. (Source: D3 Dimension, Drafting and Design Inc.)

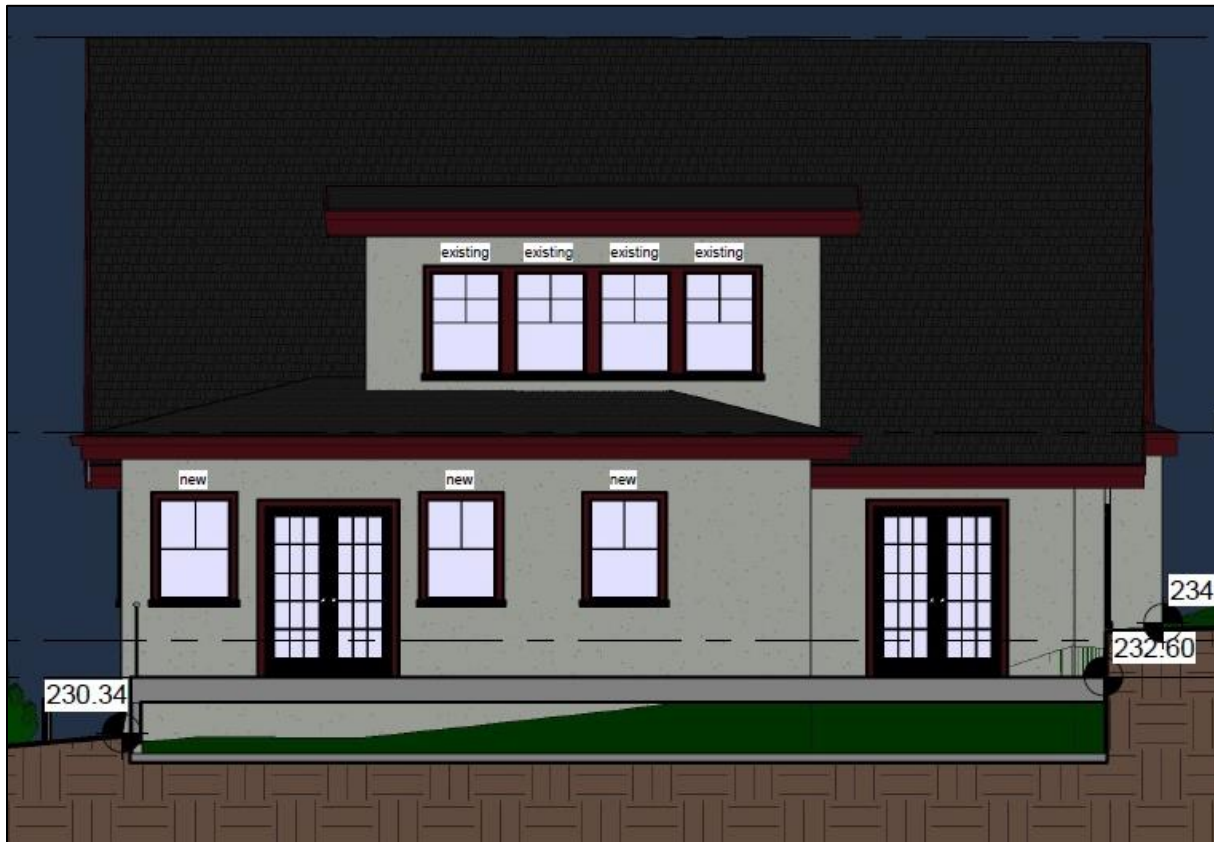
Fig. 30: Rendering of the restored rear façade of Henderson House, 2020. Note the removed back-porch. (Source: D3 Dimension, Drafting and Design Inc.)
