# Heritage Conservation Plan

102 Seventh Avenue, New Westminster BC :: Maddock House ~ 1941

Prepared by Elana Zysblat, CAHP :: Ance Building Services :: Revised for September 2021

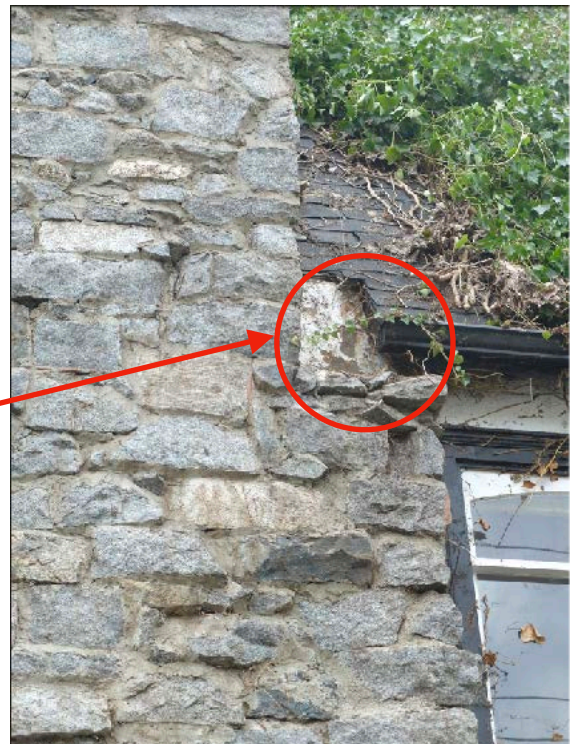
### f. Chimneys - *Restoration*

The internal brick chimney at side gable peak is in **fair** condition with gaping mortar joints and possibly inappropriate mortar. The excessive flashing is distracting. This chimney needs to be closely assessed by a conservation mason.

The granite & concrete brick top end-wall chimney on the 1st Street elevation is also in **fair** condition. There is evidence of inappropriate or inconsistent repairs in the concrete brick portion of the stack and evidence of missing mortar, loose granite stones and even missing granite stores on the north edge where it meets the roof. This chimney needs to be closely assessed by a conservation mason.

Work with a conservation mason to assess both chimneys and conduct careful repointing for internal red brick chimney and carry out repointing, repairs and installation of missing granite stones (rustic, organic cuts as per current character of chimney) at granite end-wall chimney. For end-wall chimney also restore missing granite stones (see missing area in photo) using the ashlar pattern and multi-sized rough cut stones, and address inconsistent repairs and brick sizes at concrete brick stack.
