*Special Limited Study Heritage Value Assessment;
Heritage Conservation Plan and
Statement of Significance*

Property Heritage Value Assessment

323 Regina Street

Edgar House, 323 Regina Street, New Westminster, BC

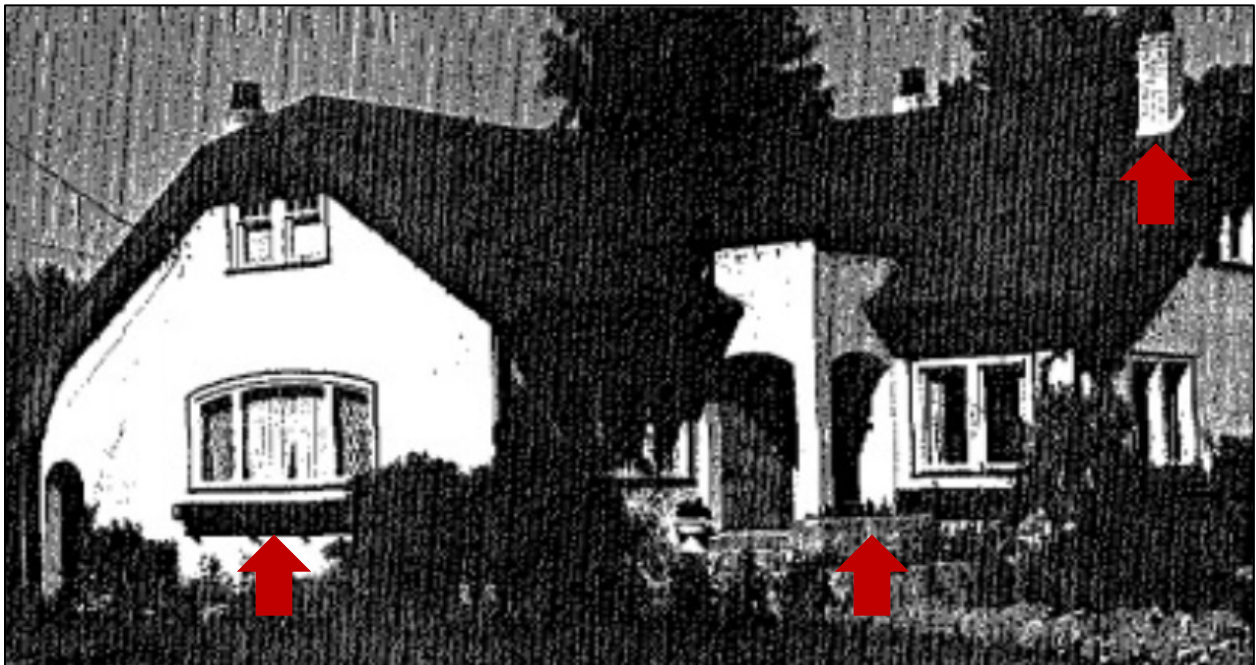
Unfortunately, no other historical photographs of the property were available beyond the 1928 newspaper article (Fig. 11) and the accompanying photograph of the 1989 heritage inventory description (Fig. 12). It is interesting to note the few changes to the property, such as the addition of a window box on the front window, which was apparently done shortly after the house was built in 1928 by a local ironworker. Other changes of note are the switch of the front entry staircase from being double-sided to single-sided and the addition of a chimney on the southeast corner, which has since been removed.

Fig. 12: Historical photograph of 323 Regina Street, 1989, taken from Volume 2 of the Heritage Resource Inventory. Note the largely similar look and condition of the property, with only minor changes, such as the addition of a window box on the front window, the change of the front entry staircase from being double-sided to being single-sided and the addition of another chimney, which has since been removed (please see the red arrows pinpointing these changed areas). (Source: Sleath 1989, p. 177)

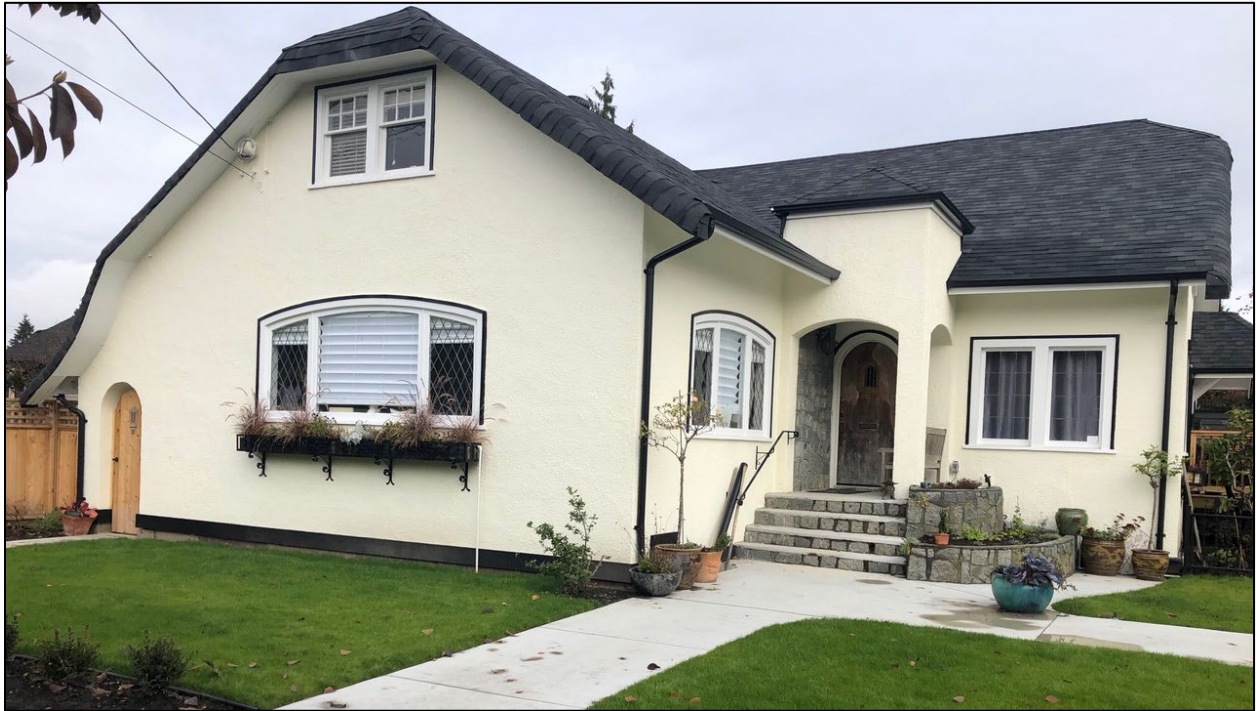
Fig. 13: Southern corner view of Edgar House at 323 Regina Street, 2020. (Source: Holisko)

Some of the windows of the house have been replaced (or repurposed on site), although many are still original and, considering the age of the building, these intact windows and doors are in good to very good condition (as visible in Figs. 13 and 14 above and Fig. 22 below).
