*Statement of Significance and
Condition Assessment for
63 Merivale Street*

Condition Assessment

April 2021

63 Merivale Street ~ New Westminster BC

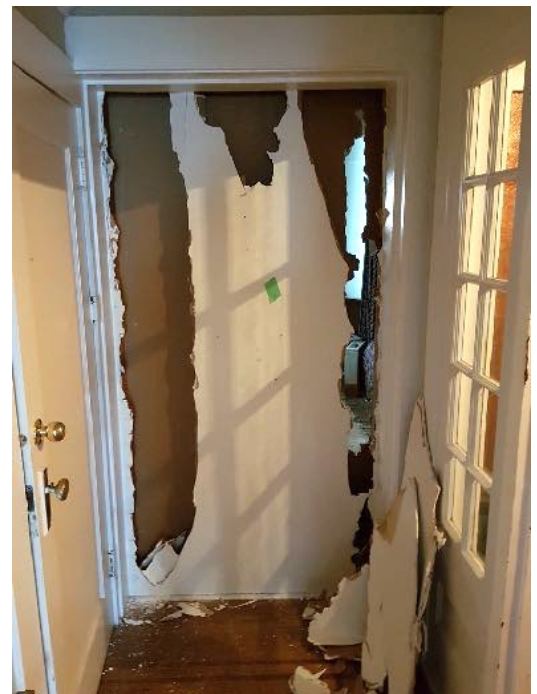
The interior is in good condition. floors and ceilings on the interior are solid, level and dry. There is no evidence of damage due to lack of maintenance or mechanical failures, except for what appears to be water damage in the ceiling in a corner of the main stairway leading to the second floor (see photo on next page). As the building is vacant, and disconnected from electricity, the lack of mechanical heat in the winter and and natural ventilation in the summer can bring on significant and quick damage and deterioration. Furthermore, it is evident that since the building was vacated, break-in/s have occurred for the purpose of stealing the copper wires which has left damage to certain wall and ceilings (see photo, right). The vacant state of the building puts it at risk of further vandalism, damage and deterioration.

This photo shows water damage in the ceiling in a corner of the main stairway leading to the second floor
