Heritage Conservation Plan

Holy Eucharist Cathedral - 501 Fourth Avenue - New Westminster, BC

Elana Zysblat, CAHP - heritage consultant - Ance Building Services

November 2023

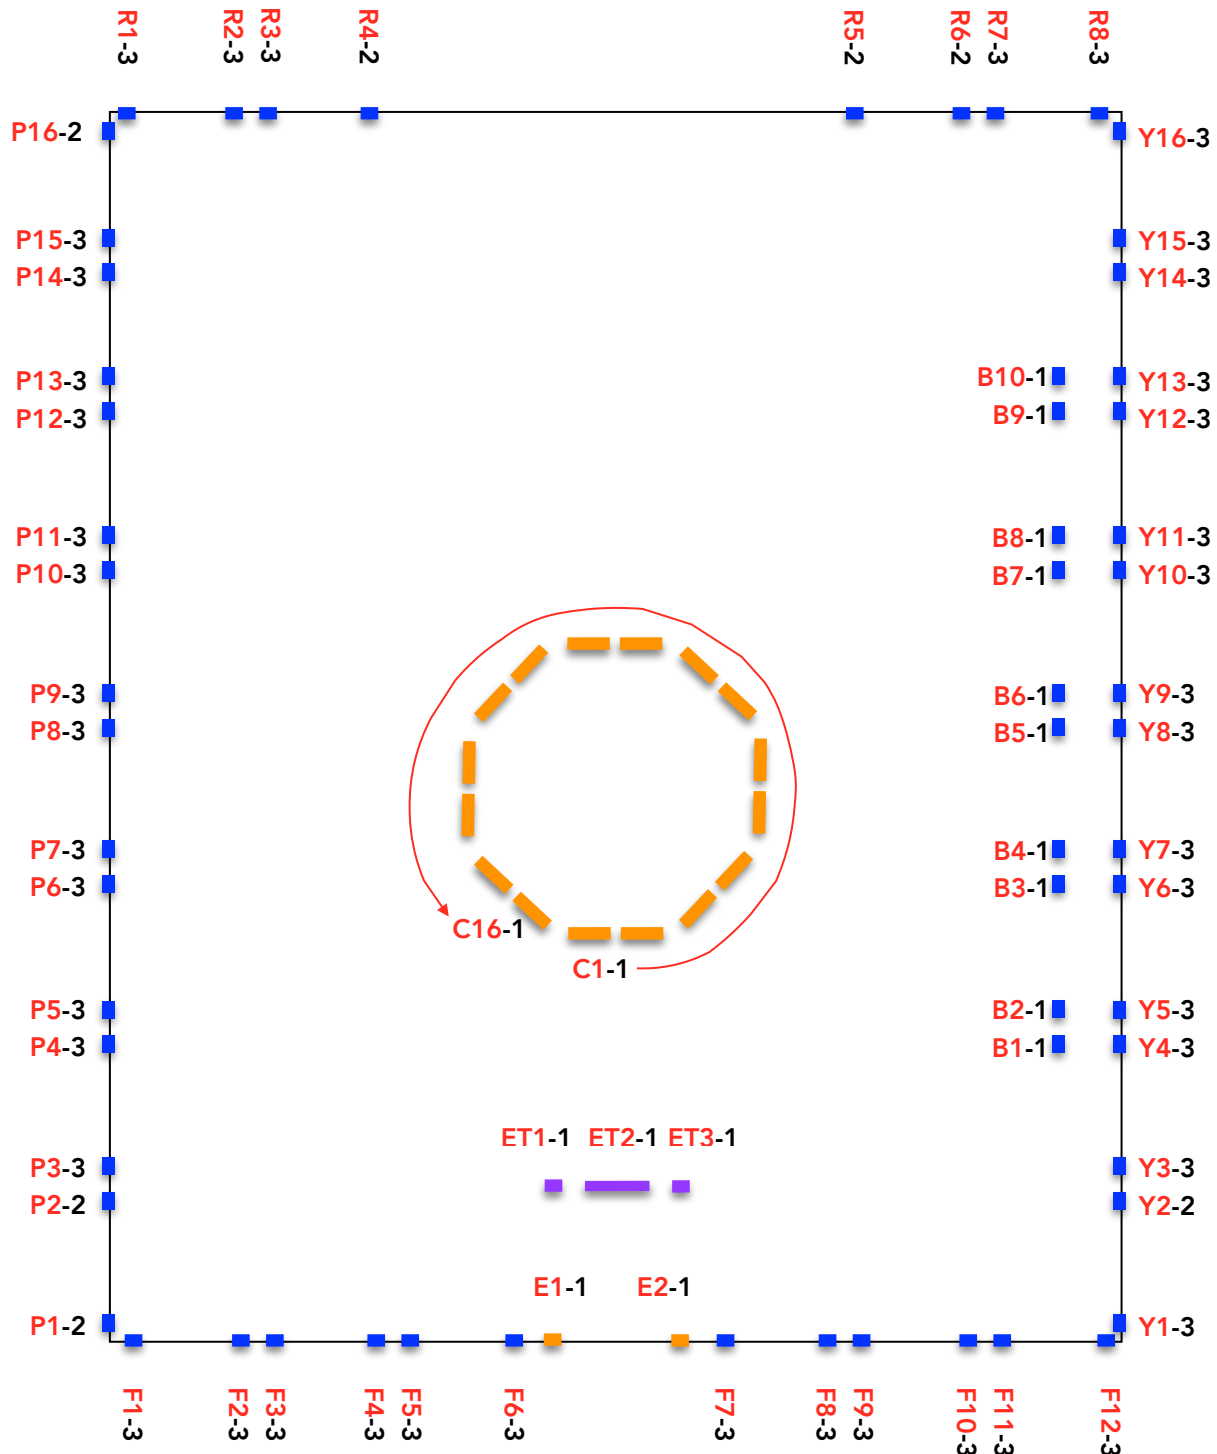
Window map index

The church has a total of 83 windows as illustrated on the below window map: 17 on the front and entrance (F and E windows), 26 on the yard elevation (Y and B windows), 8 on the rear (R windows), 16 on the parking elevation (P windows) and 16 in the cupola (C windows).

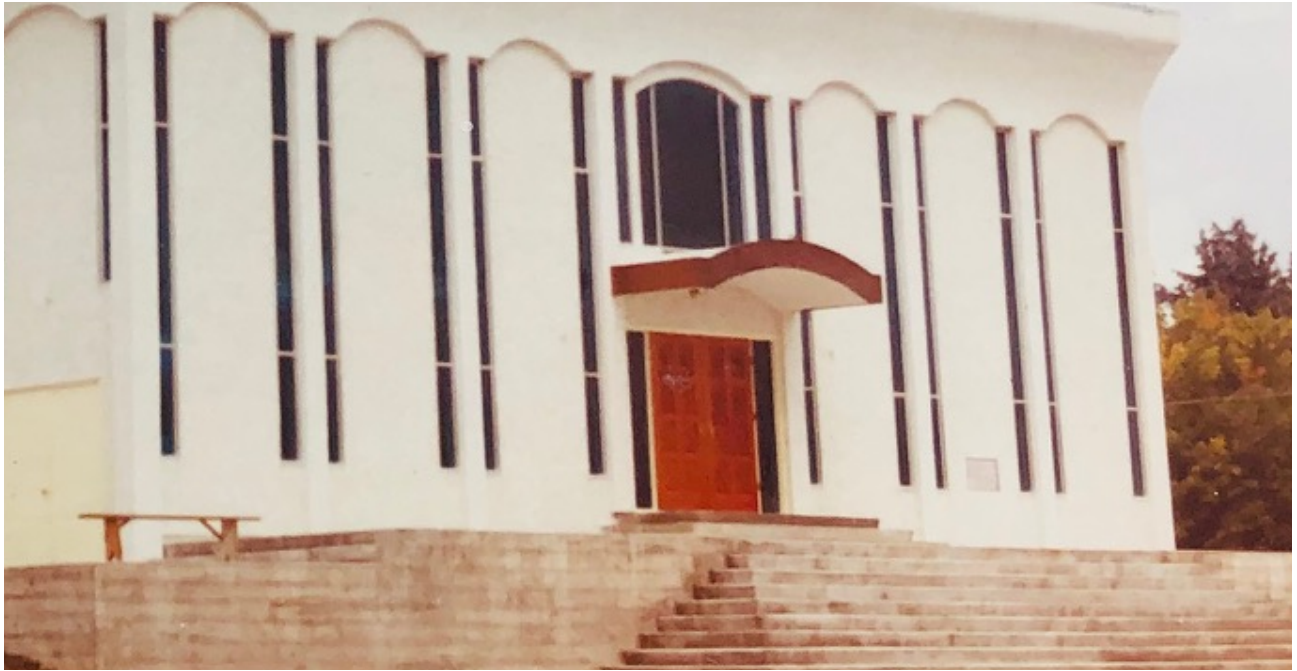
Doors

The current front door assembly (below) is of insulated steel, however it is not properly sealed in its frame. There is noticeable air leak around the entire assembly in winter time. The design, colour and material of this door are not in keeping with the original 1960s door which was solid, carved wood with a lacquered finish and full height blue glass sidelights on either side (see above archival photo). The incompatible appearance of the current door, which was installed in recent decades, diminishes the authentic design of the facade elevation.

Front door assembly - Restoration

Restore a solid carved, unpainted wood door assembly with glazed sidelights to the front entrance, as per the original 1968 design, and based on the earliest colour photographs of the church upon completion. The sidelights can be of textured blue glass or match the blue-toned stained glass sidelights above the door depicting traditional Ukrainian octagonal stars. Final design, intervention plans and construction supervision to be guided by a heritage professional.
