Heritage Conservation Plan

Holy Eucharist Cathedral - 501 4 Avenue - New Westminster, BC

Elana Zysblat, CAHP - heritage consultant - Ance Building Services

December 2021

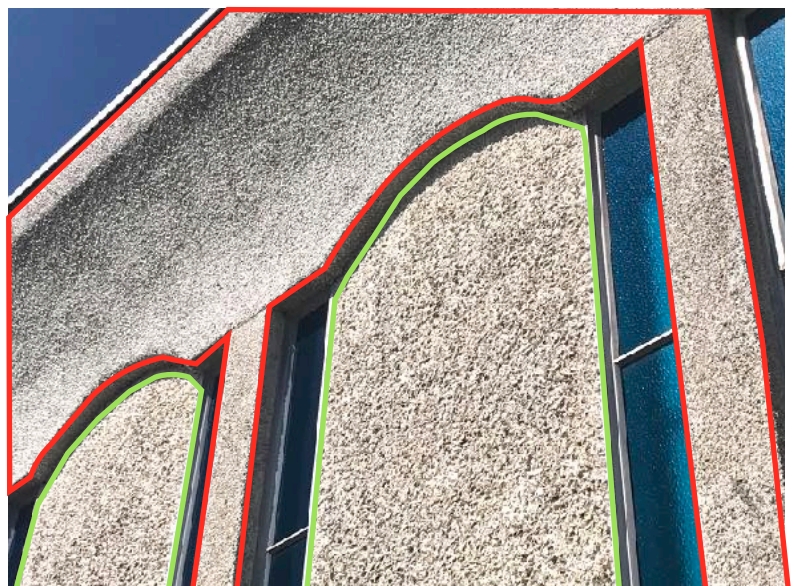
Stucco damage

The stucco is generally in good condition but several areas of minor damage (staining, cracks or failure) have been identified, mostly at the cornice corners.

Above left: Cornice at corner of parking lot and lane showing a crack in the stucco.

Above right: Cornice at corner of lane and yard showing missing/failing stucco just below an new roof drain installed 13 years ago. **Below left:** Cornice at corner of front and yard showing stucco damage caused by woodpeckers **below Right:** Evidence of moisture staining on stucco below windows at parking lot.

Address the sources of damage to the exterior stucco finish (woodpeckers and faulty roof drainage) and spot repair the stucco by matching the specific original texture. Trade hiring and repair supervision to be guided by a heritage professional.

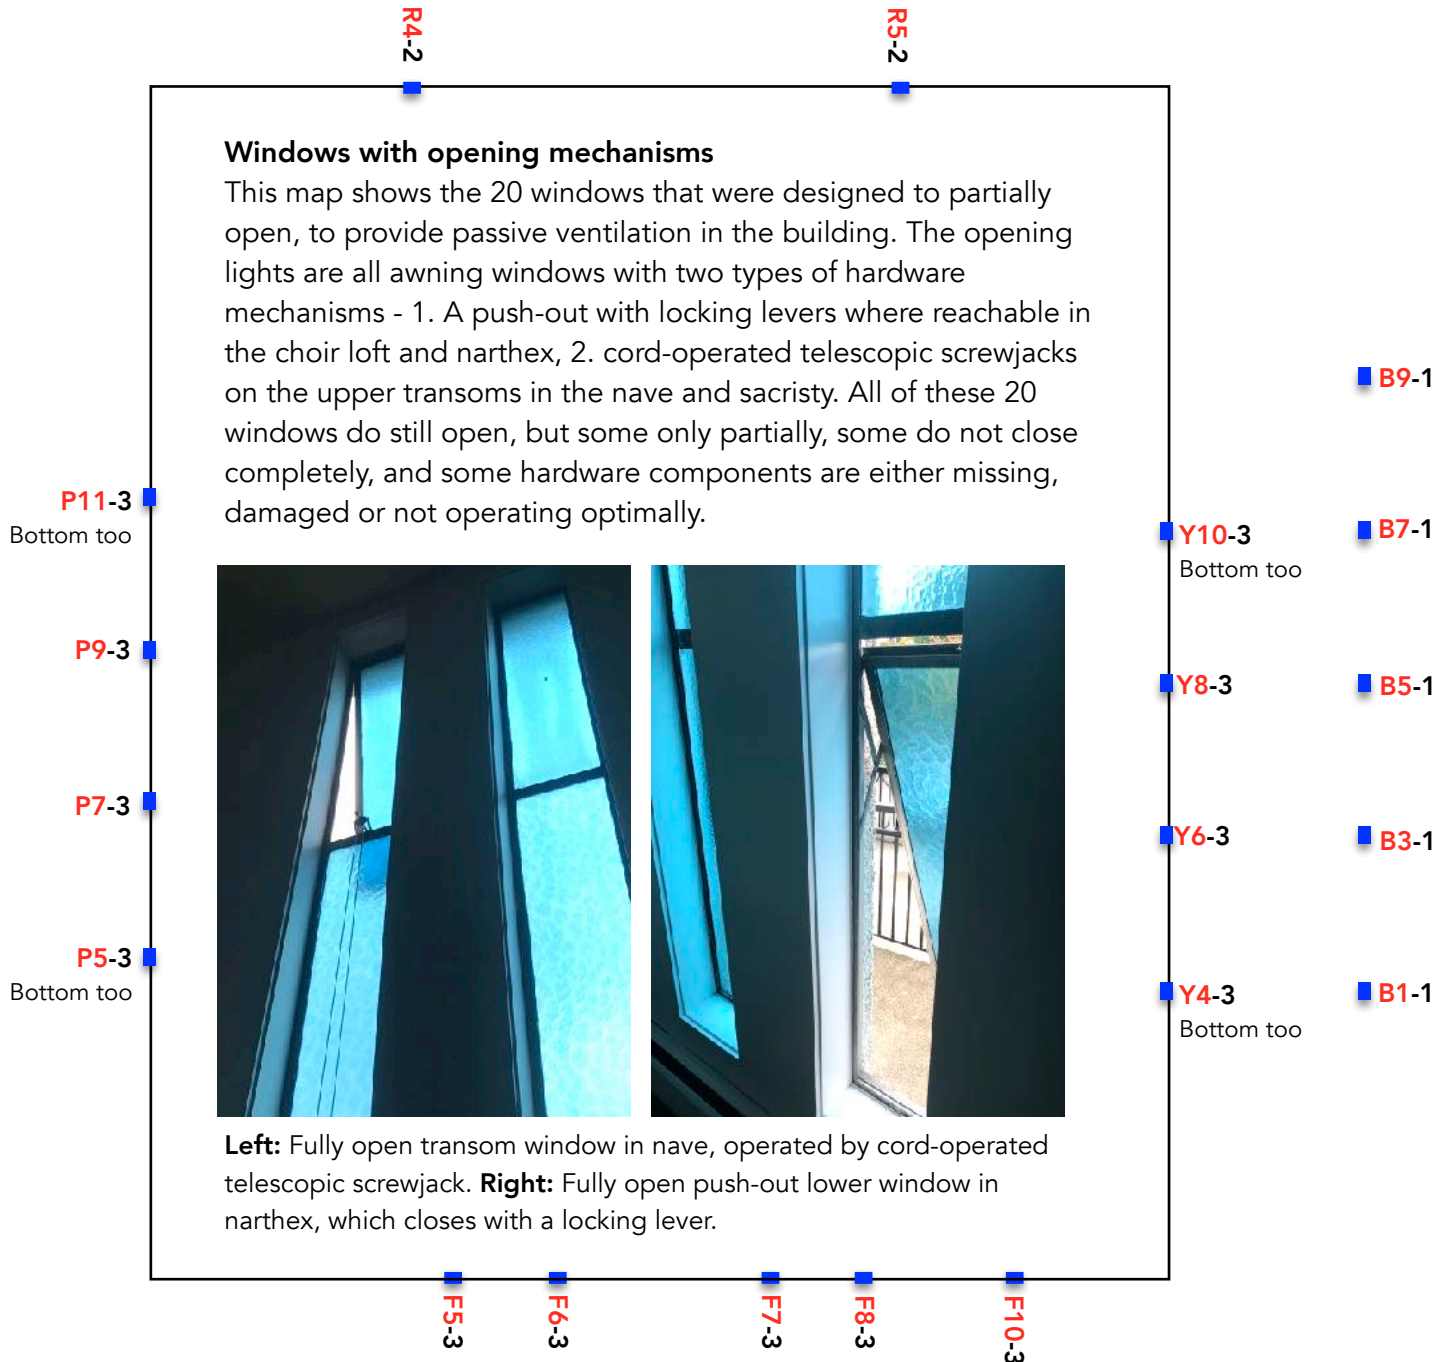
Cracked window panes:

The original design of facing upper and lower opening windows in the church was intended to enable passive (natural) ventilation in the church and needs to be used regularly and fully (both upper and lower lights) in the summer months. Replace broken window panes in-kind with

textured blue glass and restore the original opening and closing mechanisms of all opening windows to open fully, lock securely and be sealed properly when closed. All opening transom windows (upper windows) will need to be fitted with removable bird screens (ideally with transparent nylon netting to reduce aesthetic impact) to ensure that birds cannot fly into the church when the windows are open. Trade hiring and repair supervision to be guided by a heritage professional.

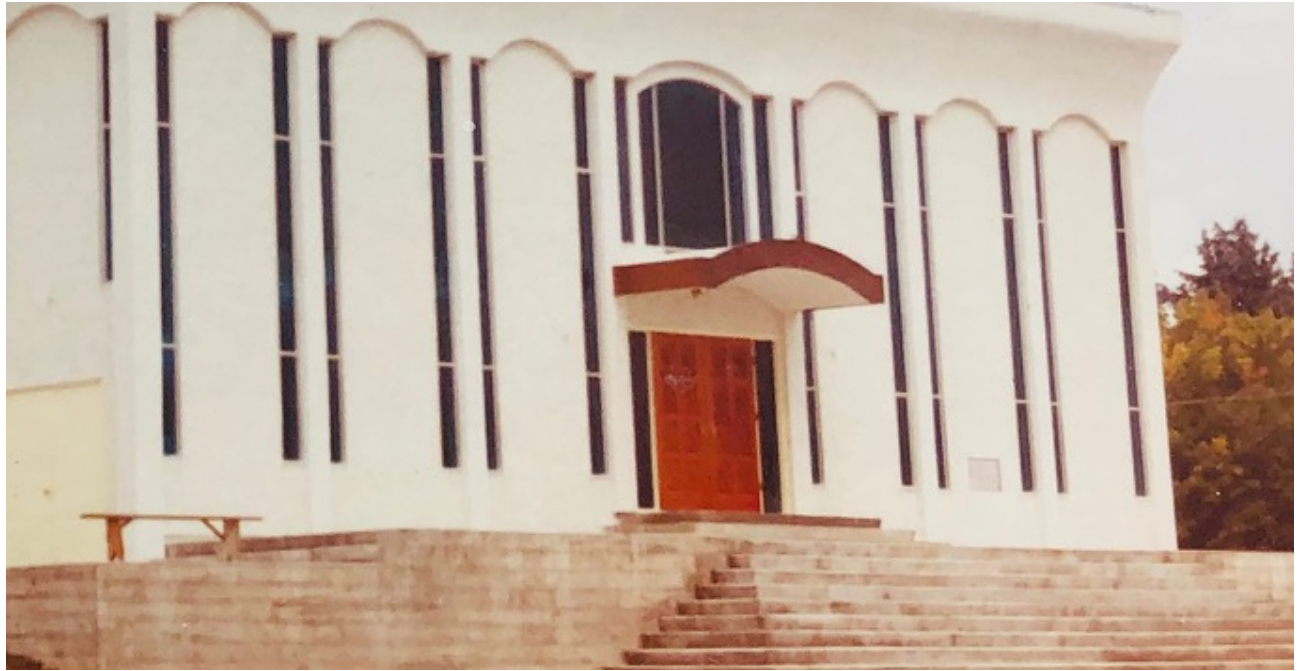
Doors

The current front door assembly (below) is of insulated steel, however it is not properly sealed in its frame. There is noticeable air leak around the entire assembly in winter time. The design, colour and material of this door are not in keeping with the original 1960s door which was solid, carved wood with a lacquered finish and full height blue glass sidelights on either side (see above archival photo). The incompatible appearance of the current door, which was installed in recent decades, diminishes the authentic design of the facade elevation.

Restore a solid carved, unpainted wood door assembly with glazed sidelights to the front entrance, as per the original 1968 design, and based on the earliest colour photographs of the church upon completion. The sidelights can be of textured blue glass or match the blue-toned stained glass sidelights above the door depicting traditional Ukrainian octagonal stars. Final design, intervention plans and construction supervision to be guided by a heritage professional.
