# *Heritage Conservation Plan and Statement of Significance*

# Heritage Conservation Plan

328 Second Street, New Westminster BC :: H.H. & Jane Mackenzie House - 1889

Prepared by Elana Zysblat, CAHP :: Ance Building Services :: February 2021

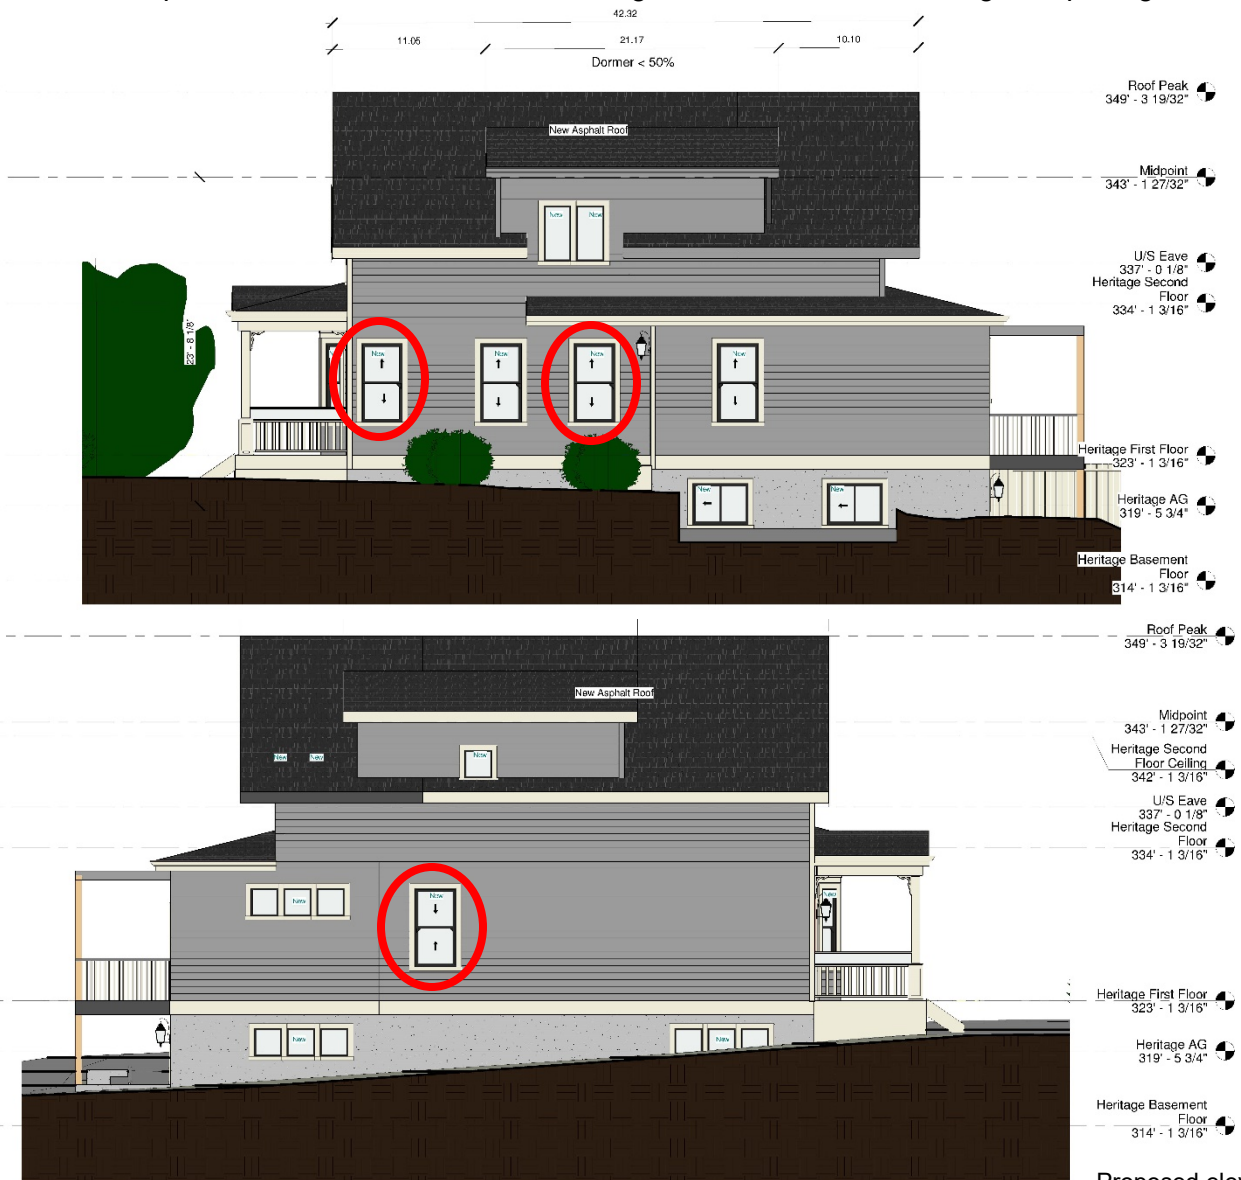
Proposed elevations  
 Source D3 Dimension Drafting  
 and Design Inc.

All of the window and door openings appear to be original or early (tall vertical openings in Victorian-era dimensions), except for the front gable window and the front porch windows which are not of 1889 proportions and were likely altered at the time the stucco was applied to the house. Wood window sills survive throughout, but the window sashes themselves have been replaced either with aluminum or vinyl sashes. All the window sashes are in **fair** condition, towards the end of their life expectancy. The glazed wood enclosure of the front porch dates from post 1982 and is in **good** condition. The front, side and back door openings are early or original but all the doors themselves are replacement doors from recent decades.

Restore replica wood sash horned double-hung windows in the below original openings:
