Memorandum

Subject: 114 and 118 Royal Avenue Demolitions

82 First Street, New Westminster, BC

E. M. N. Woods House ~ 1890

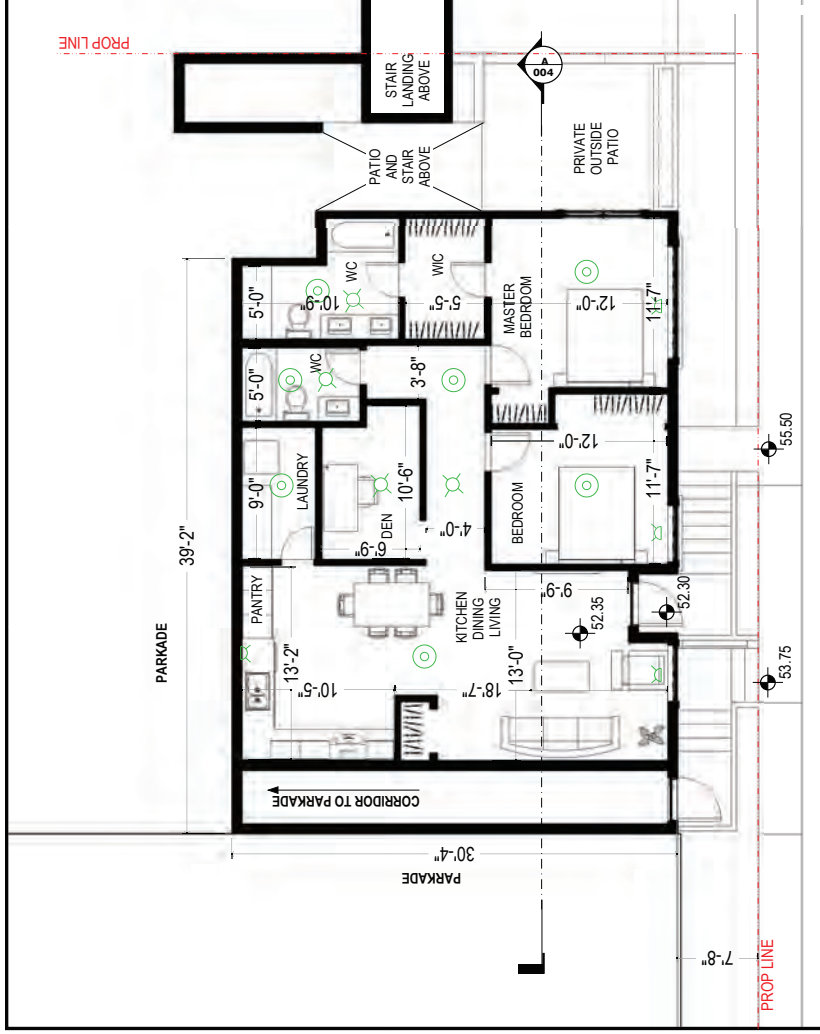
B BASEMENT FLOOR PLAN

- ALL SMOKE DETECTORS & SPRINKLER SYSTEM TO BE ALARMED WITH MAIN BUILDING ANNUNCIATOR PANEL
- SPRINKLER SYSTEM TO BE DESIGNED & INSTALLED BY CERTIFIED PROFESSIONALS AND INTEGRATED IN MAIN ANNUNCIATOR PANEL
- BASEMENT UNIT WILL SERVE AS FOUNDATION FOR THE RELOCATED HERITAGE HOME ABOVE
- COORDINATE WALL OPENINGS FOR PLACEMENT OF TEMPORARY BEAMS WITH HOUSE MOVING COMPANY
- COORDINATE BASEMENT UNIT CONSTRUCTION WITH STRUCTURAL ENGINEER FOR HERITAGE HOME

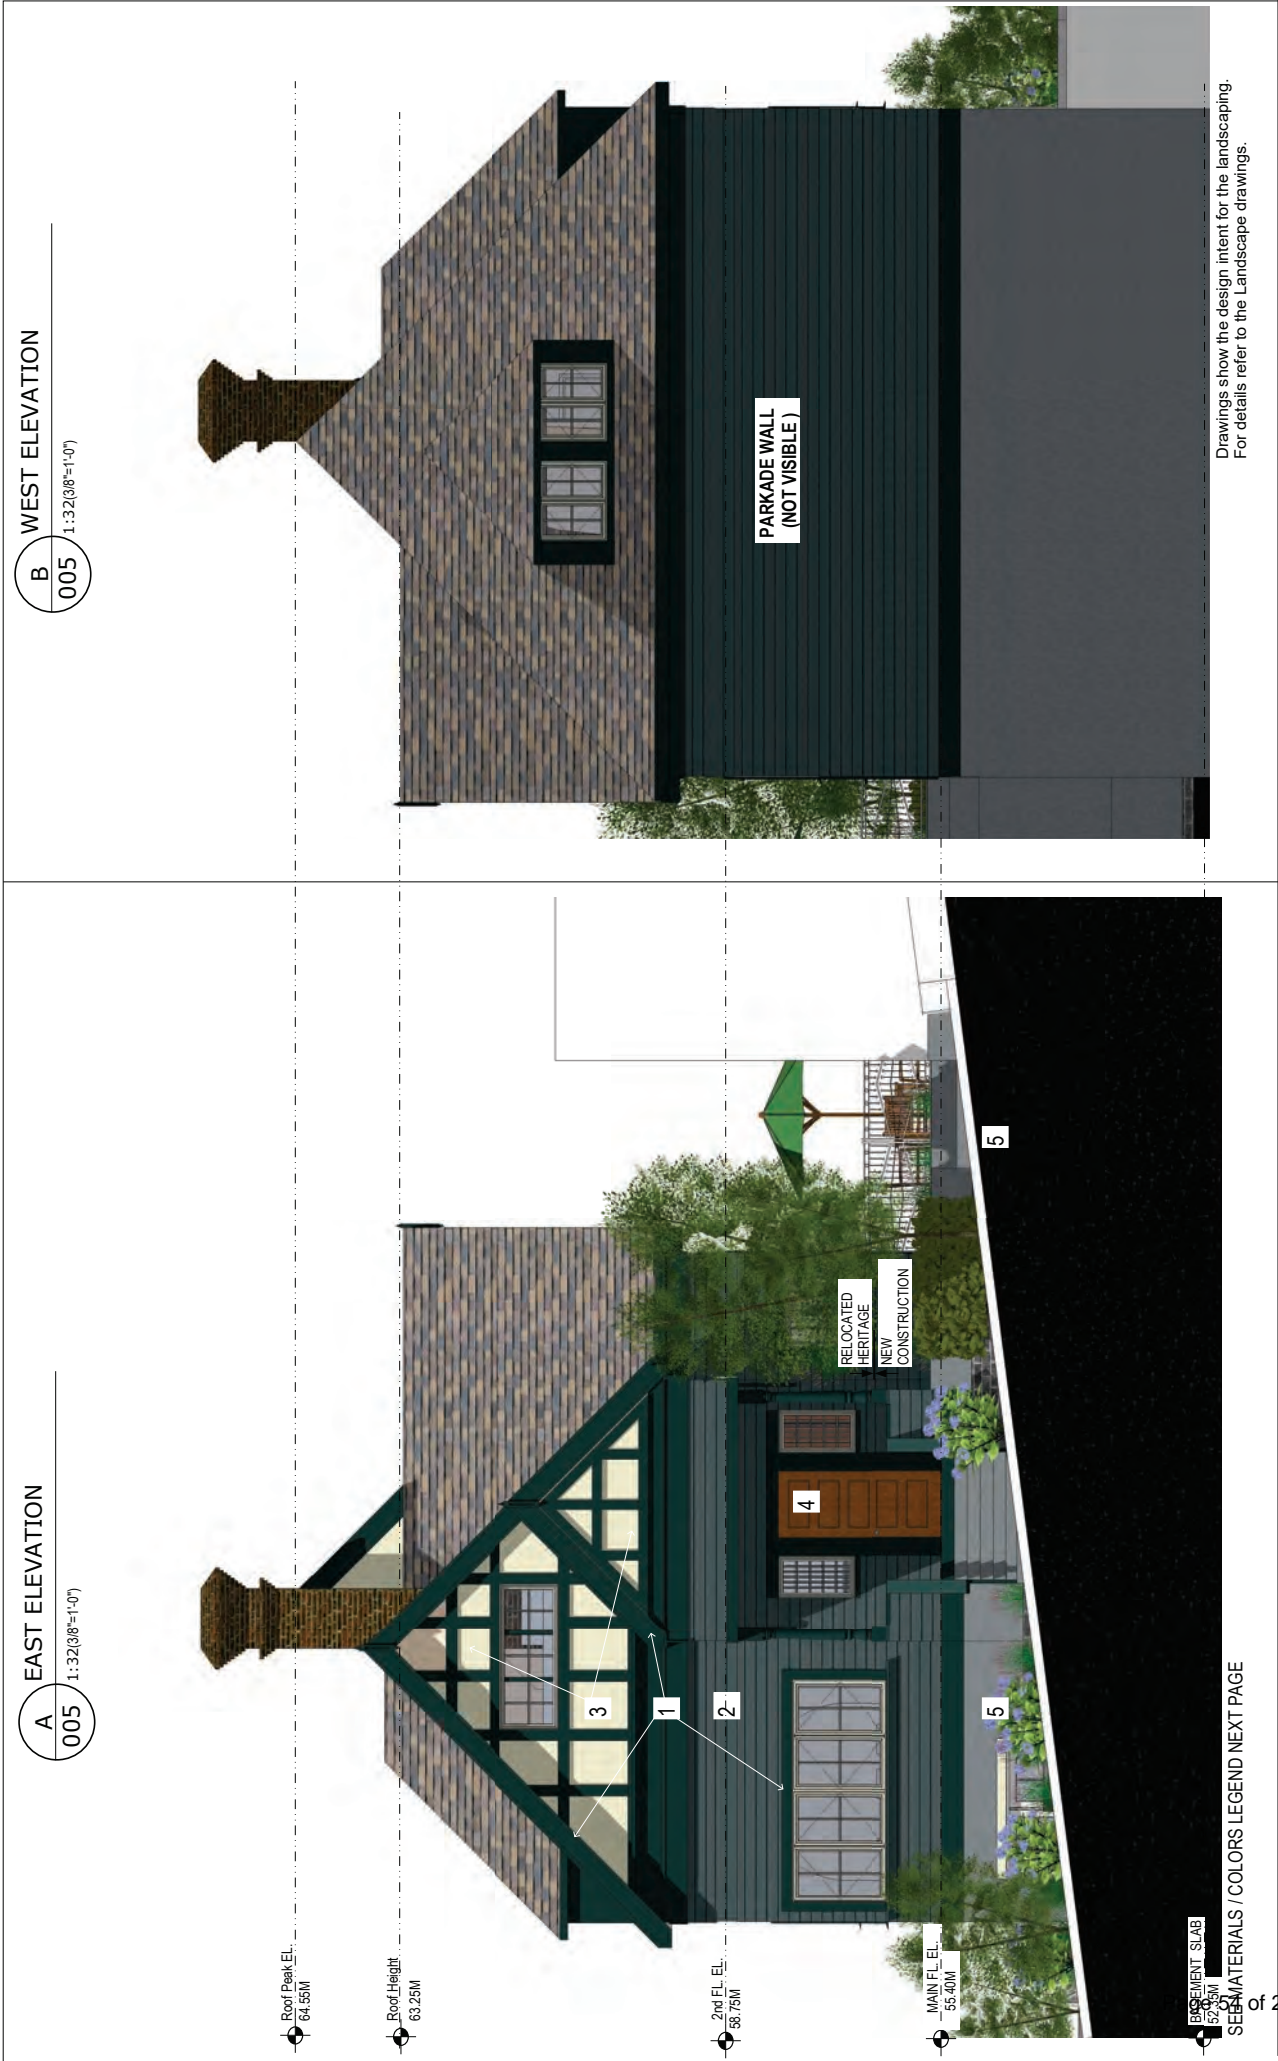
1
all trim boards including window and door trim, fascia, brackets, columns and finials
Salamander 2050-10 (matched to original paint colour found on building)
semi-gloss finish

4
front door
clear lacquer/stain

5
new construction body and trim
concrete (or)
concrete colour

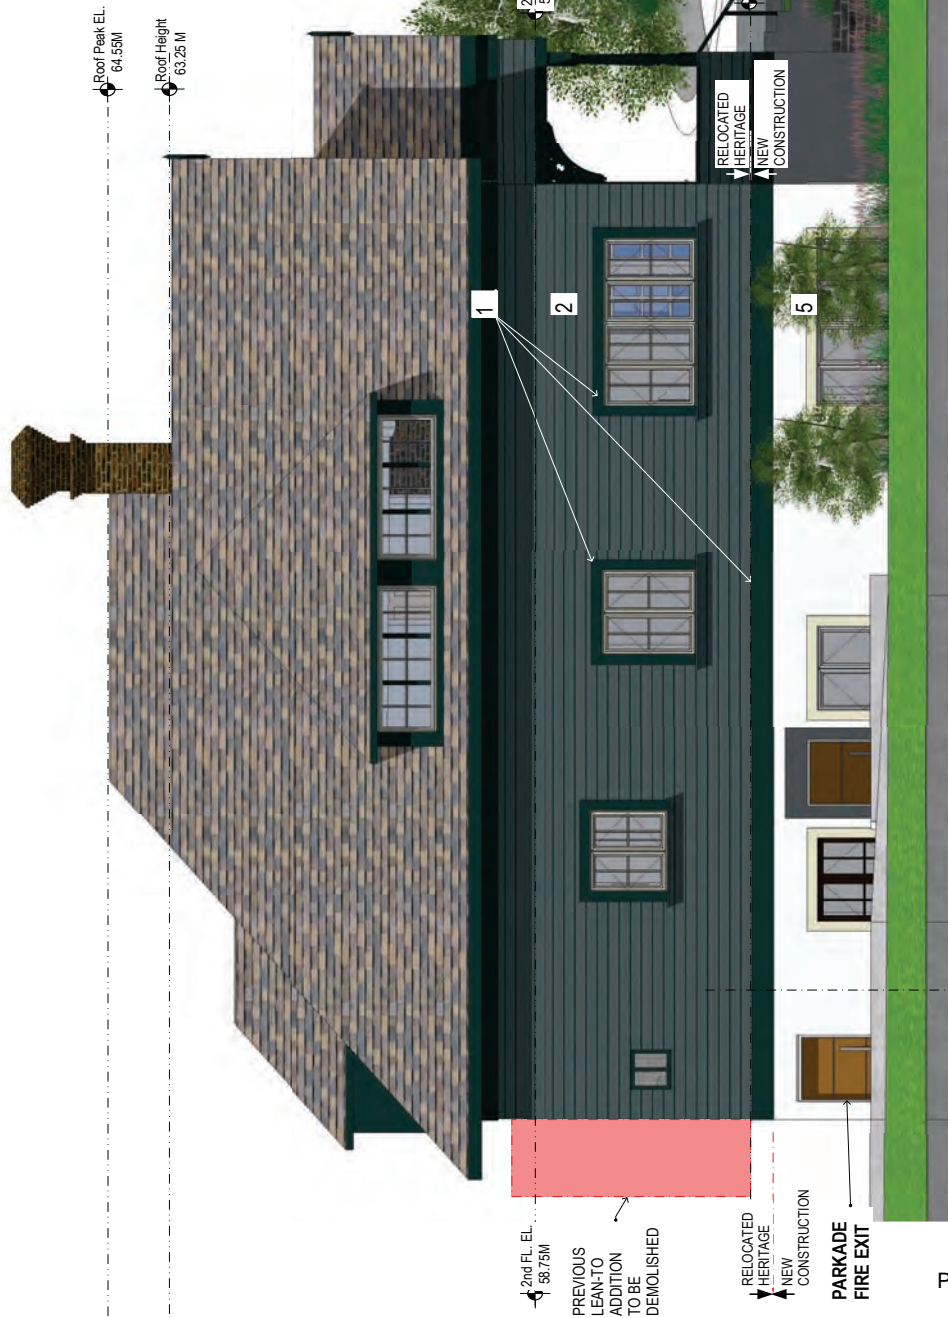
Drawings show the design intent for the landscaping.
For details refer to the Landscape drawings.

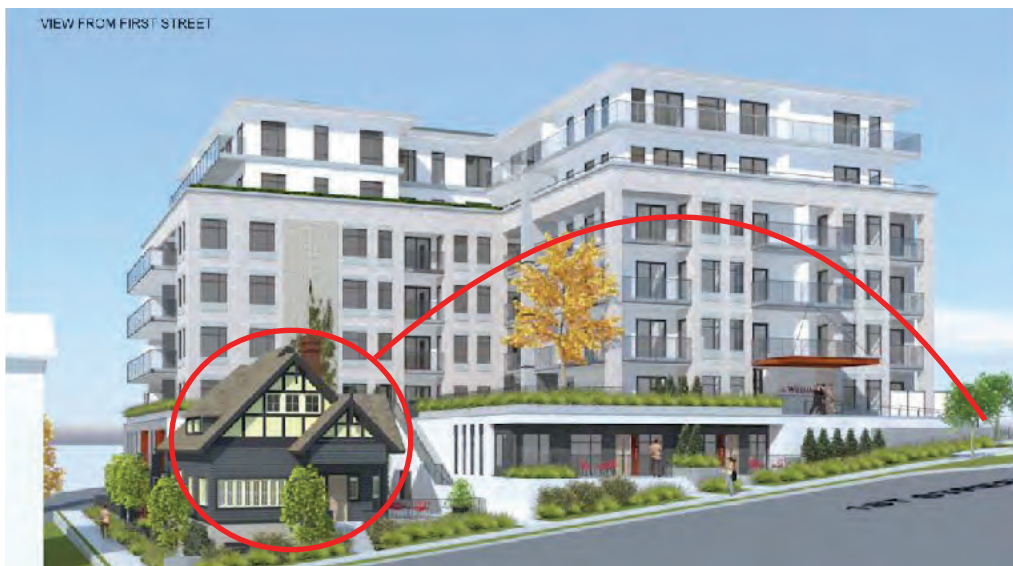
Rendering of the proposed development showing the historic house in its new, adjusted location (circled) and the new apartment complex.

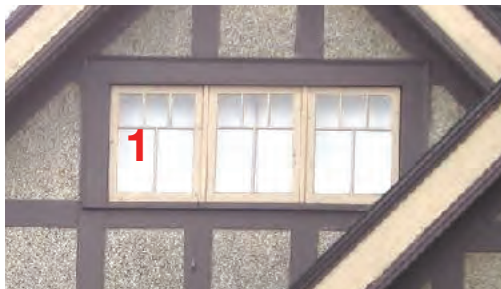
1 gable triple-assembly window

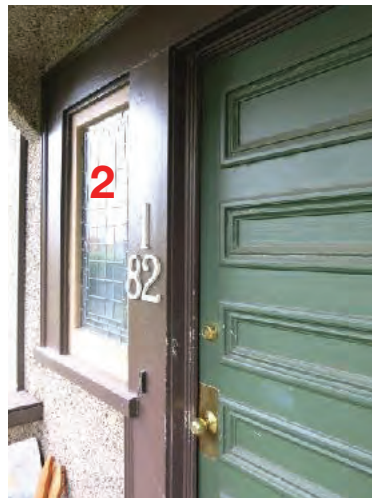
2 & 3 front door leaded side lights

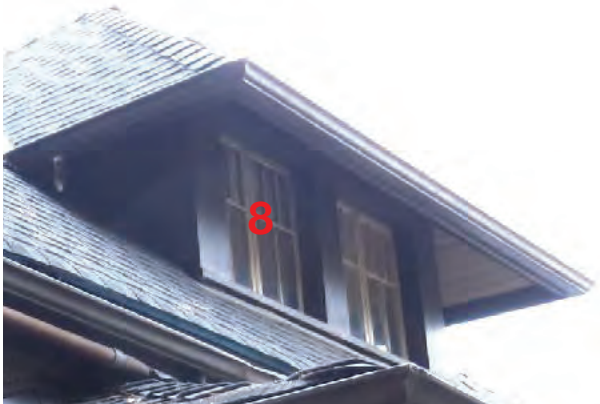
8 dormer double assembly windows

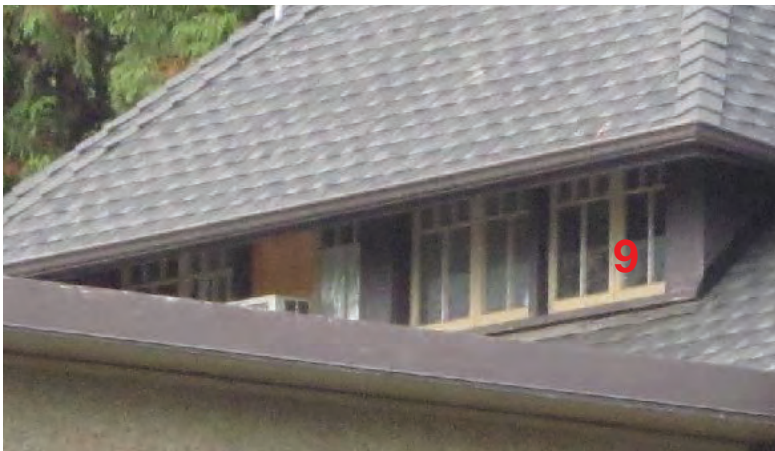
9 dormer double assembly windows. One sash is missing where an air conditioning unit was installed.

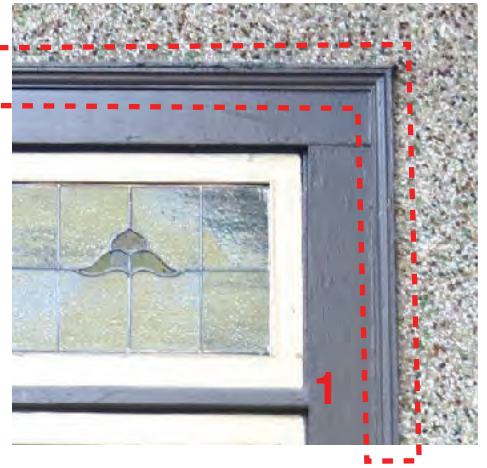
1 window trim - The original 5.5" window and door casings survive on the building around many original openings such as in the photographs below, however an additional back band moulding was added (outlined in red in photo - right), likely at the time the stucco was applied in 1958. This additional moulding should be removed where present.

2 soffits, **3 gable finials**, **4 fascia boards**, **5 half timbering**
6 railing caps.

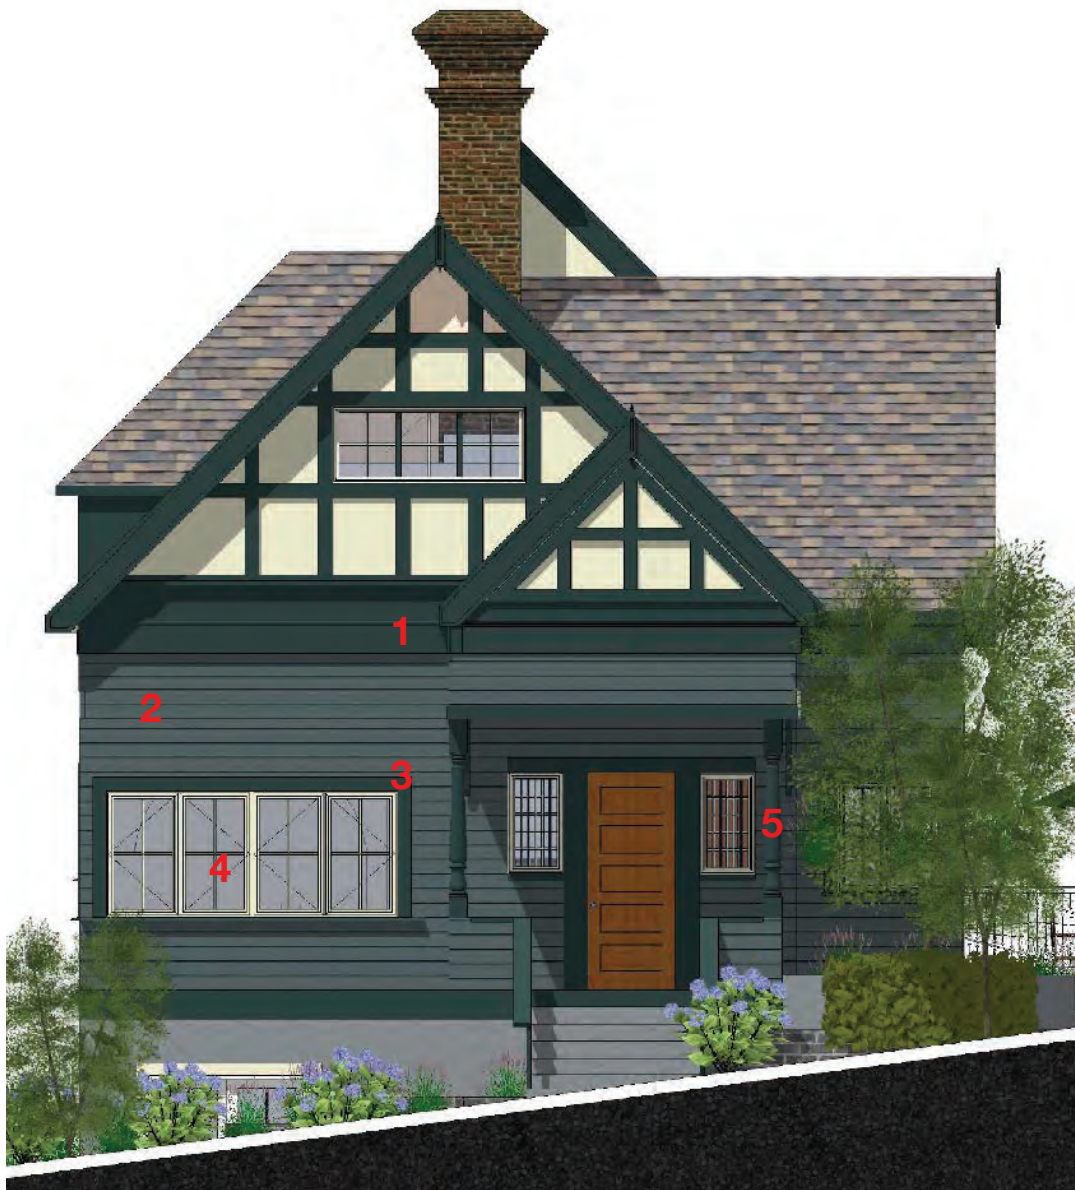
The below crop from the proposed elevation drawings illustrates some of the restored wood elements on the facade elevation:

- 1** gable boards restored to wood
- 2** stucco removed and wood cladding repaired
- 3** window trim restored to historic dimensions and materials
- 4** window sash restored to historic dimensions and materials
- 5** turned wood columns exposed and restored

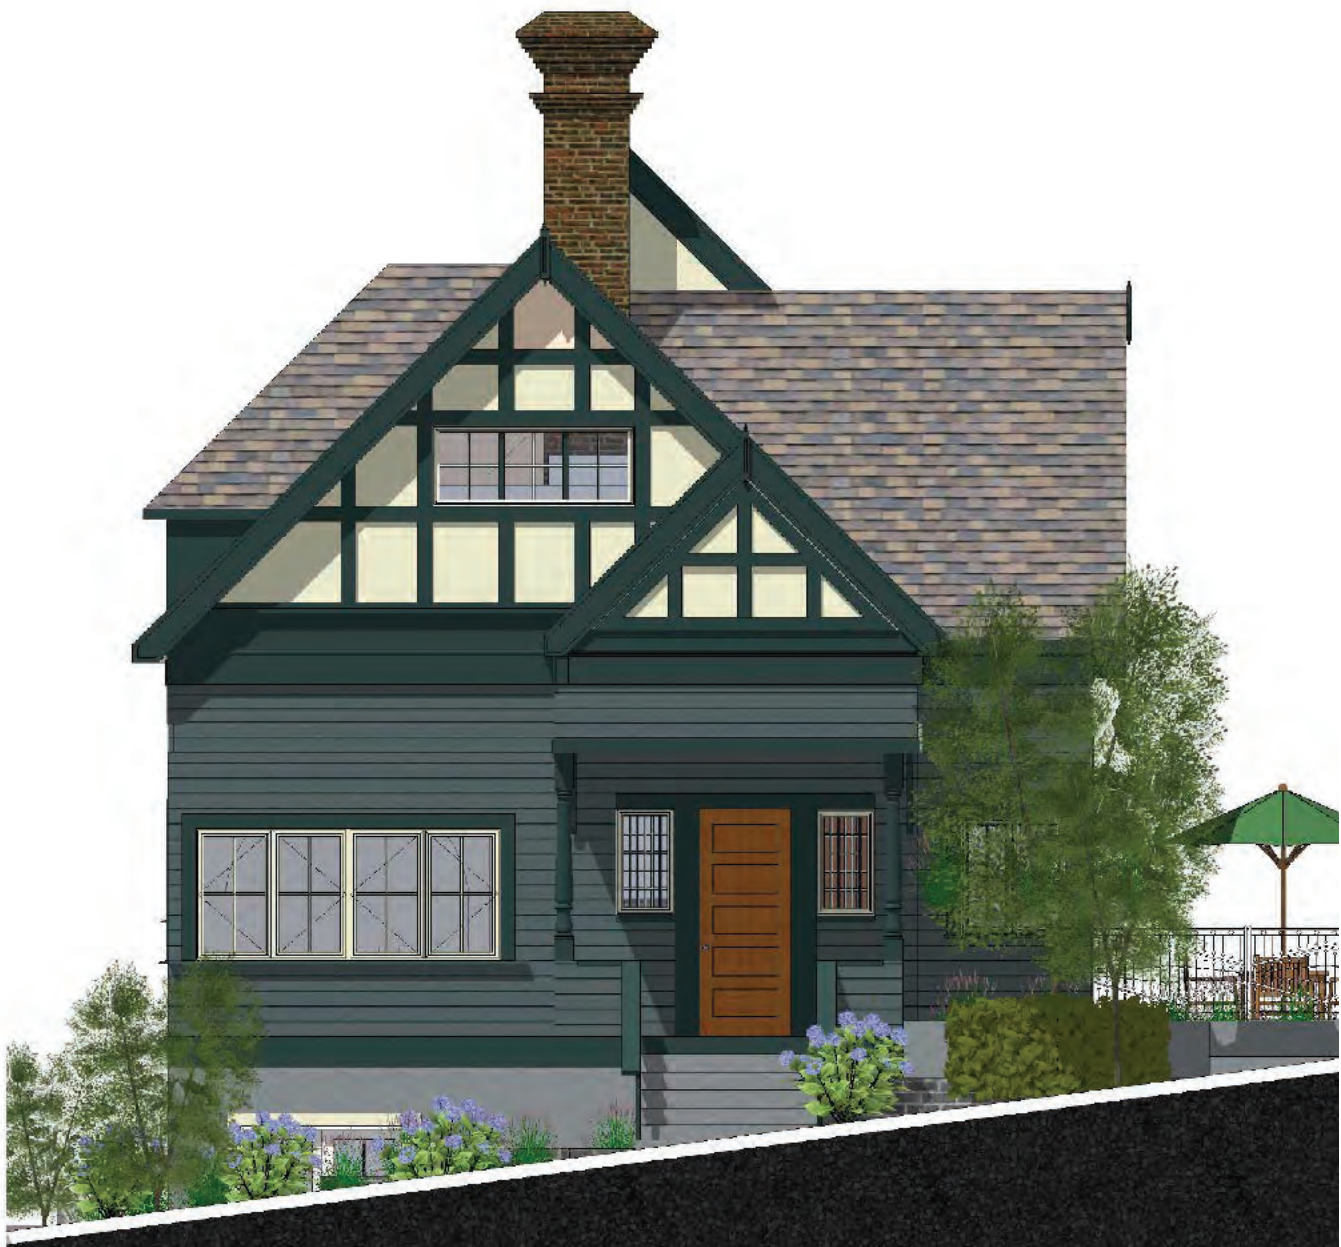
East elevation (front):

source for elevation render: CityState Consulting Group Ltd.

This proposed addition to the historic house will be subtle and discreet in its siting behind landscaping (planted and constructed) so that the historic portion of the house is the most visible portion of the building from the street. The finishes on this level will be contemporary (concrete finish) and the window and door openings will mimic the historic ones in size but the trim detail will be slimmer. The basement addition will thus be compatible with, subordinate to and distinguishable from the historic place, as required in the Conservation Standards & Guidelines for additions. See illustration of this level on the proposed elevation drawings on pages 23 to 26.

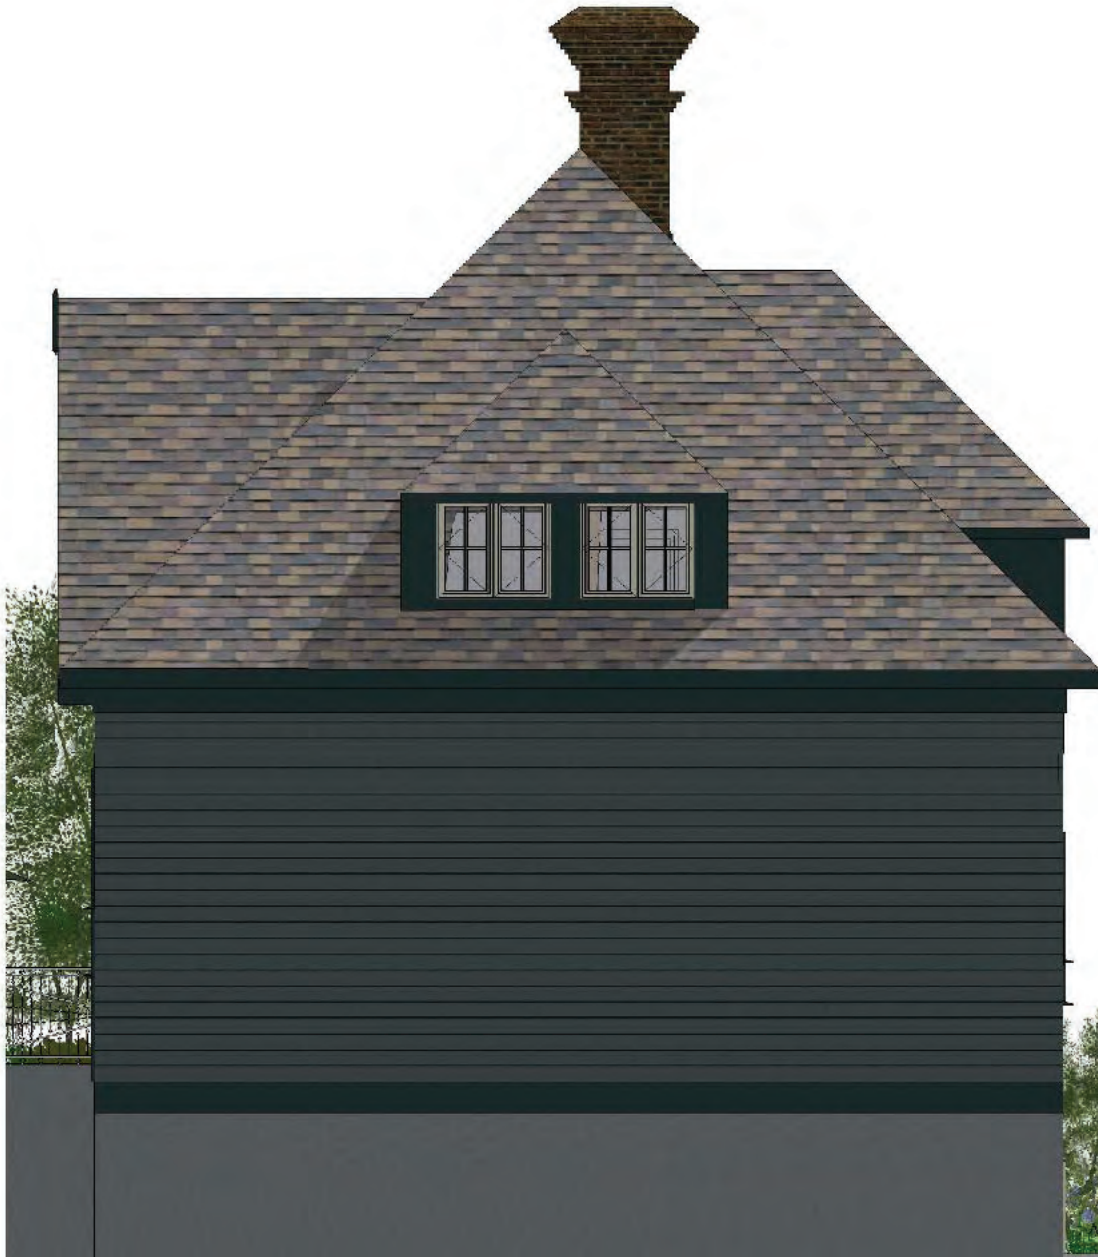
West elevation (rear)

source for elevation drawing: CityState Consulting Group Ltd.

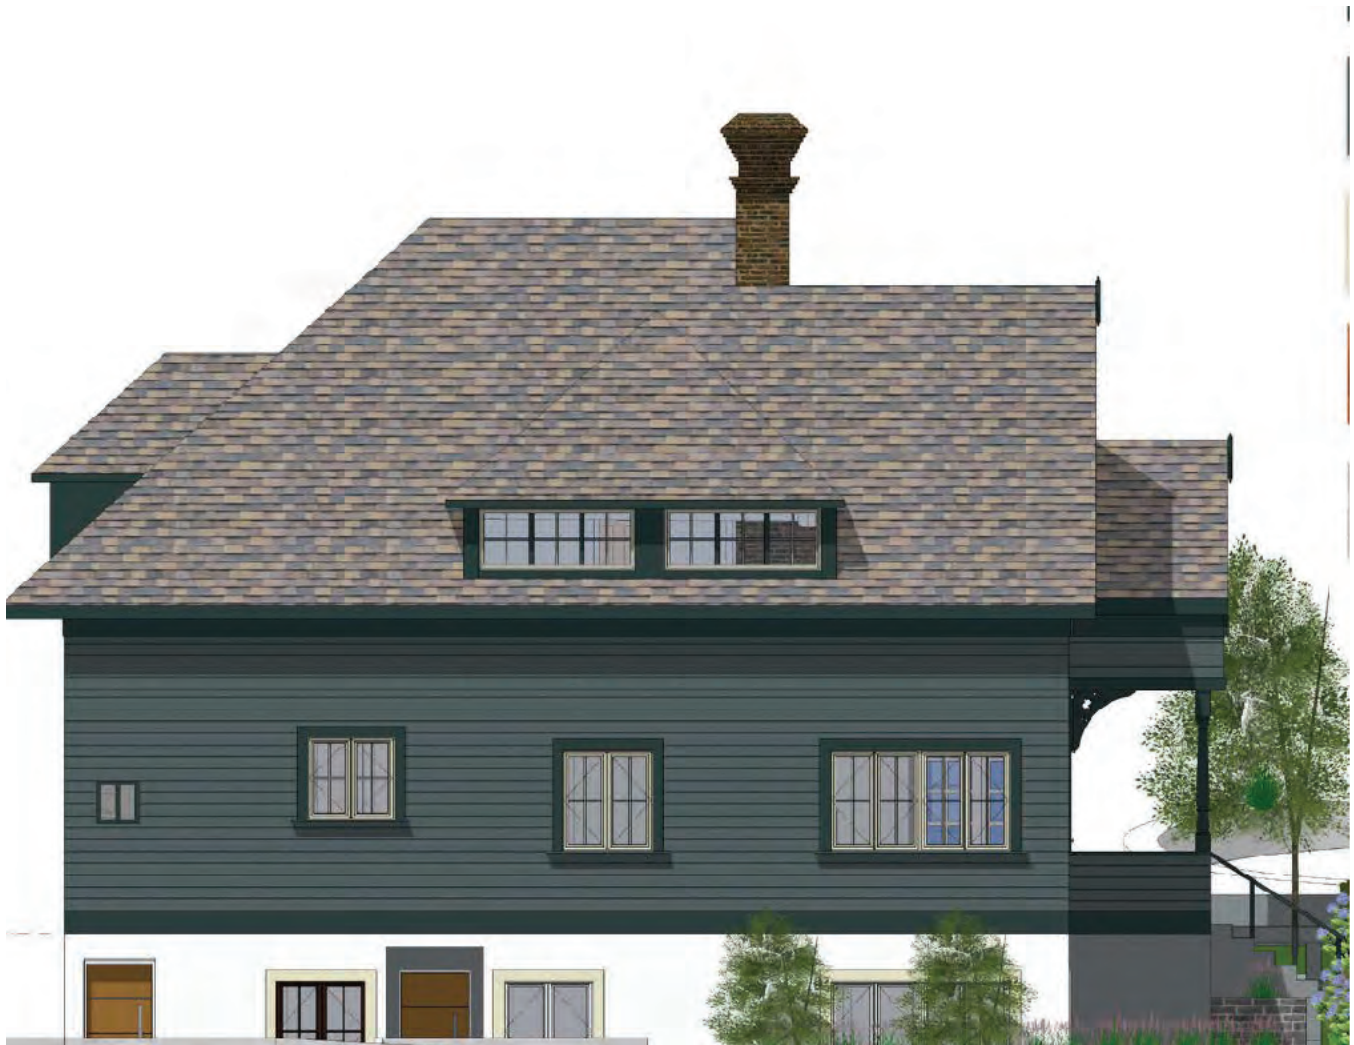
South elevation (side)

source for elevation drawing: CityState Consulting Group Ltd.

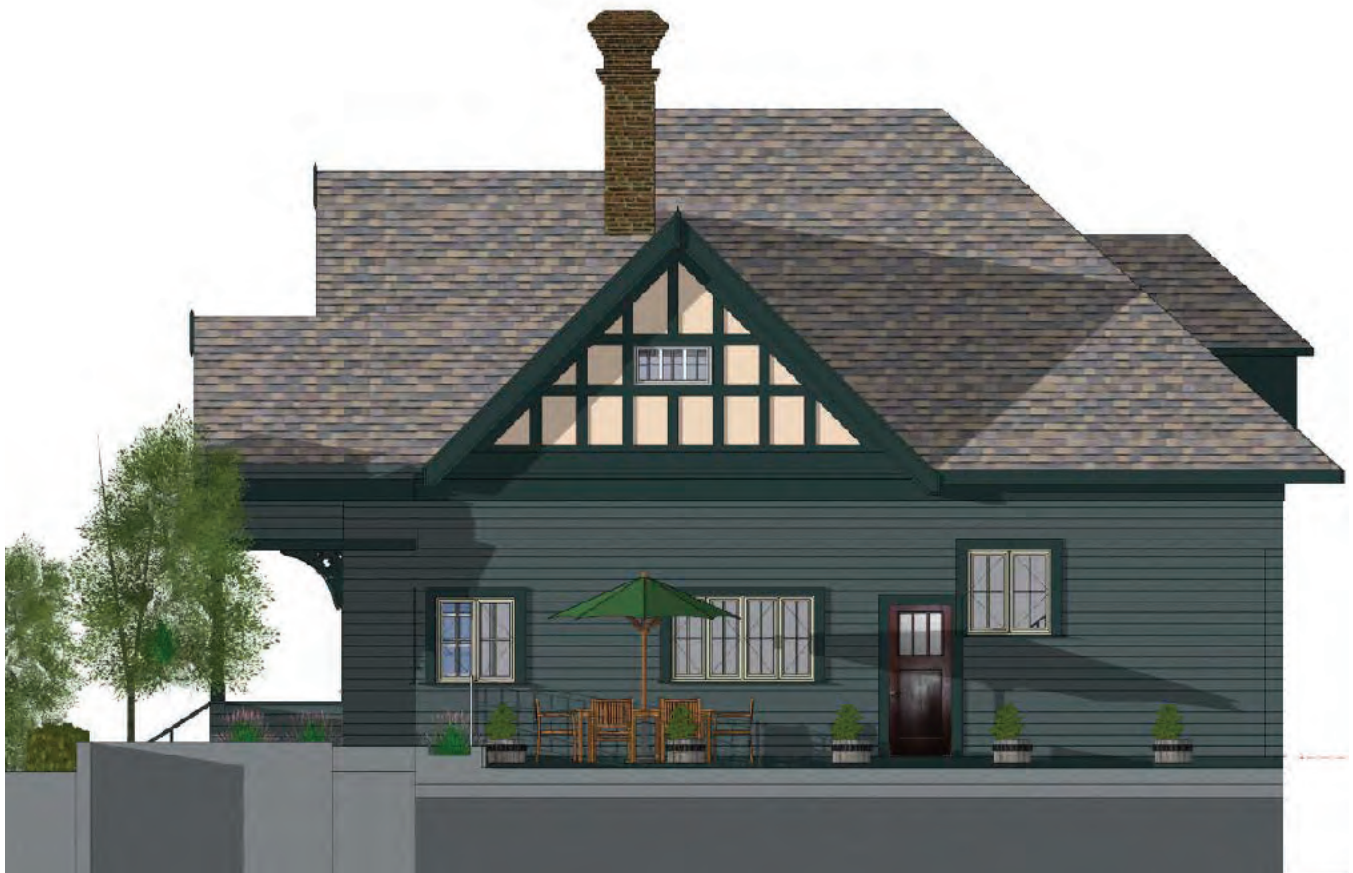
North elevation (side)

source for elevation drawing: CityState Consulting Group Ltd.

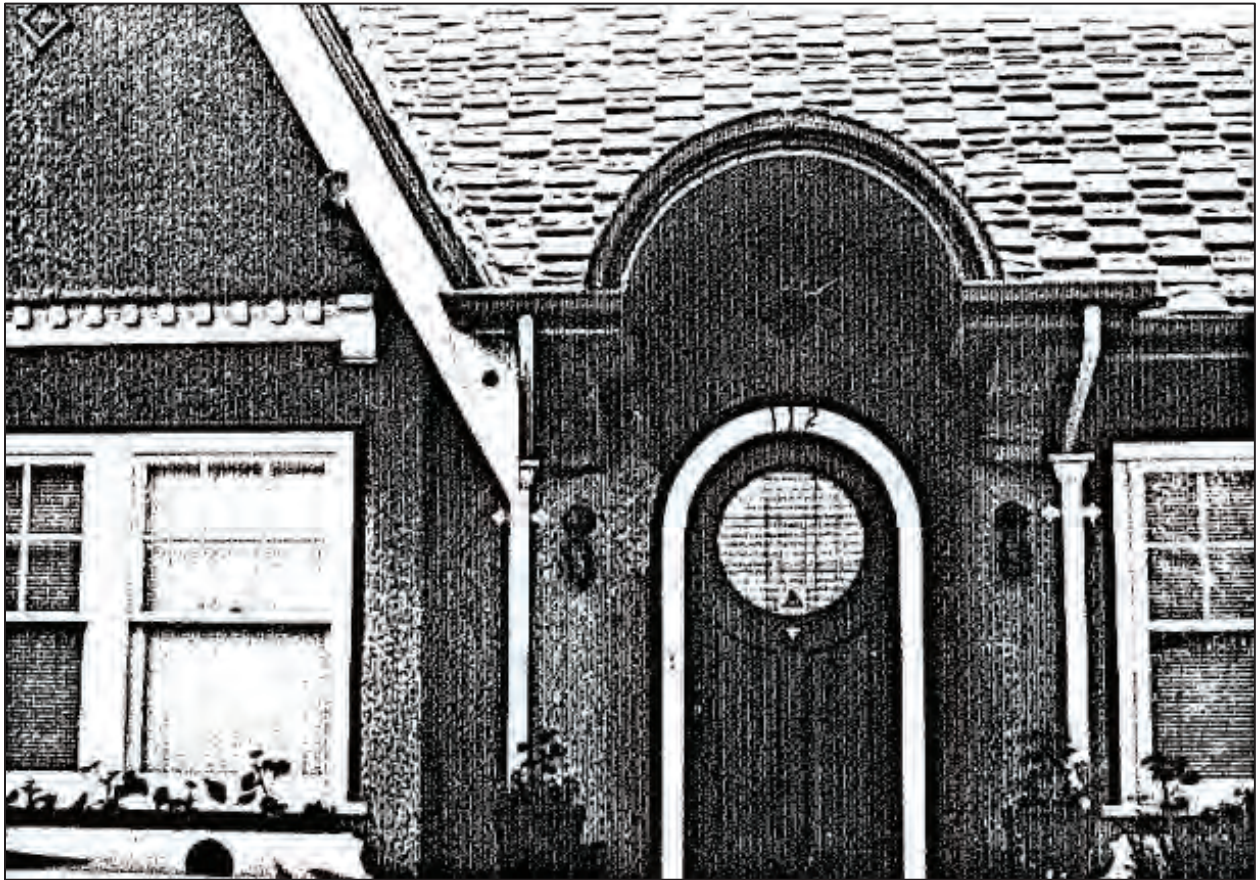
Fig. 8: The only available historical photograph of 112 Royal Avenue, 1980s. Although only a partial view, a number of the extensive ornamentation is distinctly visible, such as the diamond detailing in the top left, dentil moulding, arched roofline and arched front door with stained glass window. The now missing window boxes are also still visible. (Source: Enns 1990, p. 89)

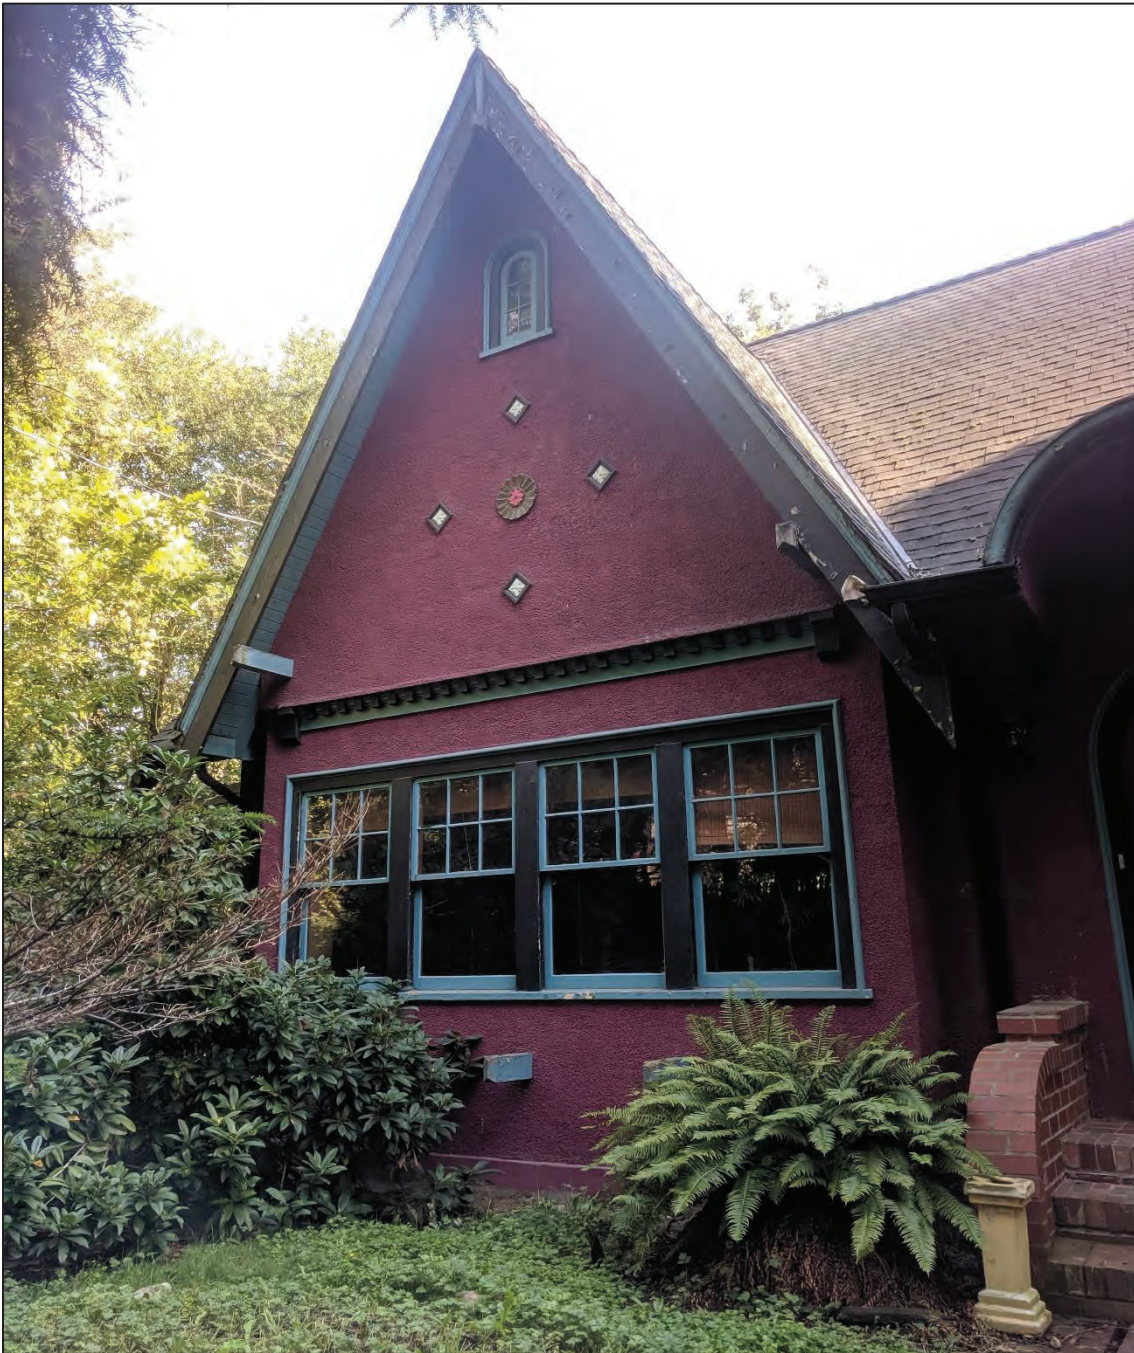
Fig. 9: Partial front view of Henderson House at 112 Royal Avenue, 2019, illustrating the steeply pitched offset front gable with ornamental diamond detailing, floral roundel and small arched window at the top as well as the dentil moulding, with a partial view of the arched roofline over the front door and the arched brick front stairs. Note the surviving window box supports, although the window boxes themselves are missing. (Source: Cummer)

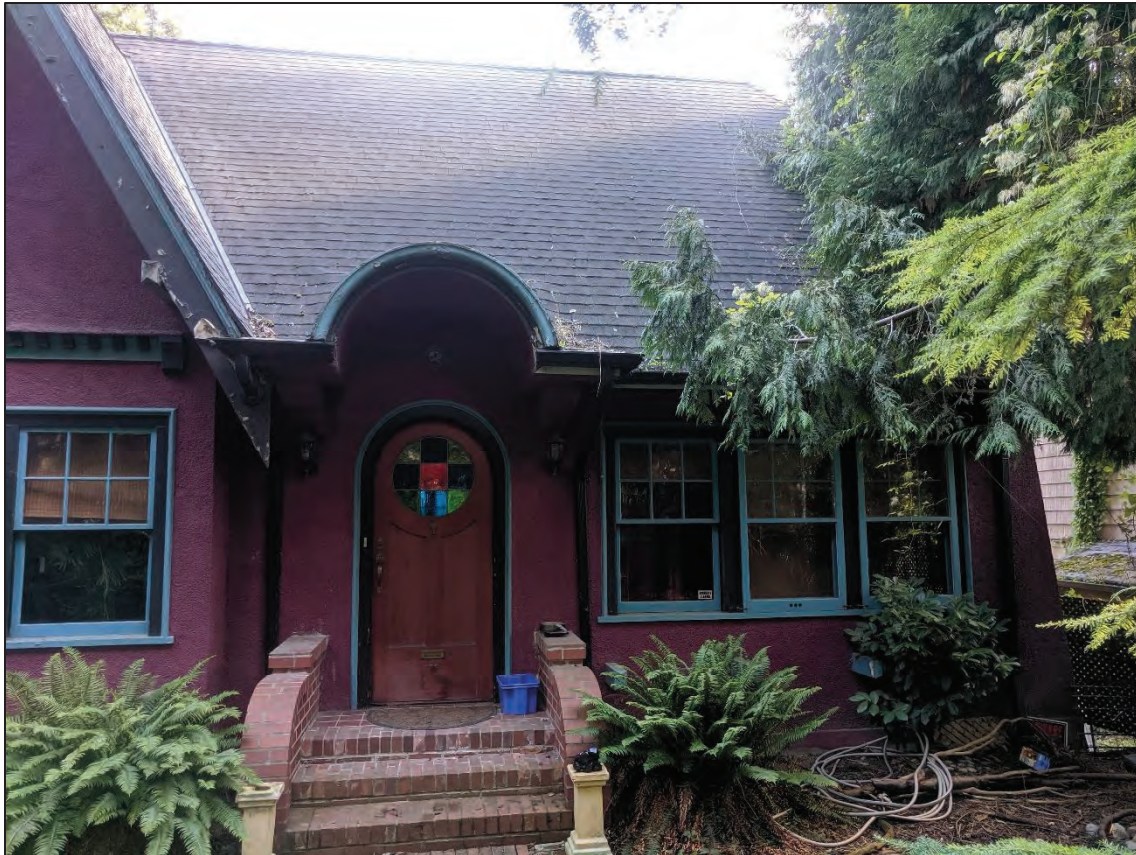
Fig. 10: Partial front view of Henderson House at 112 Royal Avenue, 2019, highlighting the arched roofline over the arched front door with multi coloured stained glass window and the arched brick front stairs, as well as some of the double-hung divided-light wood windows. (Source: Cummer)

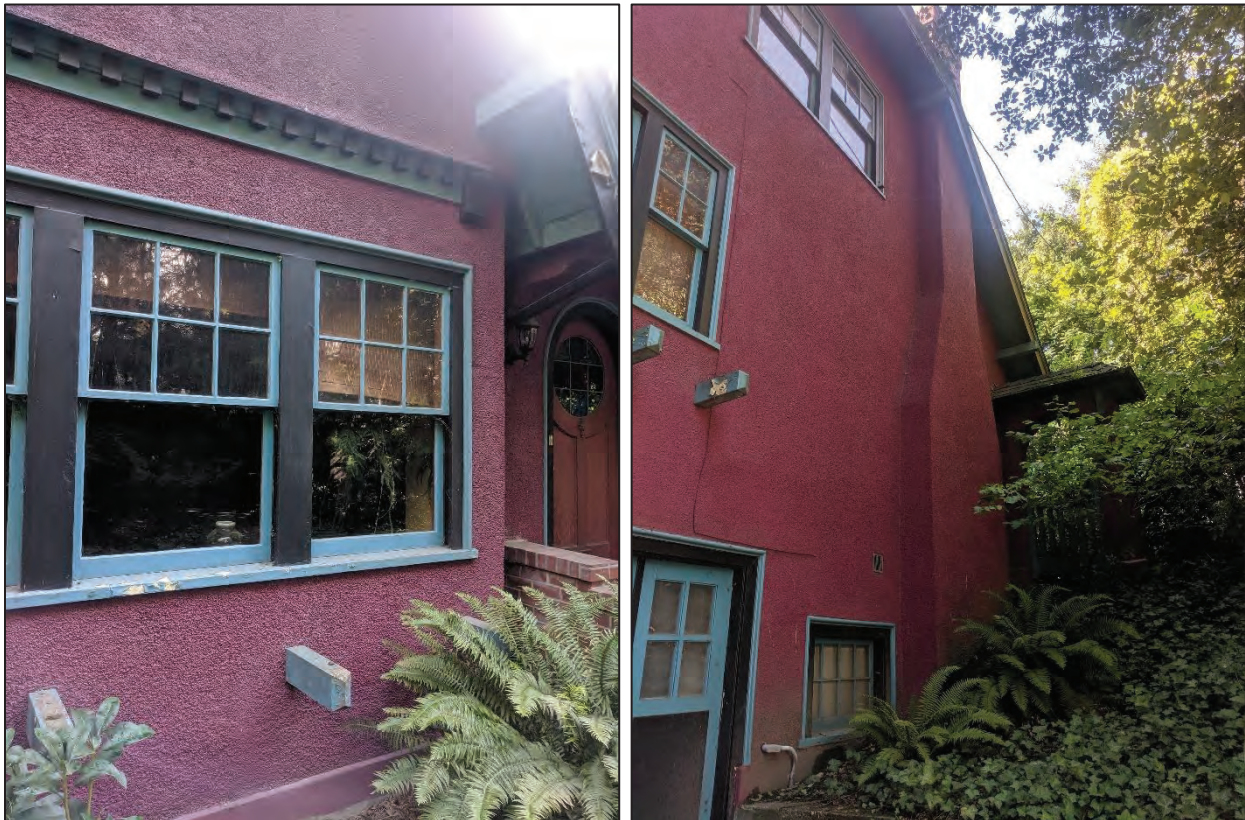
Figs. 13 and 14: Left (Fig. 13) shows a partial view of the front of Henderson House at 112 Royal Avenue, highlighting the overall good condition of the walls and foundation. Right (Fig. 14) shows a partial view of the eastern side, beside Windsor Street, again highlighting the good condition. (Sources: Cummer)

Overall, the condition of the walls and building envelope of Henderson House, from roof to foundation, appears to be good and having aged well. In particular, there are no major cracks visible in either the stuccoed walls or foundation (Figs. 13 and 14). Please note an interior inspection was not conducted. A structural engineer should conduct a thorough investigation of the structure and foundations prior to the house being moved to ensure its structural stability.

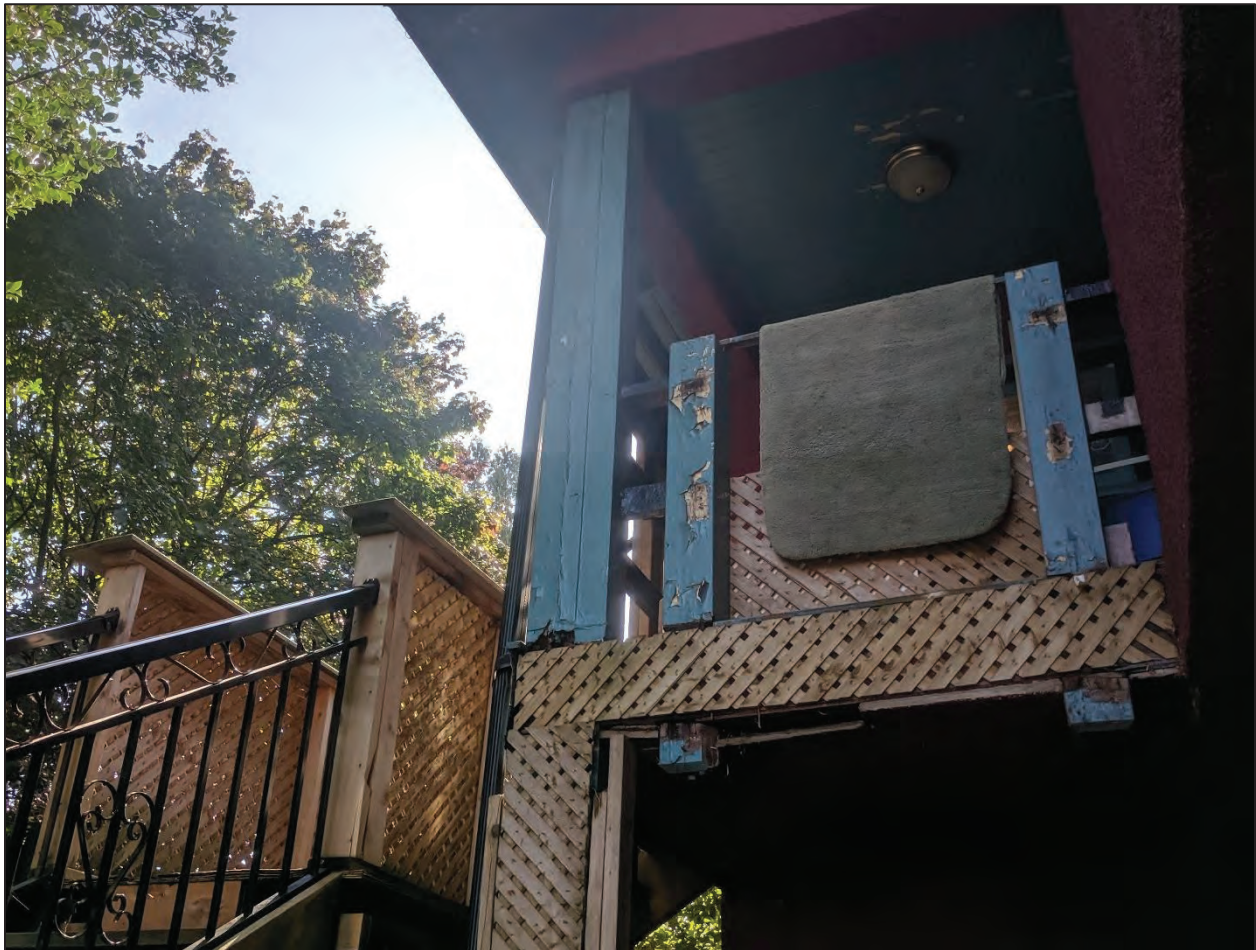
Fig. 15: Southeastern view of the back of Henderson House at 112 Royal Avenue, 2019, illustrating some of the deterioration of the house's back porch. (Source: Cummer)

The visible, exterior wood elements, such as the doors, door frames, roof fascia and windows are, for the most part, in good condition. Any signs of deterioration are largely cosmetic, as illustrated and discussed further in the relevant sections below. That being said, the porch at the back of the house, does appear to be in need of greater repair and maintenance (Fig. 15). However, considering that this back addition will be removed as part of the conservation work, the poorer condition of this aspect of the building is of

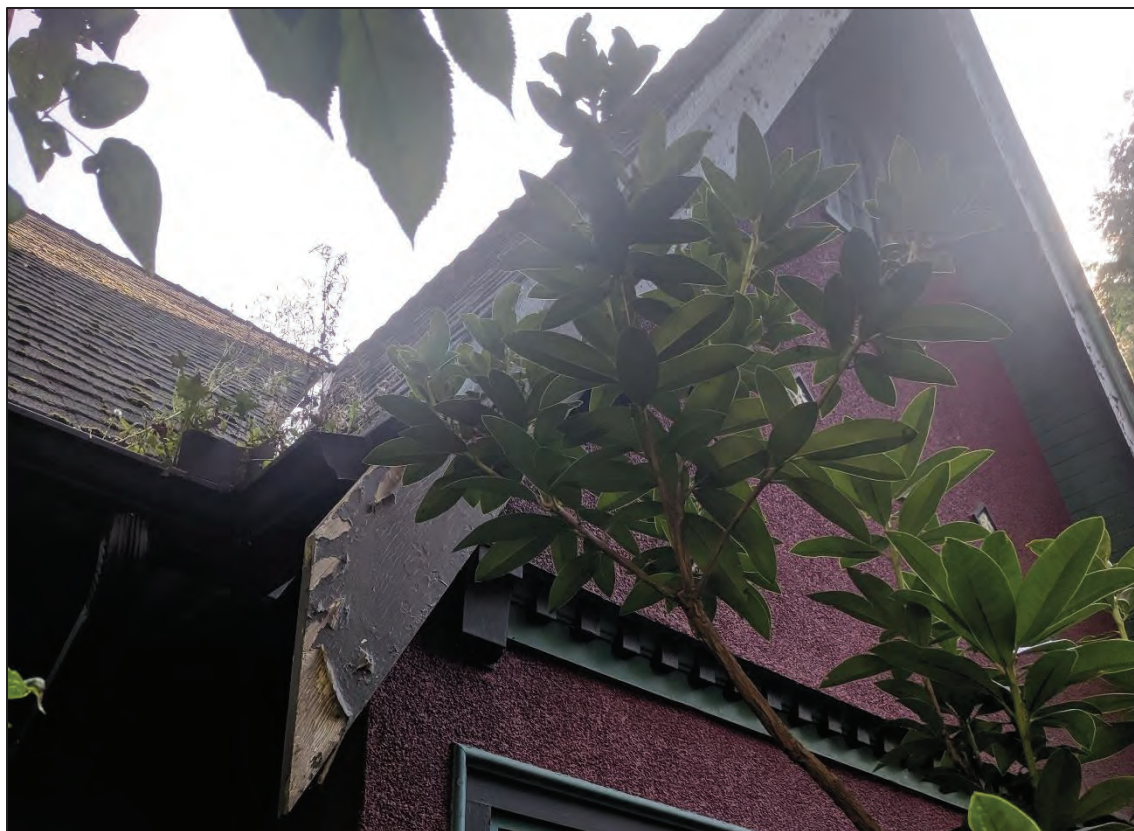
Fig. 16: Northeastern view of Henderson House at 112 Royal Avenue, 2019, illustrating the roof fascia deterioration in the front offset gable, as well as some plant growth in the house's gutters. (Source: Cummer)

Although the roof is in fair condition, overall, there are areas in need of repair and maintenance. As mentioned above, there are fascia boards in need of repainting (Fig. 16) and sections of the roof and gutters in need of cleaning and clearing (Fig. 17).

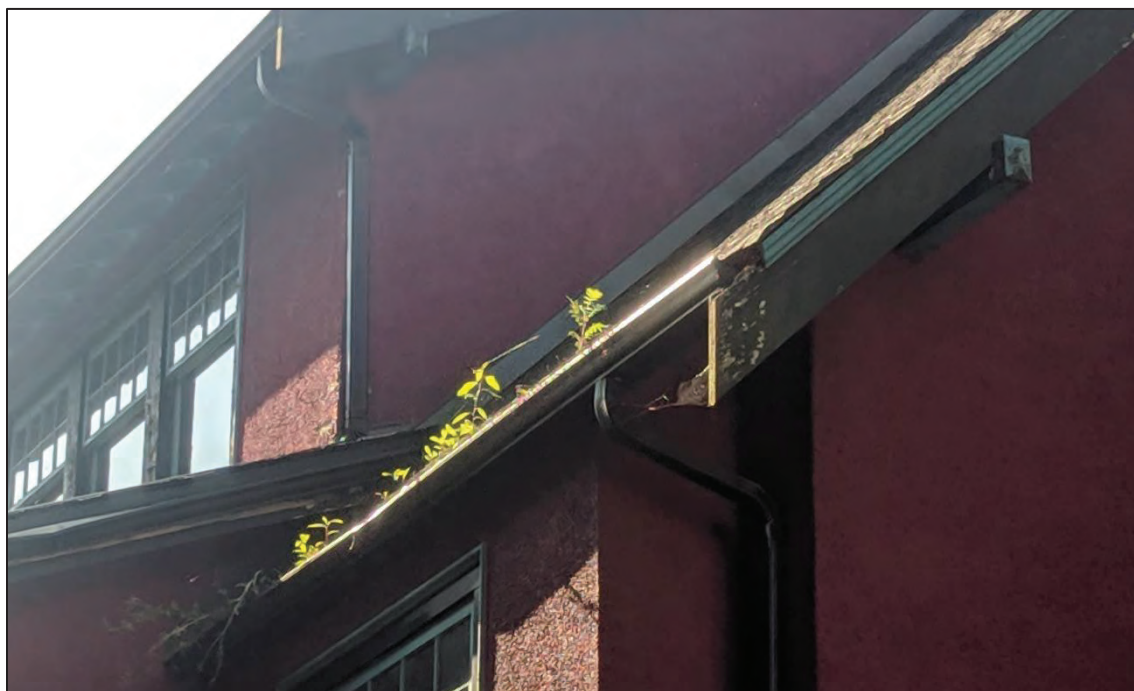
Fig. 17: Southeastern view of Henderson House at 112 Royal Avenue, 2019, illustrating another fascia board deterioration as well as additional plant growth in the house's gutters. (Source: Cummer)
