Memorandum

Subject: 114 and 118 Royal Avenue Demolitions

82 First Street, New Westminster, BC

E. M. N. Woods House ~ 1890

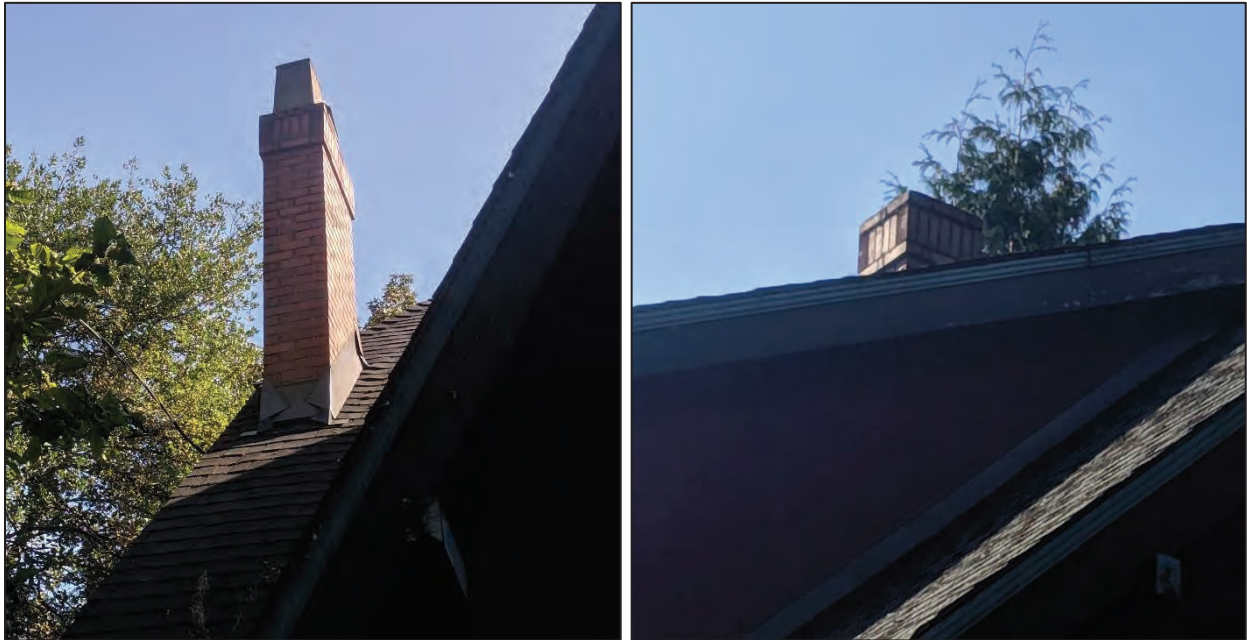
Figs. 18 and 19: Left (Fig. 18) shows the northeastern view of Henderson House at 112 Royal Avenue, 2019, illustrating its well conditioned taller chimney. Right (Fig. 19) shows the smaller chimney located nearer the back, closer to the roof line. (Sources: Cummer)

It appears there are two chimneys currently on the house and they seem, externally, in good condition. On the eastern side of the house, there is a tall and prominent brick chimney stack (Fig. 18) and another smaller one nearer the back, in the middle of the roof line (Fig. 19).

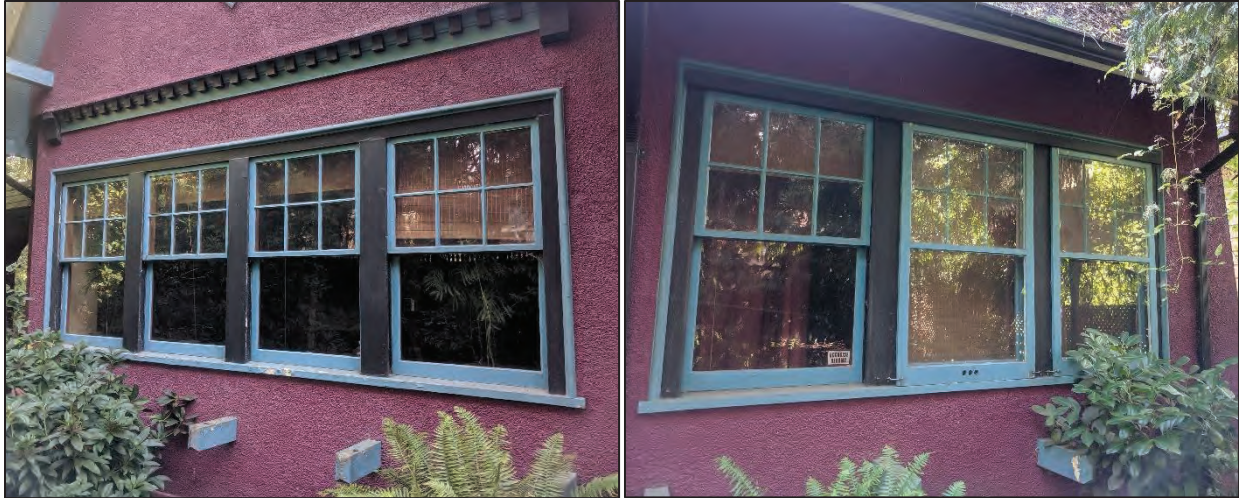
Figs. 20 and 21: Left (Fig. 20) shows the front windows beneath the offset side gable of Henderson House at 112 Royal Avenue, 2019. Right (Fig. 21) shows the front windows on the other side of the front door (the western side of the building). All appear to be in good condition. Note the visible supports of where the window boxes used to be. (Sources: Cummer)

Considering the age of the building, the windows and doors are in quite good condition (Figs. 20 to 26). The only condition concerns appear to be cosmetic with paint peeling in places. Most (if not all) of the windows (their frames, sashes and hardware) appear to be the original ones from 1930, particularly the double-hung divided-light wood windows. The arched wooden front door, with round multi-coloured stained-glass window, also appears to be original and in good condition (Fig. 27), as do the other doors on the property, including the four-panel set of doors along the eastern façade (Fig. 28).

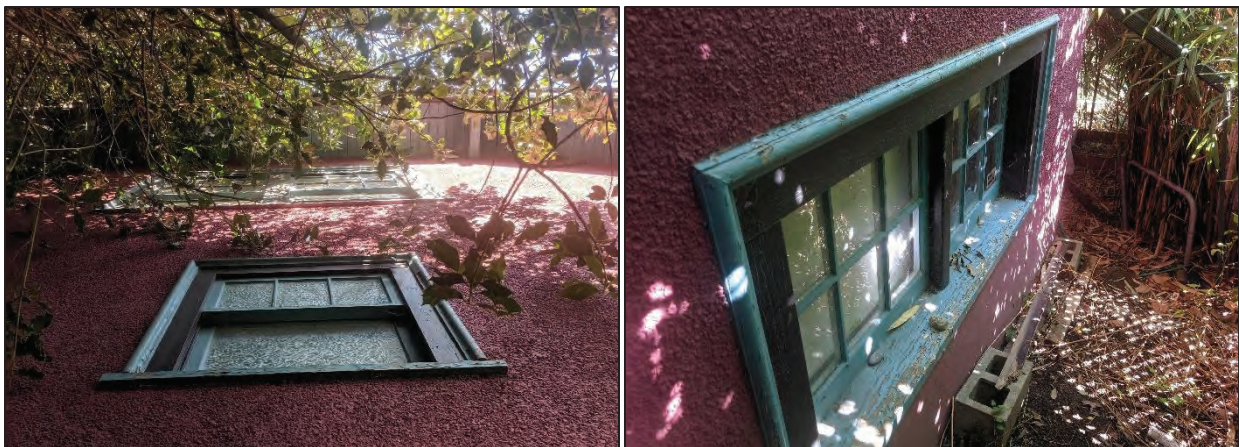
Figs. 22 and 23: Left (Fig. 22) shows a frosted double-hung, divided-light wood window along the western side of the building. Right (Fig. 23) shows a lower window along the same side with visible paint peeling. (Sources: Cummer)

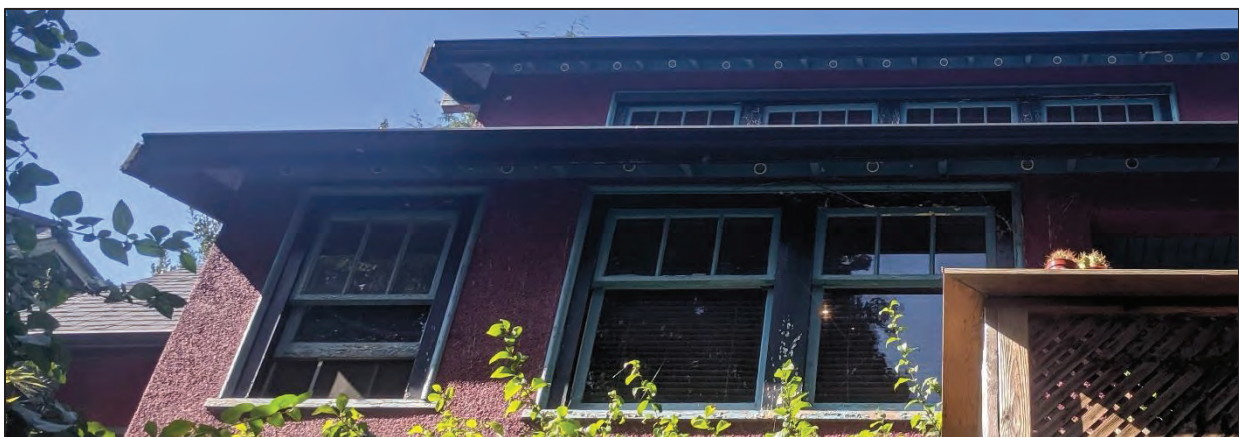
Fig. 24: Shows the windows at the back of Henderson House at 112 Royal Avenue, 2019. (Source: Cummer)

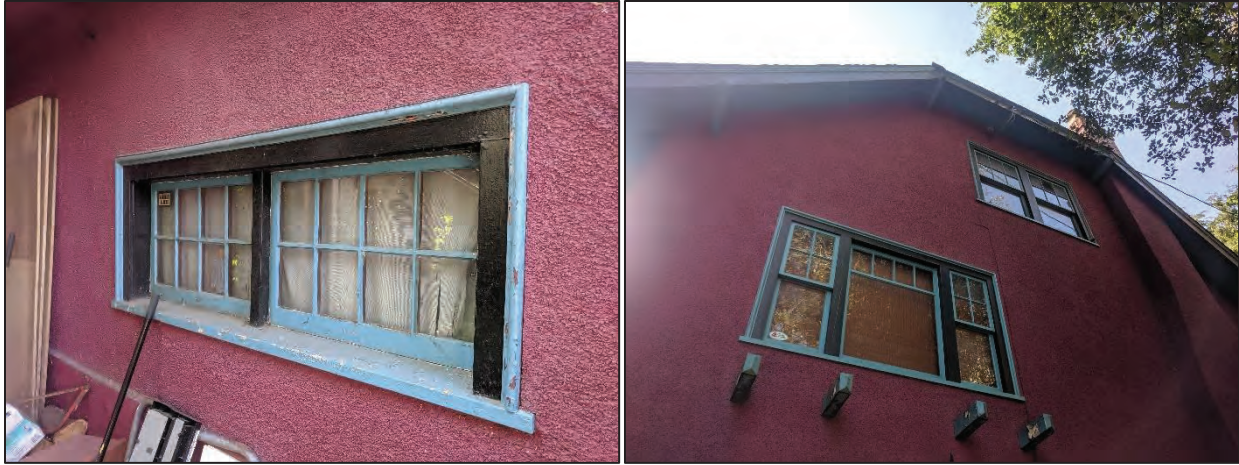
Figs. 25 and 26: Left (Fig. 25) shows a divided-light wood window at the back of Henderson House at 112 Royal Avenue, 2019, illustrating some deterioration. Right (Fig. 26) shows the eastern side of the property and its double-hung, divided-light wood windows. Again, note the supports for the missing window boxes. (Sources: Cummer)

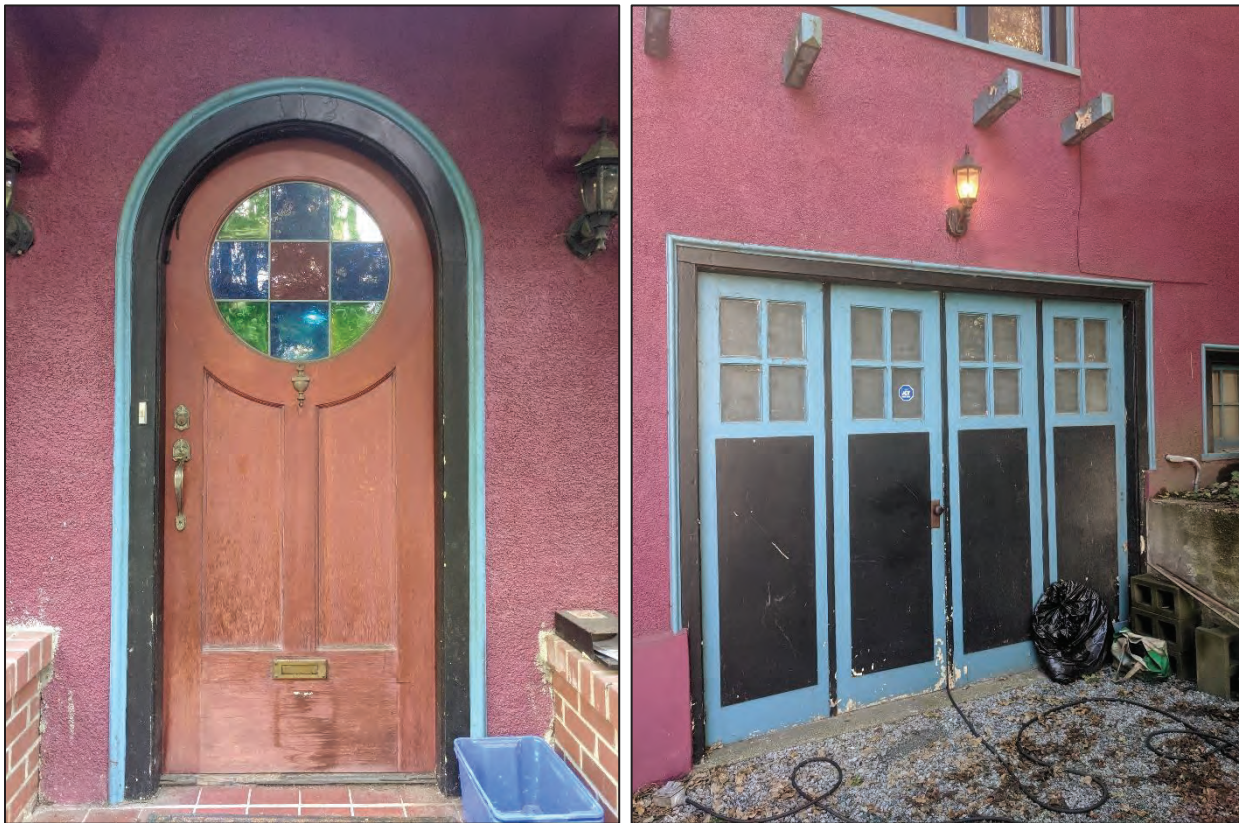
Figs. 27 and 28: Left (Fig. 27) shows the front door of Henderson House at 112 Royal Avenue, 2019, illustrating its largely good condition, minus some weathering at the bottom of the door, along with its intact, multi-coloured stained-glass window. Right (Fig. 28) shows the four-panel set of doors along the eastern façade of the house. It is also in good condition, minus some paint peeling near the bottom of some of the panels. (Sources: Cummer)

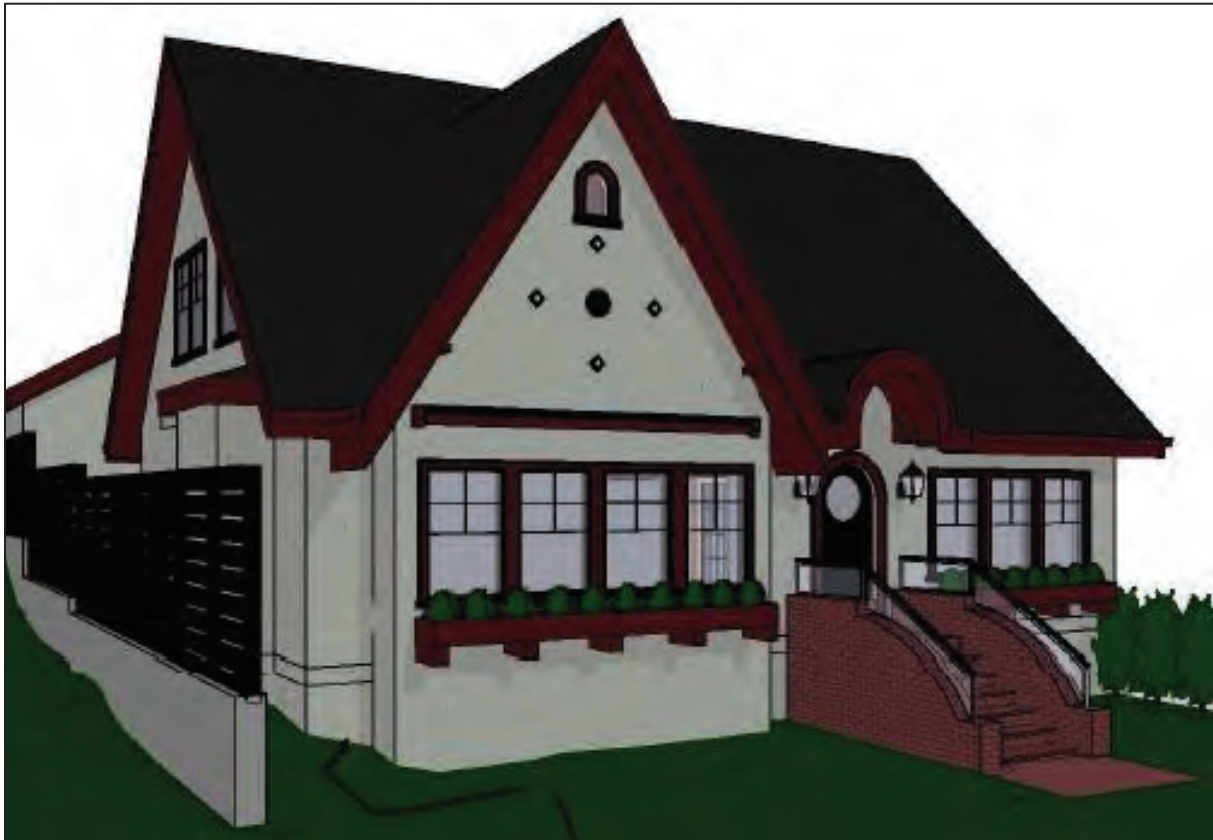
Fig. 29: Rendering of the restored front façade of Henderson House, 2020, including the restored window boxes. Note the extended height for the basement, and the resultant extended front staircase, still maintaining its brick and arched form. (Source: D3 Dimension, Drafting and Design Inc.)

- 1) Moving the house to a new location within New Westminster;
- 2) Extending the basement height;
- 3) Preserving, but extending the arched front stairs (Fig. 29); and
- 4) Removing the back-porch addition (Fig. 30).

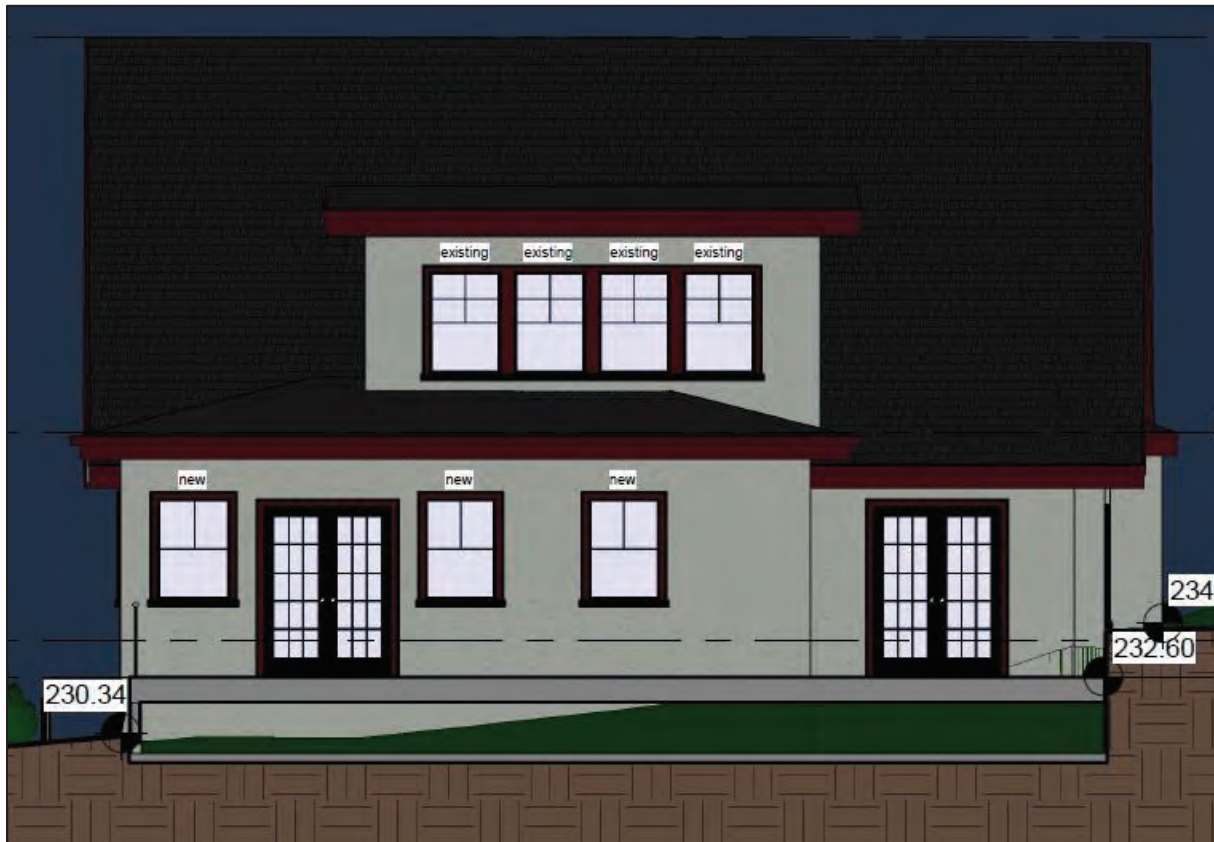
Fig. 30: Rendering of the restored rear façade of Henderson House, 2020. Note the removed back-porch. (Source: D3 Dimension, Drafting and Design Inc.)

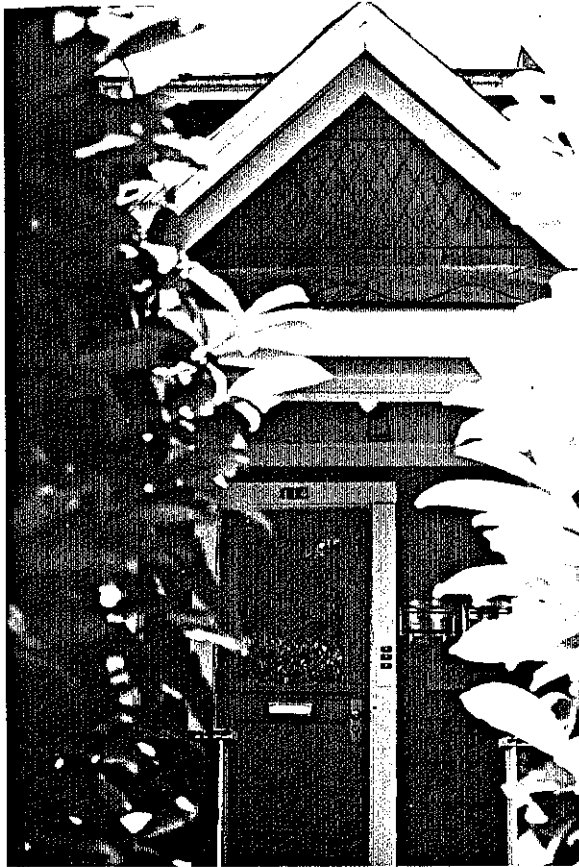
52. 114 Royal Avenue
(1944)

The rear side view of 114 Royal Avenue is similar to 112 Royal Avenue. Both period revival homes have side gabled chamfered roof lines, and rear shed dormers. 114 Royal Avenue with its blue shingle and clapboard exterior, and pedimented porch with leaded glass windows was the residence of the J. G. Gibson family and was built in 1944.

Period Revival Style
