### **Stantec Memo on Temporary Trail Options**

**Reference: Glenbrook Combined Sewer Overflow Gate Replacement - Temporary Trails Conceptual Design**

Stantec was retained by Metro Vancouver (MV) to provide engineering services for the *Glenbrook Combined Sewer Overflow Gate Replacement Project* (the Project) in New Westminster. The Project involves the replacement of the combined sewer overflow (CSO) chamber gate on the New Westminster Interceptor sewer (NWI), located within Glenbrook Ravine Park. Because the sewer is active, the replacement of this CSO gate requires that the sewer be bypassed to allow safe access to the gate while maintaining service.

RE: Arborist Report - Glenbrook CSO Gate Replacement Project  
Temporary Pathway Tree-Impact Assessment

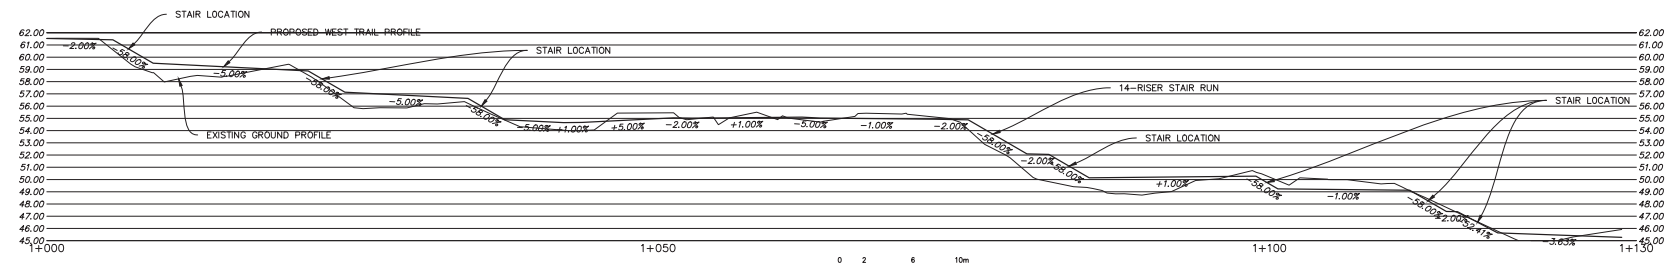
PROFILE  
H 1:200 V 1:200

NEW WESTMINSTER INTERCEPTOR  
GLENBROOK DIVERSION  
GLENBROOK COMBINED SEWER  
OVERFLOW GATE REPLACEMENT  
WEST TRAIL PLAN & PROFILE

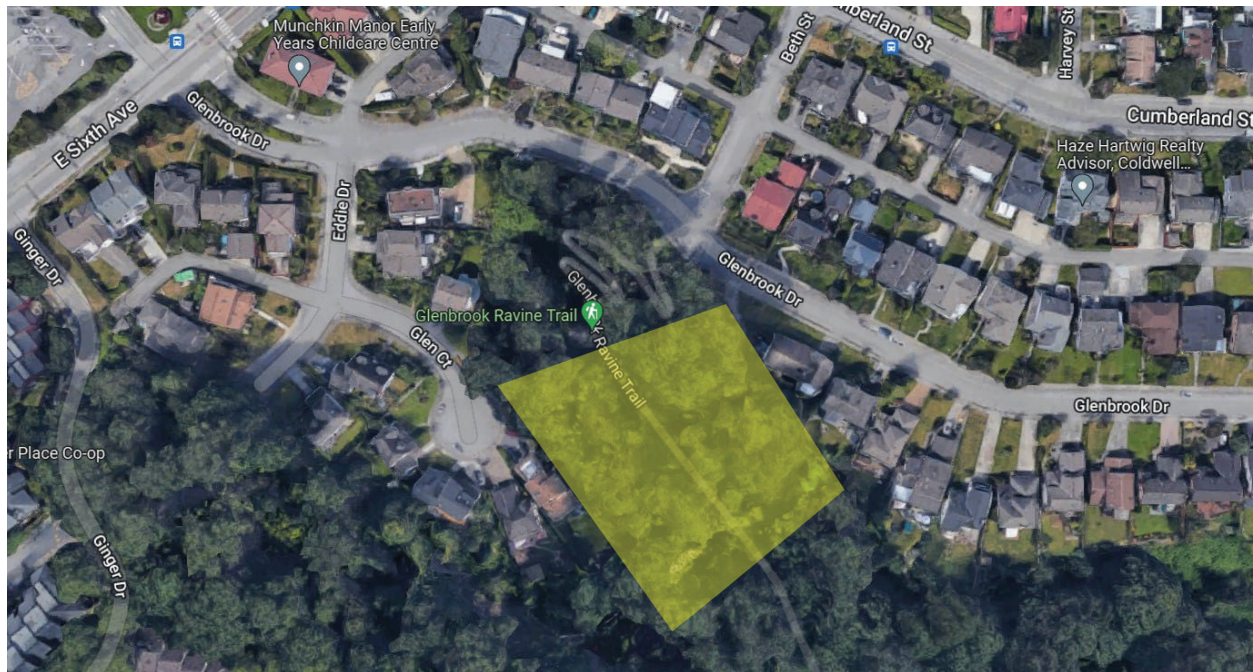
Figure 1: Context – Study Area at North End of Glenbrook Ravine in New Westminister

This arborist report relates to trees located at the north end of the Glenbrook Ravine in New Westminister. Specifically, trees are examined within the study area (Fig.1) associated with the Glenbrook CSO Gate Replacement project led by Metro Vancouver. This report examines tree impacts in consideration of two possible temporary trails to accommodate access to the north end of the ravine system. Trail 'A' is located on the west side of the Glenbrook Ravine Trail and impacts forty (40) trees, while Trail 'B' located on the east side of the trail ties into the existing switchback ramp and impacts twenty-three (23) trees. Potential impacts of proposed development activities and associated mitigation recommendations are included to guide tree and forest stewardship decisions.

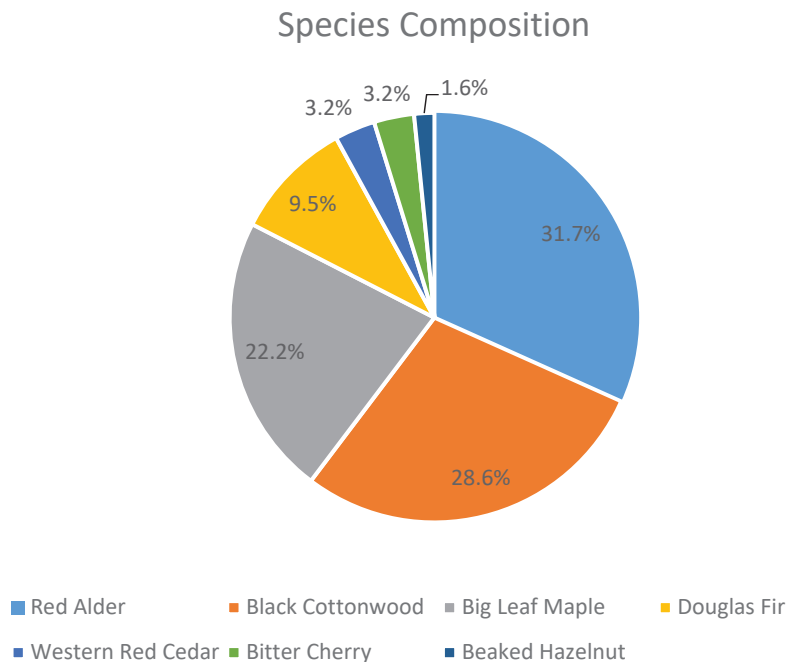
Figure 2: Species Composition (63-Trees inventoried)

There were 63 trees examined in this inventory – forty (40) which were within the footprint and potential construction area of Trail 'A' on the west side of the ravine and twenty-three (23) associated with Trail 'B' on the east side of the ravine. The species composition (Fig.2) is dominated by Red Alder, Black Cottonwood and Big Leaf Maple.

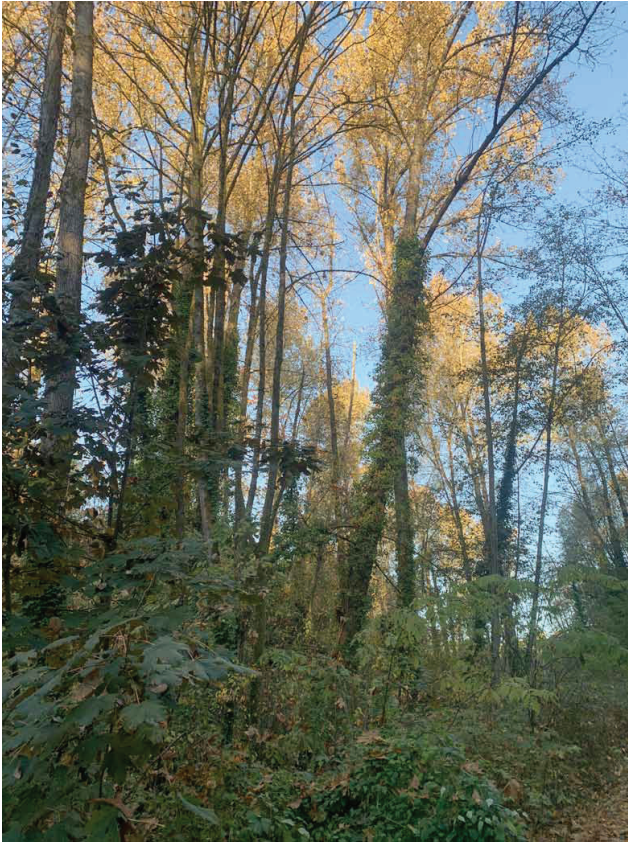
View northwest to tree-covered slope and Trail 'A' path alignment. Note extensive English ivy

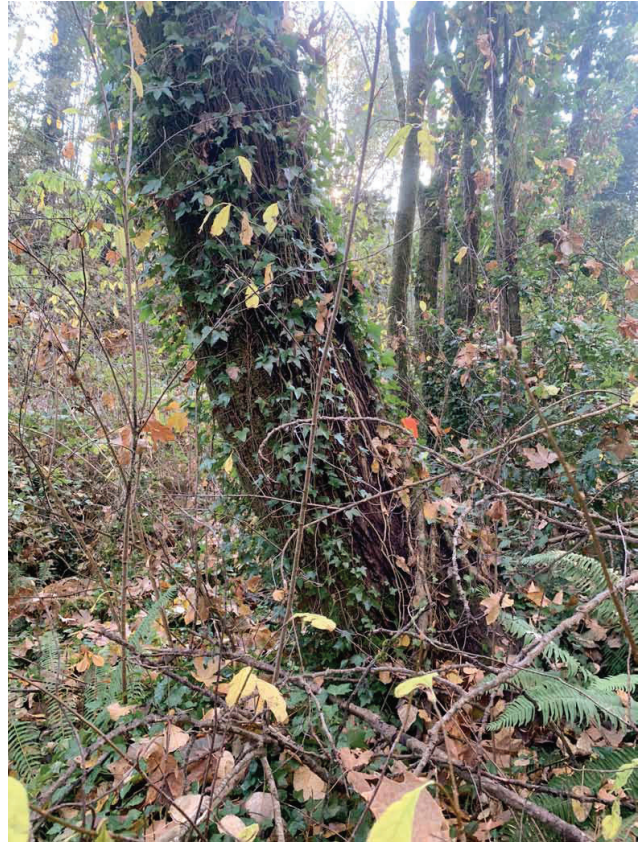
View of base of tree on Trail 'A' alignment. Note extensive groundcovers and understory.

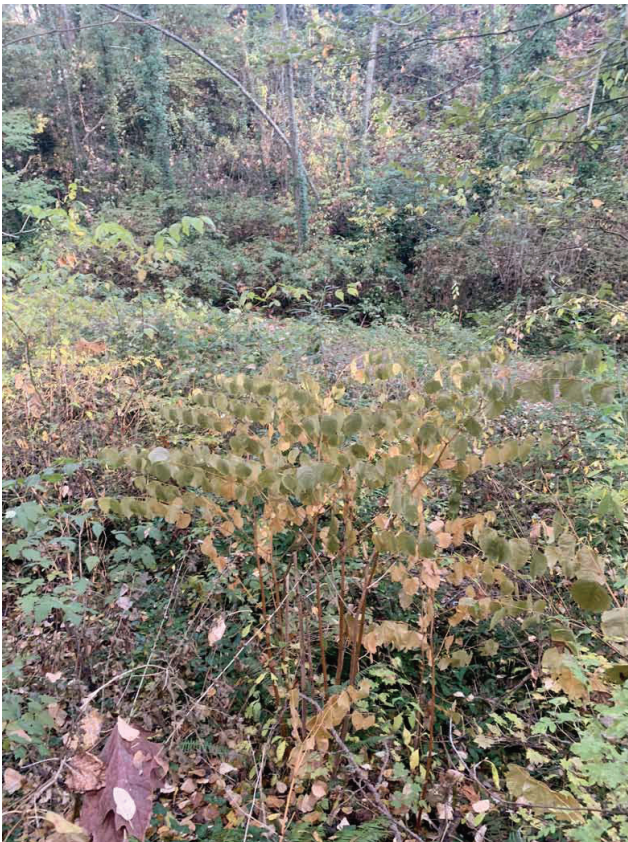
Japanese Knotweed along Trail 'A' alignment

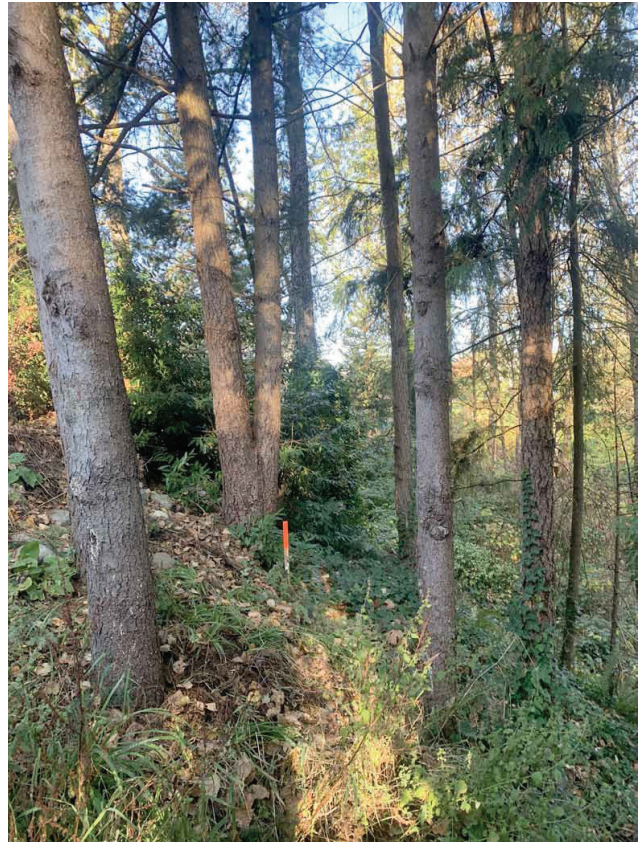
View north toward Tree #33 - #41 at top of slope and west extent of Trail 'A' alignment

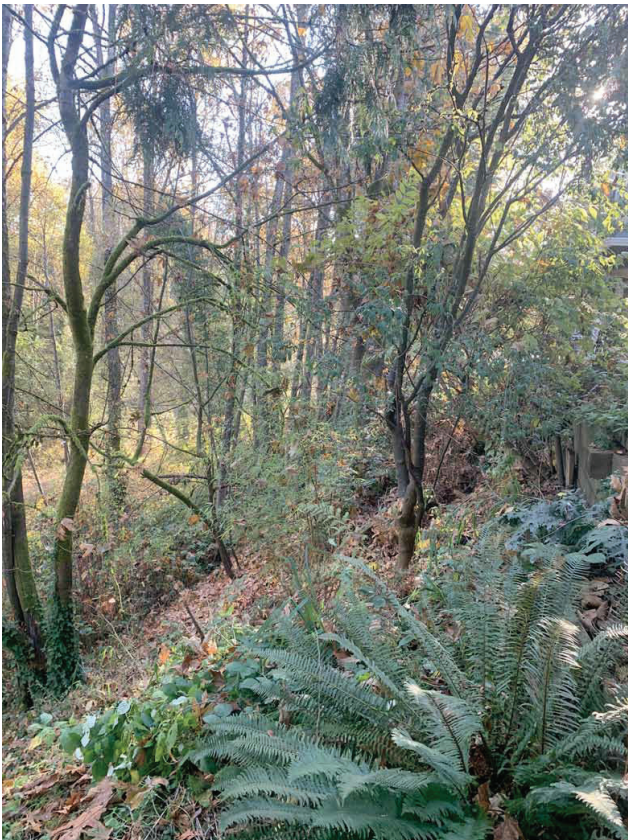
View south along Trail 'A' alignment

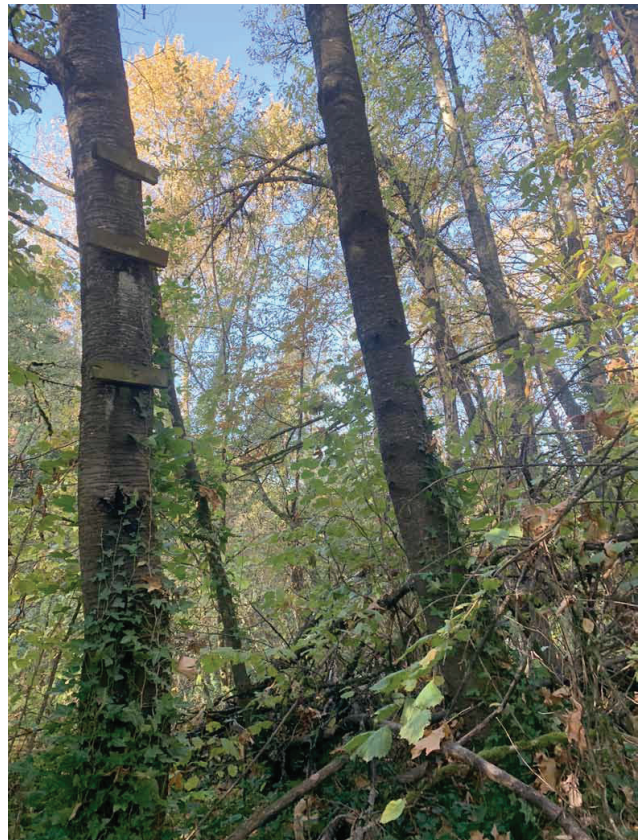
View of Tree #50 & #51 - both Bitter Cherries - along Trail 'B' alignment

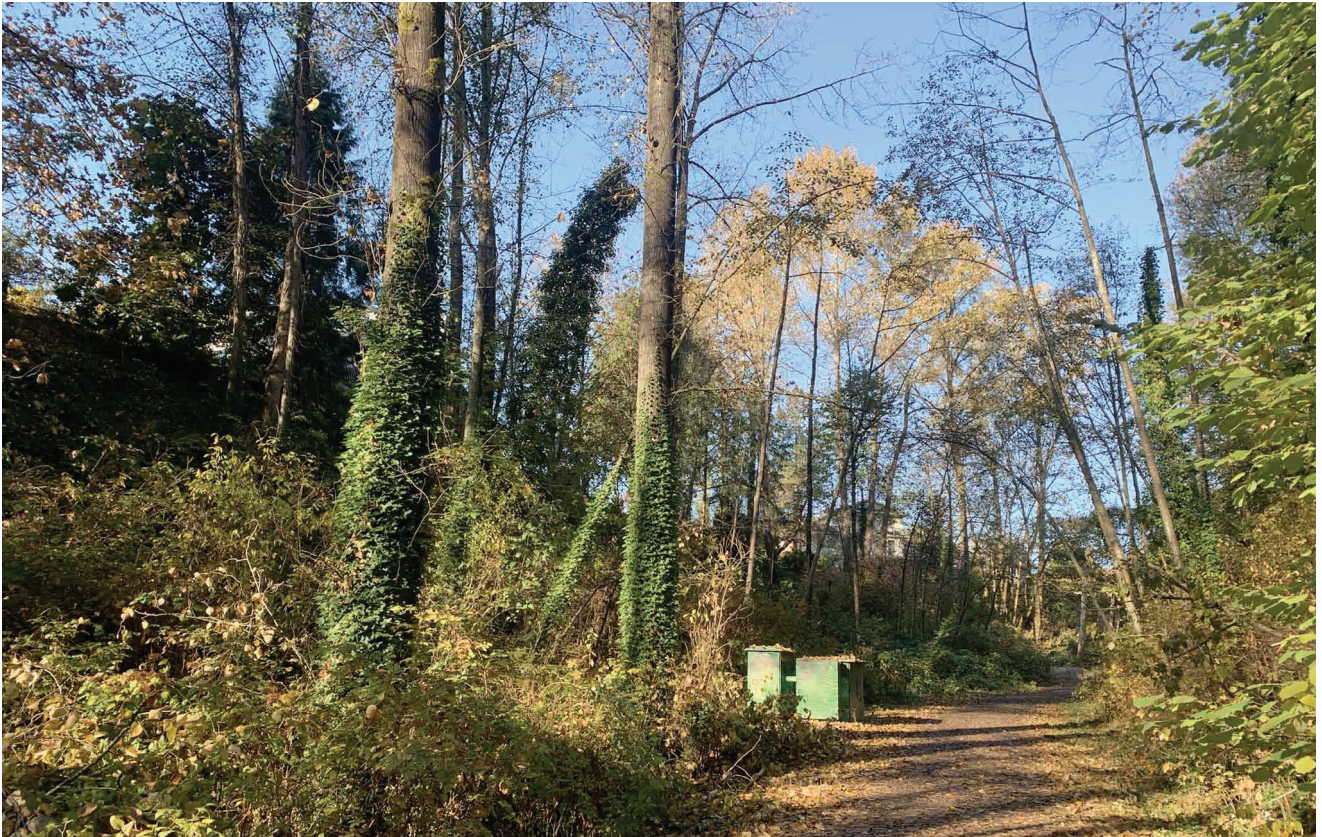
View north along centre of R.O.W. with Trail 'A' alignment on western slope (left image) and Trail 'B' alignment on eastern slope (right edge of image)

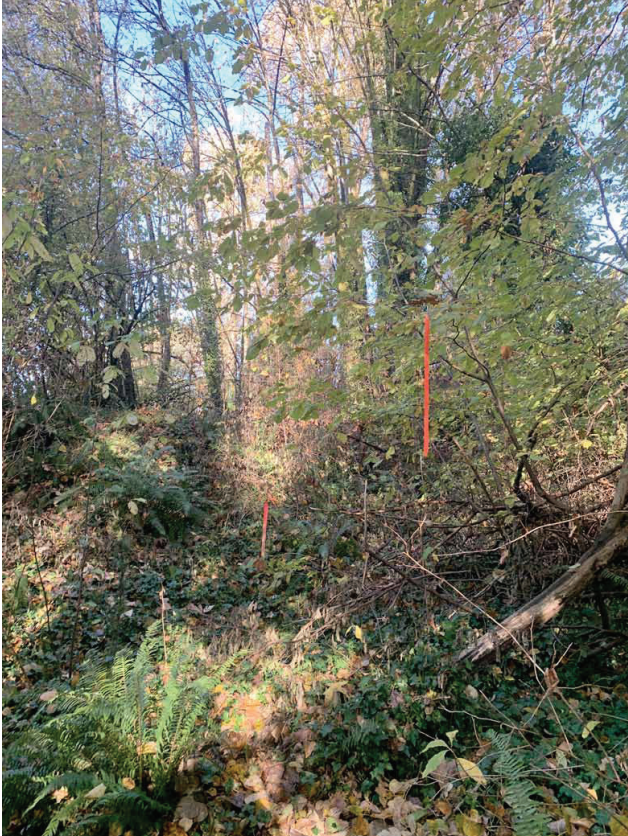
View northeast along Trail 'B' alignment with orange flagging tape demarcating alignment
